Town of Middlebury

Flooding Concerns
July- August 2023

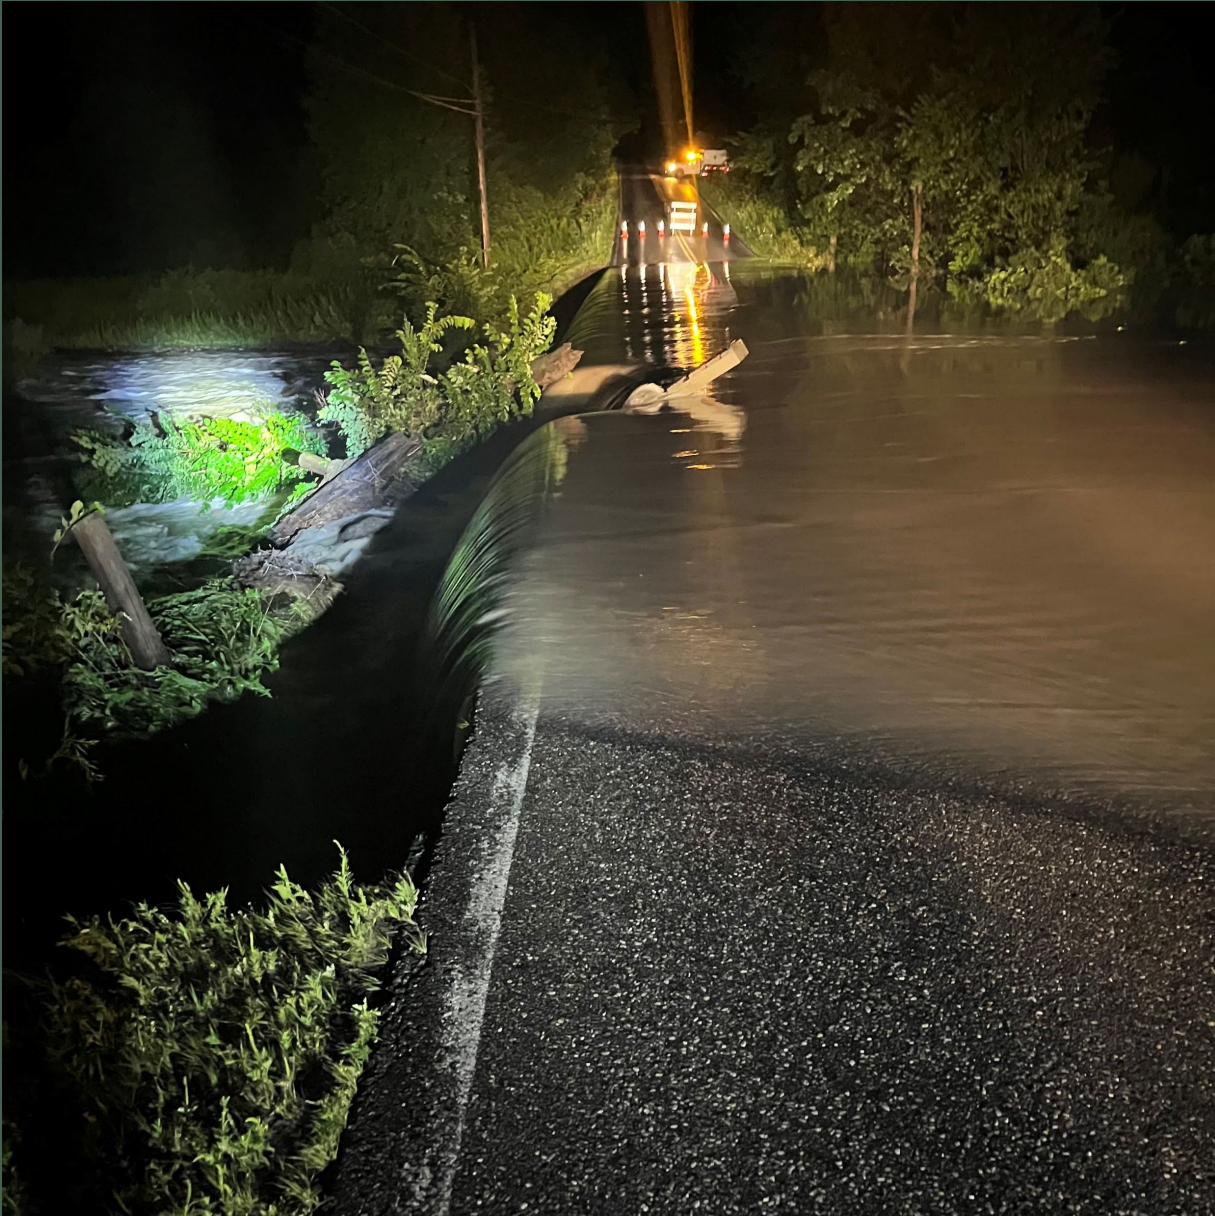
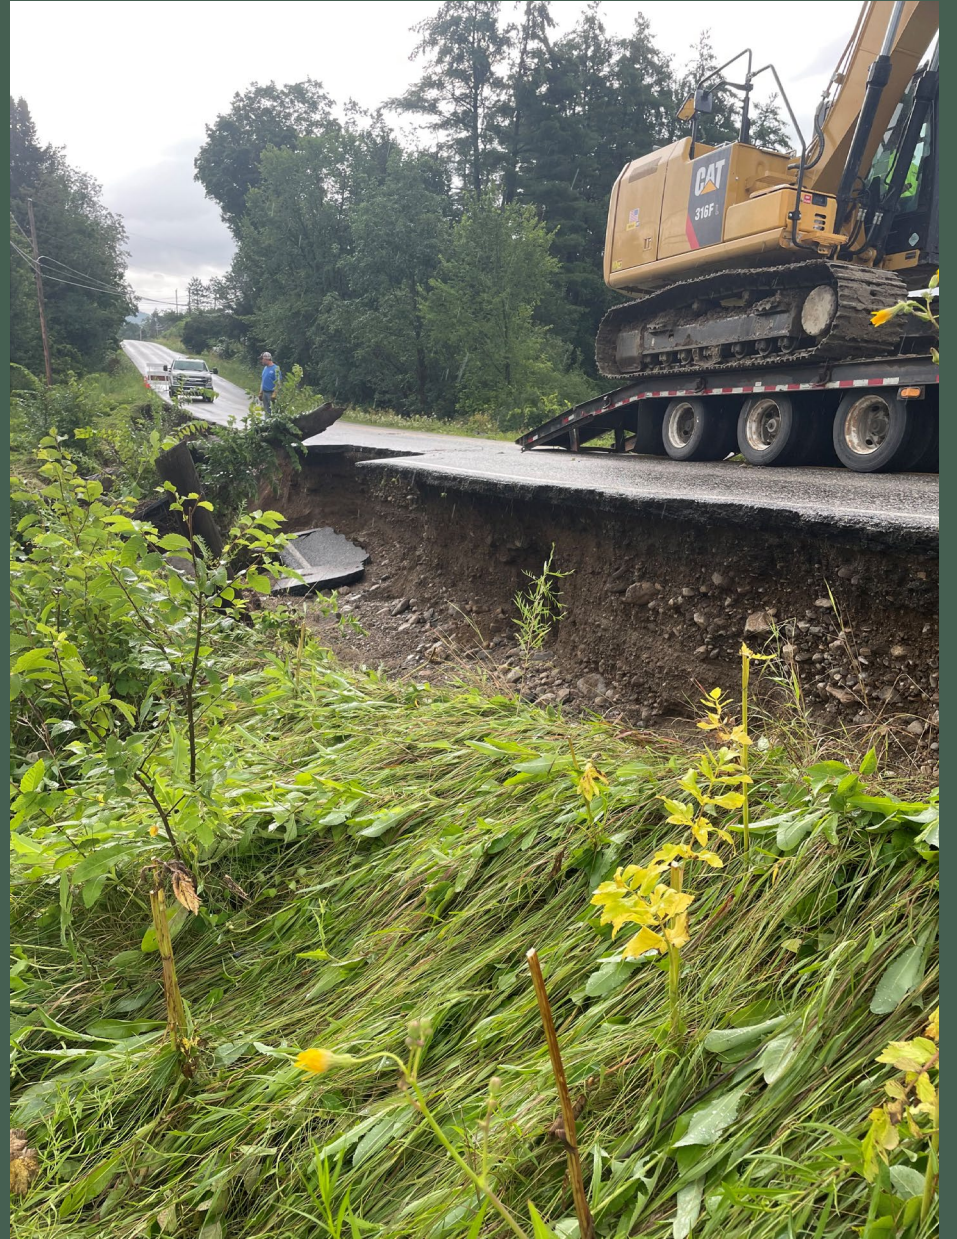
Figures 1 & 2: Shoulder/ Road Failure- Painter Rd.

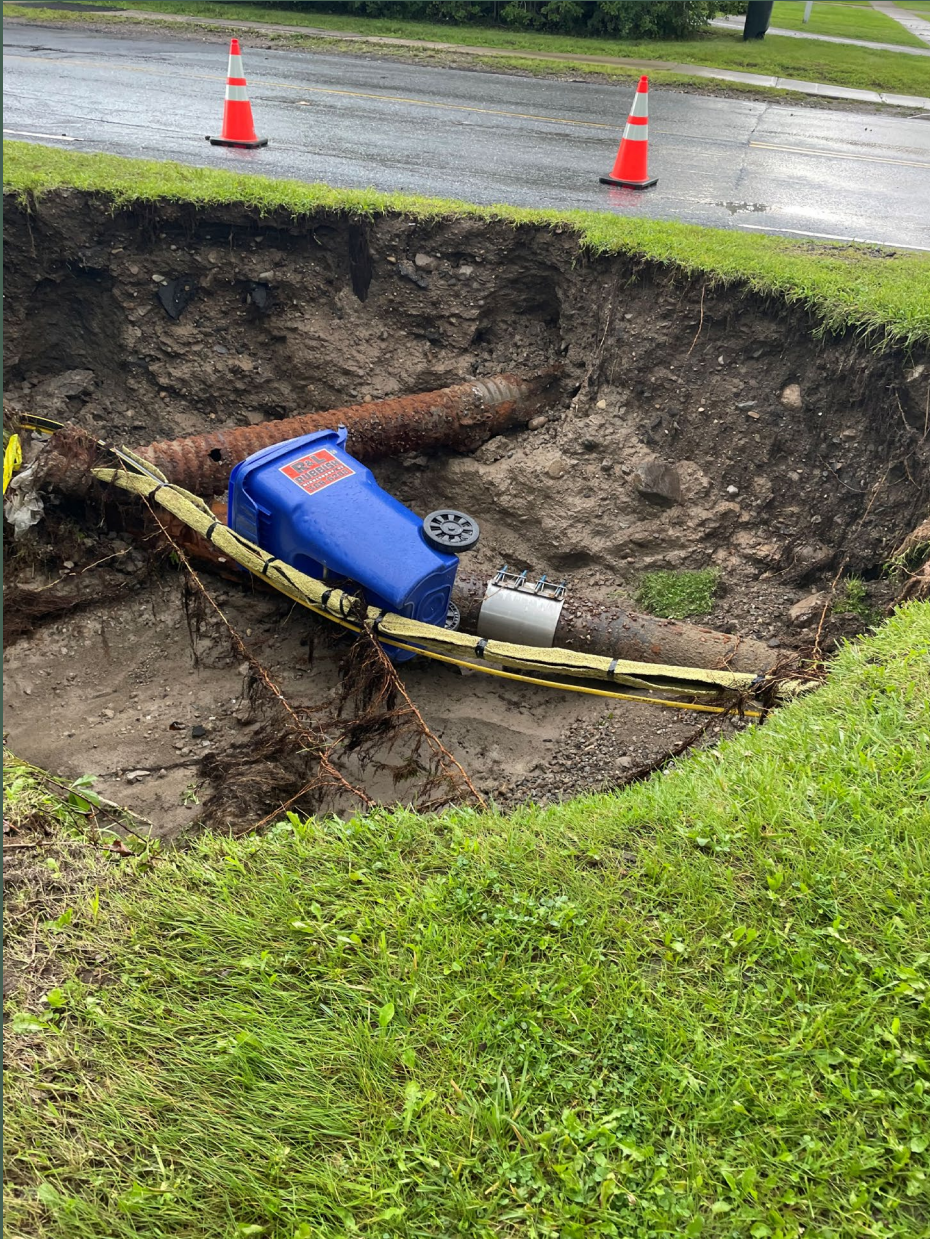
Figure 1: Sinkhole at Maverick Gas Station

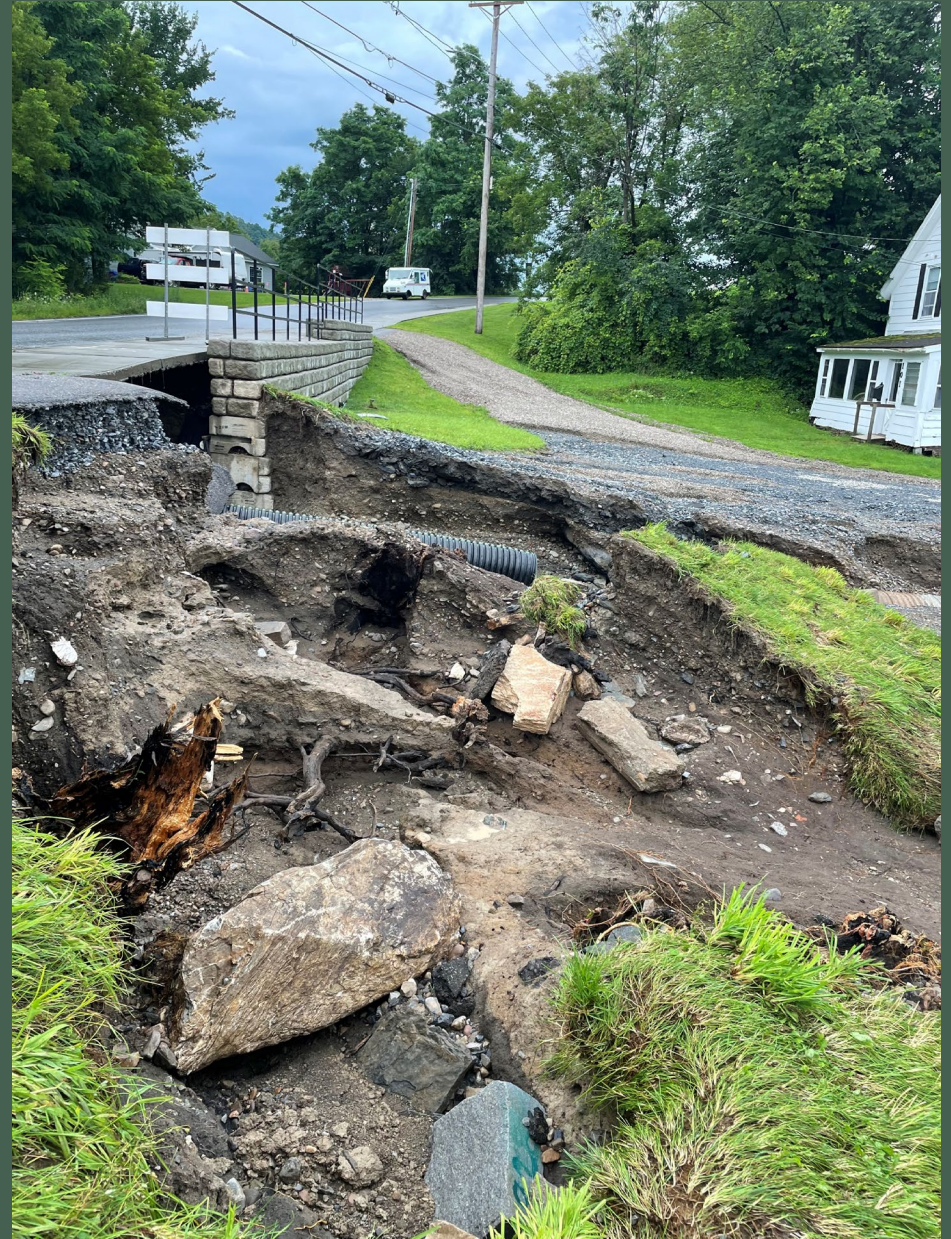
Figure 2: Seymour St- Culvert Failure

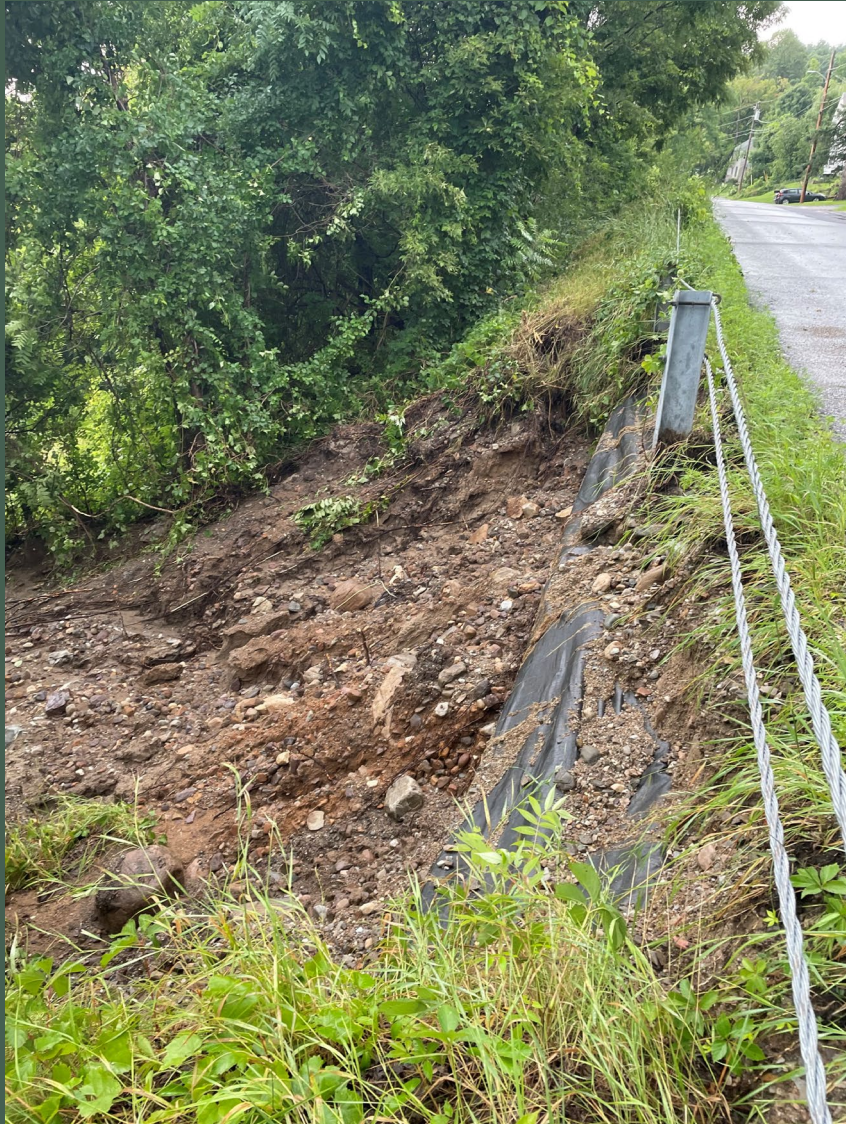
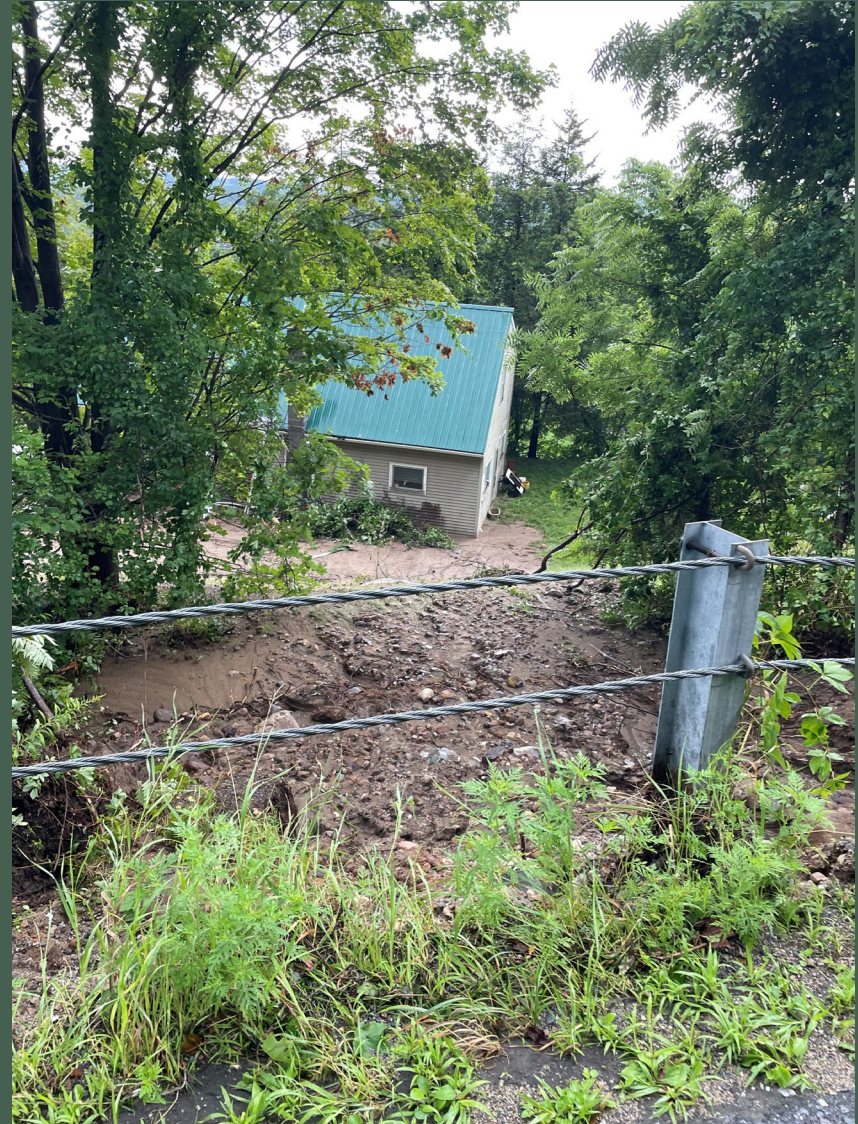
Figures 1 & 2: Landslide on High Street to 77 N. Pleasant.

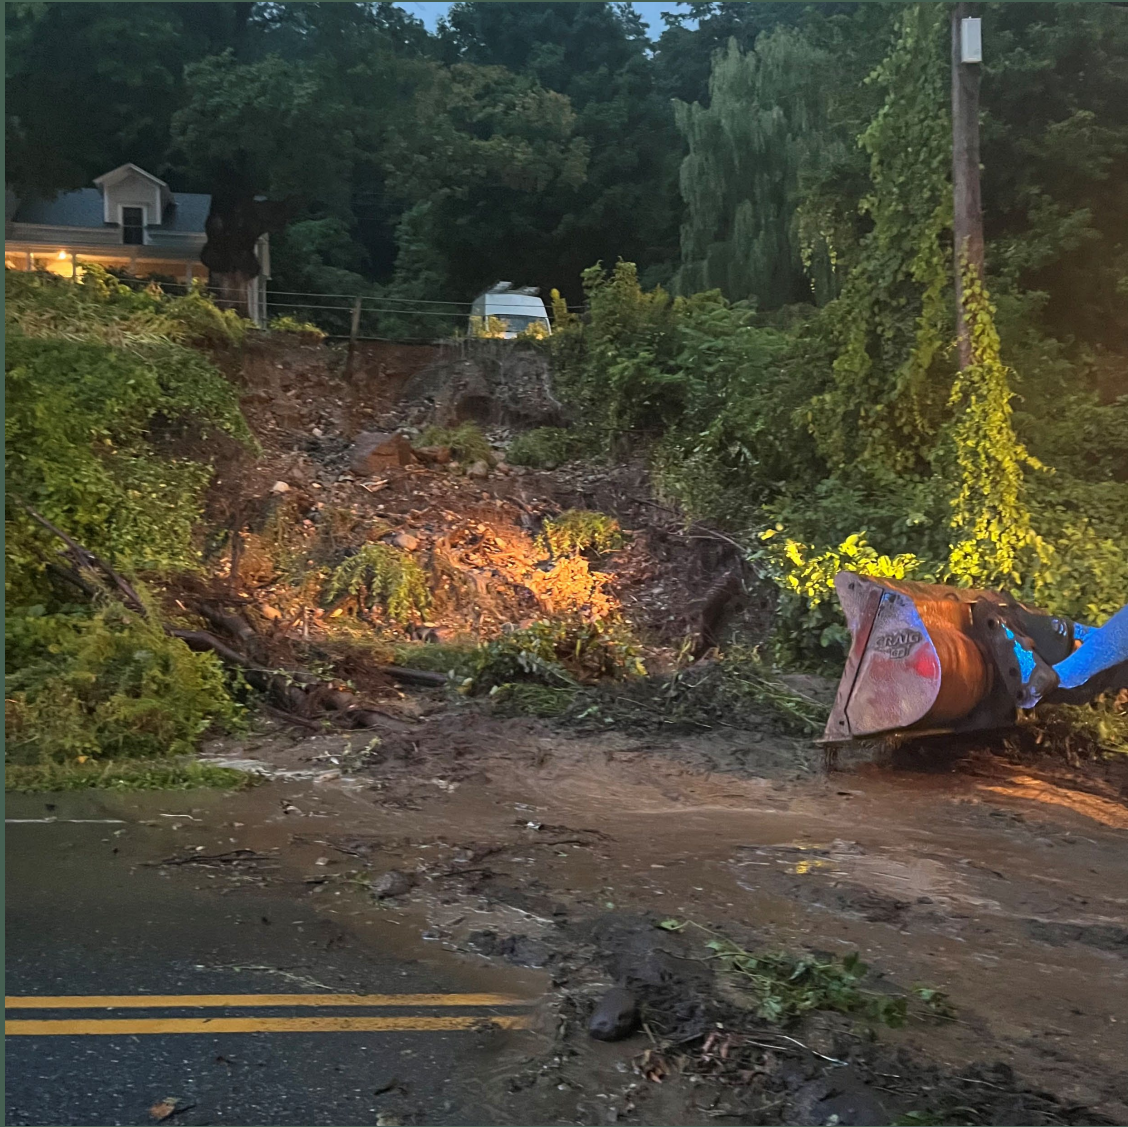
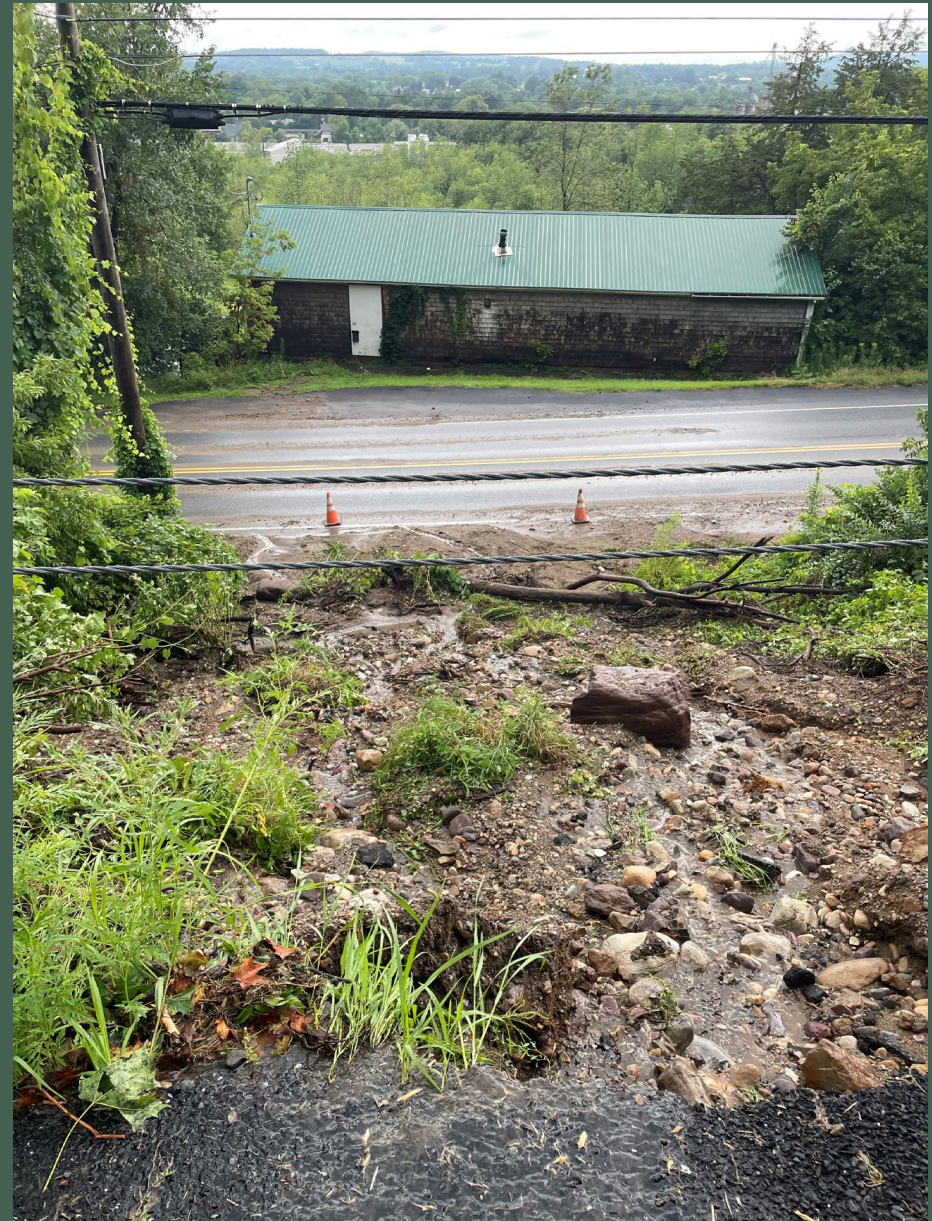
Figures 1& 2: Landslide from High St to N. Pleasant.

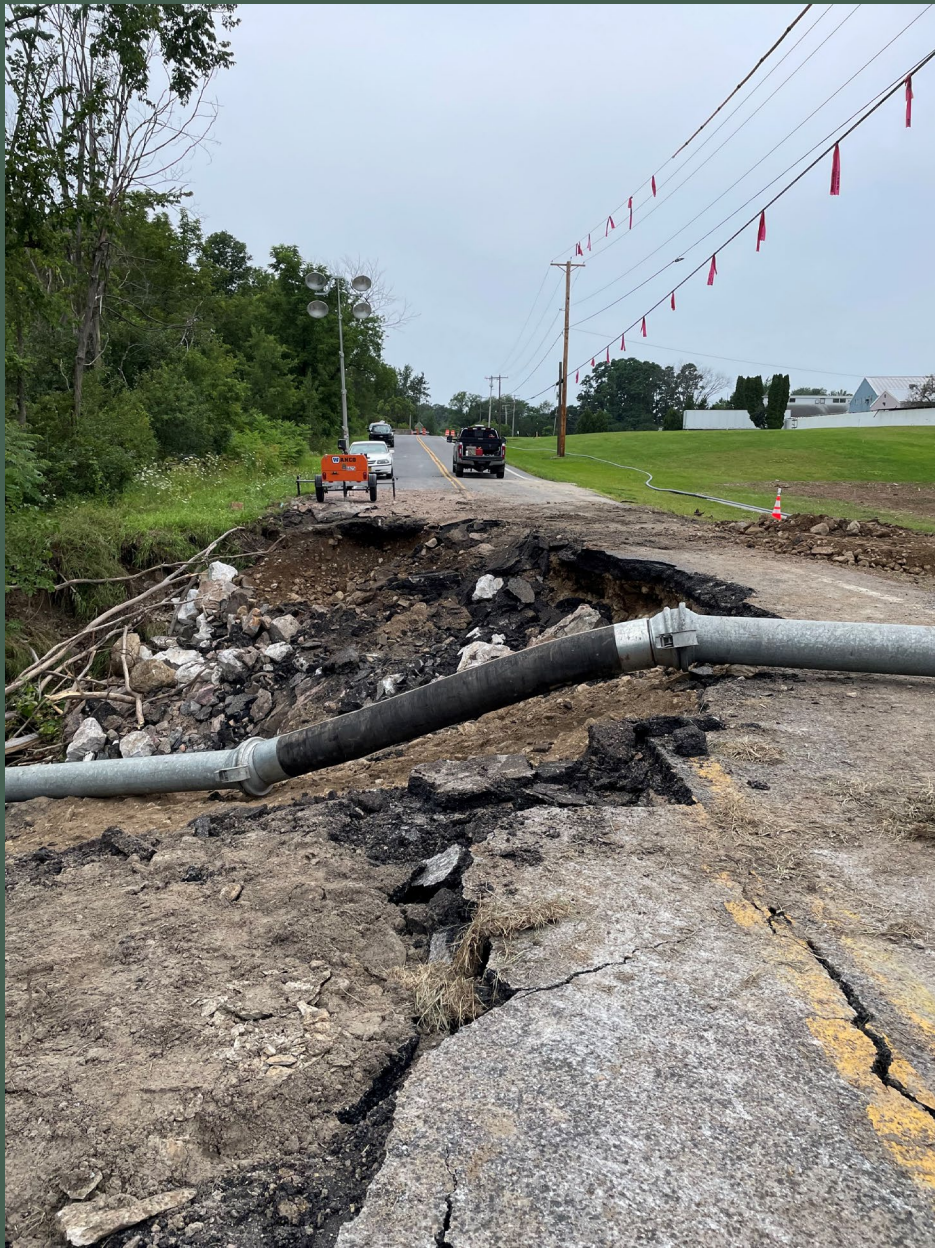
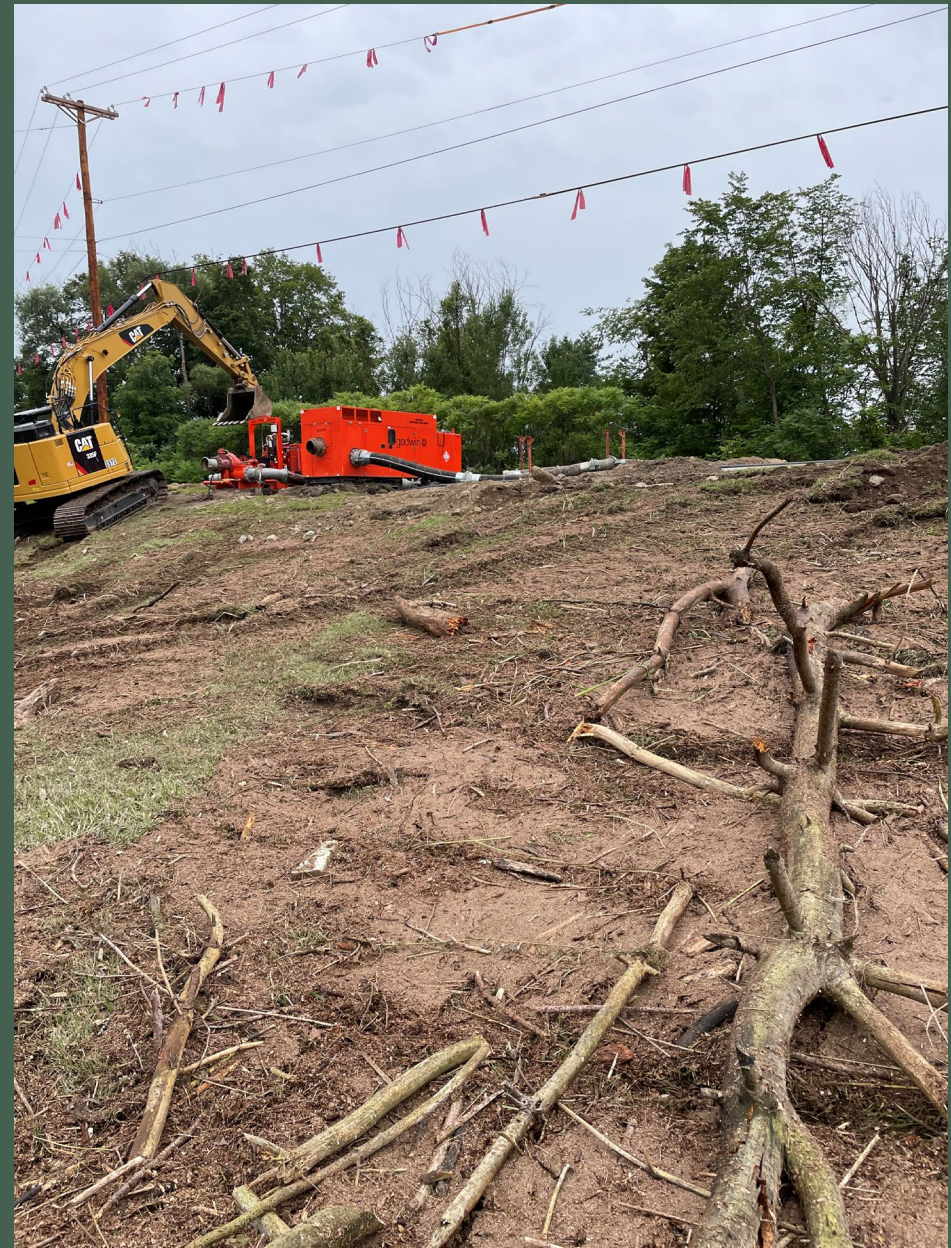
Figures 1& 2: Dow Pond- Water Line Break and Rt. 116 Failure

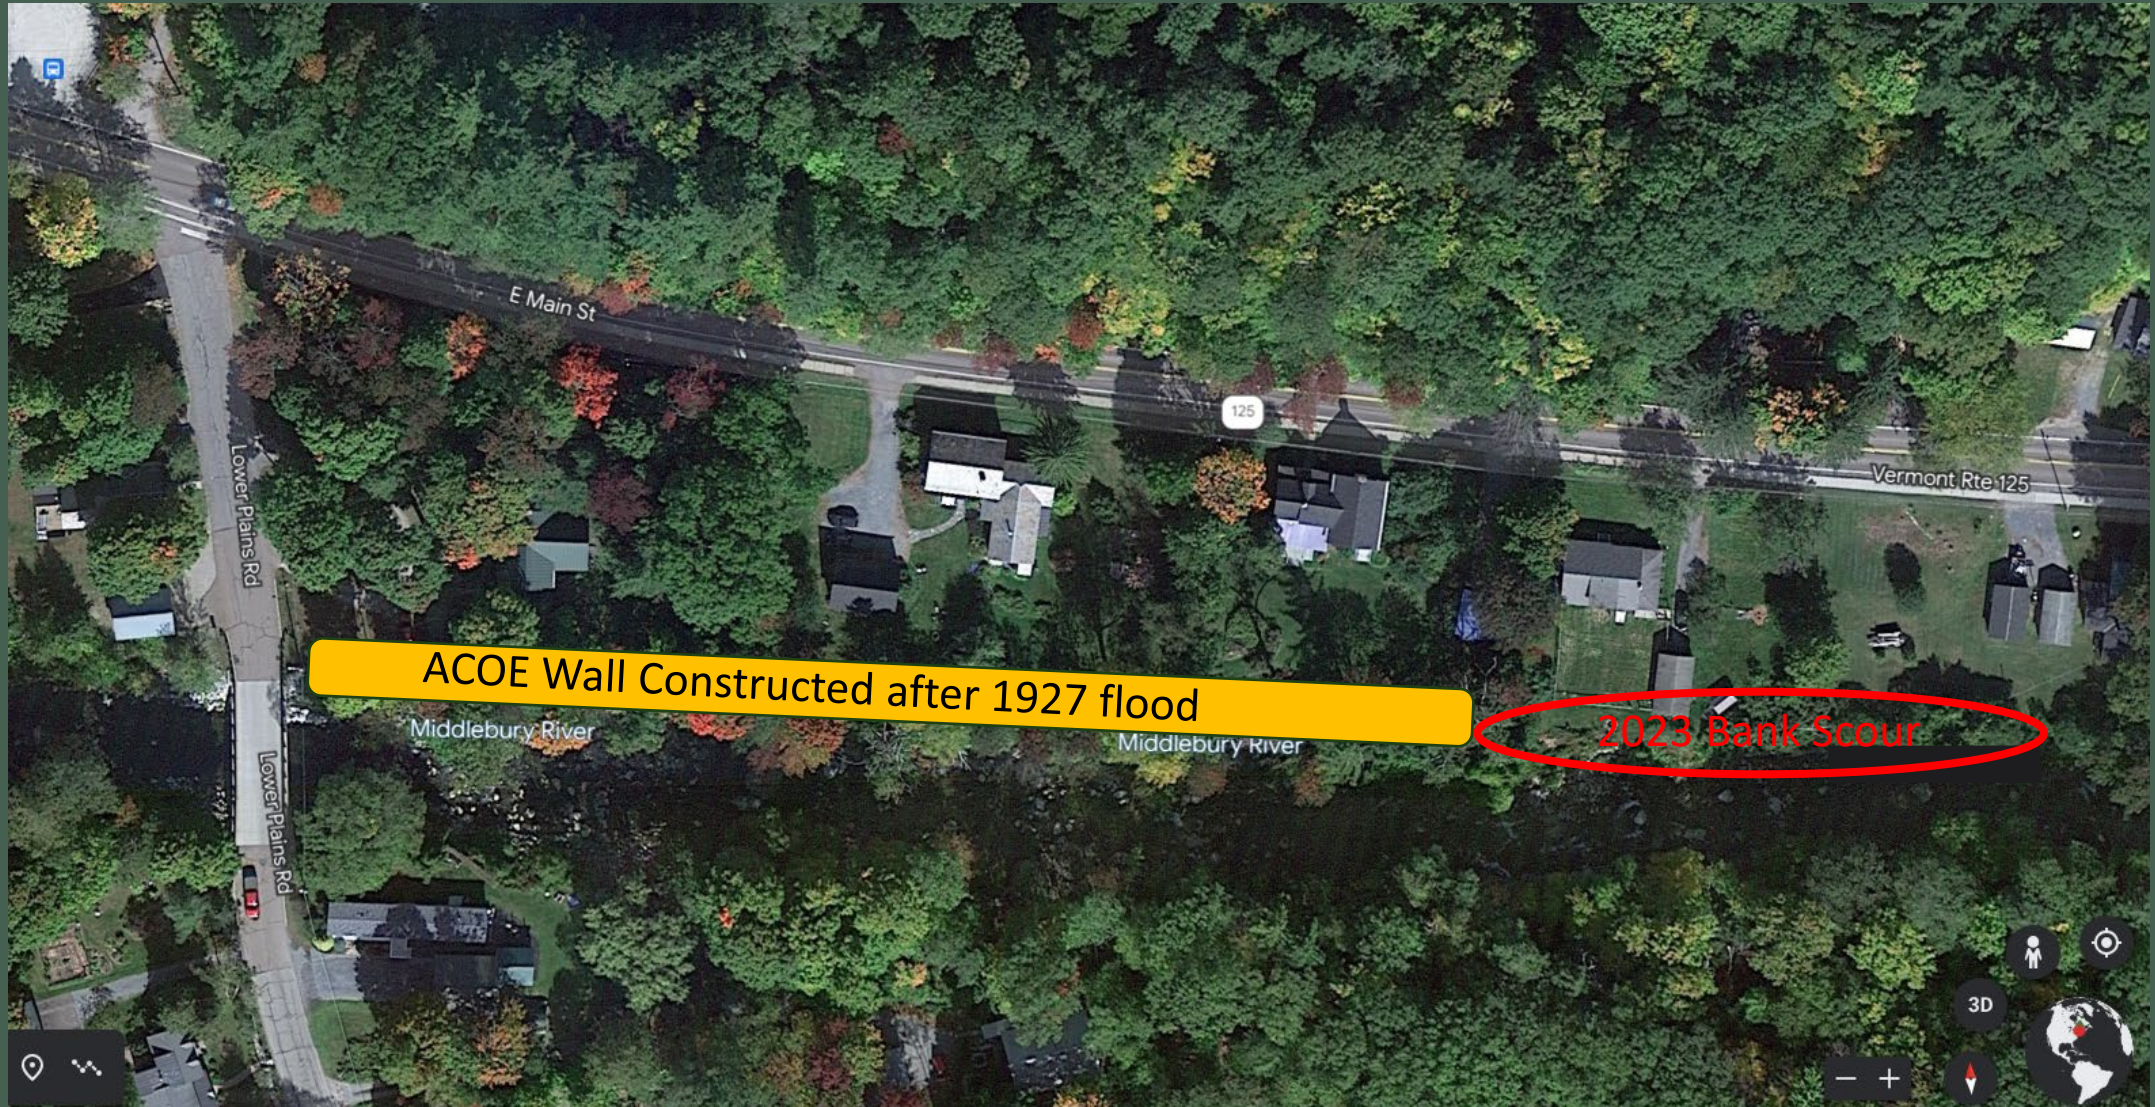
468 E Main St

ACOE Wall Constructed after 1927 flood

2023 Bank Scour

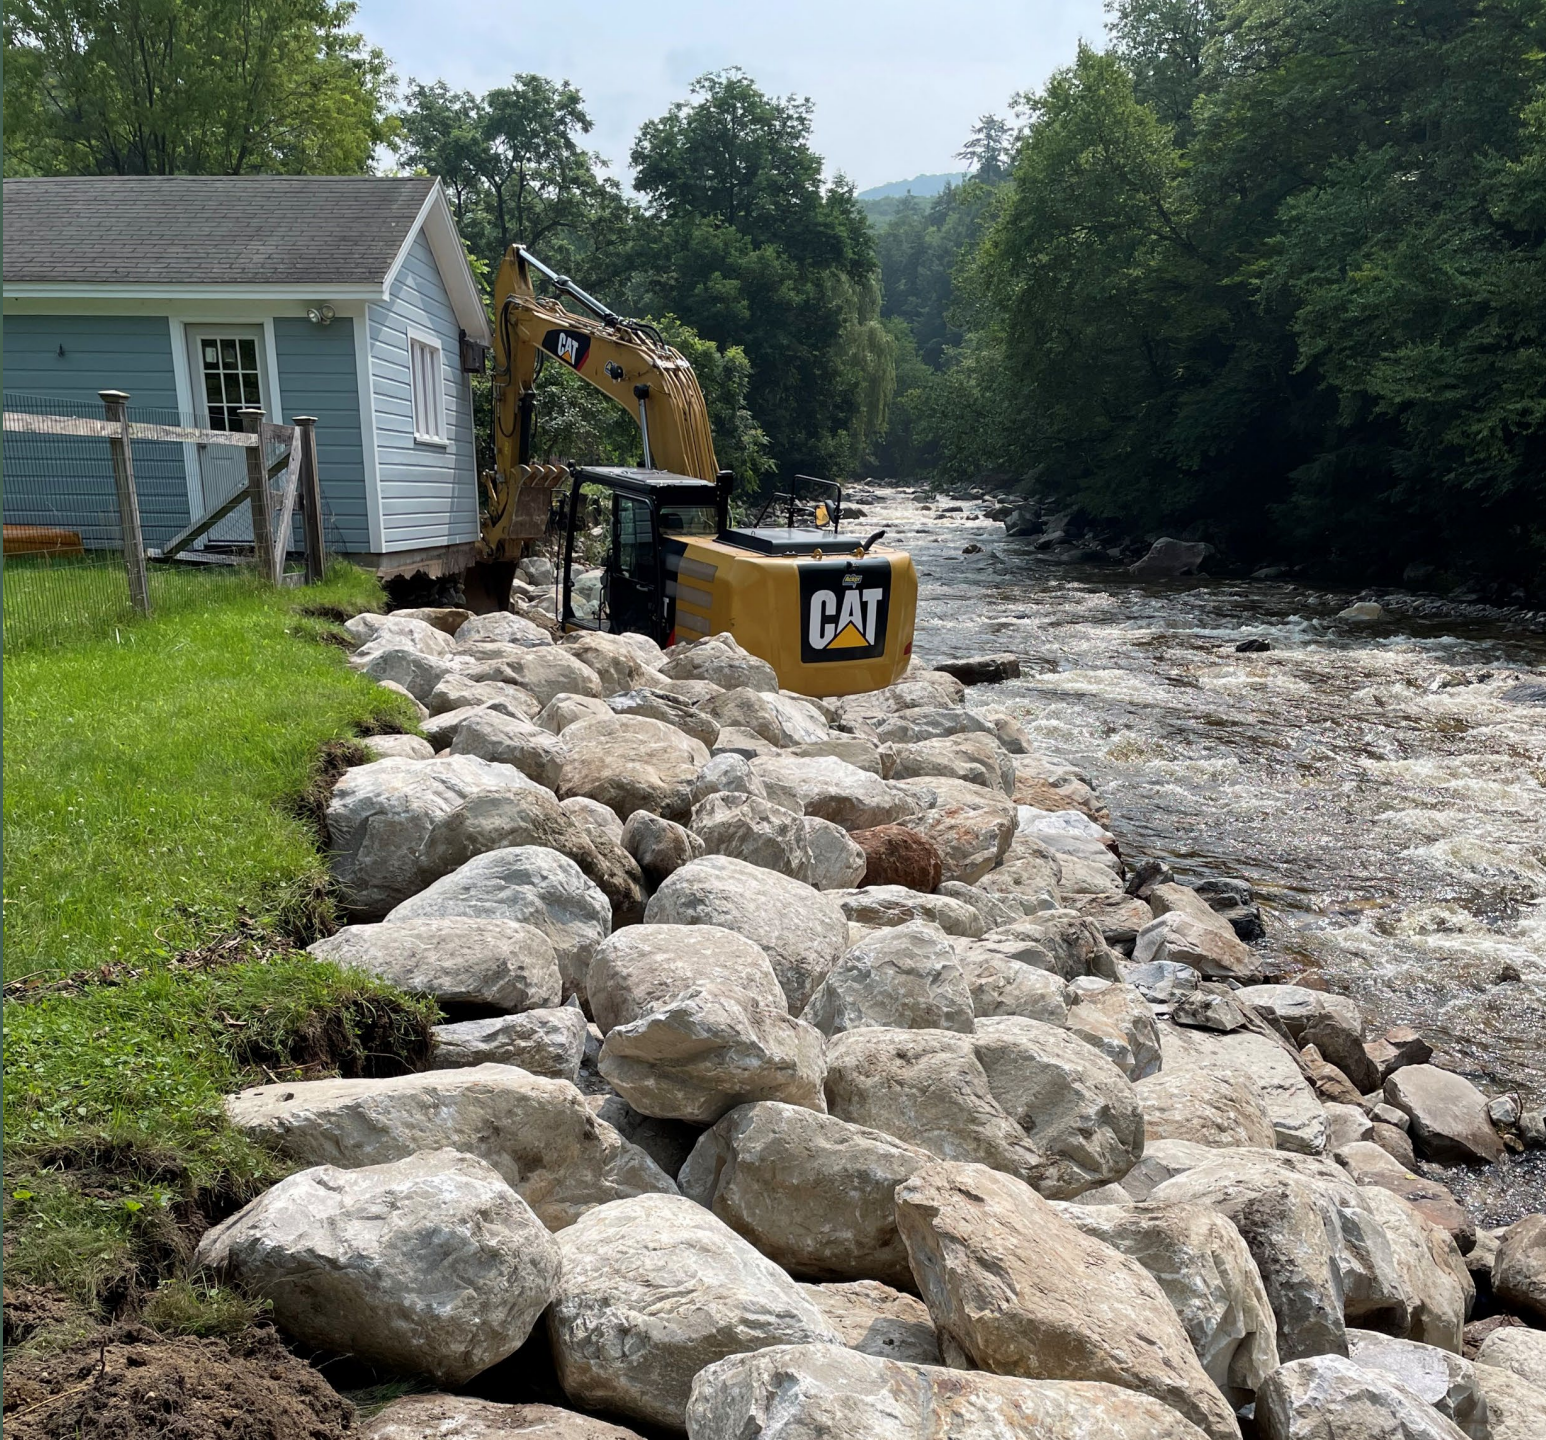
468 E Main St

Slope stabilized to prevent
further infrastructure
impacts

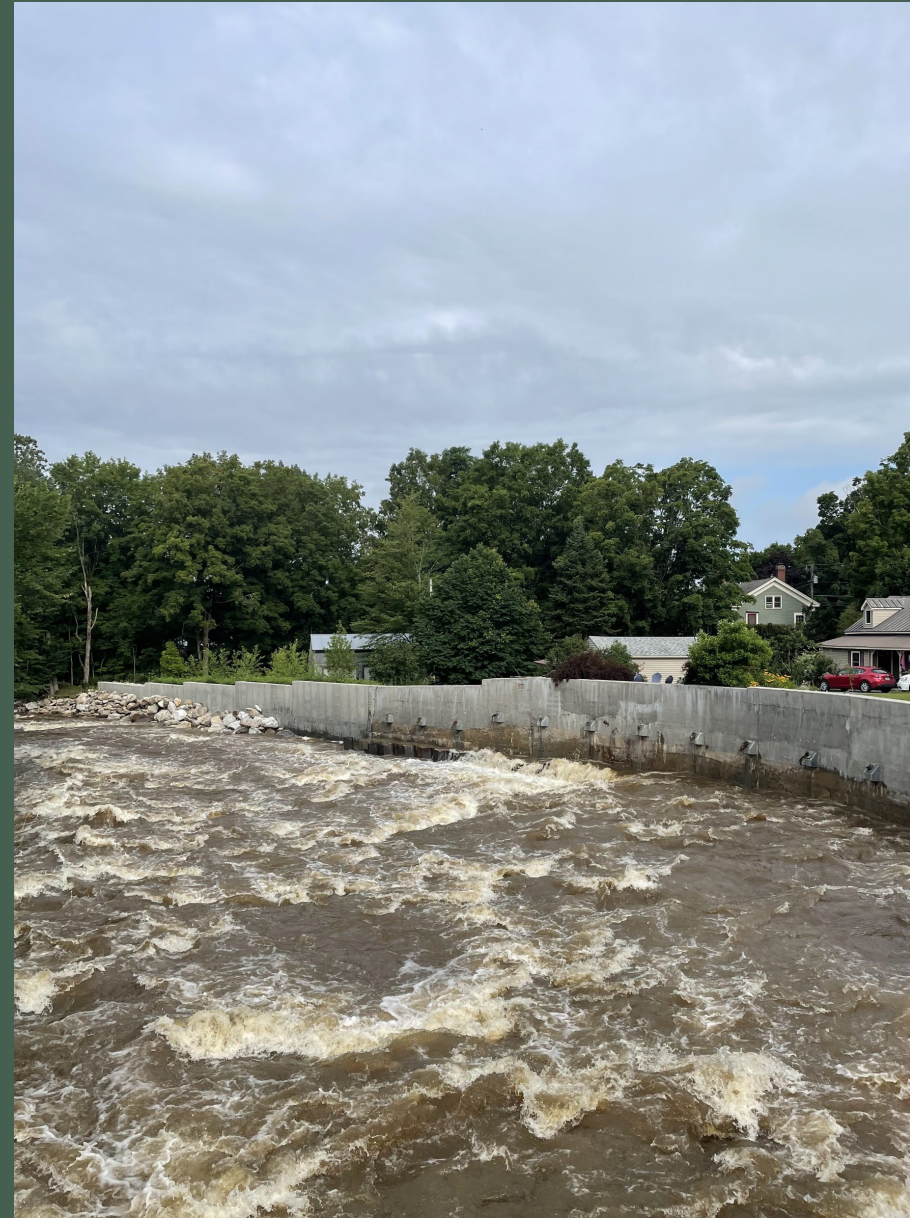
Photo- Saturday July 15, 2023

- Wall below Grist Mill Bridge
- Armoring stone has been carried away
- Need to inspect for scour
- Flood level did not breach the wall

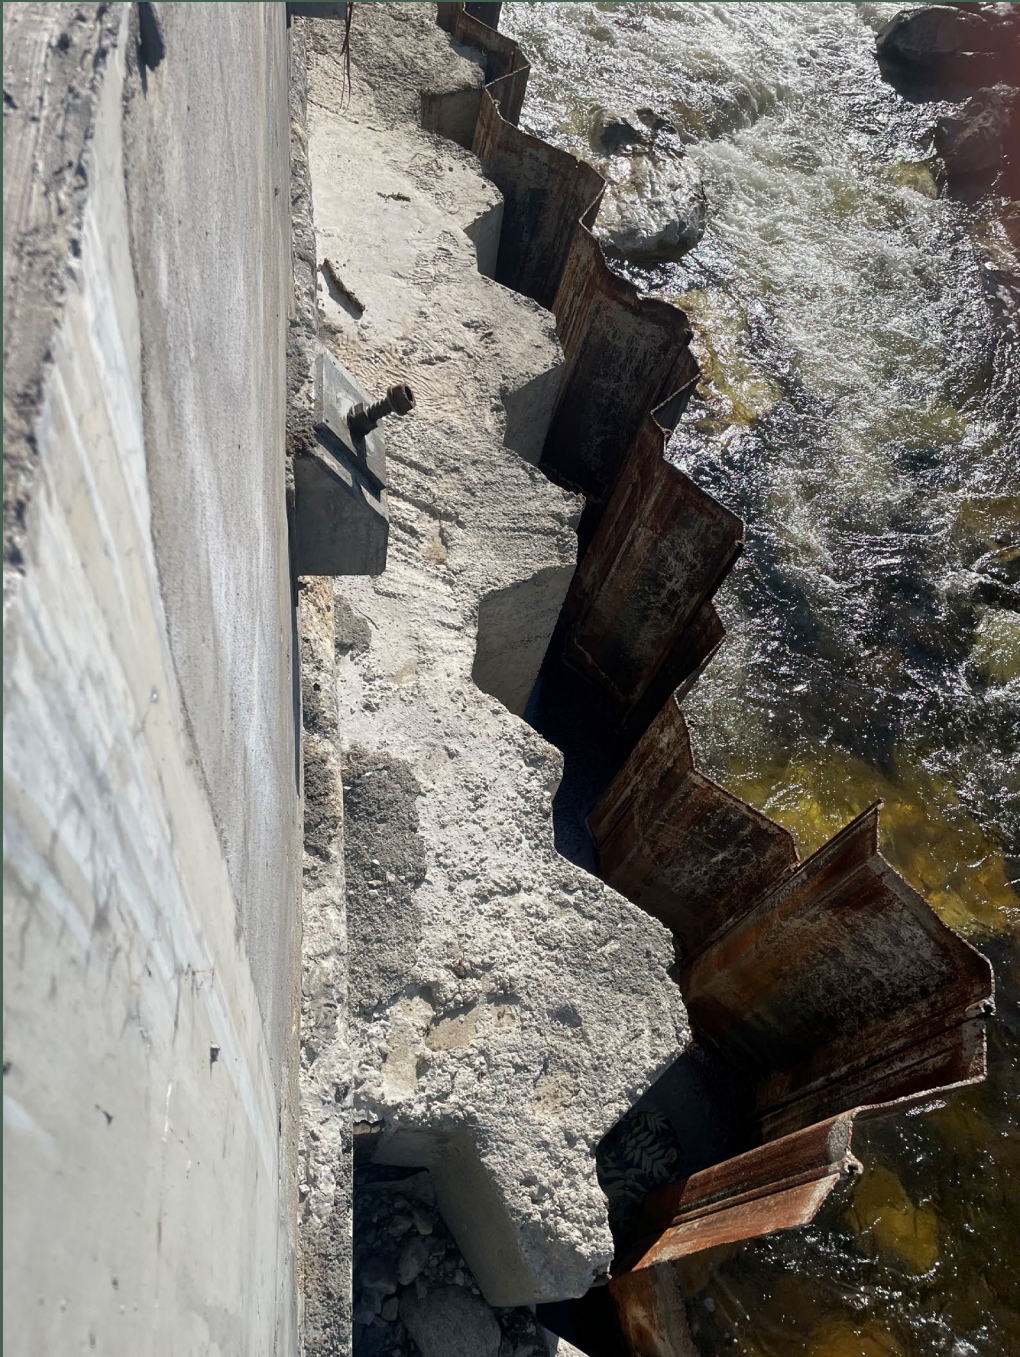
Photo- Thursday August 2, 2023

Steel sheets designed to prevent scour at wall footing.

Sheets have pulled away from concrete- leaving flowable fill exposed.

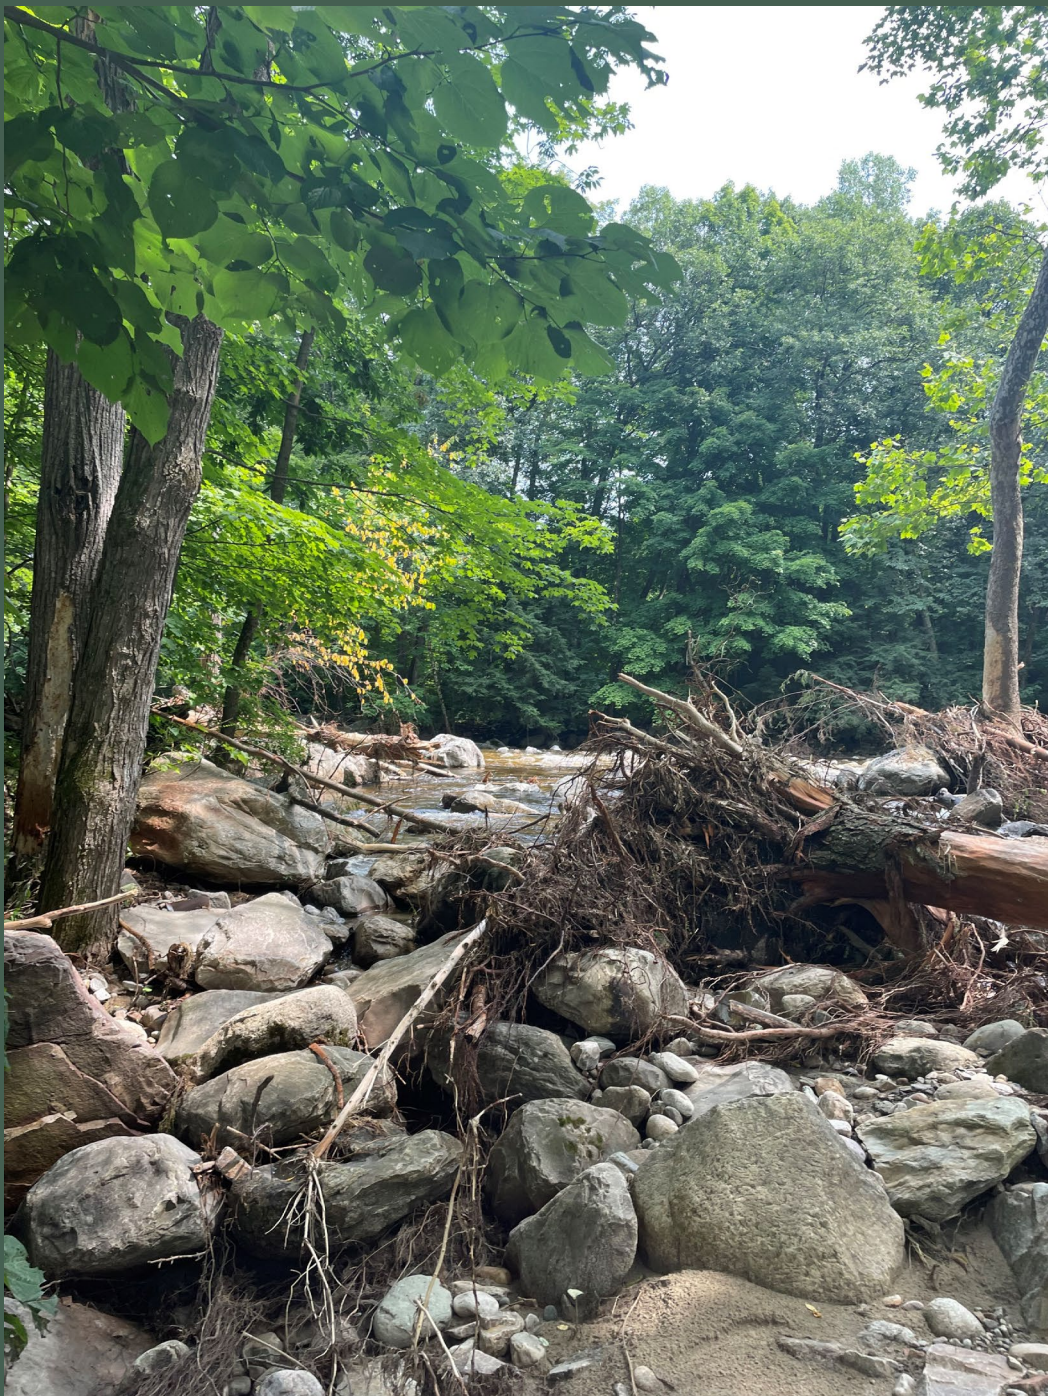
Behind Goodrow Lumber

Significant debris and
stone blocking chutes and
floodways.

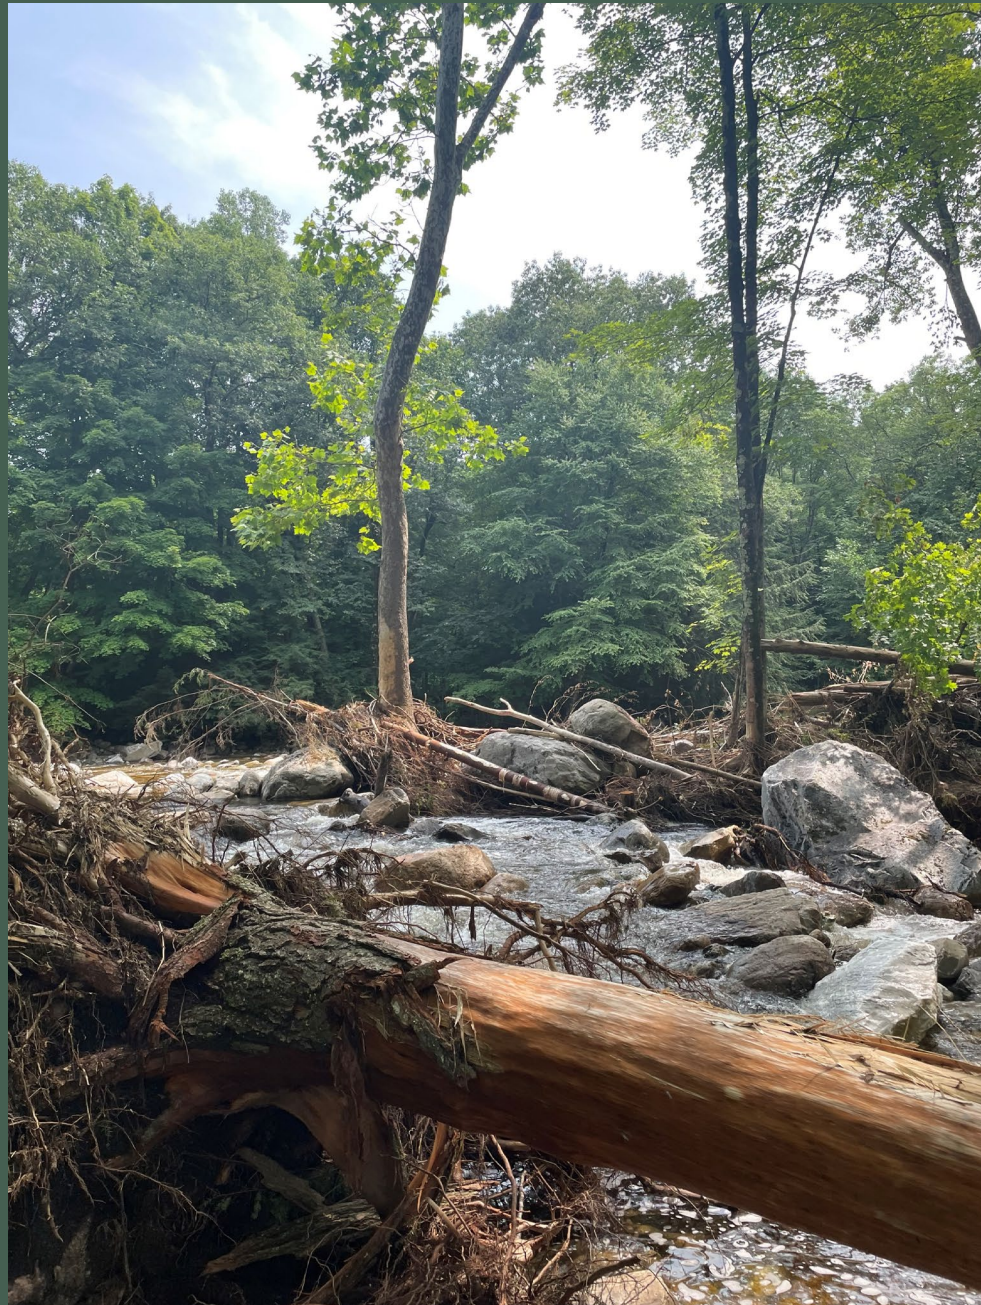
Significant debris and stone is filling chutes designed to take excessive flow.
