Town of Middlebury

Flooding Concerns
July- August 2023

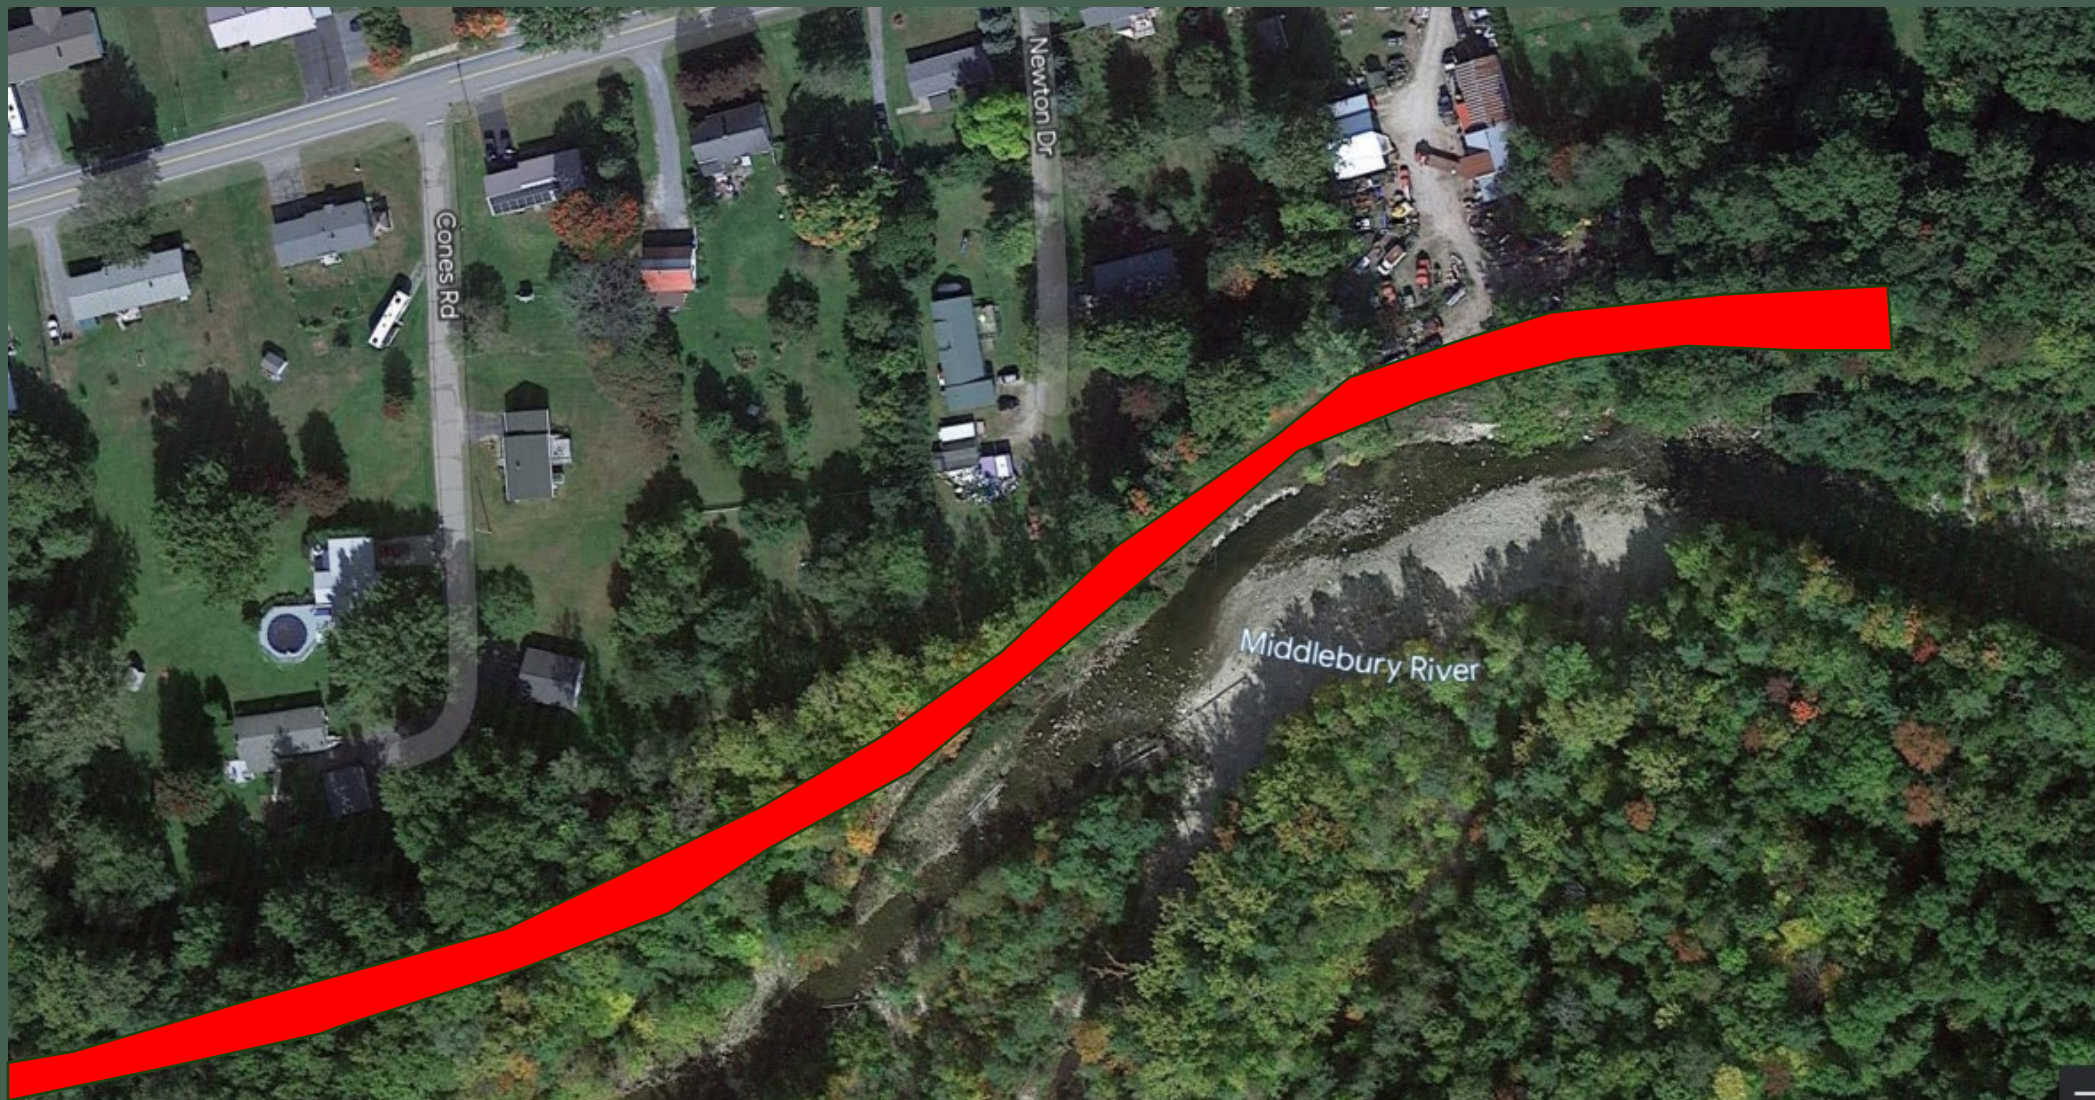
52 Ossie Rd

- Berm initially constructed after 1988 flood
- Stone Armoring was reinforced with recent efforts
- Significant scour occurred along berm.
- Flood chute does not appear to be active
- Flood level did not breach the berm but caused significant scour

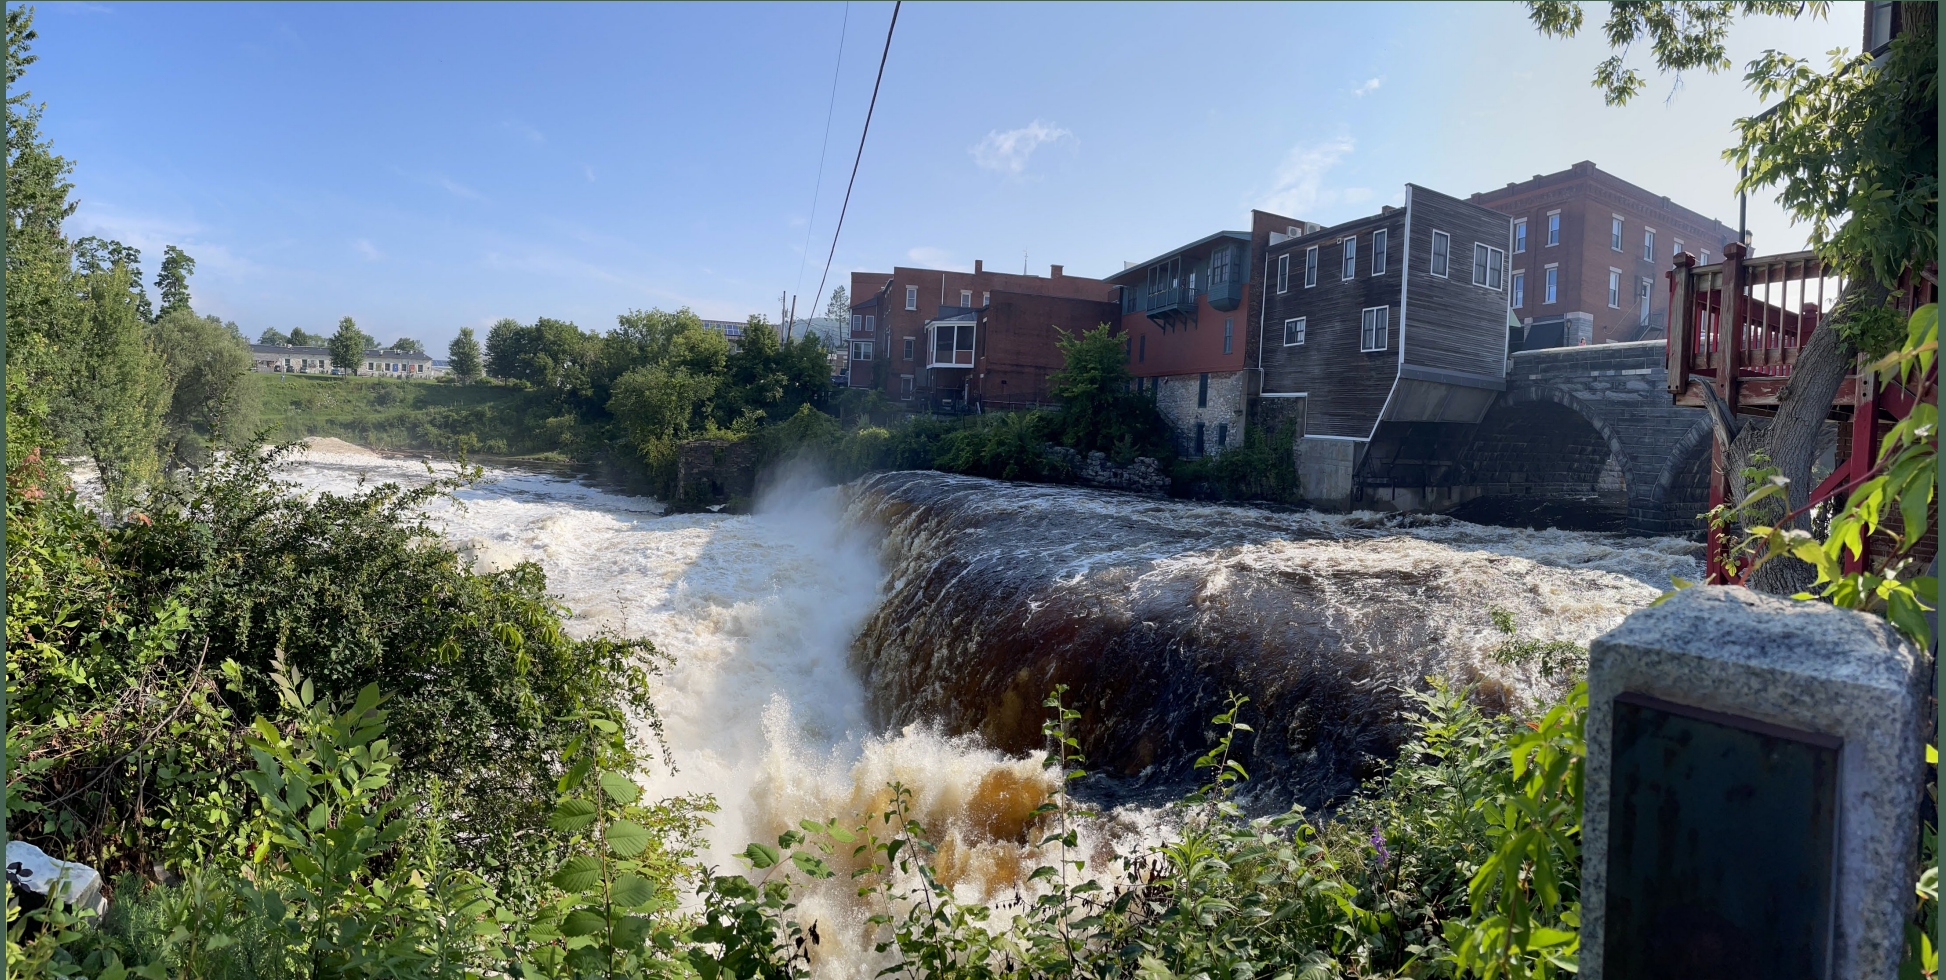
- VHB inspected the bridge 8/2/2023
- Found no significant concerns
- Full bridge inspection is proposed for FY25 budget.

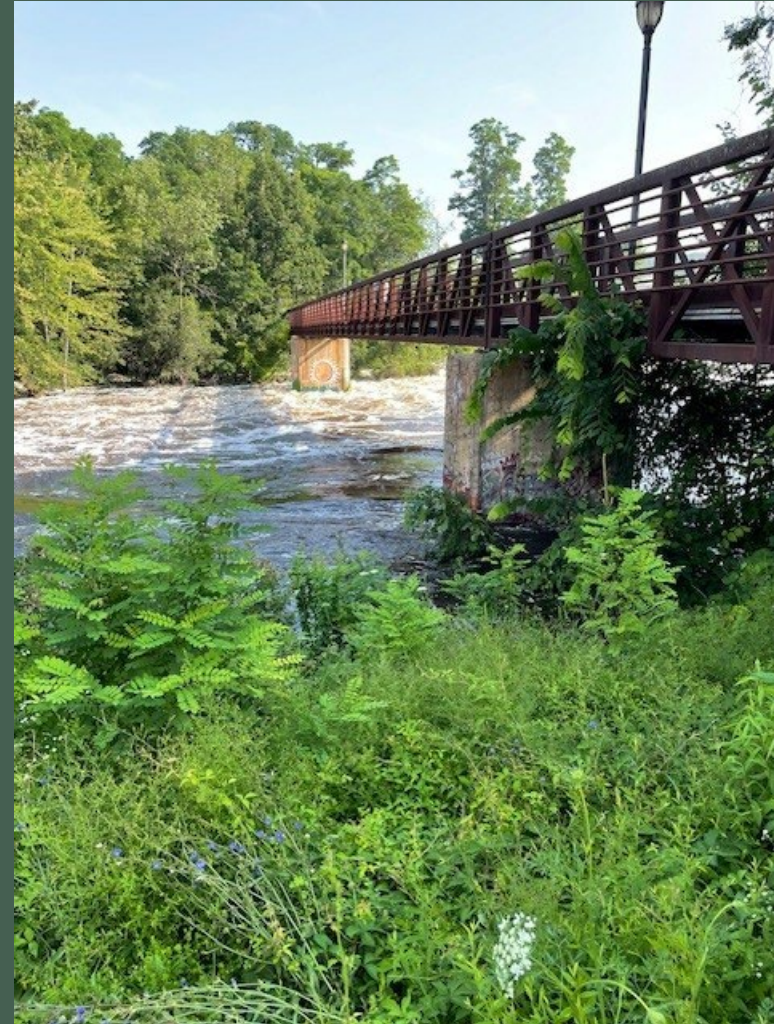
Pedestrian bridge- concerns for scour

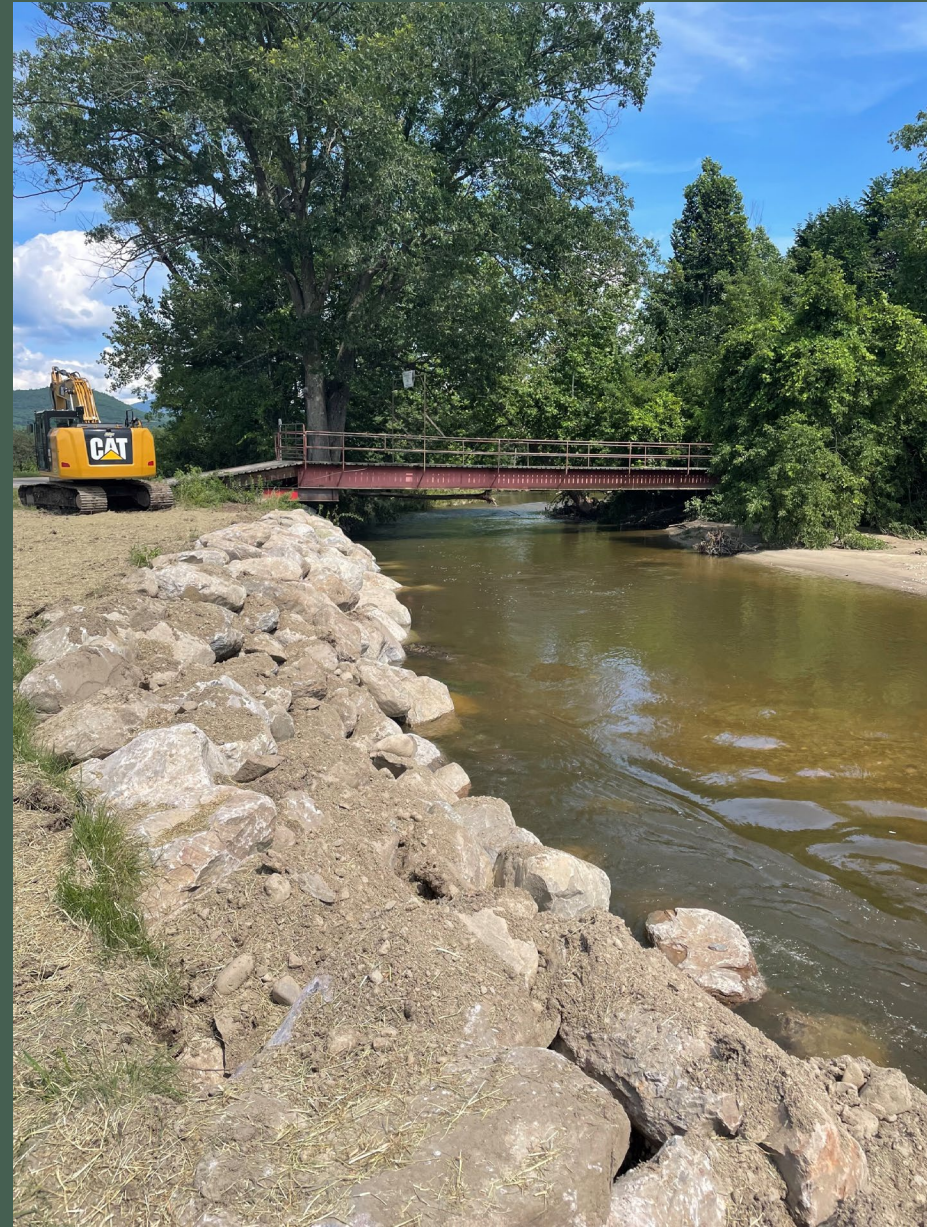
- Significant scour along bank .
- Provided stone armoring as emergency effort.
- Streambanks require further stabilization of soil and vegetation for long-term benefit.

Three Mile Bridge Rd- significant scour

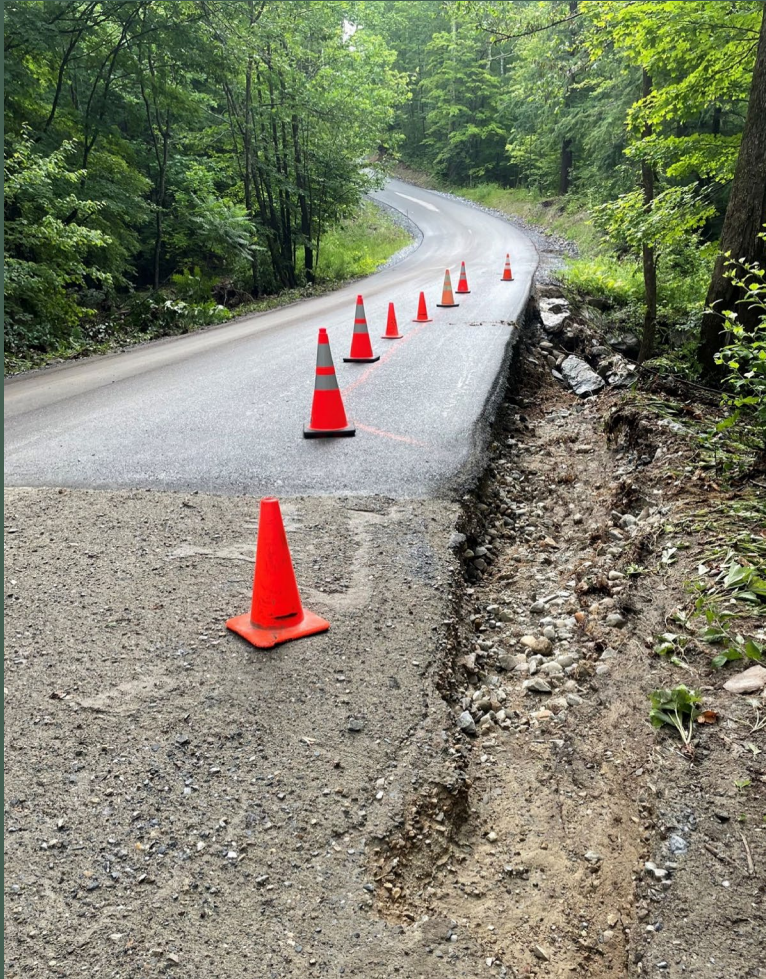
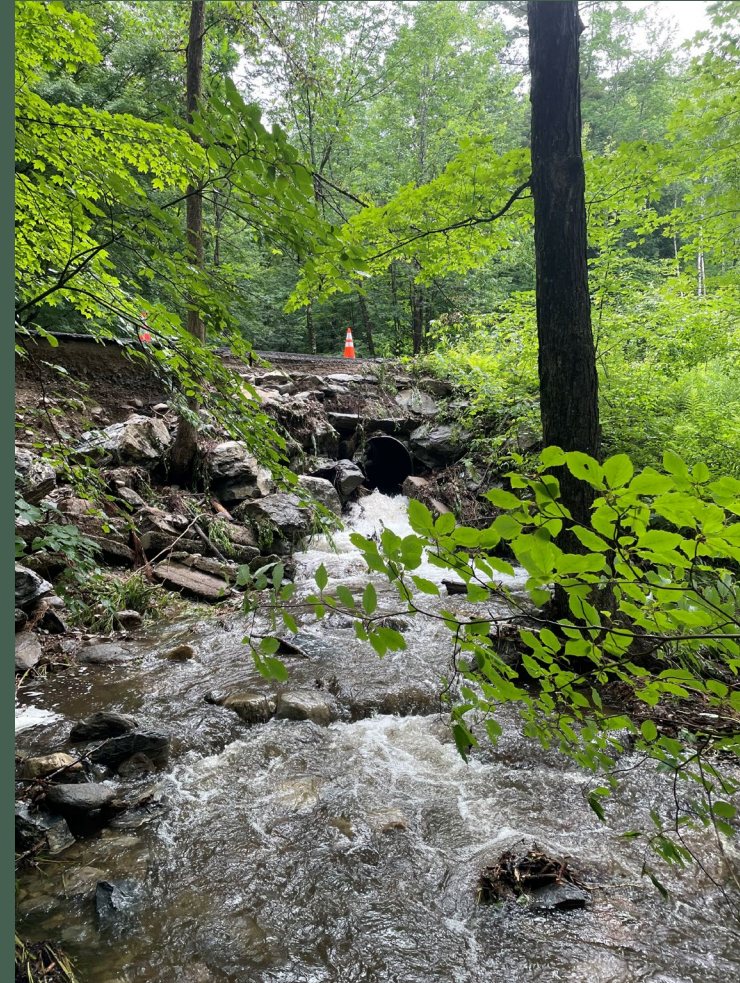
North Branch Rd- significant shoulder issues and undersized culverts
