**BURLINGTON NORTH WASTEWATER
POST JULY 2023 FLOOD
TREATMENT PLANT ASSESSMENT
WASHINGTON COUNTY,
VERMONT**

**NPDES PERMIT NUMBER VT0100226
STATE OF VERMONT PERMIT NUMBER 3-0271**

November 6th, 2023

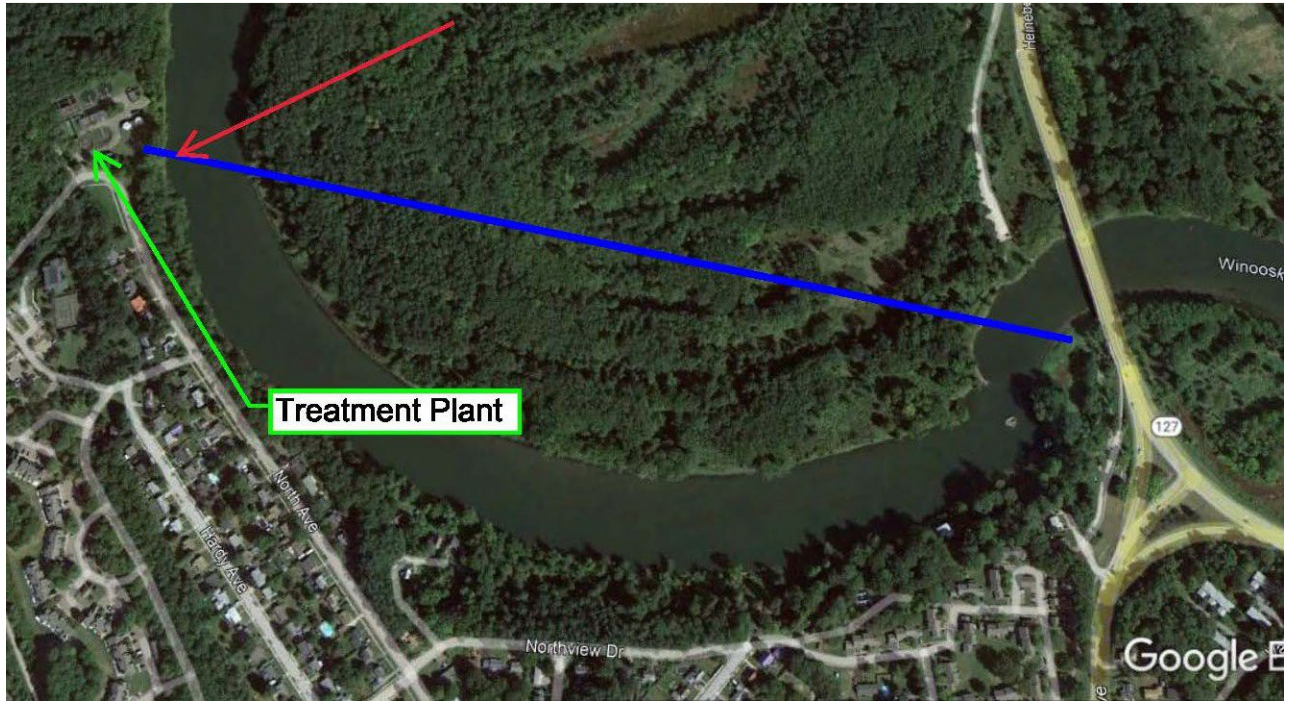
The river crossing pipe could not be visually assessed due to flows. The utility shared a drone video of a dye test demonstrating the point of origin near the riverbank closest to the facility. The upstream pipe had not been assessed at the time of visit. A more comprehensive assessment is planned once river flows have returned to a safe level.

- The currently identified point of failure is on the outer, higher velocity, cut bank side of the river bend. Erosion and/or debris is the probable cause of the failure. If a repair is made to the existing line, bank protection (riprap, shot rock, or similar) is advisable.

The approximate sewer main location is in blue, approximate leak location is in red.

- The utility plugged the upstream line and began pumping operations immediately.
- A fused HDPE overland bypass force main was under construction during the visit. This bypass was completed in the interim between the site visit and this report.
- Possible replacement options include a local break repair or new pipe installation via horizontal directional drill.

- Alternately, if horizontal directional drill method is utilized, installation with appreciable cover depth along the riverbanks will inherently provide an additional measure of protection.
