**HARDWICK WASTEWATER
POST JULY 2023 FLOOD
TREATMENT PLANT ASSESSMENT
CALEDONIA COUNTY, VERMONT**

**NPDES PERMIT NUMBER VT0100137
STATE OF VERMONT PERMIT NUMBER 3-1143**

August 29, 2023

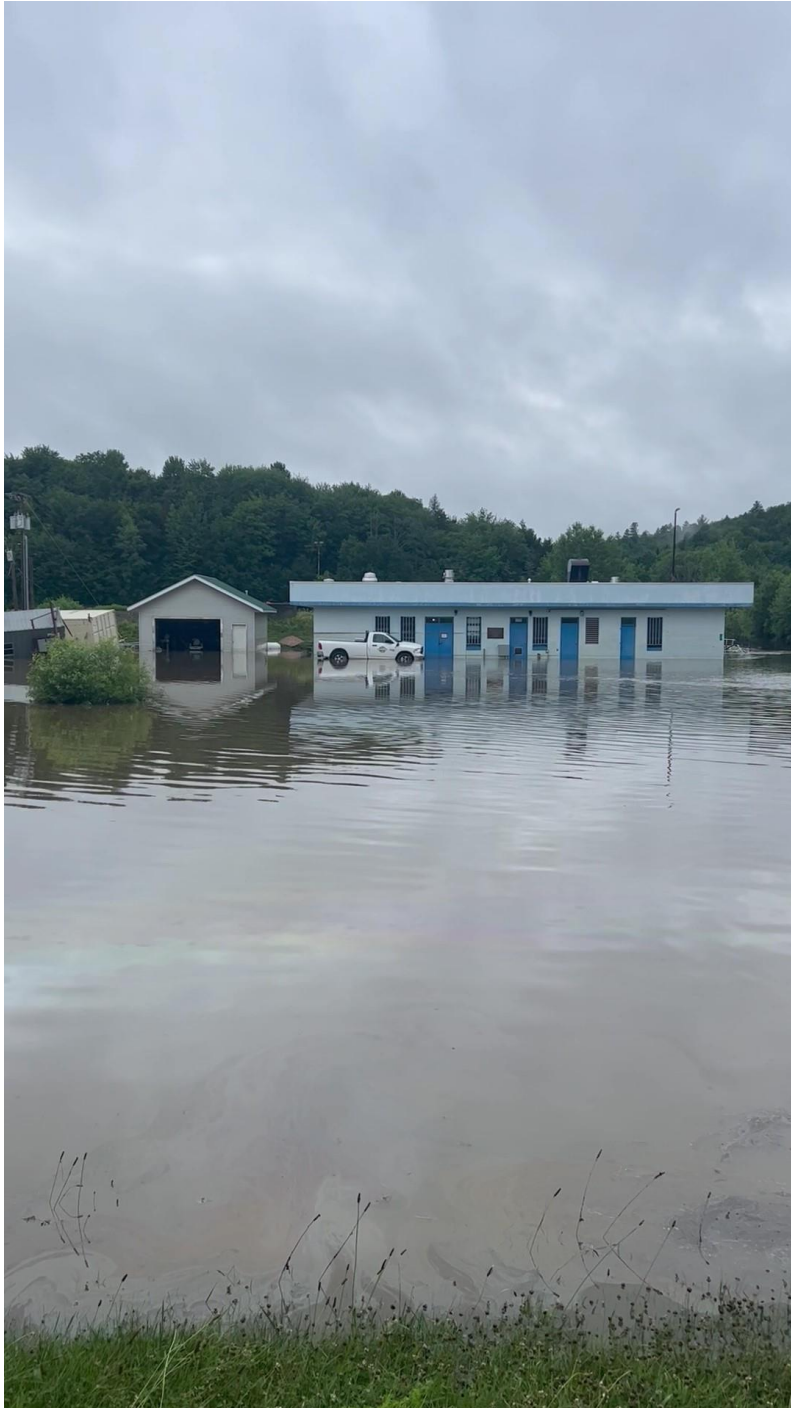
1 – Receded Flood Waters at Main Plant (photo by Chief Operator Ken LaCasse)

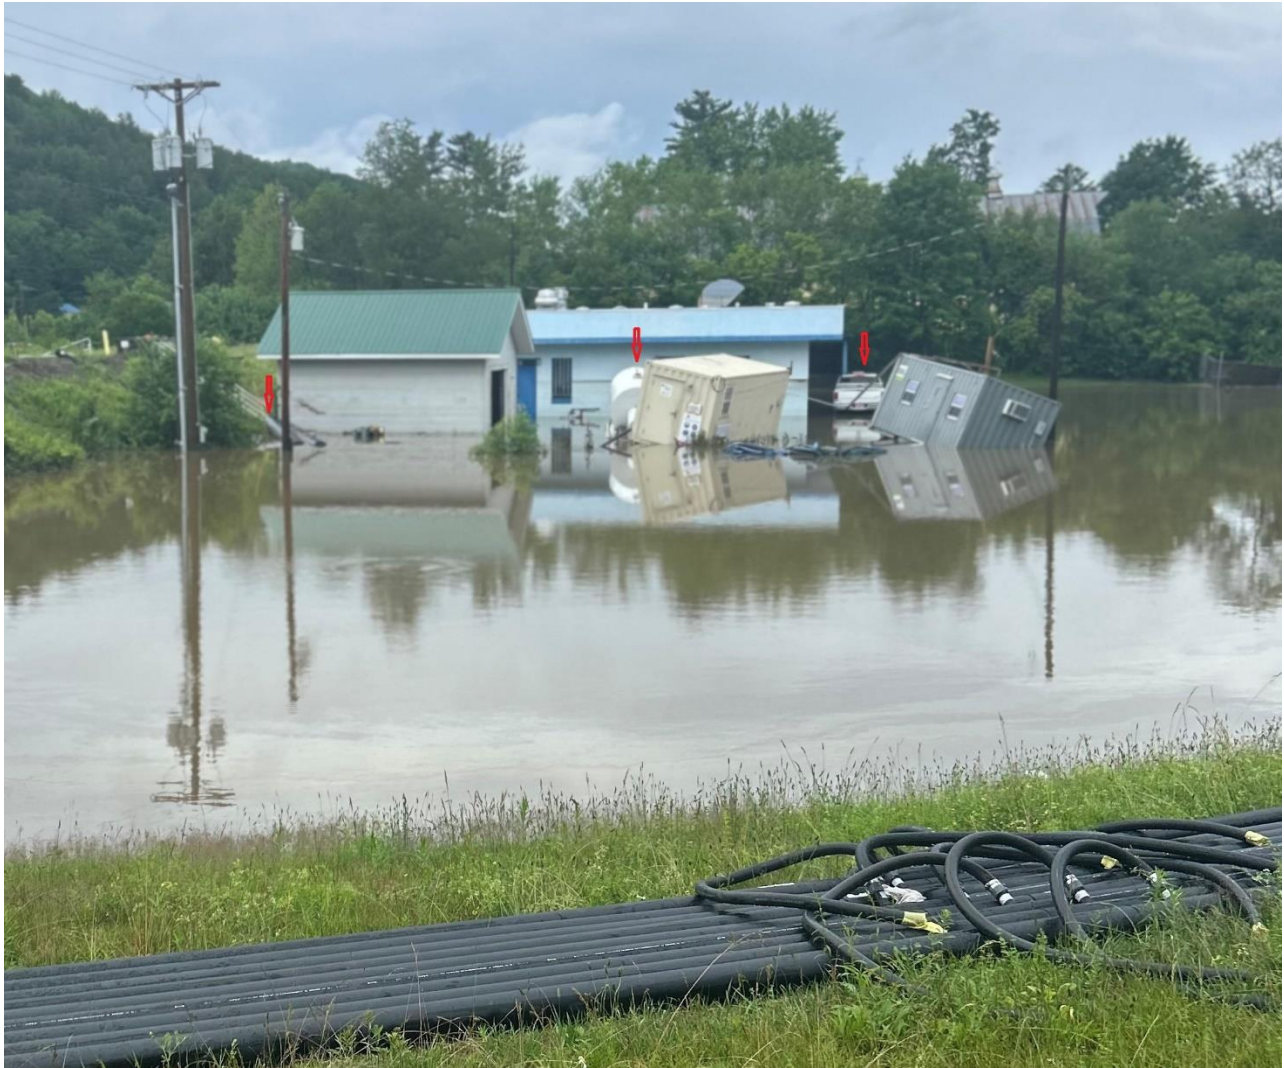
2- Receded Flood Waters at Main Plant, Note Two Rolls of Lagoon Liner Laid Against Stairs to the Lagoon Level, Sewer Rodder and Facility's Dodge Truck (photo by Chief Operator Ken LaCasse)

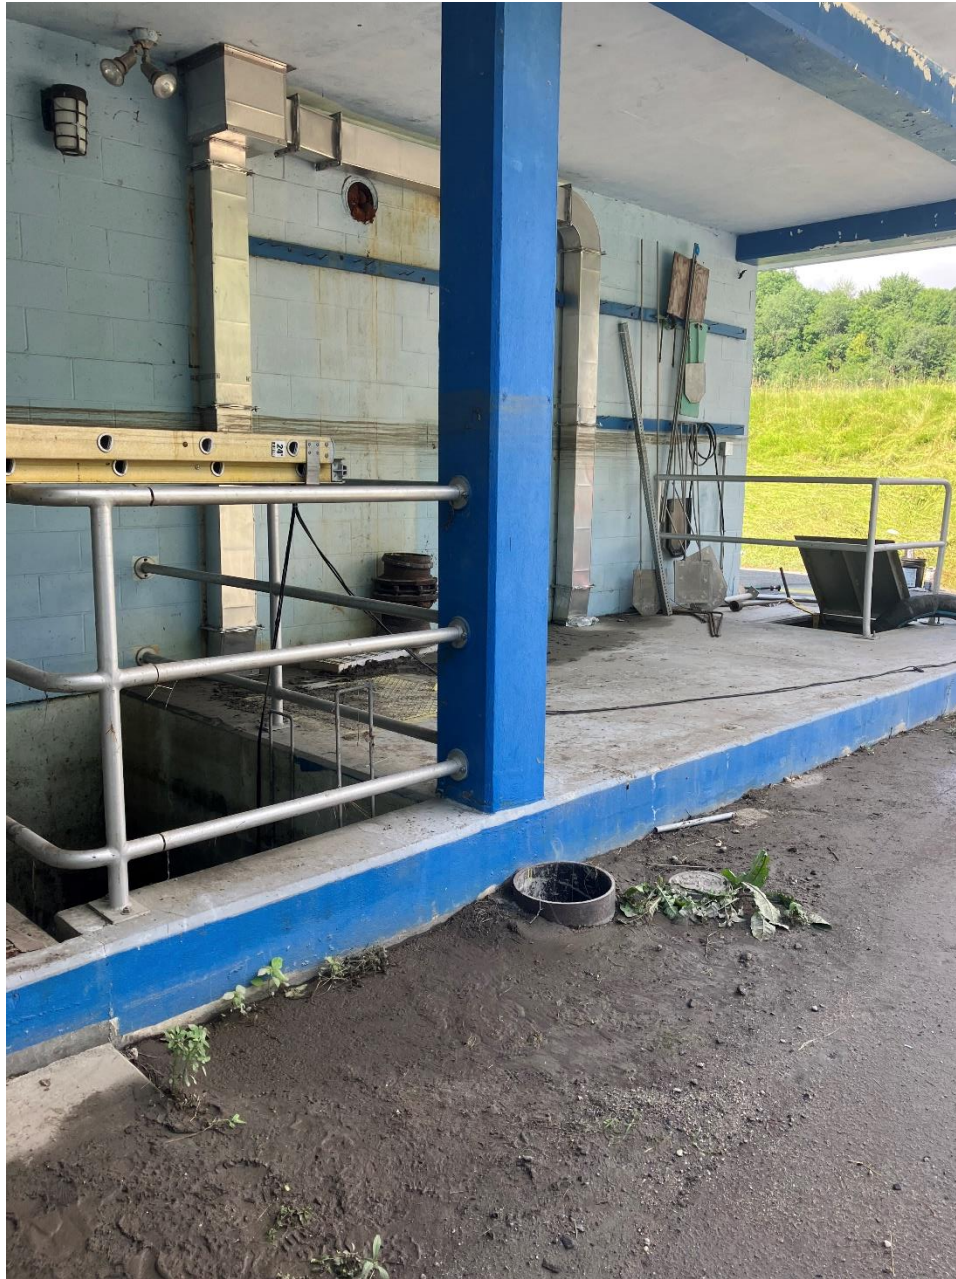
3- High Water Mark Above Grit Chamber and Influent Wet Well

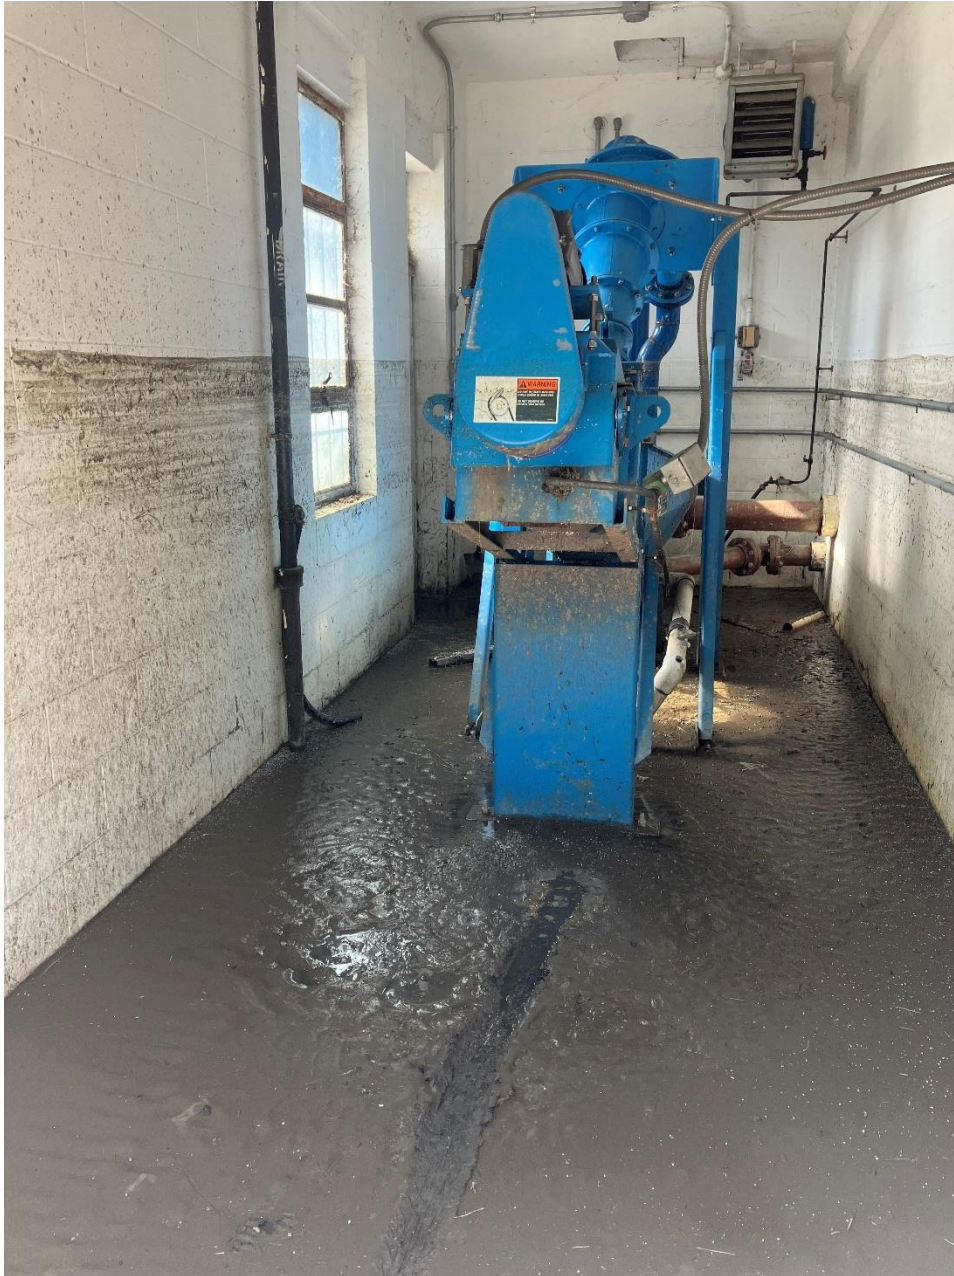
4- High Water Mark in Grit Cyclone Room

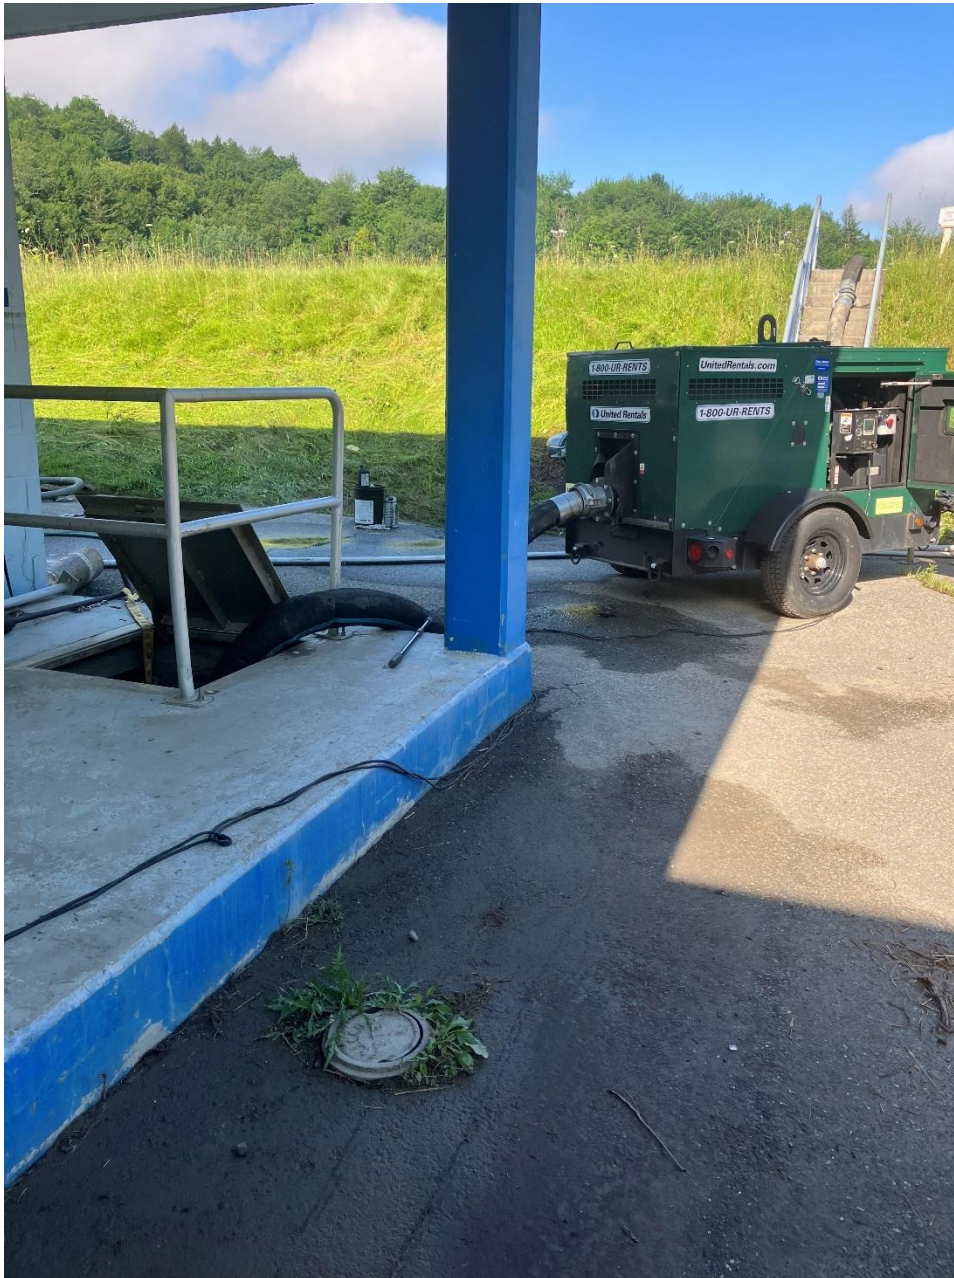
The influent wet well pump station was being bypassed using a portable diesel pump and temporary float system to pump influent to Lagoon 1. The aeration system and mixers were not functional without power. Influent was flowing via gravity through Lagoon 1 to Lagoon 2. No chemical addition for nutrient control (PAC) was being added at this time as the power was still off to the facility. The system was not discharging at the time of the site visit.

5- Portable Pump Pumping from Influent Wet Well to Lagoon 1

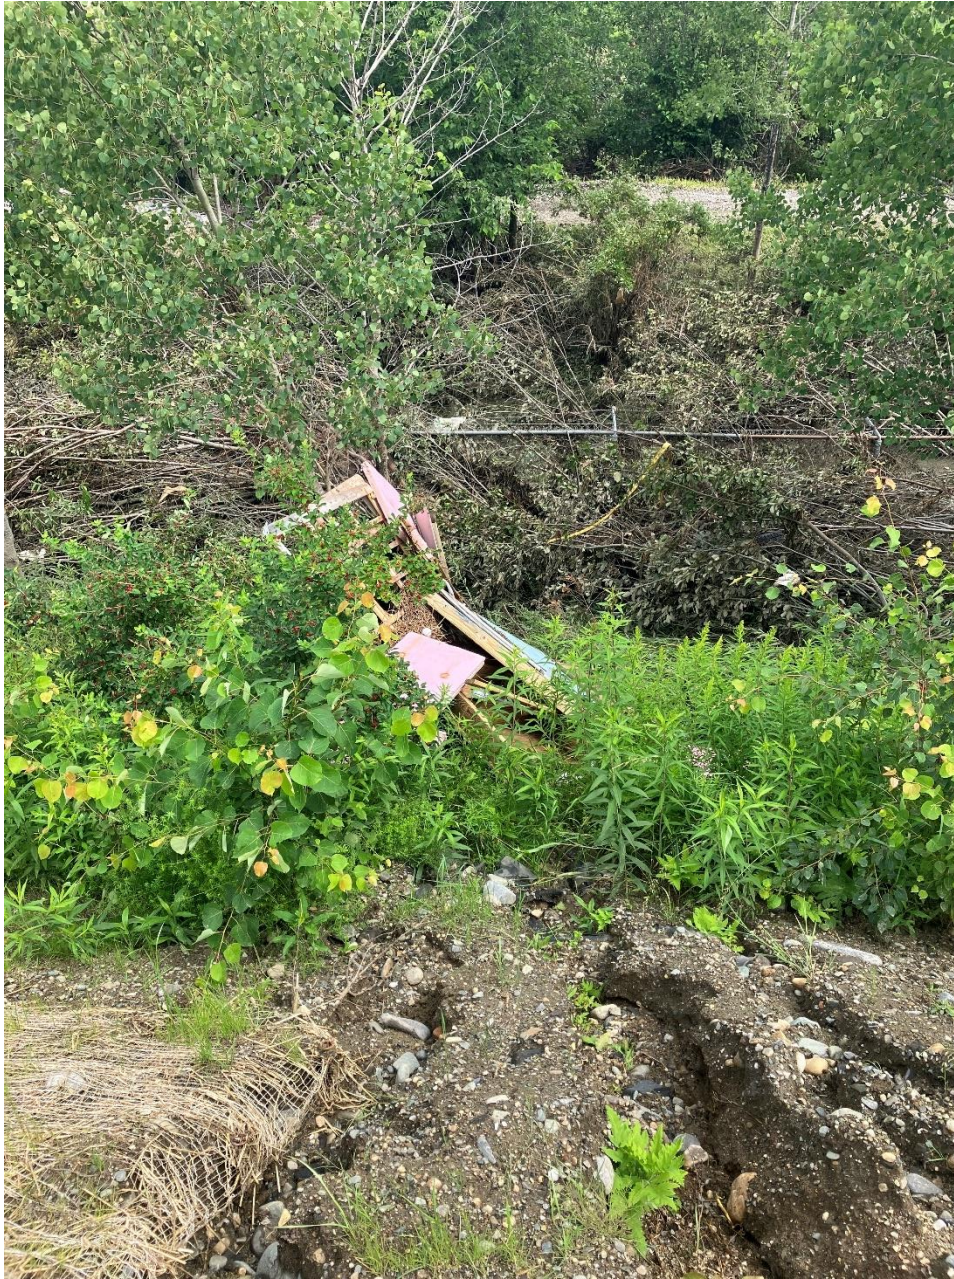
6 – Scour Over Berm of Lagoons and Remnants of Chlorine Injection A-Frame Building Along Site Fencing

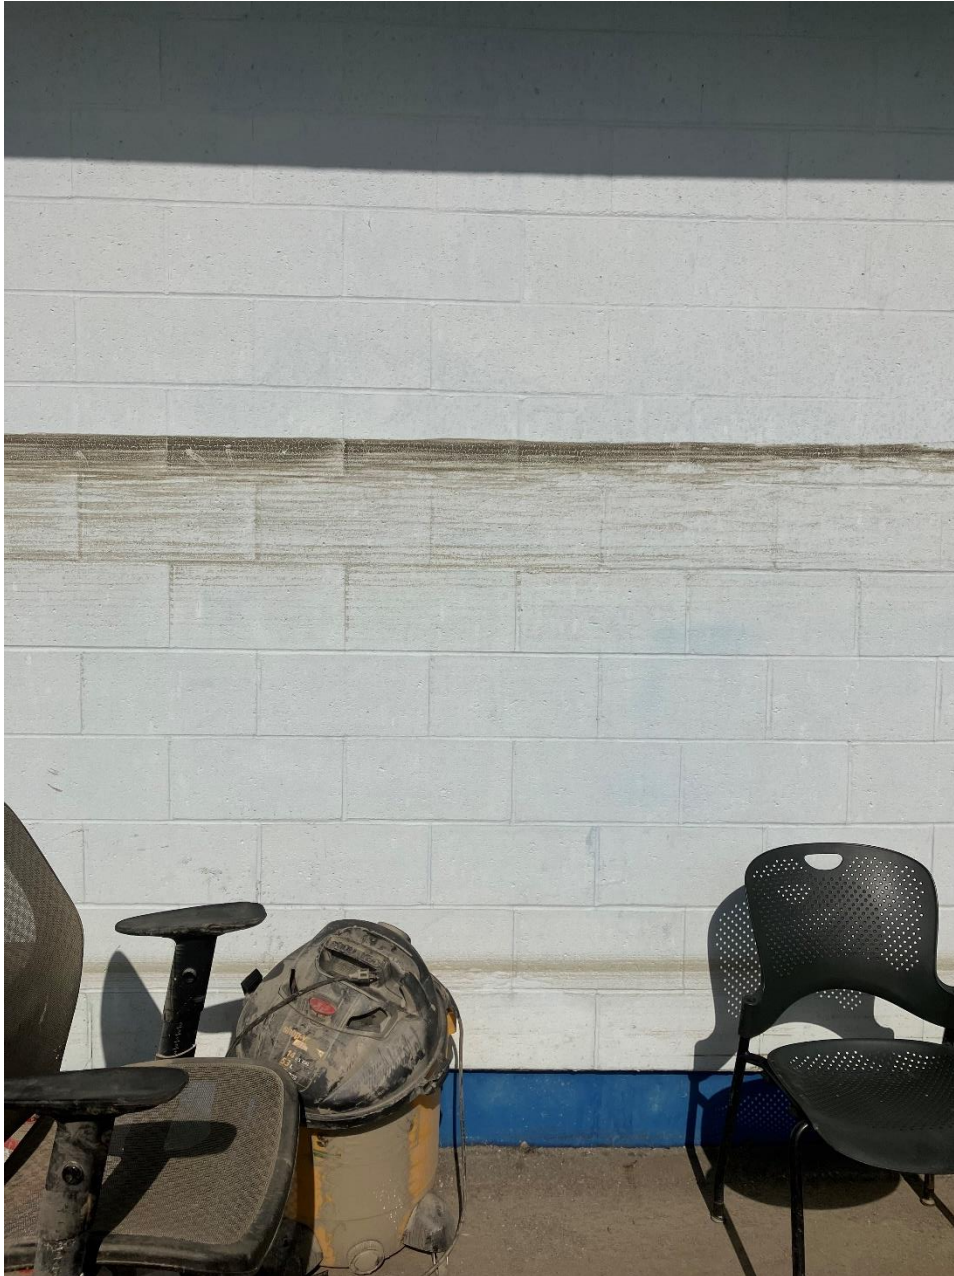
appeared to be backwater type with high water marks observed at approximately 5' above the first floor of the main plant building.

7- High Water Mark on Exterior of Main Plant Building

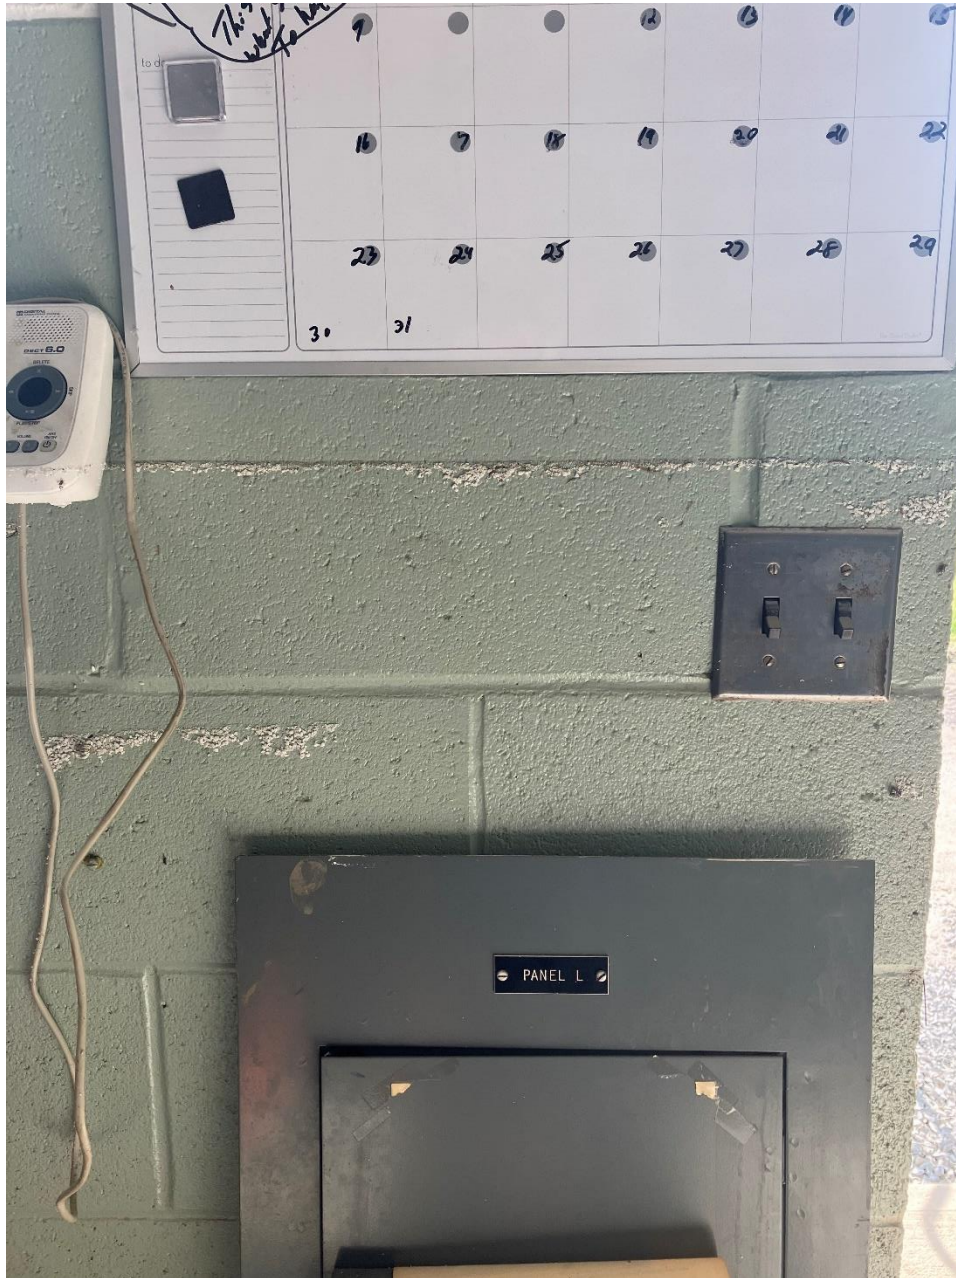
8- High Water Mark with Insulation from Concrete Block Construction in Main Office Area

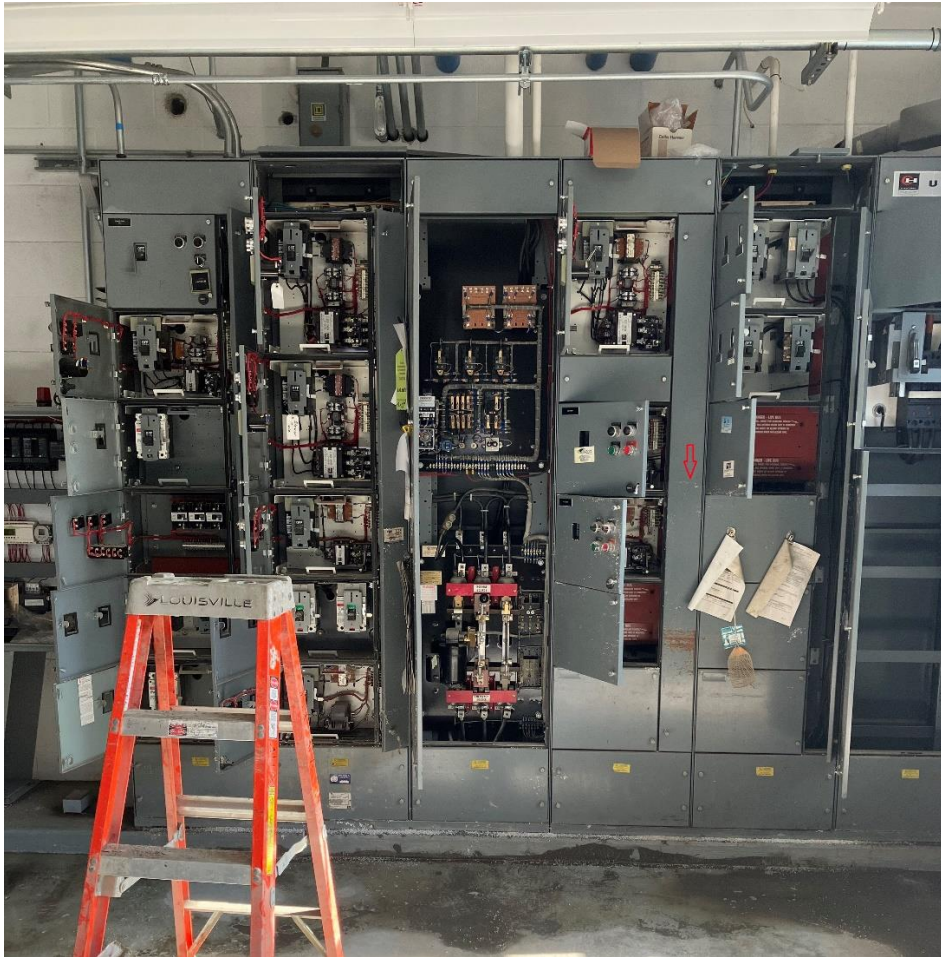
The motor control center (MCC) including nearly all pump and motor starters, variable frequency drives (VFDs), branch circuit breakers, and electrical conduits were inundated and likely destroyed. The same is true for the plant's heating and hot water system, meters, analytical monitors, recorders, laboratory equipment and supplies, and automatic samplers. The plant's automatic transfer switch (ATS), main control panel, grinder hydraulic power pack, chemical feed pumps and tanks (sodium hypochlorite and sodium bisulfite), blowers (two original and one new), and backup generator will also require complete re-build or replacement. The facility's small chlorination building that sat atop the chlorine contact chamber was completely washed away in the flood waters. The Facility's lawn tractor, portable pumps with hosing and spare parts located in the adjacent garage were submerged in flood waters. The facility's Dodge truck and trailer mount sewer rodder parked adjacent to the facility were also submerged in flood waters.

9-Main Building MCC Showing High Water Mark

- Evaluate electrical components, wiring and conduits. All may need replacing.
- Complete replacement or professional rehabilitation of all electrical and mechanical equipment and instrumentation below the high-water mark which show evidence of water intrusion. Even equipment quickly brought back into operation may suffer shortened life due to silt and containments in flood waters.

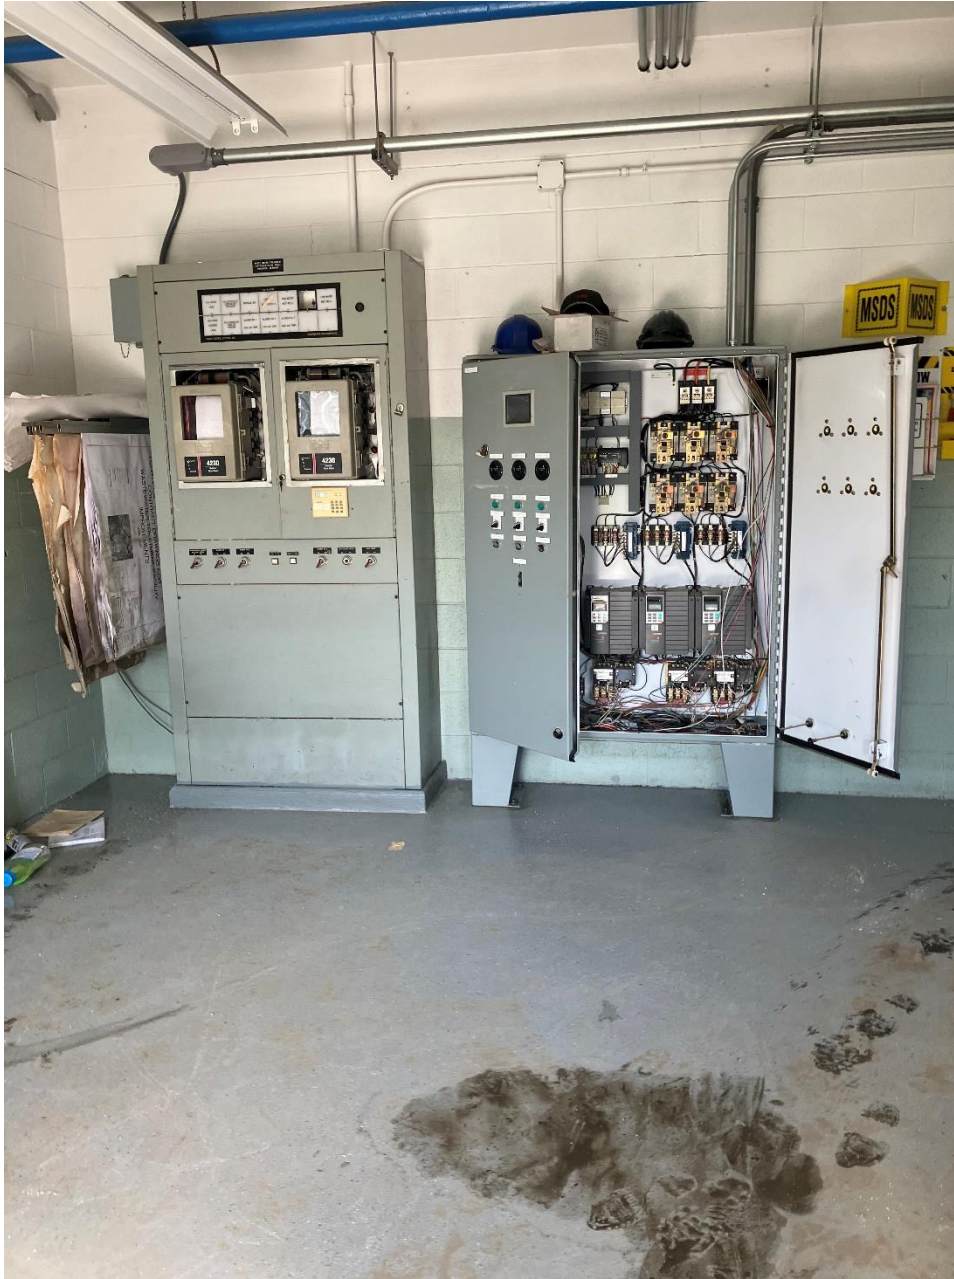
10- Instrumentation and PLC Panel High Water Mark

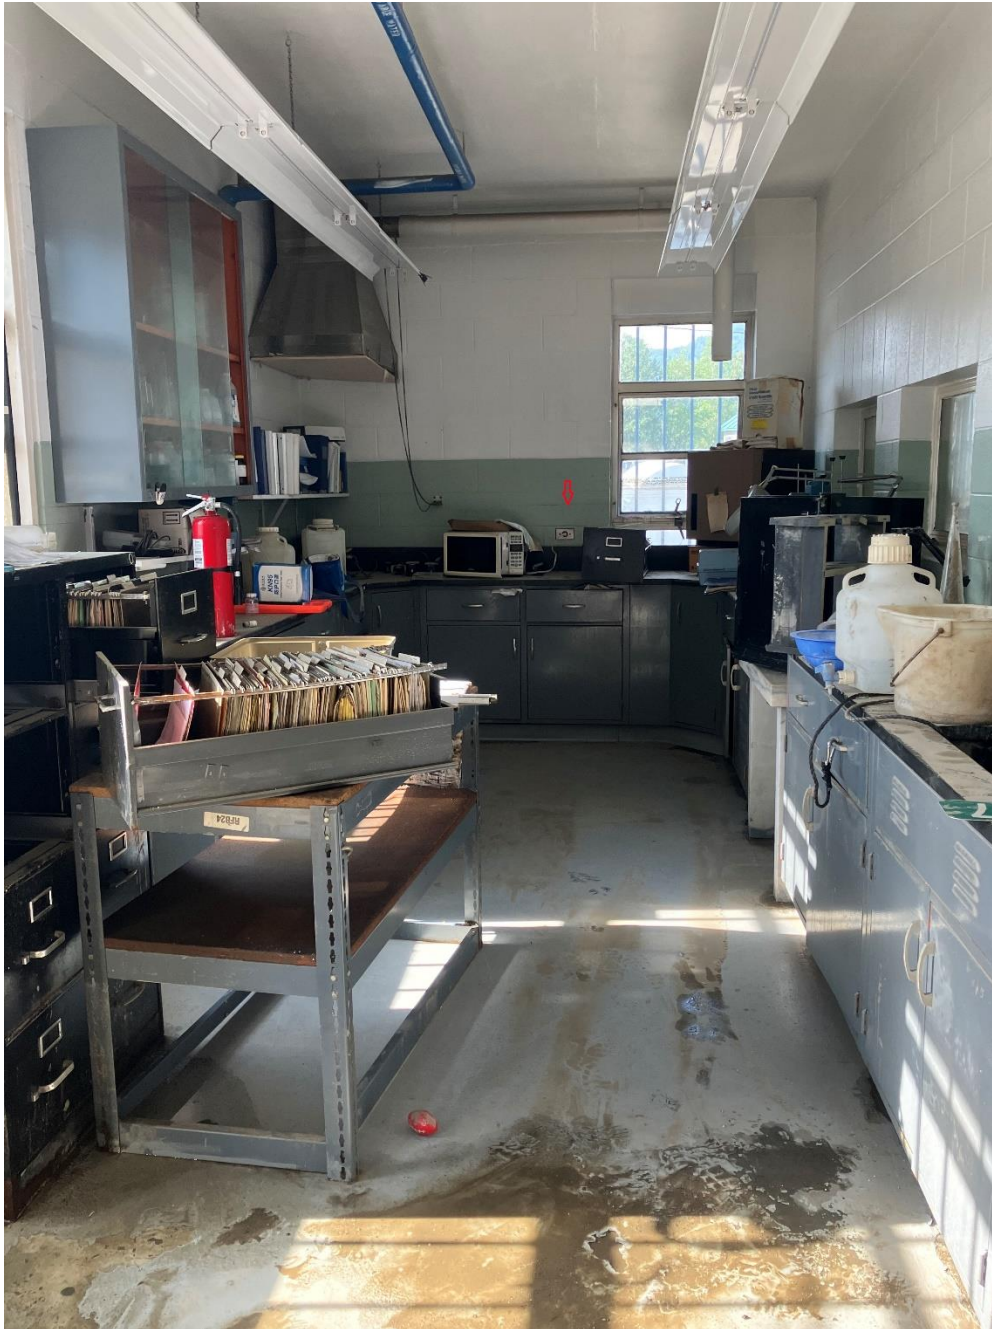
11- High Water Mark in Laboratory Area

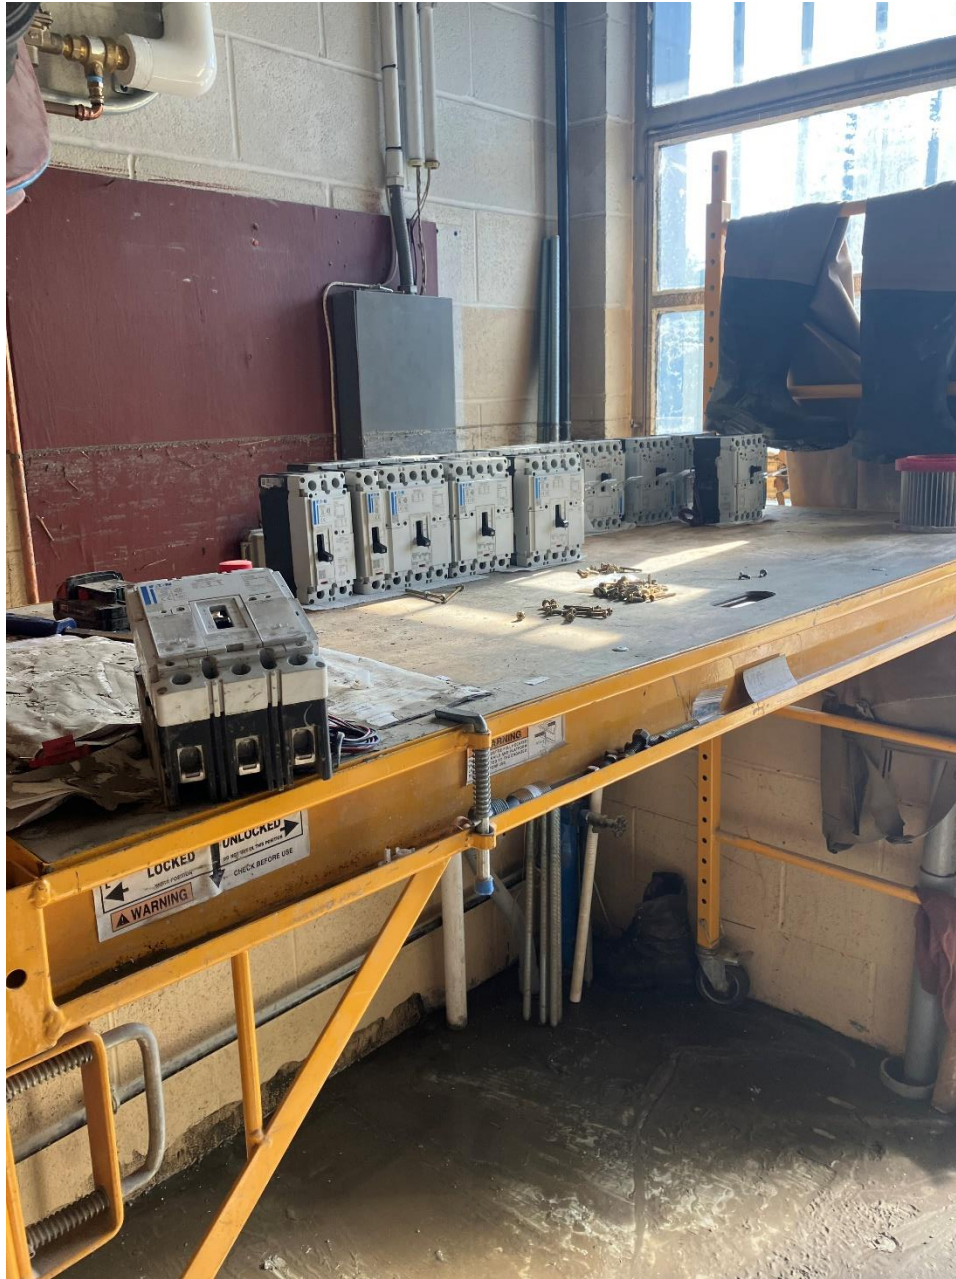
12- New Switches for Upgrade that were Submerged

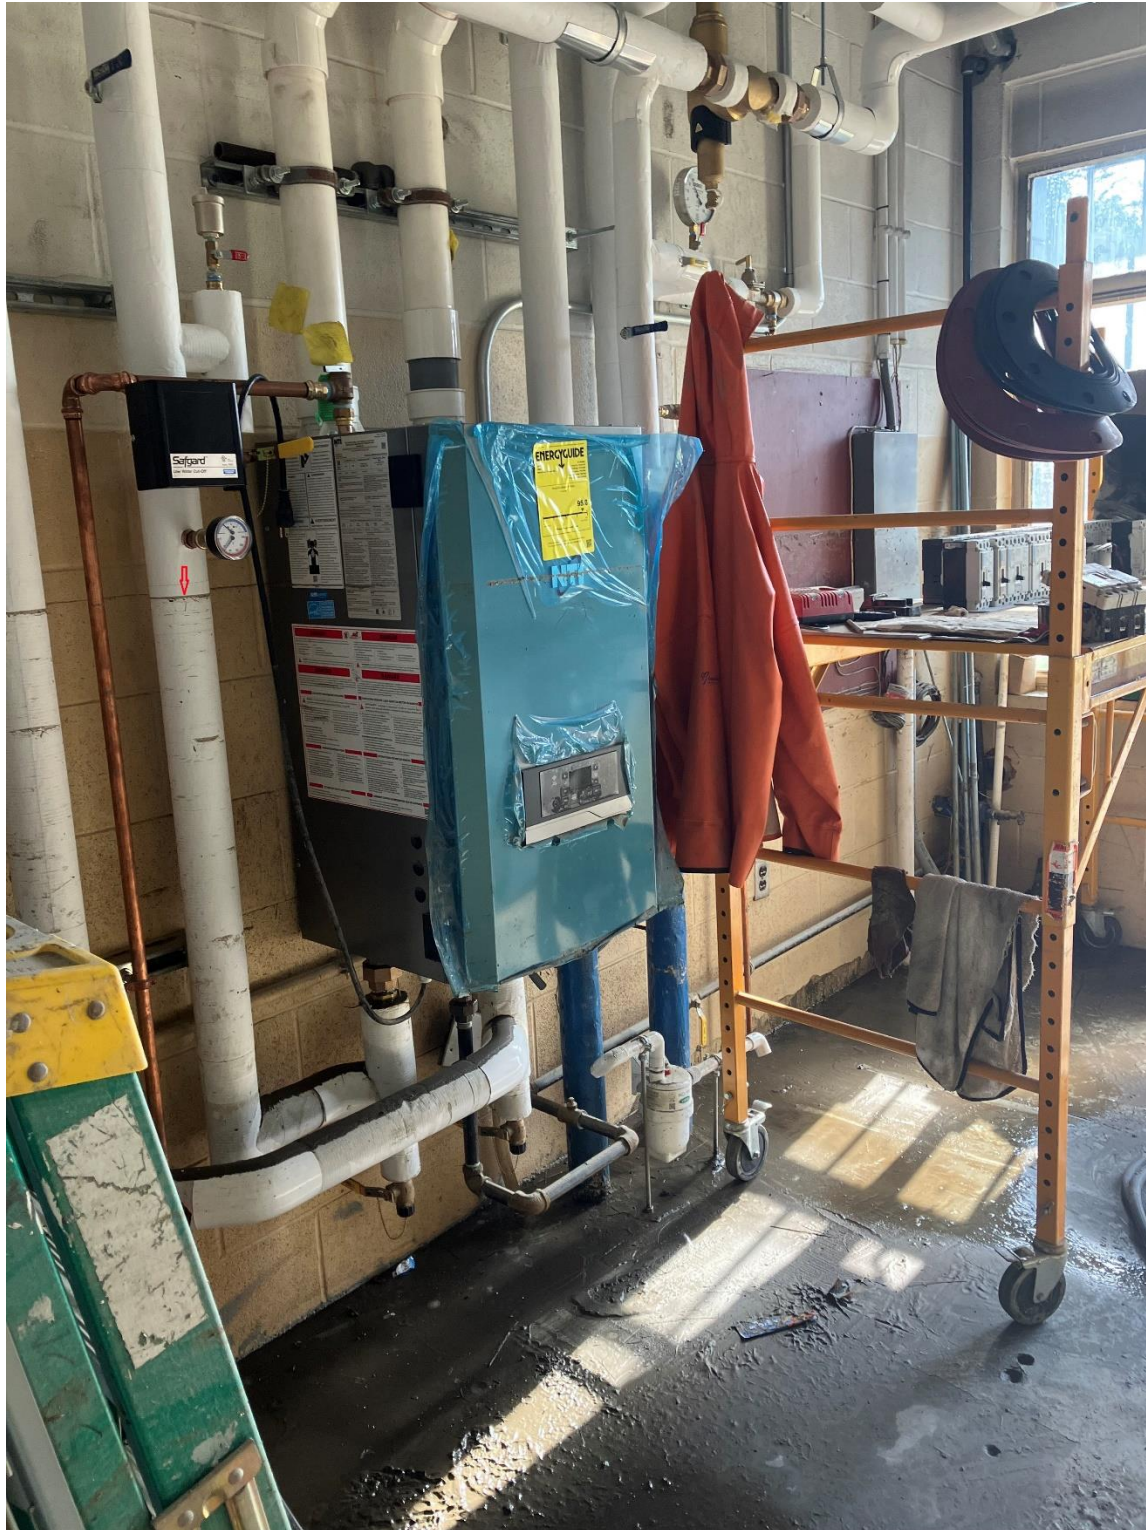
13- Boiler Room with High Water Mark

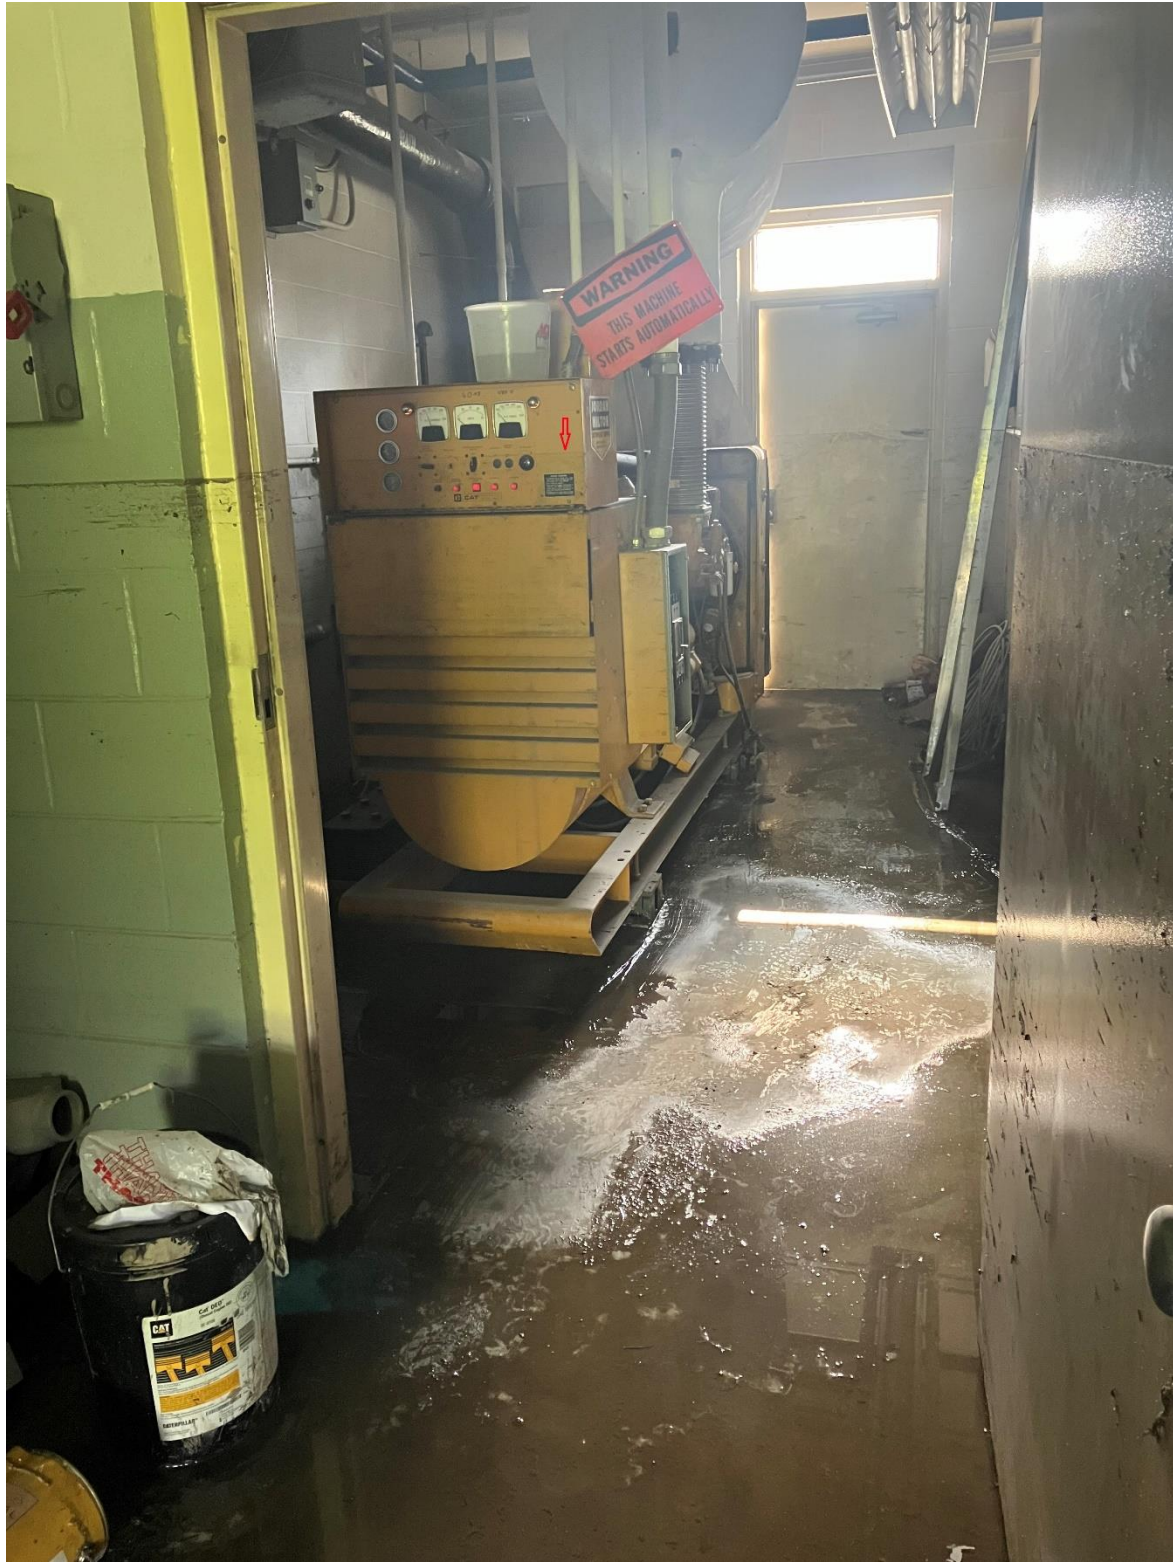
14- Plant Generator High Water Mark

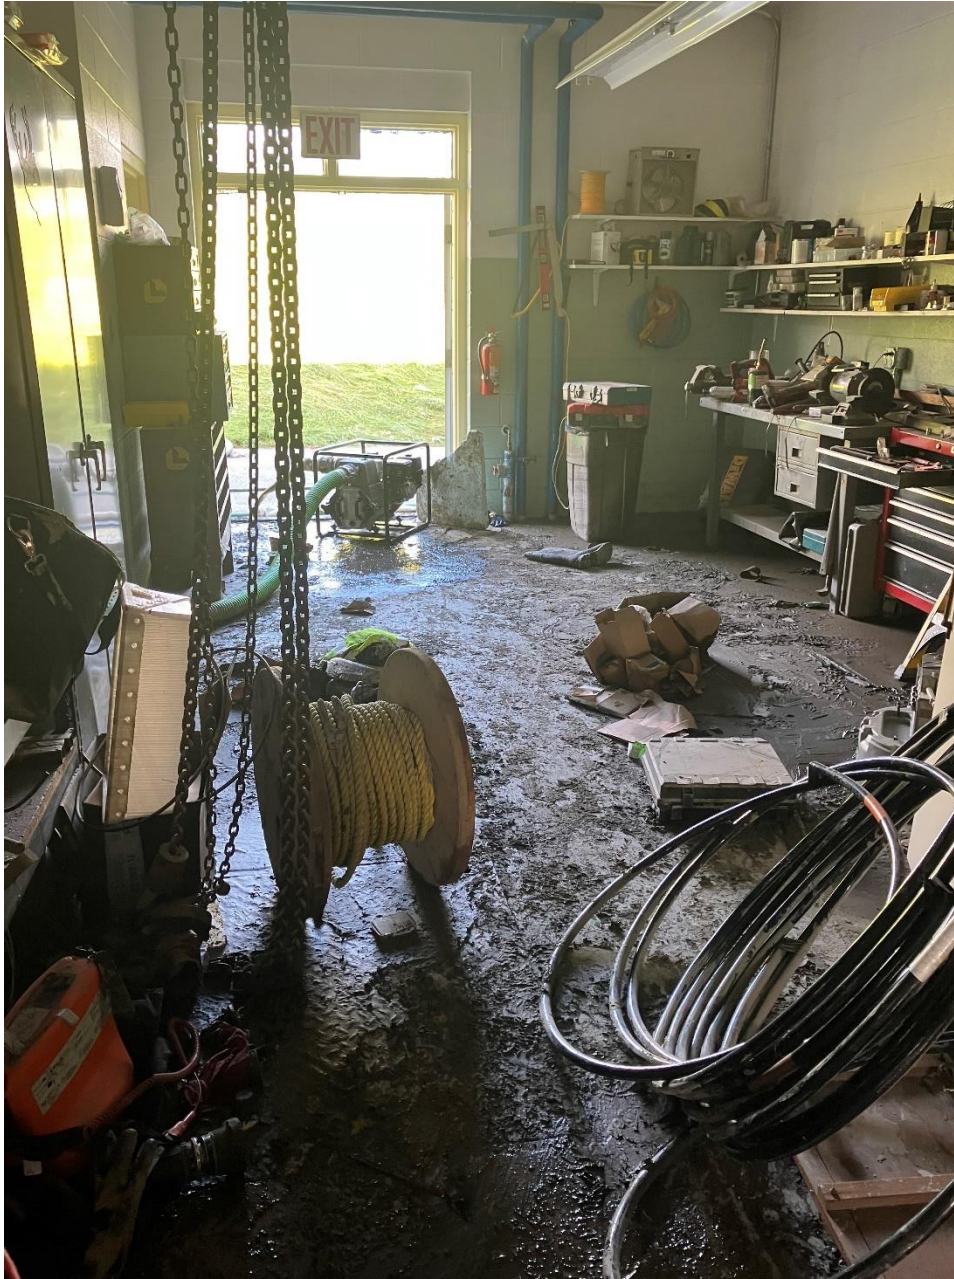
16- Maintenance Room Showing Portable Pump Pumping Out Basement Level

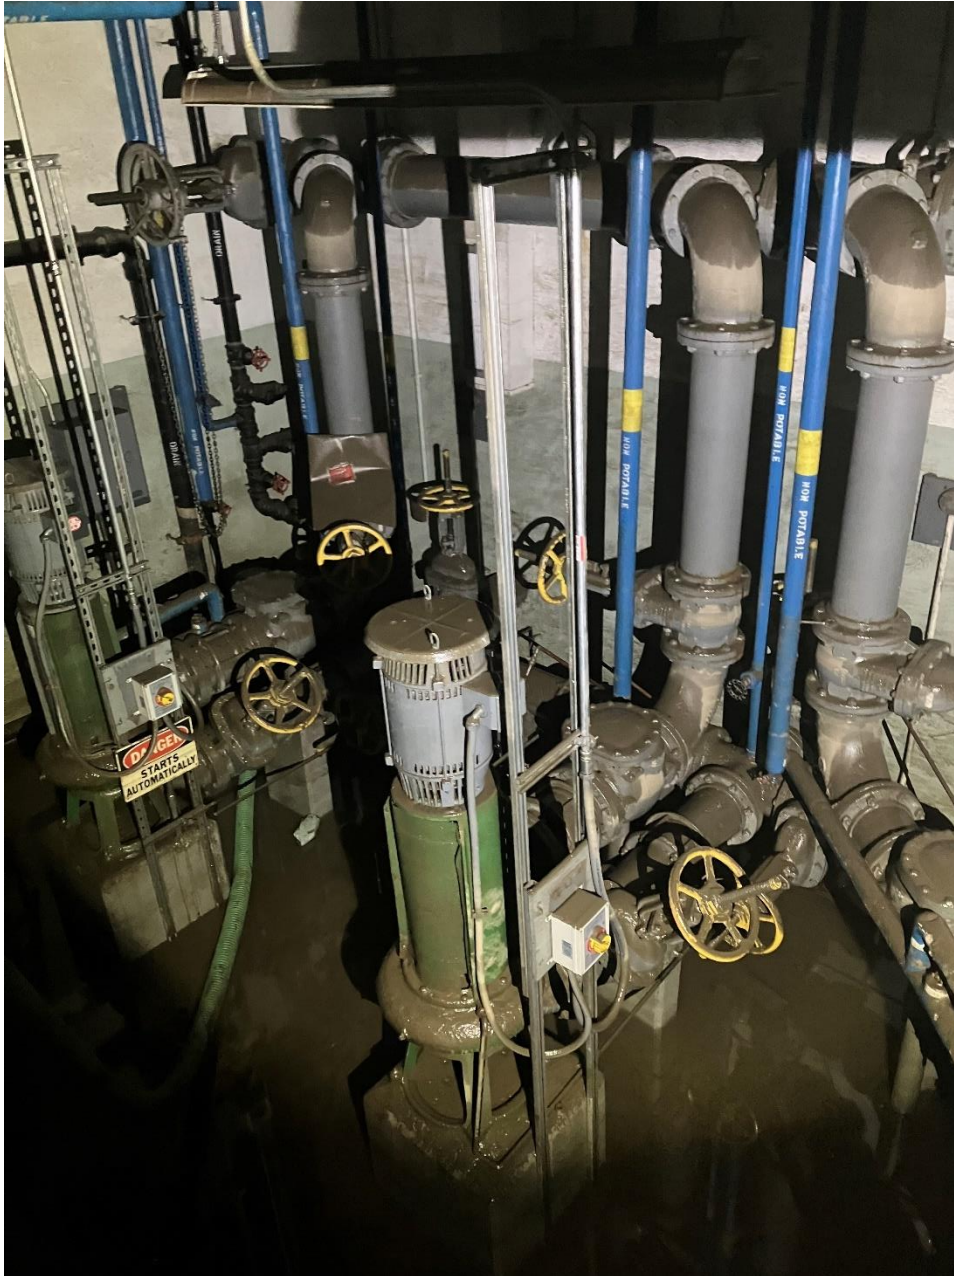
18- Influent Pumps Located in Basement Level

- Replace main influent and grit pumps sludge pumps with immersible units.
- Install flood doors and flood barriers at windows. Inspect and replace as necessary flood proofing at all building penetrations.

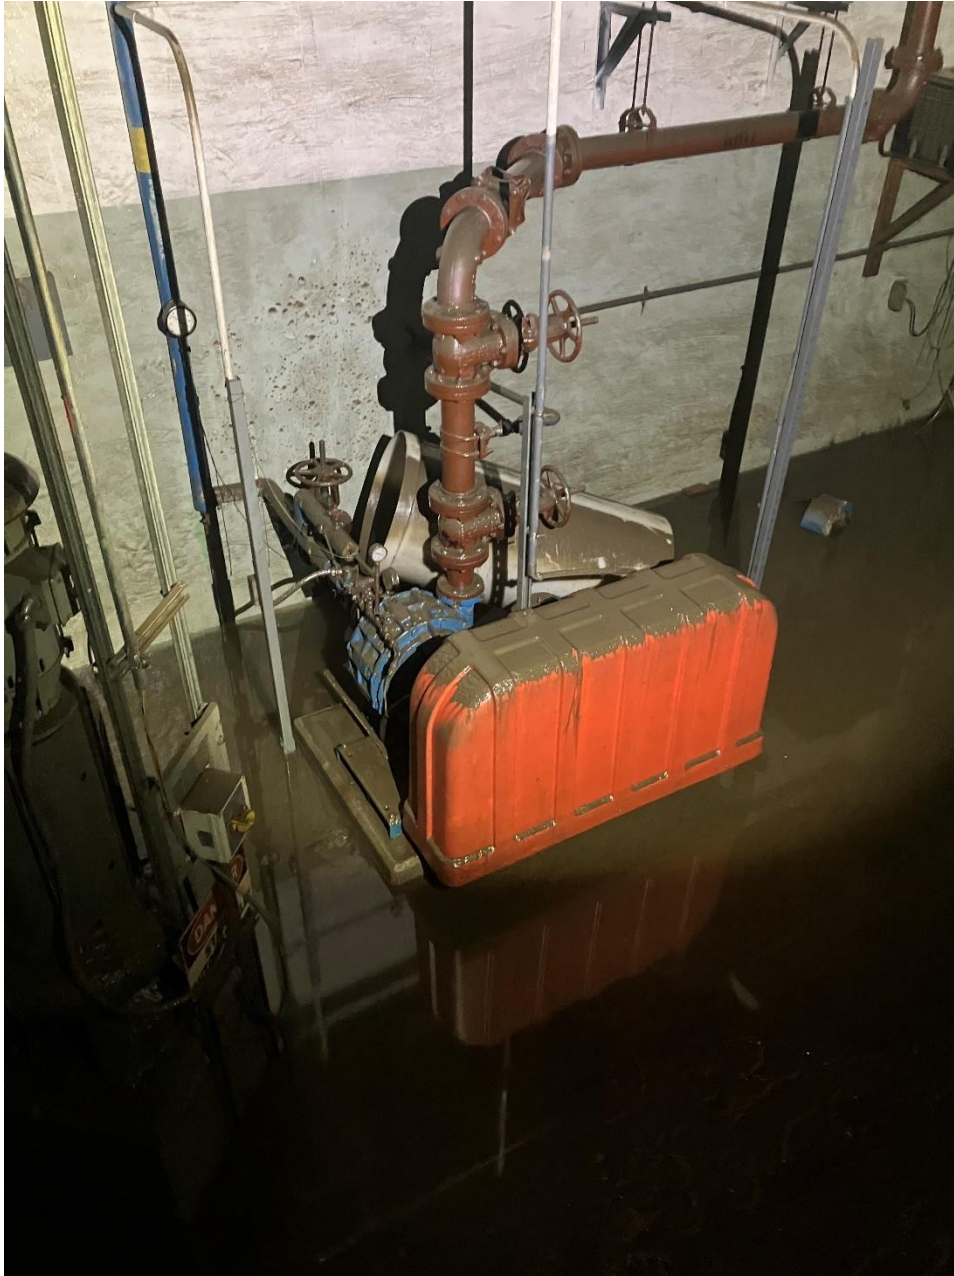
19- Grit Pump Located in Basement Level
