**HARDWICK WASTEWATER
POST JULY 2023 FLOOD
TREATMENT PLANT ASSESSMENT
CALEDONIA COUNTY, VERMONT**

**NPDES PERMIT NUMBER VT0100137
STATE OF VERMONT PERMIT NUMBER 3-1143**

August 29, 2023

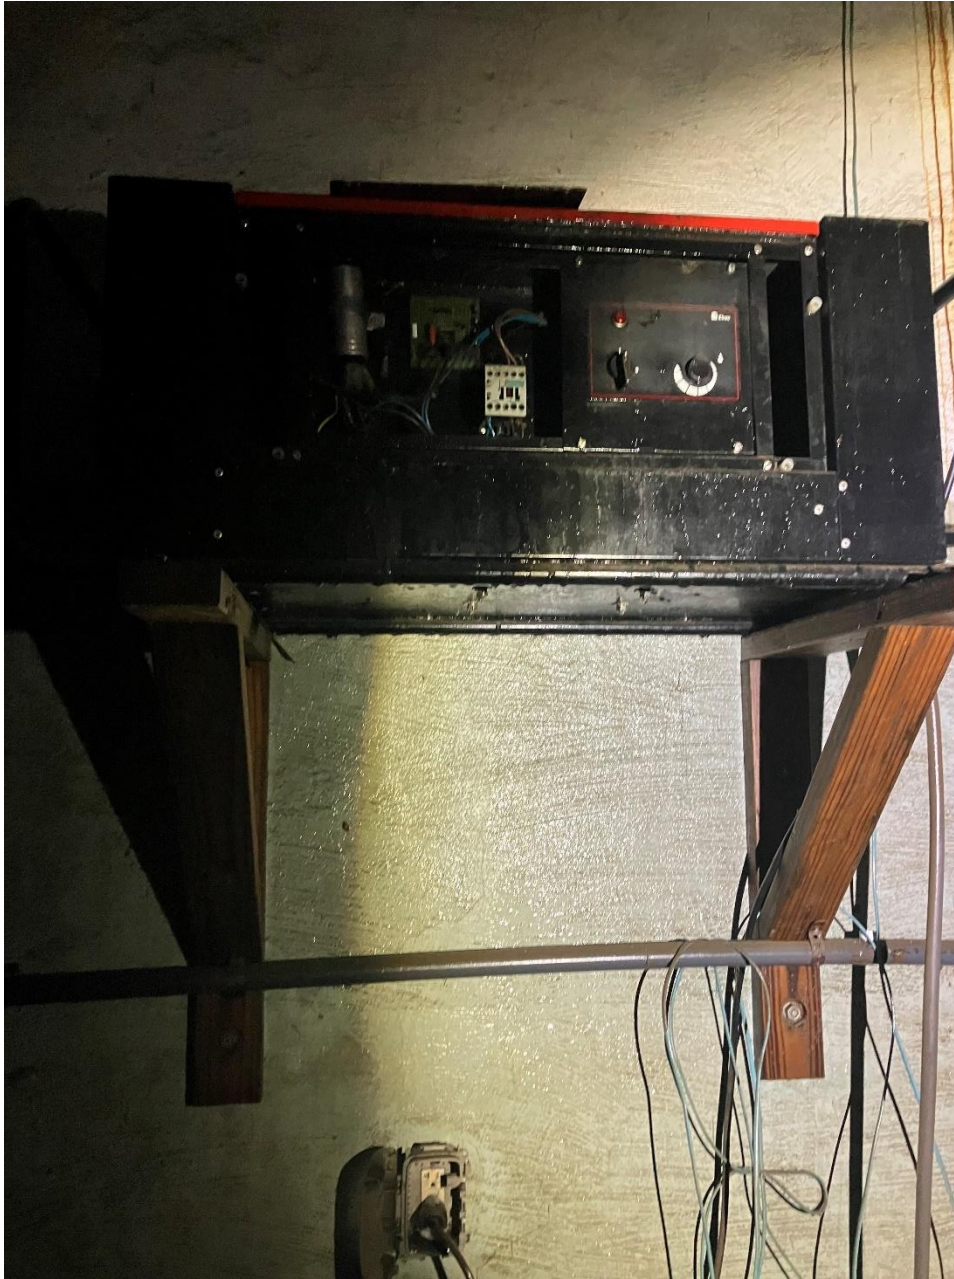
20- Dehumidifier Located in Basement Level

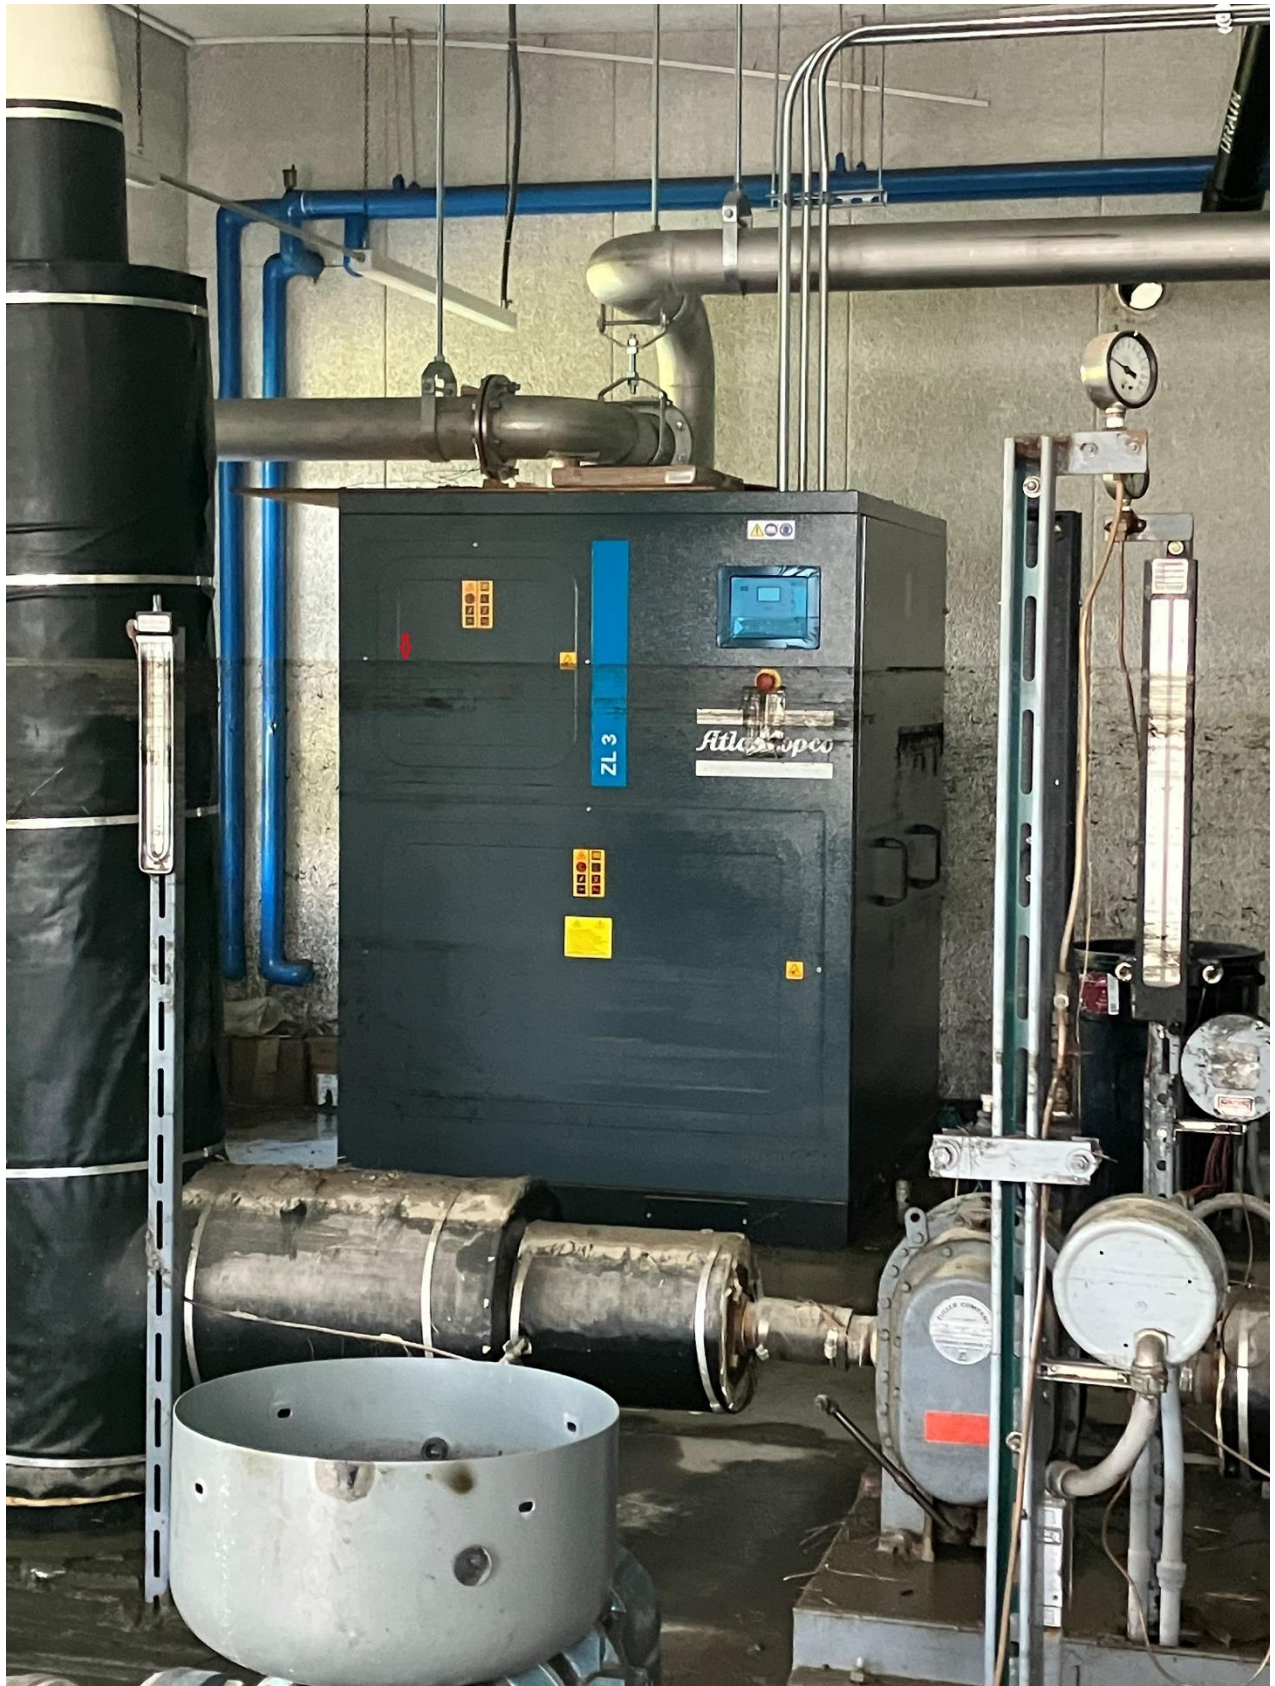
As of July 17, 2023, power had been restored to partial components of the plant and the new blower that had been onsite as part of the improvements project had been installed. Lagoons were being partially aerated.

23- New Blower Installed for Improvements Project High Water Mark

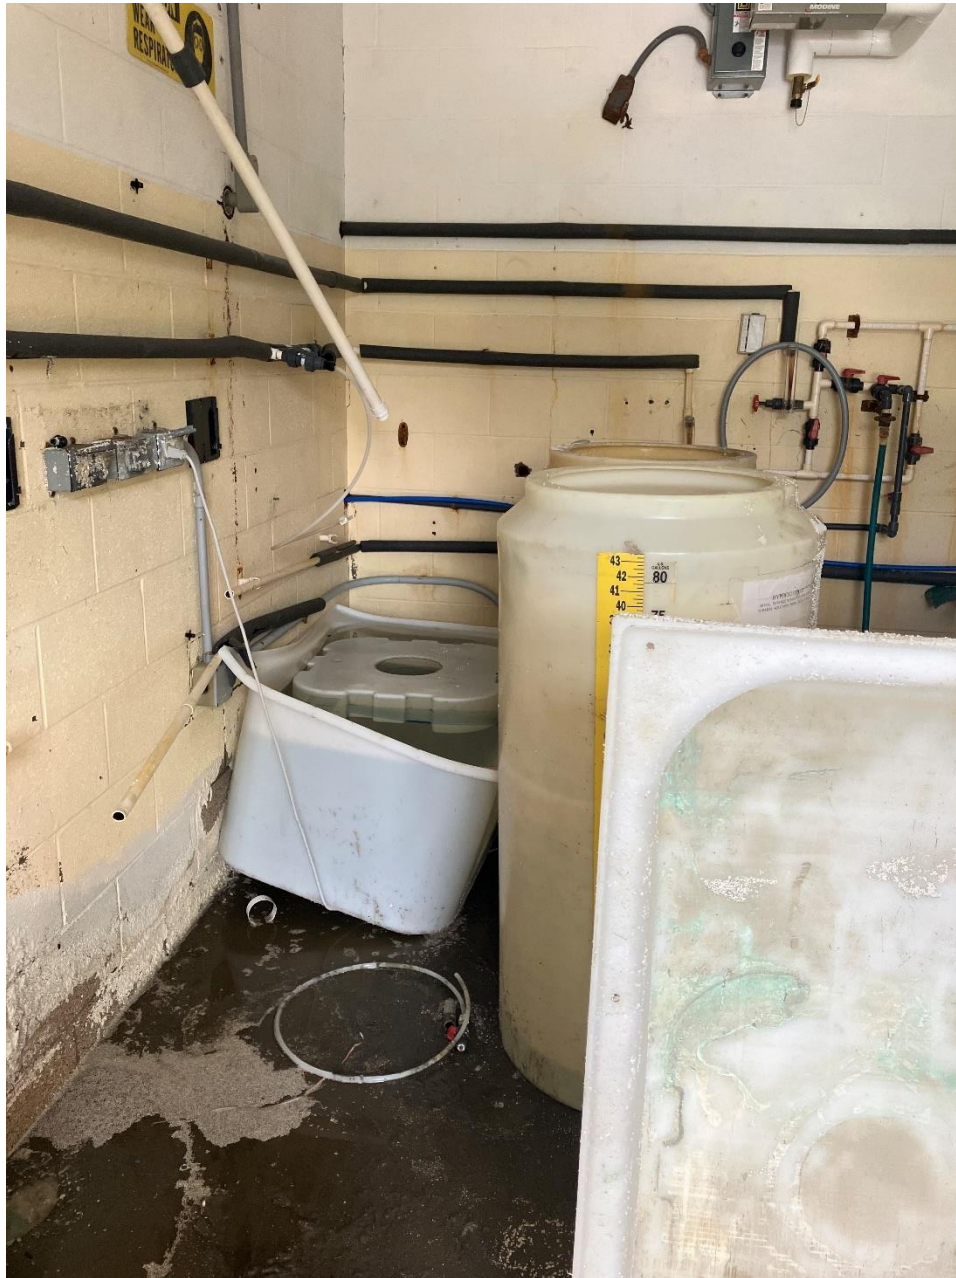
24- Chemical Feed Room with Tanks and Feed Lines

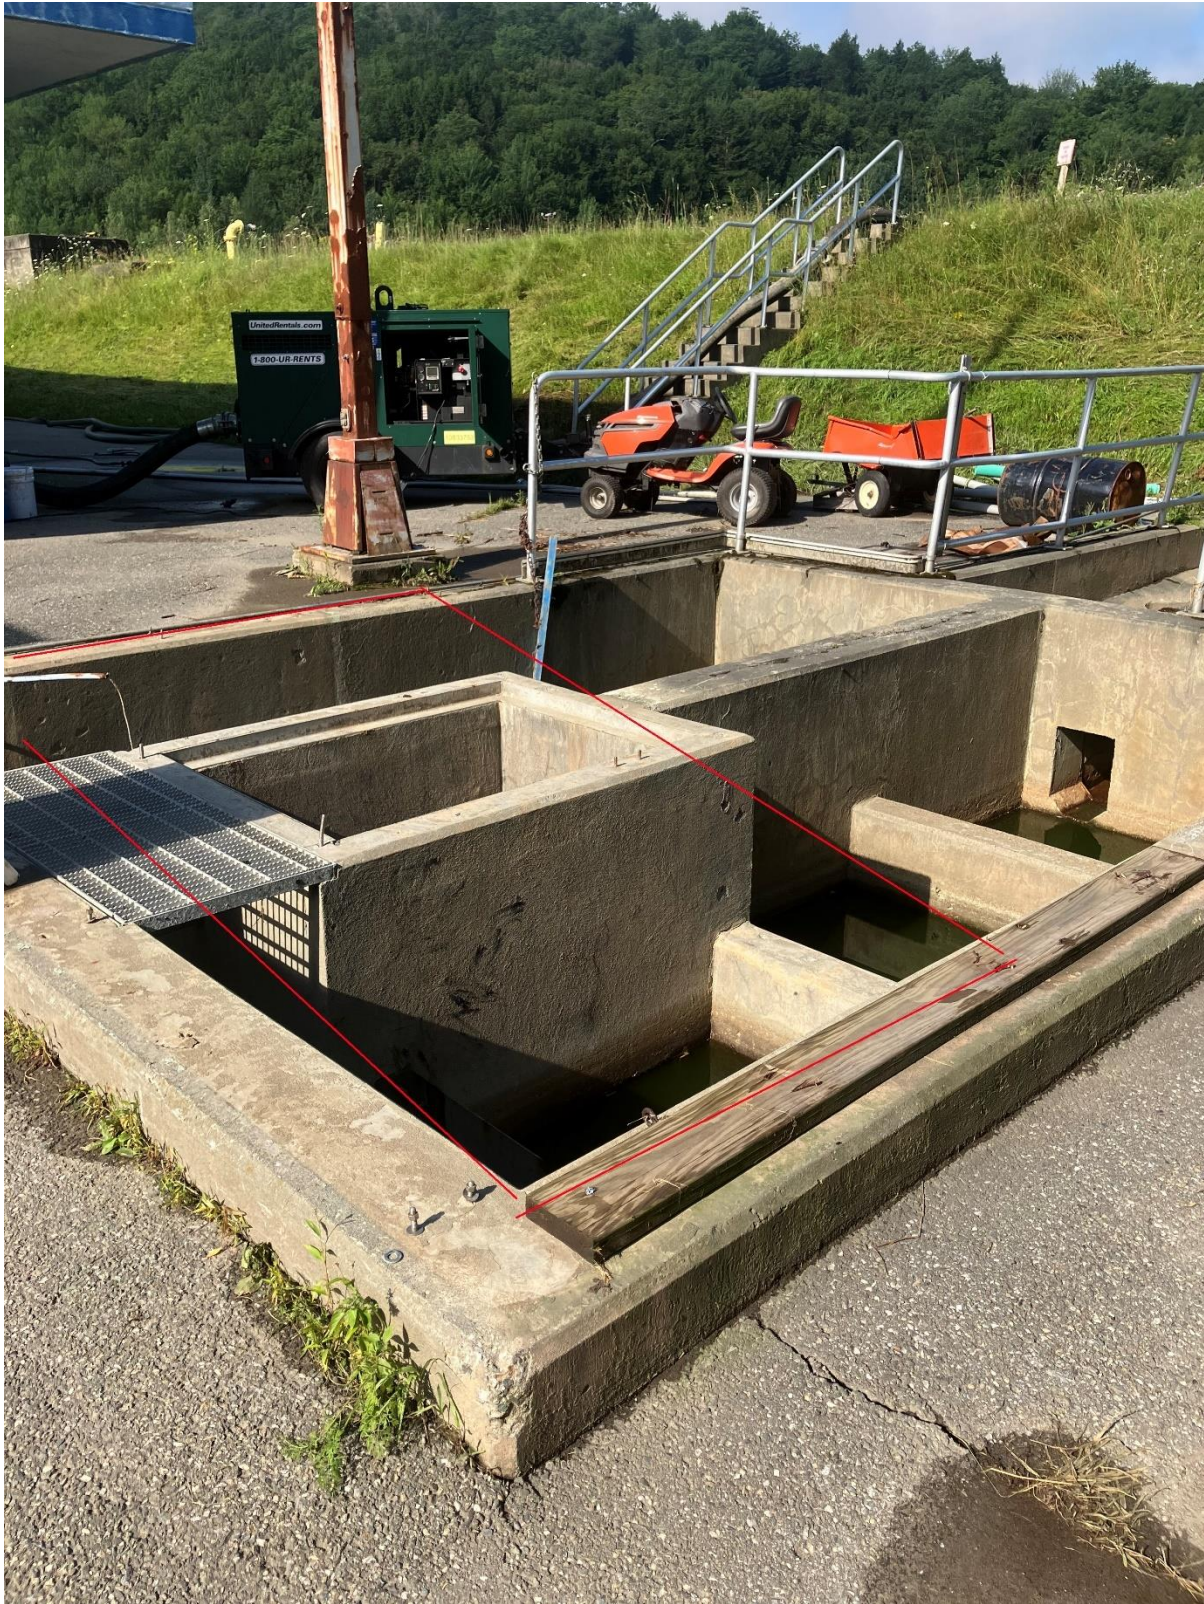
25- Plant Chlorine Contact Chamber with Approximate Location of Where A-Frame Structure Used to Sit

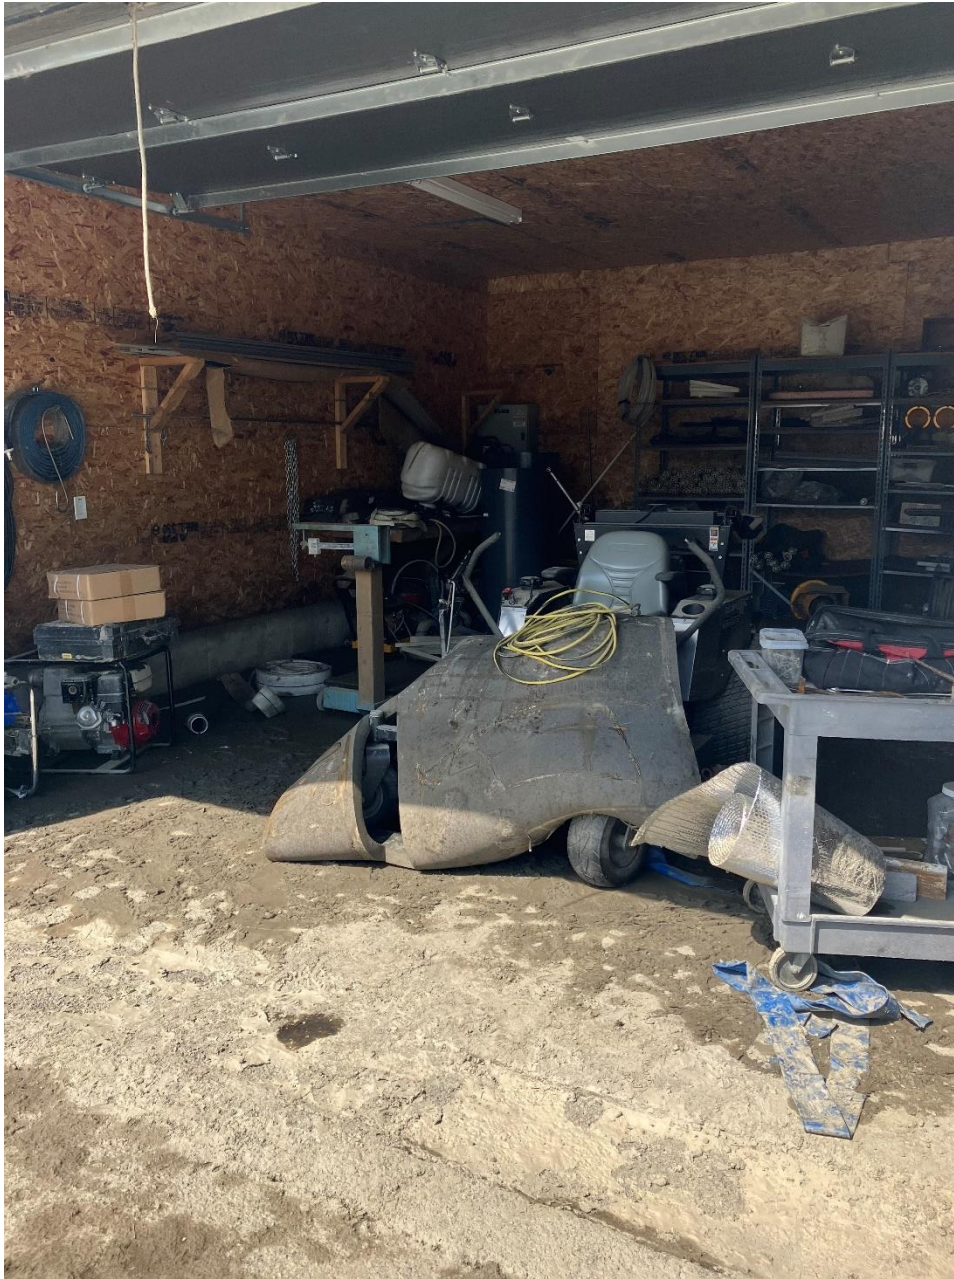
26- Garage Where Lawn Mowing Equipment, Portable Pumps and Hoses, and Spare Parts Were Stored

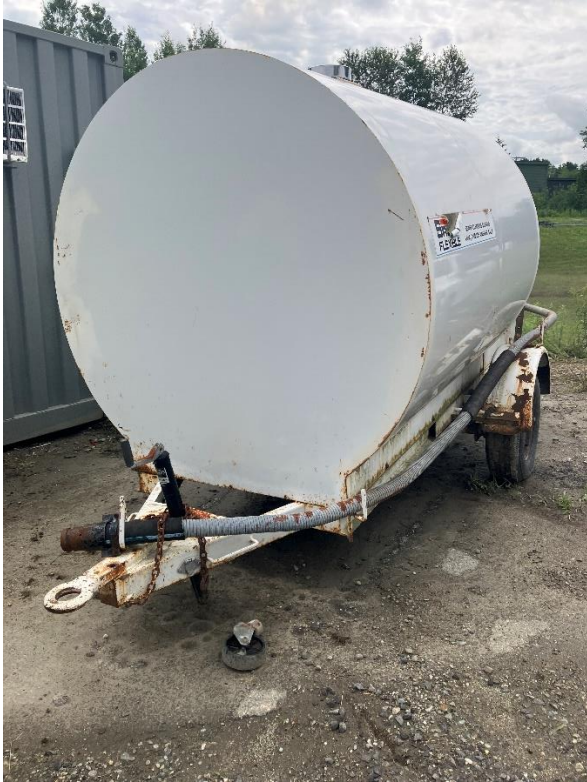
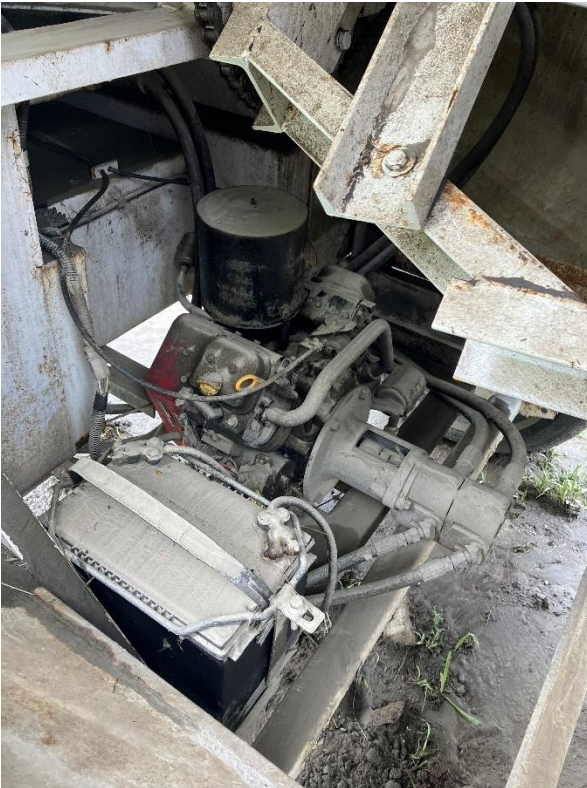
27- Exterior and Interior of Sewer Rodder

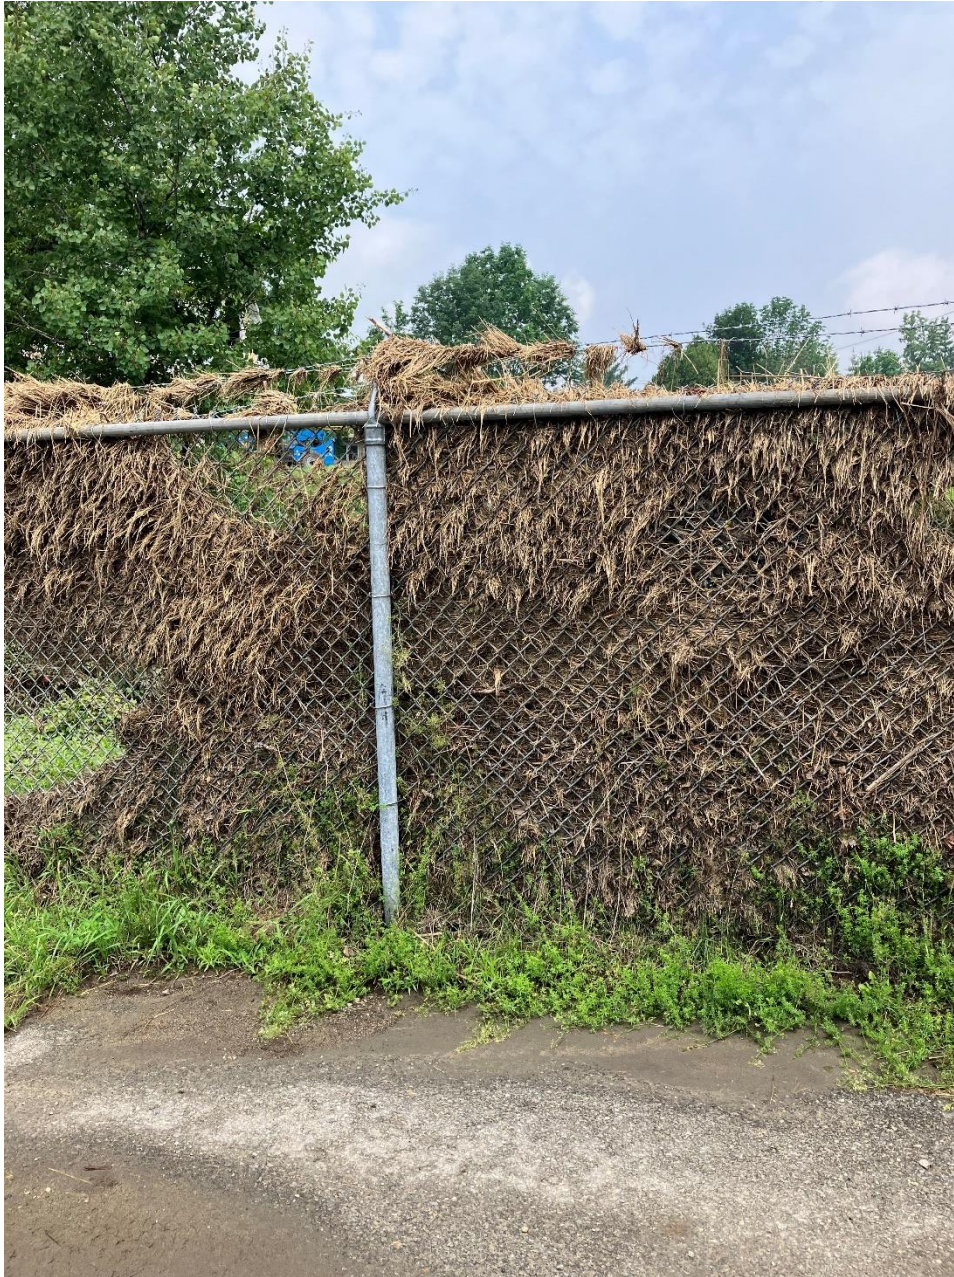
No physical damage to structures was visually observed other than the chlorination building mentioned above. There was damage to the existing site fencing.

28- Site Fencing

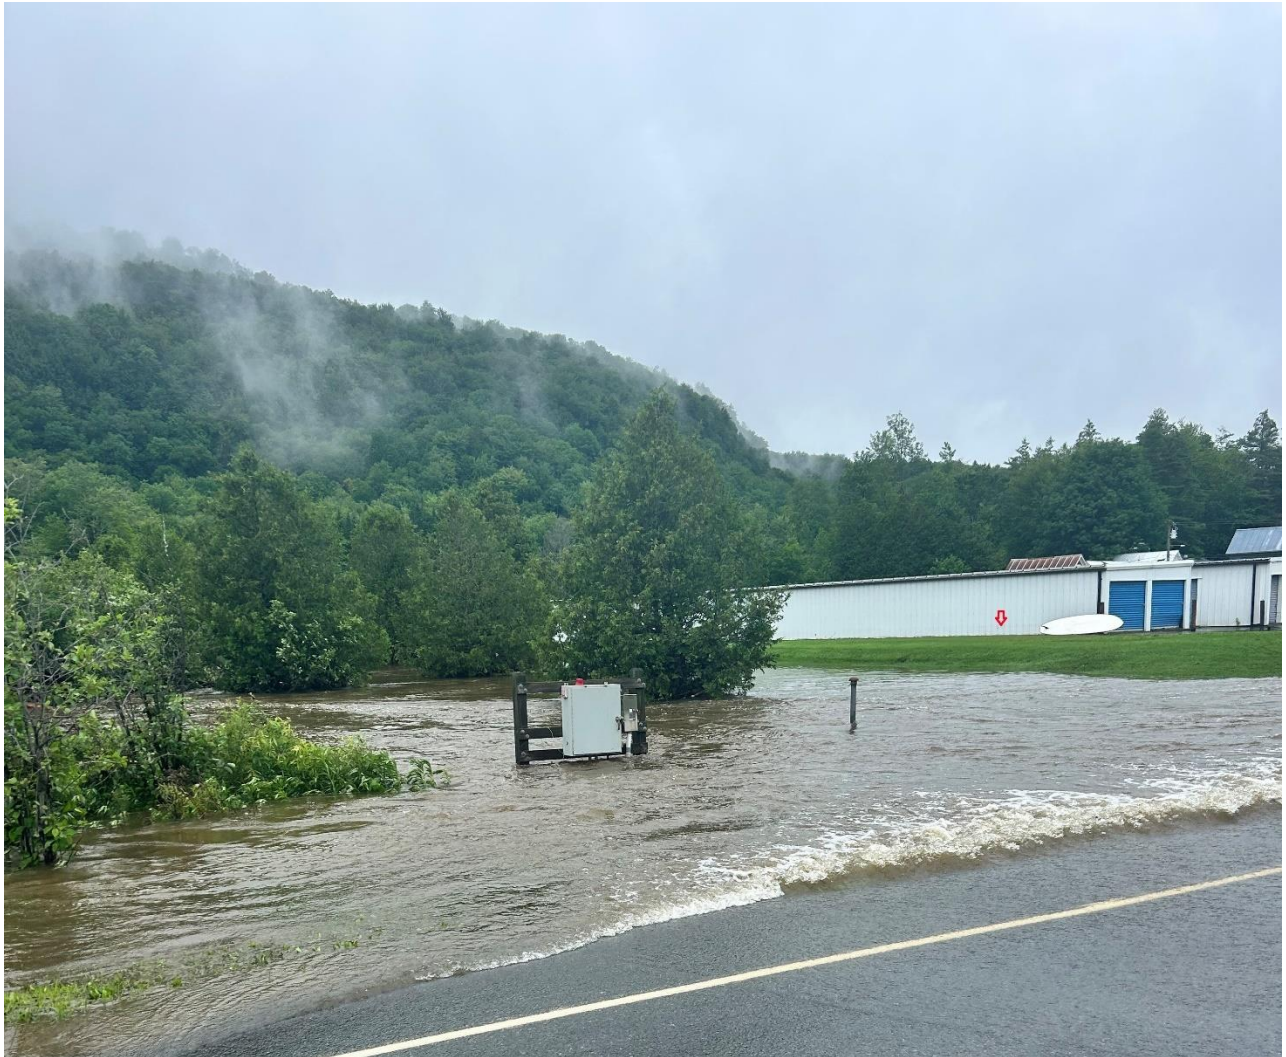
The entire pumpstation with control panel, electrical components and remote monitoring system were submerged. There was silt and debris accumulation, and likely damaged conduits. The wet well interior appeared unimpacted. The pump station was not operable during the first two site visits. Waste was being pumped and trucked to the Buffalo Street Pump Station. By the July 18th site visit a temporary control panel had been installed to allow manual on/off operation of pumps.

29- Rte. 14 Pump Station After Flood Waters Receded, Note High Water Mark on Adjacent Building (photo by Chief Operator Ken LaCasse)

- The Rte. 14 and Buffalo Street Pump Stations received appreciable amounts of grit and sediment from the upstream collection system inundation were likely conveyed into the wet wells. Subsequently, pump performance should be checked for accelerated wear. Pumps which show evidence of water intrusion in bearing grease or oil should be replaced or reconditioned. Replacement of VFD's, panel heaters, and miscellaneous associated relays & terminal strips. Extended manual operation may necessitate replacement of main breakers. Complete panel replacements may be more economical than component replacements.

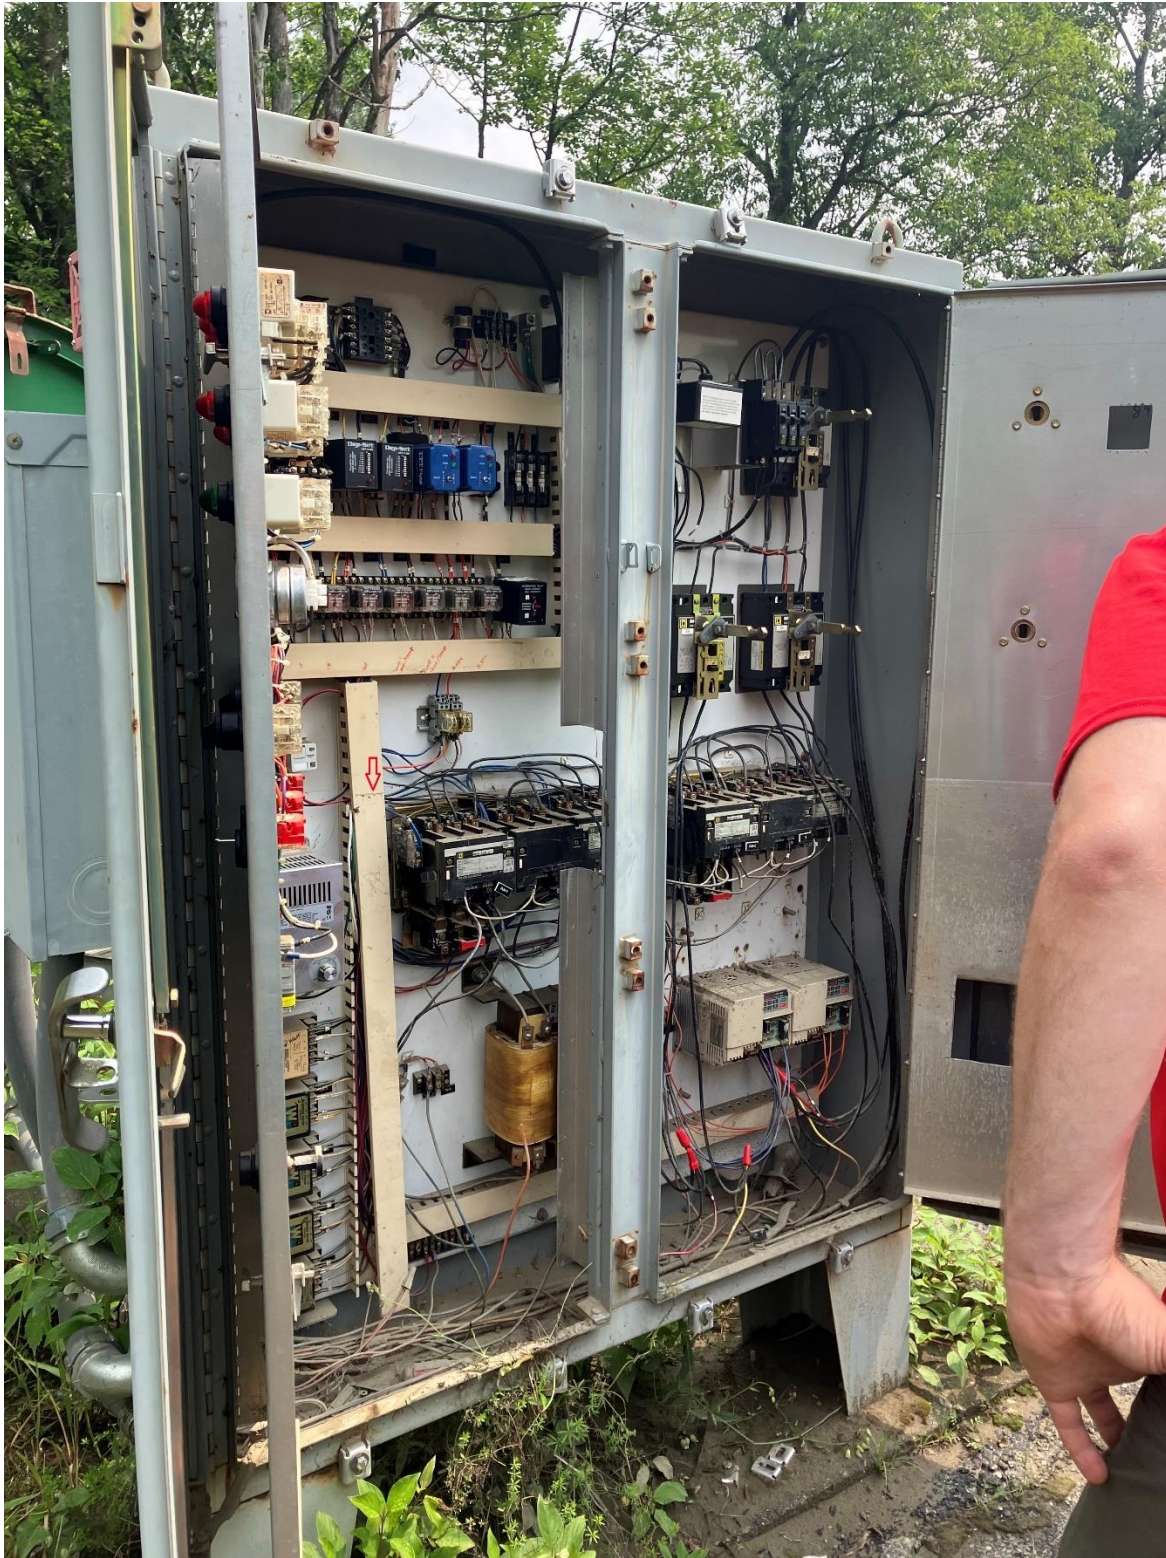
The main components of the wastewater pump station were submerged. Damage was limited to the partially submerged control panel, electrical components, dehumidifier, phone communications, silt and debris accumulation, and likely damaged conduits. The panel had been temporarily modified to allow manual on/off operation of pumps.

30- Buffalo Street Pump Station Control Panel High Water Mark

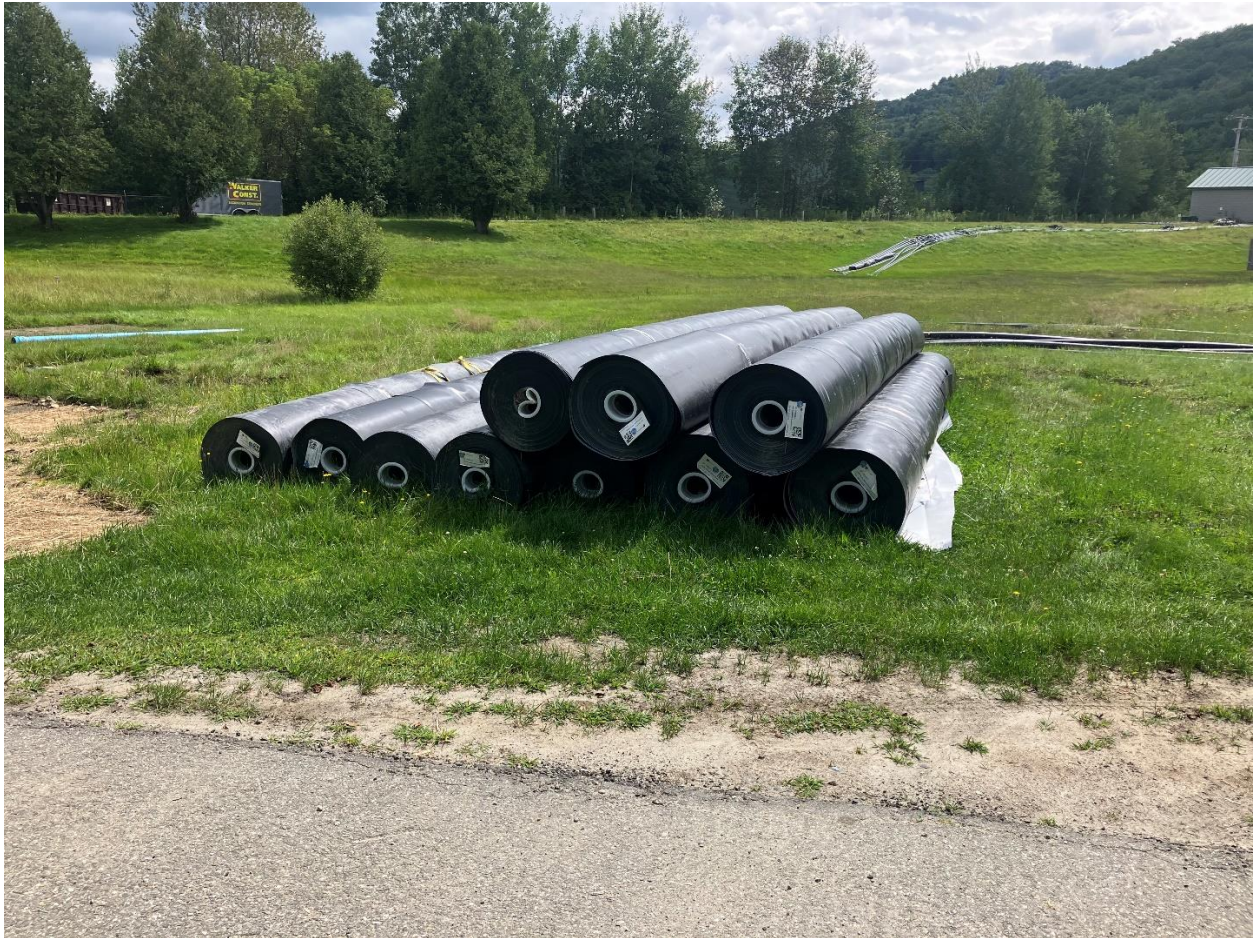
Ten (10) new rolls of liner for the lagoons were on-site and slated for installation as part of the capital improvement project. Several rolls were carried by flood waters several hundred yards. The extent of damage is unknown and should be elevated prior to installation.

31- Ten (10) Rolls of Lagoon Liner Awaiting Installation for Improvements Project. All Ten Rolls Were Submerged, Several Rolls Were Carried Away by Flood Waters and Retrieved After Flood Waters Receded.
