**LUDLOW WASTEWATER
POST JULY 2023 FLOOD
TREATMENT PLANT ASSESSMENT
WINDSOR COUNTY, VERMONT**

**NPDES PERMIT NUMBER VT0100145
STATE OF VERMONT PERMIT NUMBER 3-1208**

September 13, 2023

This report was prepared based on observations made during the July 18th site visit by Heather Collins, VT DEC, WSMD, WWMP in conjunction with Army Corps of Engineers and US EPA Region 1 representatives.

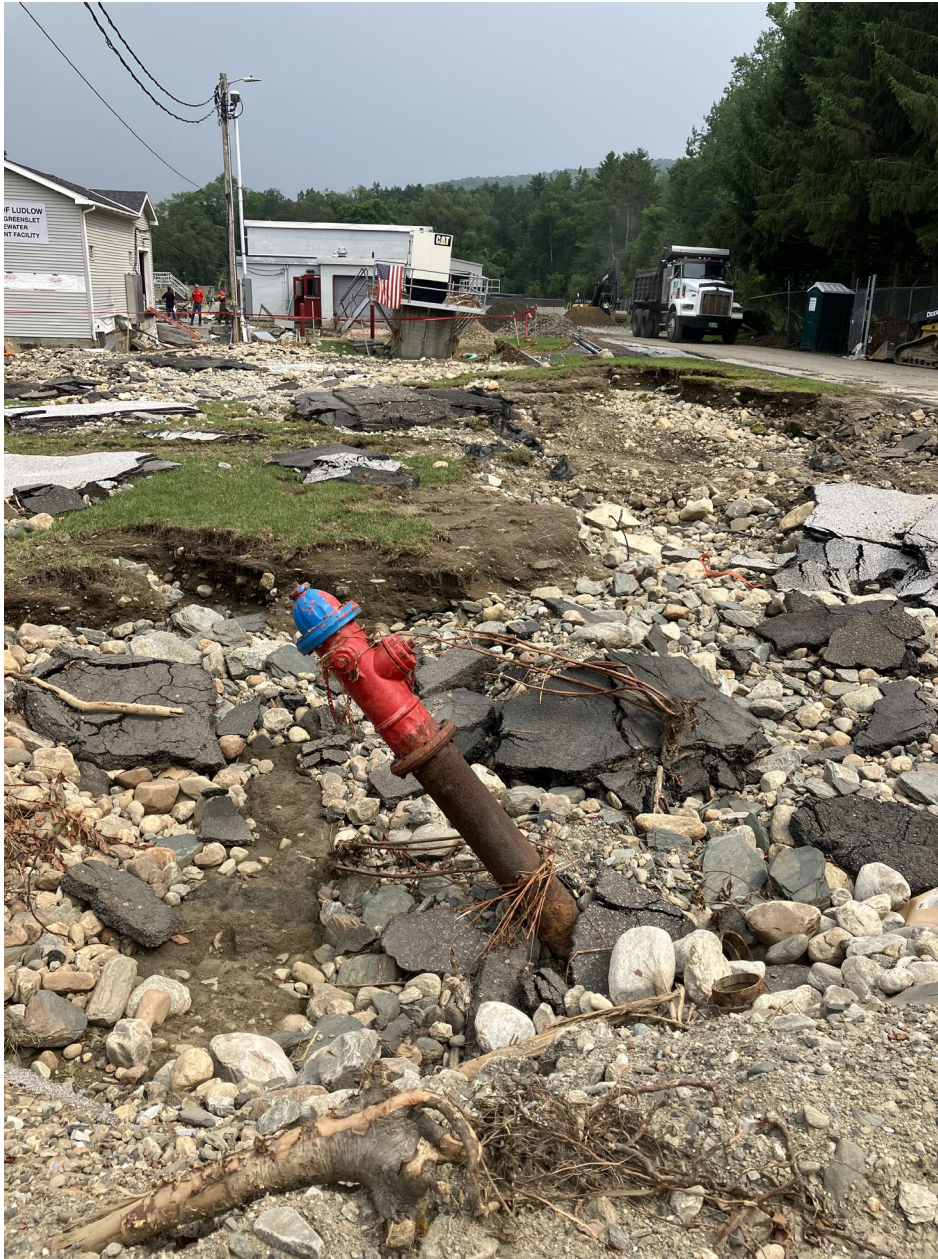
The facility site suffered appreciable damage from erosion and scour. Much of the site's asphalt had been destroyed and pieces scattered throughout the property. The majority of the facility's fencing was destroyed. Buried piping and conduits were exposed in several locations. Aside from the plant's potable water service, the operator did not believe any process piping was leaking. A sludge pipe was showing joint deflection but had not yet been tested.

1 – Entrance to Ludlow WWTF Showing Extreme Scour and Asphalt Displacement

- The site will require replacement of fill materials as well as replacement of multiple conduits and conductors throughout. Overall fine grading and repaving of the entire site will be required. A significant portion of the site fence was damaged or completely destroyed.

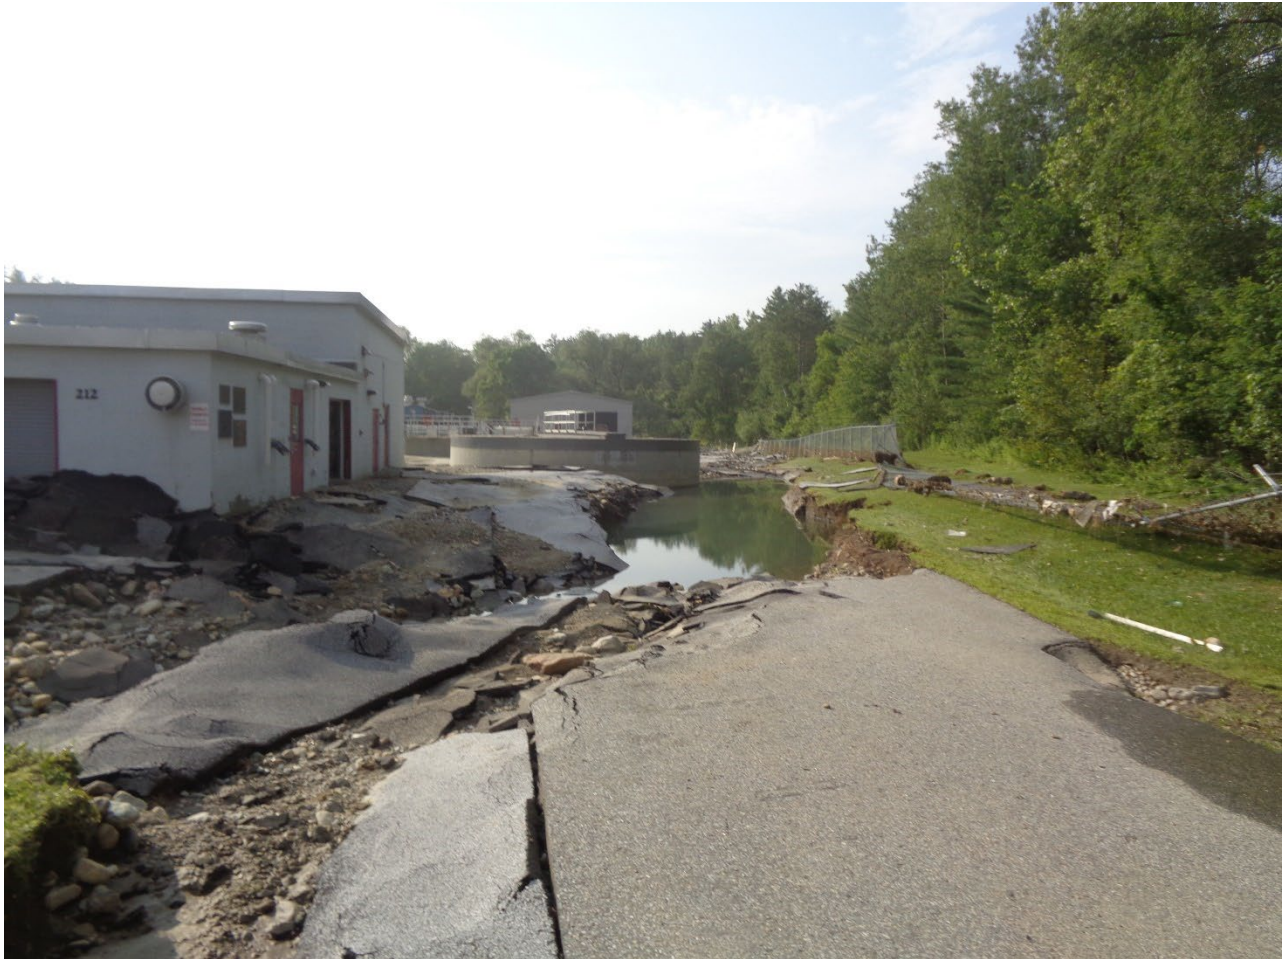
2 – Entrance to Ludlow WWTF Showing Extreme Scour and Asphalt Displacement, No. 3 Secondary Clarifier in the Background (Photo courtesy of Aldrich and Elliot, PC)

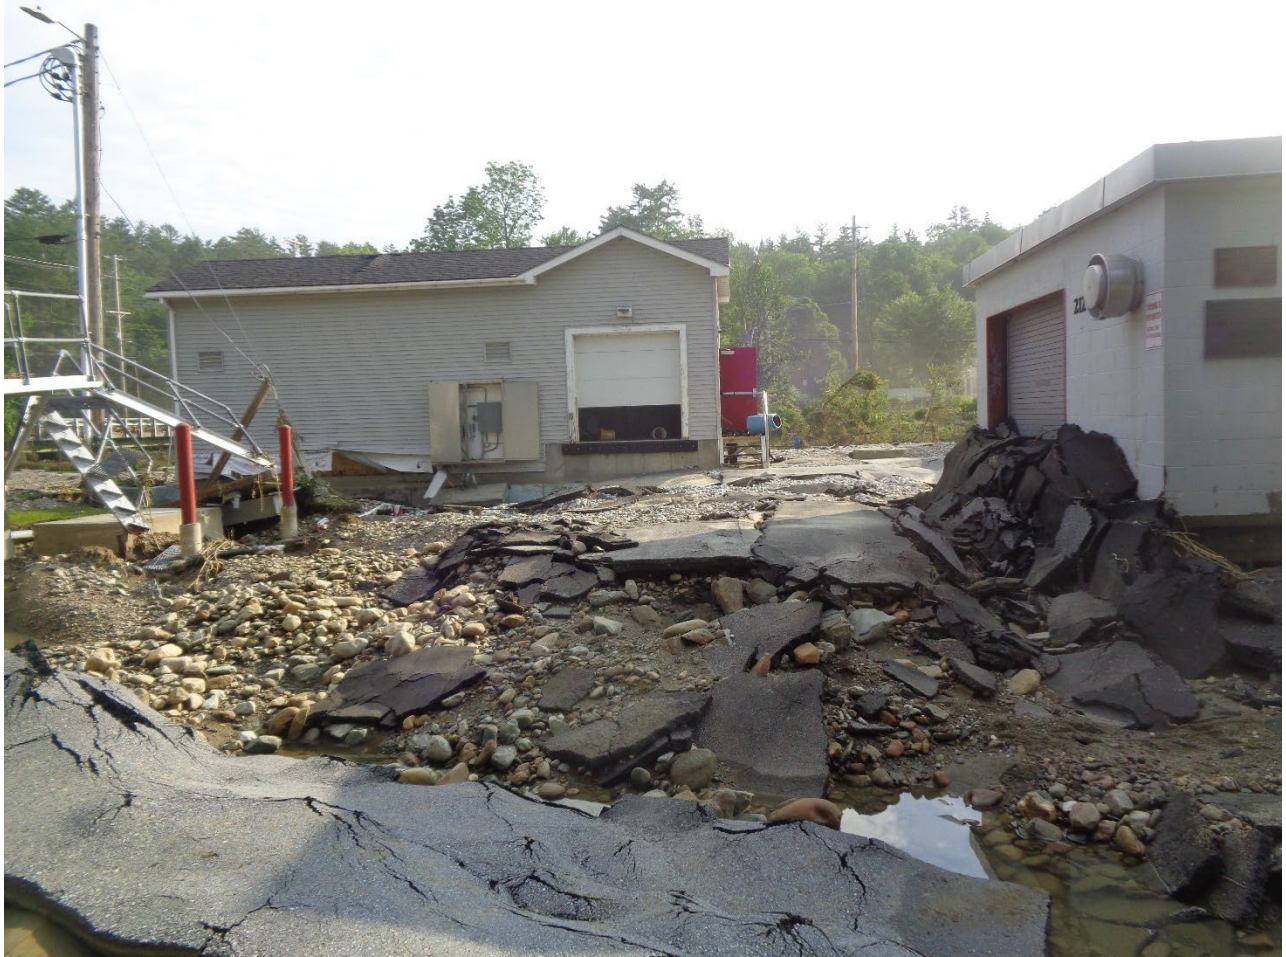
Headworks Building: An appreciable amount scour was observed around the upstream side of the drum screen / headworks building. The below grade structure is deep and constructed of reinforced concrete. Damage appears limited to some siding on the upper, stick-built portion of the building and electric service. The interior was full of silt and debris. The rotary drum screen was submerged in flood waters and was offline due to control/power issues and influent was being bypassed through the bar racks. The external control panel was damaged. The headworks appeared to be operational with a temporary electric service from the main plant building.

3 – Left Side: Headworks Building, Right Side Main Control Building. Displaced Asphalt Deposited and Extreme Scour (Photo courtesy of Aldrich and Elliot, PC)

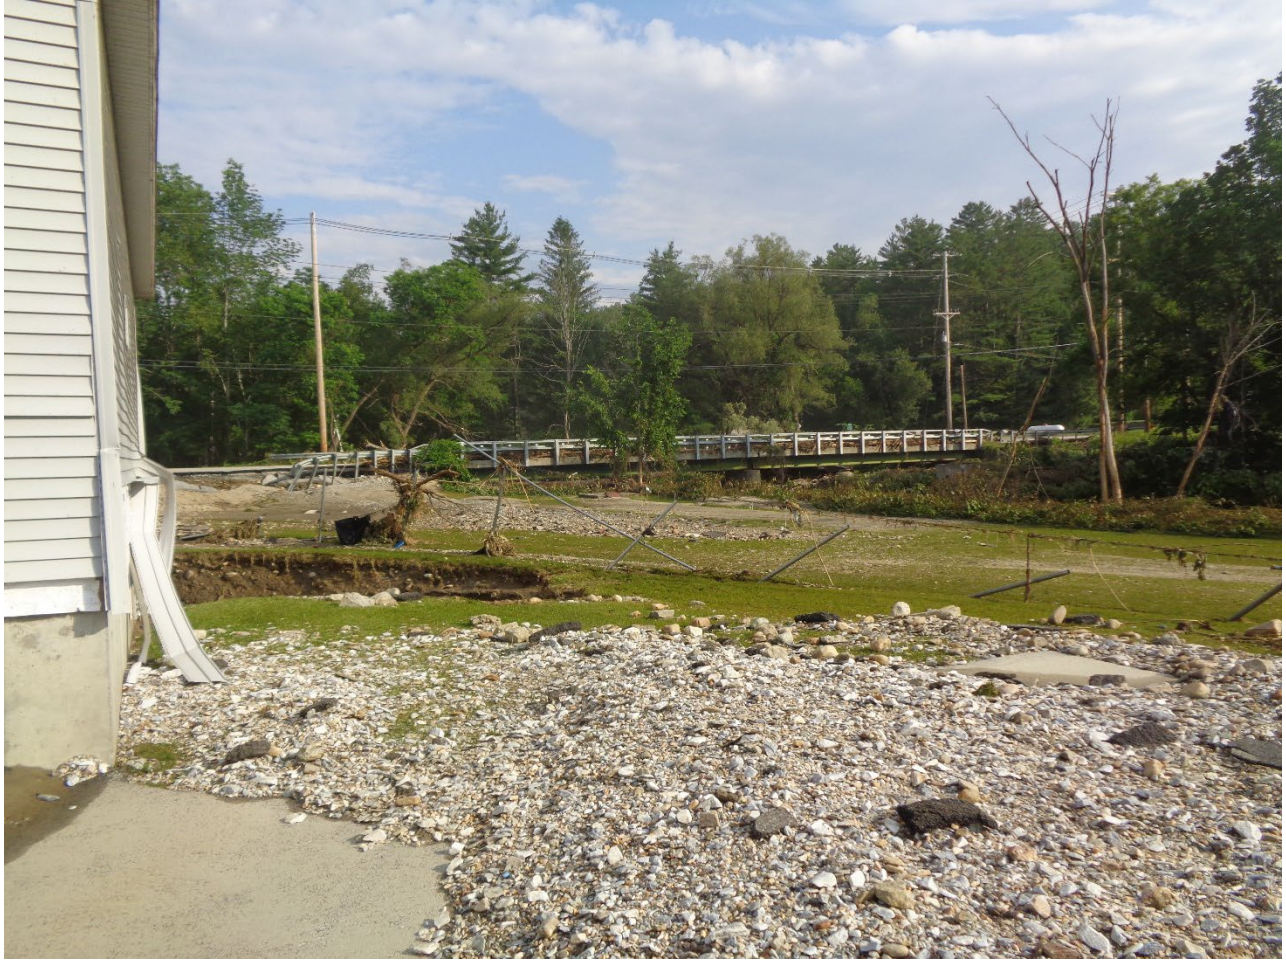
4 – Left Side: Headworks Building, Looking Back Towards Entrance. Extreme Scour and Site Fence Damage (Photo courtesy of Aldrich and Elliot, PC)

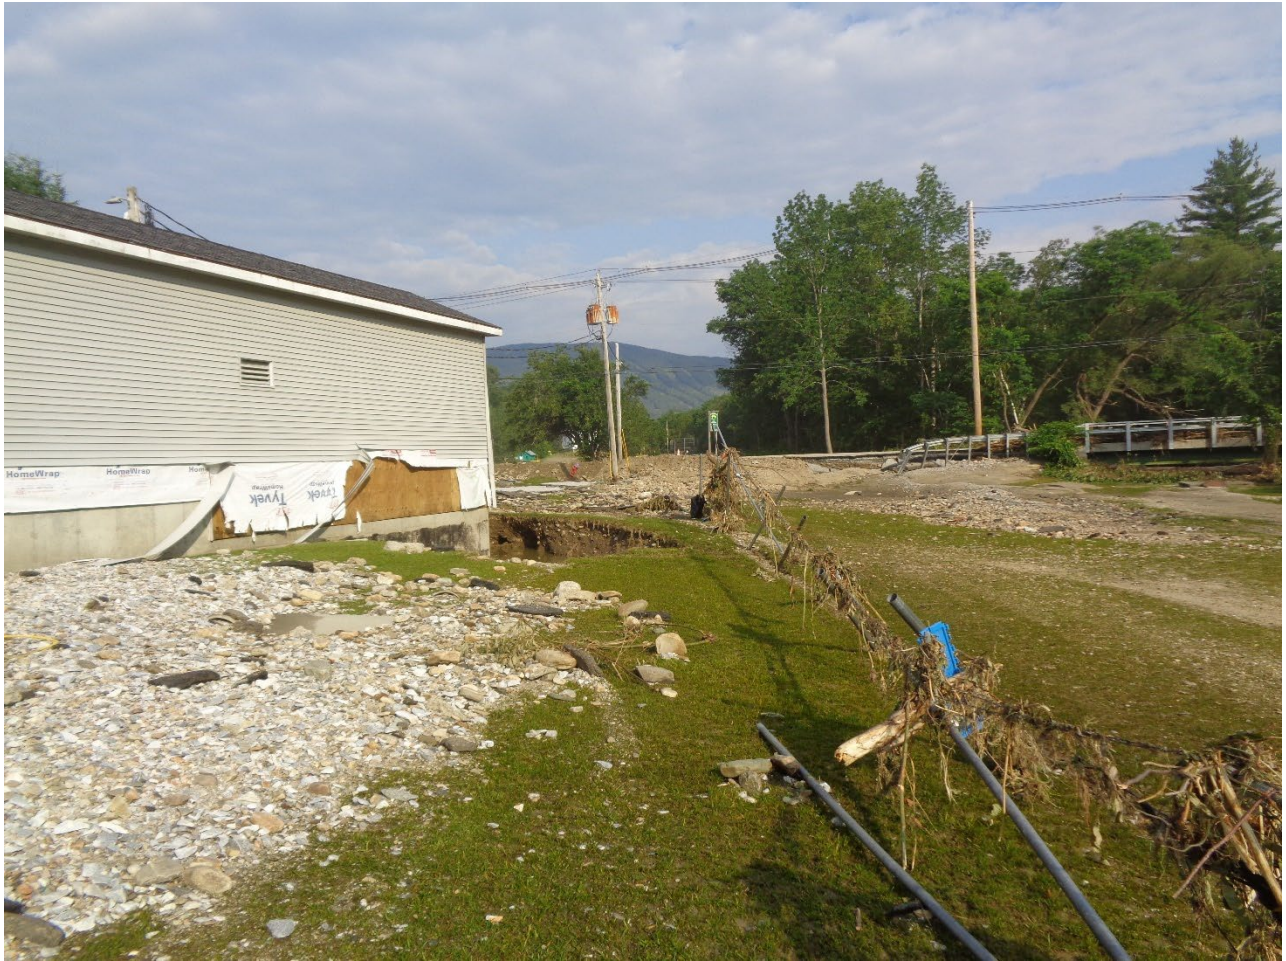
5 – Left Side: Headworks Building, Looking Back Towards Entrance. Damage to Exterior of Building and Extreme Scour and Site Fence Damage (Photo courtesy of Aldrich and Elliot, PC)

- Grit, mud and debris removal from the headworks will be necessary and evaluating the performance of the rotary drum screen.
- The Headworks building also has siding replacement that will be required.

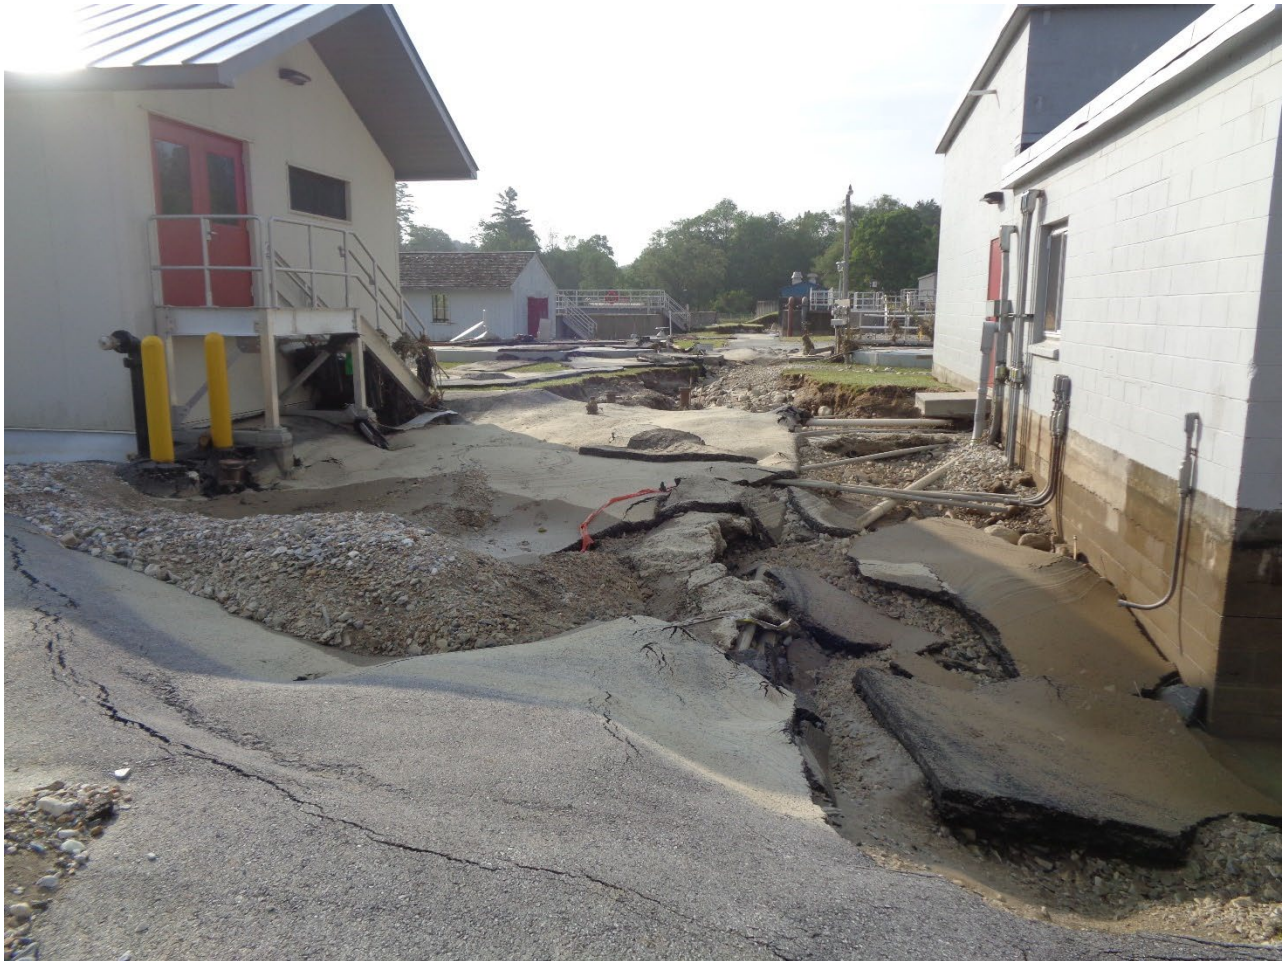
7 – Left Side: Influent Pump Station, Right Side Main Control Building. Displaced Asphalt Deposited, Extreme Scour, and Exposed Conduit and Piping (Photo courtesy of Aldrich and Elliot, PC)

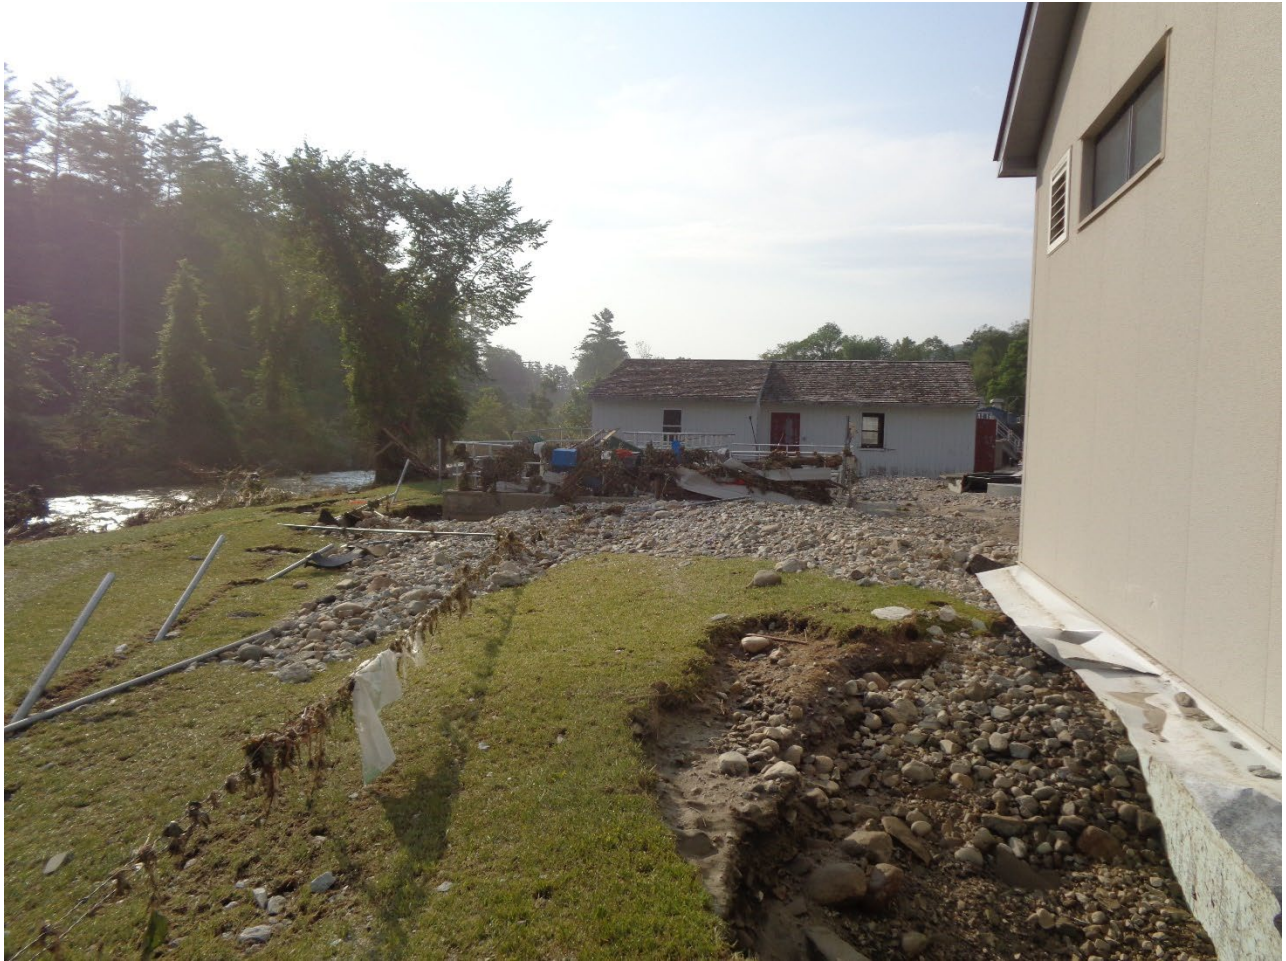
8 – Back of Influent Pump Station, Looking Towards Chlorine Contact Chamber. Note Extreme Scour and Damaged Site Fencing (Photo courtesy of Aldrich and Elliot, PC)

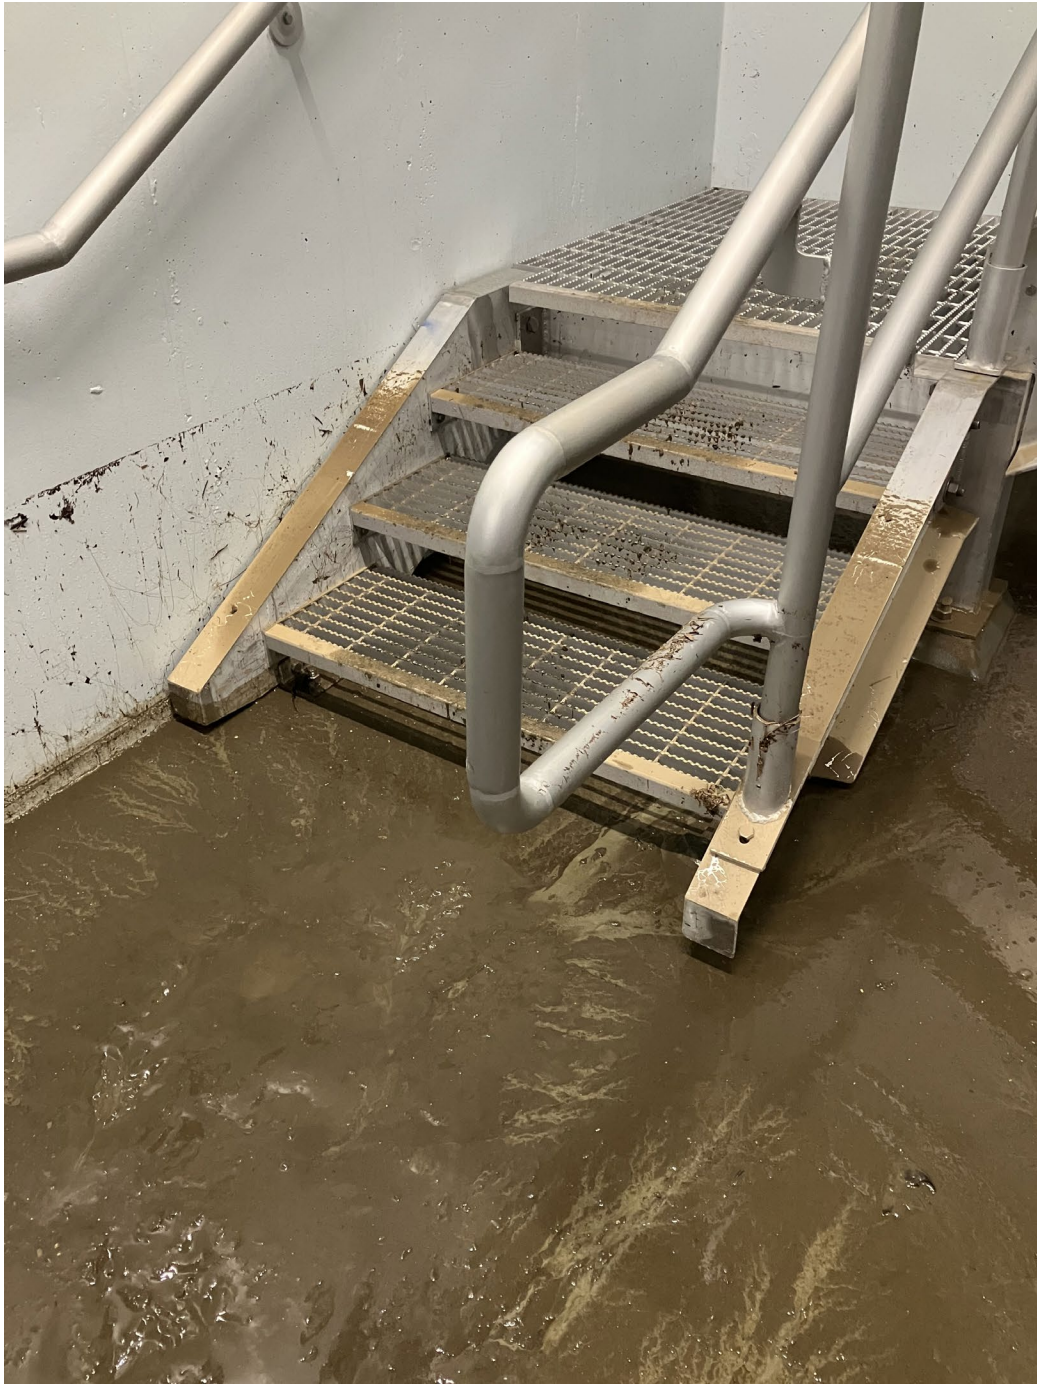
Main Pump Station: This building was recently constructed (reportedly complete in 2021) and notably had no significant damage other than scour and debris around the building. Some flood water had made it under the door and leaked into the basement where the influent pumps and sludge pumps are located. The basement high water mark was at approximately 18".

9 – Basement Area of Influent Pump Station Showing High Water Mark at Approximately 18”.

- The facility will need to drain all treatment tanks to remove silt, sand, and grit.
- A new level transducer or transmitter will likely be required in the main pump station.

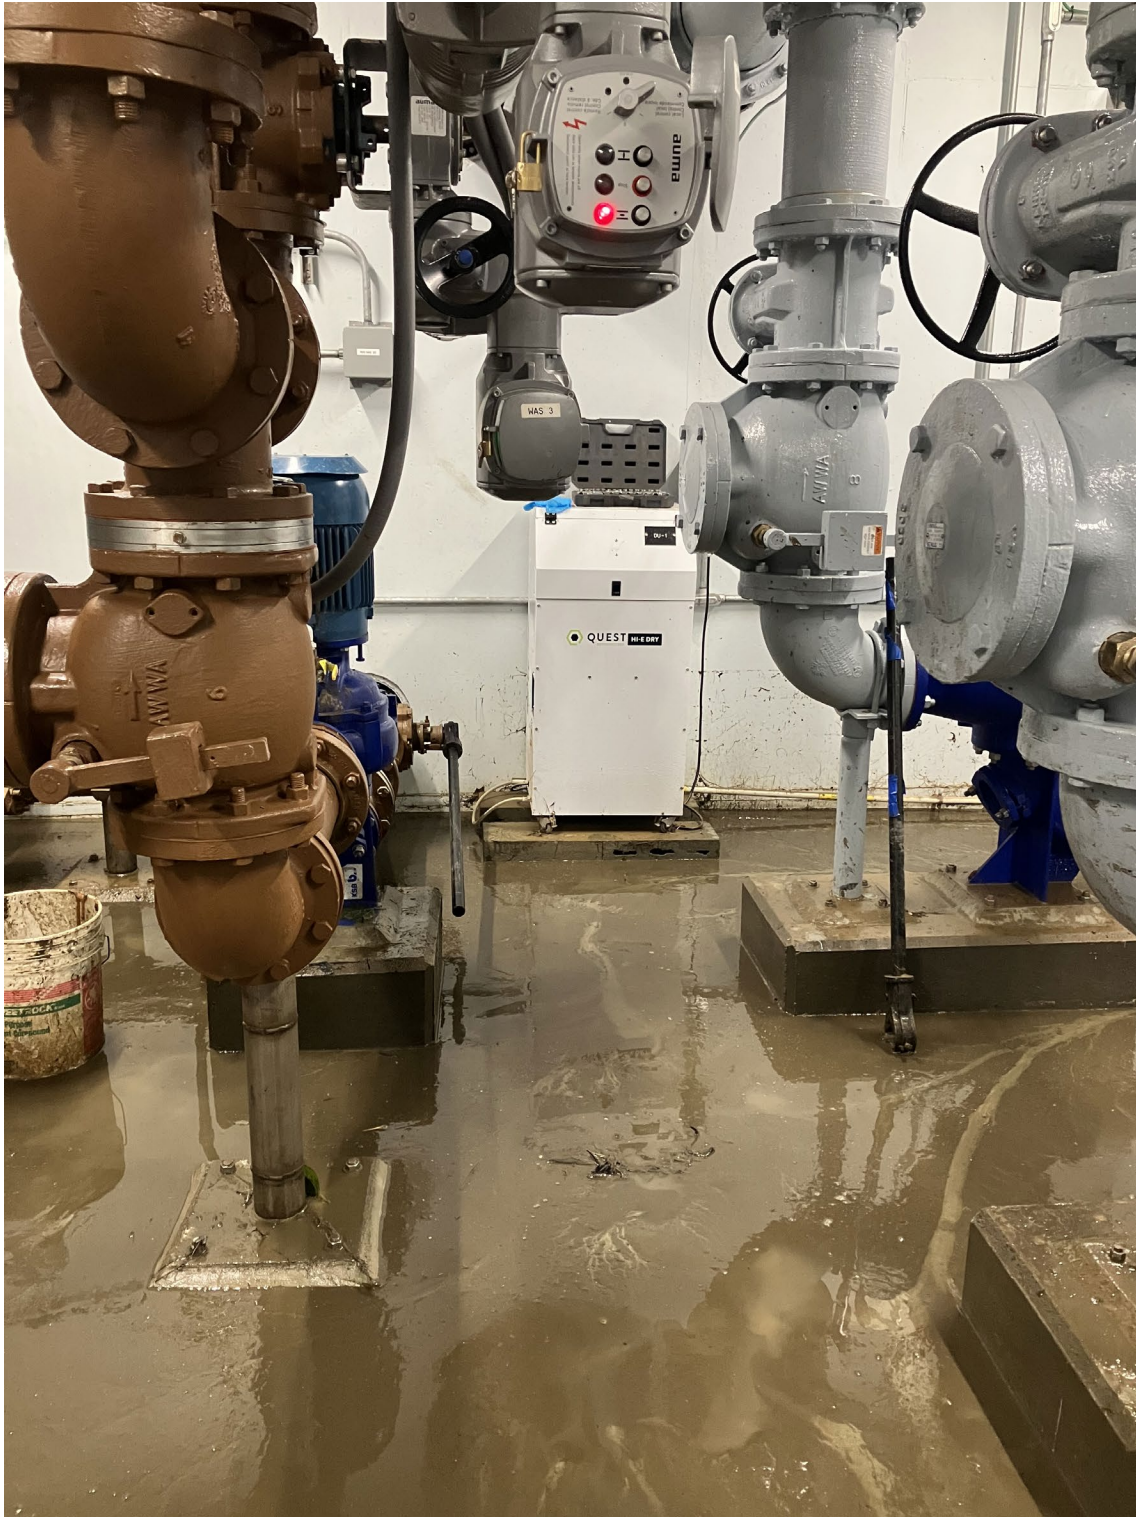
The main pump station was operational and had minimal water intrusion and did not reach pump motors, variable frequency drives (VFD's) or control panel. There was a dehumidifier which was partially submerged but appeared to be operational. The main pumps were operating on the backup level control. There is an error with the level controls communicating with the pumps to pump the influent to the pre-anoxic zone with cascading mixing tanks. The emergency backup controller is being triggered and pumping once levels achieve 63" instead of the normal operational level of 40". One pump is currently operating at a time. This was likely due to a damaged wet well level transducer. Pumps should be assessed for damage from incoming excess silt and debris.

10 – Basement Area of Influent Pump Station Showing Influent Pumps, Sludge Pumps and Dehumidifier, High Water Mark at approximately 18”.

- An appreciable amount of grit and sediment from the upstream collection system and headworks inundation was likely conveyed into the plant. Subsequently, main influent pump performance should be checked for accelerated wear.

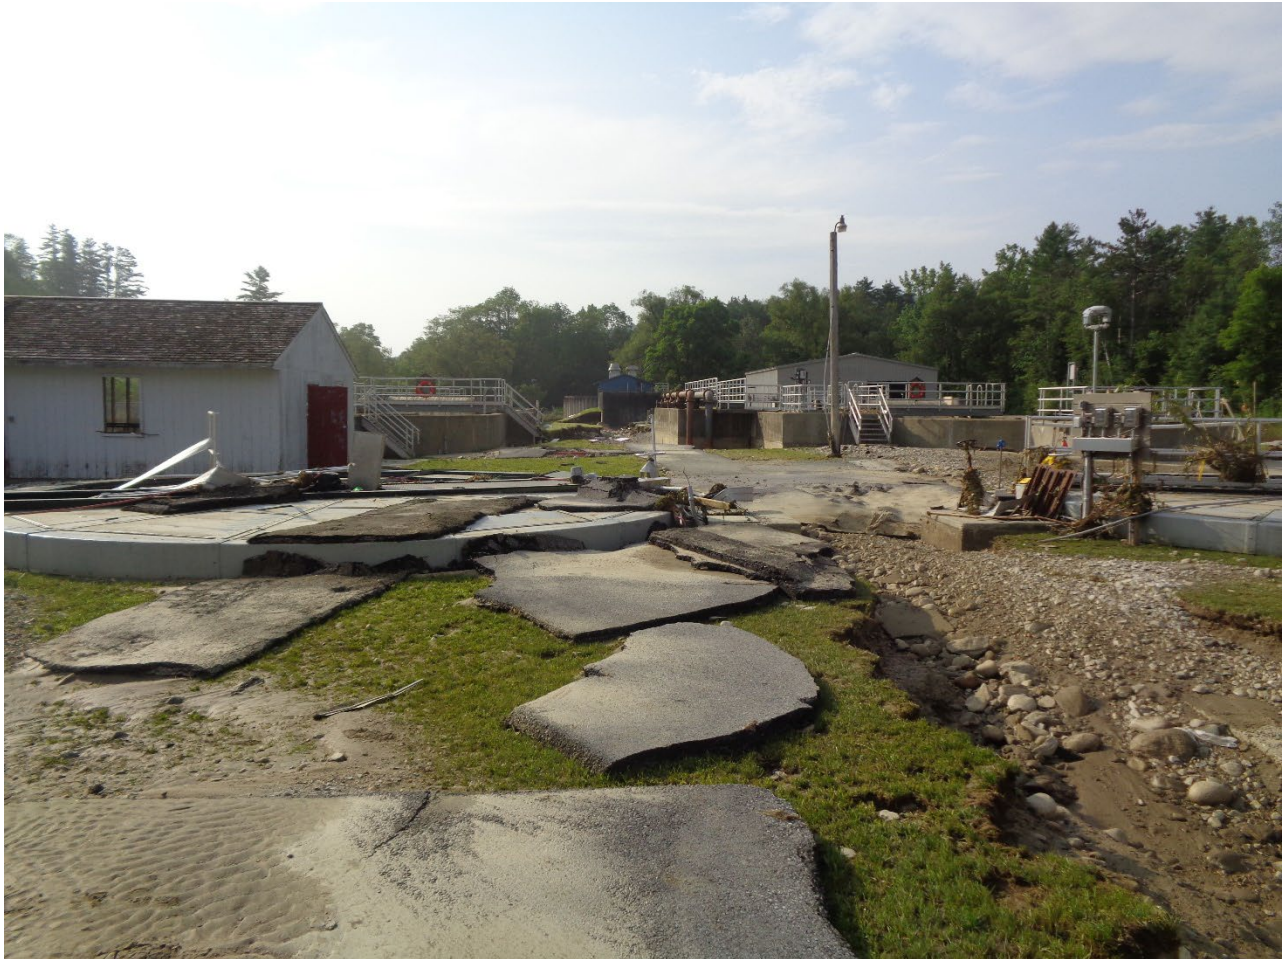
Secondary Clarifiers: There are three secondary clarifiers, two of which are nearly at grade level (Clarifier 1 (West), Clarifier 2 (East)) and the third (Clarifier 3) extending 3'-4' above grade. All three operate at the same hydraulic grade. All three are covered. The lower clarifiers were completely submerged. The motor disconnects and mounts were knocked over, several covers were opened. Large sections of displaced asphalt were observed laying on top of the covers. The drives and motors had been submerged. It is probable the clarifiers contain sand, rocks, and pieces of asphalt and should be completely drained prior to attempting to restart the drive motors. Aside from some damage to the covers and submerged drives and motors, the clarifiers are likely suitable for reuse once properly cleared of debris.

11 – Left Side: Clarifier No. 1 With Displaced Asphalt Around and on Top of Clarifier. Right Side: Clarifier No. 2. Looking Towards Oxidation Ditches. Note Extreme Scour (Photo courtesy of Aldrich and Elliot, PC)

- The lower secondary clarifiers will require new disconnect supports, thorough cleanings, repairs to damaged covers, drive motor replacements and possibly replacement of gear drives. Sludge piping should be checked and debris / clogs if present should be removed.

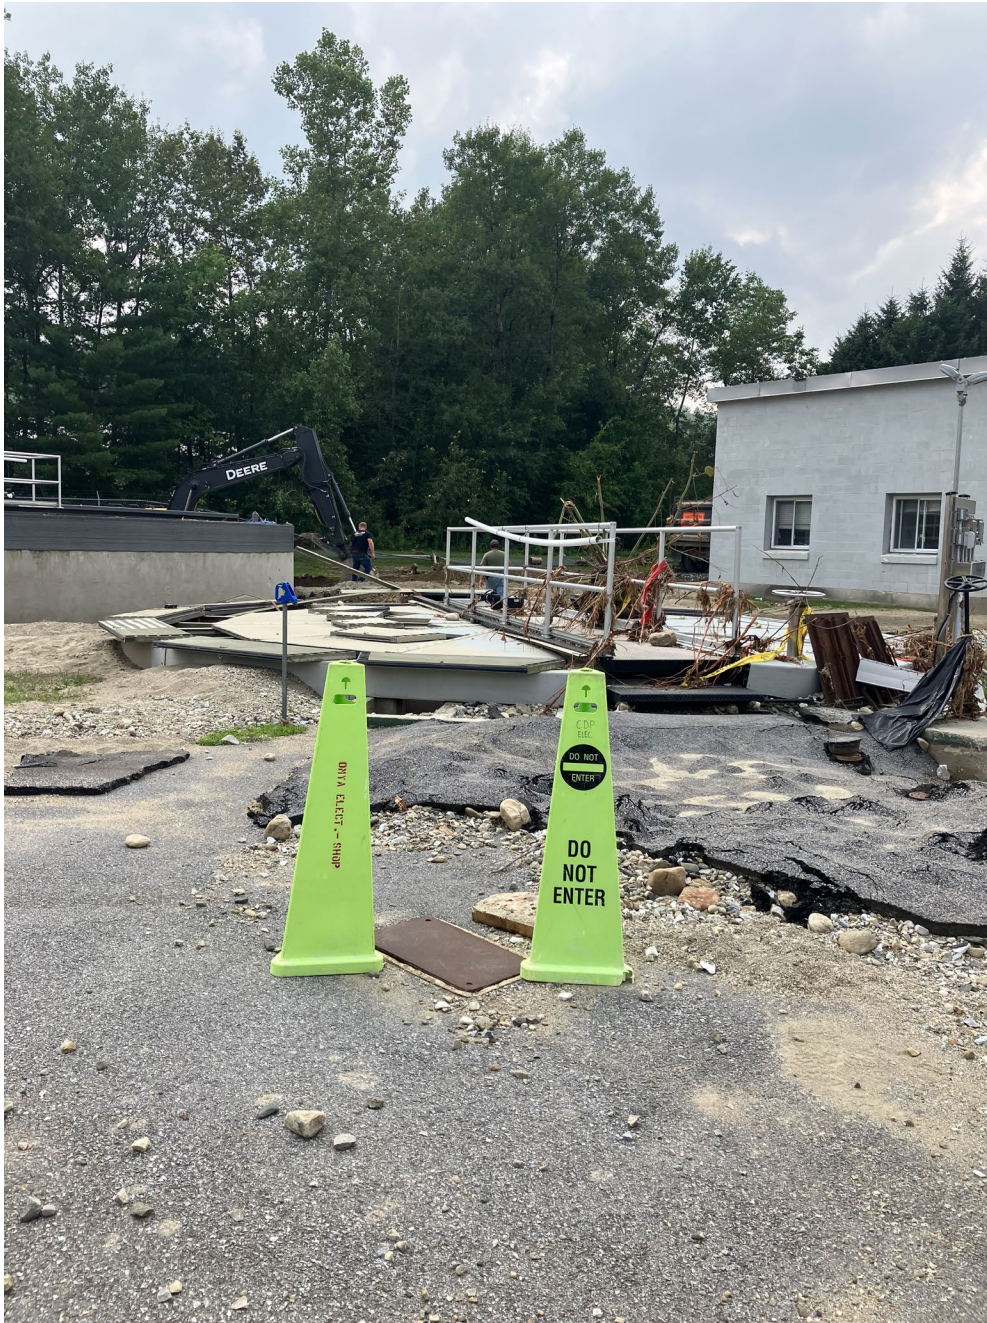
12 –Clarifier No. 2. In foreground, Clarifier No. 3 in Background. Note Debris and Extreme Scour

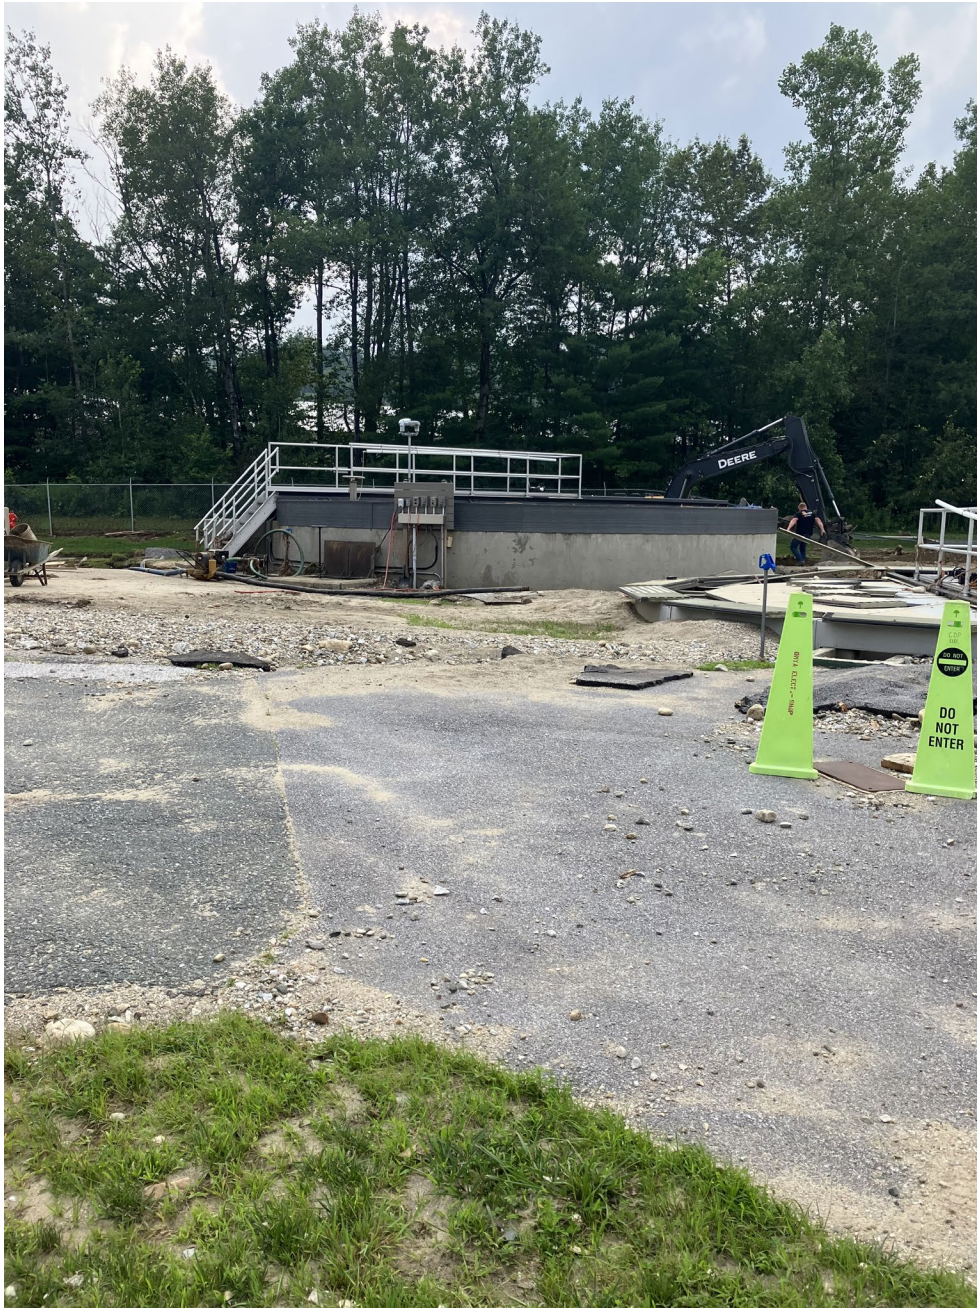
The upper clarifier was operational during the site visit. Operational Staff reported said there was a partial blockage between the clarifier and sludge pumps, located in the main pump station. They had a plan to attempt to clear the line. There was significant scour near the upper clarifier exposing its influent pipe. Operational staff had installed a temporary support below the pipe; the line was not showing evidence of leakage.

13 –Clarifier No. 3. Note Debris and Extreme Scour

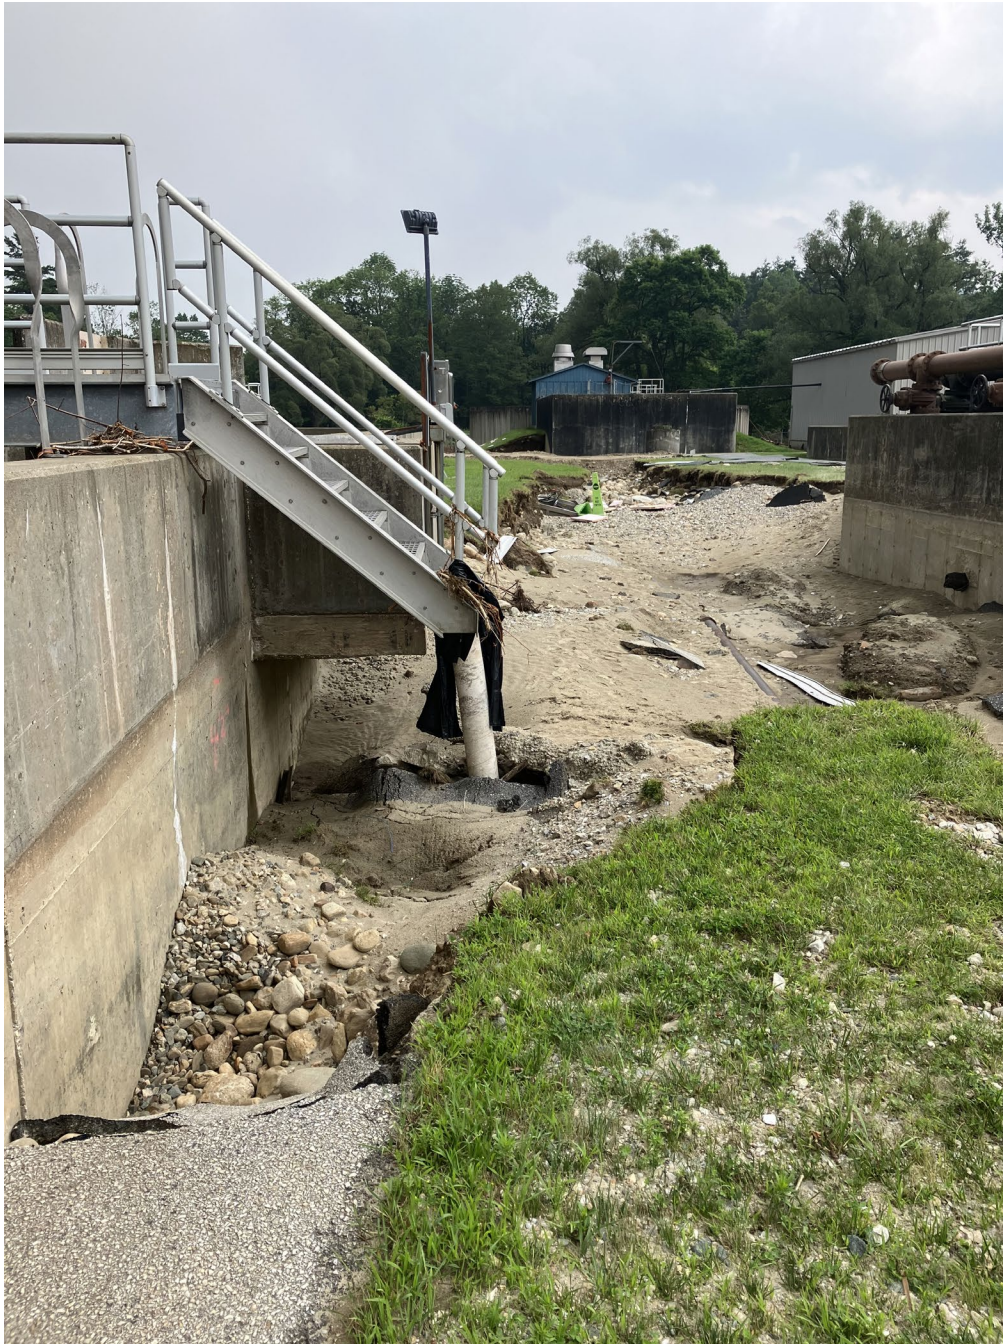
Oxidation Ditches: Scour was noted around both oxidation ditches, undermining the shallower ends. The selector tank and oxidation ditches were submerged. Debris and silt were noted in the ditches and tanks. Each ditch contains two electrical motors which drive the aeration rotors and were submerged. The rotary drum motors are blown, and the oxidation ditch was not being aerated. The operator reported they had replacement motors and would likely be installed and in service soon.

14 –East Oxidation Ditch Exterior. Note Debris and Extreme Scour

- Undercut portions of oxidation ditches will likely require flowable fill or pressure

grouting to provide a new, firm bearing surface. Grit and debris should be removed from the ditches.

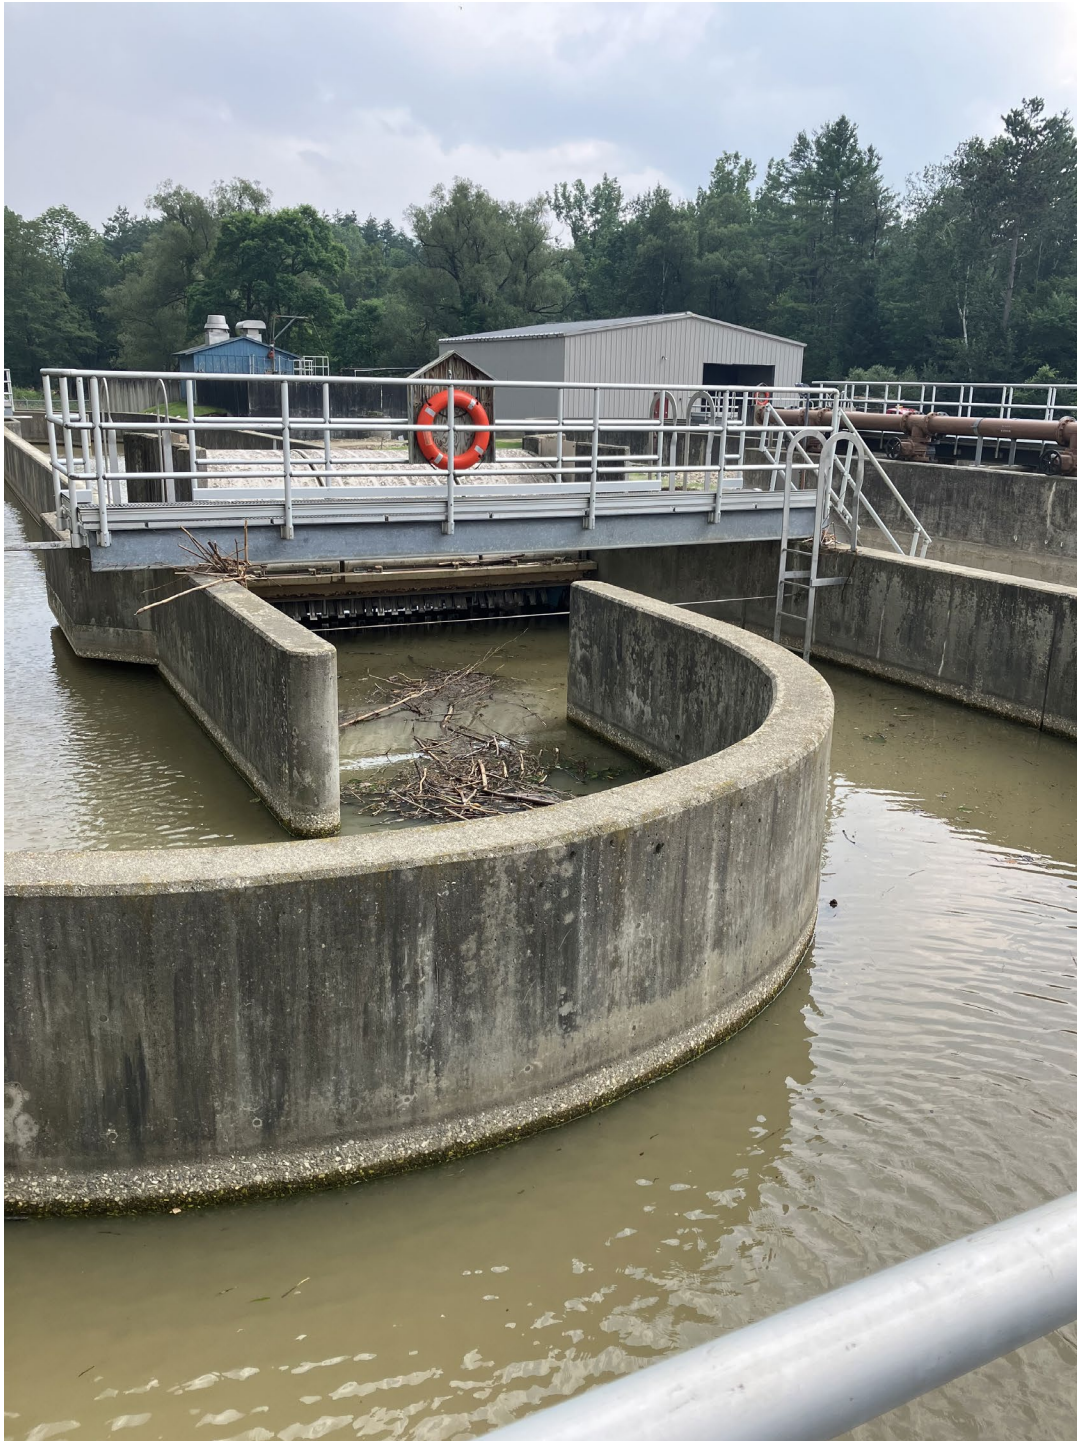
15 –East Oxidation Ditch Interior. Note Debris

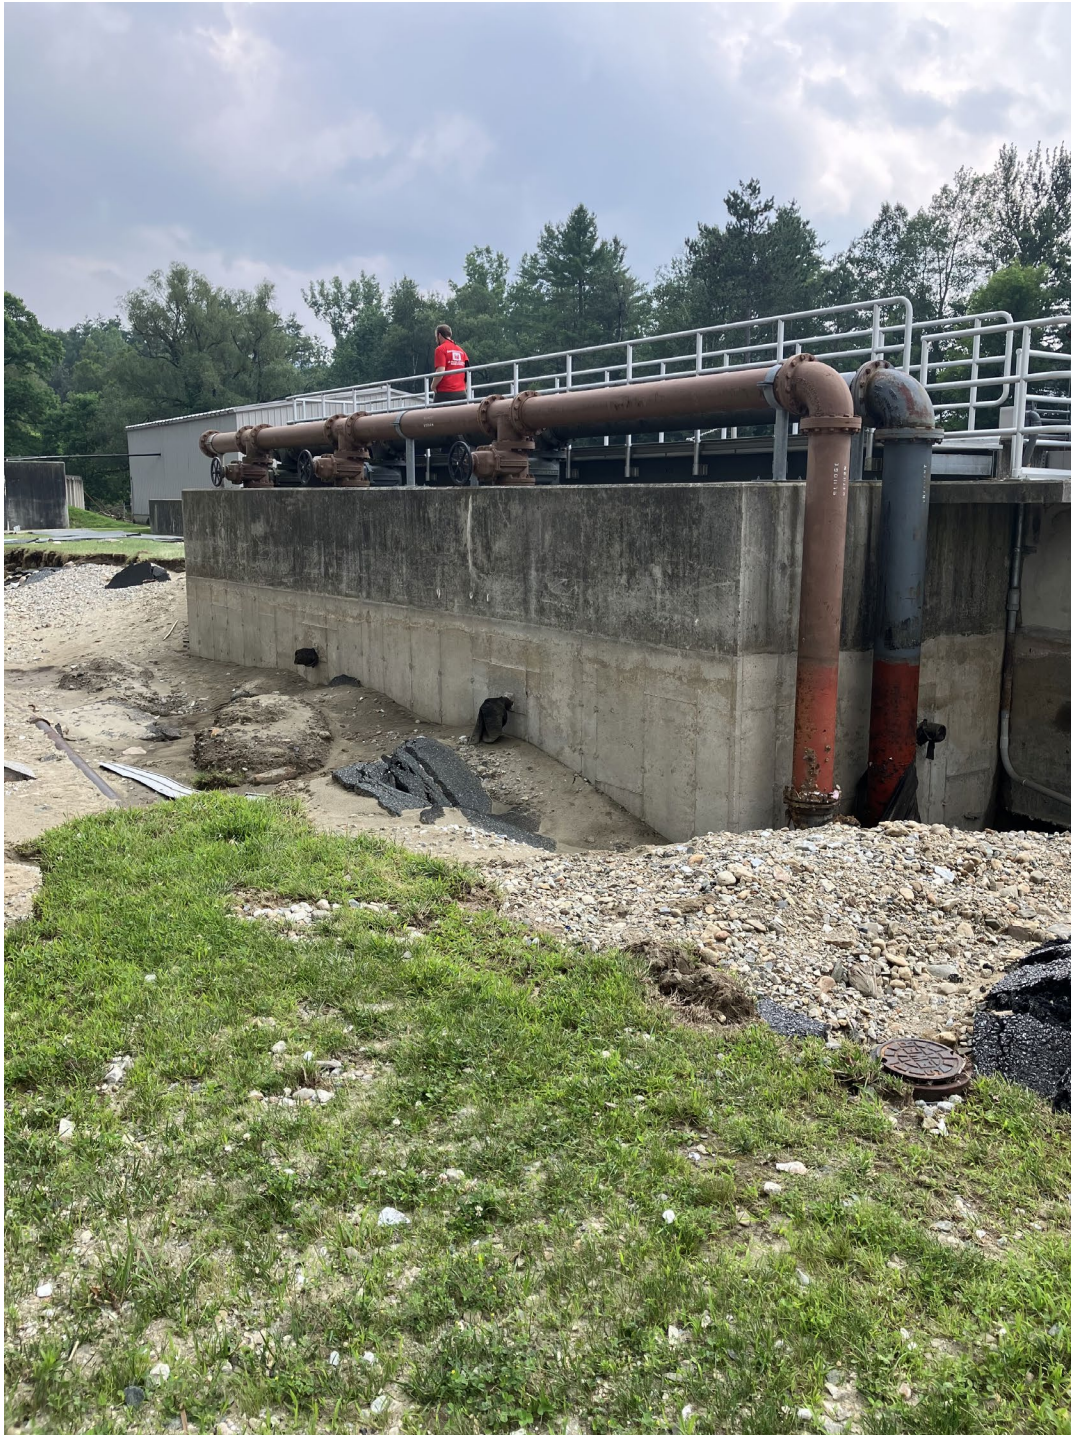
16 –West Oxidation Ditch Exterior. Note Extreme Scour
