**LUDLOW WASTEWATER
POST JULY 2023 FLOOD
TREATMENT PLANT ASSESSMENT
WINDSOR COUNTY, VERMONT**

**NPDES PERMIT NUMBER VT0100145
STATE OF VERMONT PERMIT NUMBER 3-1208**

September 13, 2023

This report was prepared based on observations made during the July 18th site visit by Heather Collins, VT DEC, WSMD, WWMP in conjunction with Army Corps of Engineers and US EPA Region 1 representatives.

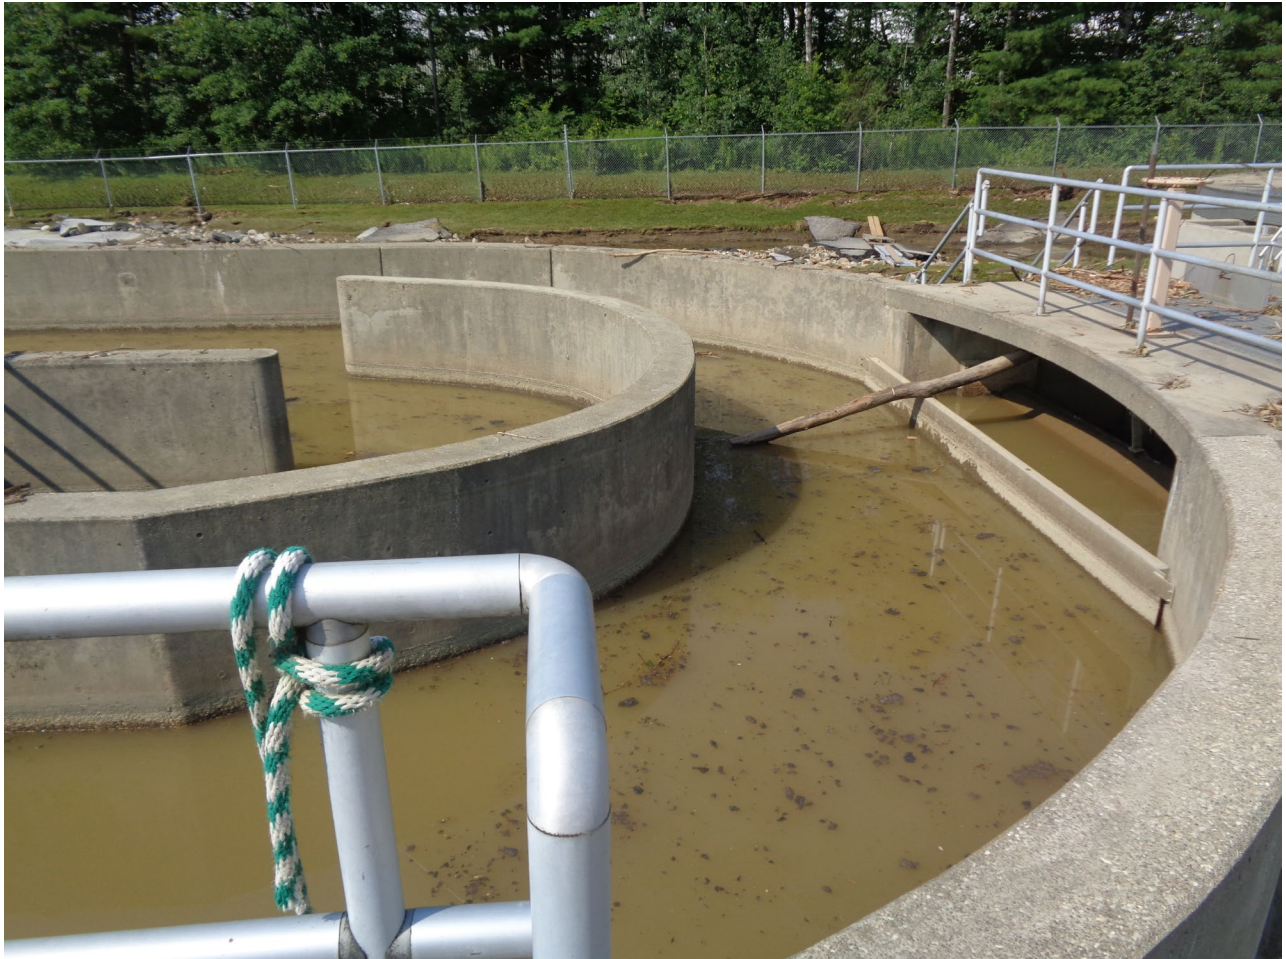
Oxidation Ditches: Scour was noted around both oxidation ditches, undermining the shallower ends. The selector tank and oxidation ditches were submerged. Debris and silt were noted in the ditches and tanks. Each ditch contains two electrical motors which drive the aeration rotors and were submerged. The rotary drum motors are blown, and the oxidation ditch was not being aerated. The operator reported they had replacement motors and would likely be installed and in service soon.

17 – West Oxidation Ditch Interior. Note Debris

grouting to provide a new, firm bearing surface. Grit and debris should be removed from the ditches.

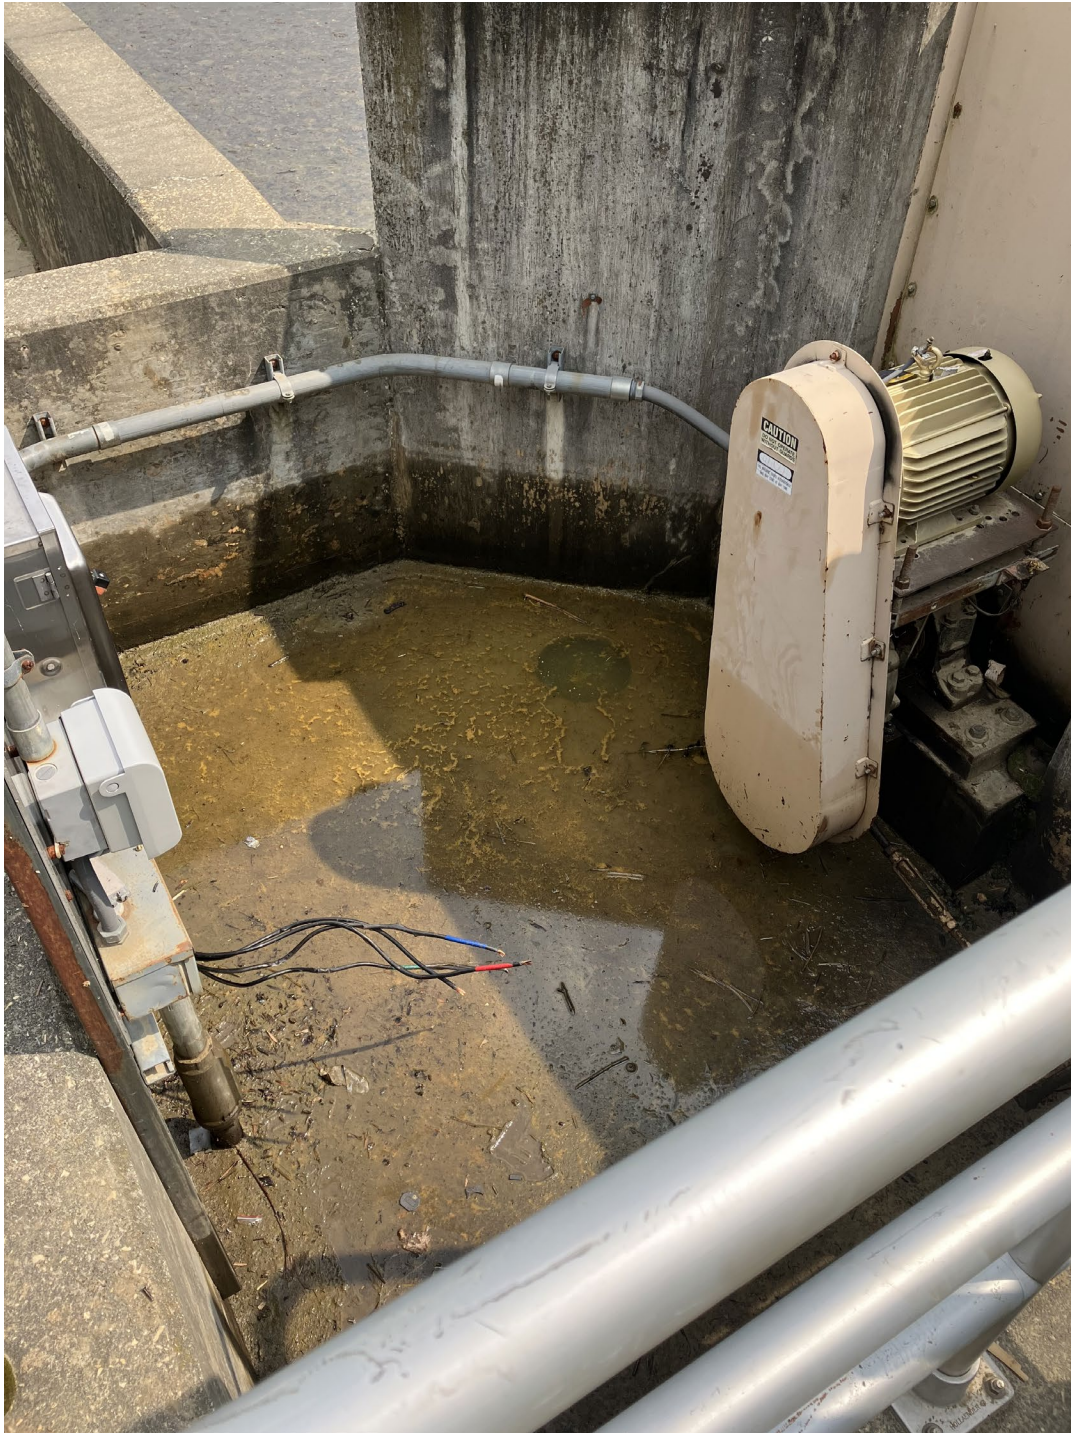
18 –Rotary Drum Motor in West Oxidation Ditch Interior. Note Debris

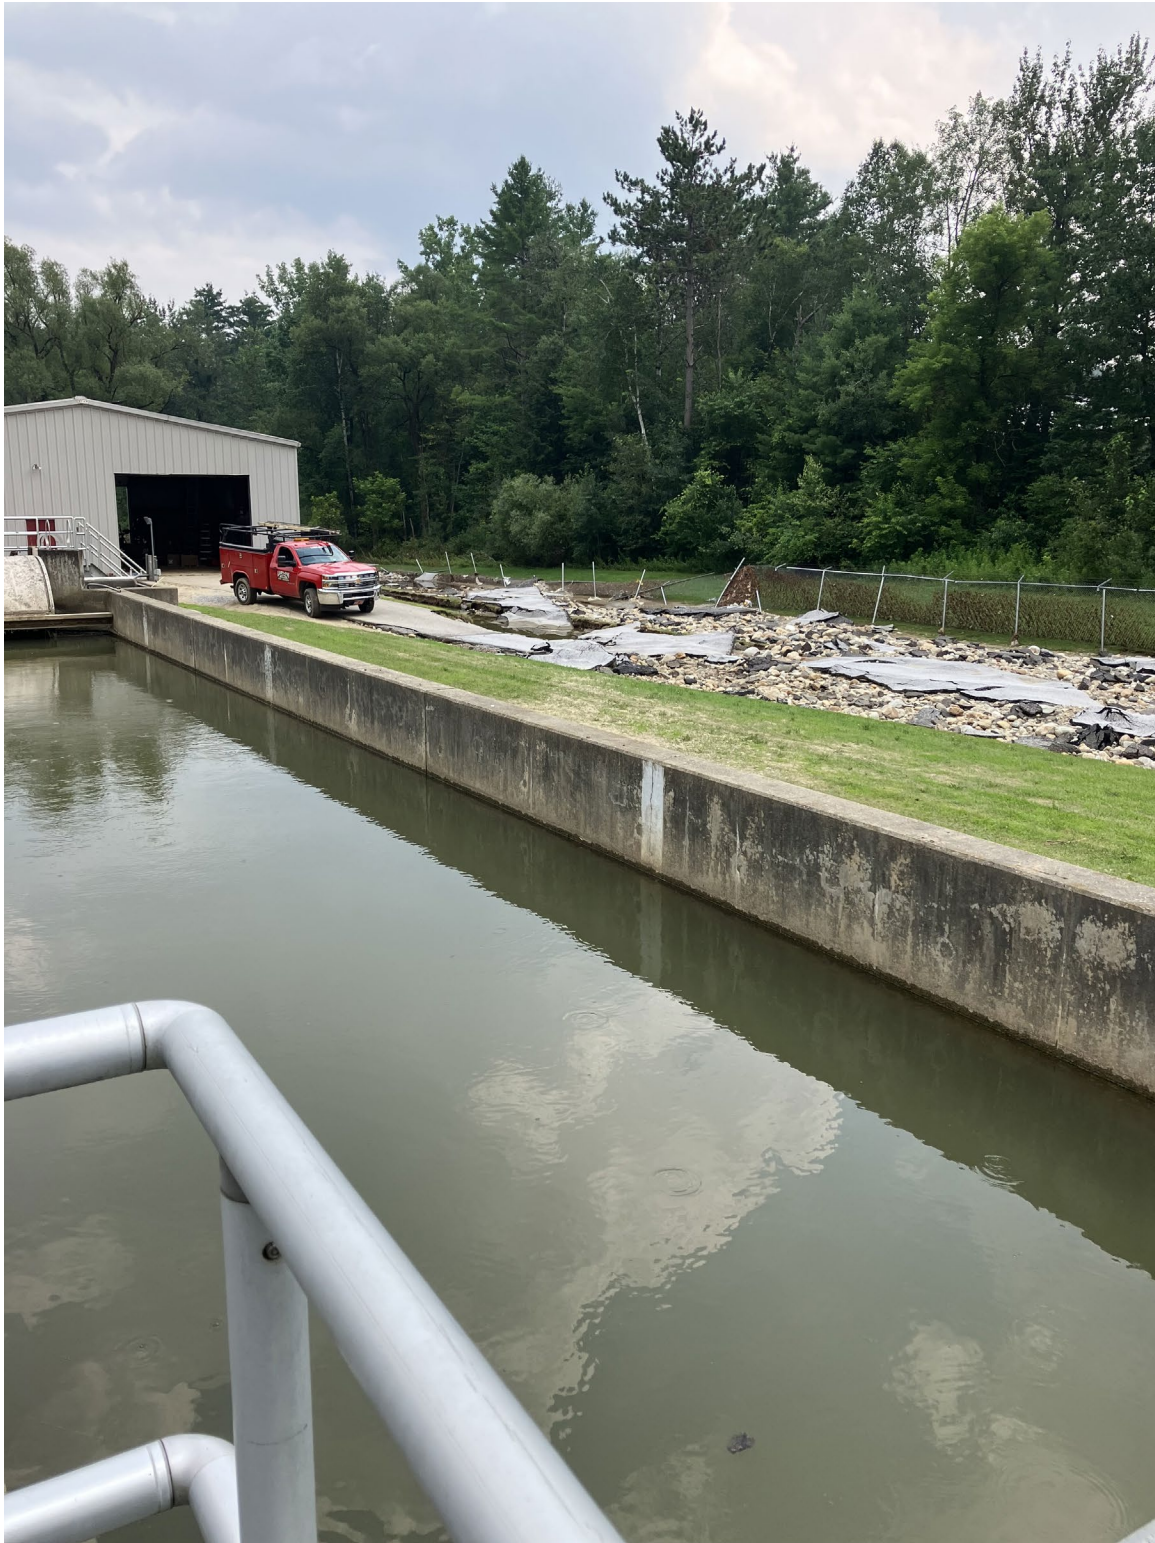
19 –West Oxidation Ditch Interior. Note Extreme Scour Along Drive and Damaged Fencing Behind Oxidation Ditch

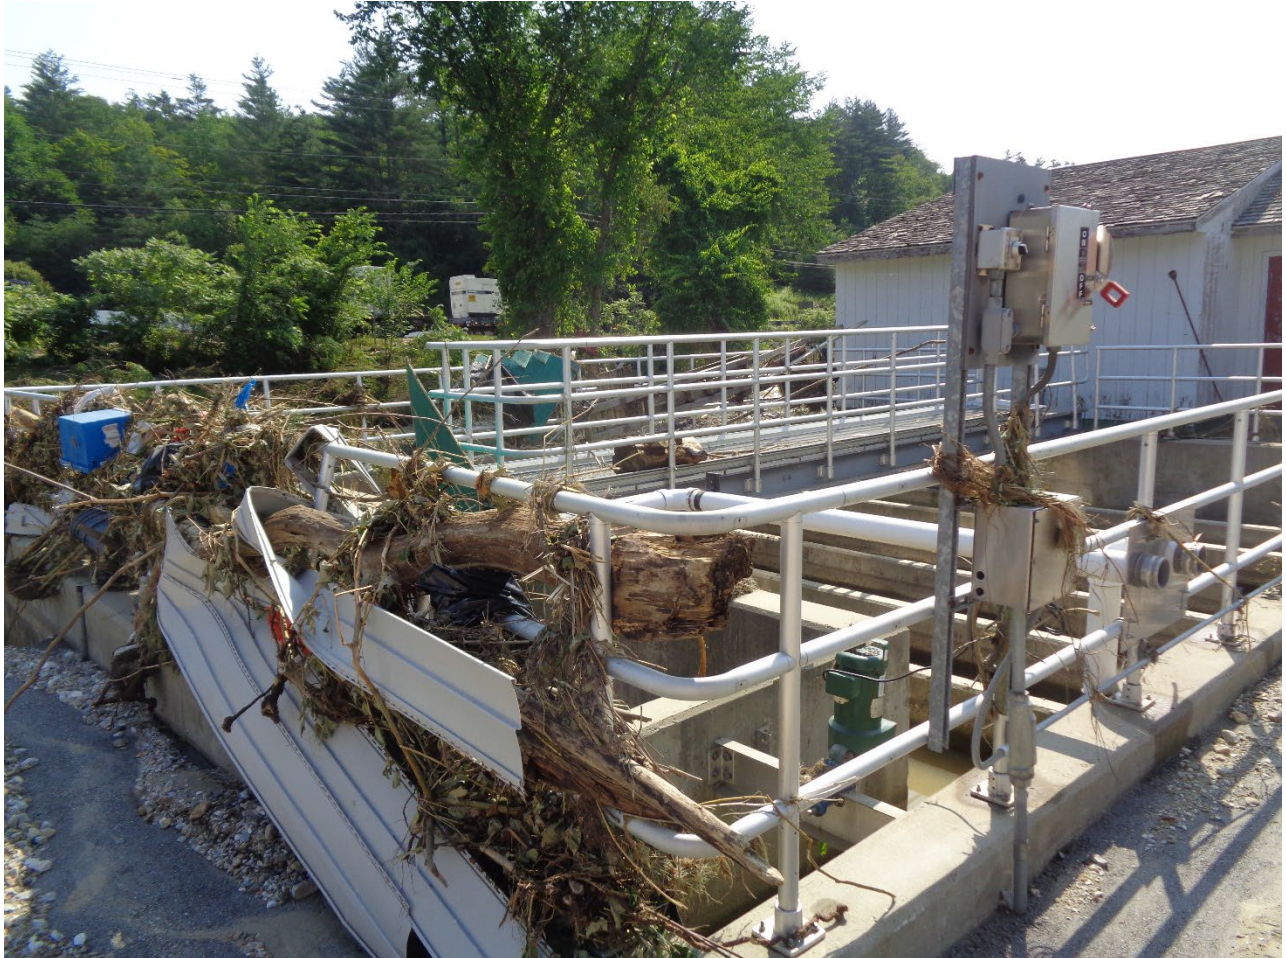
Chlorine Contact Chambers: The plant has two chlorine contact chambers, one of which is covered by a stick-built building (covered tank). Both showed evidence of scour around the structures but no apparent damage to the concrete. The exterior contact chamber suffered bent railings, broken conduits, and submergence of the mixers. The covered tank building was missing several pieces of exterior sheeting and broken windows. An appreciable amount of silt, grit and debris were conveyed to the chambers. This infill will limit the effectiveness of treatment and will need to be cleaned.

20 –Chlorine Contact Chamber. Note Extreme Scour and Debris (Photo courtesy of Aldrich and Elliot, PC)

- Railing, mixers, level measurement transmitters, and siding at the chlorine contact basins will require replacement. Although one tank is conveying flow, sediment and debris will need removed from both tanks.

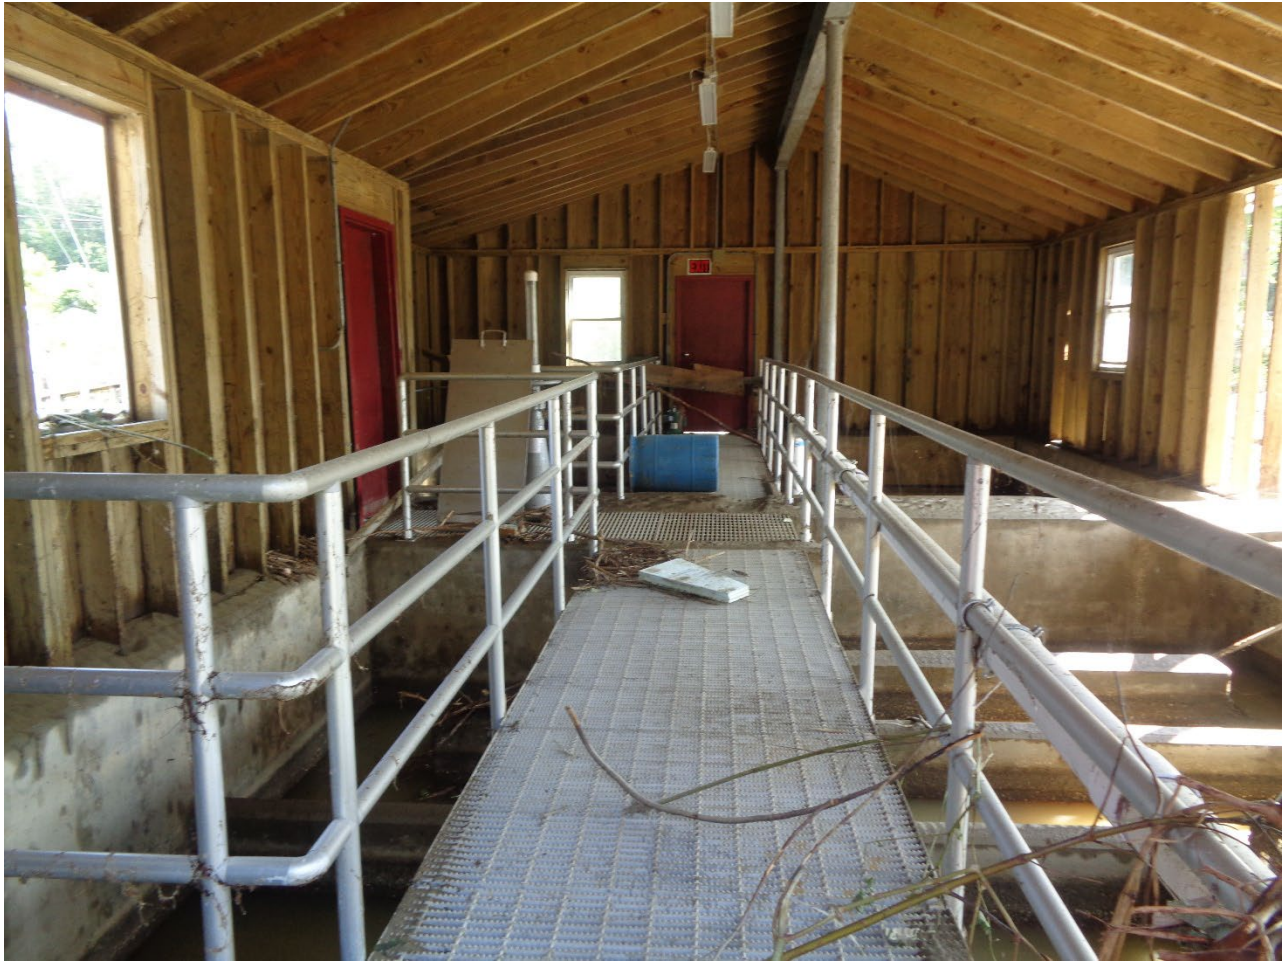
22 –Chlorine Contact Tank Building Interior. Note Window Missing on Left Side and Debris

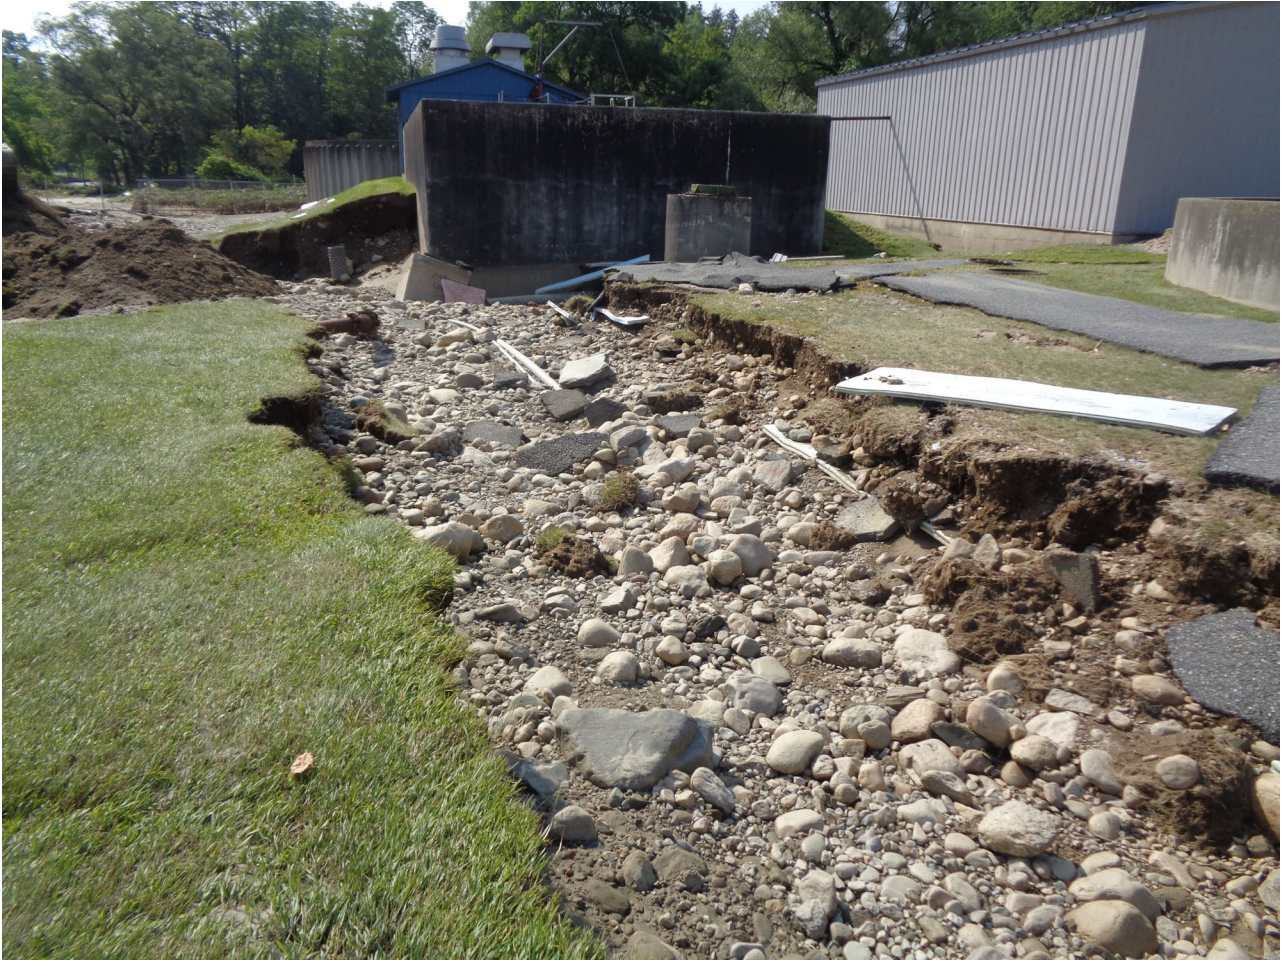
Aerobic Digester: The digester has two compartments, each 38-feet by 12-feet-4-inches with a normal liquid depth of 8-feet. Evidence of scour around the structure was noted but no apparent damage to the concrete.

23- Aerobic Digester. Note Extreme Scour and Debris (Photo courtesy of Aldrich and Elliot, PC)

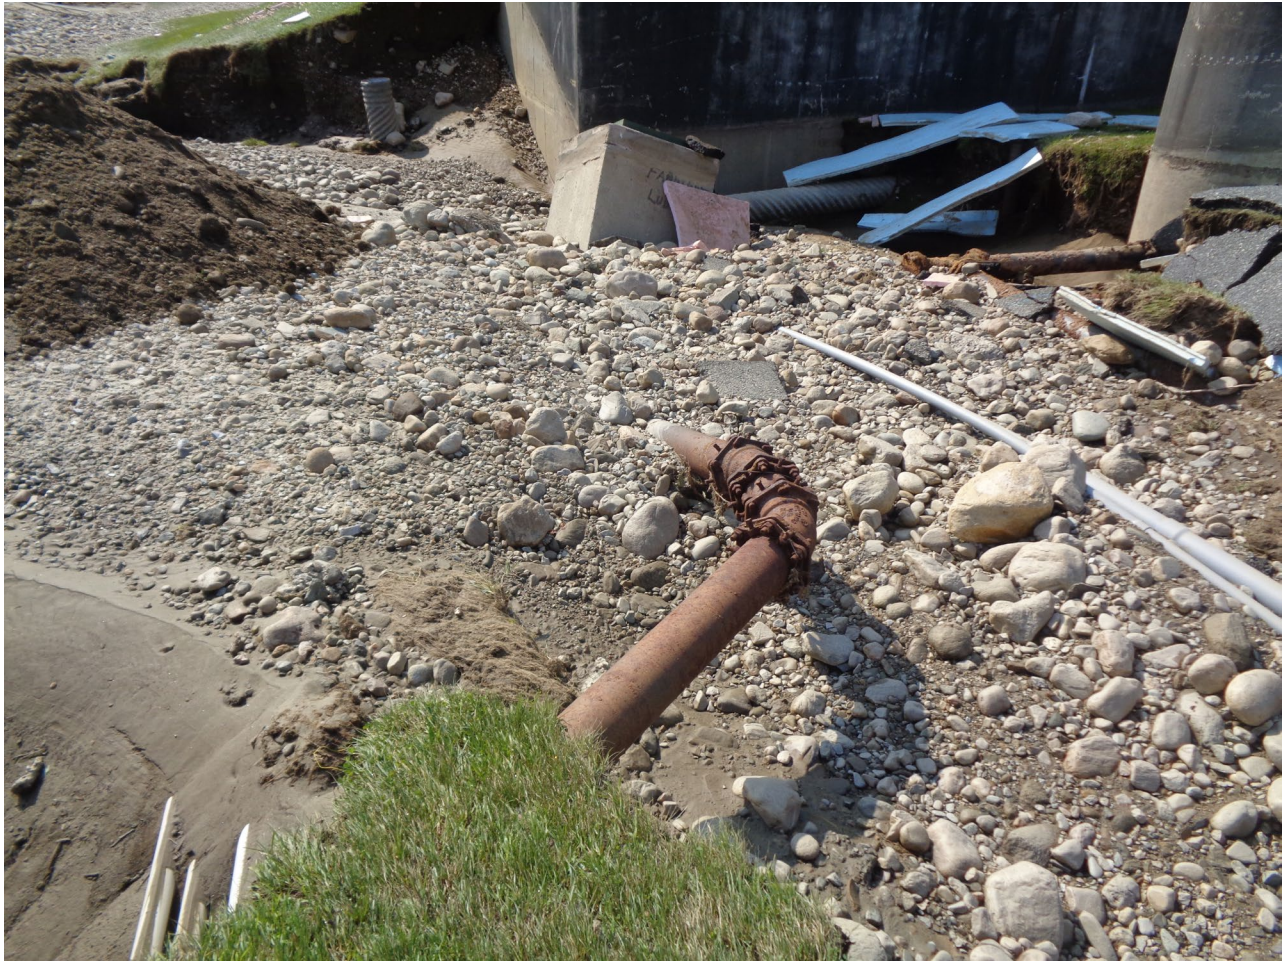
24- Aerobic Digester. Note Exposed Piping and Conduits (Photo courtesy of Aldrich and Elliot, PC)

- The site will require replacement of fill materials as well as replacement of multiple conduits and conductors throughout. Overall fine grading and repaving of the entire site will be required. A significant portion of the site fence was damaged or completely destroyed.

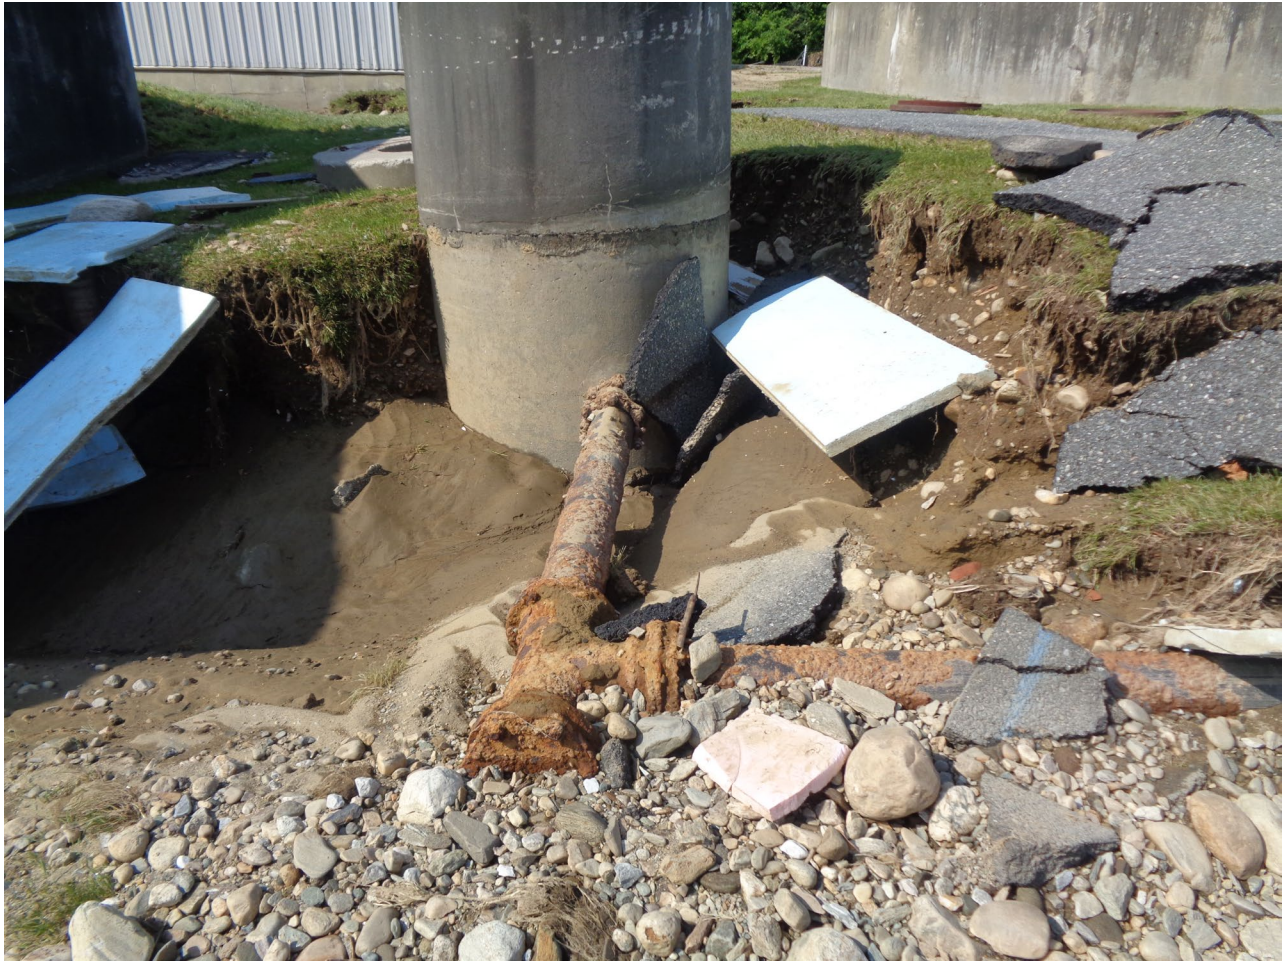
25- Aerobic Digester. Note Exposed Piping Scour and Debris (Photo courtesy of Aldrich and Elliot, PC)

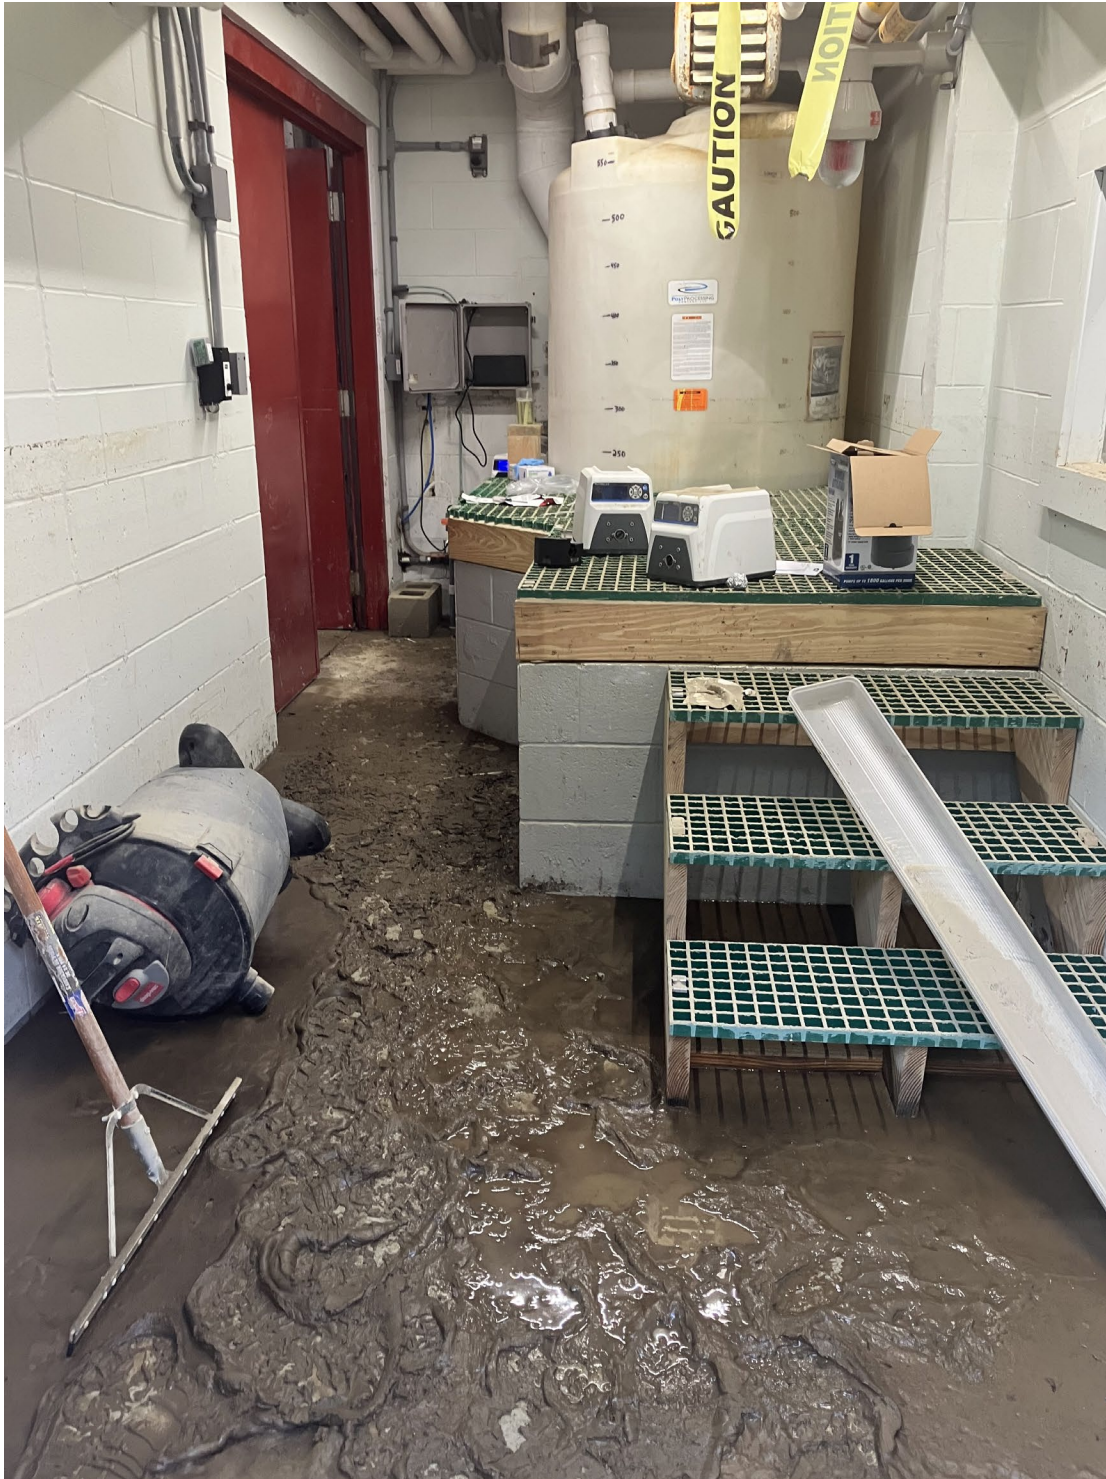
Main Building: Significant scour was observed around the upstream side of the main plant building and exposed the foundation / footer. A horizontal crack at a concrete block grout joint indicated some minor movement / settlement may have occurred. A high-water line was noted approximately 4' above the building finished floor. The motor control center (MCC) including nearly all pump and motor starters, variable frequency drives (VFDs), branch circuit breakers, and electrical conduits were inundated and likely

26- Main Control Building Chlorine Tank. Note High Water Mark at Approximately 4 feet.

- A significant amount of equipment was impacted, including most of the motor control center (MCC), chlorination & de-chlorination pumps/tanks/feed lines, instrumentation, analytical monitors & recorders, all submerged control panels and generator.

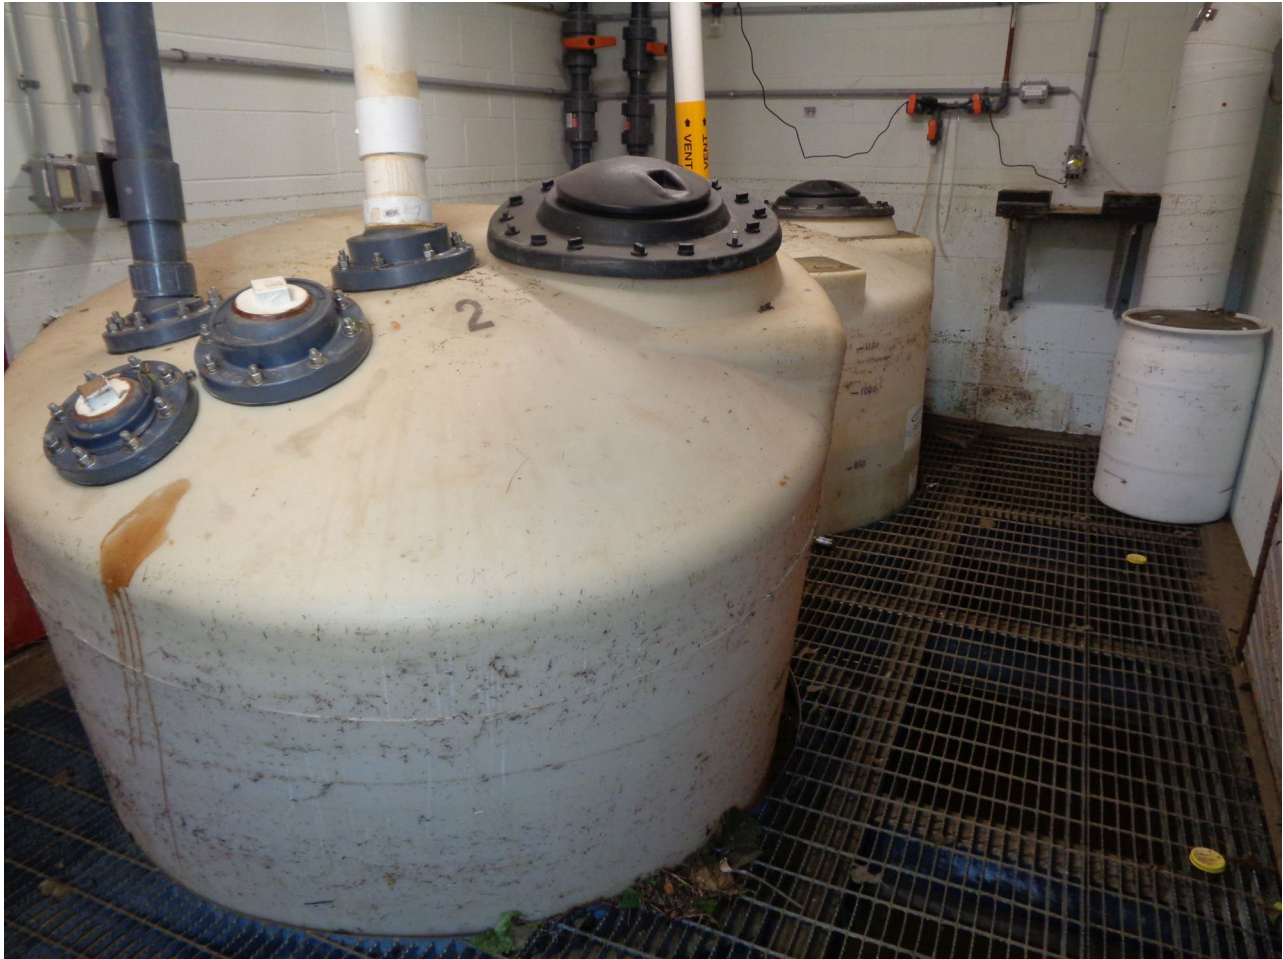
27- Main Control Building Bisulfite Tanks. Note High Water Mark at Approximately 4 Feet. (Photo courtesy of Aldrich and Elliot, PC)

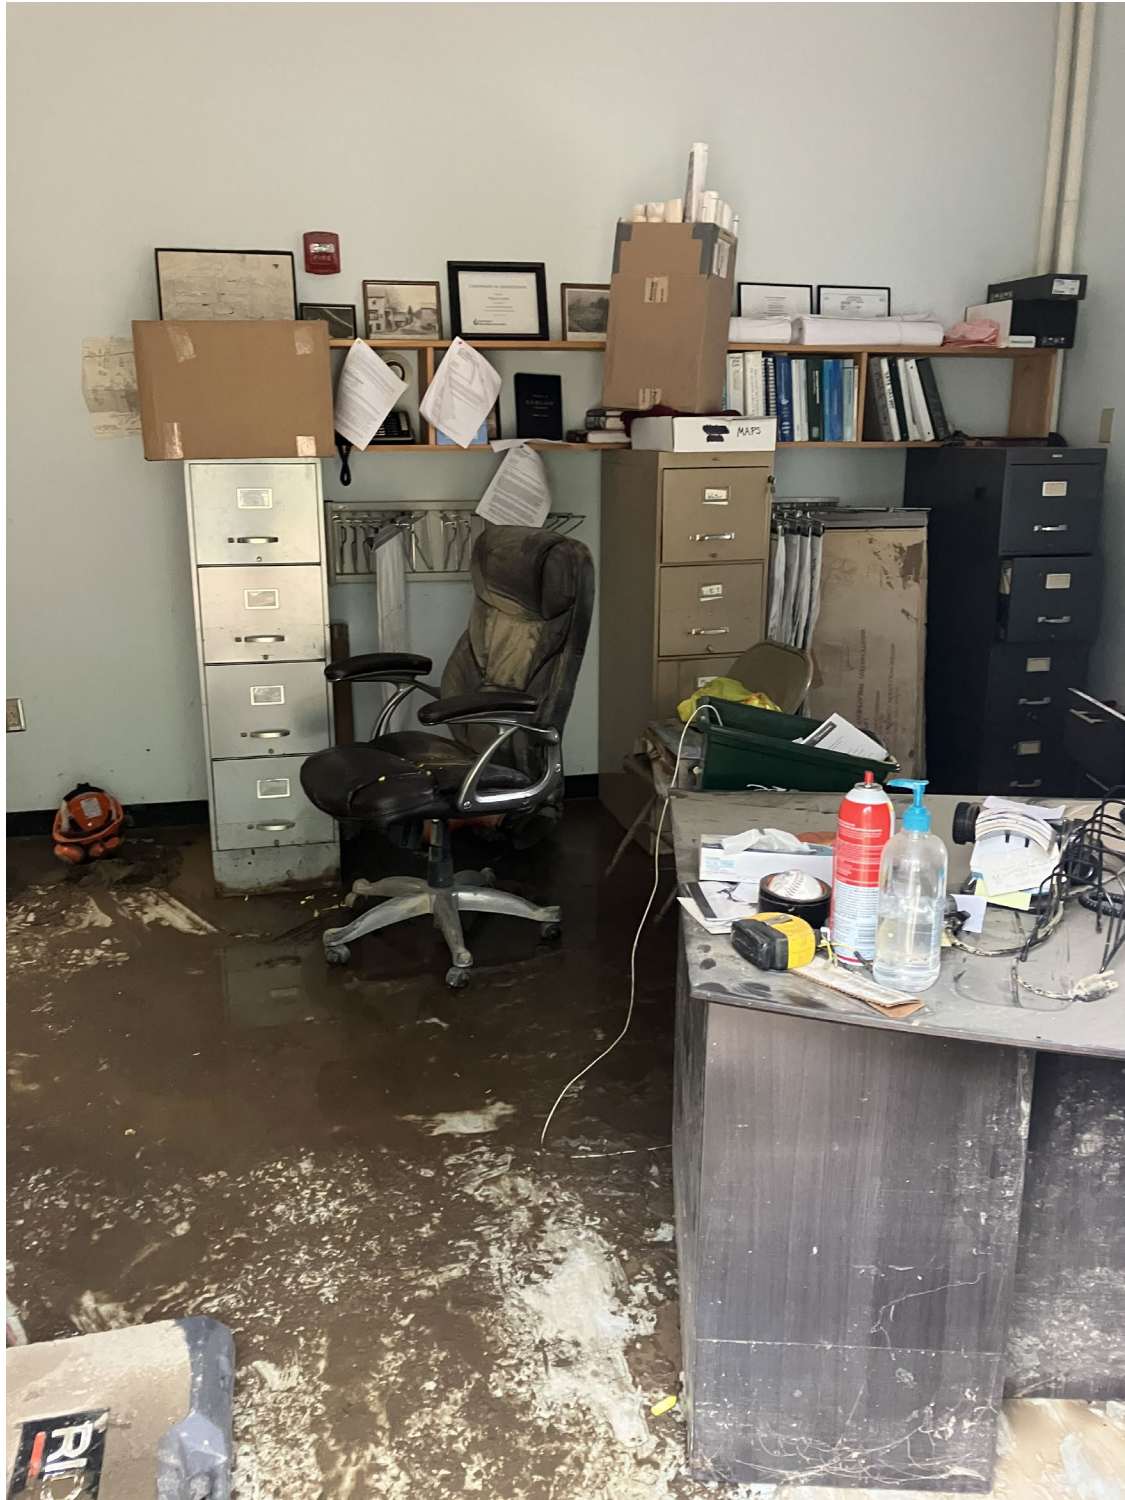
28- Main Control Building Office.

destroyed. The same is true for the plant's chemical storage tanks, meters, analytical monitors, recorders, laboratory equipment and supplies, chemical feed pumps and associated equipment, mechanical room, maintenance area, staff break room, office heating system and hot water system all of which were submerged. The garage door was damaged by displaced site asphalt.

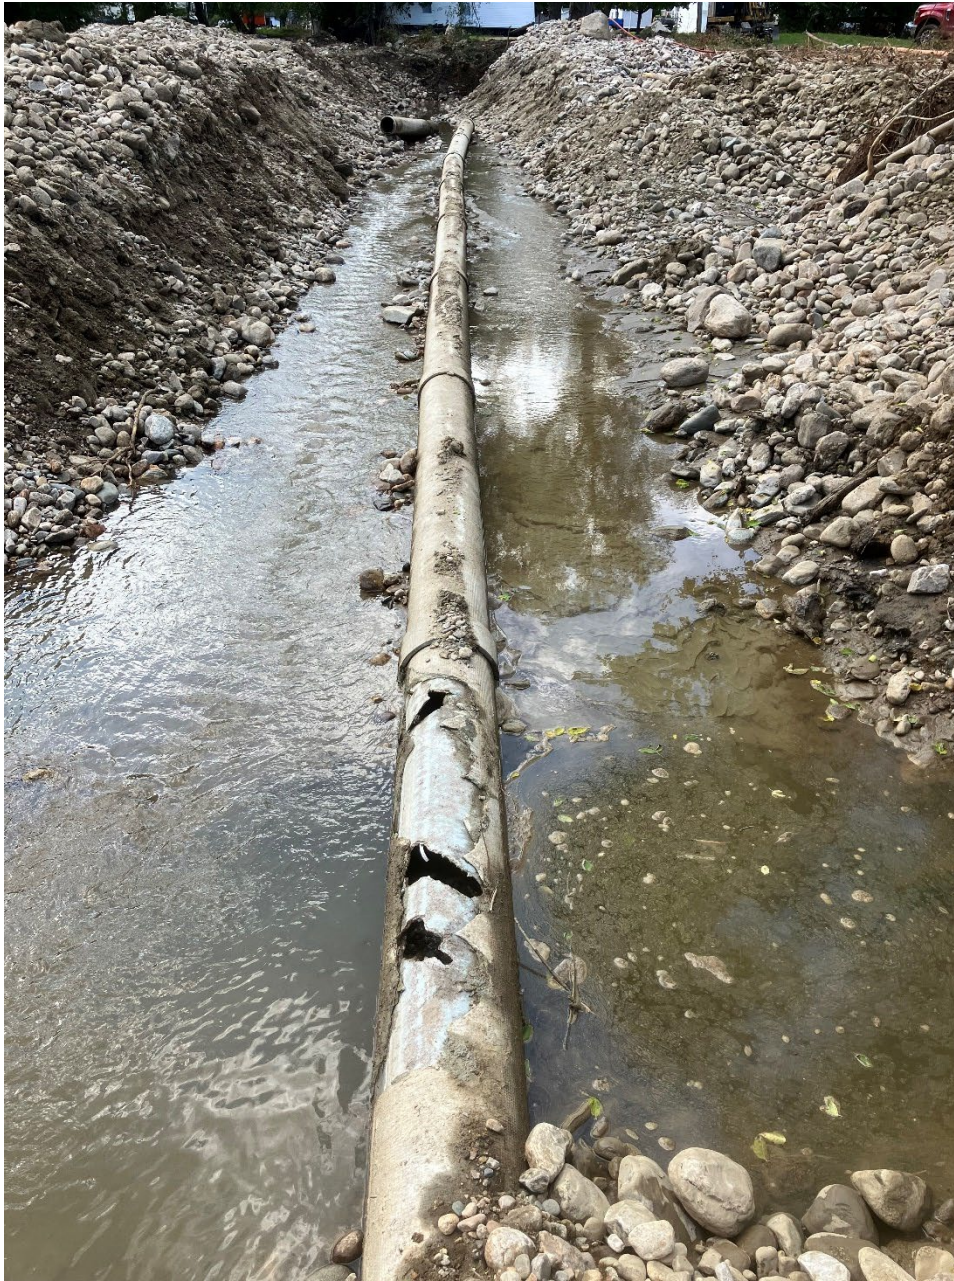
Overall, the collection system received large amounts of grit/silt/debris. Sections of collection system piping were exposed along Black River. At one section a break in the 15" AC line occurred and was being temporarily bypassed awaiting repair.

30- 15" AC Sewer Main Along Black River (Photo courtesy of Chief operator Joe Gaudiana)

- The plant will likely require seed sludge to restart biological treatment.
- Jetting and camera inspection of low-lying collection system areas as the collection system received an appreciable amount of grit/silt/debris. Camera inspections should be explored to ascertain collection system damages.
