**2013 UPDATE  
OF THE  
EXTERIOR ENVELOPE SECTIONS**

**2006 FACILITIES ASSESSMENT REPORT  
FOR  
THE VERMONT VETERANS' HOME  
Bennington, Vermont**

**State of Vermont  
Department of Buildings and General Services  
Michael J. Obuchowski Commissioner  
and  
The Vermont Veterans' Home  
Melissa Jackson, Administrator**

**Timothy D. Smith & Associates, PC Architects  
North Bennington, Vermont**

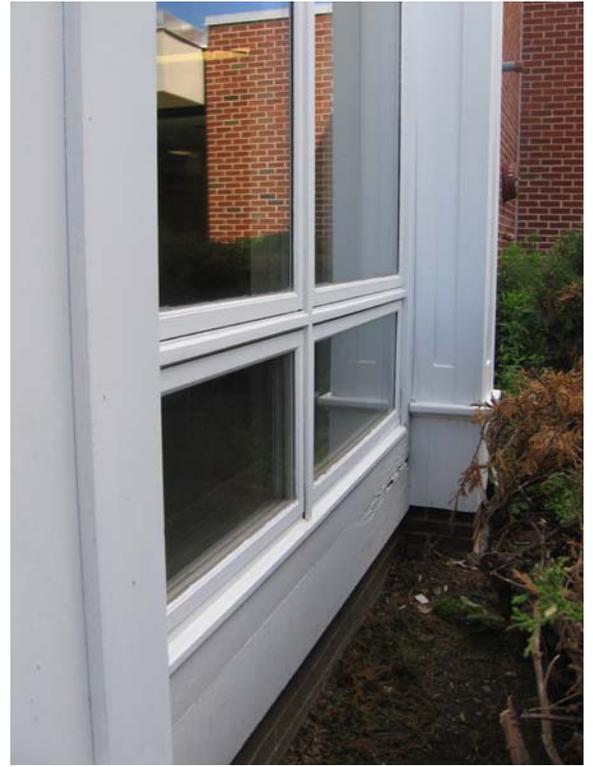
AD01-2013

wood columns are rotted at the base. See Photo AD02. Hardboard siding above the head of the lower windows is rotted (window drip cap flashing). Paint is peeling from the upper level roof cornice trim. Rotted cornice trim, hardboard siding, and corner trim is evident) See Photos AD08 & AD09. *Conditions have worsened, now Critical Condition. Wood trim is rotted. Open joints need to be caulked. Sash sealant is cracked and water is getting in. See photo AD01-2013.*

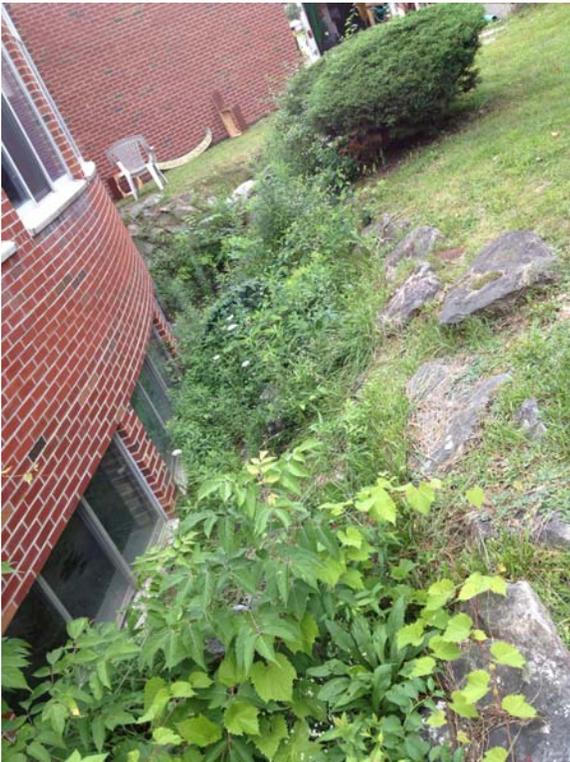
FS01-2013

At the time of this inspection, there was significant vegetation within the well area, the soil level at the bottom of the well was right up to the sills (typically the soil level should be at least 8" below sills), window/louver lintels are rusting, window/louver perimeter sealants are cracked, sealants between cast stone sills have failed, and brick at the window lintel bearing conditions is cracked at a few locations. See photos FS01-2013, FS02-2013, FS03-2013, FS04-2013, FS05-2013, FS06-2013, and FS07-2013.

In general this area is in poor condition. In addition to the necessary building elements repairs and replacements, the entire well area should be restored by removing all vegetation, excavating and removing soil and stone, rebuilding battered stone wall, and installing new filter fabric and gravel above and around the drainpipes. Elevation of bottom of the well should be established at a minimum of 8" below window/louver sills. Existing drainpipes should be checked and replaced if damaged or full of soil.

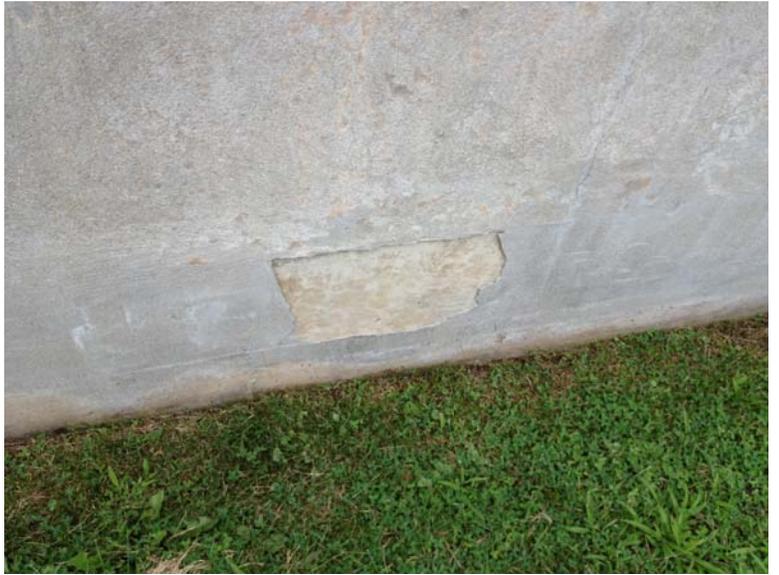
CH02-2013

Connecting Corridor/Ramp: At the foundation(south side), minor repairs are needed as the bond of the cement plaster applied to the concrete has failed in areas. See Photo CH03. [At the South elevation connecting corridor/ramp foundation, bond of the cement plaster applied to the concrete foundation has many cracks, spalls, and areas where portions have fallen off. See photo CH01-2013. Also, a pipe penetration through the concrete foundation wall is not properly sealed. See photo CH02-2013.](#)
