16-2655.00

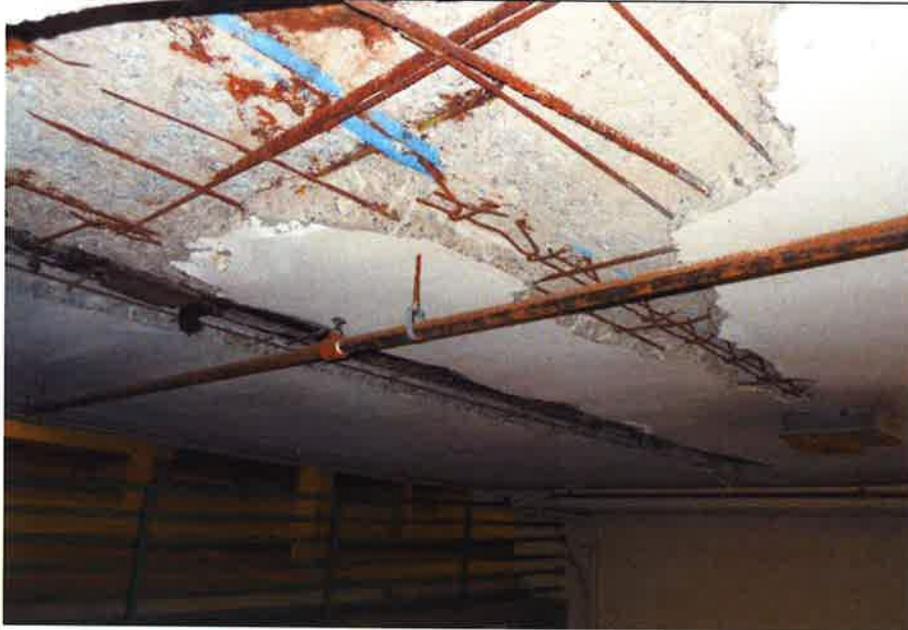
Photo 17: Level 2 Underside – View of precast filigree floor panel with significant loss of section and exposed and corroded prestress strands and triangulated trusses

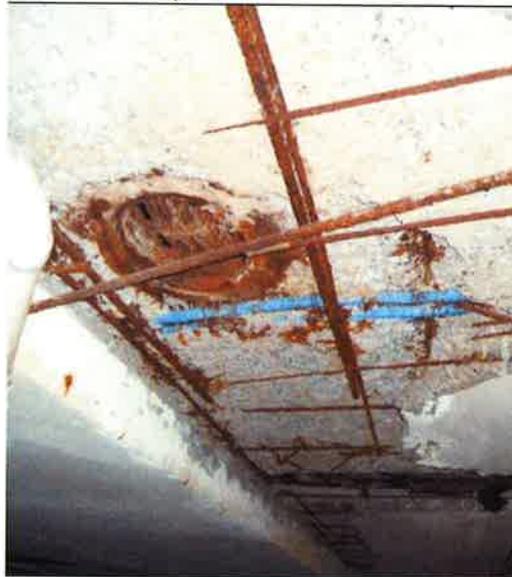
Photo 18: Level 2 Underside – View showing severe corrosion damage and sectional loss of precast filigree panel. Also note severe corrosion & complete loss of floor drain

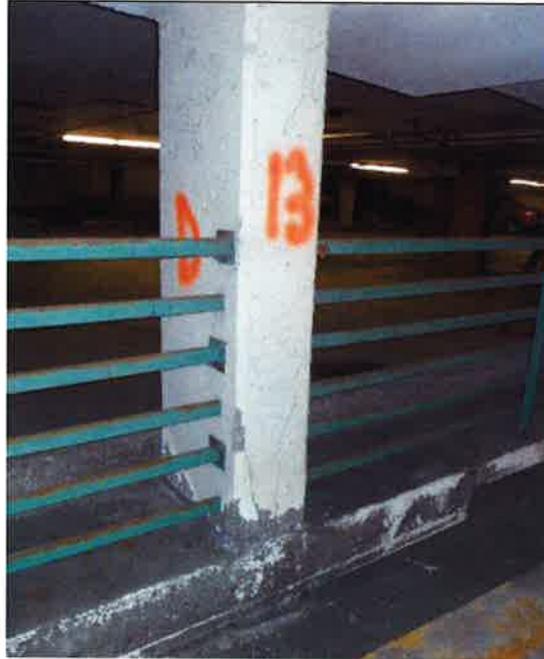
Photo 27: Level 3 – View of typical cracking and delamination at the column base

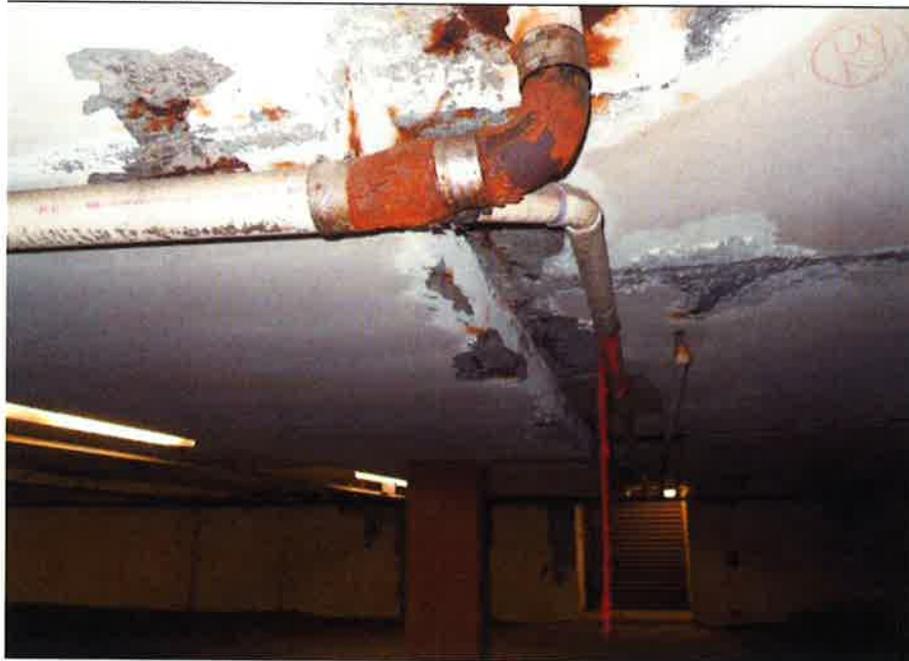
Photo 28: View of supplemental added floor drains and lines non-functional and in disrepair
