WALLINGFORD FIRE DISTRICT #1
WASTEWATER
POST JULY 2023 FLOOD
TREATMENT PLANT ASSESSMENT
RUTLAND COUNTY, VERMONT

NPDES PERMIT NUMBER VT0100552
STATE OF VERMONT PERMIT NUMBER 3-0365

September 27, 2023

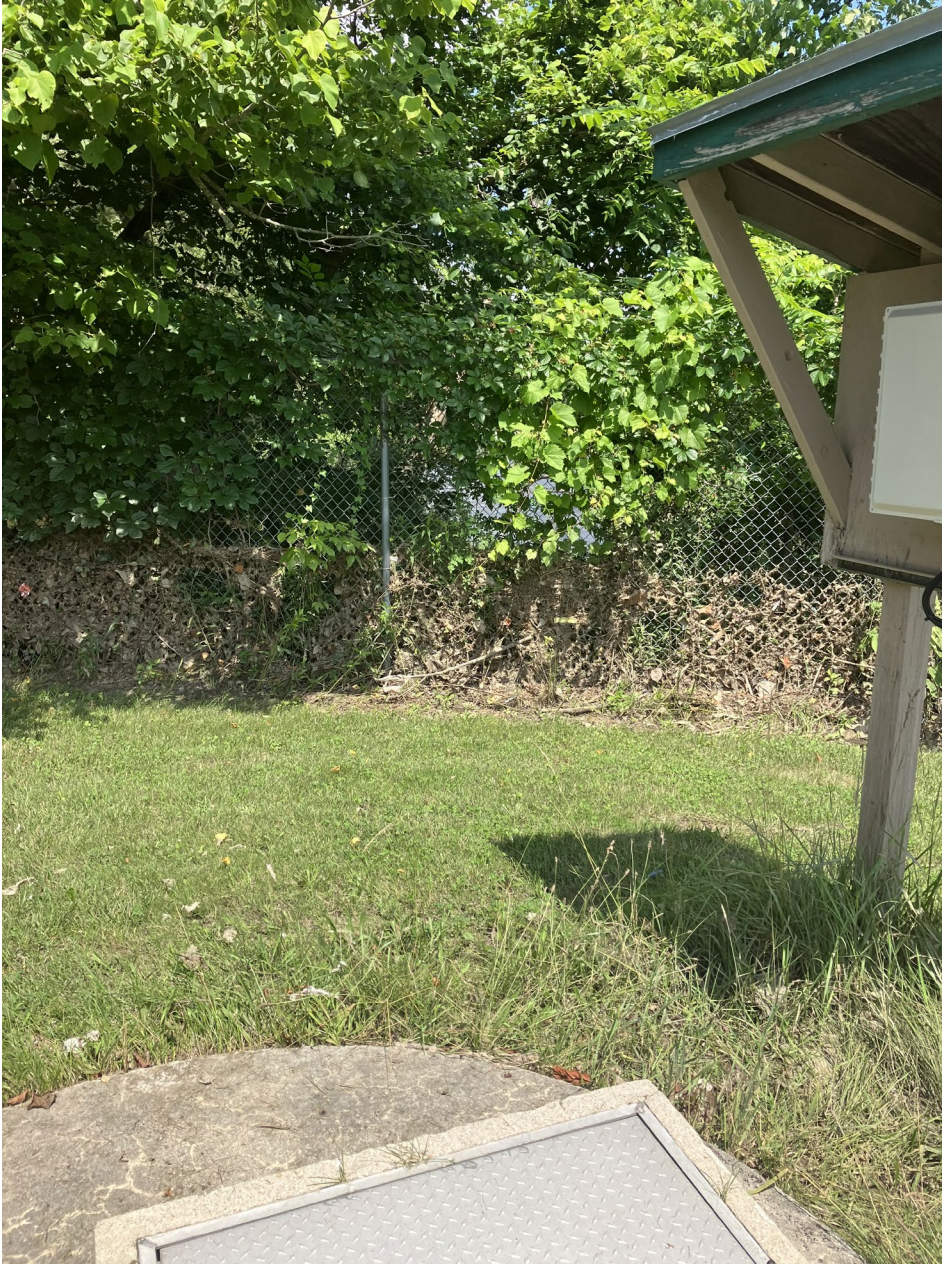
1- Perimeter Fence Showing Debris From High Water and Influent Pump Station

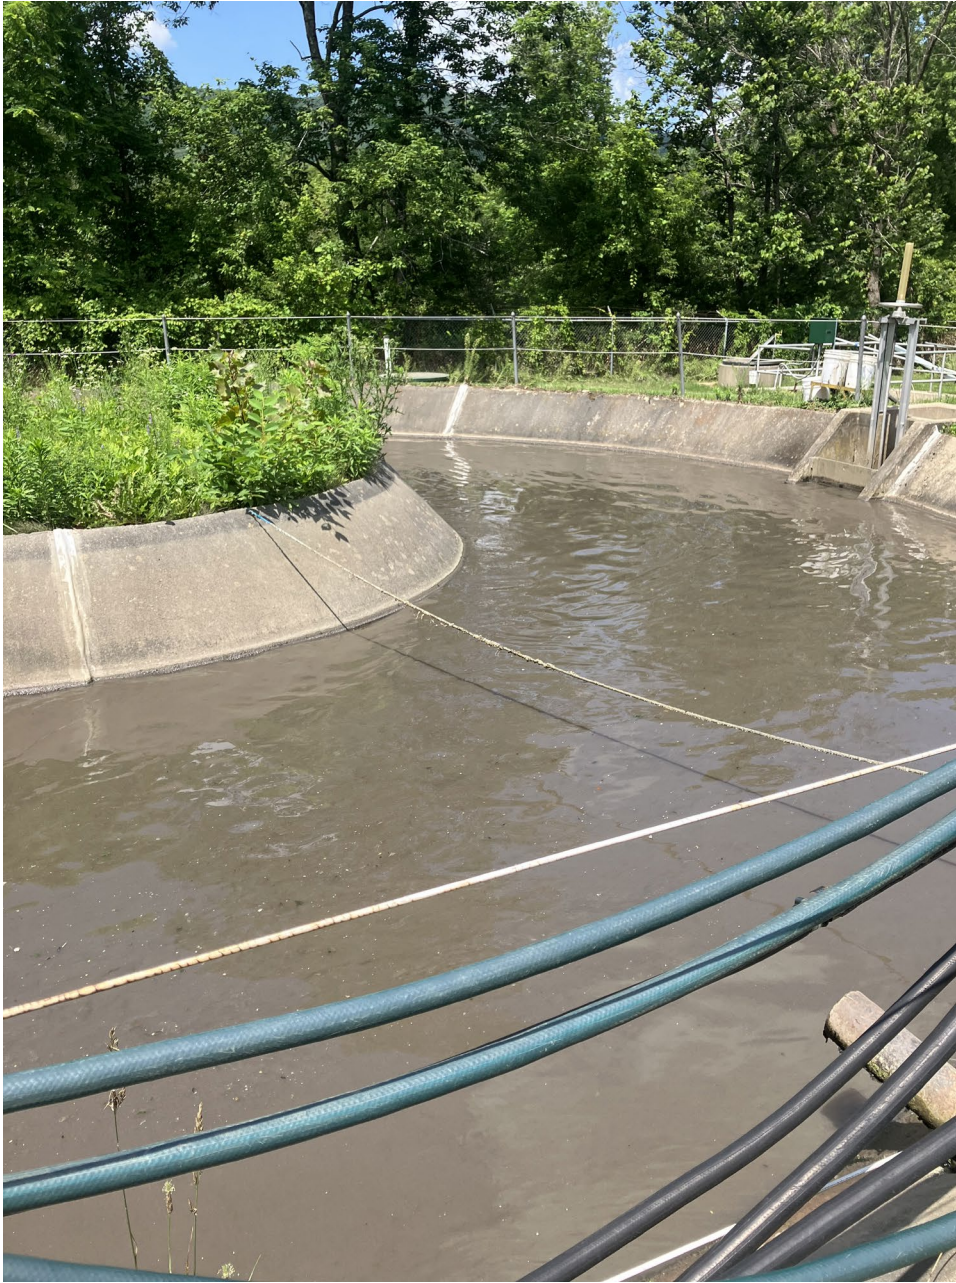
3-Oxidation Ditch with Residual Debris

- The aeration ditch grit level should be also checked and compared to pre-flood measurements. Excess buildup of solids should be removed.
- Jetting and camera inspection of low-lying collection system areas as the collection system received an appreciable amount of grit/silt/debris. Camera inspections should be explored to ascertain collection system damages.

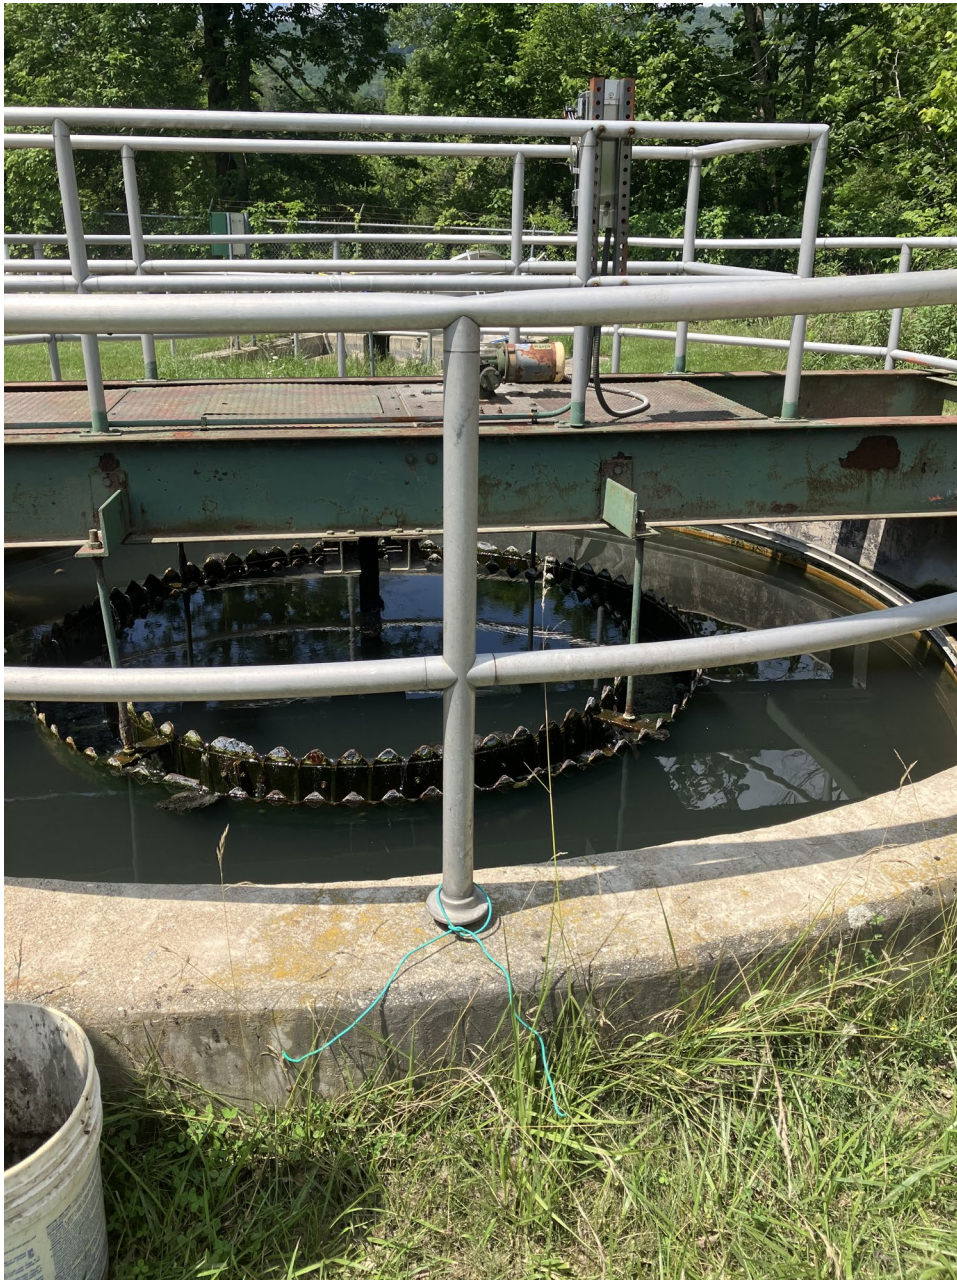
5-Clarifier Converted to Contact Chamber

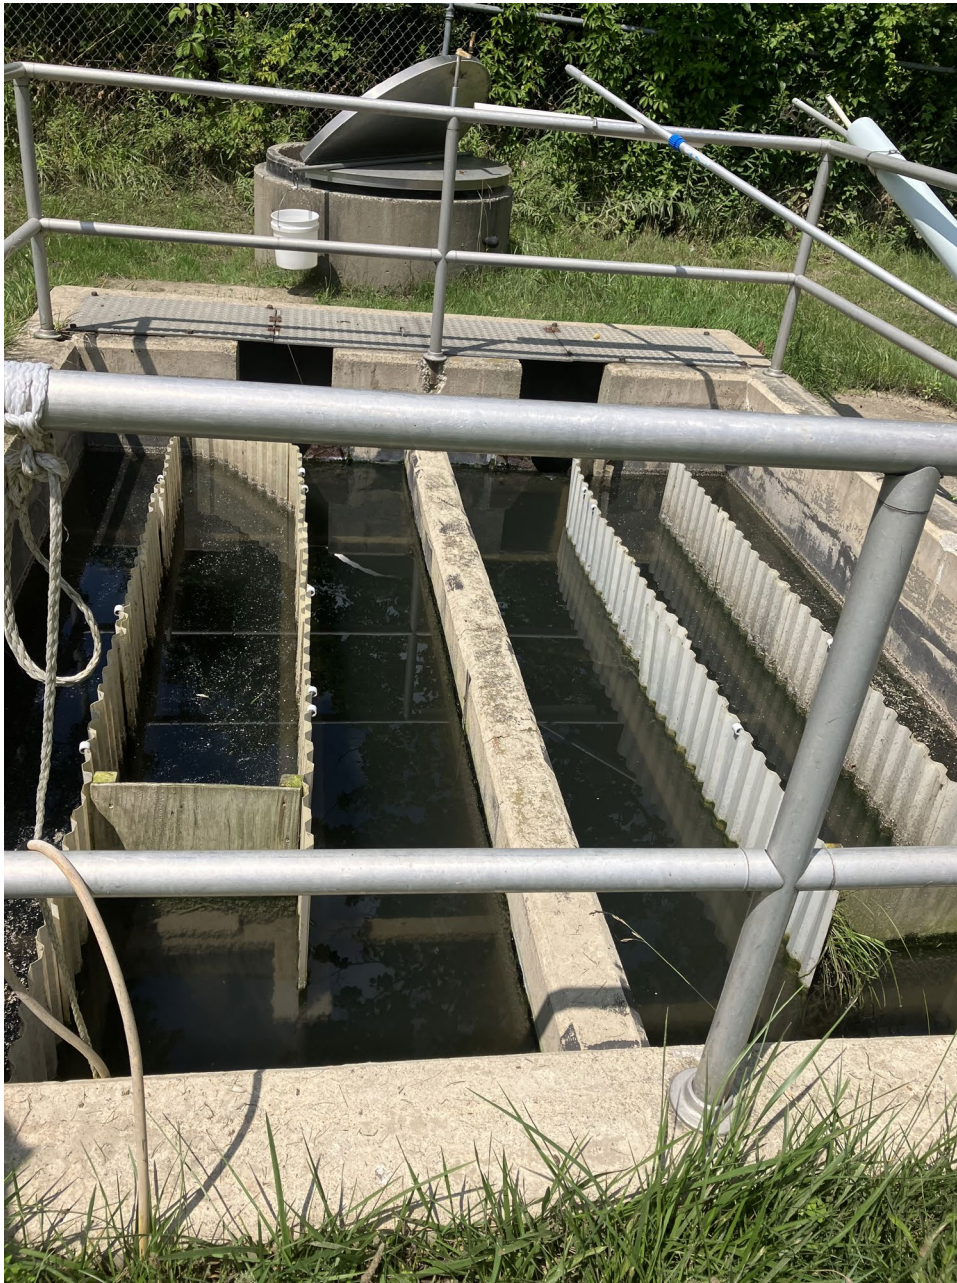
6-Chlorine Contact Chamber

The primary concern during this and even less intense events is the tendency for the very short effluent run between the chlorine contact chamber and the outfall (approximately 15 feet) to back up into the treatment works. The operators must be diligent to valve off the effluent to prevent backflow into the chlorine contact chamber as

Otter Creek rises. Rainfall events as low as one-inch can cause enough creek rise to threaten backflow.

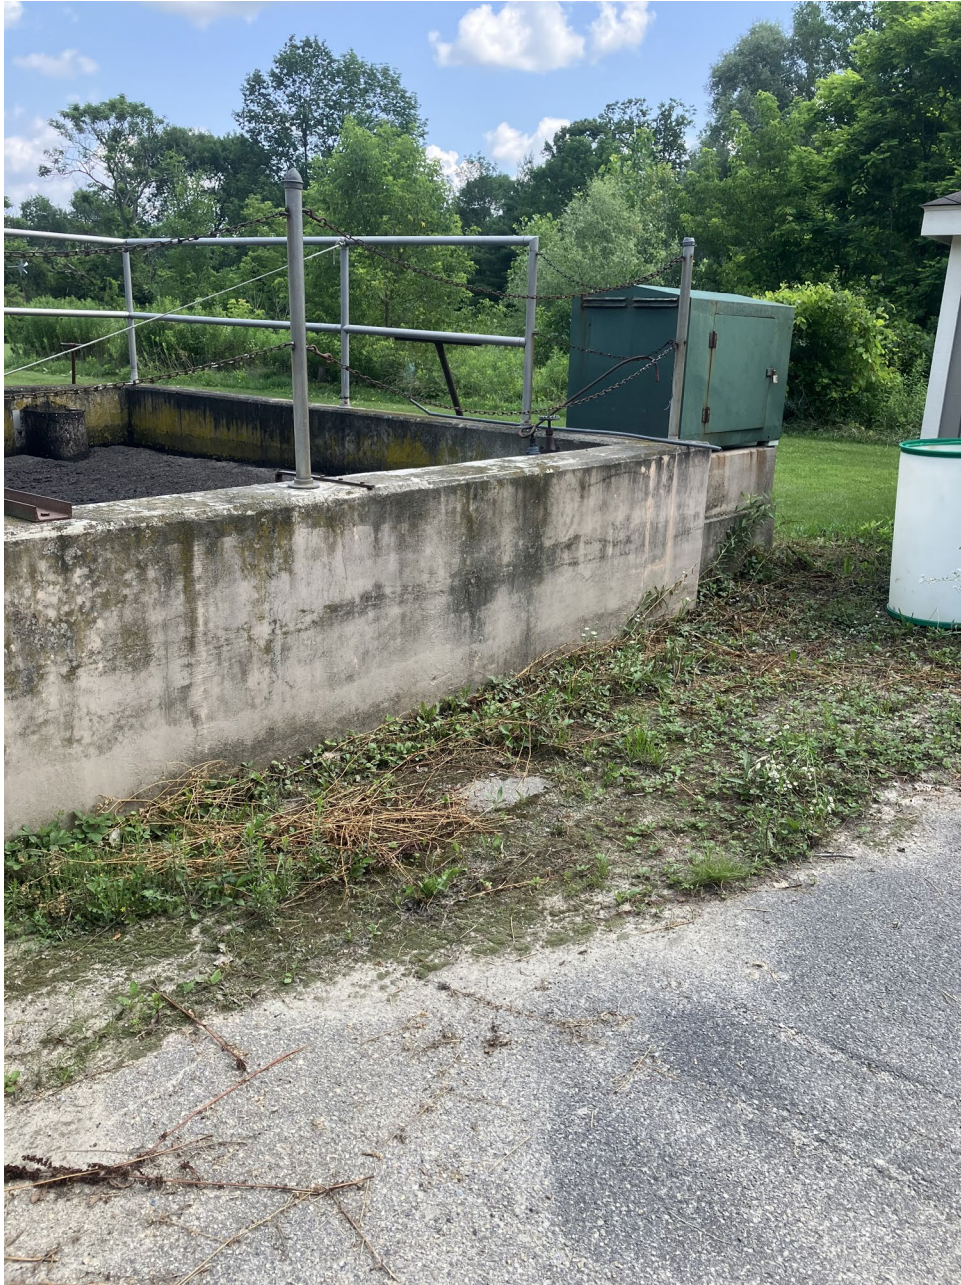
9- Aerated Sludge Holding Tank with High Water Mark Line Approximately 2 feet
