INDOOR MOLD ASSESSMENT REPORT

Vermont Veterans Home
325 North Street – Bennington, Vermont

September 27, 2012

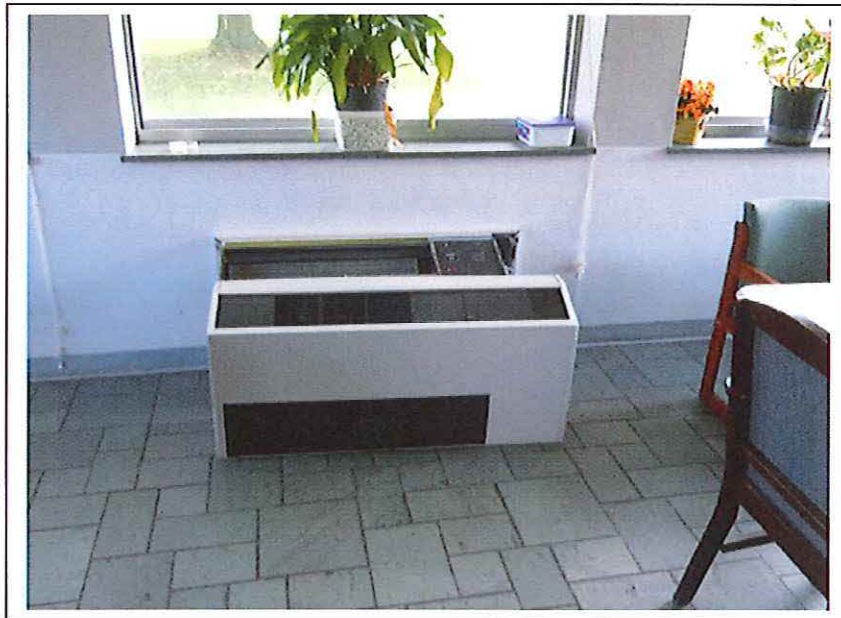
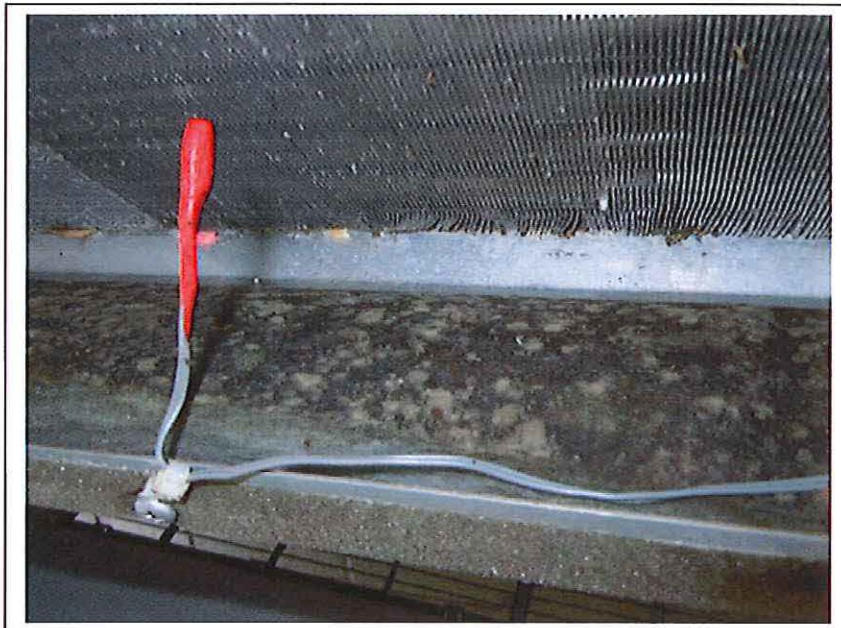
At the request of Melissa Jackson, Home Administrator with the Vermont Veterans Home (VVH), Crothers Environmental Group, LLC (CEG) conducted indoor mold assessments and assisted with remediation of mold discovered growing on insulation inside Trane® heating and cooling heat pumps.

JK brought the consultants down to the dining room at the east end of C-Wing in order to open up one of the WHPs in this area. This room was not being used by building occupants at that time. When the unit was opened up, elevated concentrations of *Cladosporium cladosporioides* type mold spores were released into the air (though this was not known until the air samples collected from the room had been analyzed at the laboratory the following day). It was immediately noticed that visible mold growth was present on the black fiberglass insulation inside the unit (see bottom photo on page 1 of this report). This was likely caused by condensation accumulating on the insulation (or more likely the dirt, dust and debris on the insulation) during the cooling season.

Though airborne concentrations of *Cladosporium cladosporioides* spores were nearly non-existent in the rooms/areas sampled, surface samples collected of visible growth on fiberglass insulation and on coils inside the WHPs revealed the presence of heavy concentrations of *Cladosporium cladosporioides* type mold.

- b) Based on recent research and the success of ultraviolet (UV) light technology in a State building in Burlington, Vermont, we suggest serious consideration be given to utilizing UV lights in both the individual room WHPs and FCUs as well as incorporating them into the existing ducted HVAC systems downstream of all cooling coils. It is not known if the UV lights will be visually irritating to the room occupants at night when the main lights are off. It may be prudent to install the UV lights in a few rooms at first to determine if they will be problematic to the occupants. After the first year of use, it may be a viable option to turn the UV lights off during the heating season; which would add to the life of the bulbs (though we recommend checking with the manufacturer first).
