# FACILITY CONDITION ASSESSMENT AND ENERGY AUDIT

#### VERMONT VETERANS' HOME

325 North Street Bennington, Vermont 05201

**EMG Project #:** 106686.13R-001.305 **Date of Report:** November 18, 2013 **On-Site Date:** October 14-16, 2013

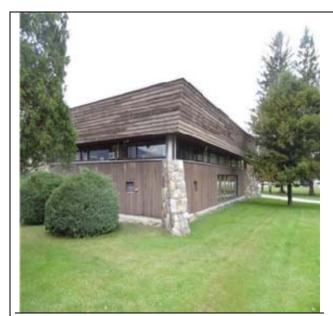
The original finish on the natural wood siding is weathered. Thorough surface preparation and application of durable stain and sealer is recommended.

Vertical and horizontal wood siding

Туре	Component Description	Qty / UOM	Unit Cost (\$)	Plan Type	Priority	Year	Expenditures (\$)
B2011	Replace Vertical Wood Siding	675.0 - SF	12.7	IN - Beyond Rated Life	Priority 4	2024	8,559

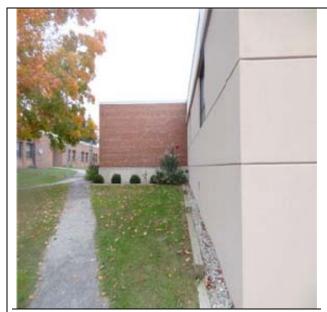
EIFS is on good condition. Maintenance is anticipated.

EIFS finish at North Village Wing

Туре	Component Description	Qty / UOM	Unit Cost (\$)	Plan Type	Priority	Year	Expenditures (\$)
	Repair 10% of Asset: EIFS with	5.0 -		OP -	Priority		
B2011	Stucco Over Cement Board	CSF	476.0	Maintenance	4	2016	2,380
	Repair 10% of Asset: EIFS with	5.0 -		OP -	Priority		
B2011	Stucco Over Cement Board	CSF	476.0	Maintenance	4	2024	2,380
	Repair 10% of Asset: EIFS with	5.0 -		OP -	Priority		
B2011	Stucco Over Cement Board	CSF	476.0	Maintenance	4	2032	2,380

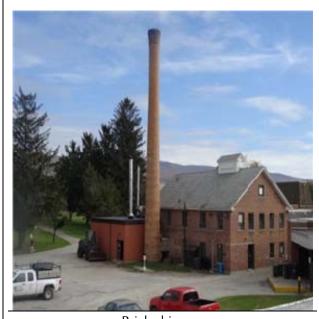
The brick chimney is no longer required for the current oil combustion equipment. Significant brick repair pointing is required, particularly near the top.

Brick chimney

Туре	Component Description	Qty / UOM	Unit Cost (\$)	Plan Type	Priority	Year	Expenditures (\$)
B2011	Repair Brick Chimney	1.0 - EA	25000.0	OP - Maintenance	Priority 4	2014	25,000
B2011	Repair Brick Chimney	1.0 - EA	25000.0	OP - Maintenance	Priority 4	2024	25,000

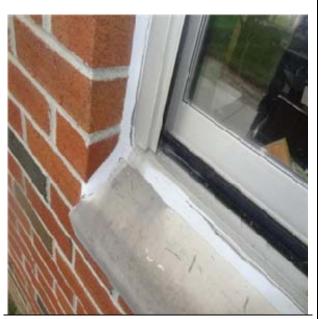
Caulking is reasonably well maintained. Seasonal inspection and routine caulk repair is required.

Window sealant

Туре	Component Description	Qty / UOM	Unit Cost (\$)	Plan Type	Priority	Year	Expenditures (\$)
B2011	Replace Caulk sealant at joints and openings	3,000.0 - LF	3.8	OP - Maintenance	Priority 4	2019	11,520

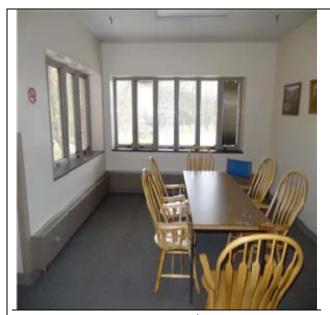
Fixed windows

Туре	Component Description	Qty / UOM	Unit Cost (\$)	Plan Type	Priority	Year	Expenditures (\$)
B2021	Replace Corridor Windows	18.0 - EA	1277.0	IN - Beyond Rated Life	Priority 3	2013	22,986

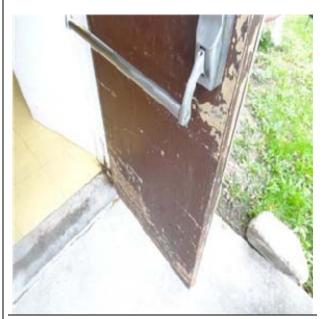
Exterior doors in some areas receive high usage and wear. Ongoing replacements are required.

Exterior door

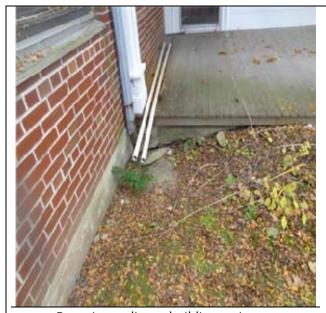
Landscape grades along many building perimeters have settled causing surface drainage towards foundation walls and basements. Soil replenishment and grading is required.

Poor site garding at building perimeter

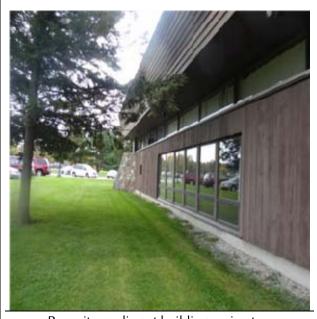
Poor site grading at building perimeters
