COMPREHENSIVE MOLD REPORT

VERMONT VETERAN'S HOME

BENNINGTON, VERMONT

February 15, 2014

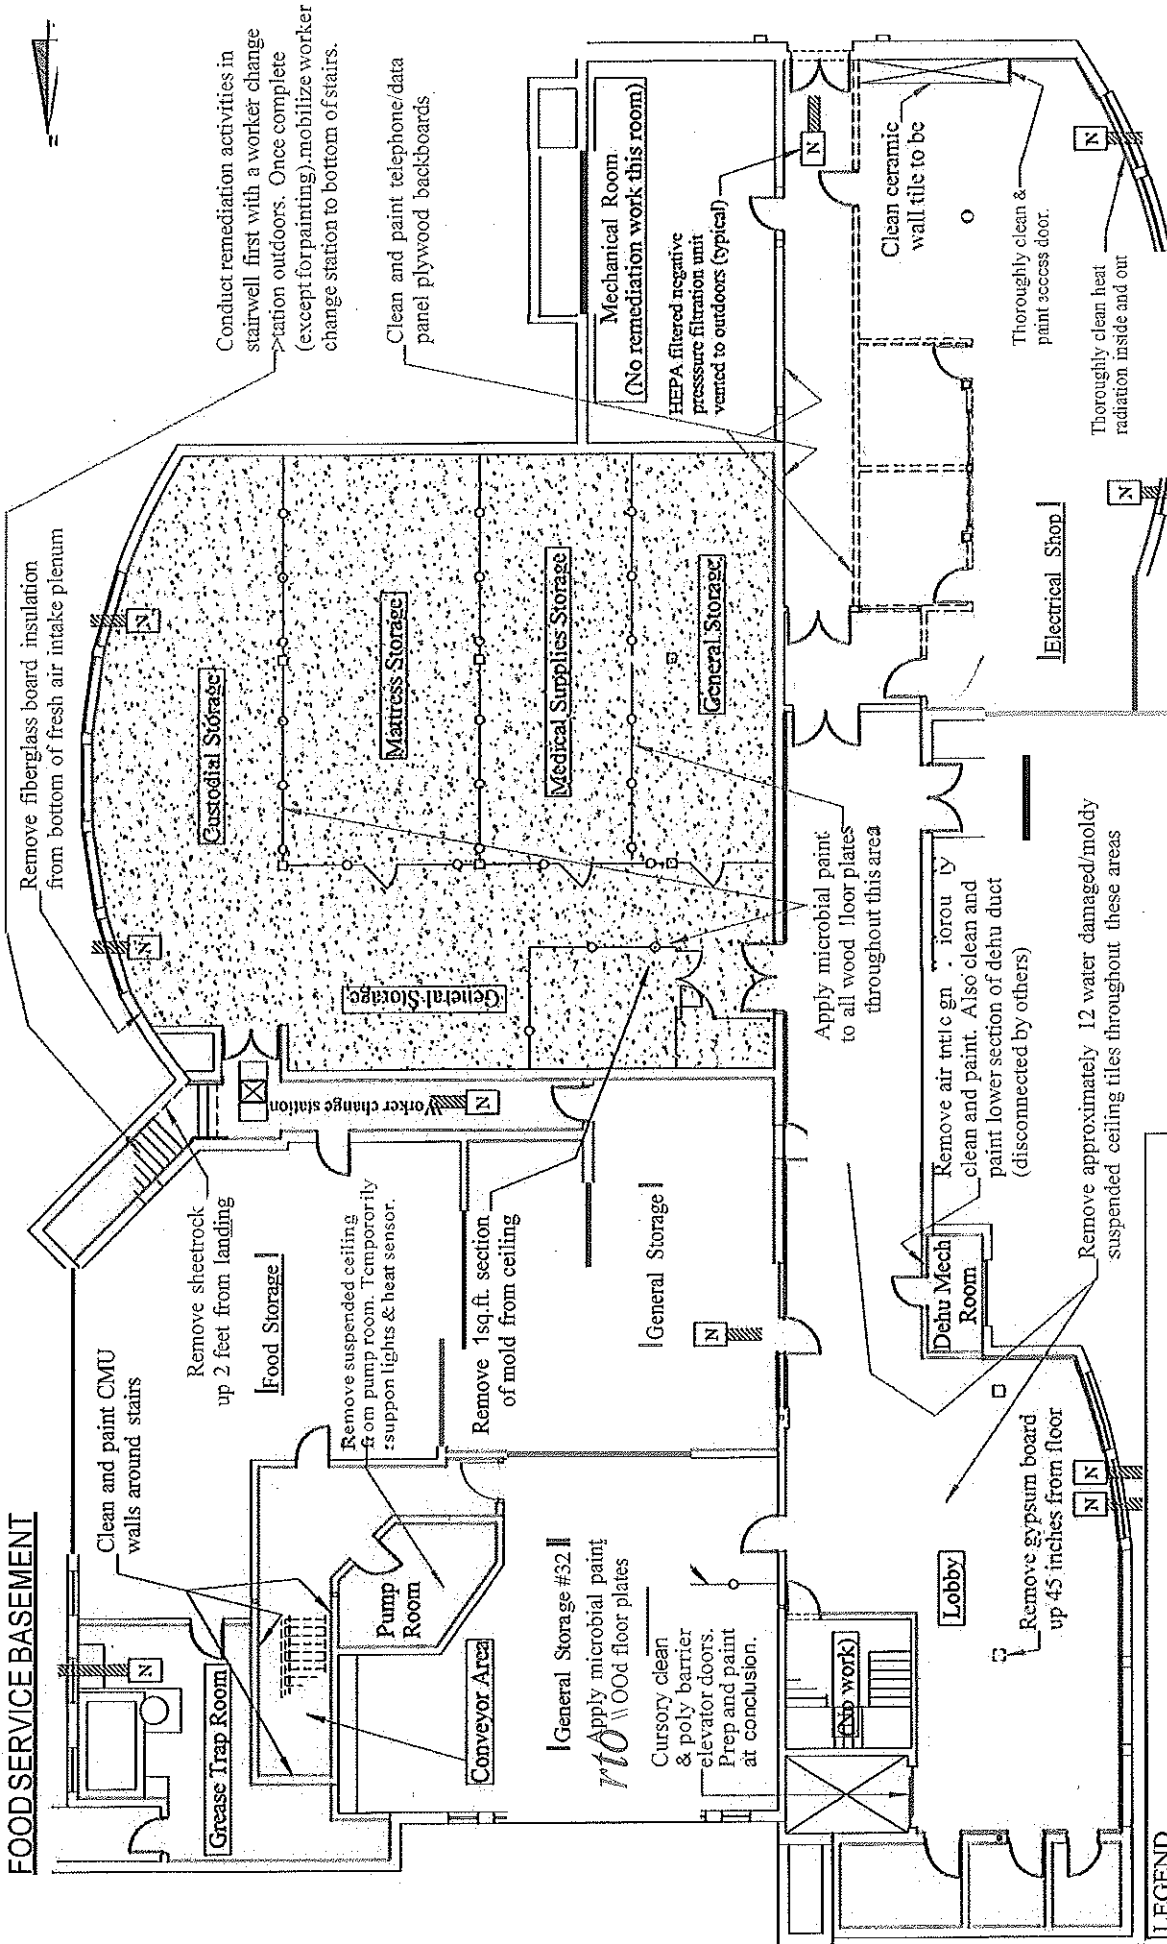
FOOD SERVICE BASEMENT

The first Phase of remediation work was begun in July of 2013 and completed in October of 2013. This phase of the work also included preventative work. The project included mold testing, remediation, and post-remediation efforts as well as installing 4 HEPA blowers and over 80 UV lights plus the mold preventative work and as outlined and described in Diagrams MR1A and FS1. The remediation Work Plan prepared by CEG is also included in this report. All follow-up testing resulted in a mold safe environment for the work areas and a basement area that will be easy to inspect, monitor and detect mold growth in the future.

- Remove gypsum board up 45 inches from floor. Clean and apply microbial paint to floor plates (remove cove base where present). Take care not to damage light gage metal stud framing.
- Conduct cursory cleaning of walls, then apply microbial paint from the floor up 8 feet or to suspended ceiling height.
- Conduct cursory cleaning of ceiling, then apply microbial paint.
- Remove & dispose of fiberglass panels and associated cove base. Clean and apply microbial paint to wall.
- C. — Conduct thorough cleaning of doors, treat rust per specification, then prep door for painting and apply microbial paint.
