April 4, 2016

Representative David Deen
House of Representatives
State of Vermont
115 State Street
Montpelier, VT 05633-5301

The purpose of 6216-INDS's Condition 14, the subject of my testimony, was to ascertain if the Alternative Stormwater Treatment Practice components up at the elevation of the project are functioning to meet the specific performance standards outlined in the VT Stormwater Management Manual (VSMM). These include 1) Water Quality, 2) Channel Protection, 3) Groundwater Recharge, Overbank Flood Protection (10-year recurrence flood), and Extreme Flood Protection (100-year recurrence flood). This is accomplished, according to GMP's consultant, via photo-documentation, video and water sampling during storm events. The purpose of this required study would be to understand if the modeling was accurate and if the system will function in accordance with the regulations. The water quality monitoring, part of the 401 Water Quality Certificate and distinct from Condition 14 of 6216-INDS, is performed thousands of feet to miles downstream, and solely focuses on biological integrity at that location.

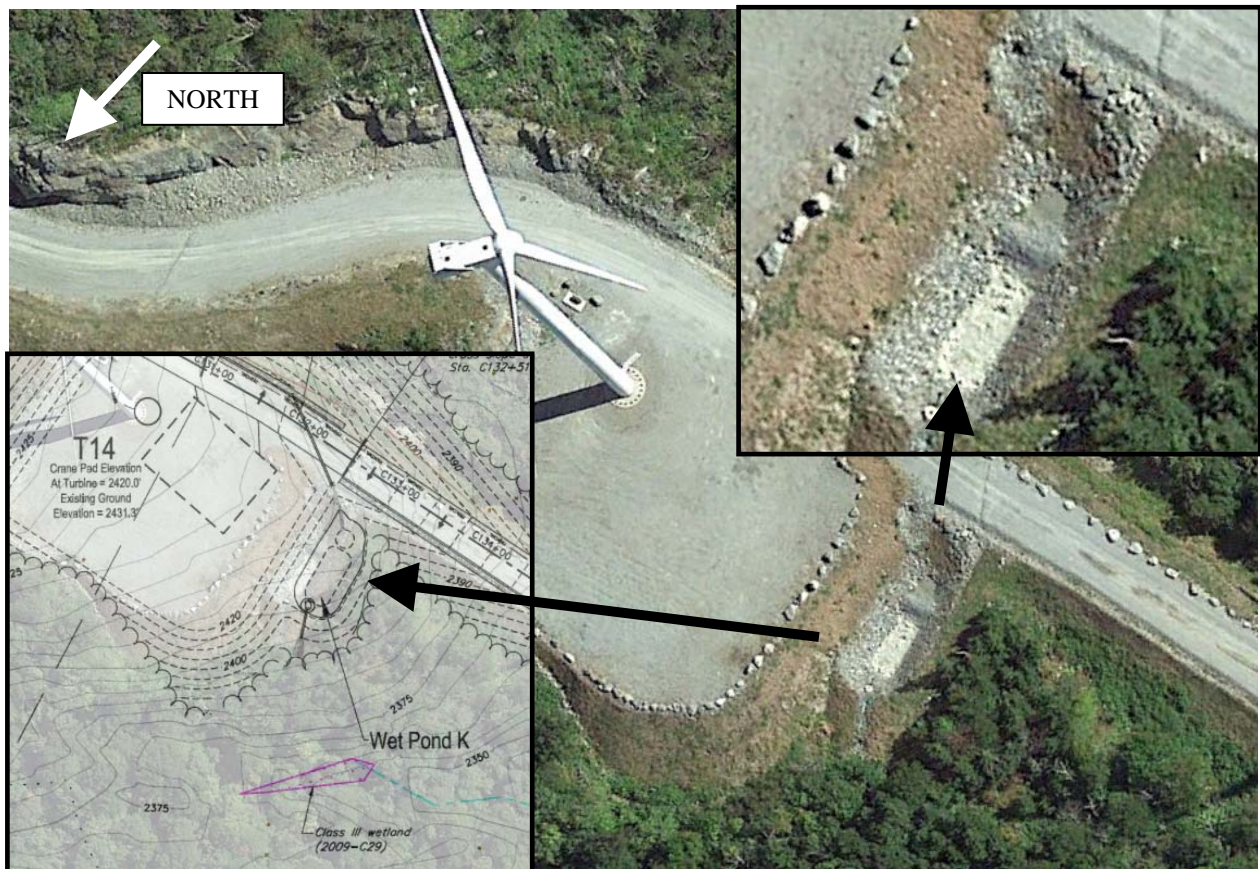
These include 13 wet ponds located along the crane path on the ridge. A wet pond’s effectiveness in removing pollutants is predominantly reliant upon the permanent pool (emphasis) that is provided to settle out suspended solids, contaminants, and nutrients. Of these 13 wet ponds, 11 of them are nearly or completely dry (empty) with no permanent pool. It is my opinion, and having been in the vicinity of several of the wet ponds back in 2013, that runoff entering the wet pond simply escapes the basins through the fractures in the rock and discharges to the mountain slopes immediately downhill. This means that the required portion of the water quality storm volume is not stored and treated in accordance with requirements of the VSMM. An example of the condition of a wet pond is in the figure below, with the engineering plans overlain on the aerial photograph. This is typical of the other empty “wet” ponds.

Wet Pond K at turbine T-14. Note, there is no permanent water pool in the basin. This is typical of 11 of the 13 ridgeline wet ponds (Sheet C-114 of the Operational Stormwater Plans, VHB, last revised June 2011).

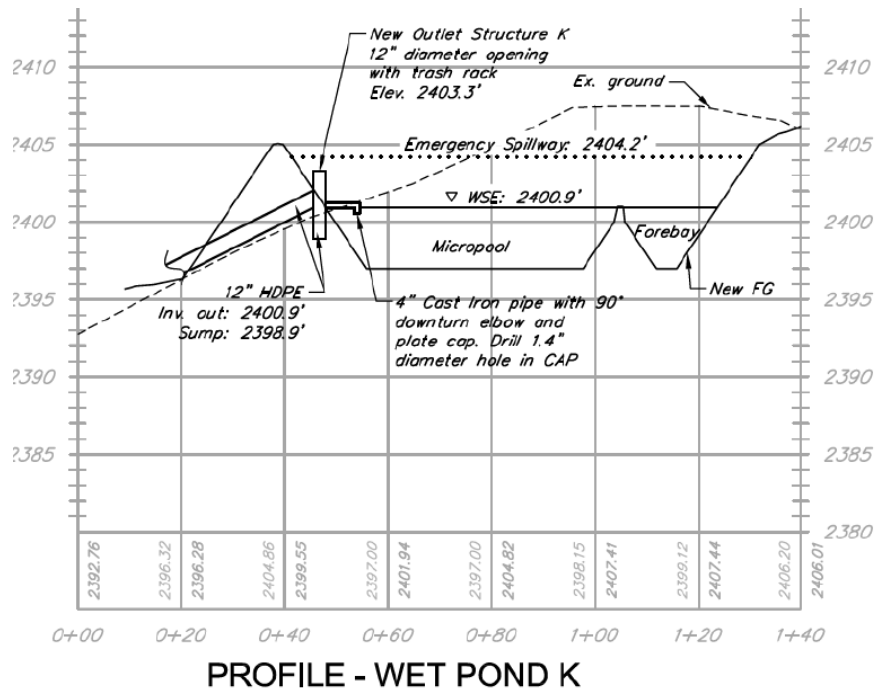
Profile of Wet Pond K at turbine T-14. The Forebay and Micropool are required to be permanently inundated (Sheet C-121 of the Operational Stormwater Plans, VHB, last revised June 2011).
