# *Bridge Inspections*

Municipalities Could be Encouraged to  
Take More Action with Improved  
Communication of Deficiencies by the  
Agency of Transportation

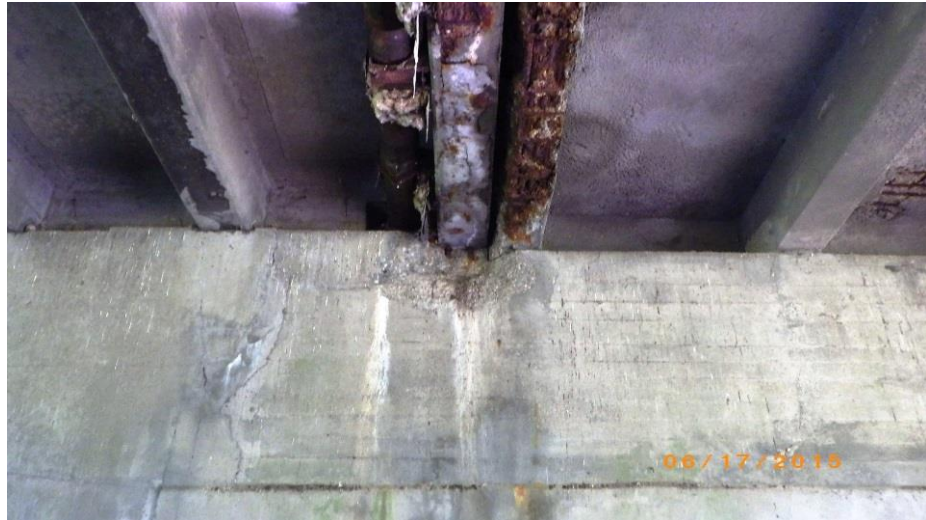
**Figure 5: Example of Concrete Deterioration on a Municipal-Owned Bridge**

*Concrete Deterioration.* Concrete is commonly used in bridge applications due to its compressive strength properties. In its inspection reports, VTrans pointed out deterioration in concrete elements, at times suggesting repairs or patches to deter further damage to the structure. See Figure 5 for an example of ongoing concrete deterioration.

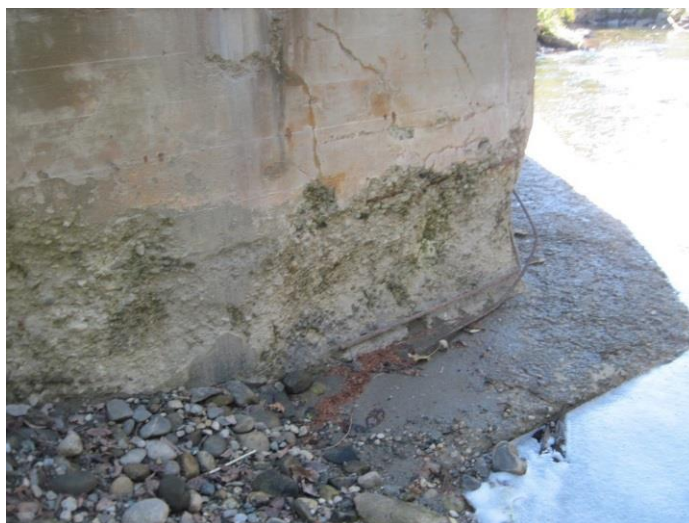
**Figure 6: Example of Effect of Scour on a Municipal-Owned Bridge**

*Scour.*<sup>14</sup> The physical conditions associated with the flow of water through the bridge may cause undermining of the slope, erosion of the banks, or realignment of the stream. In its inspection reports, VTrans pointed out waterway issues and sometimes suggested taking erosion control measures, such as adding stones or removing impediments to water flow. See Figure 6 for an example of an ongoing scour problem.

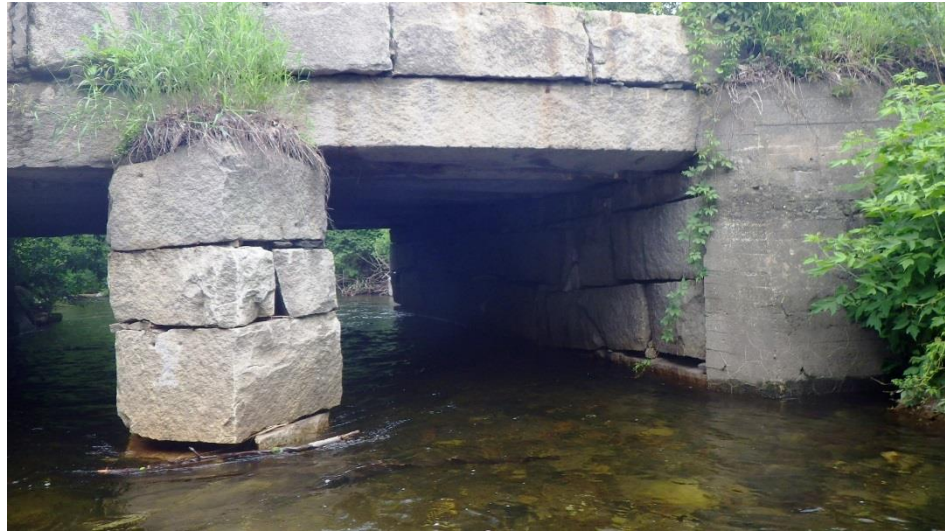
Voids in the abutments and the pier should be chinked with smaller stone.

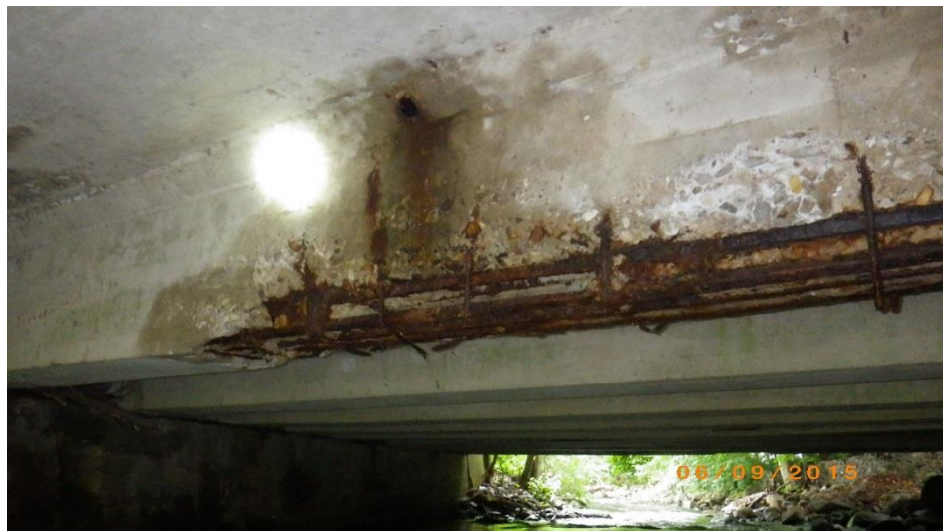
Extensive concrete repairs are needed.

VTrans is evaluating alternatives as part of town highway bridge program.

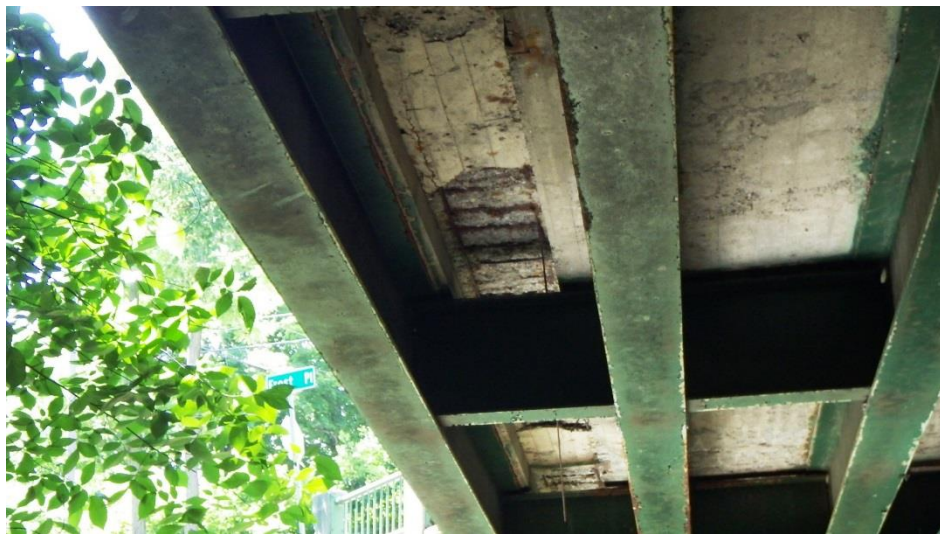
Deck will need rehabilitation in the near future.

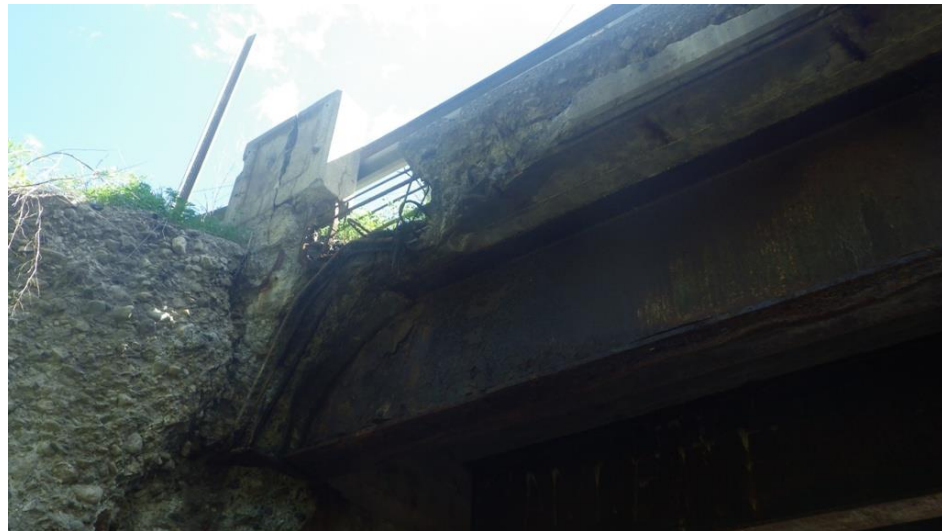
Concrete deterioration due to roadway runoff.

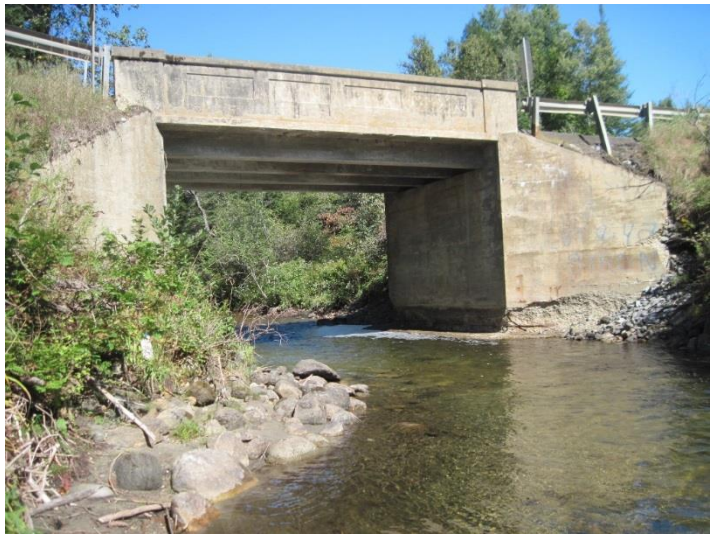
Approaches behind rail in corners need to be filled in with stone to prevent further deterioration.

Burke filled in area behind approach rails with stone.

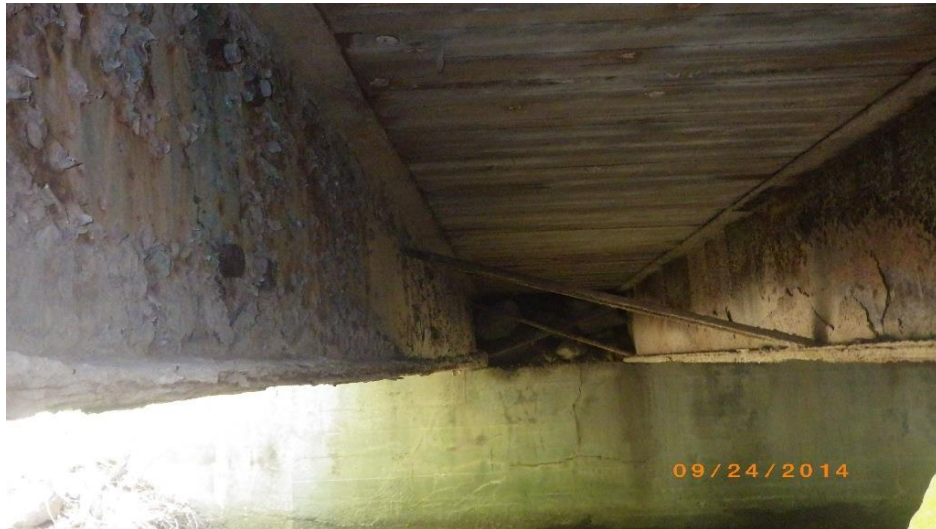
Deck and steel beam superstructure are reaching point for full replacement.

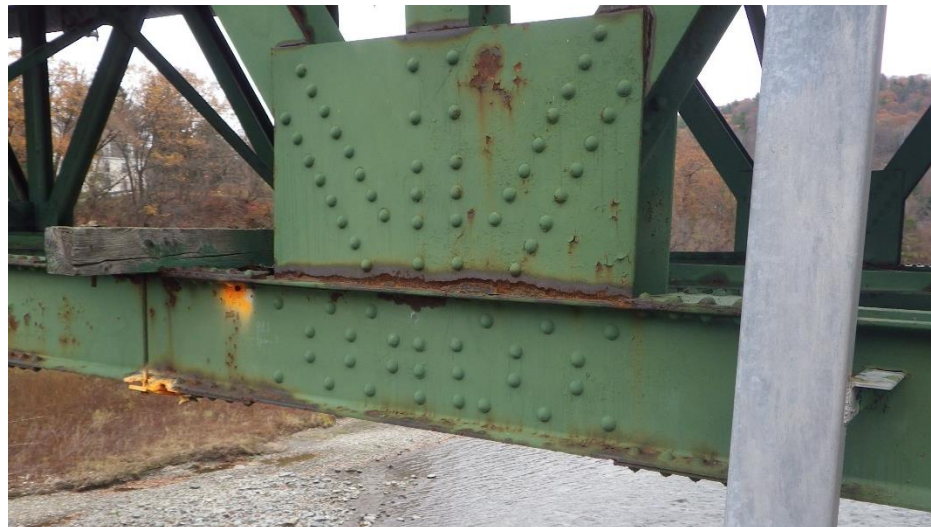
Deterioration along the lower node and bottom cord. Steel repairs and replacement of members is needed around these areas. The superstructure needs cleaning and painting.

Hartford partially addressed issue by greasing lower node in some areas, which temporarily protects the steel elements. VTrans is evaluating alternatives as part of town highway bridge program.

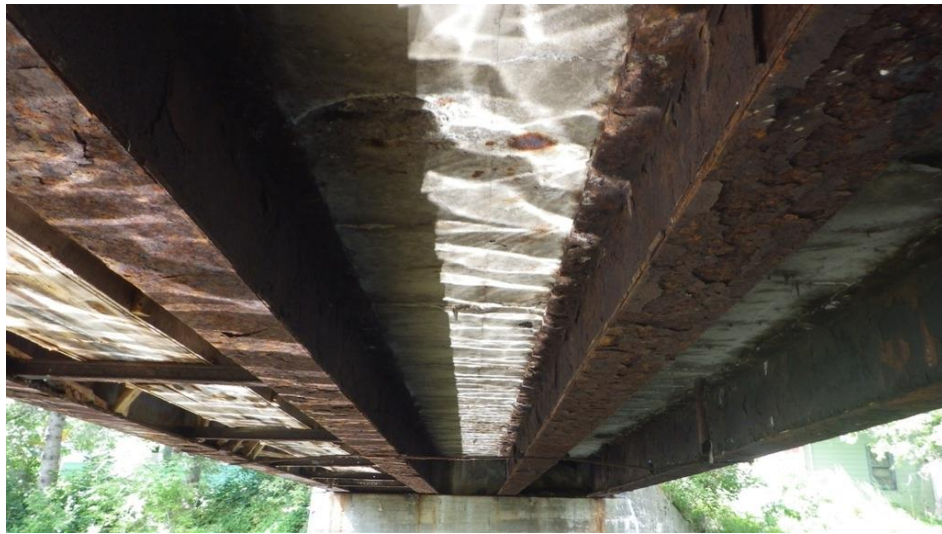
Beams have very heavy rusting and minor crushing at abutment 2 end. Bridge needs replacement or extensive reconstruction.

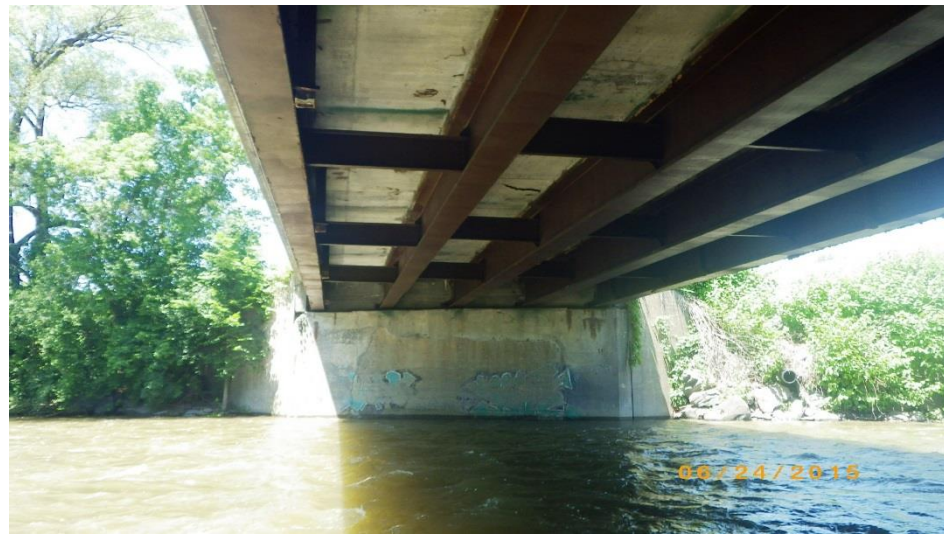
Abutments need cleaning and patch repair work

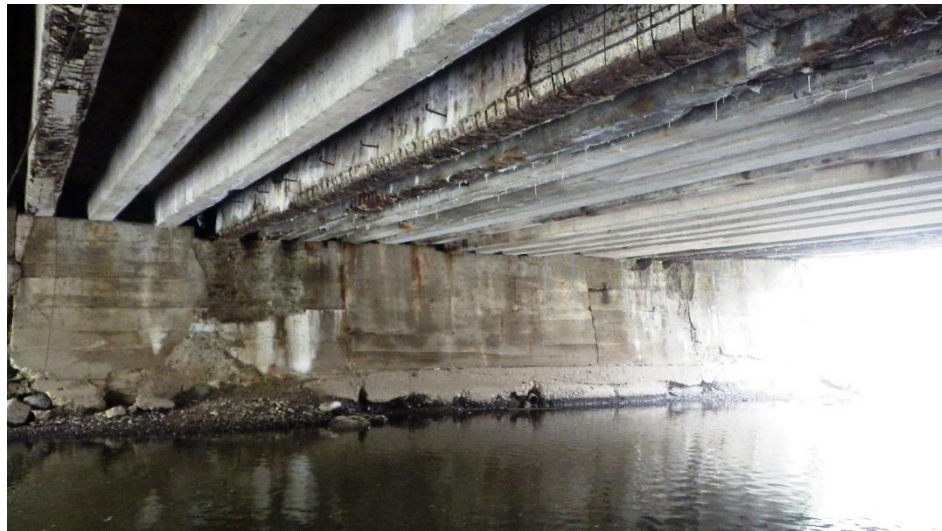
Heavy concrete damage along the western abutment stem and seats

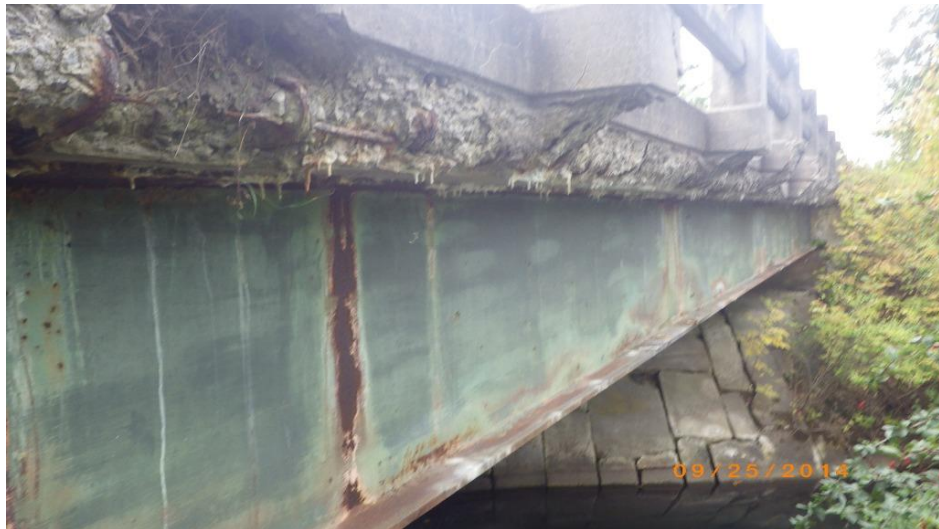
Bridge would benefit greatly from a deck replacement and cleaning and painting of steel superstructure.

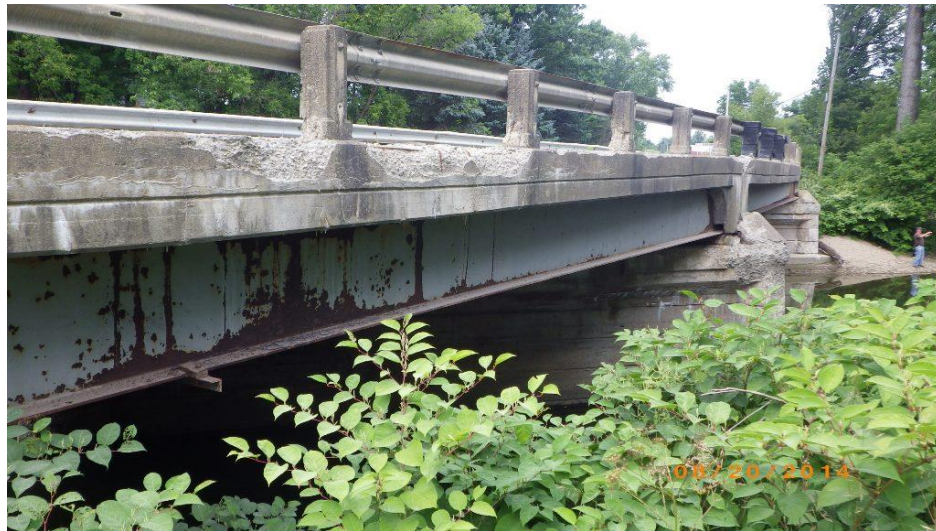
Deck is poor and bridge in need of extensive reconstruction.

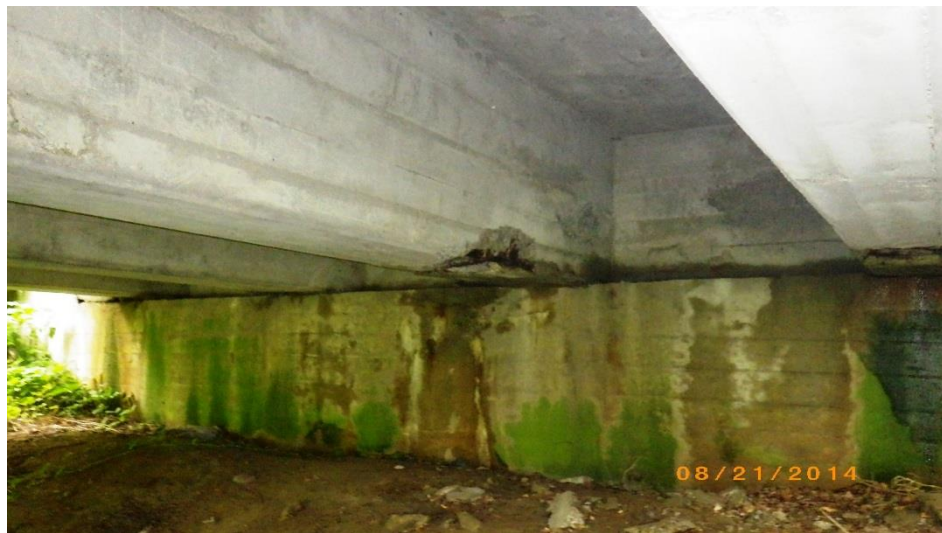
This structure should have concrete repairs to the piers and superstructure.

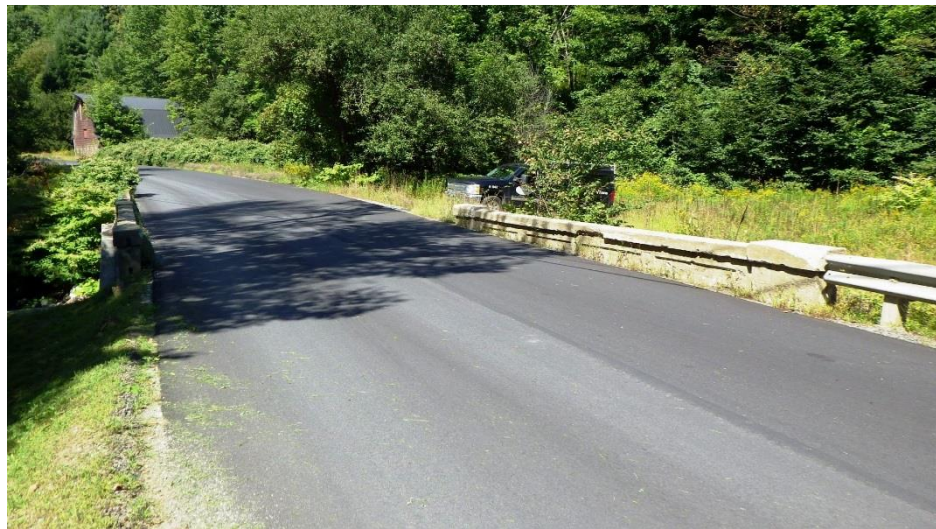
Approach rail should be raised to meet standards.

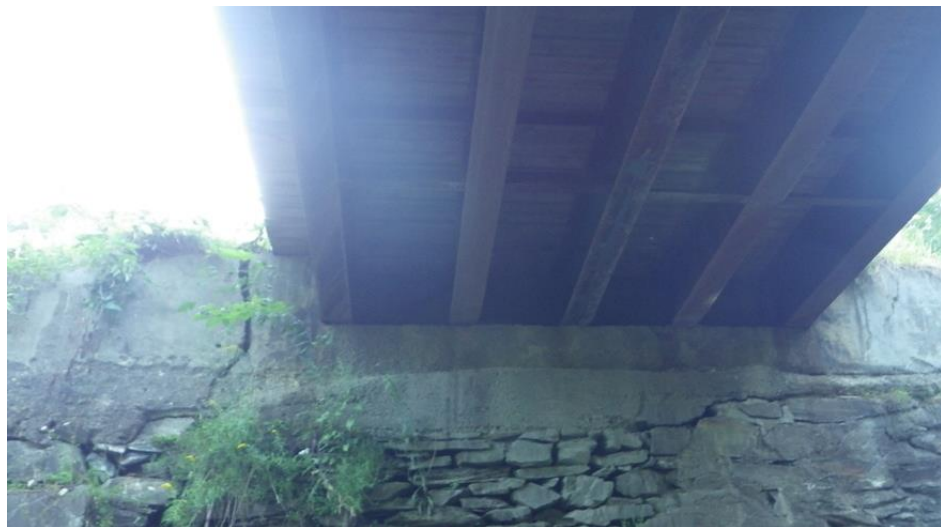
Laid-up stone at abutment needs chinking and mortar repairs.

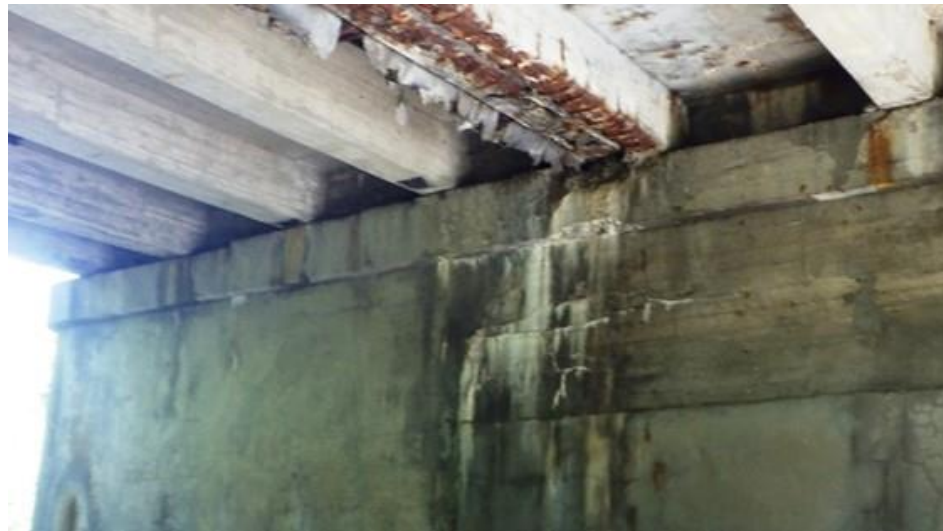
Concrete loss and substructure deterioration.

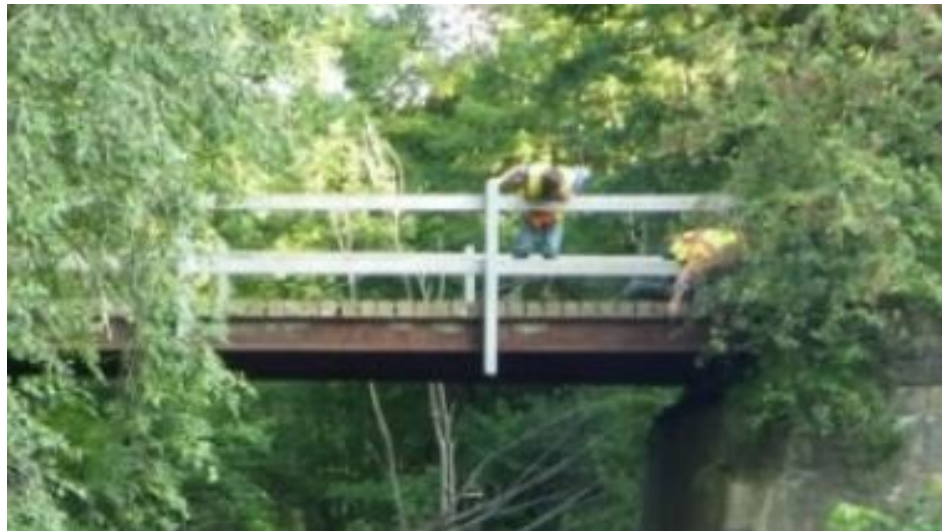
Structure deterioration is progressing. Steel superstructure is going to need replacement in five years or less.

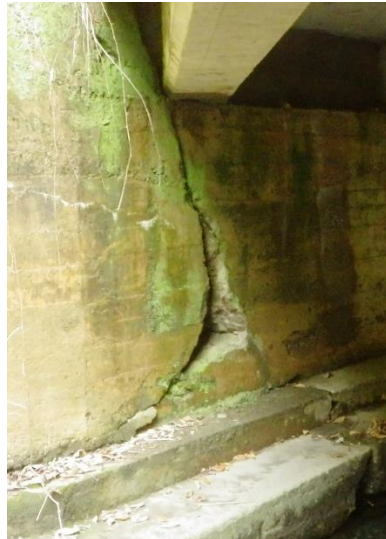
VTrans found abutment wall and footing damage but did not include this information in the report available to Randolph on VTransparency.

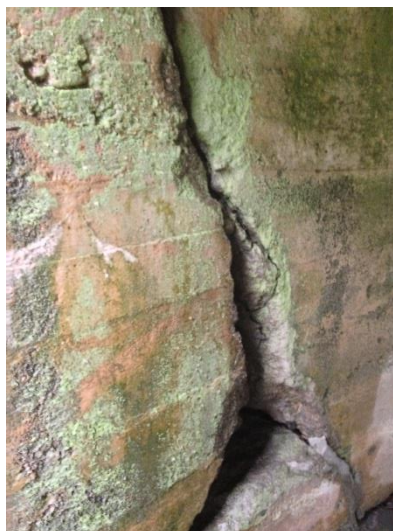
**Photo from Latest VTrans Inspection**

VTrans reported the abutment and footing damage in the report available to Randolph on VTransparency in 2017.

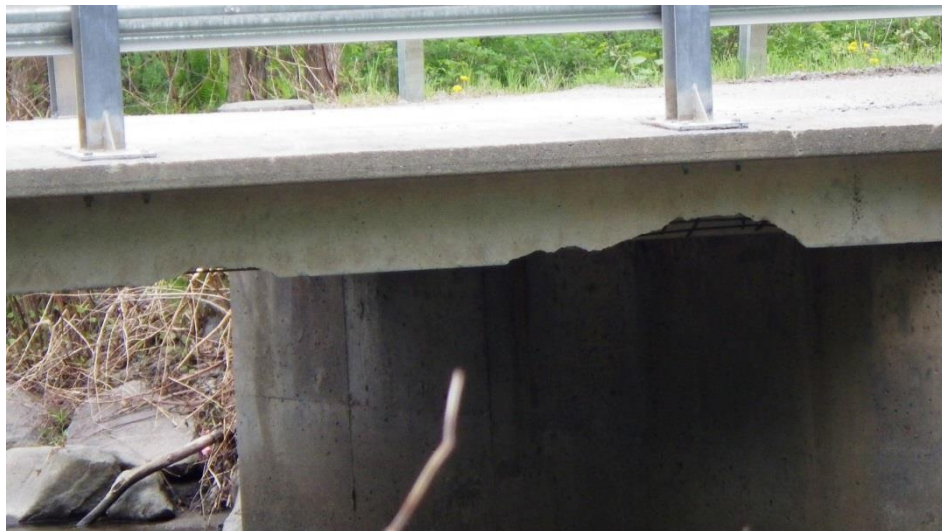
Tension cable is in good condition. Beam/cable unit should be replaced before tension cable rusts beyond repair.
