**ORLEANS WASTEWATER
POST JULY 2023 FLOOD
TREATMENT PLANT ASSESSMENT
ORLEANS COUNTY, VERMONT**

**NPDES PERMIT NUMBER VT0100251
STATE OF VERMONT PERMIT NUMBER 3-1201**

October 3, 2023

This report was prepared based on observations made during July 20, 2023 site visit by Heather Collins, VT DEC, WSMD, WWMP in conjunction with the US EPA Region 1 representative.

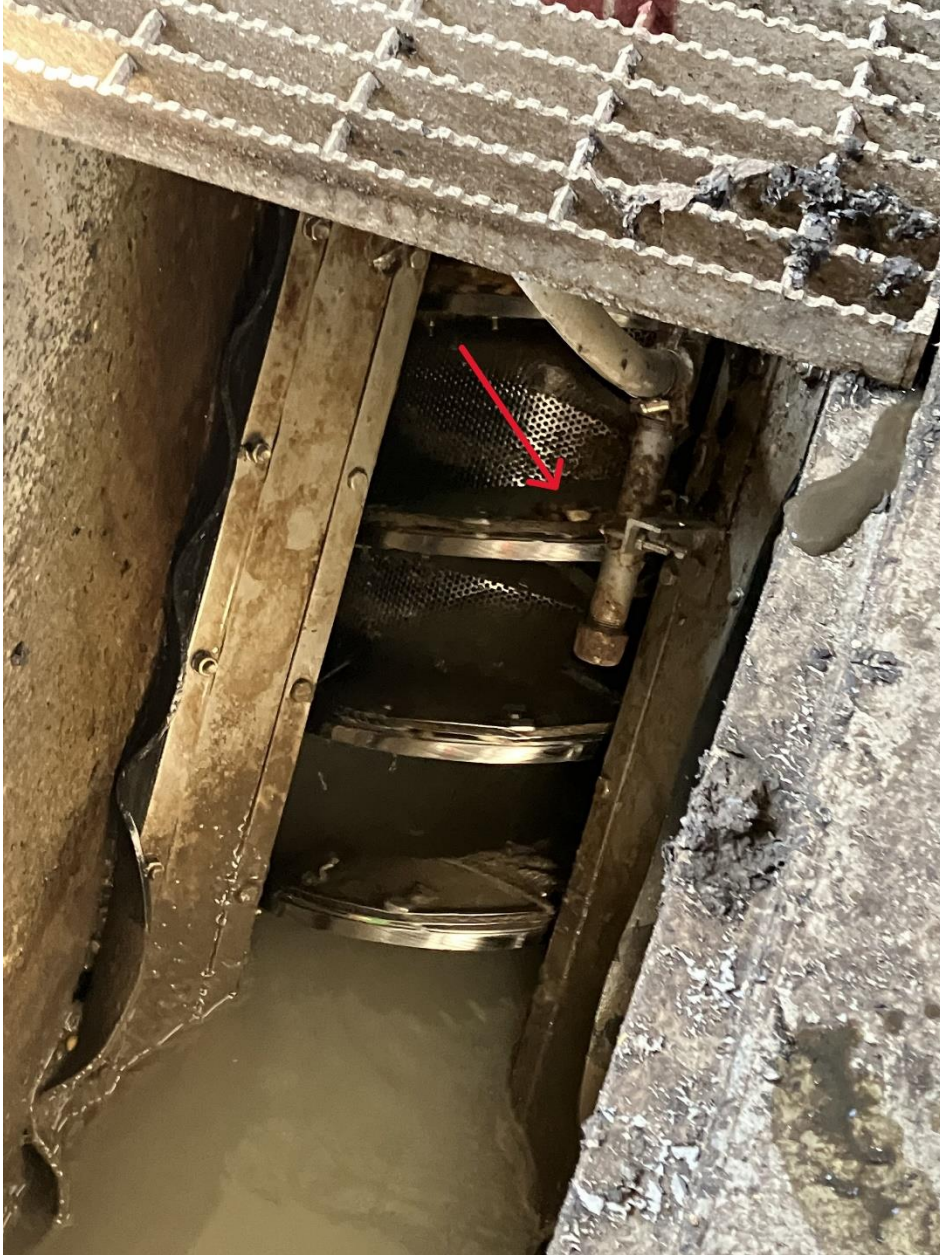
Headworks: The headworks received a large amount of gravel, grit and debris. The Lakeside fine screen auger pump was damaged due to pumping the gravel, grit, and debris.

1- Lakeside Fine Screen Auger with Residual Gravel Noted

- The Lakeside fine screen auger pump needs to be repaired/replaced.
- The facility will need to drain all treatment tanks to remove silt, sand, and grit.
- The plant will need to do a full calibration of the new flow meter since the meter

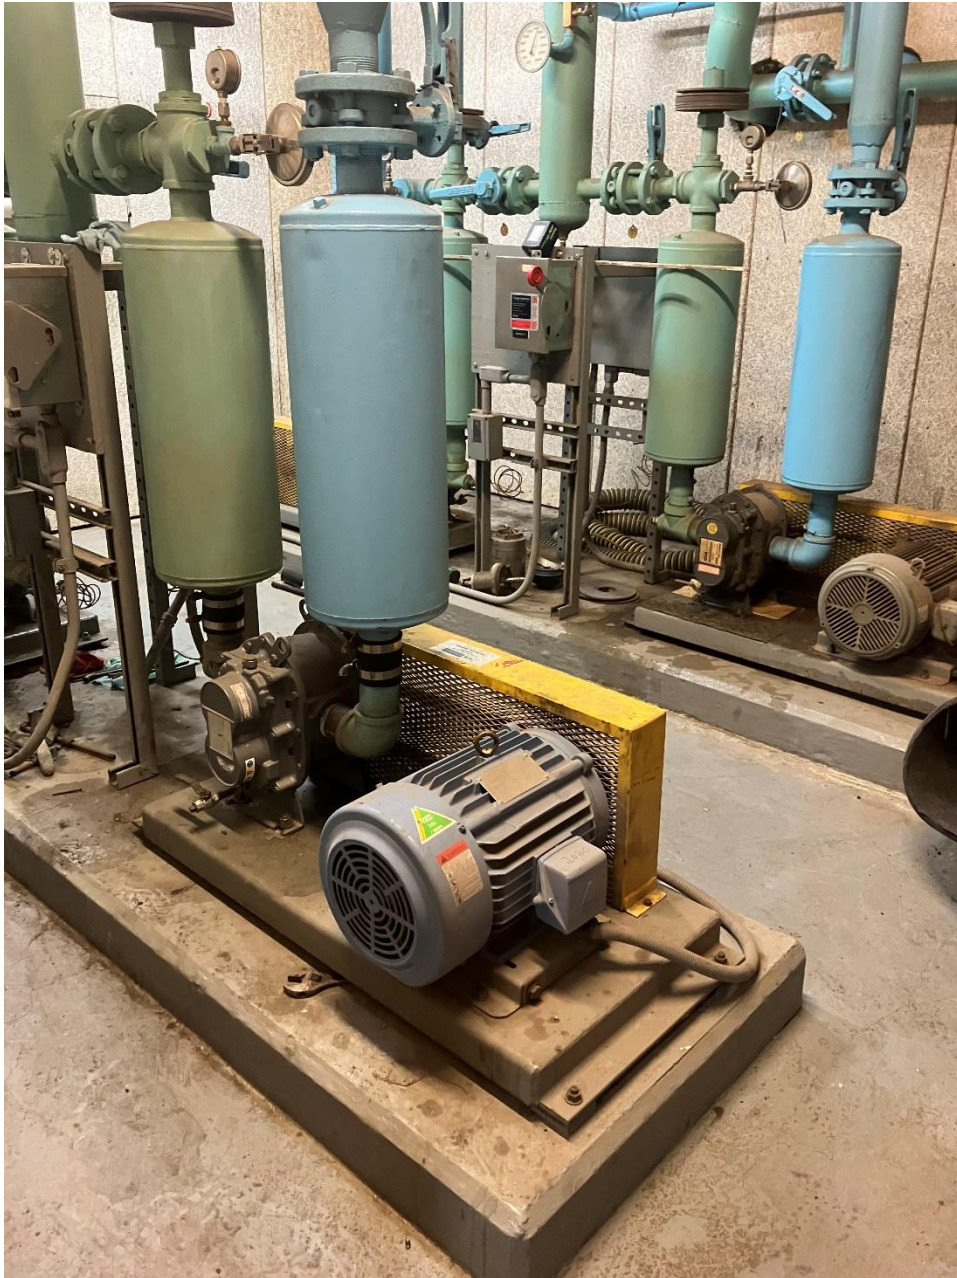
Main Building: Two feet of flood water entered the basement of the main building that houses the blower room where four Crown Triton Hyundai blowers and motors were damaged. The basement also houses the plant boiler. The Smith boiler supplies heat and hot water and is expected to be damaged although it has not been turned on given the hot summer months.

2- Crown Triton Hyundai Blowers and Motors

- The Crown Triton Hyundai blowers need to be professionally evaluated for damage and subsequent repair/replacement.
- The plant's boiler needs to be evaluated for damage and subsequent repair/replacement.

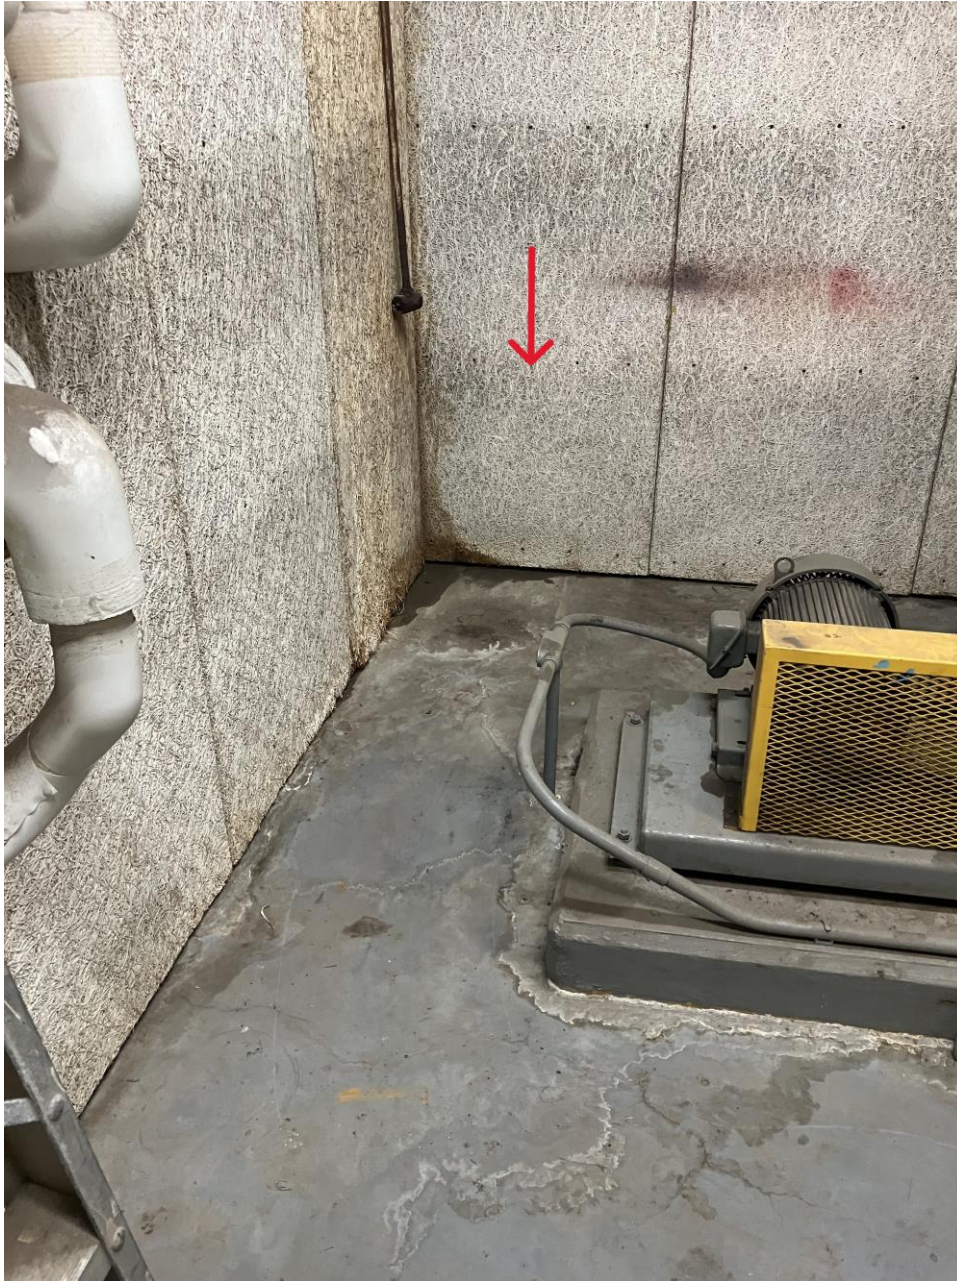
At the time of the assessment, the plant appeared to be fully operational. The majority of the plant's components did not flood due to elevation; however heavy flows from the river did back up through the outfall and into the effluent building. Approximately two feet of flood water entered the basement of the main building.

3- Blower Room Showing High Water Mark at Approximately 2 Feet

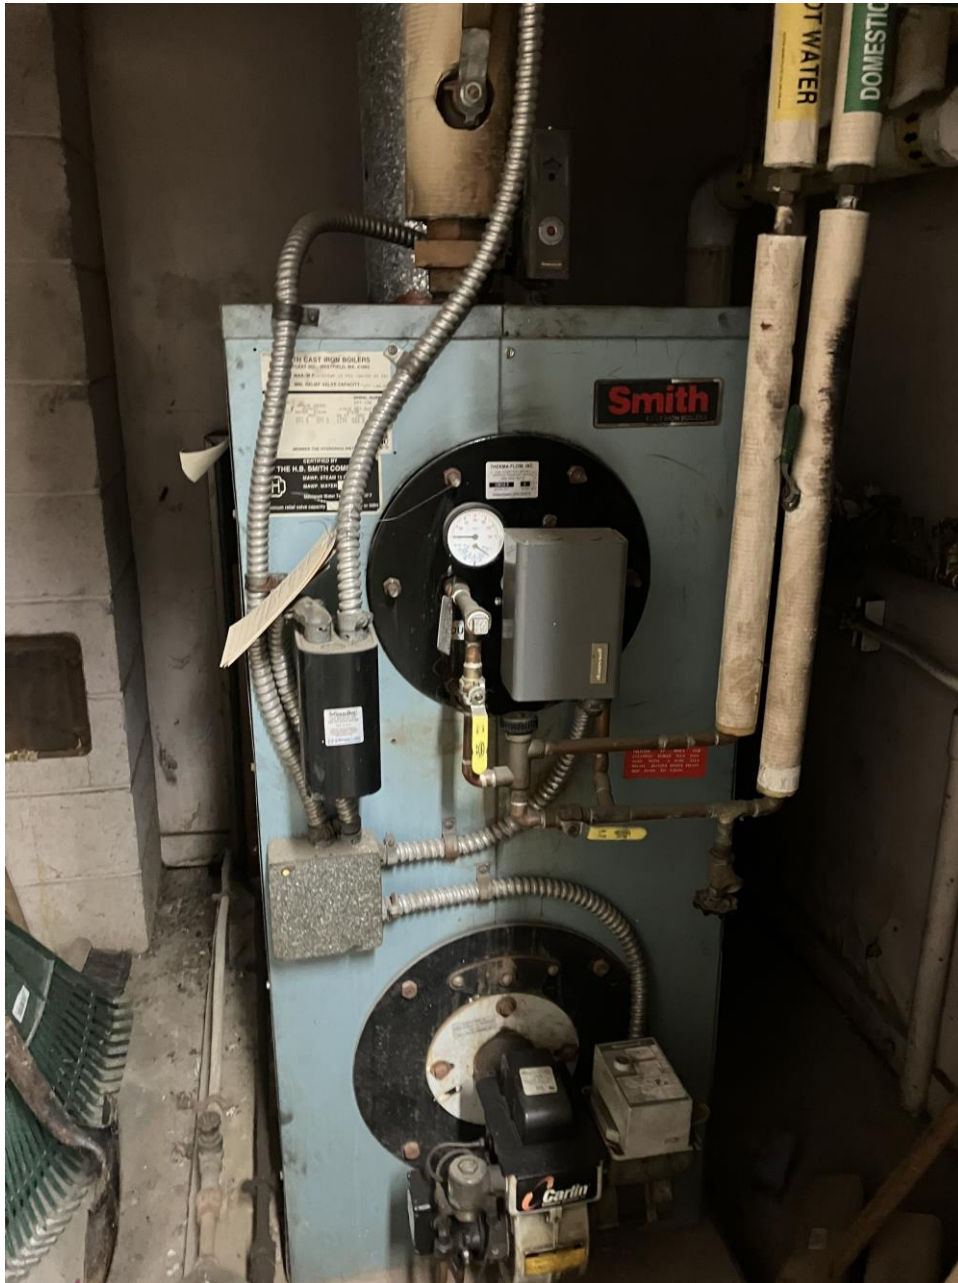
4- Smith Boiler in Basement of Main Building

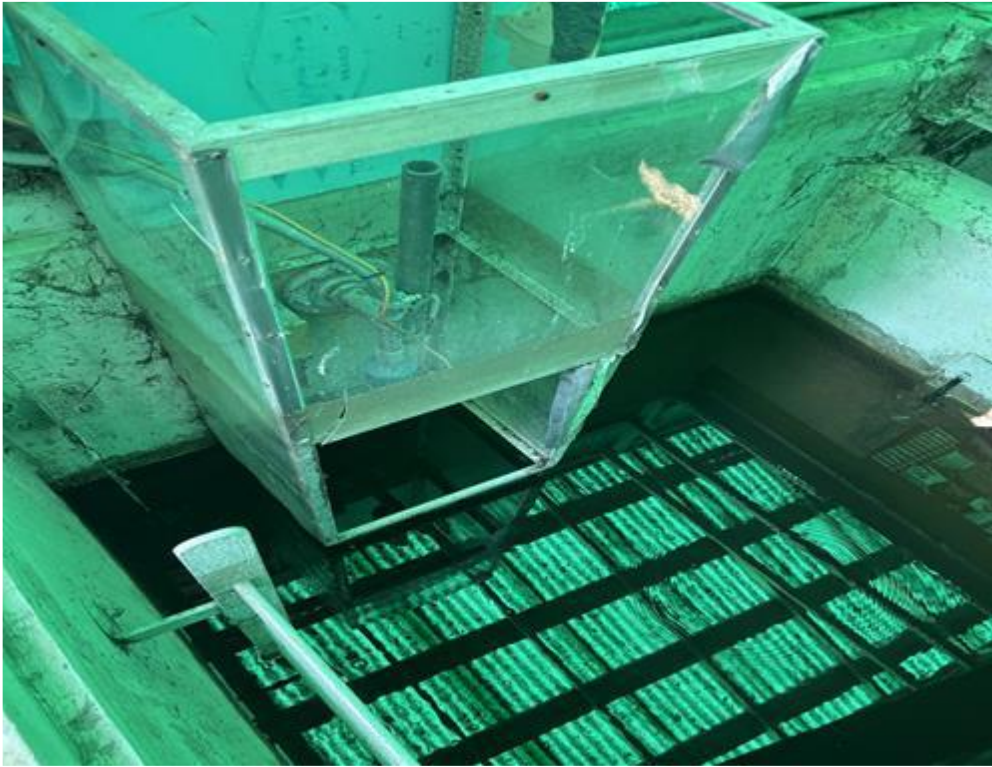
Effluent Building: Heavy flows from the river backed up through the effluent pipe into the effluent outbuilding. As a result, the flow meter gauge (picture #1) was damaged, and all electrical components will need to be replaced due to corrosion. Temporary power had been restored to the area.

6- Effluent Flow Metering Gauge and Wiring (Photo Courtesy of US EPA Region 1)

- The facility should install a back flow preventer or duckbill on the effluent pipe to the river to prevent the back up of river water from entering the facility.
- Consider relocating the flow meter within the main building.
- Controls for pump stations should be elevated above flood stage.
- High flows may exceed the working capacity of chemical pumps. Additional pumps should be provided to deliver process and disinfection chemicals during high flows. Larger day tanks and supplies of chemicals on hand may be needed.
- Consider portable or fixed pumps to discharge effluent if gravity flow is no longer possible.

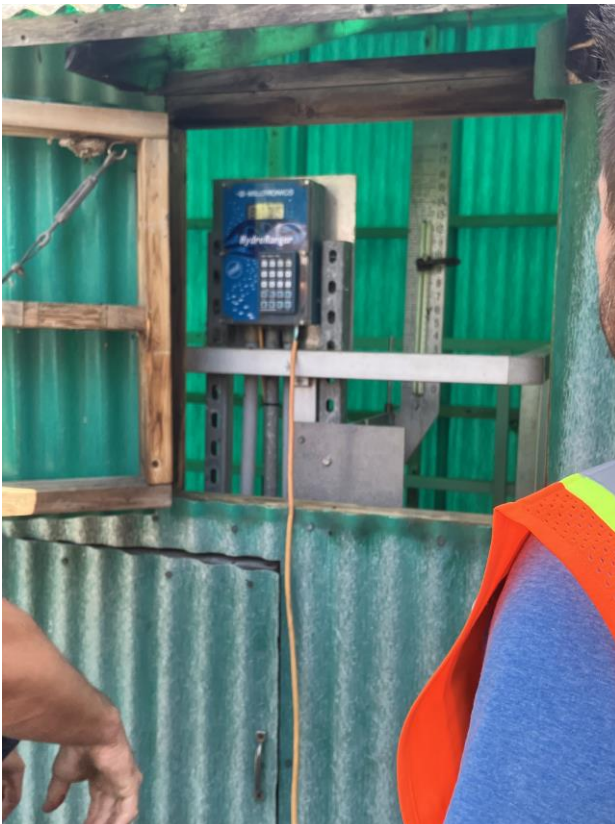
7- New Flow Meter with Temporary Wiring

gauge was damaged.

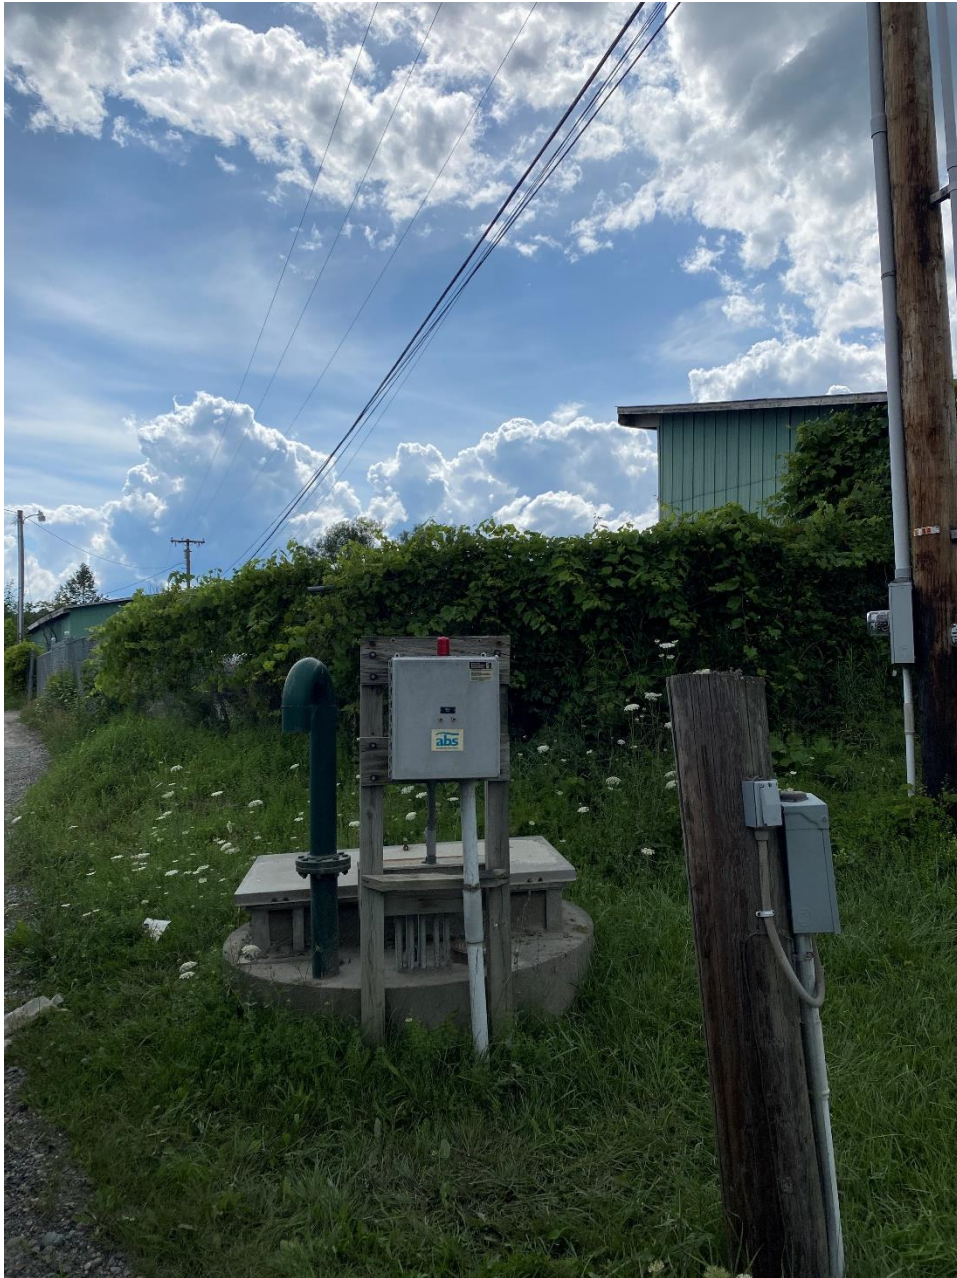
The Blanchard Oil pump station was completely submerged and two pumps were not operable during the site visit. The control panel and associated electrical components were almost completely submerged as well and will likely need replacement.

8- Blanchard Oil Pump Station with Control/Electrical Panel (Photo Courtesy of Chief Operator Phil Laramie)

- The equalization basins will need to be dewatered and cleaned. The pump will need to be rebuilt/replaced.
- Complete replacement or professional rehabilitation of all electrical and mechanical equipment and instrumentation below the high-water mark at the Blanchard Oil pumpstation. Evaluate all pump station pumps for future efficiency.

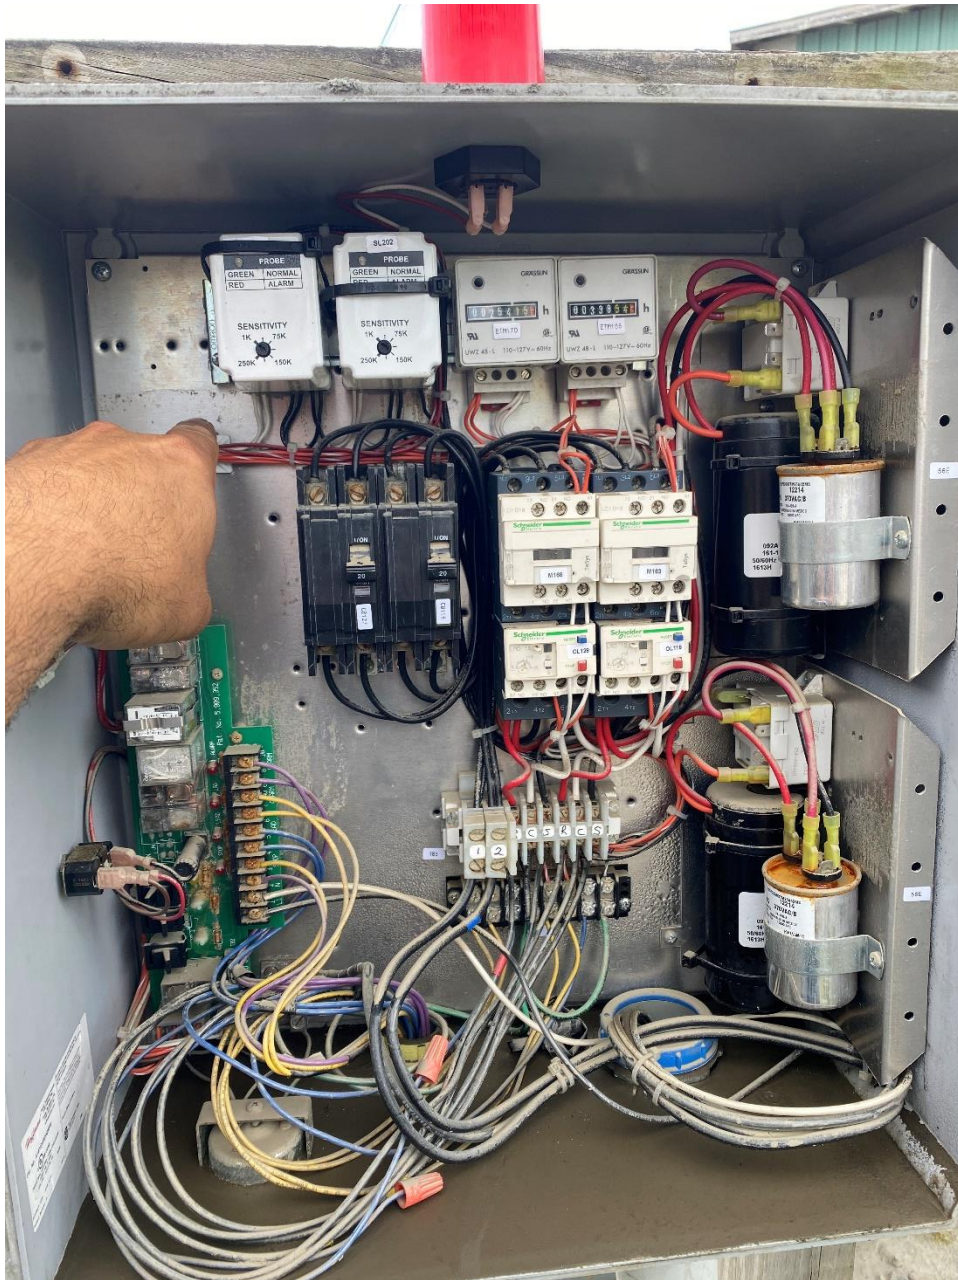
9- Blanchard Oil Pump Station Control/Electrical Panel with Finger Pointing to High Level Water Mark (Photo Courtesy of Chief Operator Phil Laramie)
