**BARRE WASTEWATER
POST JULY 2023 FLOOD
TREATMENT PLANT ASSESSMENT
WASHINGTON COUNTY,
VERMONT**

**NPDES PERMIT NUMBER VT0100889
STATE OF VERMONT PERMIT NUMBER 3-1272**

November 6th, 2023

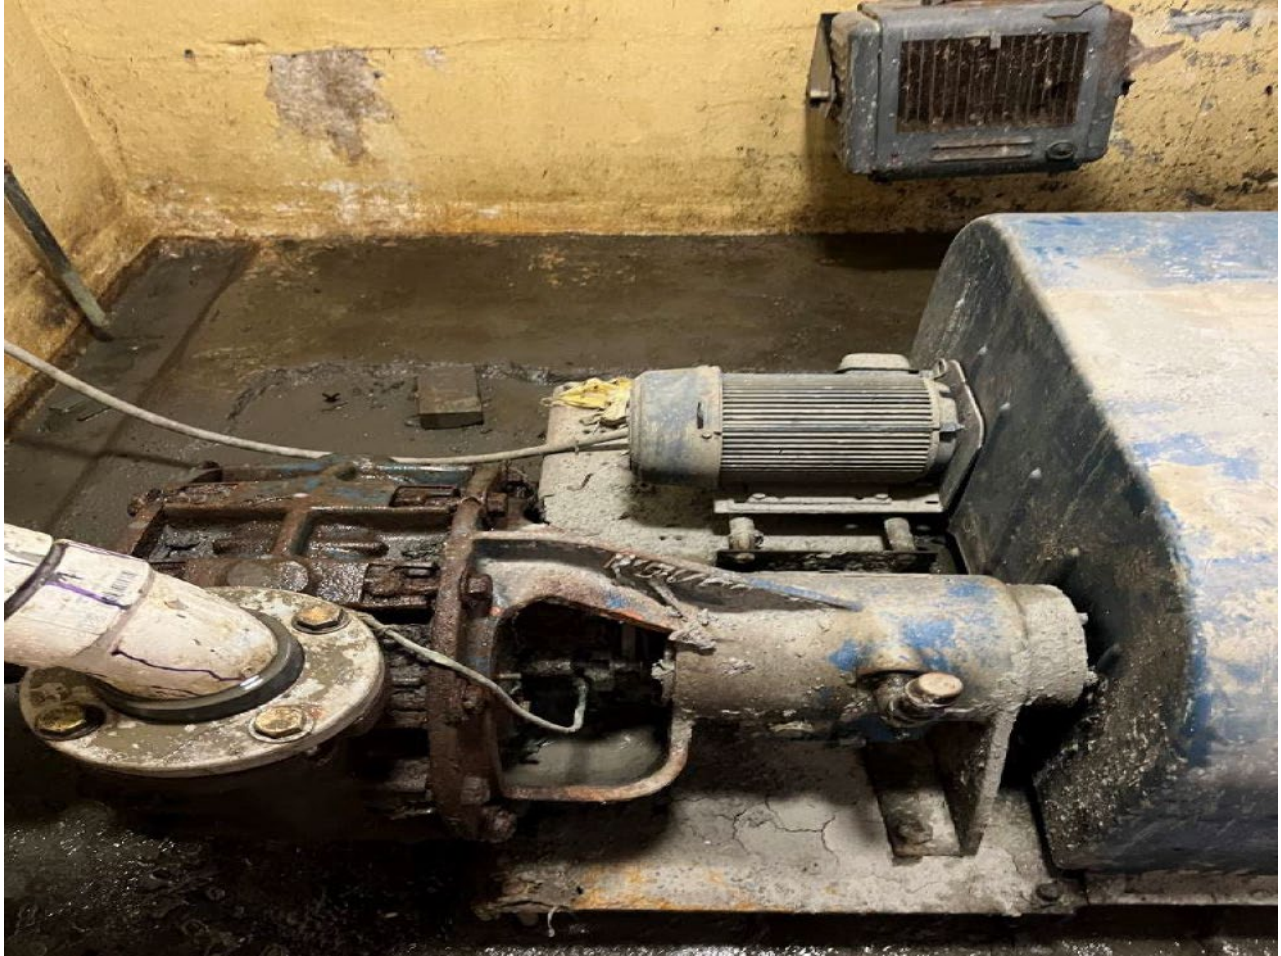
Clarifier motors and drives may have been submerged. The single grit pump, grinder control panel, heater, and branch circuit breakers in the grit pump pit were submerged during the flood event. The grit pump and clarifier drives were operational. The grinder was not operating.

Grit pump & heater

- Check and replace primary clarifier drive oil. Re-grease grit pump bearings.
- The grinder control panel, clarifier drive motors, and grit pump motor may have sustained damage due to silt or other contaminants in the flood water. Although the grit pump and clarifier drives are operational, their motors may suffer a reduced service life.
- Replacement or refurbishing of the motors is recommended. Replacement of the grinder control panel, heater, & grit pump pit breaker box is recommended.

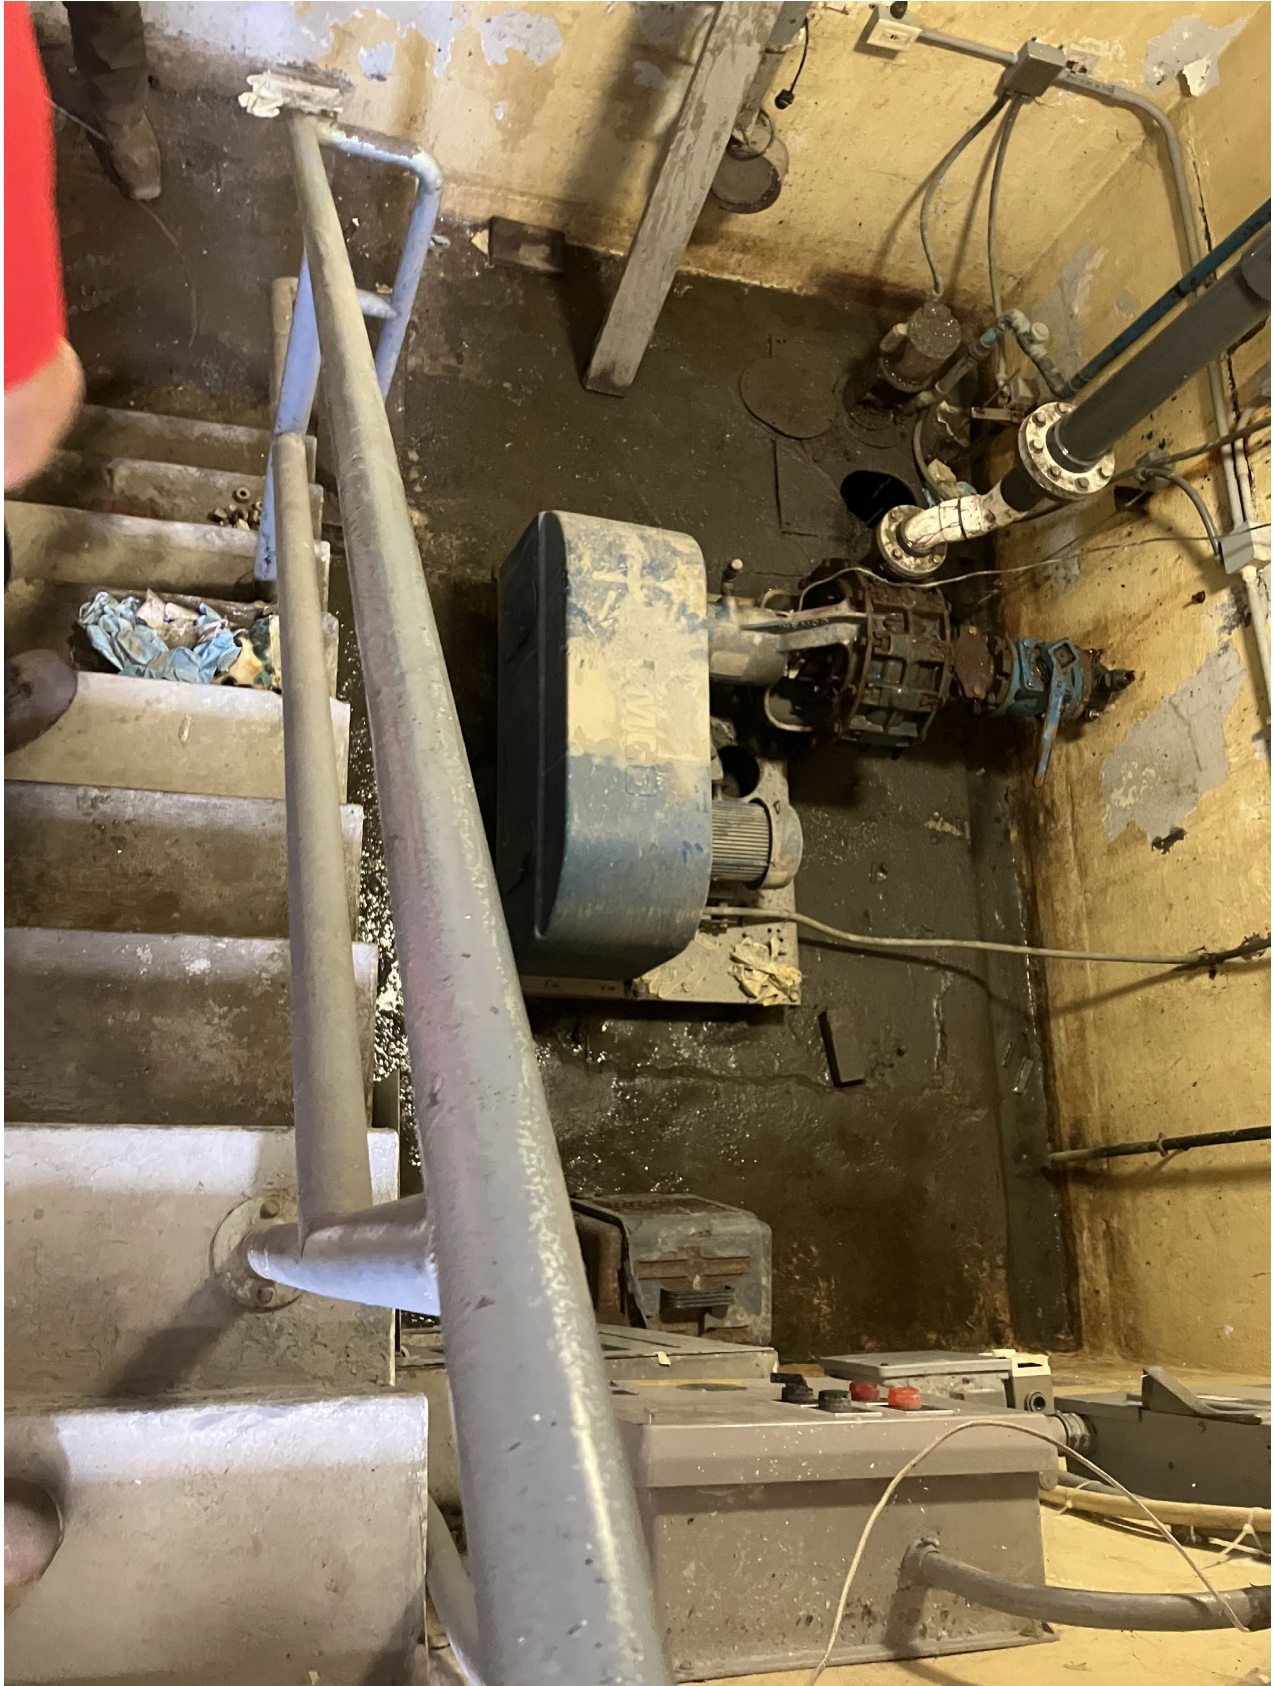
Grit pump room

- Move the grinder control panel & electrical distribution panel out of the grit pump pit, above 500-year flood levels if possible.
- Replace the grit pump with an immersible pump.
- Extend primary clarifier drive chains and elevate drive units.
- High flows may exceed the working capacity of chemical pumps. Additional pumps should be provided to deliver process and disinfection chemicals during high flows. Larger day tanks and supplies of chemicals on hand may be needed.
- Consider portable or fixed pumps to discharge effluent if gravity flow is no longer possible.

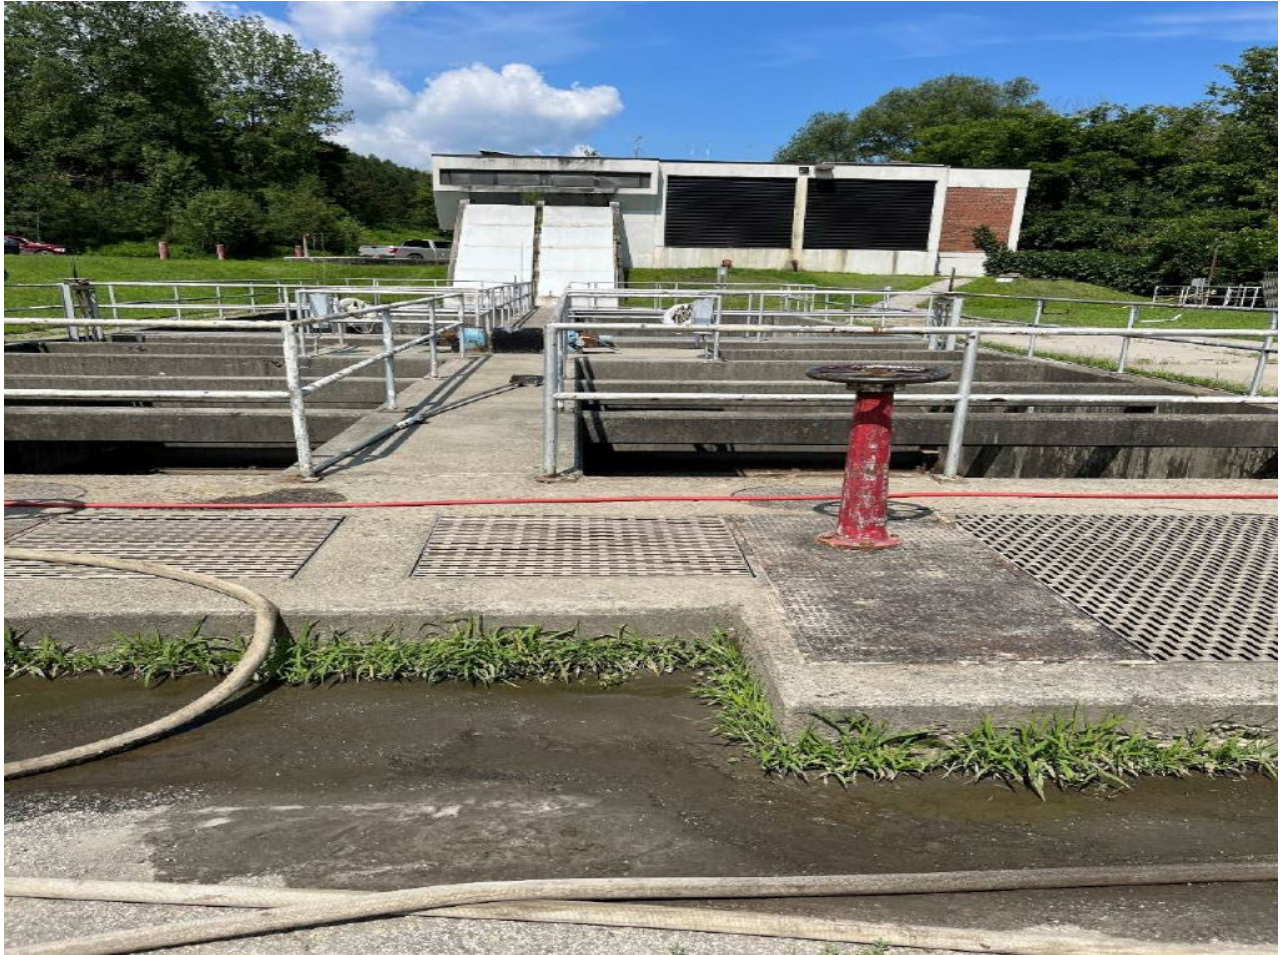
Operators reported the plant was fully operational. High water marks were not visible. The operator provided a picture which showed flood waters slightly over the tops of the primary clarifiers, however.

Primary clarifiers foreground, main plant building rear
