**EDWARD FARRAR UTILITY DISTRICT
WASTEWATER
POST JULY 2023 FLOOD
TREATMENT PLANT ASSESSMENT
WASHINGTON COUNTY,
VERMONT**

**NPDES PERMIT NUMBER VT0100463
STATE OF VERMONT PERMIT NUMBER 3-1160**

September 21, 2023

This report was prepared based on observations made during July 19, 2023 site visit by Heather Collins, VT DEC, WSMD, WWMP in conjunction with Army Corps of Engineers and US EPA Region 1 representatives.

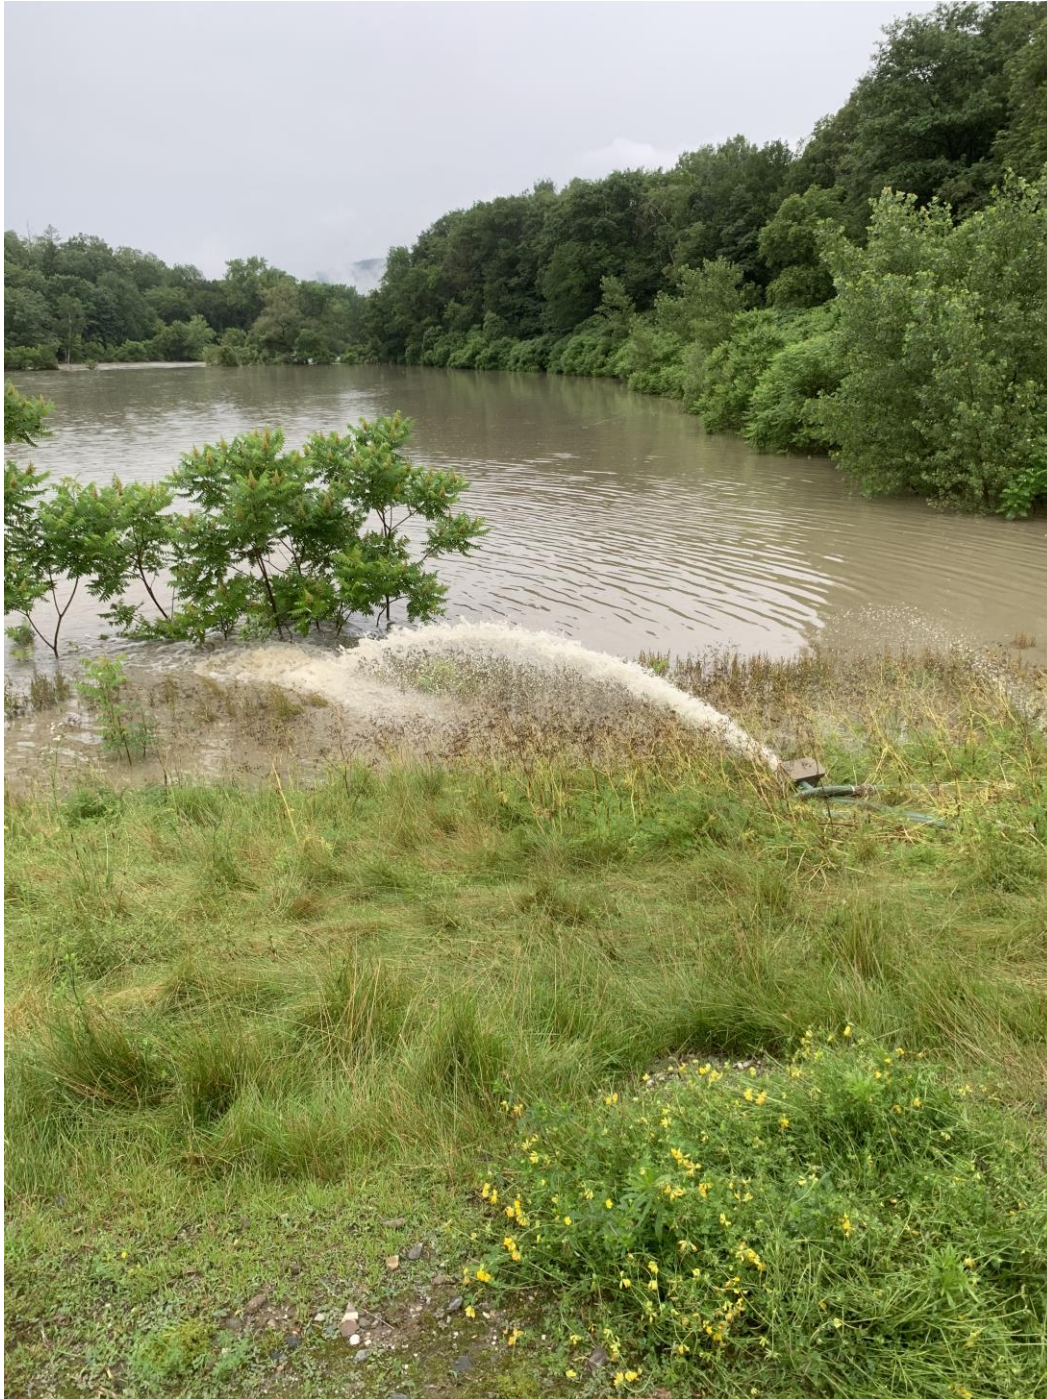
During the heavy flow event, a portable Godwin pump (550 gallons per minute) was on site from a neighboring municipality (Stowe). The pump was in operation for three days pumping lagoon wastewater over the bank to a field which drains to the river. Additionally 3 and 4 inch trash pumps as well as a 4 inch siphon were used. Flood water did not overflow the lagoon system but there was slight evidence of erosion at the toe of the lagoon slope.

1- Water from Lagoon 1 Being Pumped By Godwin Pump Into Adjacent Field During the Flood Event (Photo courtesy of Chief Operator Matt Jones)

- The portable Godwin pump was a huge benefit in preventing the primary lagoon from overflowing. The facility should consider purchasing a properly sized portable pump to prevent the lagoon from overflowing as well as have the ability to pump water from the low lying clarifier area.
- Complete replacement or professional rehabilitation of all electrical and mechanical equipment and instrumentation below the high-water mark at the pumpstations. Evaluate all pump station pumps for future efficiency as well as calibrate the flow meter in order to properly calculate actual flows.
- An appreciable amount of grit and sediment was likely conveyed into the plant. Lagoon sludge and sediment depths should be also checked and compared to

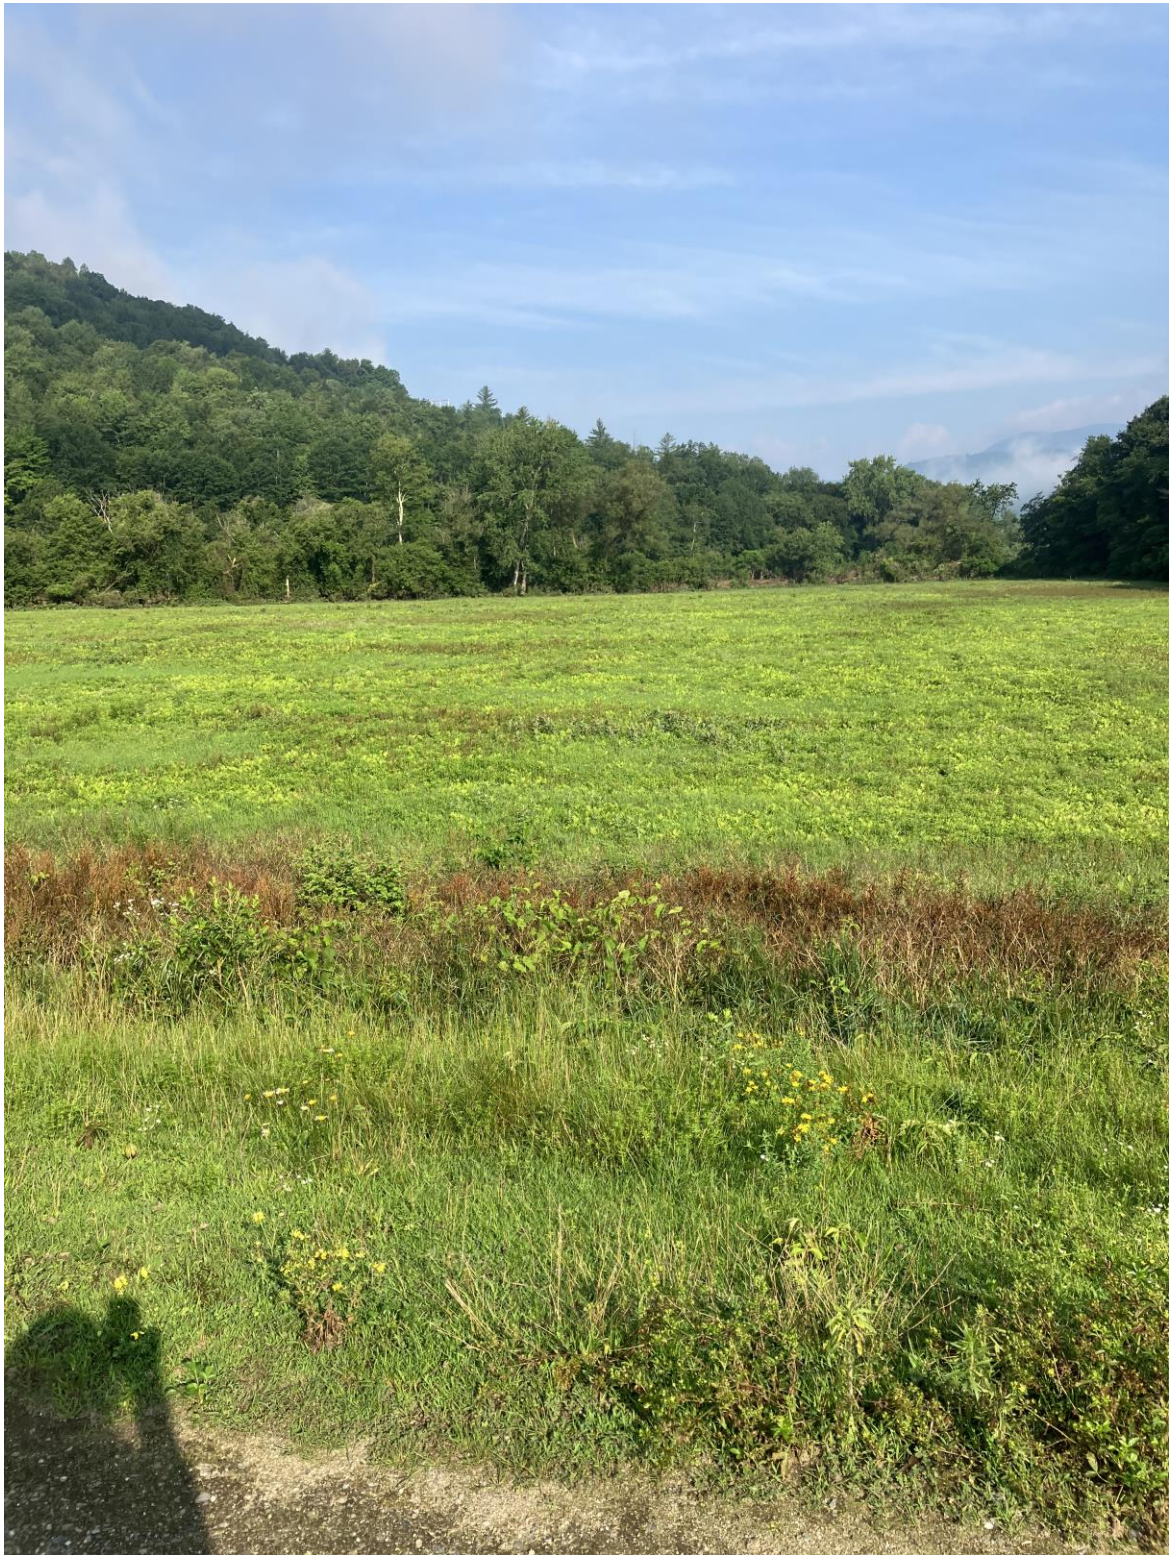
2- Same Field in Photo 1 Above After Flood Waters Receded July 19, 2023

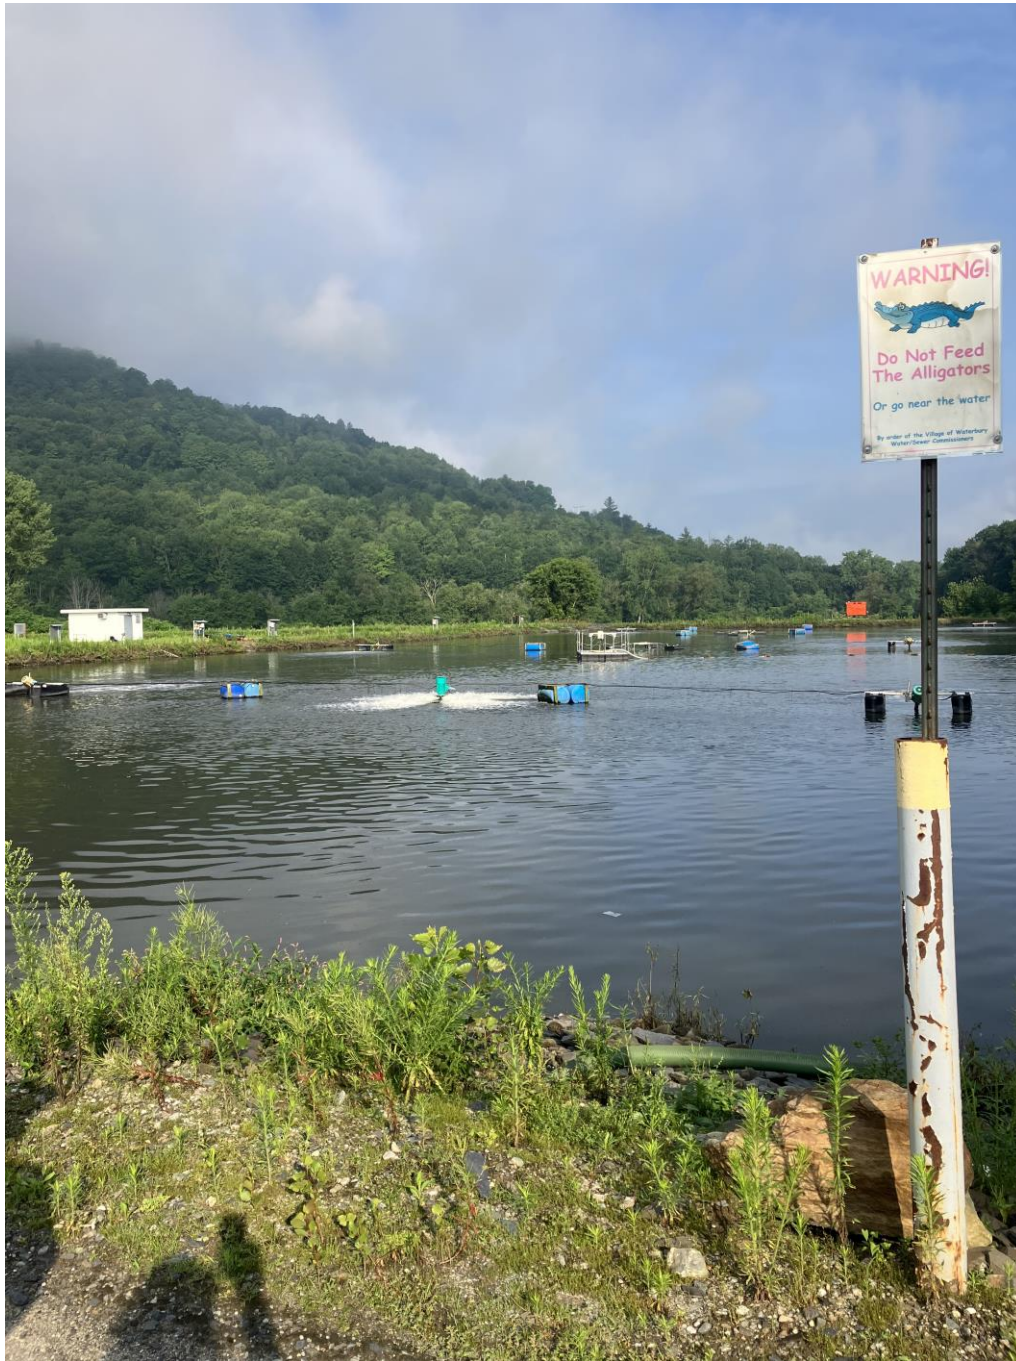
3- View of Lagoon 1

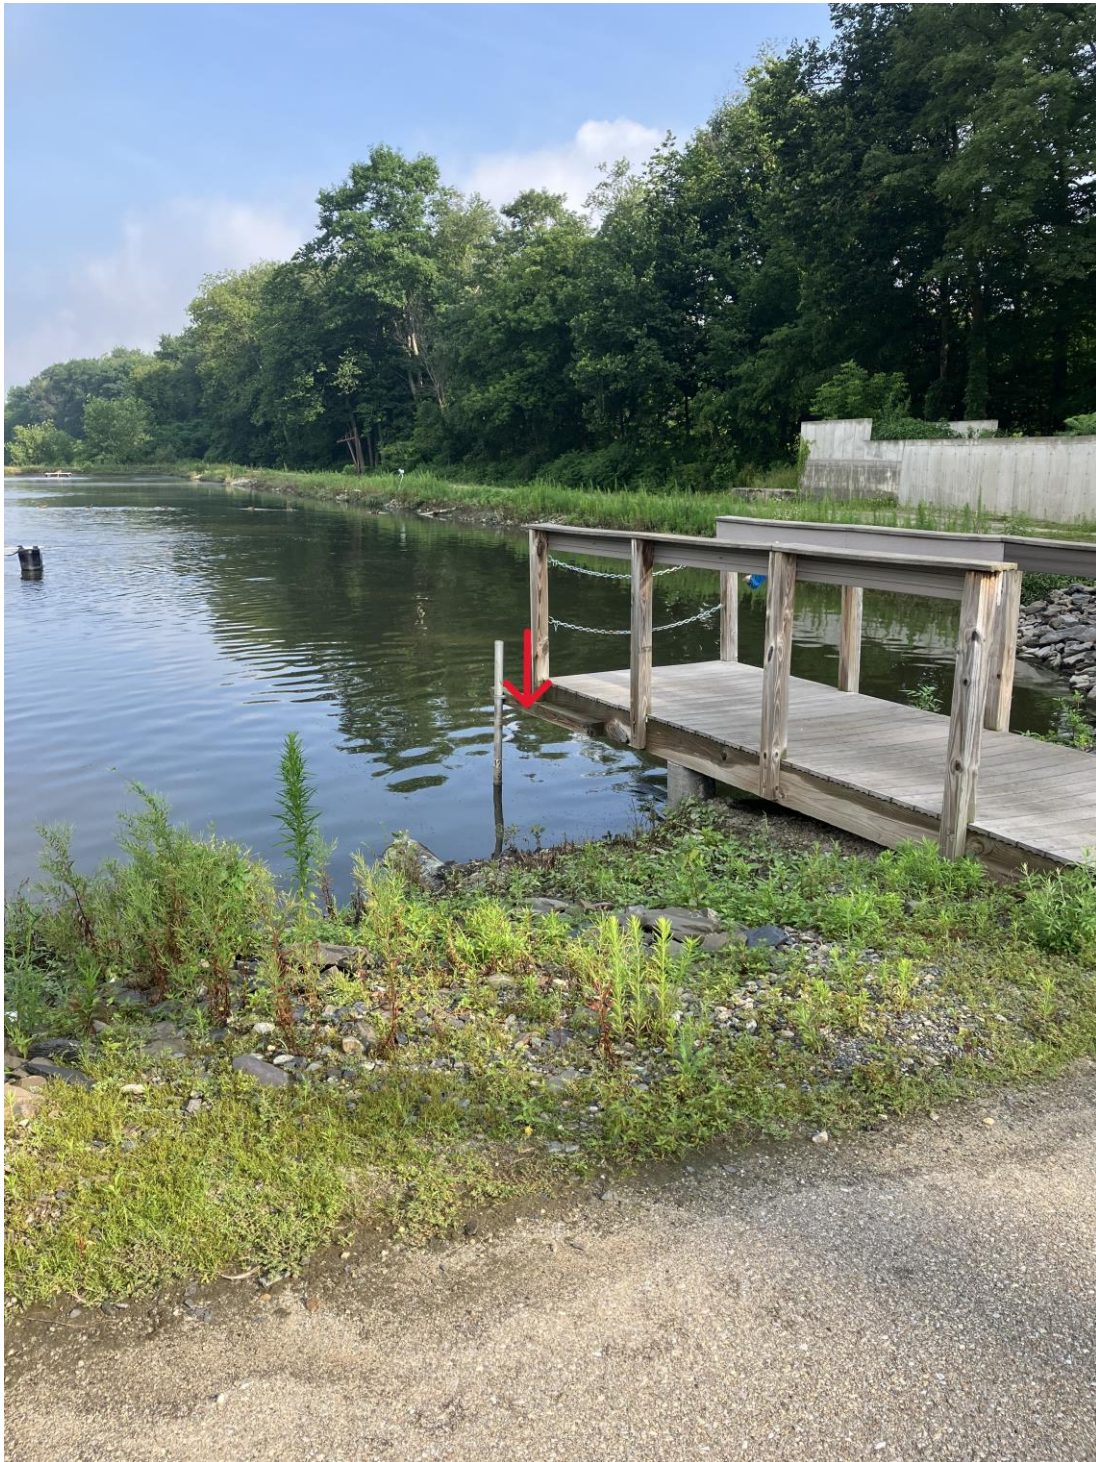
4- View of Lagoon Showing High Water Mark at Bottom of the Platform

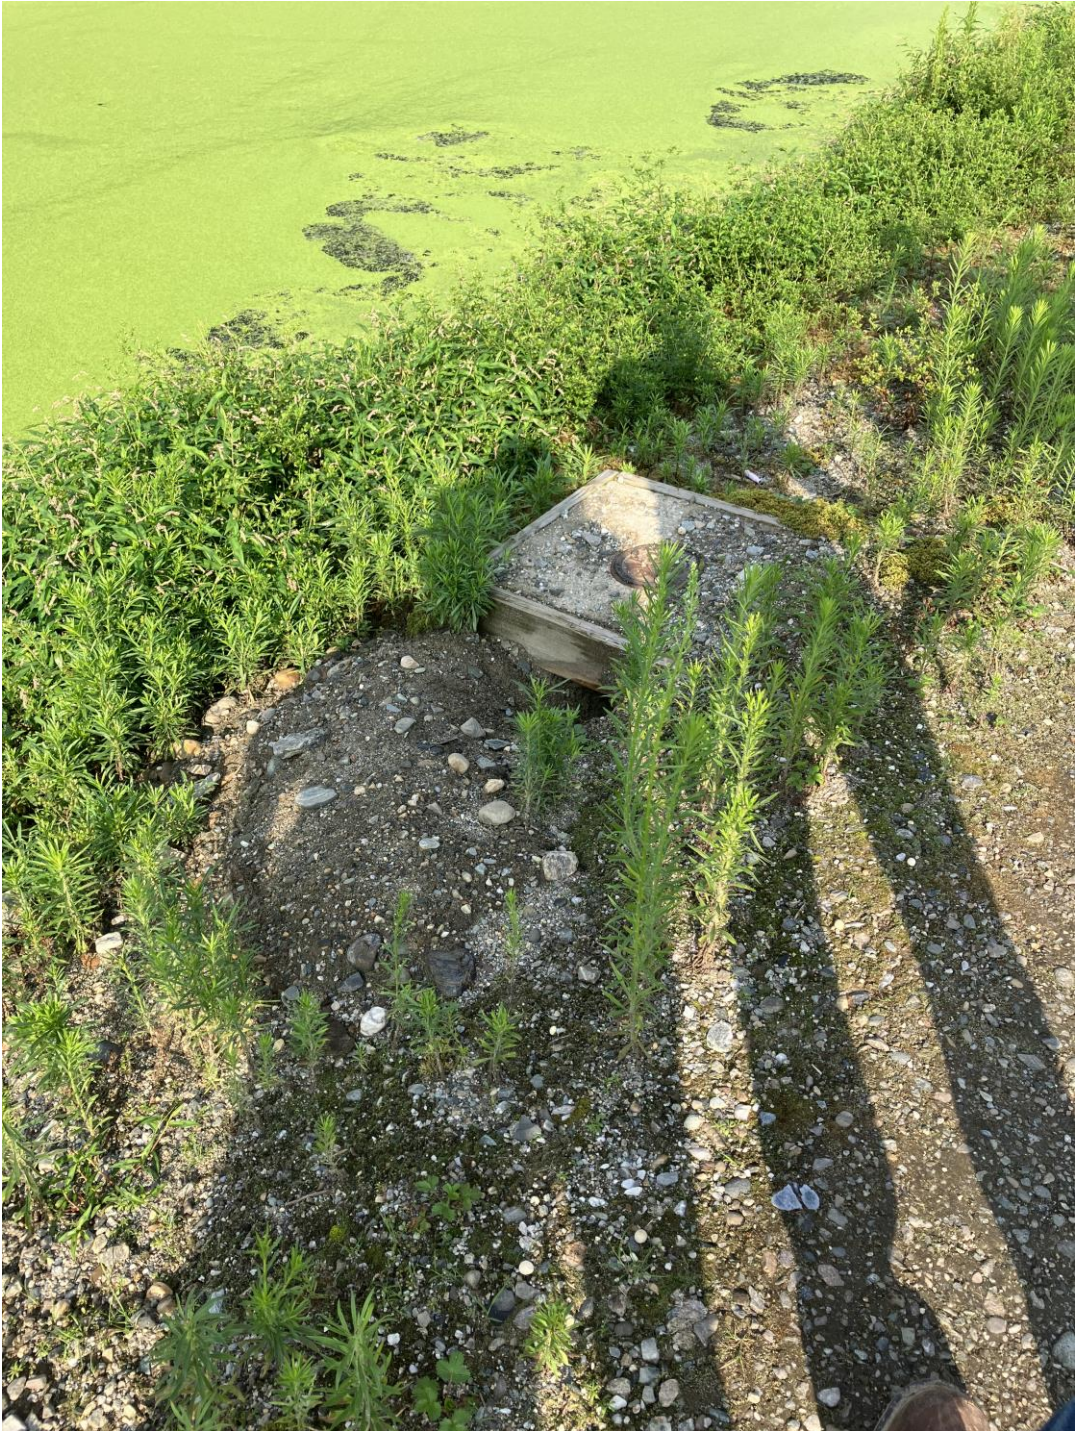
5- Erosion Near Berm of Lagoon 3

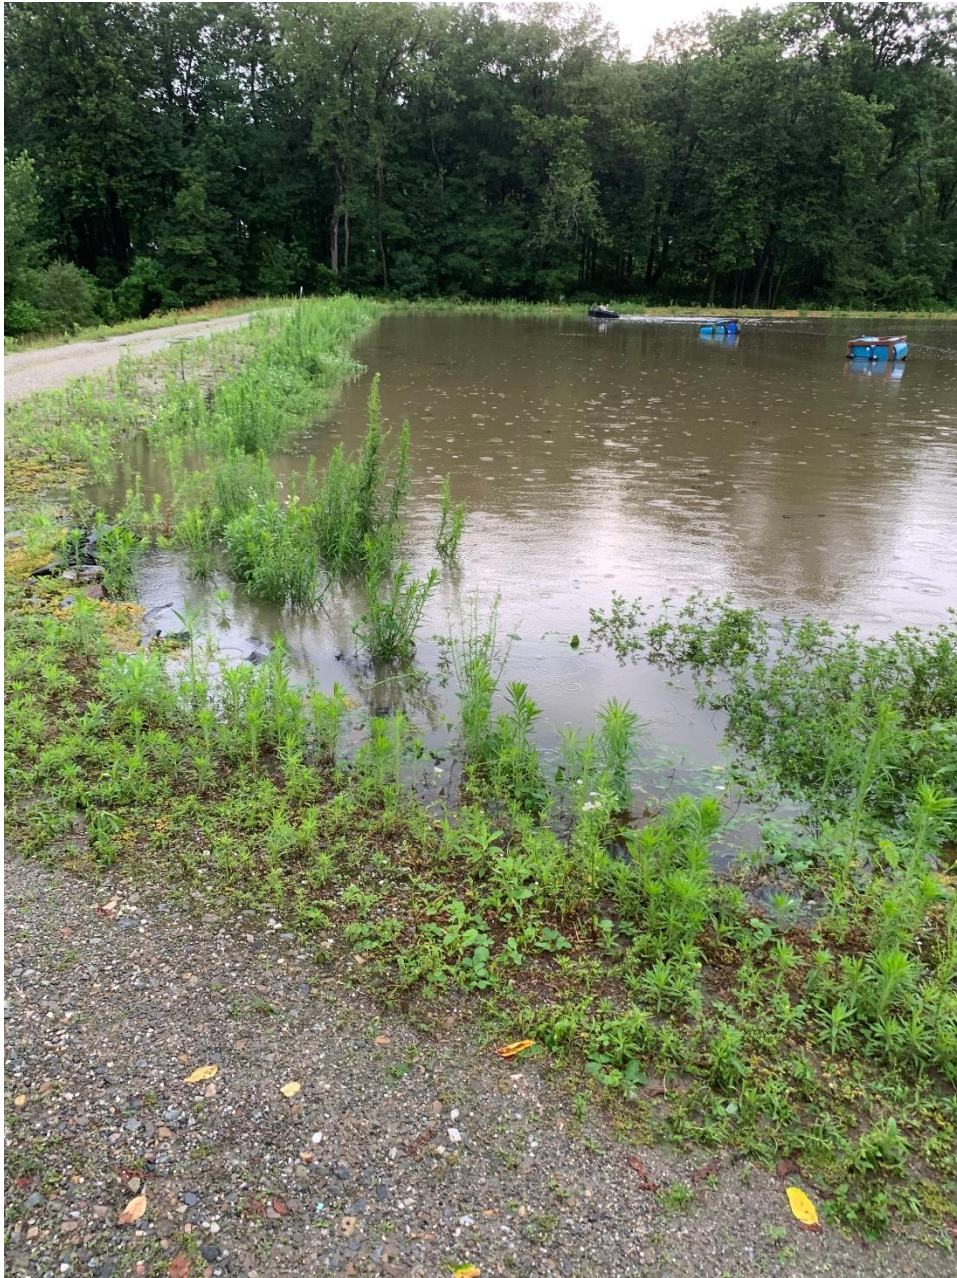
6- View of Backside of Lagoon 1 Prior to Installing the Godwin Pump During the Flood Event (Photo Courtesy of Chief Operator Matt Jones)

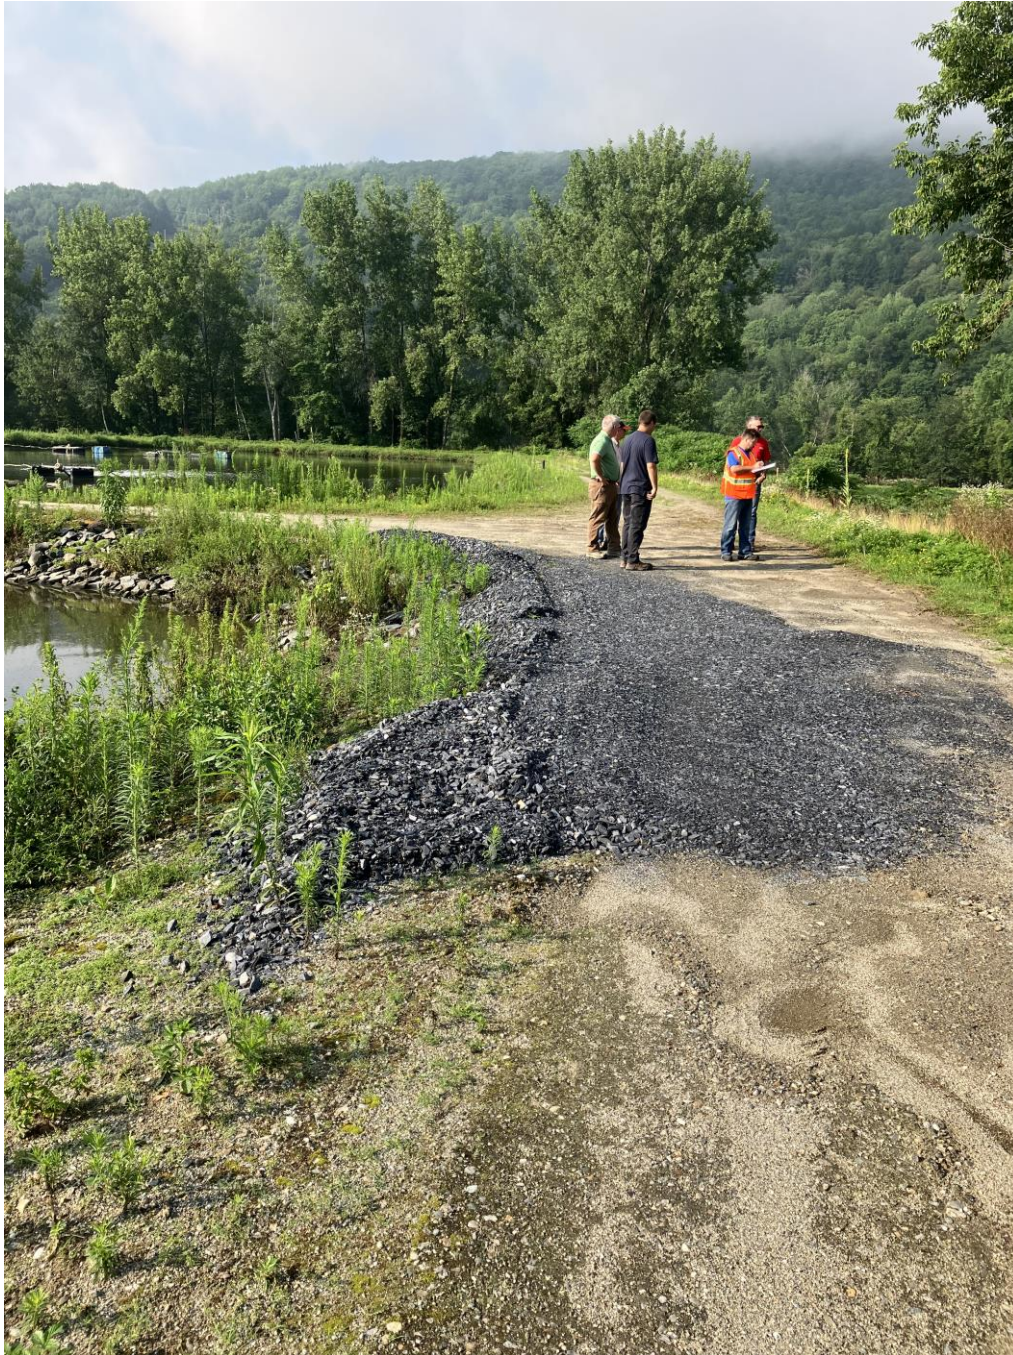
7- View of Backside of Lagoon 1 After Flood Waters Had Receded July 19,2023. Fill Material Was Added During the Flood Event to Prevent the Lagoon from Overflowing

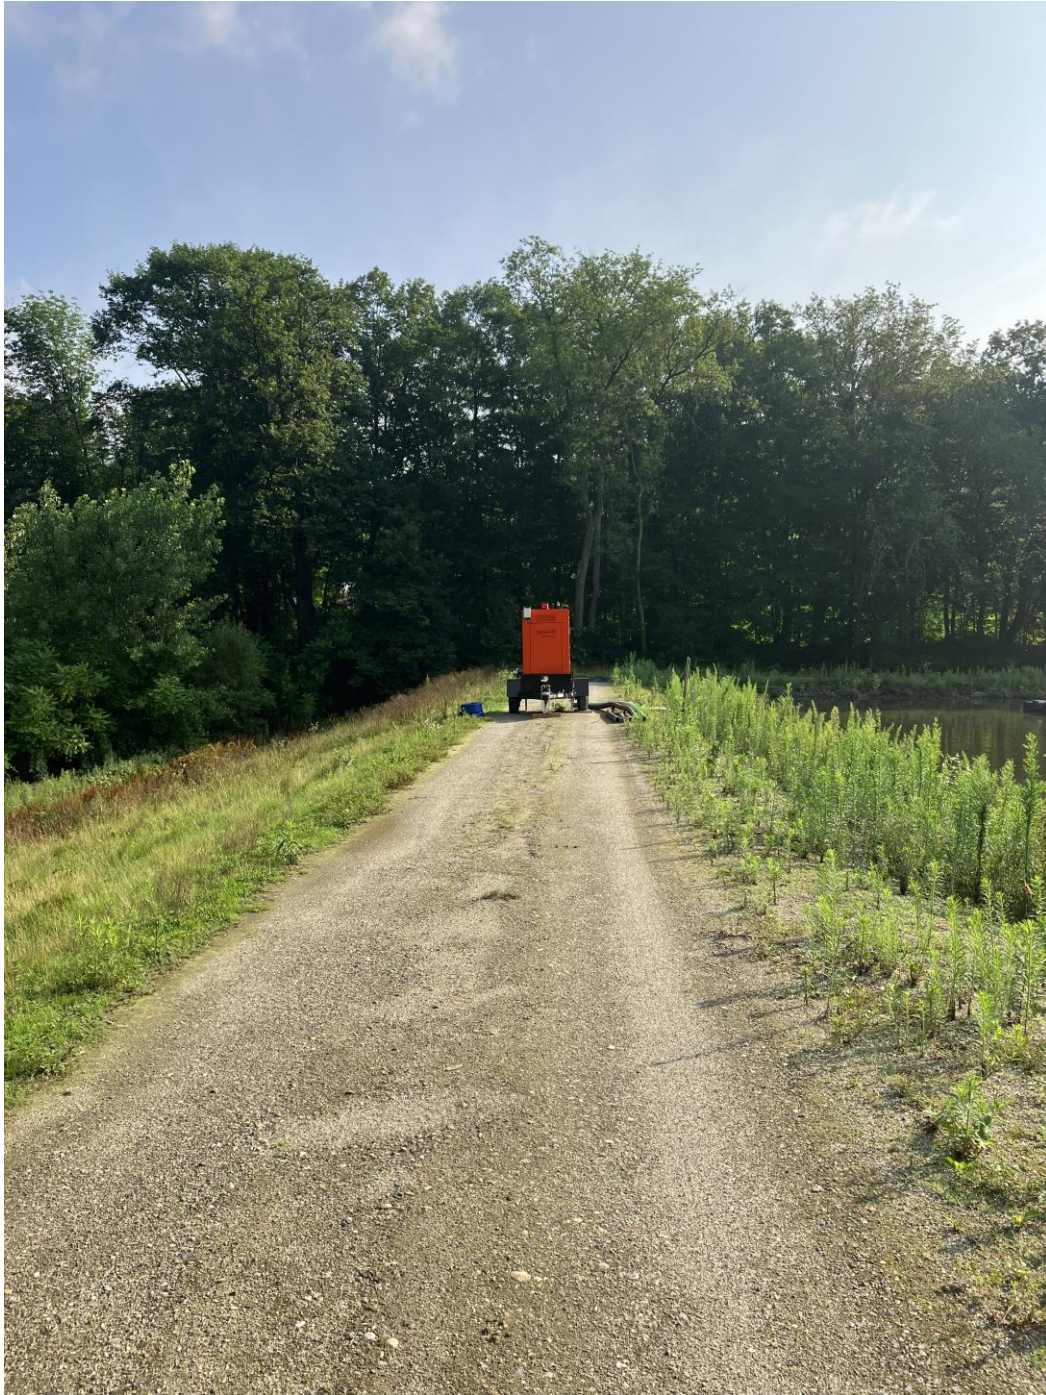
8- Godwin Pump Used to Pump Down Lagoon 1 During the Flood Event

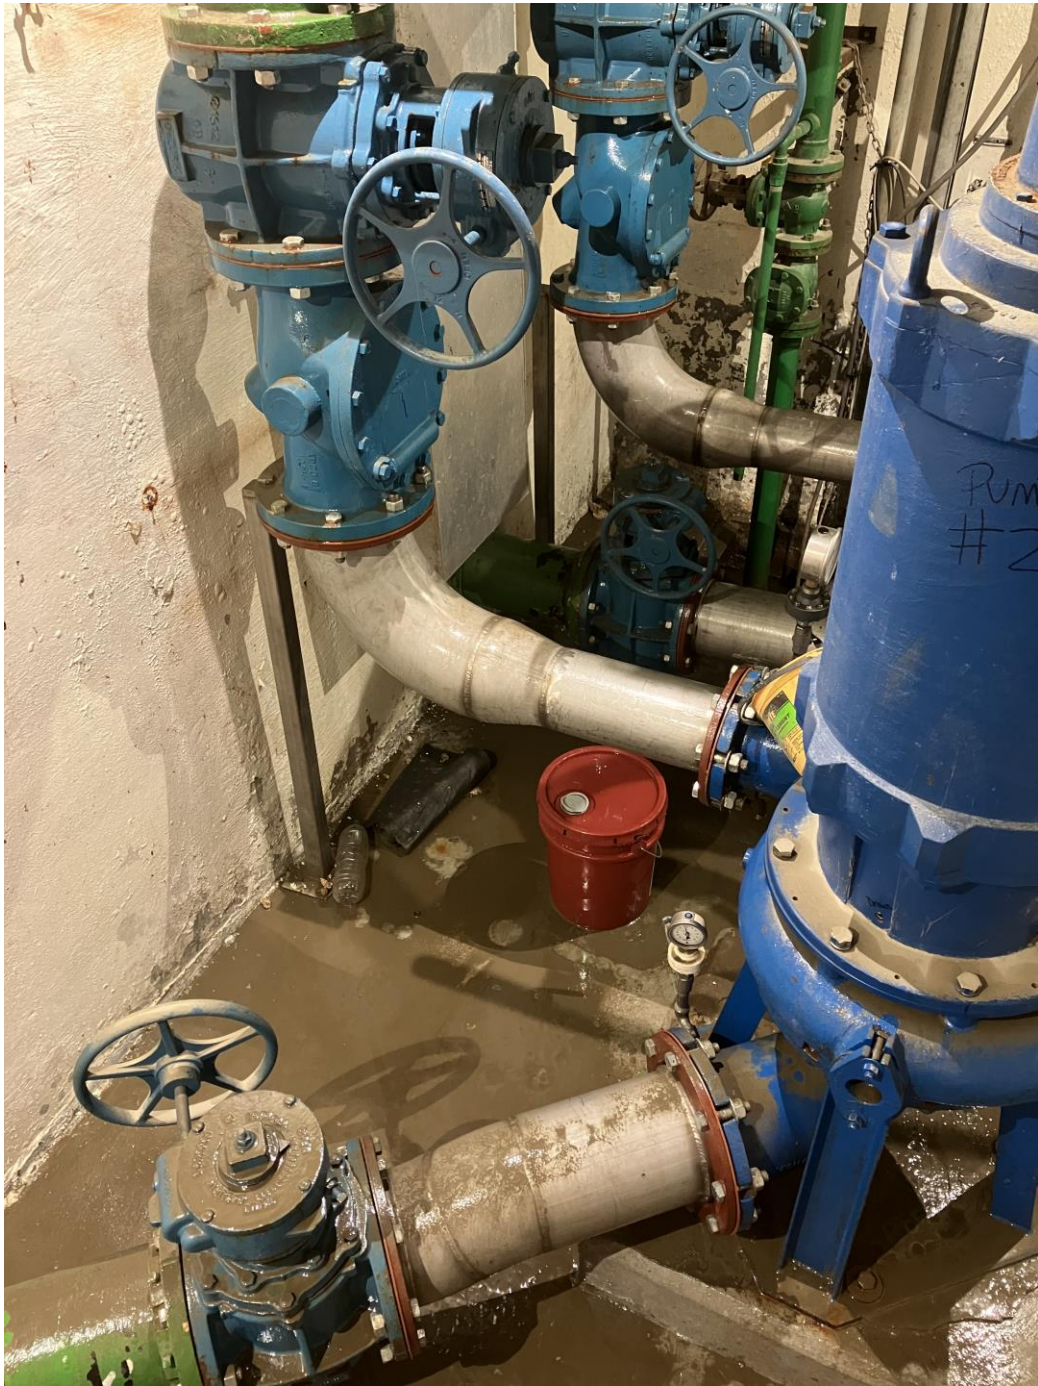
The main pump station at 34 Main Street was submerged in approximately 2 feet of water. Although pumps were running at the time of the assessment, they are showing evidence of being damaged. Damage to the flow meter is also suspected since the flow readings do not appear to be capturing actual flows. This could be indicative of a damaged pump, possibly from flood related debris (sand and silt) entering the station and passing through the pump and/or the flow meter has also been damaged.

9- Main Street Pump Station Basement Level. High Water Mark Was Approximately Feet, But Water Had Leaked Down from Upper Levels and Was in Contact With Upper Portions of the Pumps

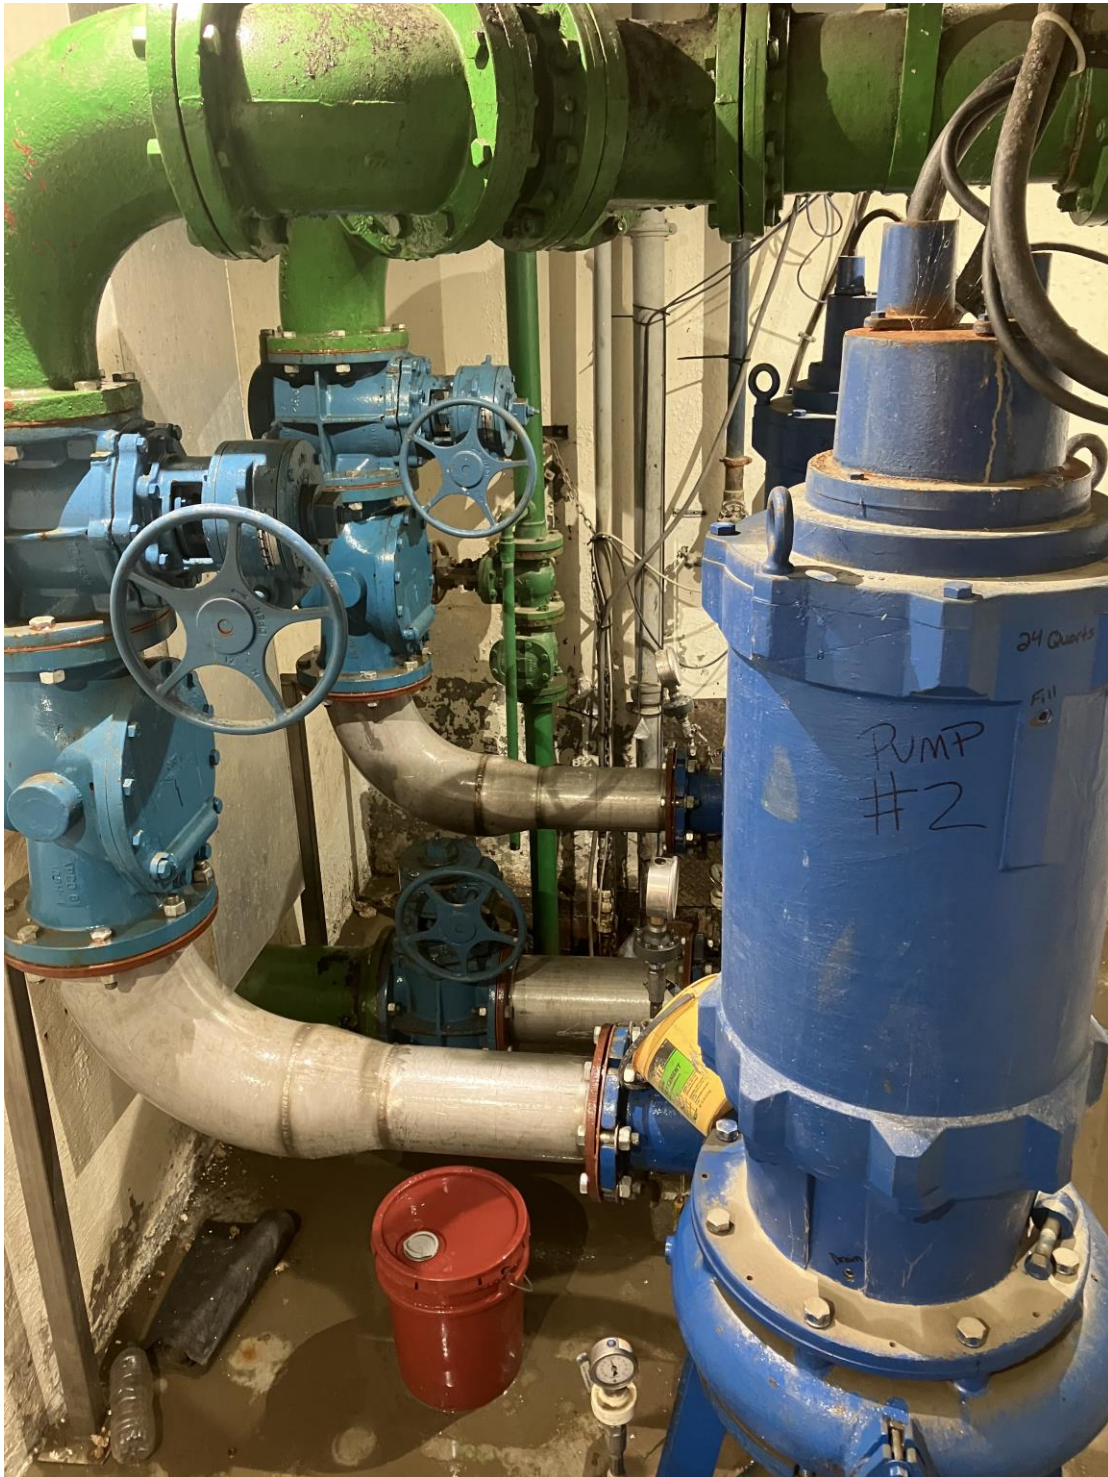
10- Main Street Pump Station Basement Level. Showing Silt on Top of Piping from Leaking Down from Upper Levels

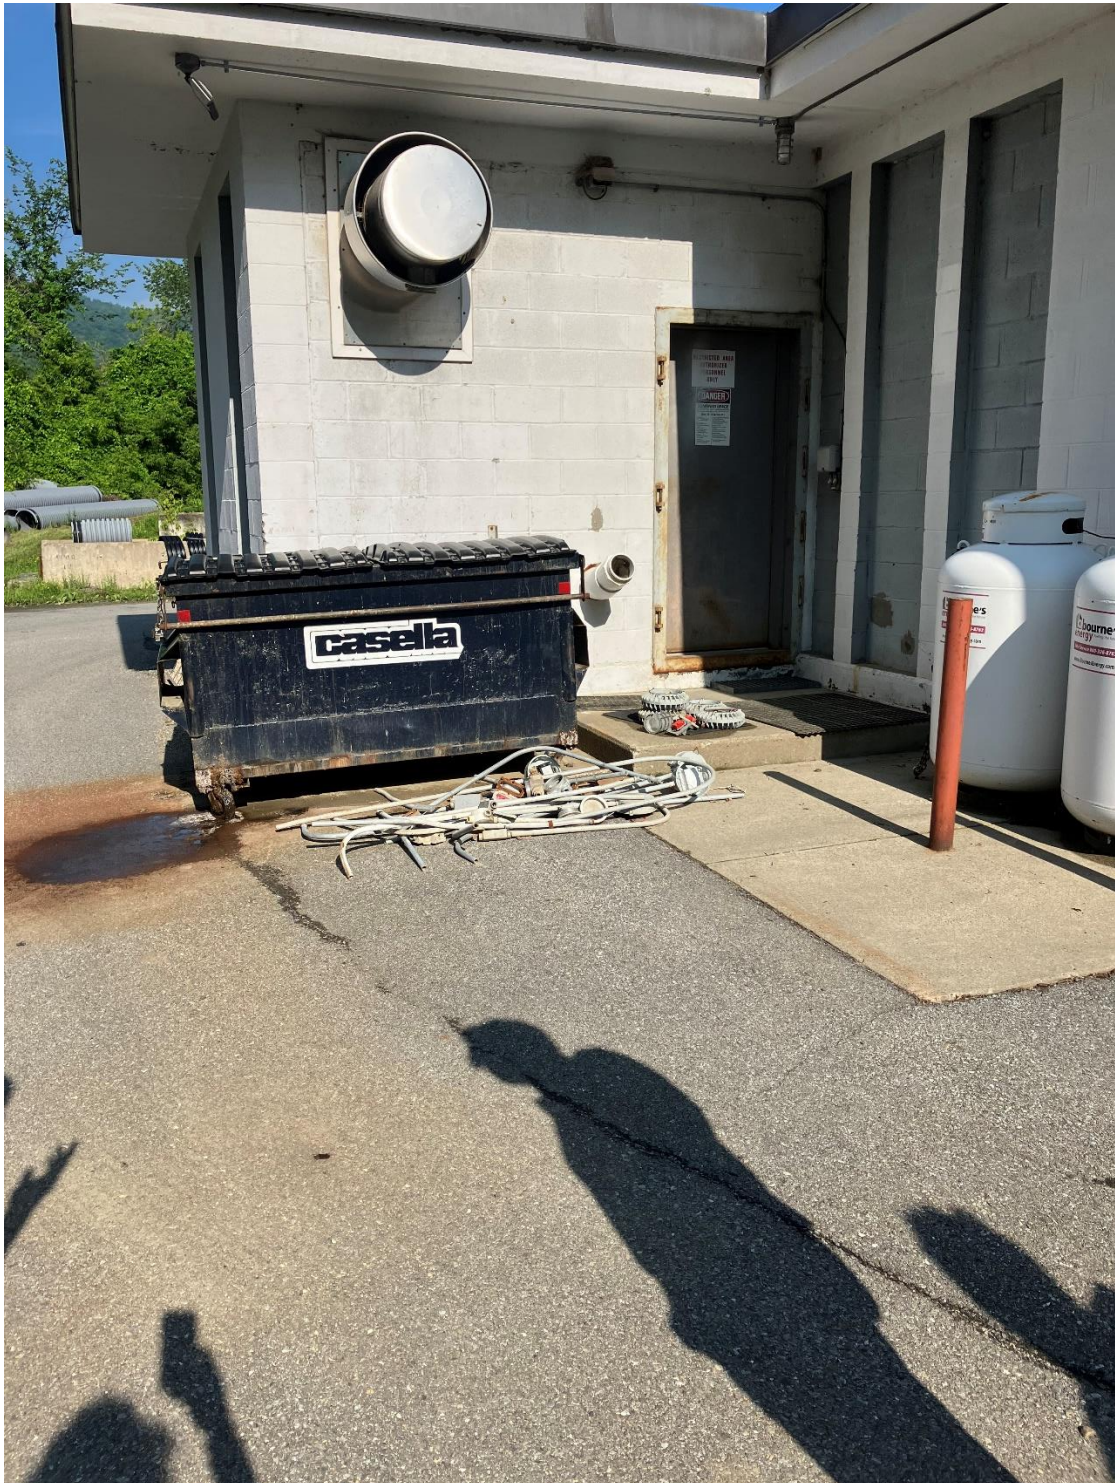
11- Main Street Pump Station Exterior. Showing Damaged Electrical Components in the Process of Being Removed.

- Controls for pump stations should be elevated above flood stage.
- Evaluate if crossover piping from Lagoons are adequately sized to allow for hydraulic balancing. Larger crossover pipes, multiple pipes and/or pumps should be considered.
