**MONTPELIER WASTEWATER
POST JULY 2023 FLOOD
TREATMENT PLANT ASSESSMENT
WASHINGTON COUNTY,
VERMONT**

**NPDES PERMIT NUMBER VT0100196
STATE OF VERMONT PERMIT NUMBER 3-1207**

September 25, 2023

This report was prepared based on observations made during July 19, 2023, site visit by Heather Collins, VT DEC, WSMD, WWMP in conjunction with Army Corps of Engineers and US EPA Region 1 representatives.

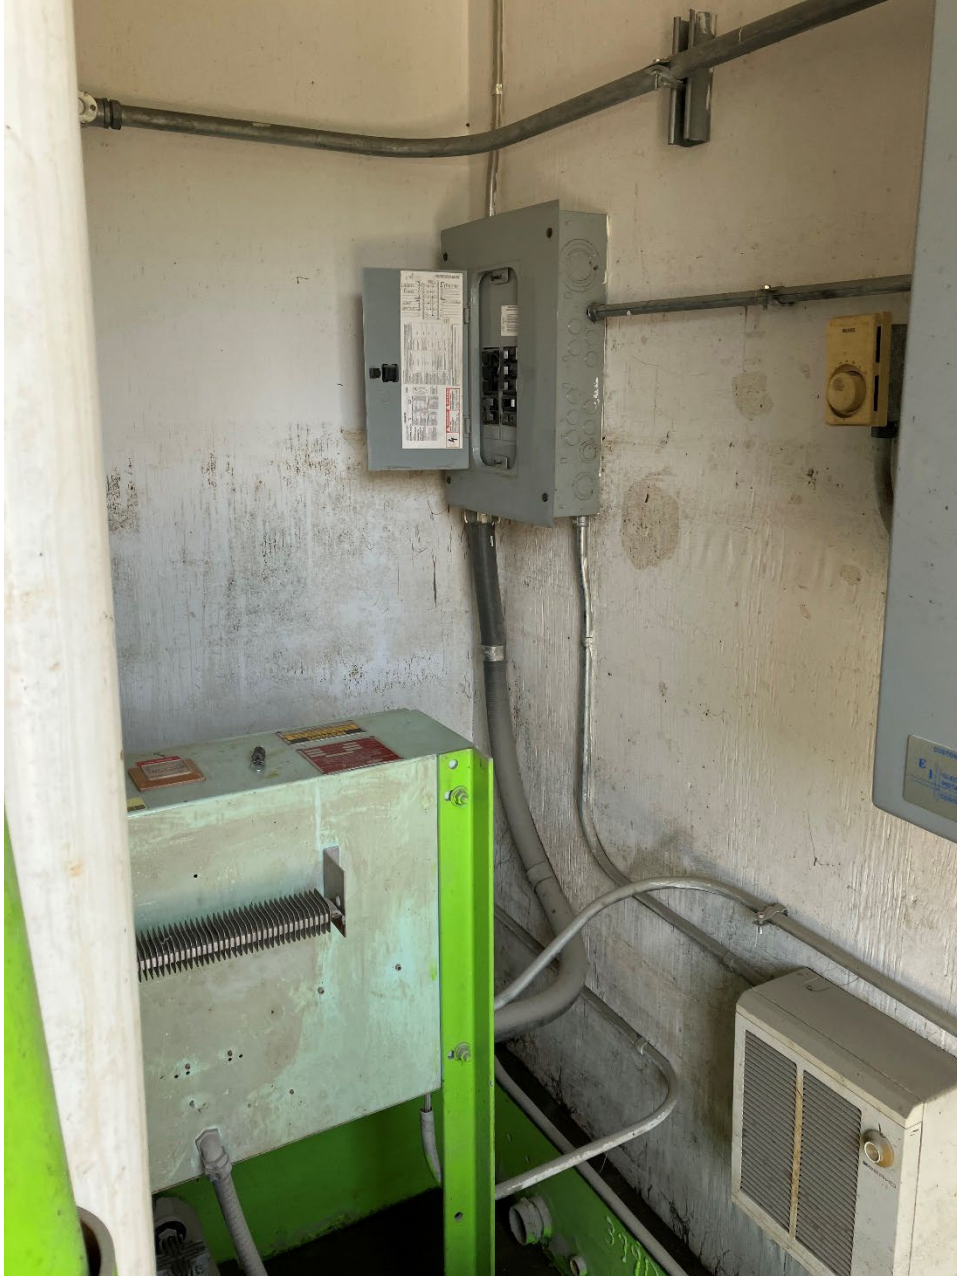
The pump station had a highwater mark of approximately 4 feet inside. Pumps, control panel and electrical components (switches and relays) were damaged. The wet well received silt and debris accumulation, and likely damaged conduits. Subsequently, pump performance should be checked for accelerated wear. Replace or recondition.

1- Interior of Lower State Street Pump Station No.2. Note Highwater Mark at Approximately 4 Feet

- Complete replacement or professional rehabilitation of all electrical and mechanical equipment and instrumentation below the high-water mark at the pumpstations. Evaluate all pump station pumps for future efficiency.

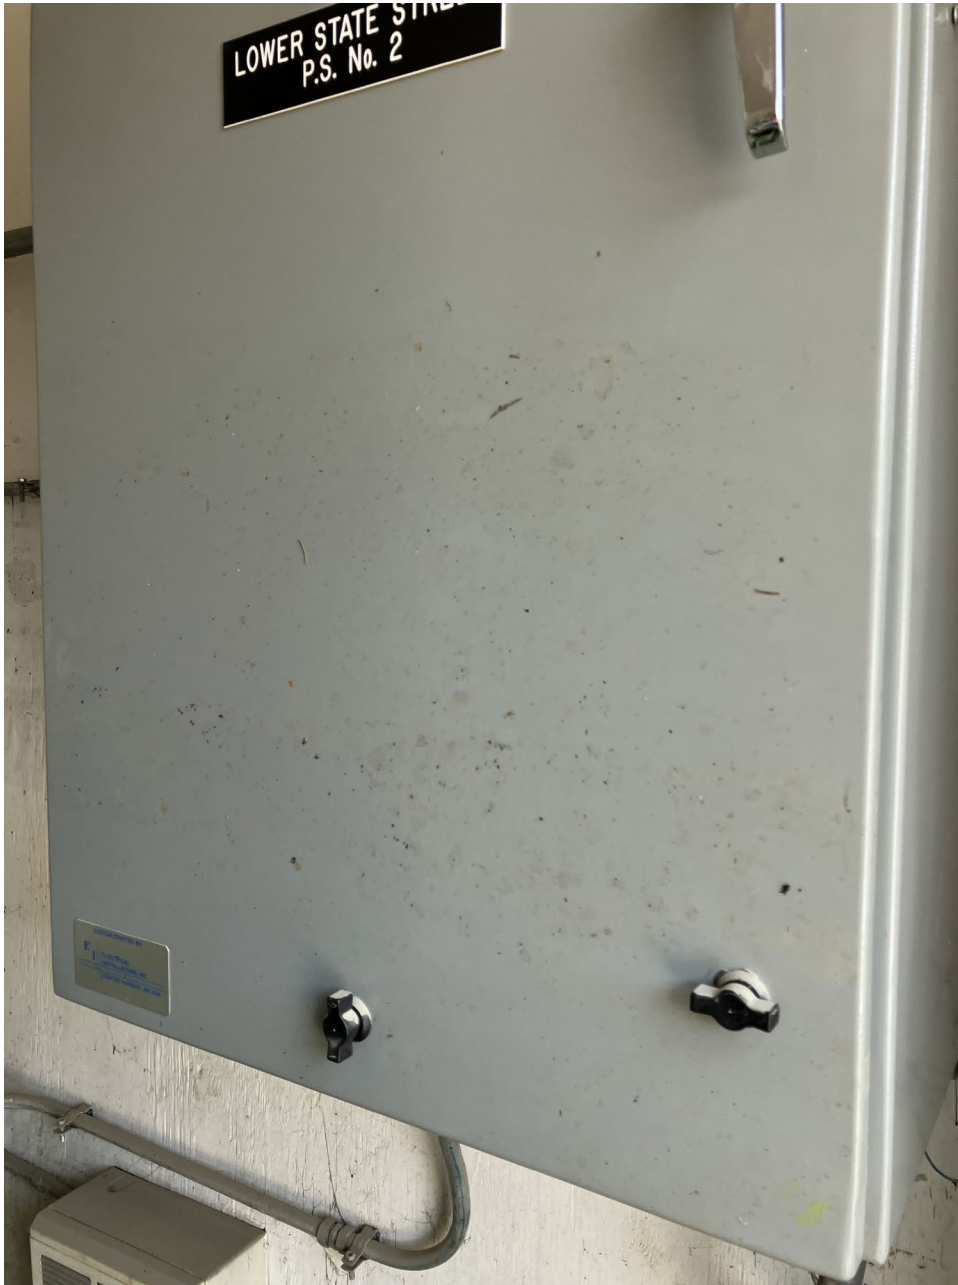
2- Control Panel of Lower State Street Pump Station No.2. Note Highwater Mark at Approximately 4 Feet

- The facility should install a back flow preventer on the effluent pipe to the river to prevent the back up of river water from entering the facility.
- Controls for pump stations should be elevated above flood stage.
- High flows may exceed the working capacity of chemical pumps. Additional pumps should be provided to deliver process and disinfection chemicals during high flows. Larger day tanks and supplies of chemicals on hand may be needed.
- Outfall pipes should have valves or duckbills to prevent river water from backing into plant components.
- Consider portable or fixed pumps to discharge effluent if gravity flow is no longer possible.

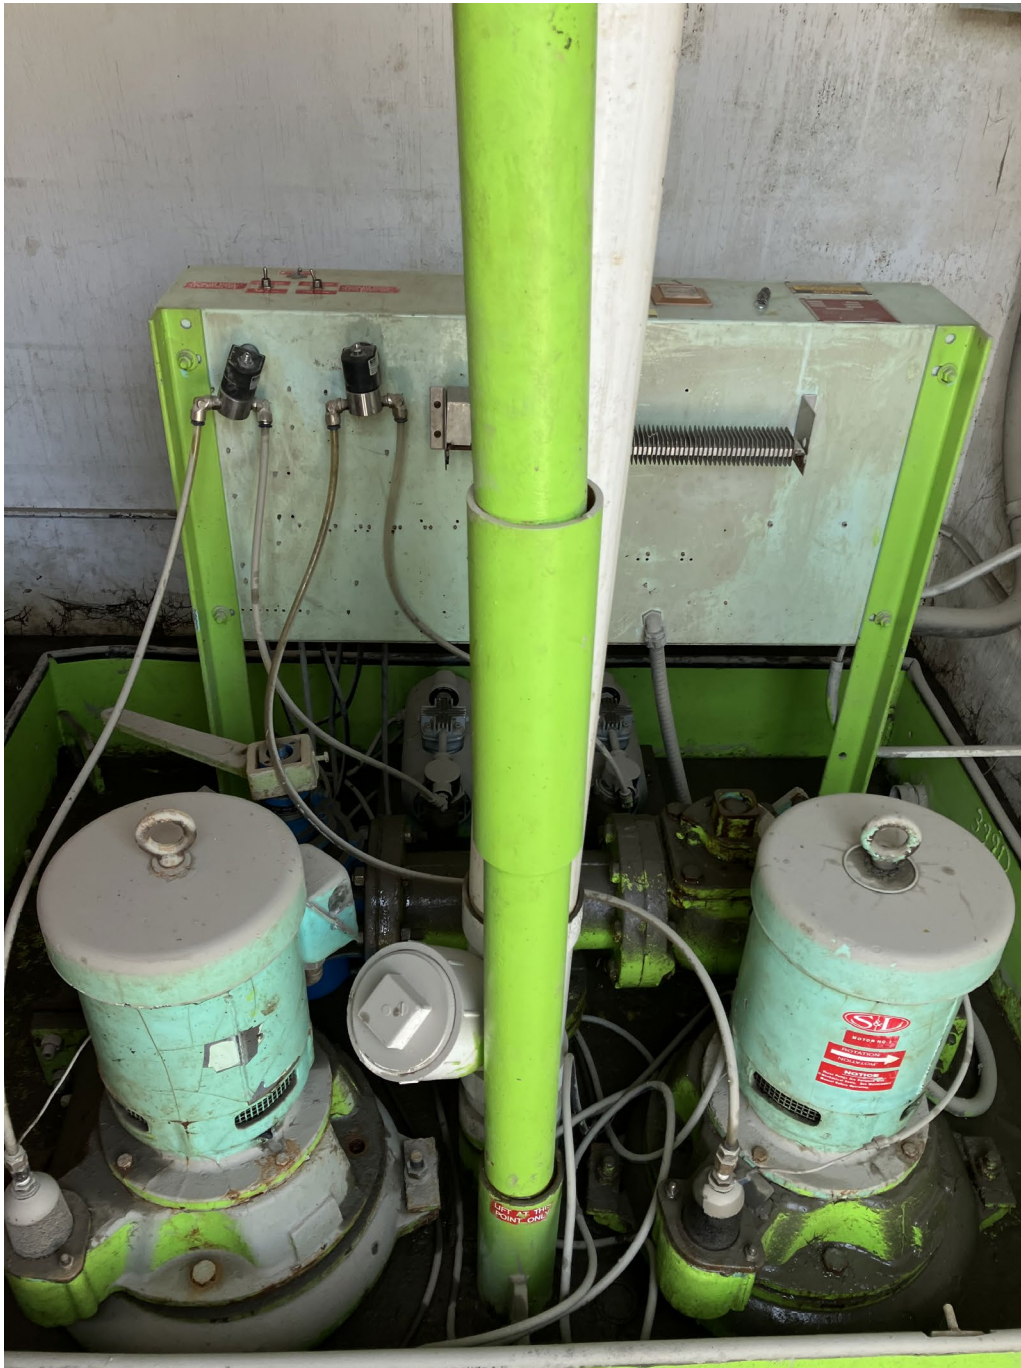
3- Pumps in Lower State Street Pump Station No.2 that Were Completely Submerged in Flood Waters

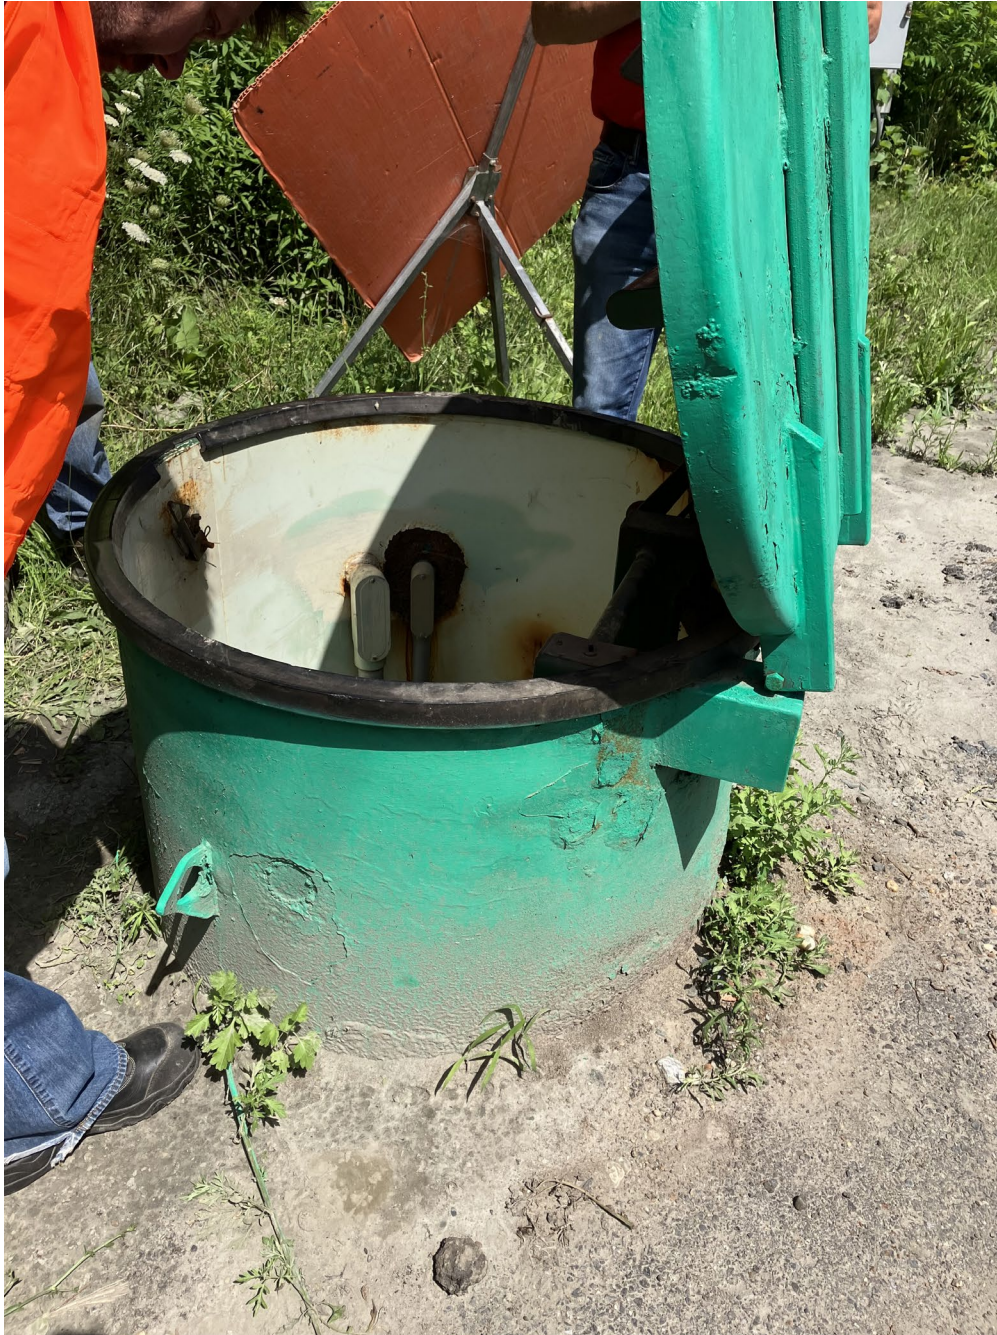
The pump station and grade mounted control panel were both completely submerged in flood water. Pumps and electrical components (switches and relays) were damaged. The wet well received silt and debris accumulation, and likely damaged conduits. Subsequently, pump performance should be checked for accelerated wear. Replace or recondition.

4- Lower State Street Pump Station No.1. Entire Unit was Submerged in Flood Water

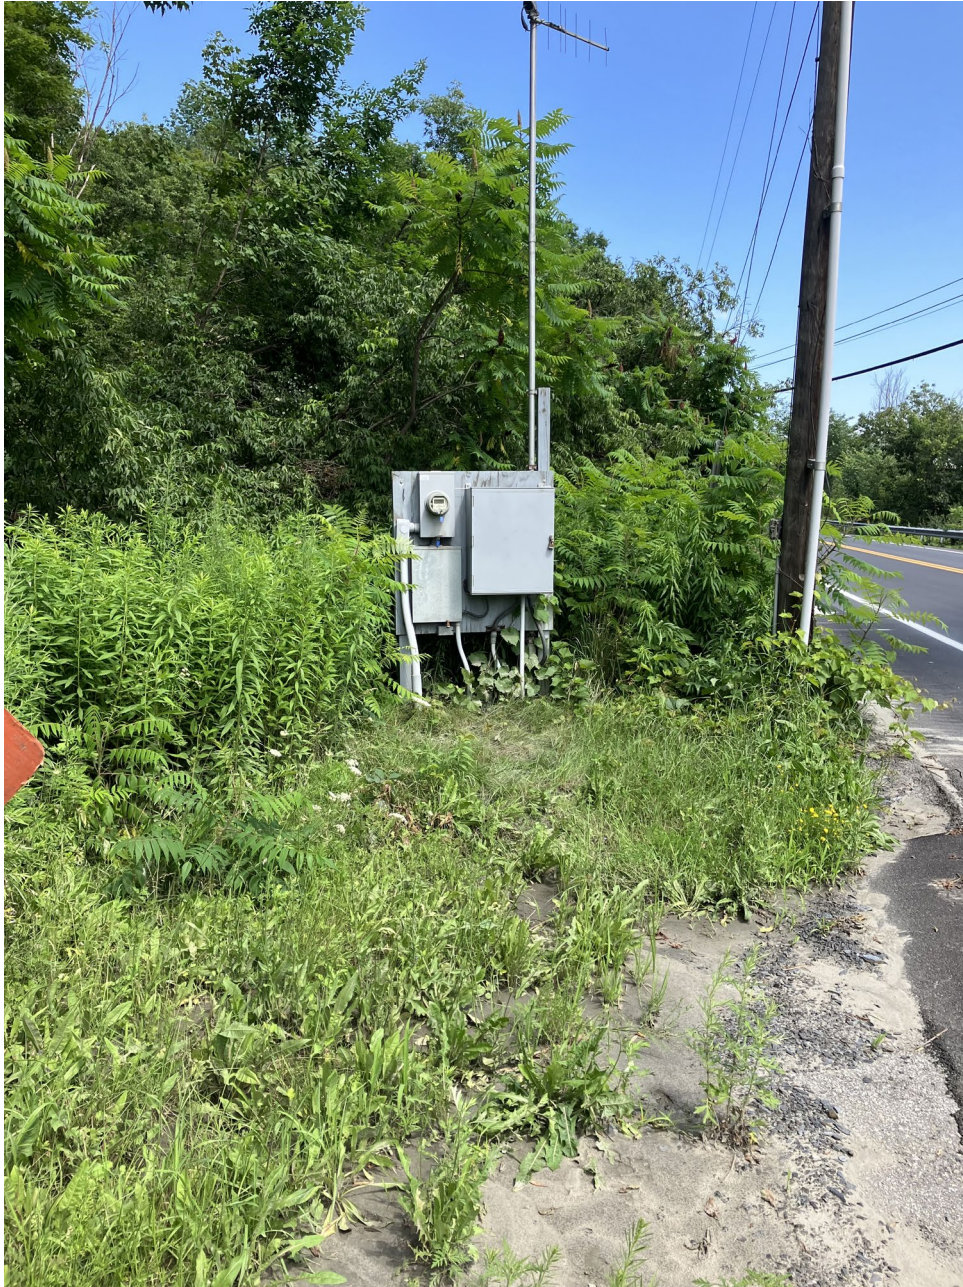
5- Lower State Street Pump Station No.1 Control Panel Which Was Submerged in Flood Water

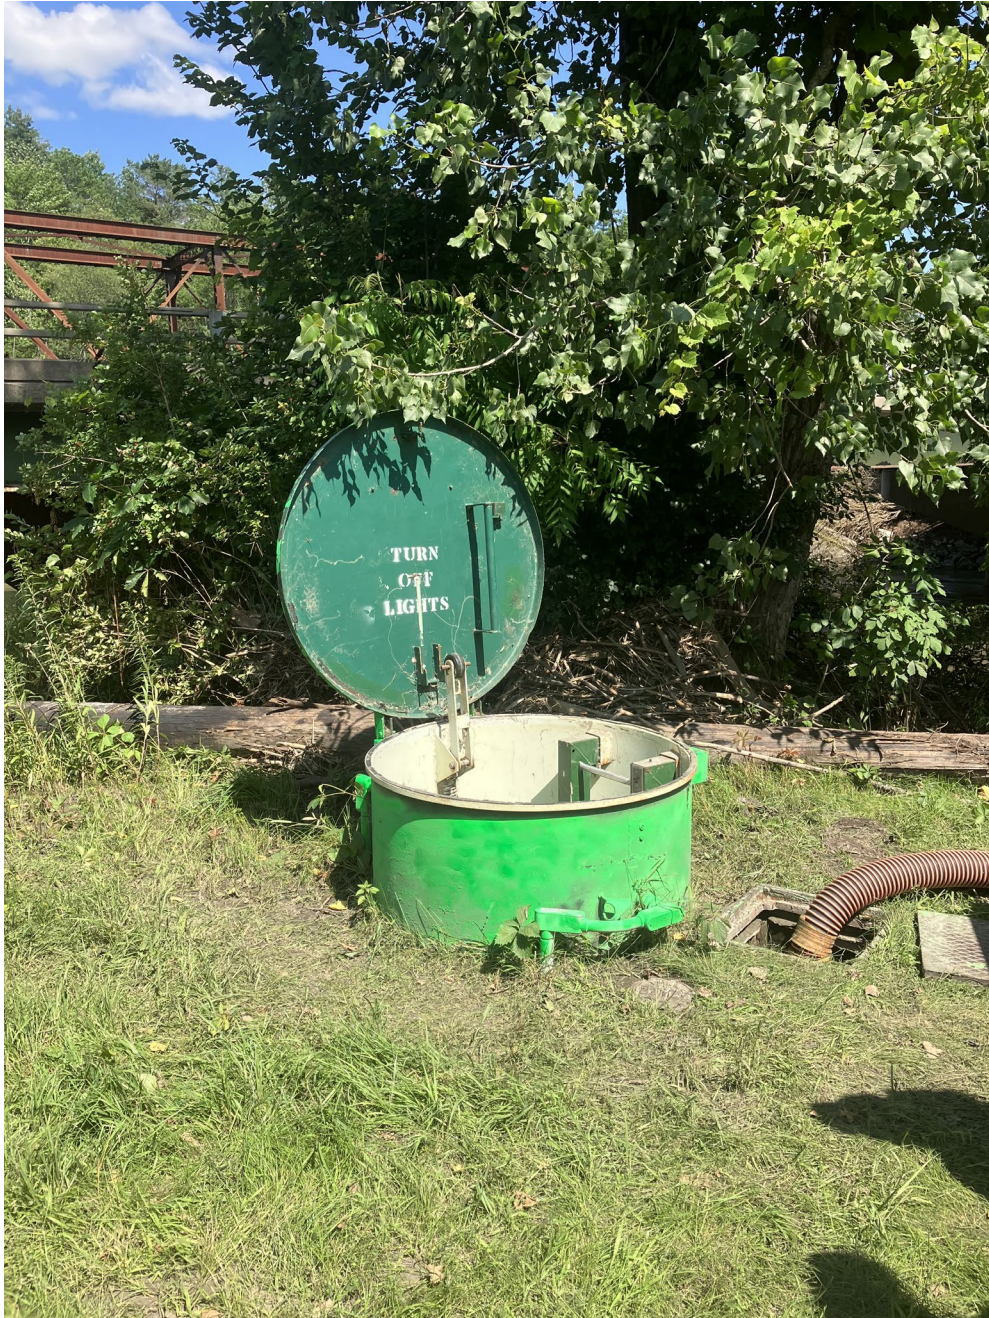
This pump station was not functional on the day of the assessment and was pumping water from the wet well via portable pump to the force main which flows to the treatment plant. The pump station and grade mounted control panel were both completely submerged in flood water. Pumps and electrical components (switches and relays) were damaged. The wet well received silt and debris accumulation, and likely damaged conduits. Subsequently, pump performance should be checked for accelerated wear. Replace or recondition.

6- Interstate Equipment Pump Station No.4 Entire Unit Was Submerged in Flood Water

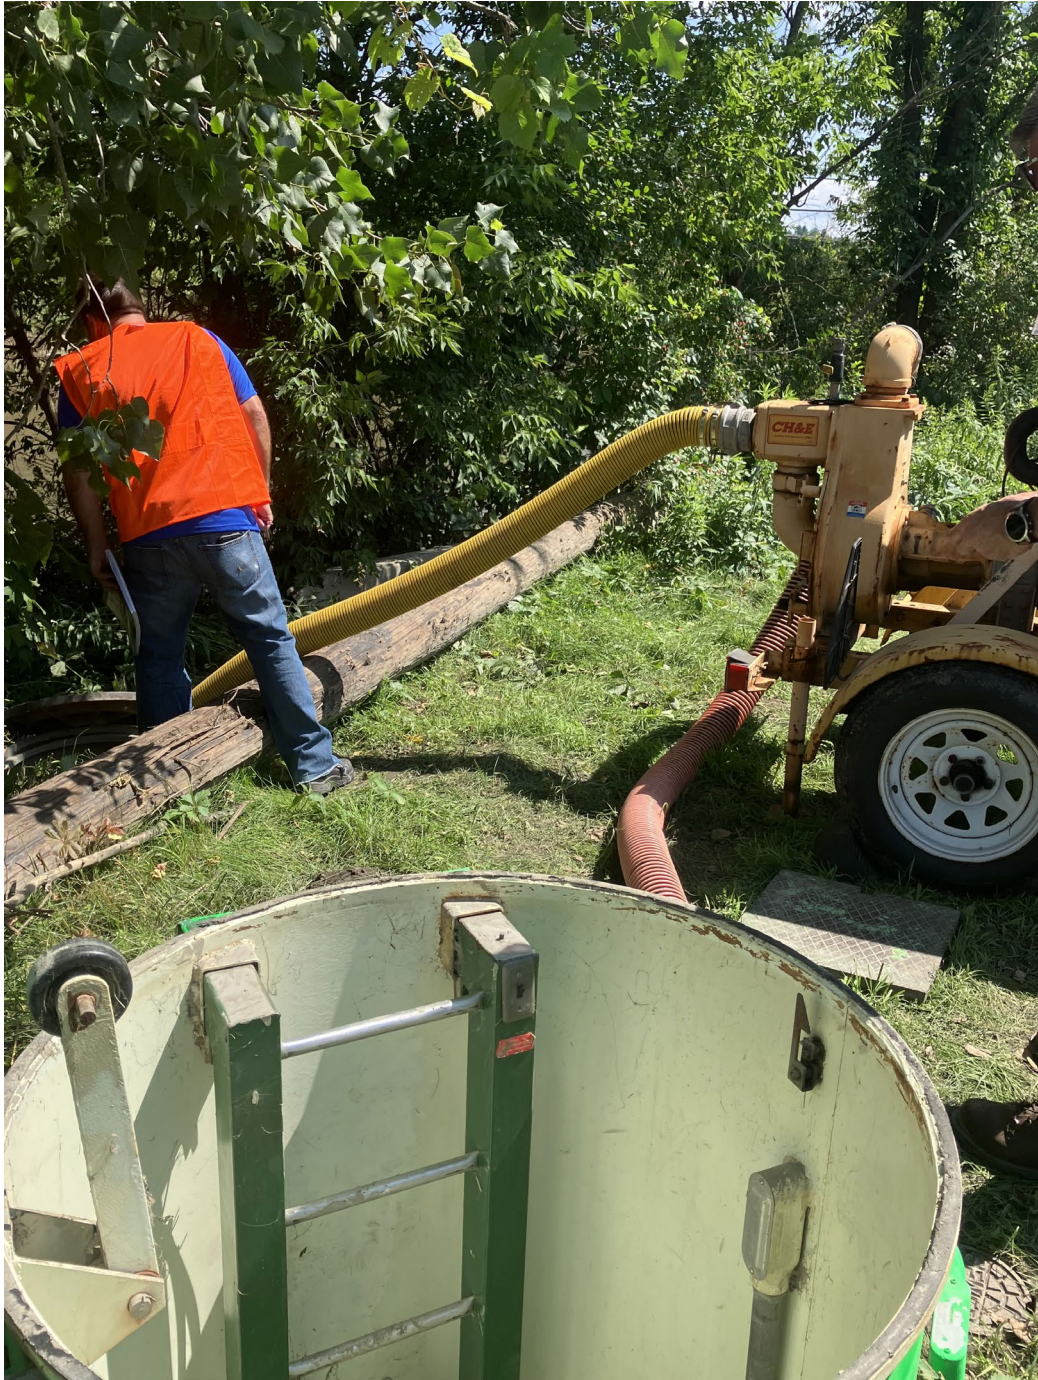
7- Interstate Equipment Pump Station No.4 With Portable Pump Being Used
