PLAINFIELD WASTEWATER POST JULY 2023 FLOOD TREATMENT PLANT ASSESSMENT WASHINGTON COUNTY, VERMONT

NPDES PERMIT NUMBER VT0100781 STATE OF VERMONT PERMIT NUMBER 3-0381

November 6th, 2023

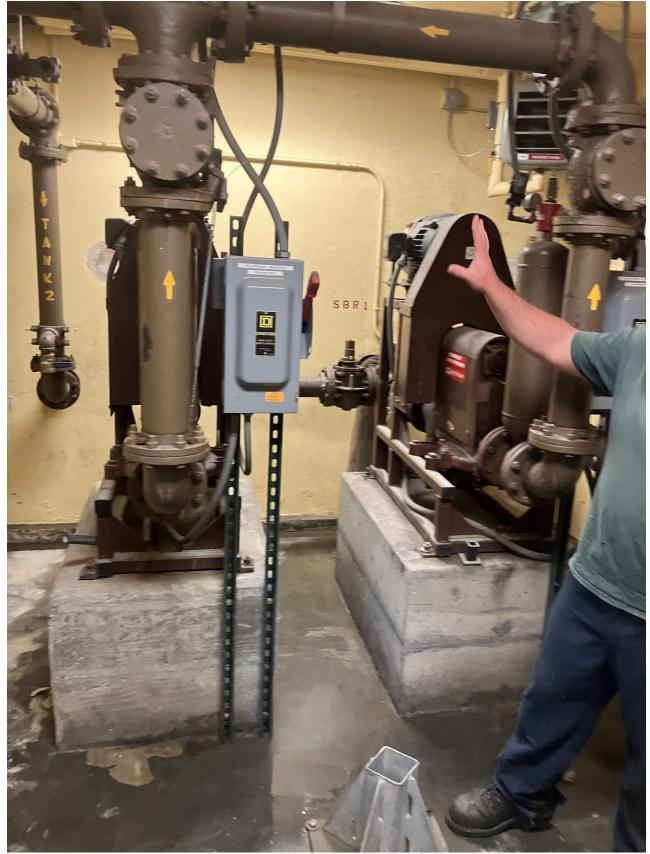
Pump room

• An appreciable amount of grit and sediment from the upstream collection system inundation was likely conveyed into the plant. SBR tanks should be checked for grit build up and removed if found. Sludge pump performance should be checked for accelerated wear. Replace or recondition if found.

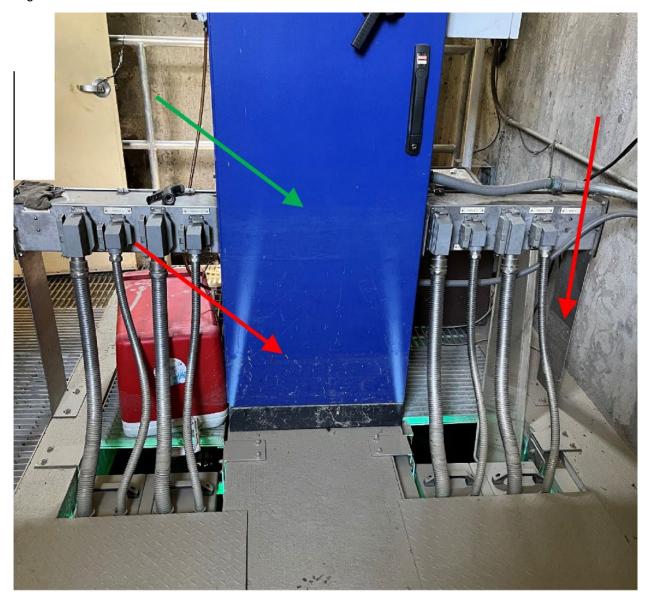
The operator reported the plant was fully operational. High flows during the flood event caused minor high water in the UV area due to the high river level and backwater through the effluent pipe. The water level did not reach electronics or cause any obvious damage.

UV System. Recent high-water marks in red, historical high-water mark in green,

- The operator was able to close influent valves to prevent excessive flows from inundating the plant. This action likely saved UV equipment from damage and prevented a process upset. Adding automation and influent valve actuators could provide similar protection if high water events happen during un-manned hours.
- The road to the plant became submerged. The operator was present and moved records, tools, and the municipal truck offsite to high ground. Raising the road would allow vehicle access during high flows.
