TOWN OF LUNENBURG

Road Erosion Inventory and Capital Budget Plan

Prepared by: *Sam Mayne*
 Assisted by: *Heather Johnson*

Essex County Natural Resources
 Conservation District

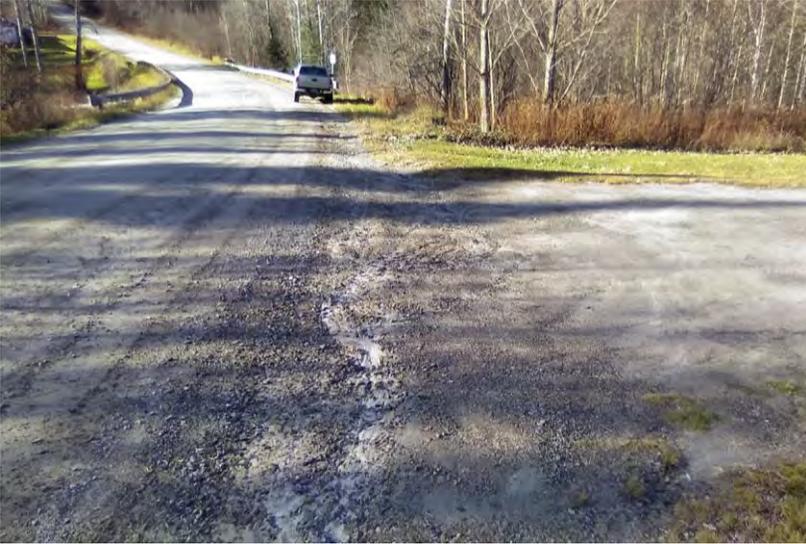
Figure 3: Rill erosion occurring at a driveway in segment 4171 that lacks a culvert

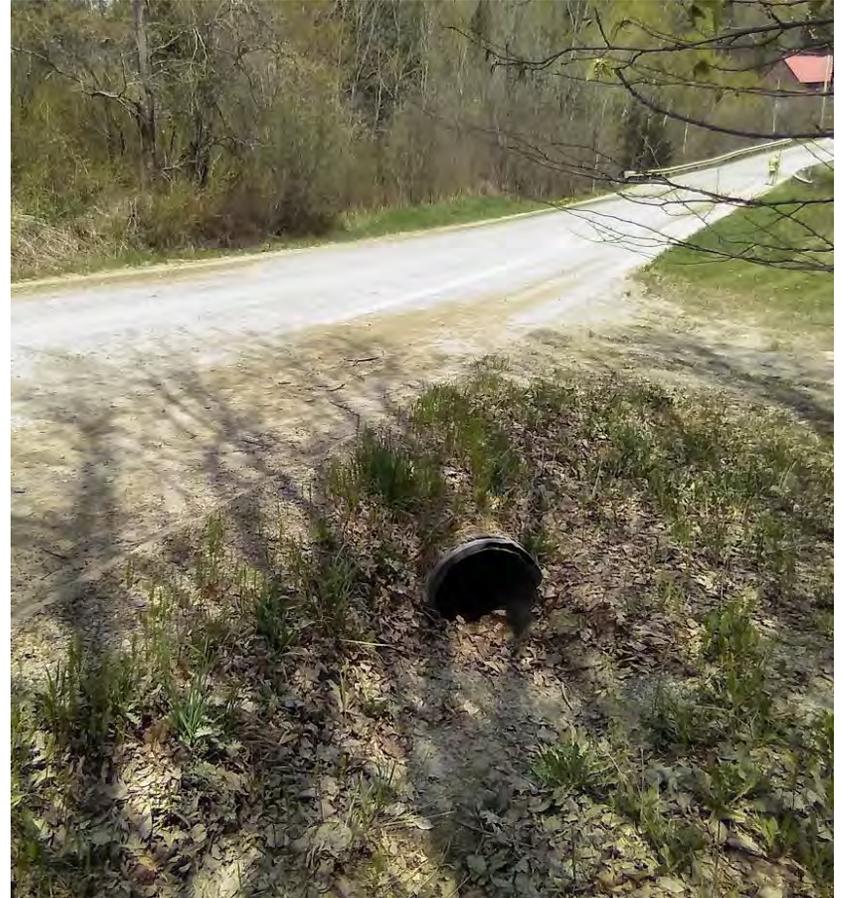
Figure 5: A cross drain in segment 4170 is filled with sediment and will be replaced with a 2' cross drain that leads to a turnout.

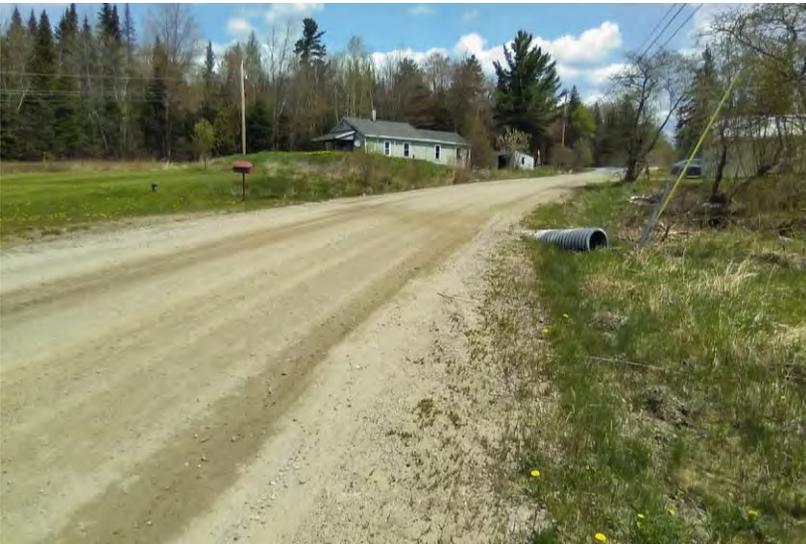
Figure 4: The cross culvert in segment 4171 has shifted and should be replaced with a metal culvert to ensure stability.

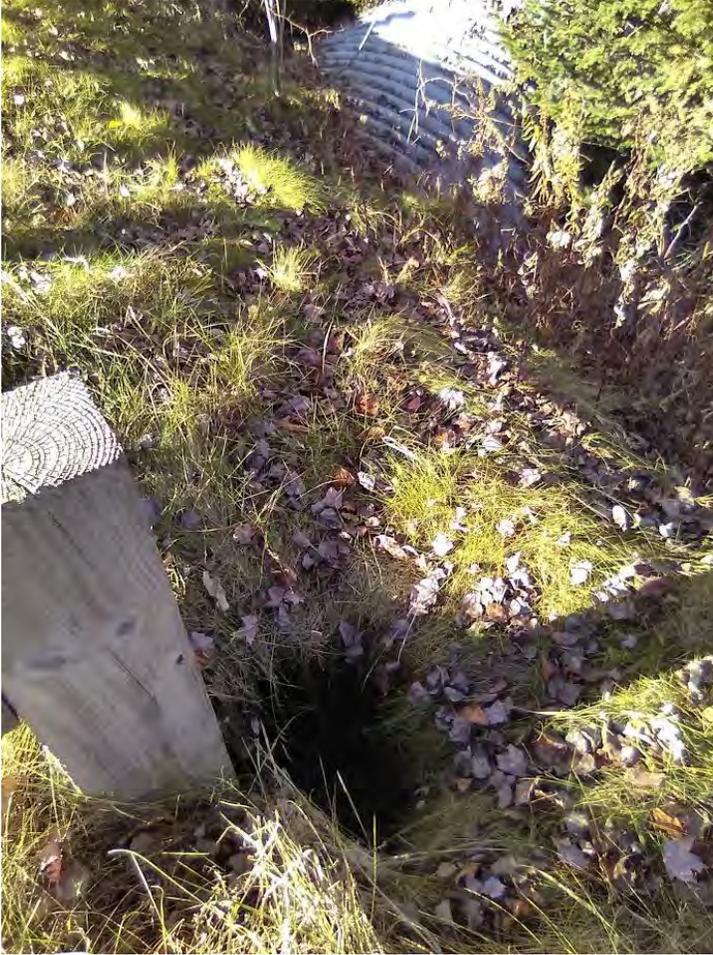
Figure 6: Erosion occurring at the Mink Brook culvert in segment 4171 will be repaired.

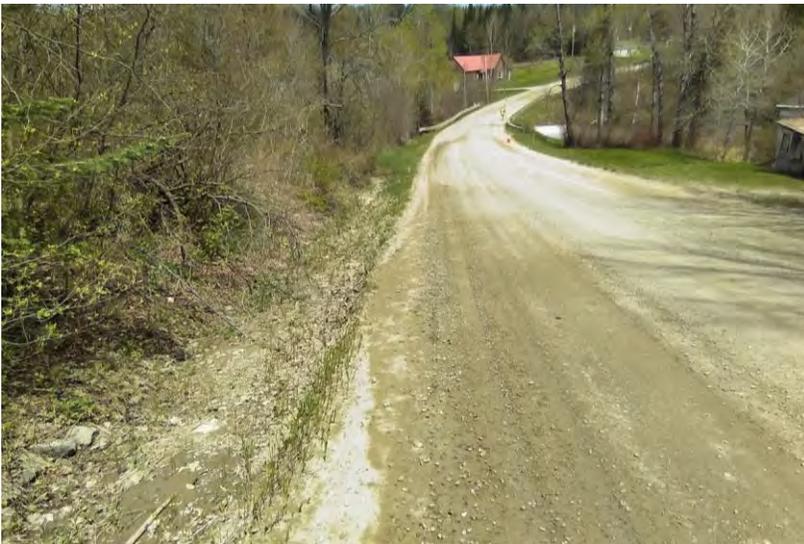
Figure 7: Ditches in both segments have filled with sediment and need additional stone added to slow water velocity and reduce sediment transport.

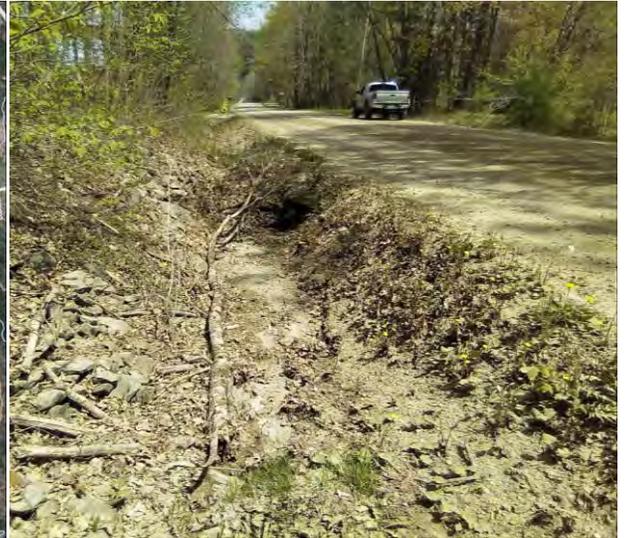
Figure 2: The ditches in segment 4166 are filling with sediment from the roadway and eroding within the ditch.

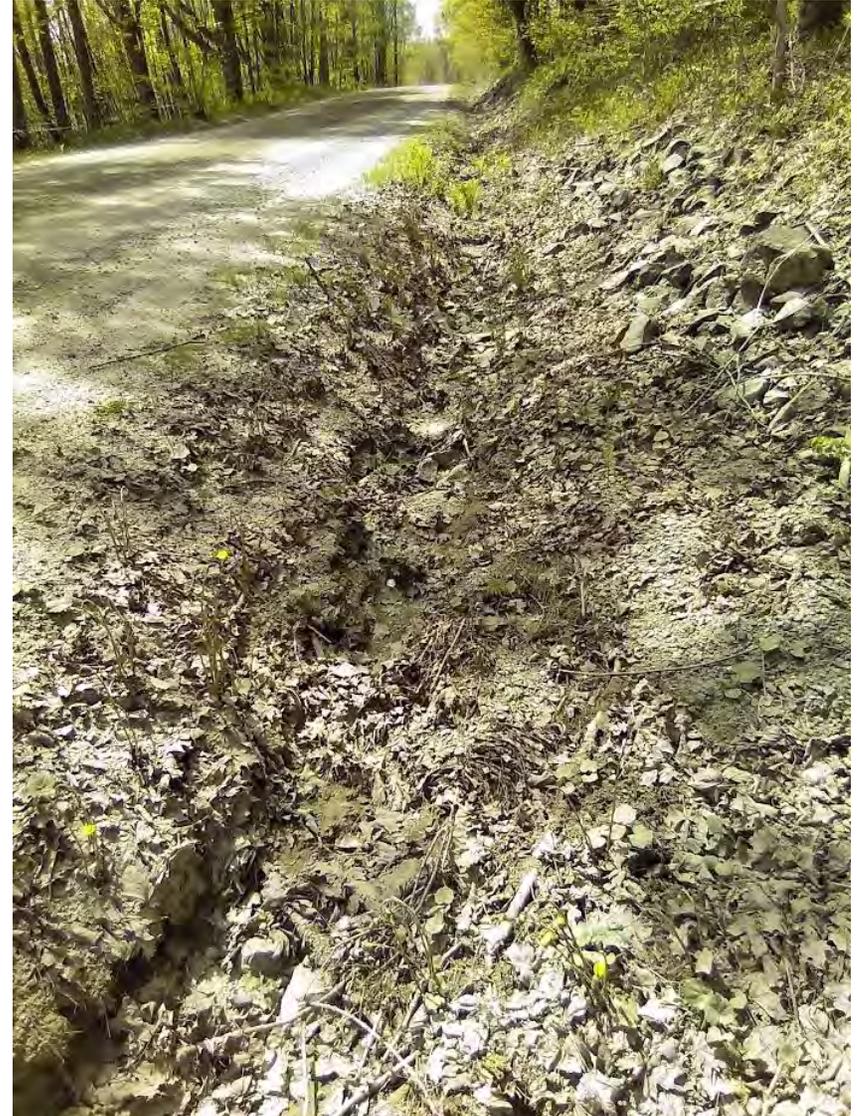
Figure 5: Not enough stone is present in ditches in segment 4166, causing erosion within the ditch.

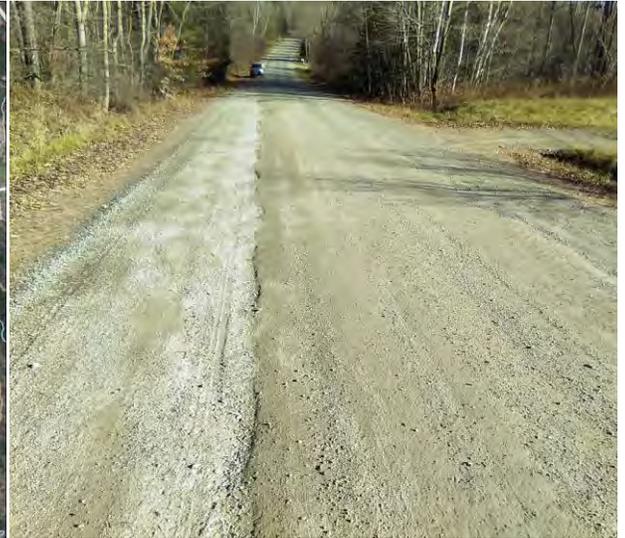
Figure 2: Water runs along the road surface through segment 4156 toward segment 4157

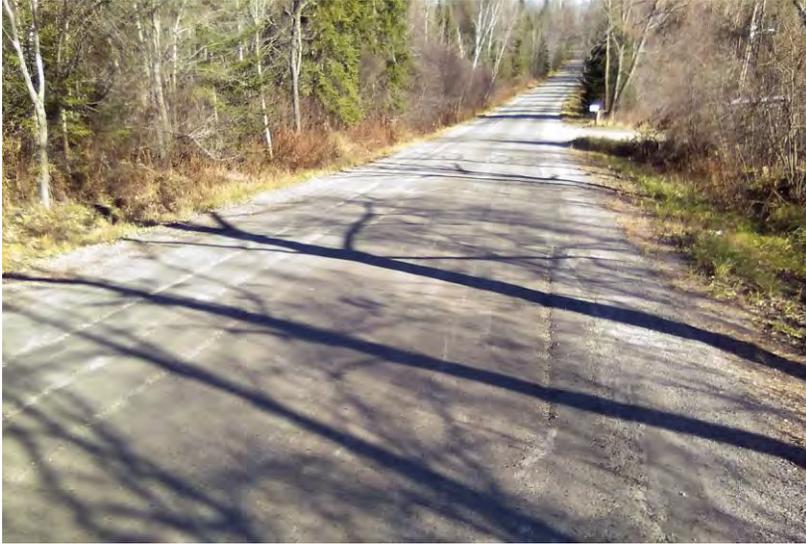
Figure 3: Rill erosion along road surface in segments 4156 & 5157

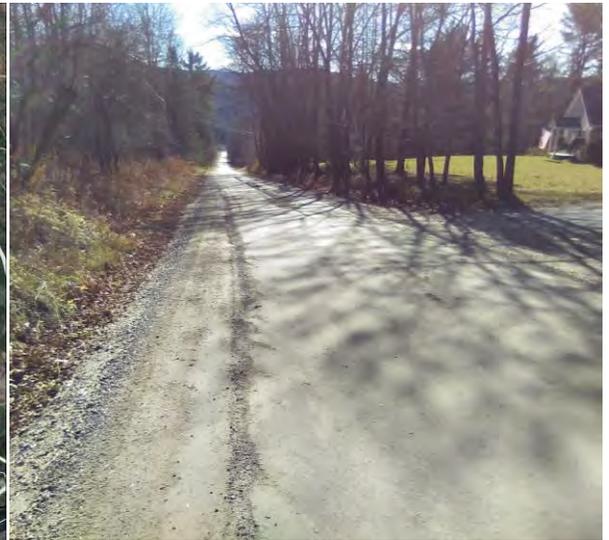
Figure 2: Water runs along the road surface in segment 1938.1 due to a poorly shaped crown and ditches

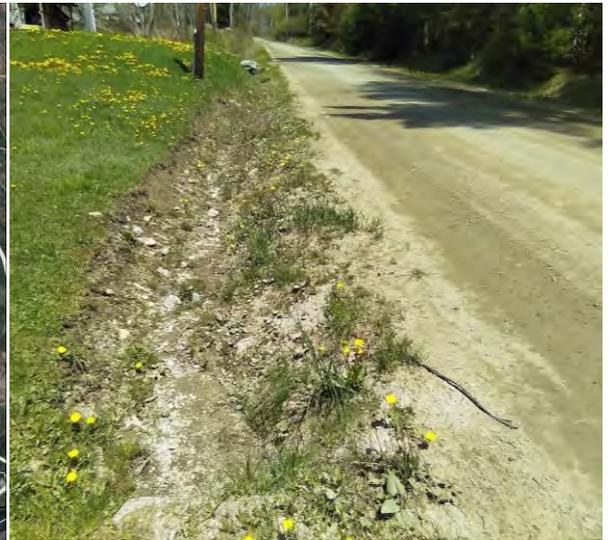
Figure 2: Figure 4: The ditches in segment 1934.1 lack stone, causing erosion in the ditch and sediment transport to streams.

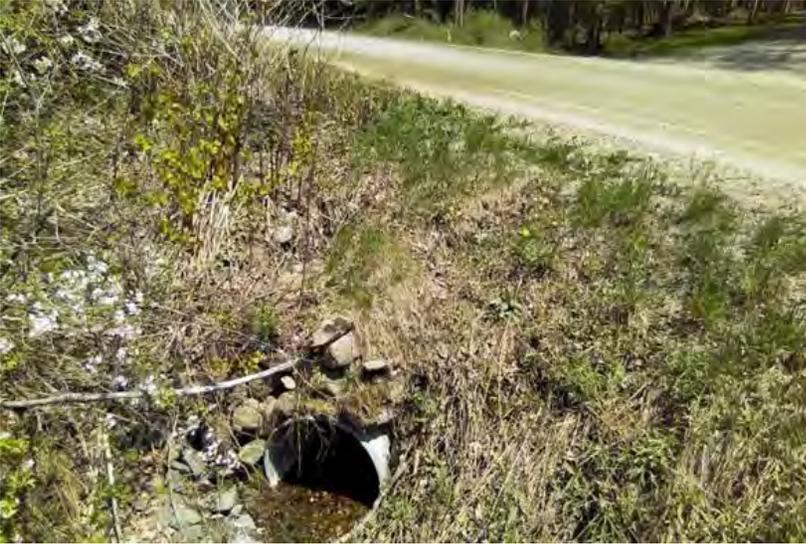
Figure 3: The inlet and outlet of culvert 42 are eroding and need stone stabilization.

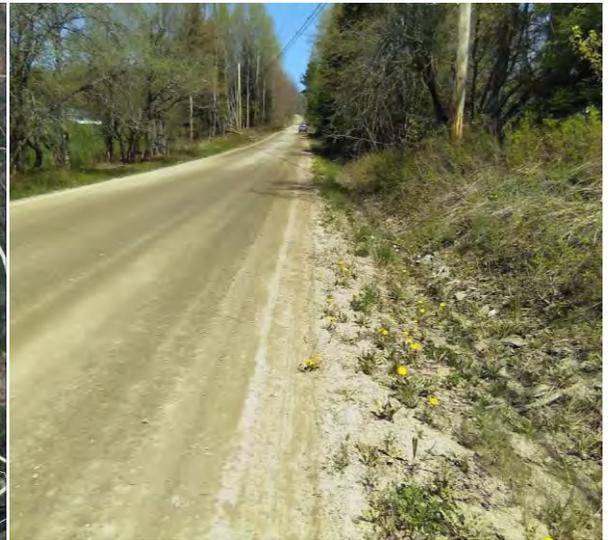
Figure 2: The ditches in segment 1931.1, 1932.1, and 1933.1 have filled with sediment and lack stone, causing sediment transport to waterbodies.

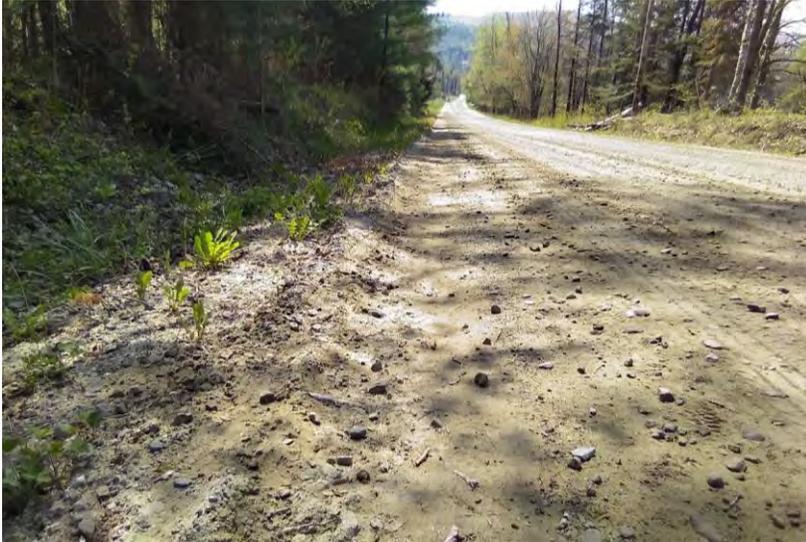
Figure 3: The ditches in segment 1931.1, 1932.1, and 1933.1 have filled with sediment and lack stone, causing sediment transport to waterbodies. Grader berms and poorly formed shoulders cause erosion on the road.

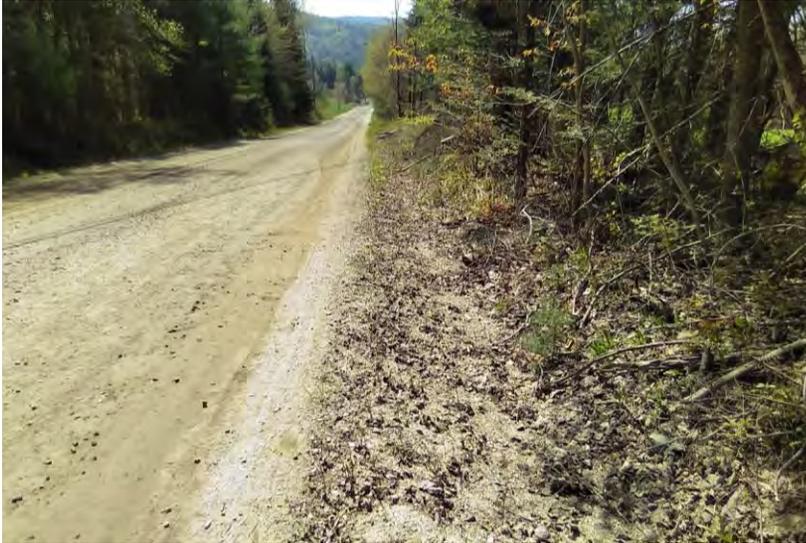
Figure 4: The ditches in segment 1931.1, 1932.1, and 1933.1 have filled with sediment and lack stone, causing sediment transport to waterbodies.

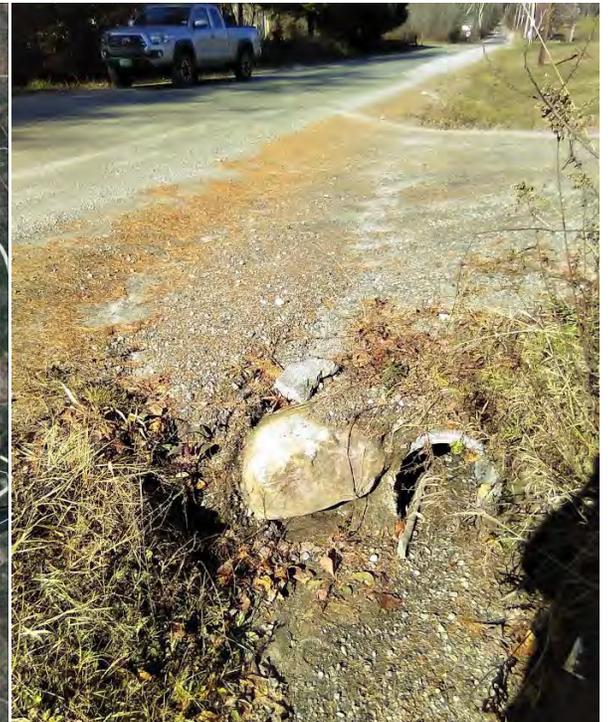
Figure 2: Driveway culvert 49 is too small and partially blocked by sediment, causing erosion at the header and on the driveway.

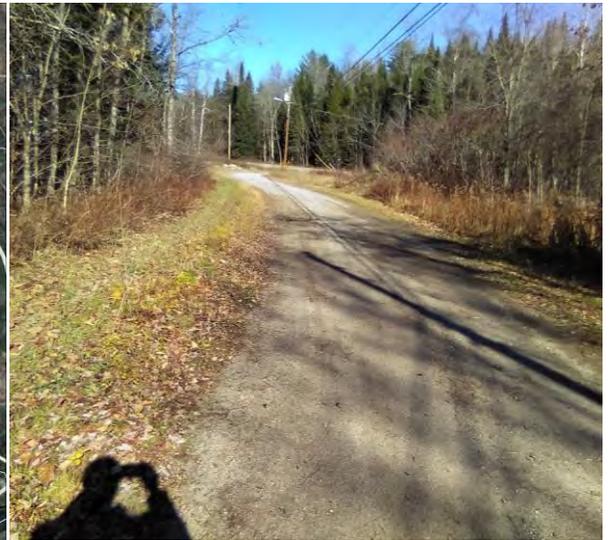
Figure 2: Segment 22134 has very little crown and no ditches, causing water to run along the road surface picking up sediment.

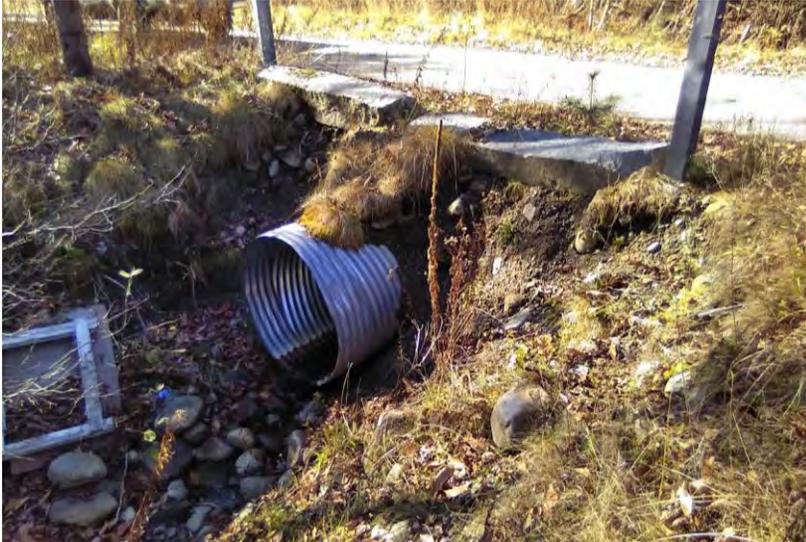
Figure 3: Culvert 102 in segment 22134 lacks adequate header stabilization, and should be reinforced to reduce erosion.

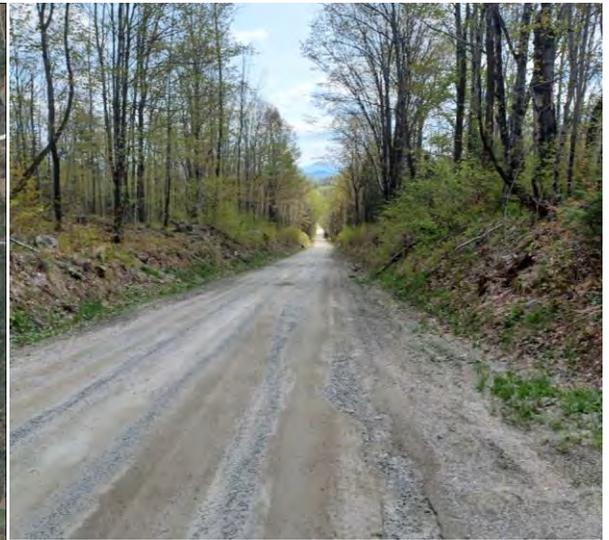
Figure 2: All segments are very steep and have ditches that are too narrow and shallow without enough stone. Crowning is also not shedding water off the road surface.

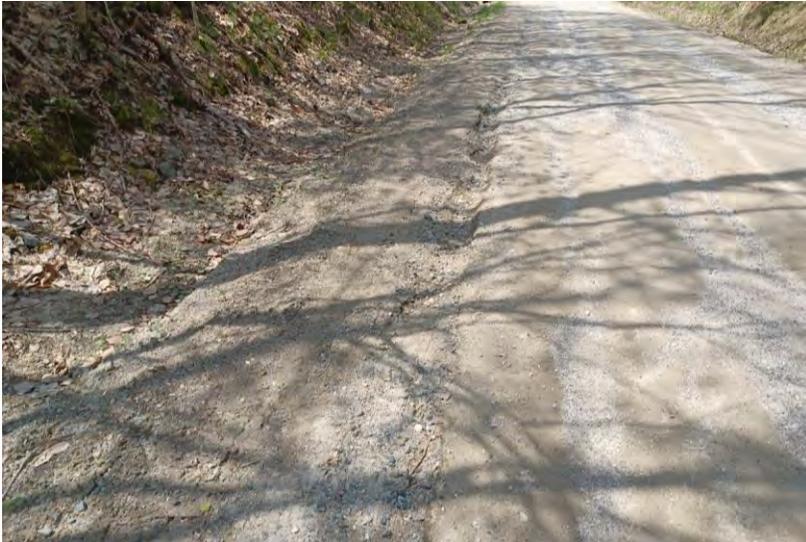
Figure 4: In segment 152093 water from the road and a driveway causes erosion because the crown does not shed it into the ditch and the ditch is full of sediment.

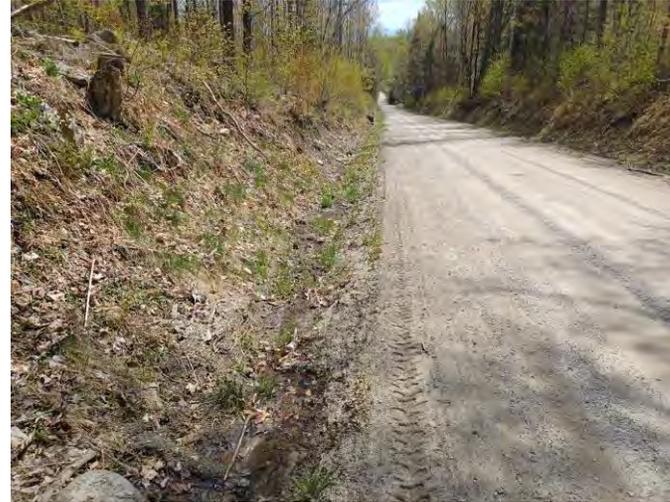
Figure 5: In all segments, steep ditches without adequate stone lining are eroding. Water enters an unnamed stream further down the hill.

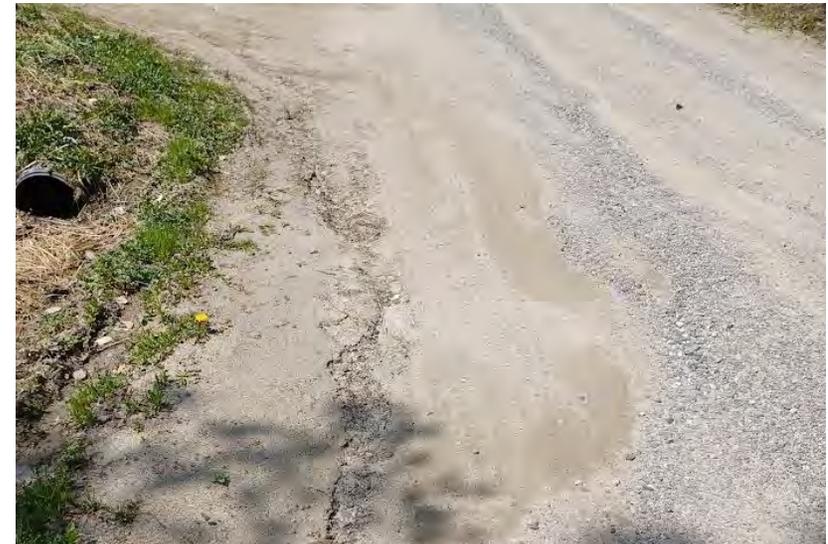
Figure 6: In segment 152093 water from the road and a driveway causes erosion because the crown does not shed water into the ditch and the ditch is full of sediment.

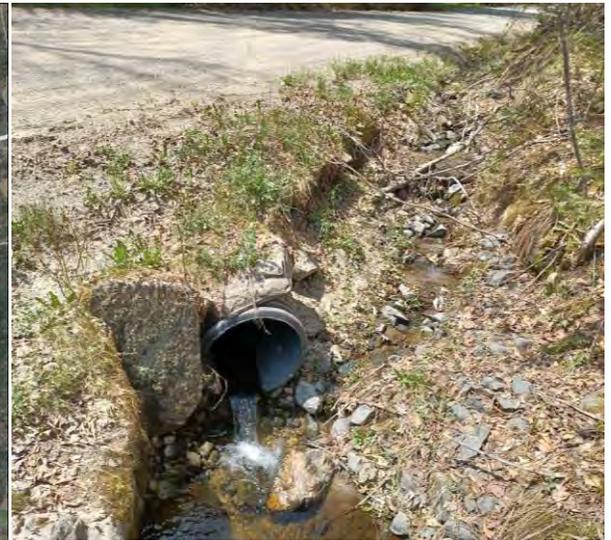
Figure 2: Culvert 263 in segment 152095 passes a perennial stream. Road runoff is eroding the ditch and the culvert outlet and runs directly into the stream.

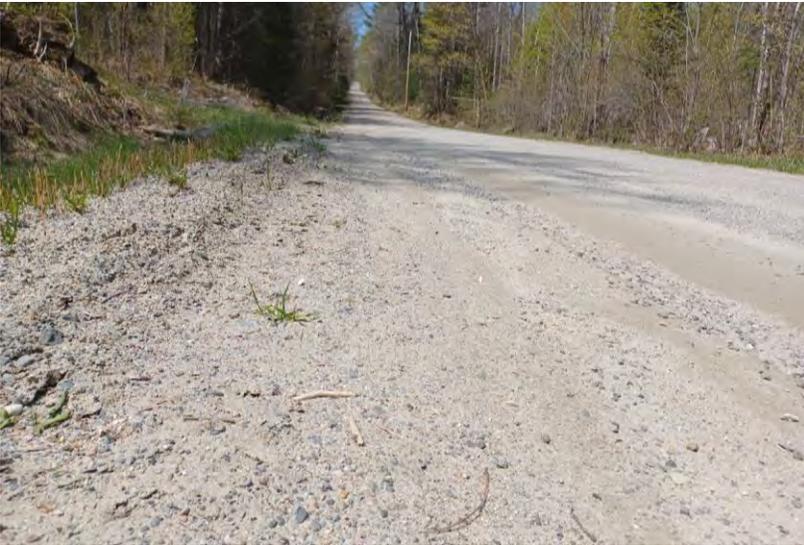
Figure 4: A grader berm and inadequate ditching prevents water from escaping the road surface.

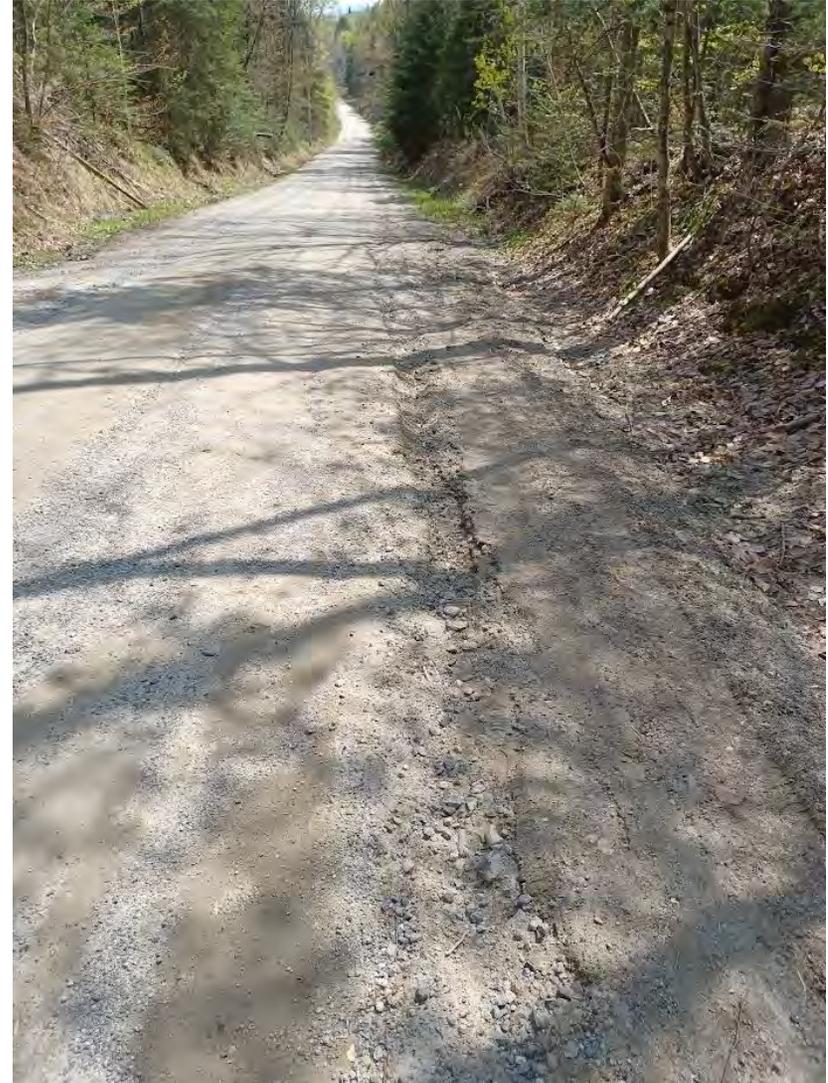
Figure 5: Water flows along the road surface in both segments, picking up sediment which is deposited in the stream in segment 152095.

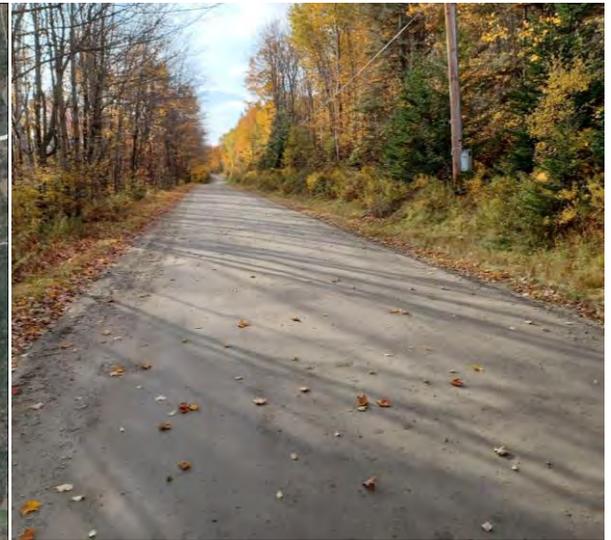
Figure 2: In segment 152097 and 152098 insufficient ditching and crowning causes water to run along the road surface, picking up sediment.

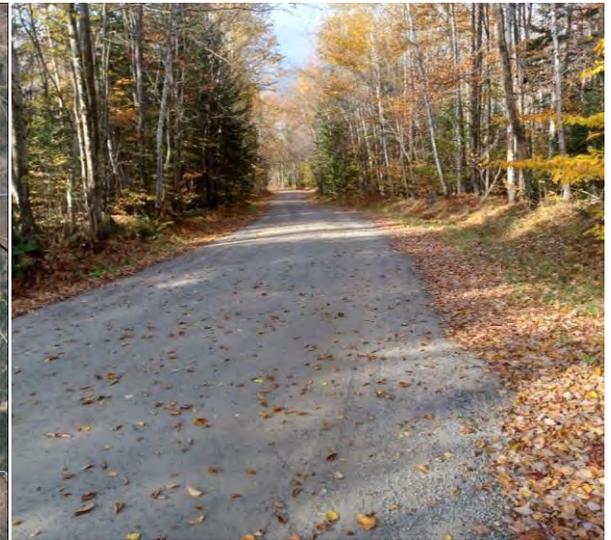
Figure 2: Shallow ditches and minimal crown in segments 134468 and 134467 causes water to run along the road surface picking up sediment. Ditches also lack stone, allowing erosion to occur.

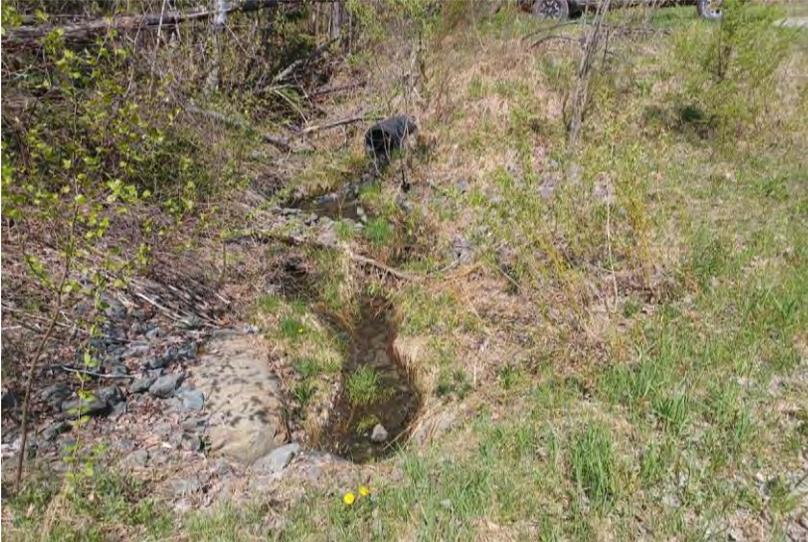
Figure 3: In segment 134467, The cross culvert (228) on Unnamed Rd 12 passes water effectively before it enters culvert 229.

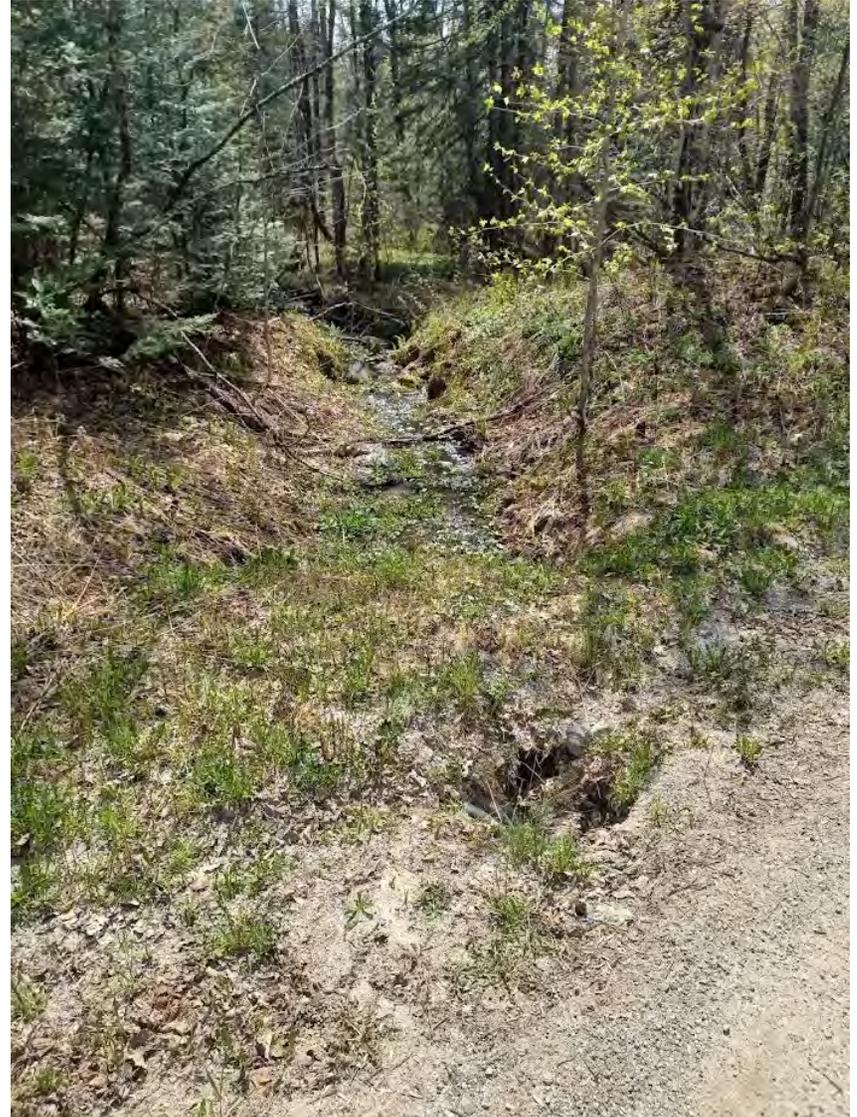
Figure 5: Gully erosion is occurring at culvert 229 in segment 134467 due to water flowing around the culvert. The culvert should be increased in size.

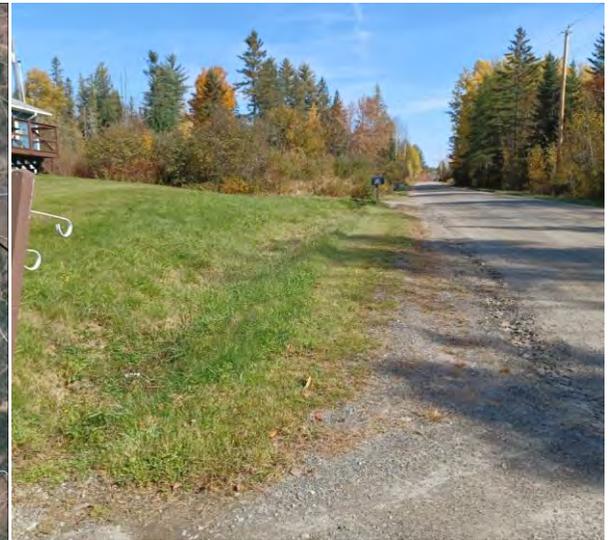
Figure 2: Water runs along the road surface in segment 4597.1 because ditches are too far away from the road for water to reach them. Ditches need to be reshaped and more crowning added to move water off the road as sheet flow.

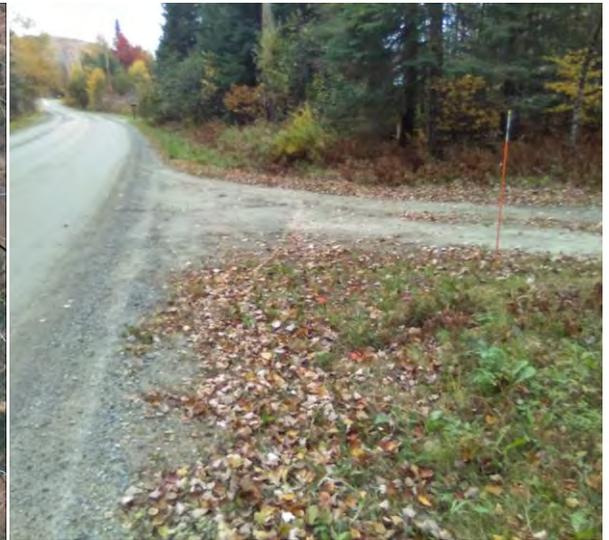
Figure 2: Two driveways in segment 10509 lack culverts. Water running across these driveways picks up sediment that is eventually transported to an unnamed stream in segment 10507.

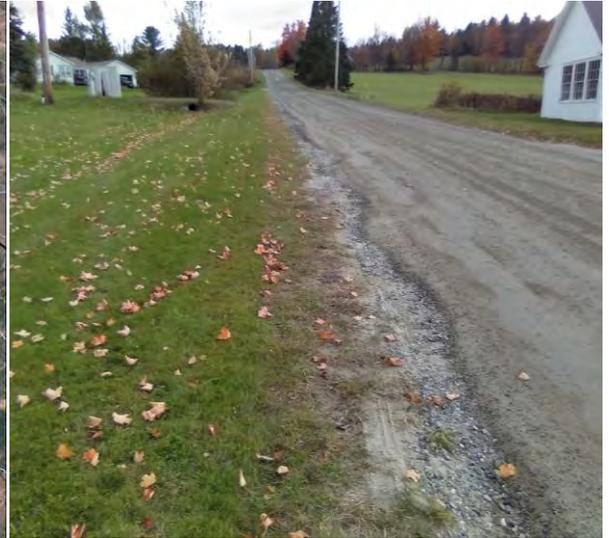
Figure 2: Water runs along the road surface in segment 1936.1 due to a poorly shaped crown and ditches

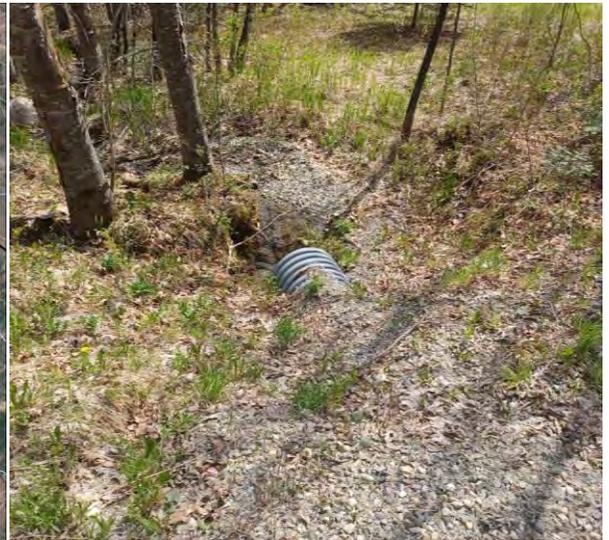
Figure 2: Culvert 359 in segment 167361 is and several other culverts in this area are undersized, causing in-channel erosion and erosion around headers.

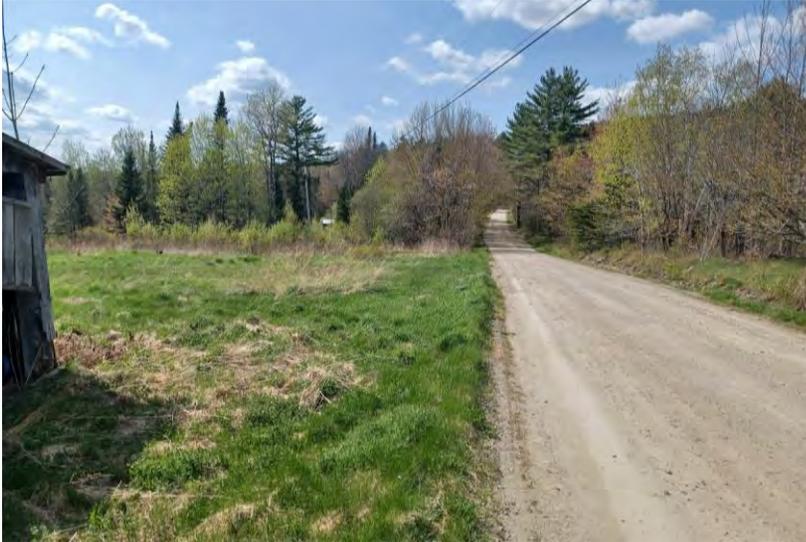
Figure 3: No ditch is present on the south side of segment 167358, causing erosion and sediment addition to a stream at culvert 361.

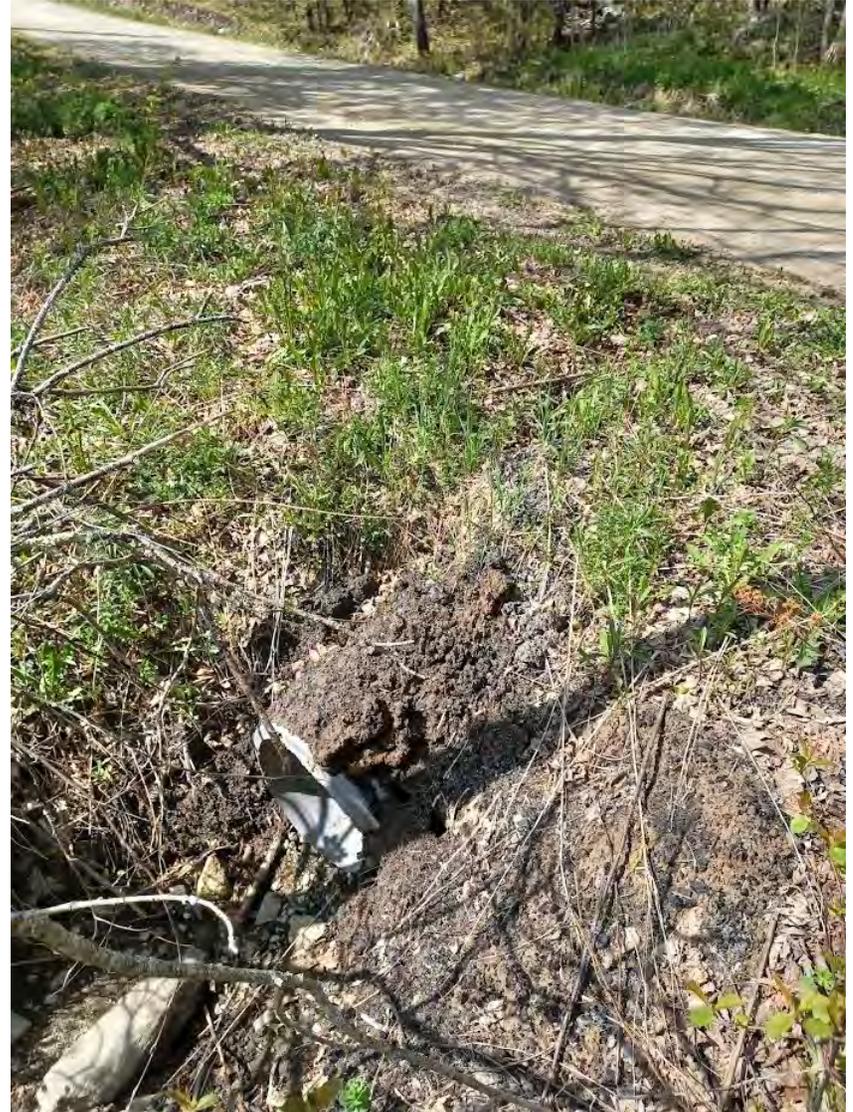
Figure 5: Erosion is occurring around the outlet of culvert 360 in segment 167360.

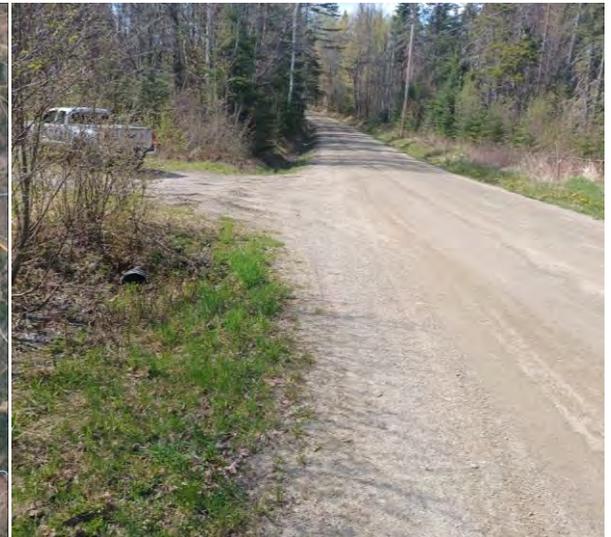
Figure 2: In segment 24571, lack of stone in ditches in steep sections results in erosion transporting sediment to streams and lower sections where it clogs ditches and culverts.

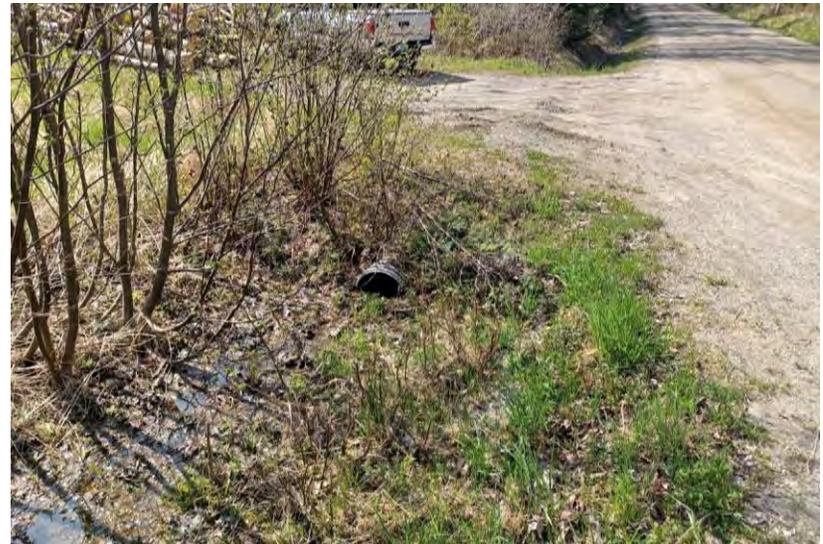
Figure 6: Culvert 124 has filled with sediment. Ditches will be cleaned out and the culvert will be replaced with an 18" pipe.

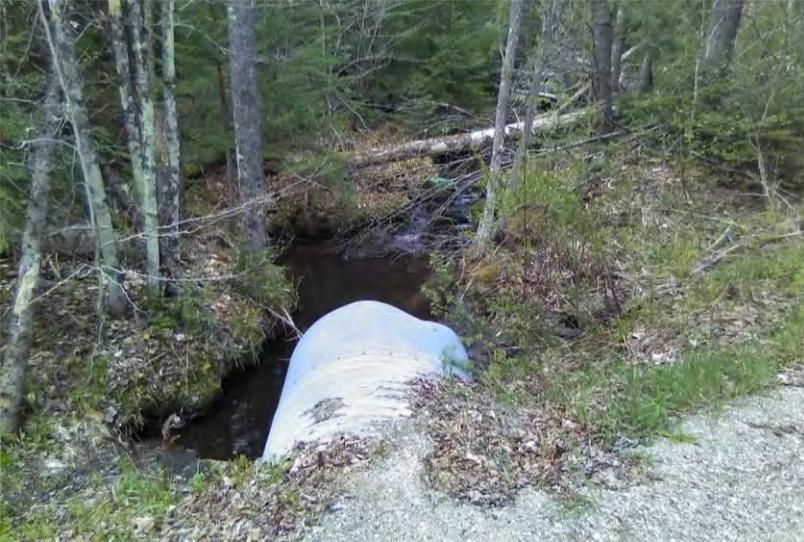
Figure 3: The headers of culvert 159 are not fully stabilized with stone, causing some erosion.

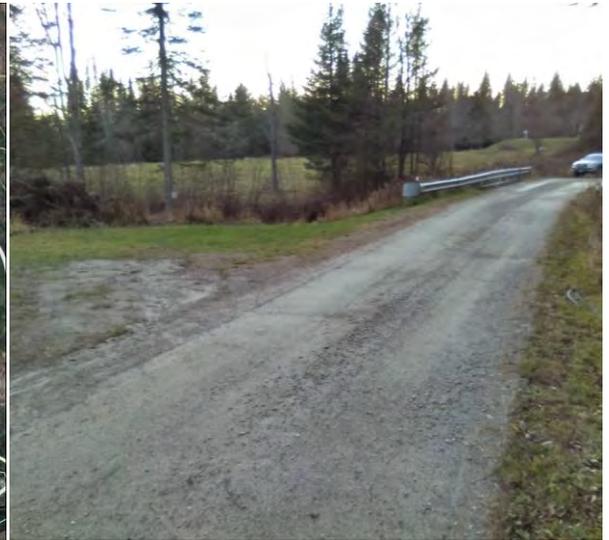
Figure 2: The south side of segment 193242 lacks ditching and driveway culverts, and enters Scales Brook through an area that is not stabilized.

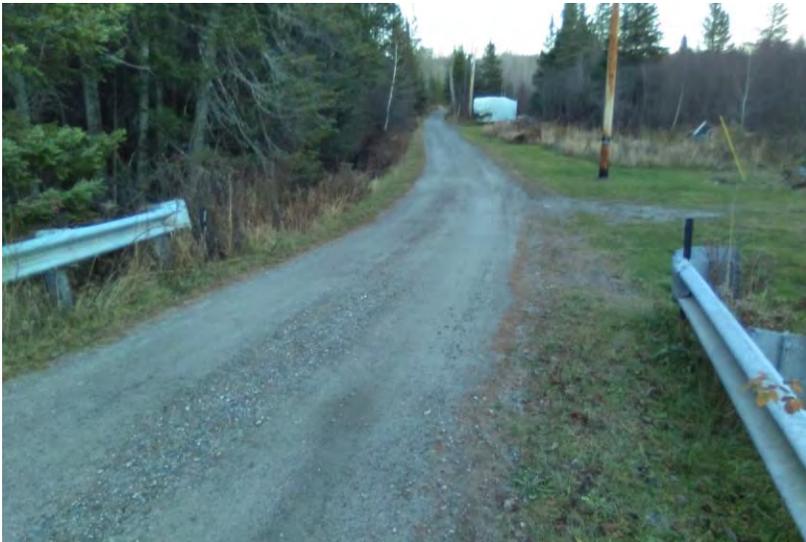
Figure 4: Lack of crown, ditching, and driveway culverts causes erosion in segment 193242.

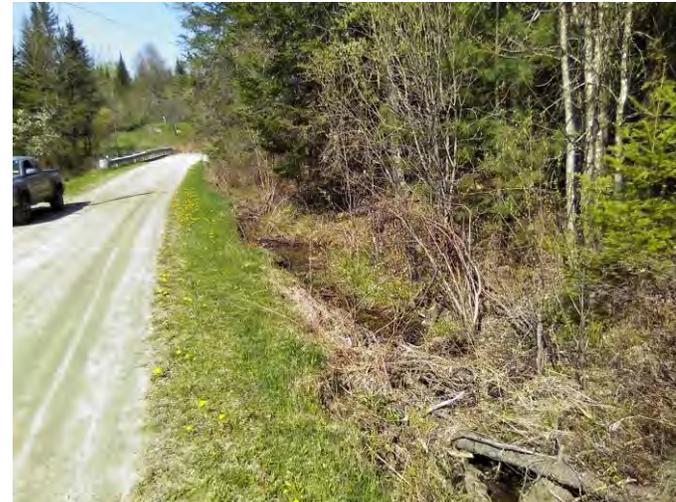
Figure 6: In segment 193242, an unnamed stream approaches the road and runs along it until entering Scales Brook. The ditch will be turned out above the stream, and the road shoulder will be stabilized adjacent to the stream.

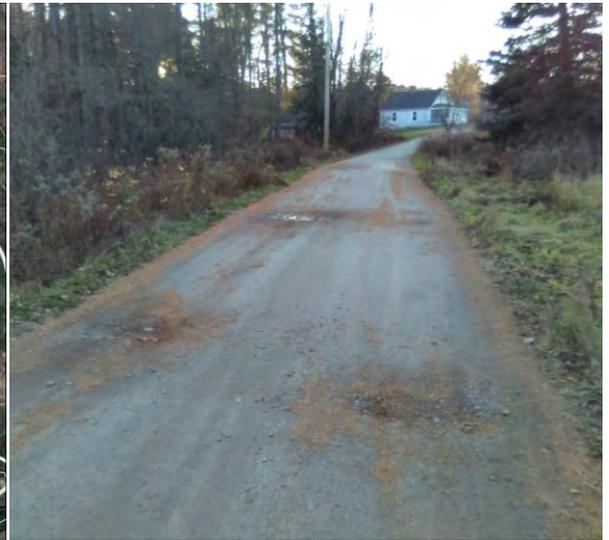
Figure 2: Water runs along the road surface causing erosion in segment 193229 due to inadequate crowning and no ditching.

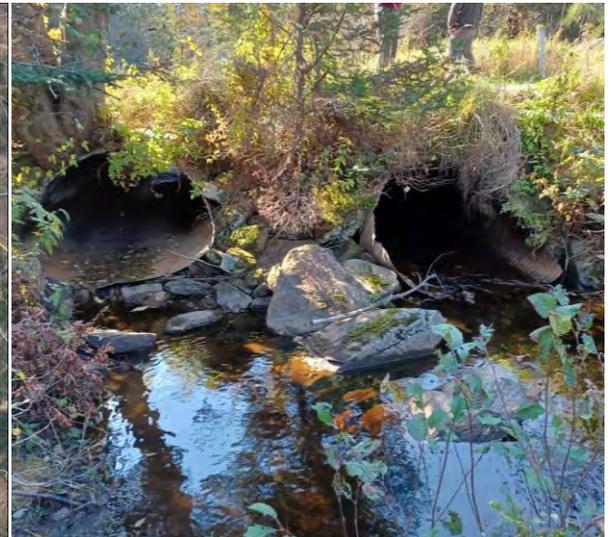
Figure 2: The existing culverts are in poor condition and undersized for the flow they receive, posing a failure risk. The multi-culvert design also poses a clogging risk.

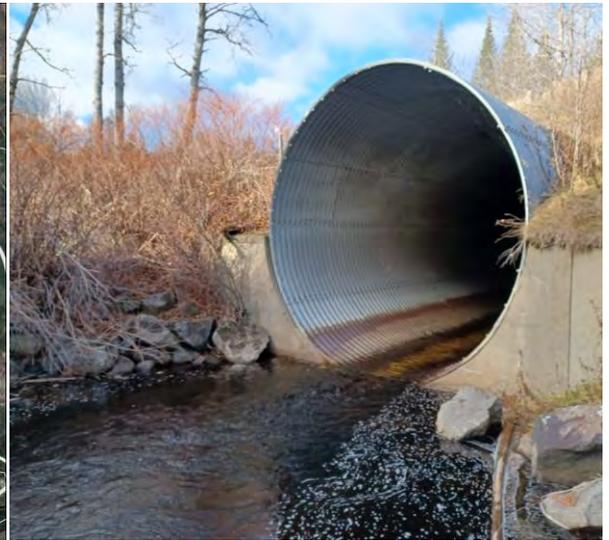
Figure 2: A large scour pool is present downstream of the culvert due to high water velocity from restricted flow. High water velocity also prevents fish passage upstream through the culvert.
