**STRUCTURAL AND ELECTRICAL ASSESSMENT OF
THE BENNINGTON BATTLE MONUMENT**

**PHASE II: COMPREHENSIVE STRUCTURAL &
MATERIAL TESTING AND EVALUATION AND
OUTLINE OF RESTORATION APPROACH**

15 MONUMENT CIRCLE
BENNINGTON, VT, 05201

PREPARED FOR:
VERMONT DEPARTMENT OF BUILDINGS & GENERAL SERVICES
BGS PROJECT ID #200016

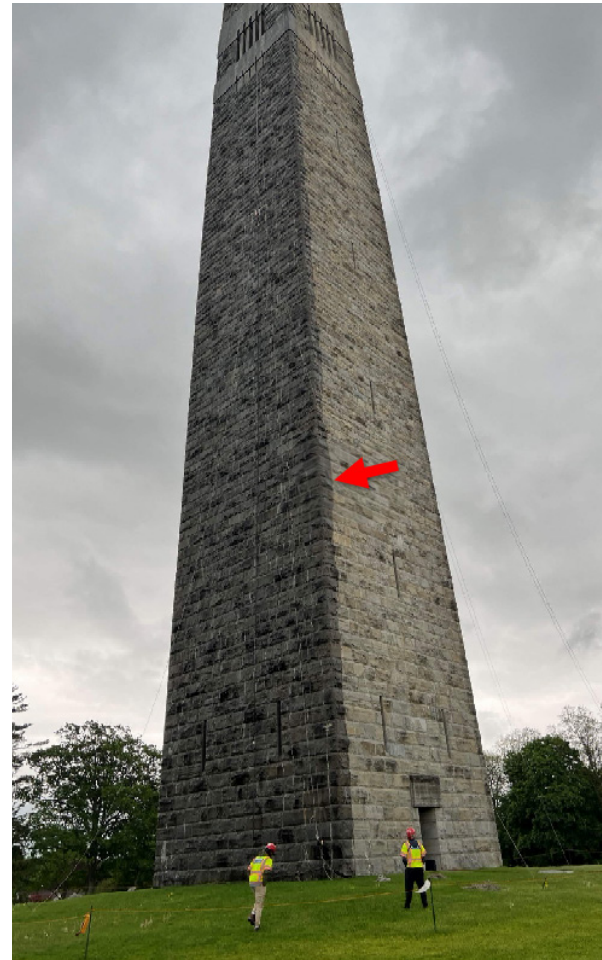
Image 27. North wall following rainstorm with the prevailing wind coming directly from the north. The monument largely blocked wind driven rain from the leeward walls, with a small amount of moisture being blown and wrapping around the corners of the monument creating a clear line of moisture approximately half the length of a stone unit to the East and West elevations.. Atkinson-Noland & Associates

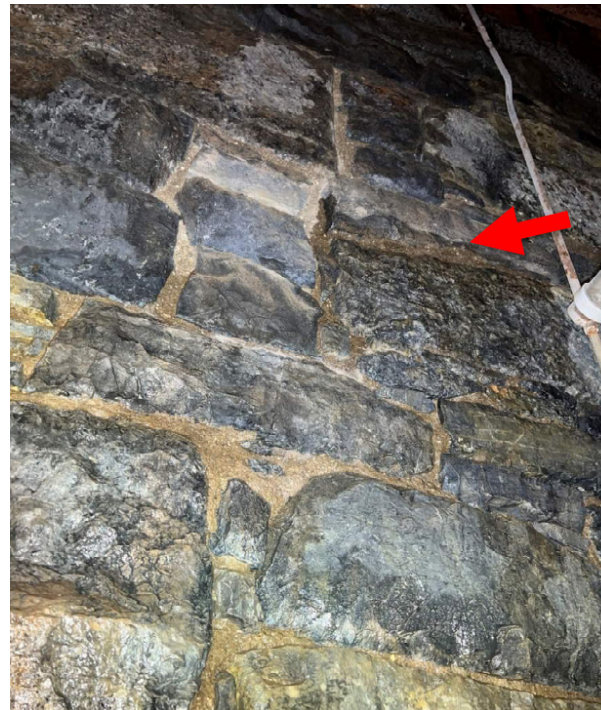
Image 25. Appearance of damp observed at mortar joint below interior stone work. Atkinson-Noland & Associates

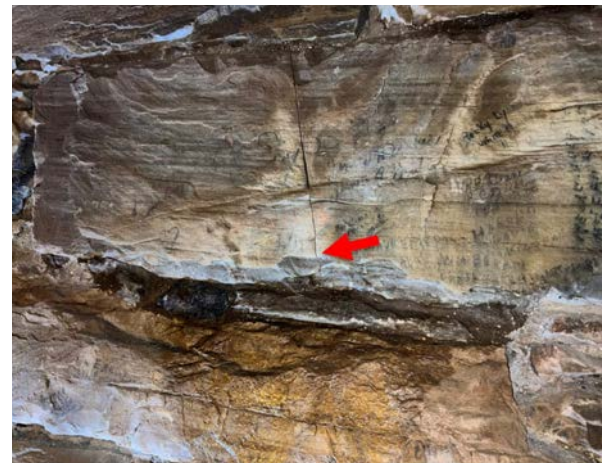
Image 24. Leak observed as a result of spray testing below crack at interior stone. Atkinson-Noland & Associates

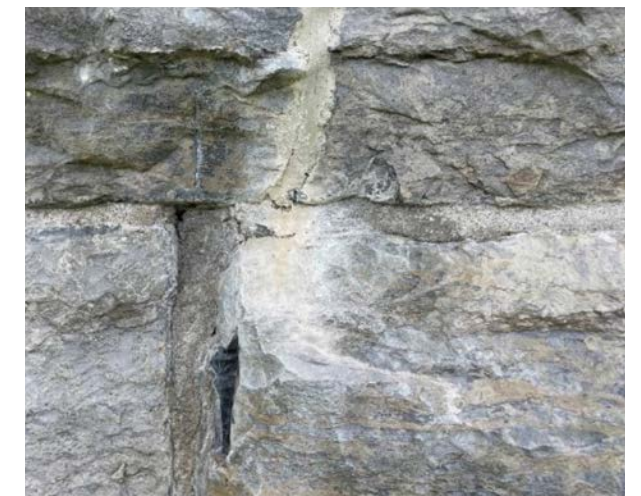
Image 29. Efflorescence and/or carbonate crusts below an earlier caulk repair. *Jablonski*

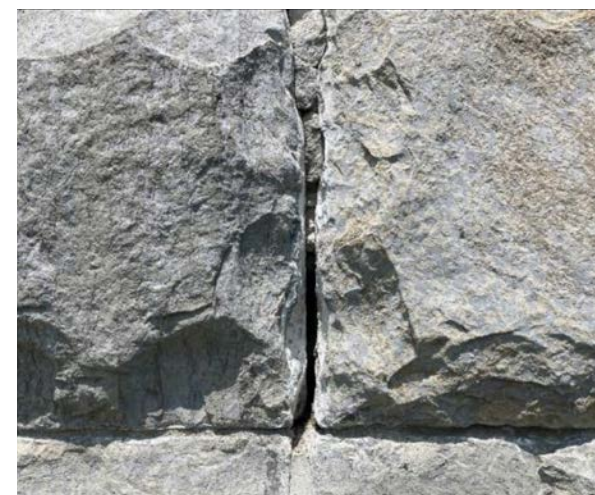
Image 31. Open joint near base of the monument. *Jablonski*

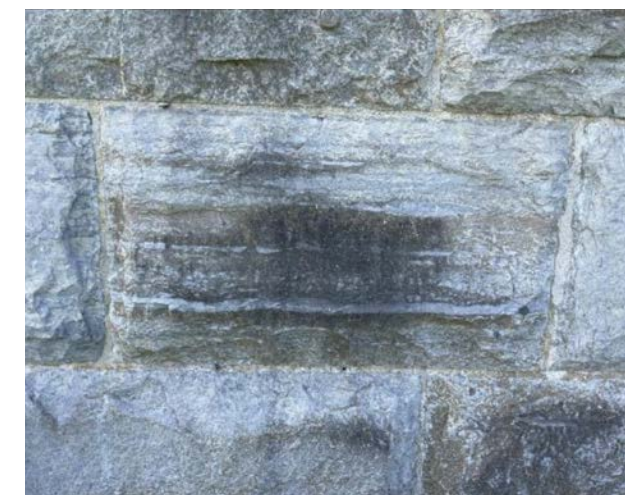
Image 28. Biological growth on surface of exterior stone. *Jablonski*

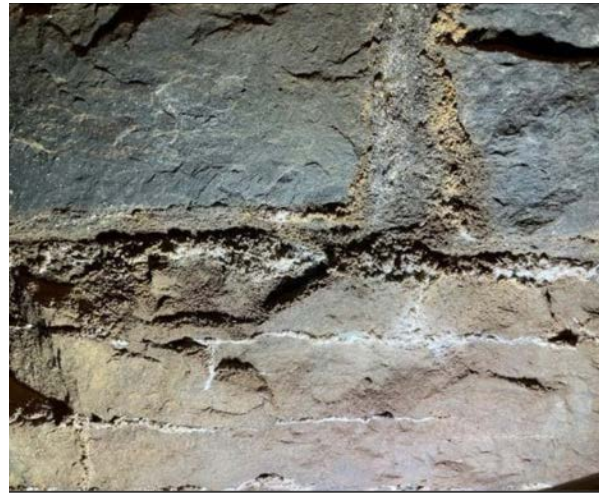
Image 36. Efflorescence and/or carbonate crusts along cracks and mortar joints. *Jablonski*

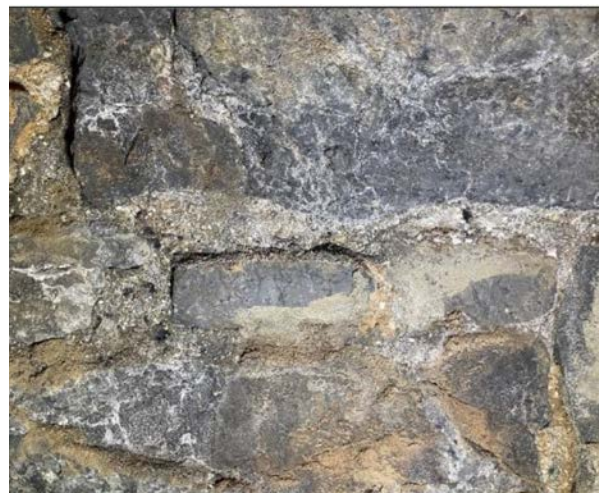
Image 35. Light efflorescence on the surface of the stone units and mortar joints. *Jablonski*

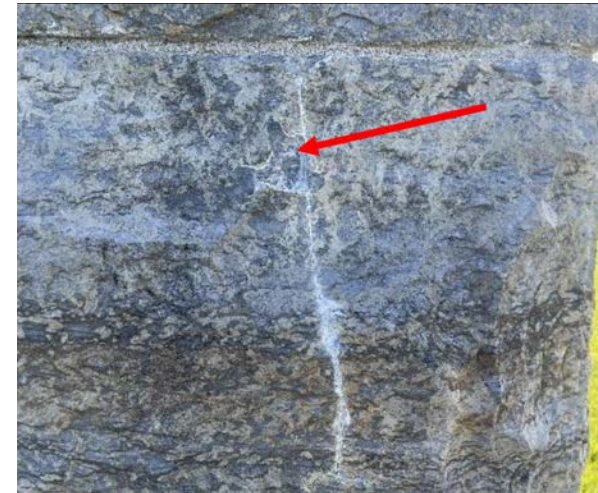
Image 45. Shallow spall. *Jablonski*

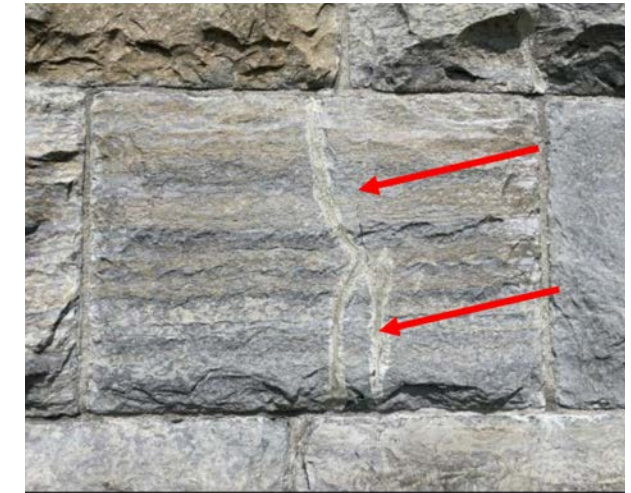
Image 42. Previously repaired crack and hairline crack extending from previous repair. *Jablonski*

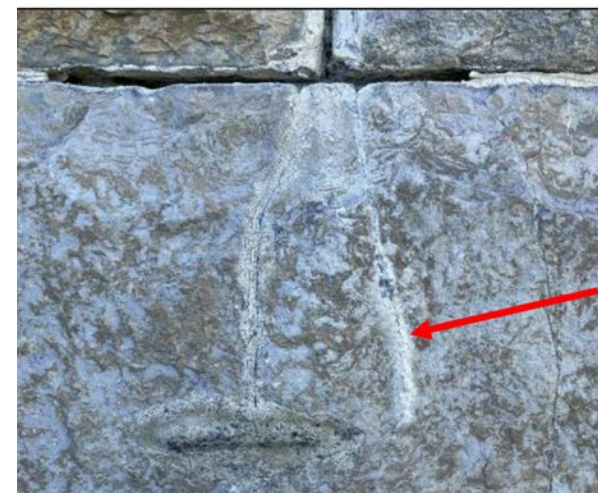
Image 44. White growth along hairline crack. *Jablonski*

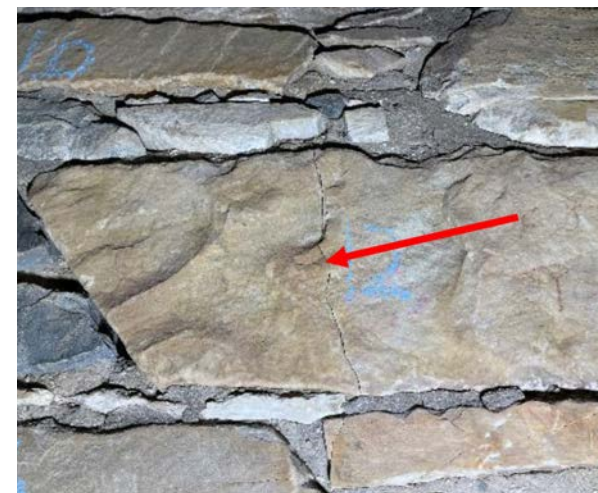
Image 43. Vertical crack. *Jablonski*

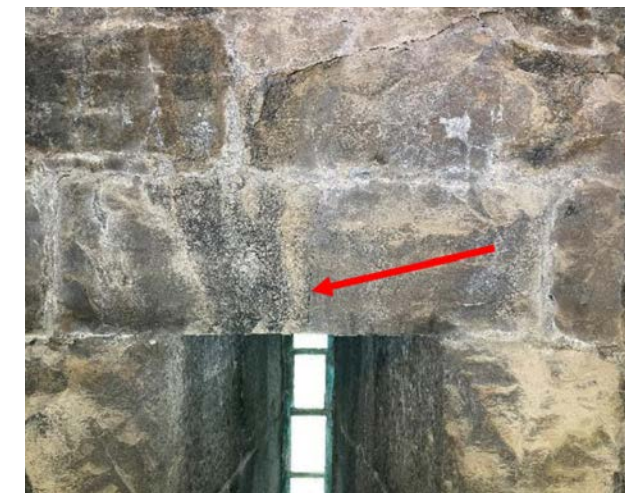
Image 40. Vertical crack running the full height of a window lintel. *Jablonski*

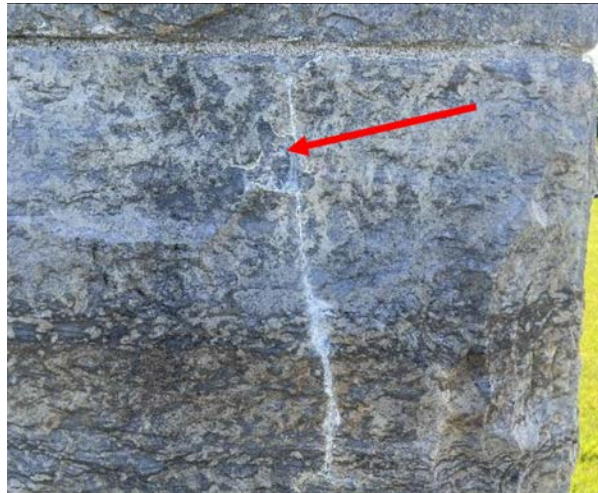
Image 51. Shallow spall. Jablonski

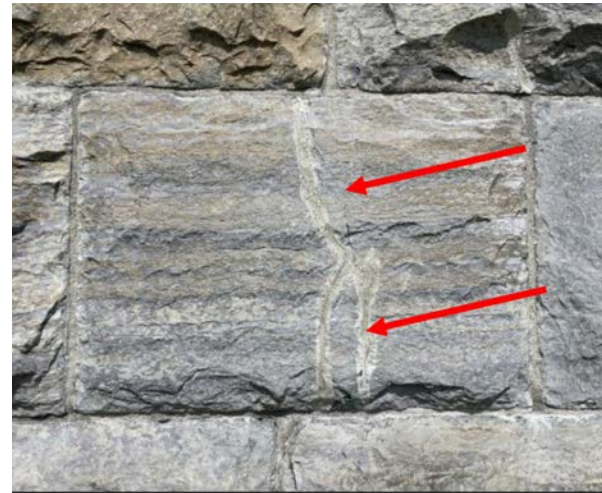
Image 48. Previously repaired crack and hairline crack extending from previous repair. Jablonski

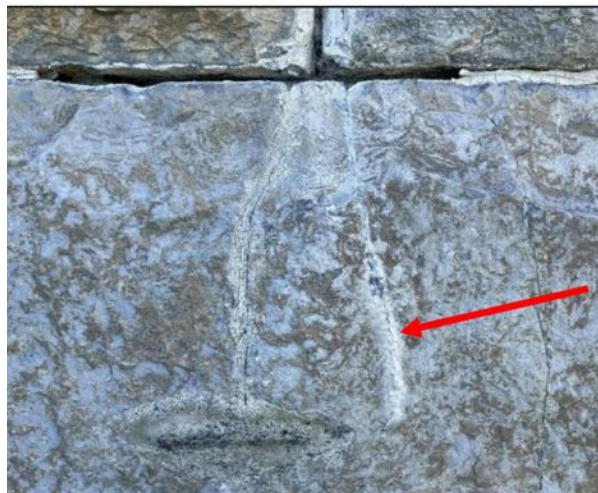
Image 50. White growth along hairline crack. Jablonski

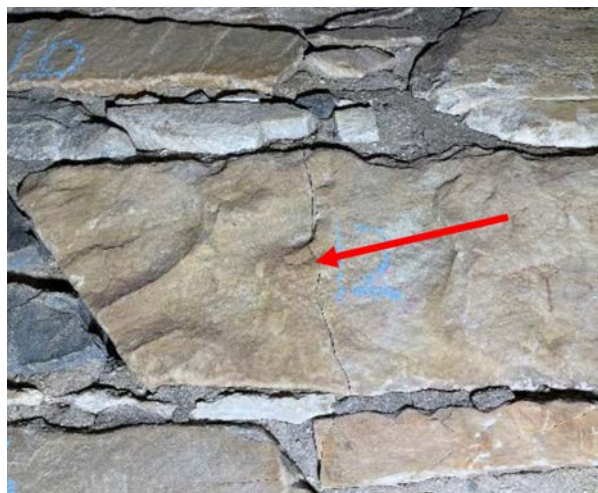
Image 49. Vertical crack. Jablonski

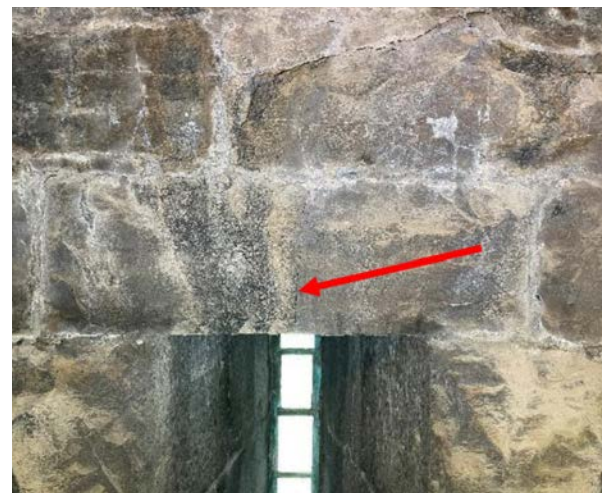
Image 46. Vertical crack running the full height of a window lintel. Jablonski

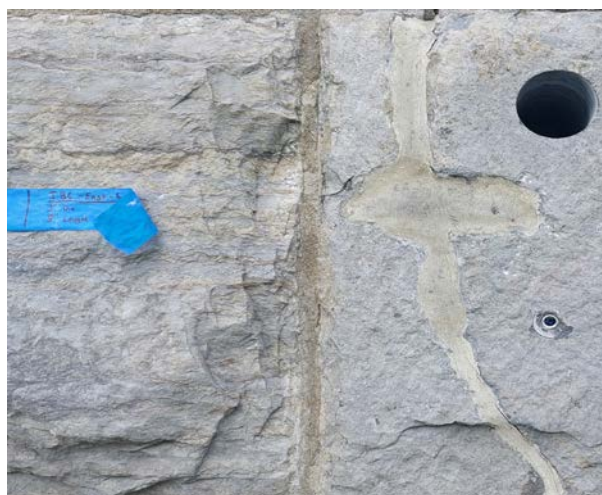
Image 74. Caulk repair and current core hole

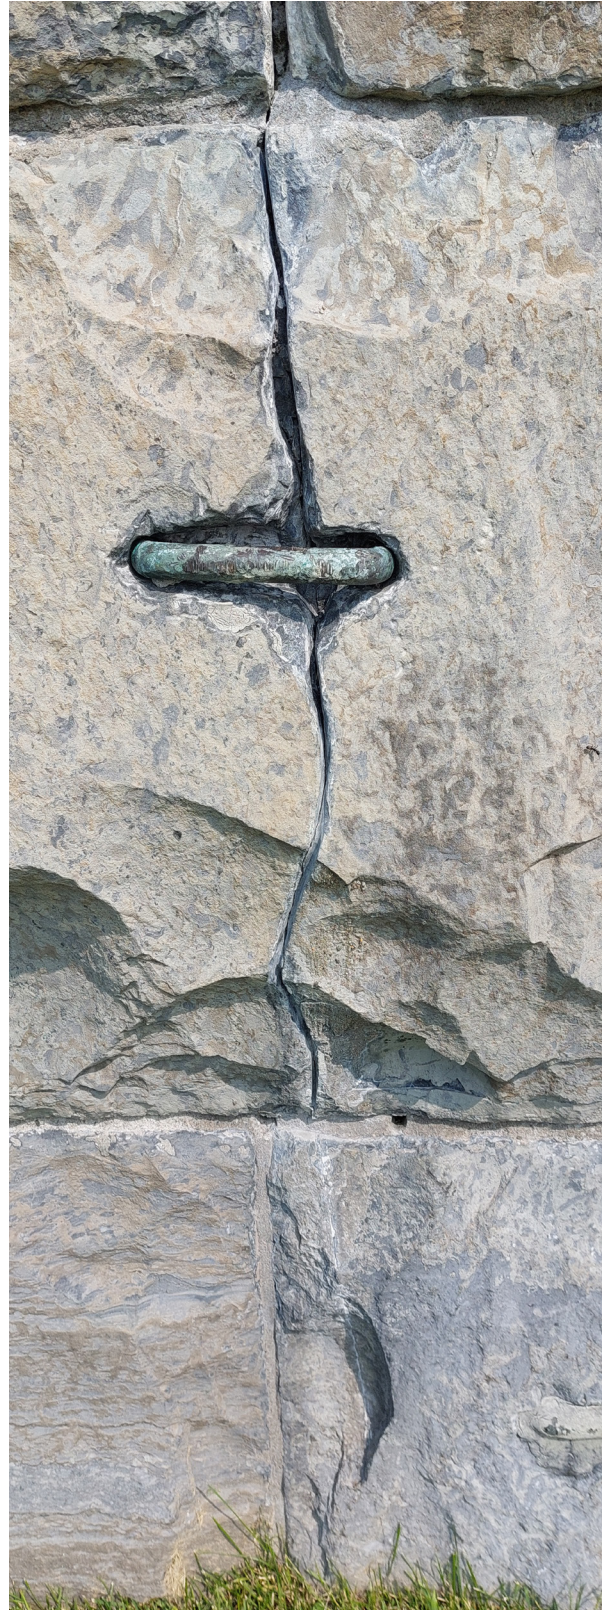
Image 75. Bronze staple condition through crack. *Easton Architects*

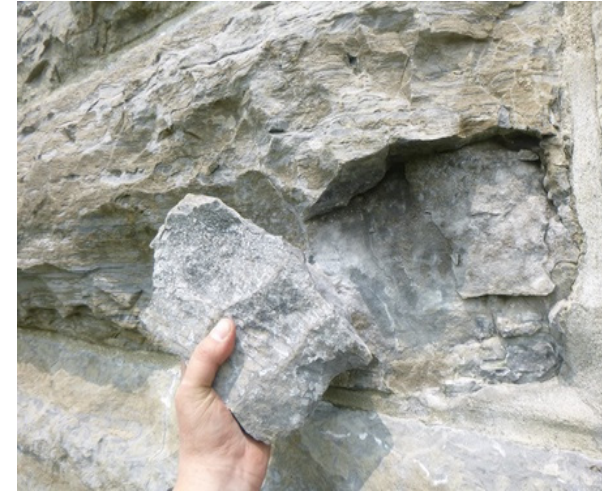
Image 79. Spall removed from the exterior stone masonry. *Vertical Access*

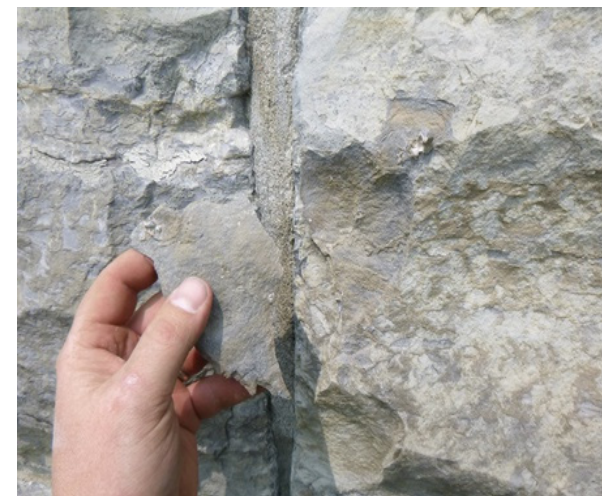
Image 78. Spall removed from the exterior stone masonry. *Vertical Access*

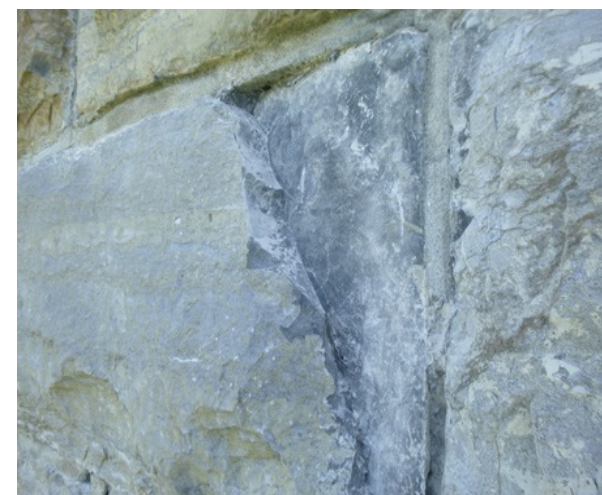
Image 76. Delamination in a stone at the upper portion of the monument. *Vertical Access*

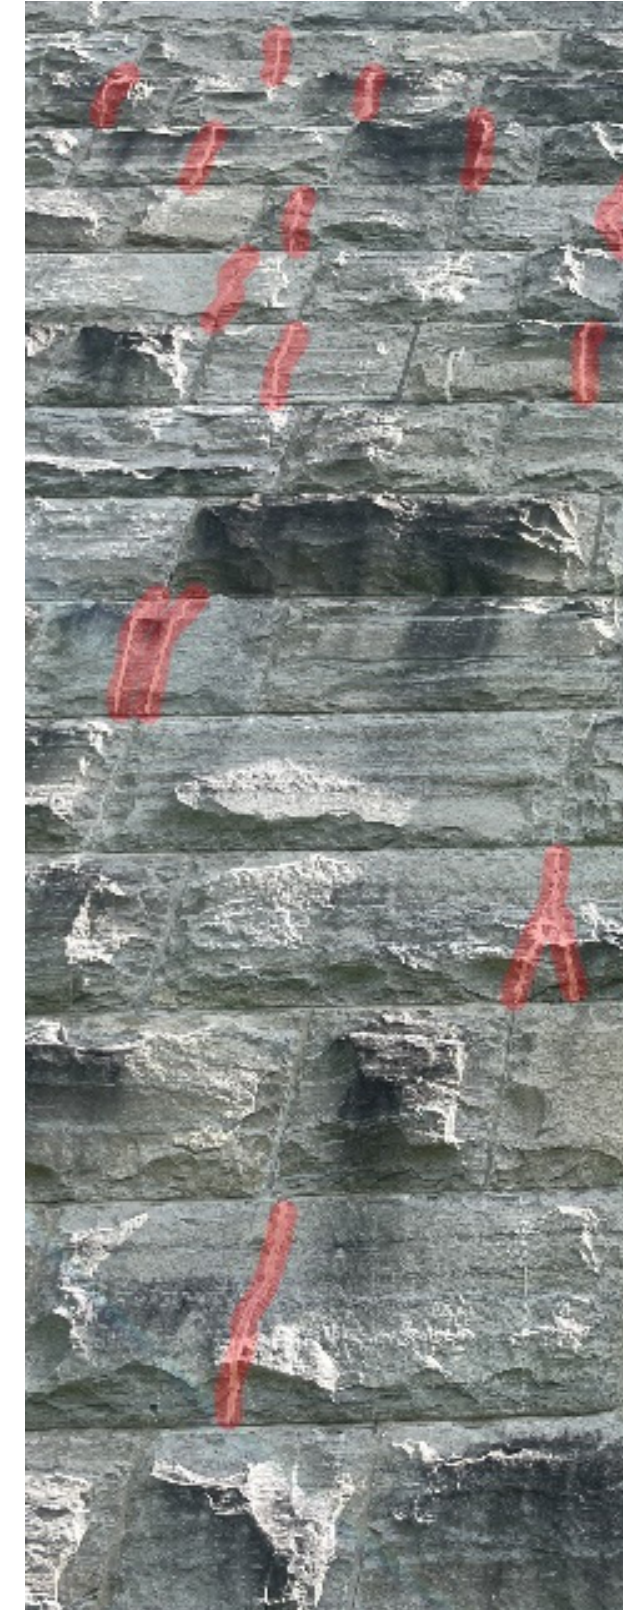
Image 77. Exterior of monument with cracks highlighted in red. Note that most cracks fall below a vertical mortar joint. *JBC.*

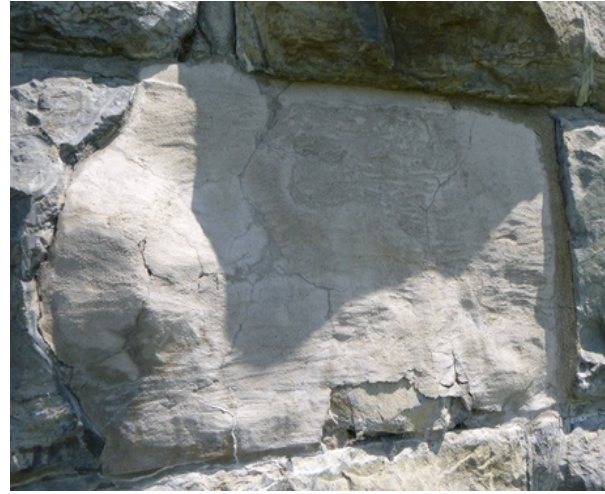
Image 84. Cracked and failed parge coat applied over the face of a stone. *Vertical Access*

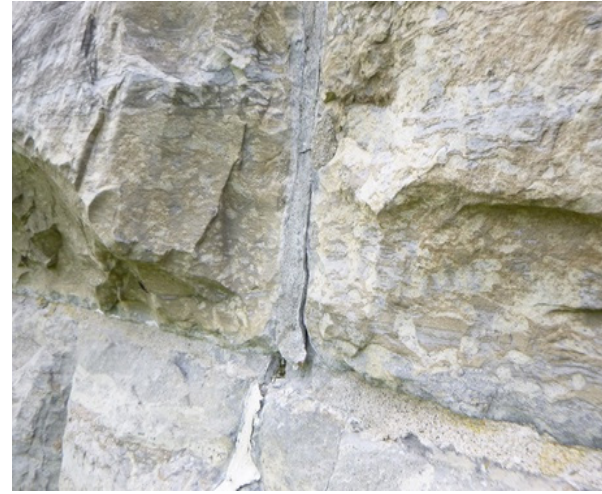
Image 85. Failed mortar joint at upper portion of monument. *Vertical Access*

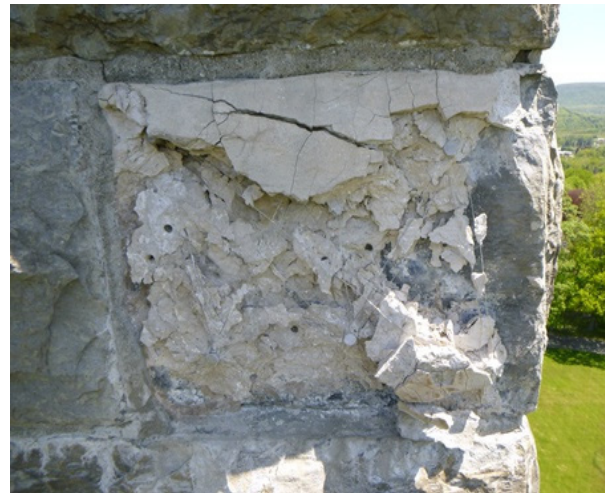
Image 82. Cracked and spalled cementitious patch repair. *Vertical Access*

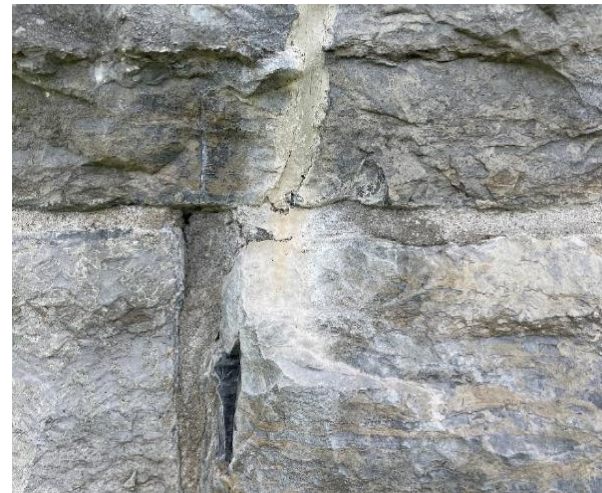
Image 83. Carbonate deposit (White material) below an epoxy crack repair. *Jablonski*

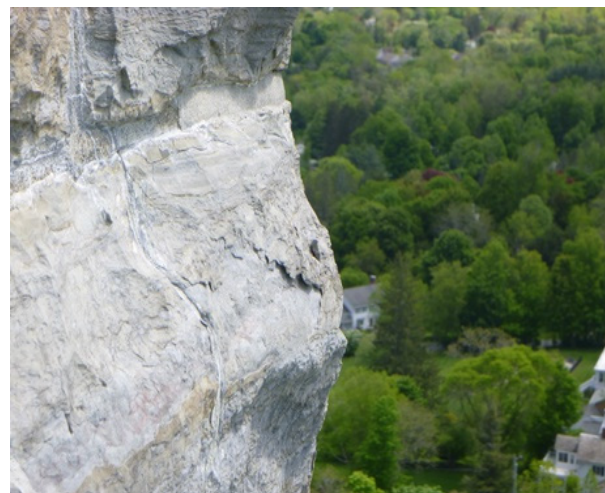
Image 80. Scaling in a stone at the upper portion of the monument. *Vertical Access*

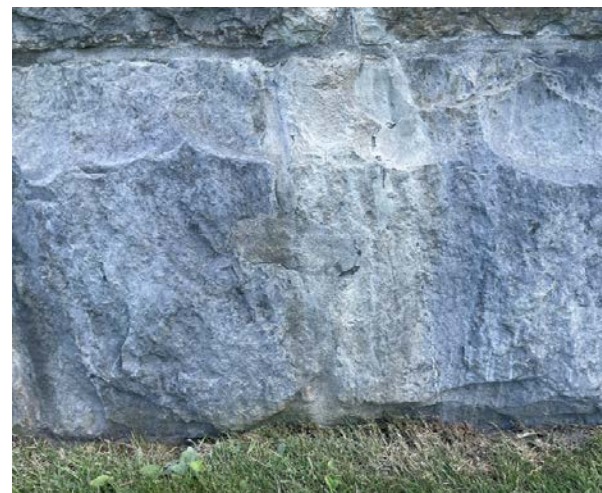
Image 81. Heavy accumulation of carbonate material leached from a cracked and deteriorated mortar joint. *Jablonski*

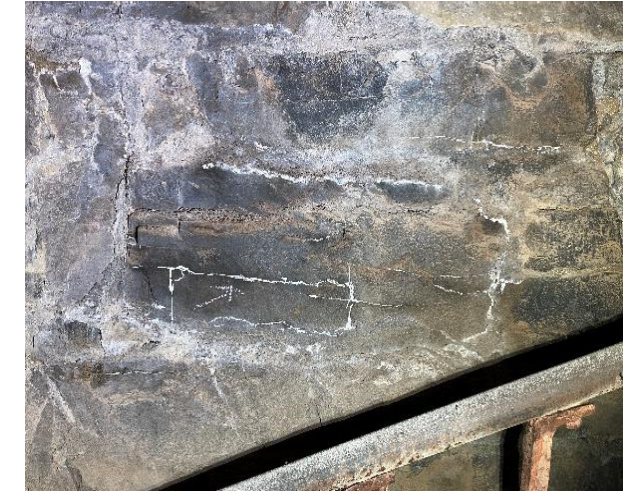
Image 90. Cracks creating an "alligatored" pattern, with white efflorescence along the cracks. *Jablonski*
