STRUCTURAL, ELECTRICAL,  
AND ELEVATOR ASSESSMENT  
OF THE  
BENNINGTON  
BATTLE MONUMENT  
OLD BENNINGTON, VERMONT

DECEMBER 22, 2023

STEVENS & ASSOCIATES, P.C.

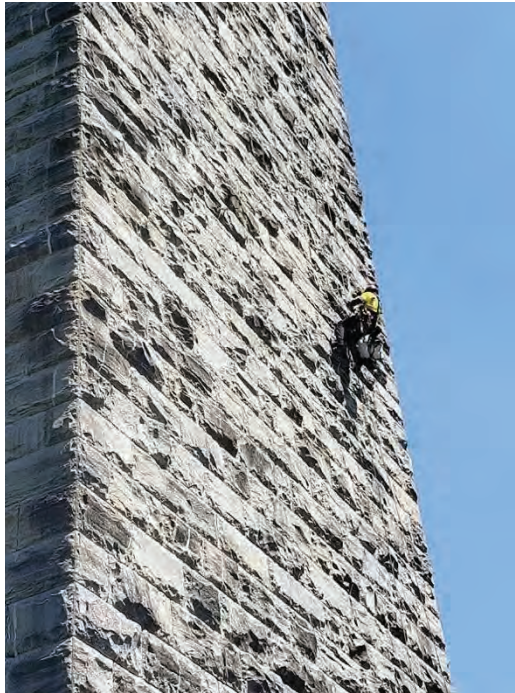
FIGURE 1

- **The interior and exterior stones of the Monument were visually observed, and the existing conditions documented.** The interior stone masonry was observed where walk-up access was available and interior elevations were annotated with observations. The exterior was observed and documented via industrial roped access performed by Vertical Access over the week of May 9th, 2022 (figure 1). Vertical Access documented the exterior conditions using their TPAS system that allowed them to accurately key photographs and notes to the CAD elevations created by the laser scan. One of the investigative "drops" on the west side of the south facing wall was live streamed to the project team on the ground and enabled the engineers to participate in the up-close examination of the stones and become familiar with the conditions that were being observed. The live stream session was recorded and will be provided digitally with the final report.

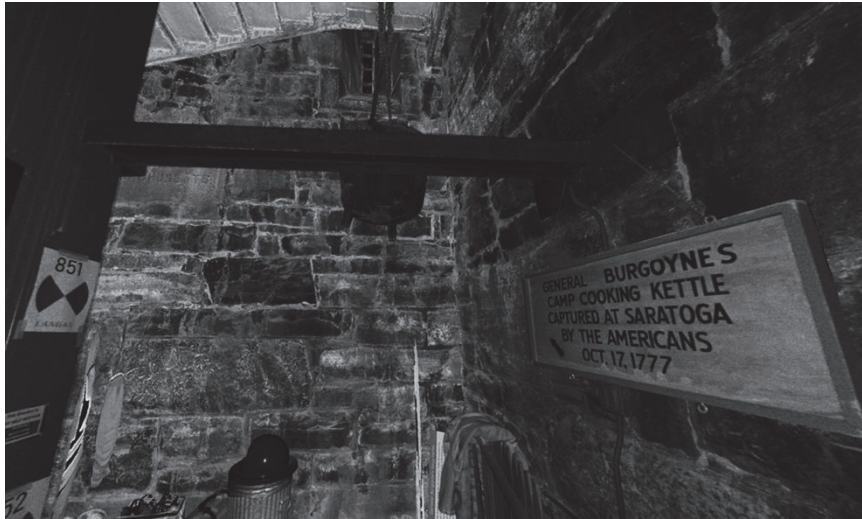
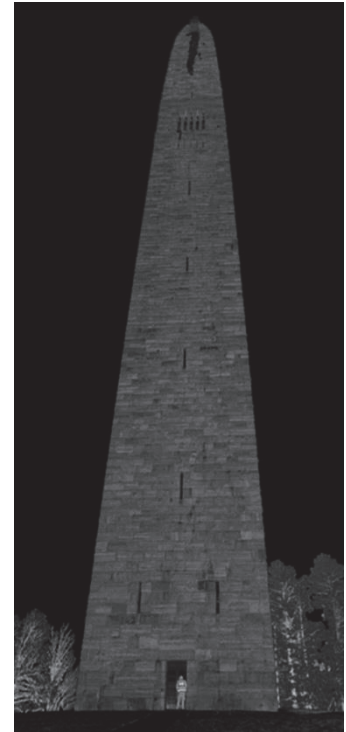
FIGURE 2

checked. Additionally, several plan sections were cut and overlayed to check for any bulging or warping in the horizontal cross sections of the Monument. This effort was necessary because such observations would be too subtle to notice visually from afar and too global to notice with close-up observation. (See figure 2 and 3)

- Overall, the Monument was found to be notably plumb and straight, well within expected construction tolerances. No significant leaning or bulging was observed.

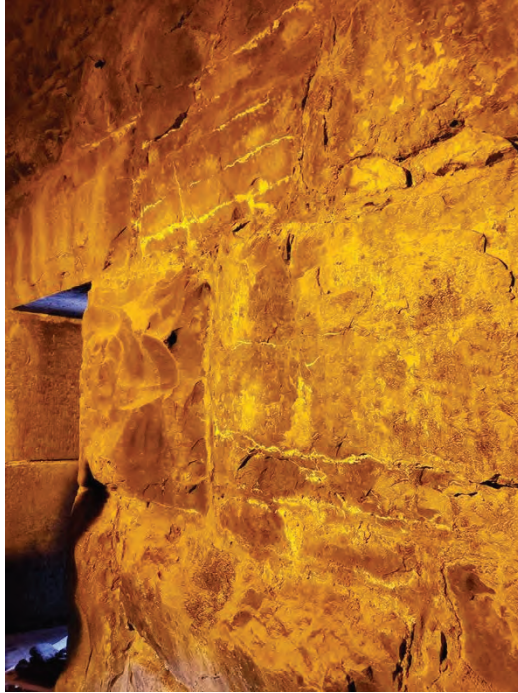
FIGURE 7

- Localized areas of a white horizontal efflorescence or leaching deposits were observed on several interior stones (figure 7). A core sample was attempted at one of these locations and crumbled upon removal from the parent stone.

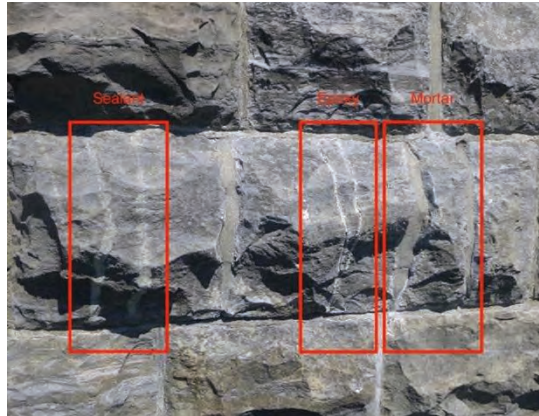
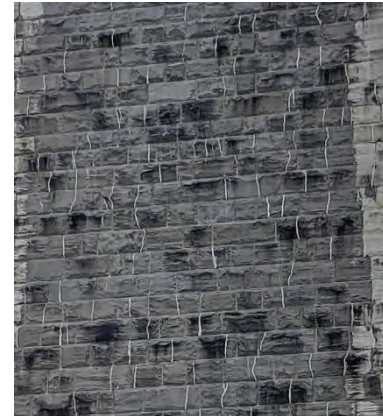
- The cracking of the exterior stones and the deterioration of the mortar joints is widespread on all four sides of Monument (figure 8 and 9). The south and west faces of the Monument have the most cracked stones and most prevalent surface loss (exfoliation). This may be due to these elevations being subject to the prevailing winds and harshest weather, as well as longer exposure to solar energy. Many of the cracks have been previously repaired, typically by covering the cracks with a bead of sealant. Other crack repairs include cementitious mortar repairs in wider or routed out cracks, and epoxy injection repairs in narrower cracks (see figure 8 for examples of different repairs). Many of the unrepaired cracks that were observed were less than 1/16 of an inch wide. It is believed that most of the existing repairs date from the 1990-91 restoration campaign. Many of the observed cracks on the north and east facades have been previously repaired.

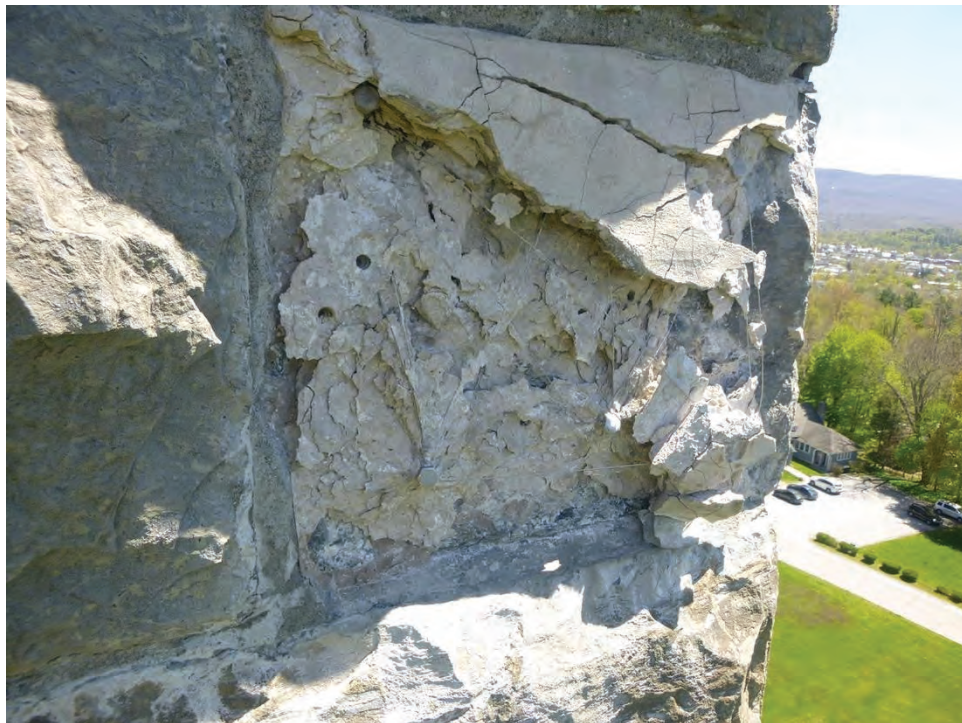
FIGURE 10

- There are currently hazardous conditions involving sizable pieces of stone and loose material from failed patch repairs that are loose and could fall. Vertical Access noted these conditions as Priority 1 and made an effort to remove loose material, but potentially dangerous pieces remain (figure 10).

**The Priority 1 conditions noted in VA's report should be repaired as soon as possible**, and we recommend that the State establishes temporary protective measures. It should be considered to have VA remove all of the potentially loose materials. We anticipate additional masonry materials may continue to fall off the monument as additional weathering occurs, and this should be monitored.

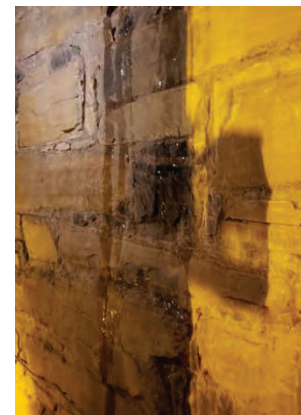
FIGURE 15

- In general, the upper half of the Monument typically had more signs of moisture than the lower elevations. An exception being that the below grade basement walls were observed to be damp in all visits, and especially damp in the fall and spring visits. In the winter, a large area of ice was observed along the middle of the south wall below the sub-observation level and extended multiple landing heights down (figure 15).

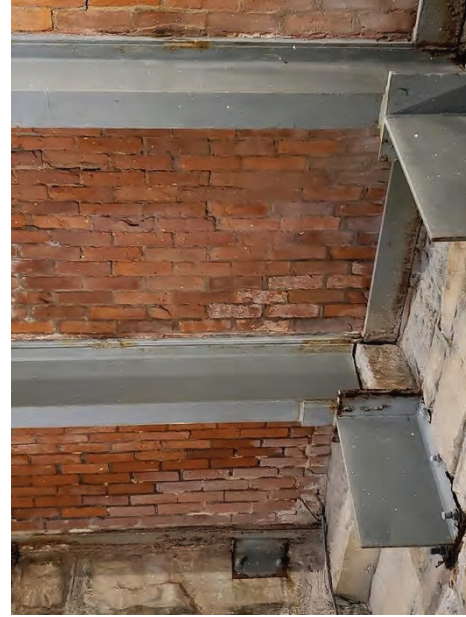
FIGURE 20

- The Observation deck, Level C, is comprised of framing from two eras (figure 20). The original construction still exists and is comprised of metal I-shaped beams with brick arches spanning between the bottom flanges of the beams. The arches support an original stone slab floor that has since had a poured concrete topping slab added. Only the very bottom flanges of the original steel beams are visible, and the remainder of the beams are concealed within in the brick and mortar. In the late 1980s the slab was cored in two locations exposing the top surface of the original beams, which were observed to be rusted. In 2005, new steel beams were added directly below the original steel beams and secured to the stone walls. The newer framing is still in fair to good condition, though the coatings are beginning to fail. The heaviest rust was observed at the support locations of the newer beams along the stone walls. The original steel framing is still rusting but has functionally been abandoned other than for supporting the brick arches. The brick arches are chipping and spalling, likely due to moisture related processes.

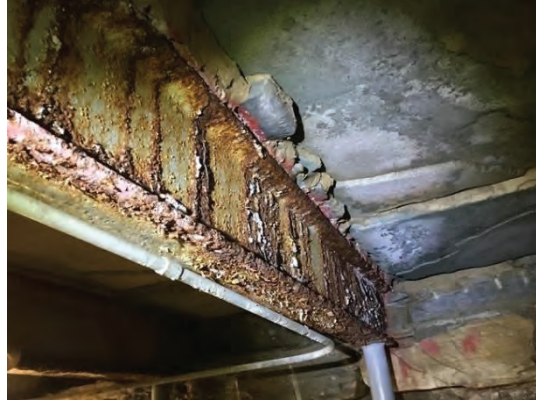
FIGURE 21

- The lobby framing consists of steel beams spanning in the north south direction supporting large stone slabs (figure 21). The coatings on the beams appear to be newer, similar in color to the coatings known to have been applied in the late 1980s and 2005. The coatings have failed on many of the beams. Several newer steel posts have been installed near the ends of the floor beams; this is from the work in 2005. The reason for the posts appears to be to add redundant support at the beam ends that are embedded into the stone walls and were observed to be heavily rusted.

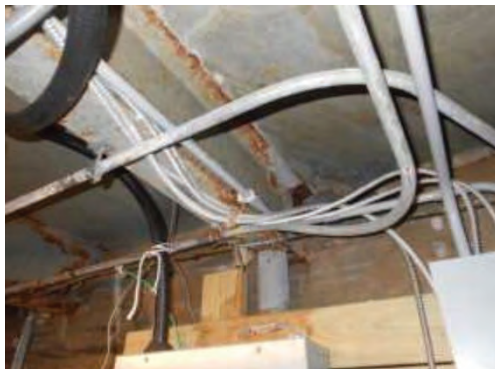
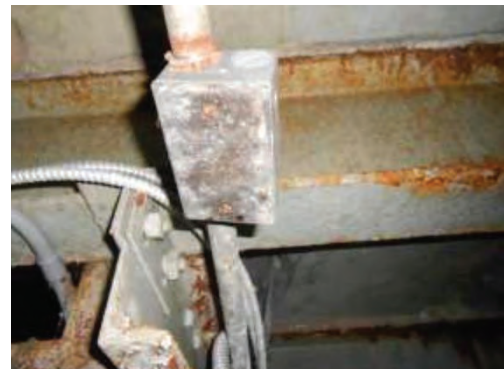
- There are several different wiring and conduit systems throughout the remainder of the Monument. The observed systems include electrical metallic tubing (EMT), rigid galvanized steel (RGS), polyvinyl chloride conduit (PVC), SO cord, liquid-tight flexible conduit, and both jacketed and un-jacketed metal clad (MC) wiring. In general, a number of the wiring installation methods lack good workmanship. The conditions of the existing systems vary from serviceable and good, to rusted, deteriorating, and abandoned. Many of the electrical wiring junction and device boxes - and associated conduits and wiring fittings - are corroded and rusted (figure 29A and 29B).
