5. State House Dome & Ceres Restoration and Renovations \$300,000

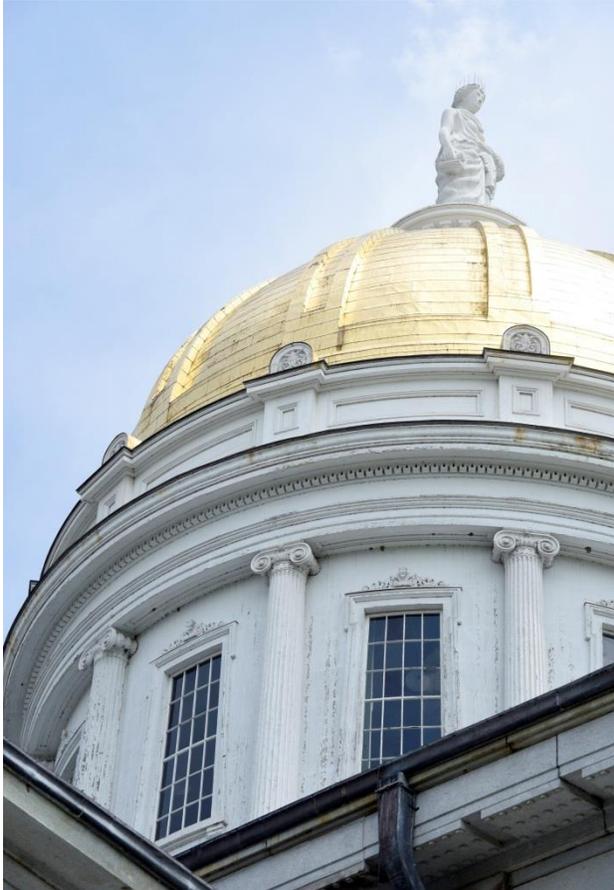
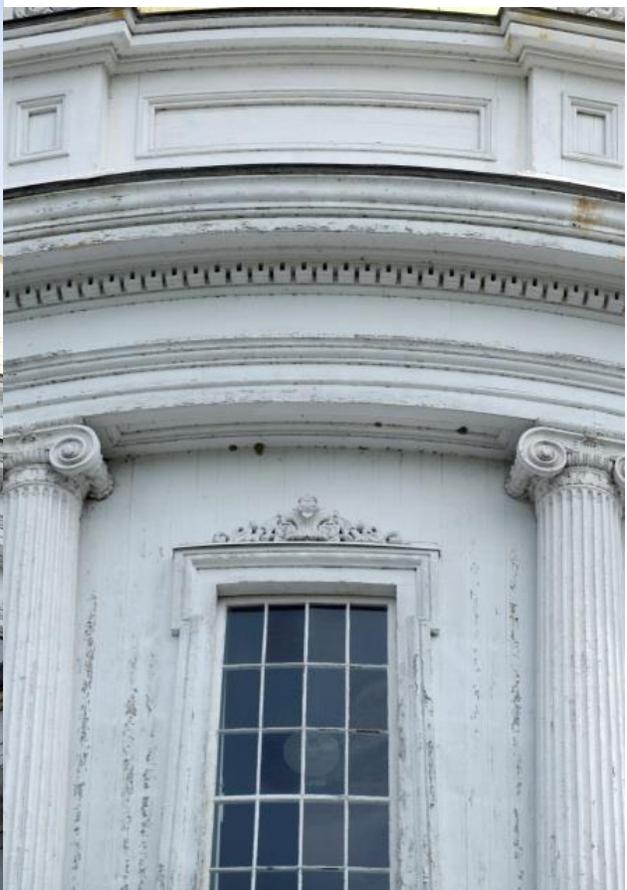
The paint finishes of the drum were last restored in 1999, but due to continuing exposure to the elements, it once again needs to be repainted. The wooden statue of Ceres, carved from Ponderosa pine, has crowned the dome since 1938. In 2001 the statue underwent significant consolidation repairs and refinishing (see bottom left photo), but at the time we were cautioned that the interior supports for the statue were failing. We know that if we intend to save this important work of art, its interior will need structural consolidation. All of this work is proposed to be done in one season due to scaffolding requirements, project efficiencies and the overall impact of the project on the Capital Complex.

2016 Photos of Statue, Dome, & Drum

Deteriorating Condition of Drum & Windows

Our Capital request of \$300,000 for FY’19 will allow us to develop construction documents and pursue pre-construction services in the fall of 2018, and erect scaffolding in the spring of 2019. Restoration work would commence as soon as the 2019 session concludes and the FY’20 funding is available.

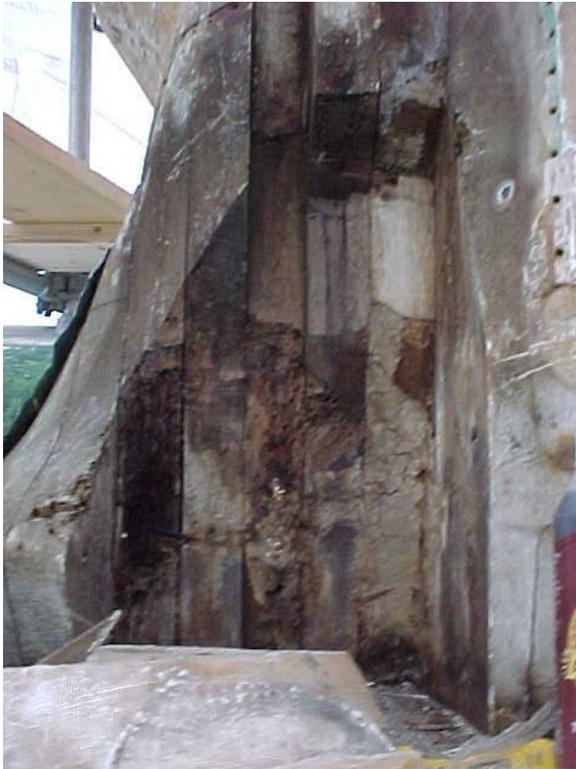
2002 Rot Removed at Base of Statue

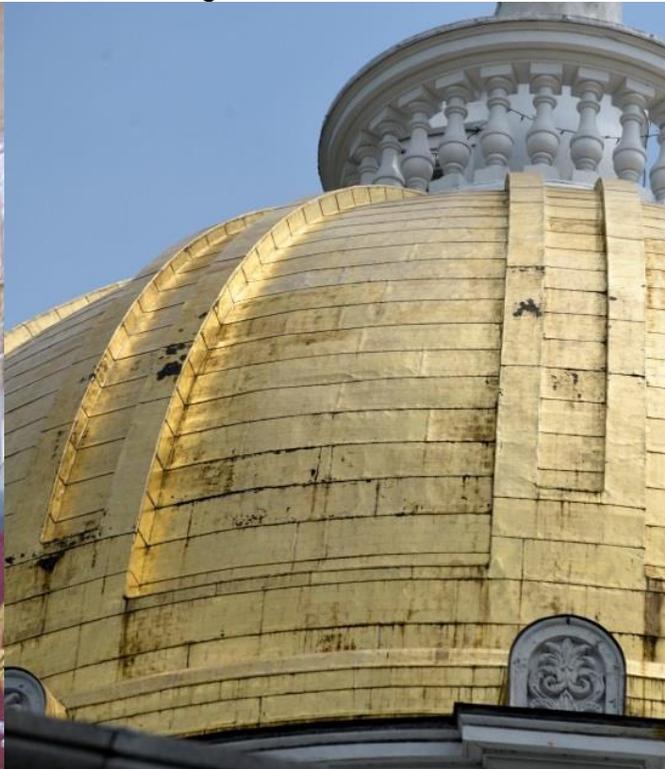
It has been 41 years since the State House dome was last regilded (see 2nd page of photo below taken in 1976). It is remarkable, in fact, that the gilding has lasted this long, and has not shown significant failure until recently, as seen in the photo on the right below. Since the very first gilding in 1906, the dome typically was regilded every 20 years until 1976.

2016 Photo of Failing Dome Gilding

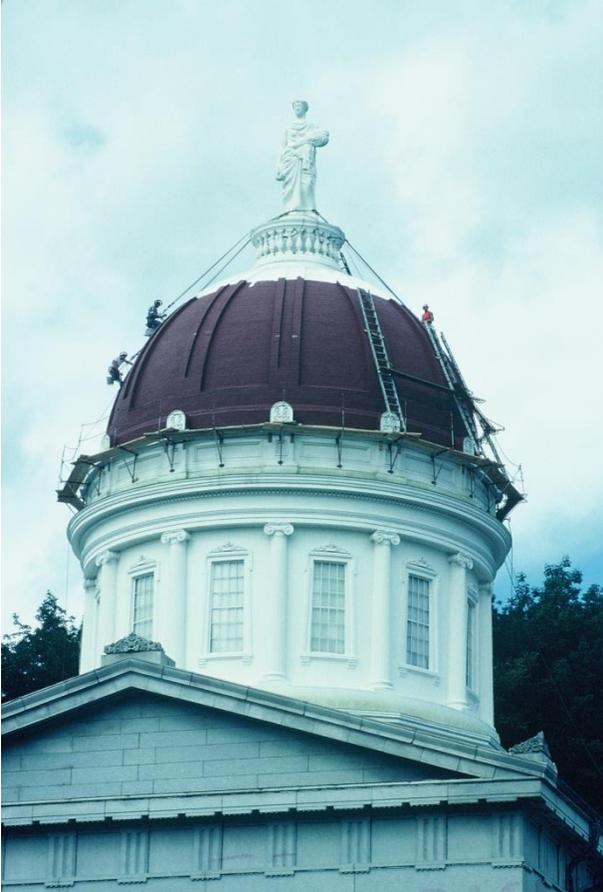
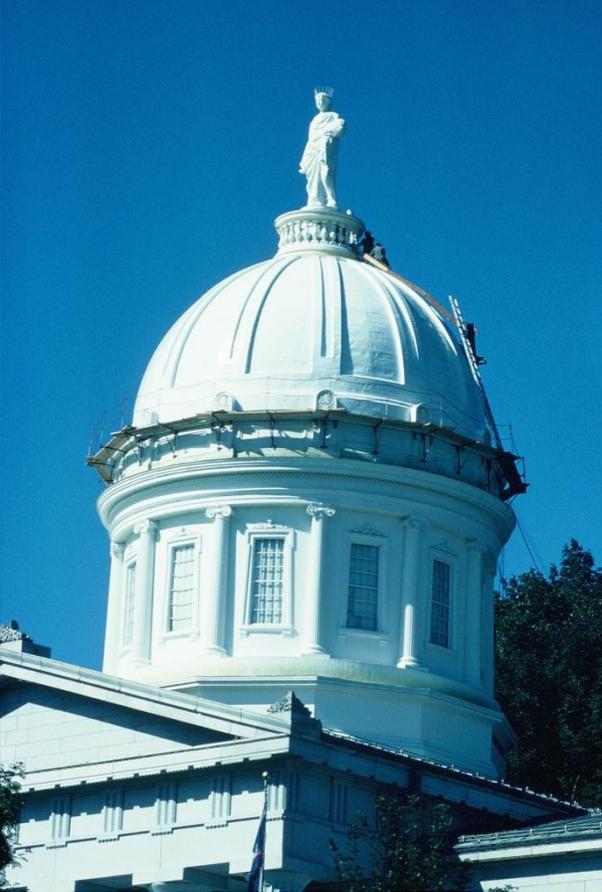
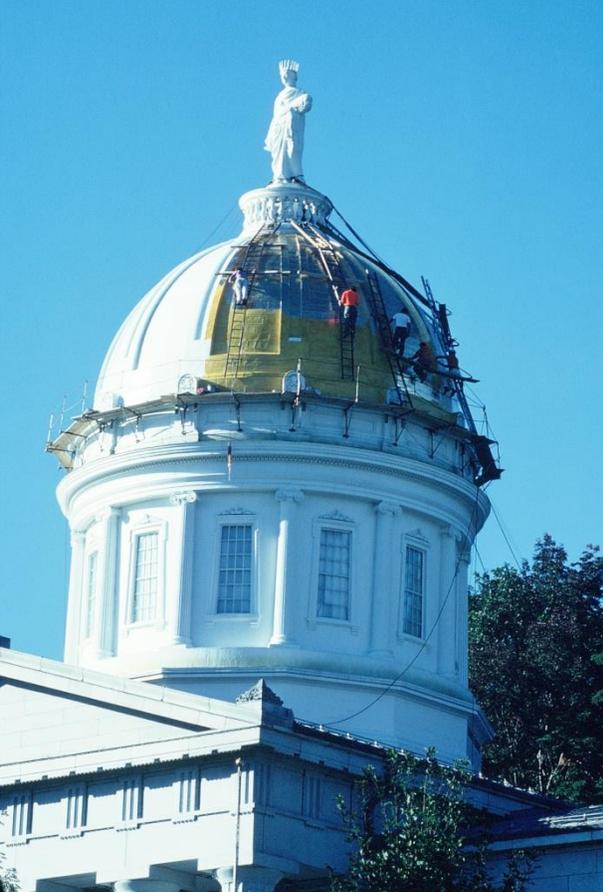
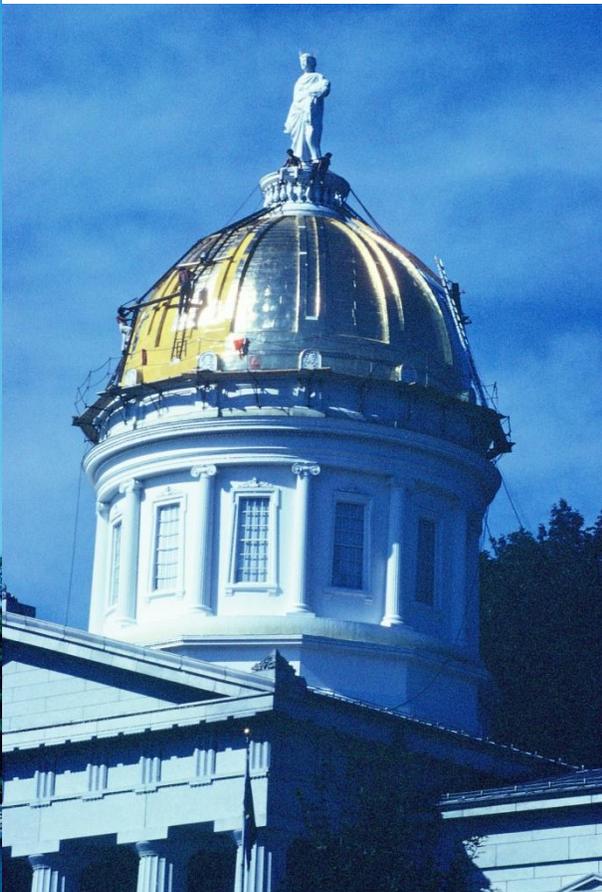
1976 Photos of 100% Regilding of Dome
