Melrose Terrace Floodplain Restoration

Jessica Louisos, PE, MS
Senior Water Resource Engineer

Prepared for Senate Committee on Economic
Development, Housing & General Affairs

October 19, 2023

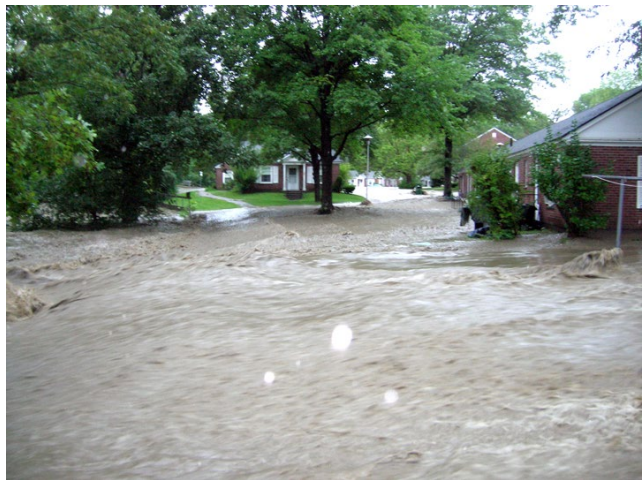
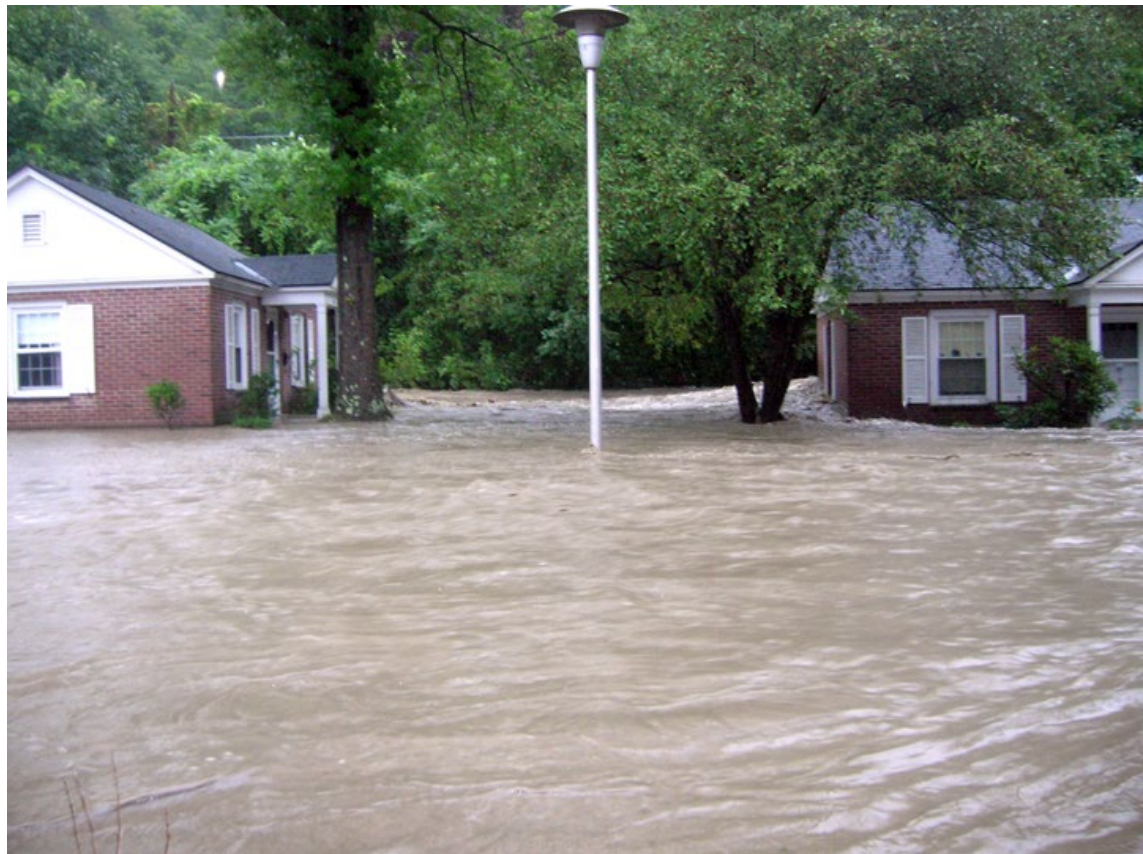
Damage from Tropical Storm Irene

Housing flooded & evacuation needed

- Water jumped river bank and travelled behind and between buildings

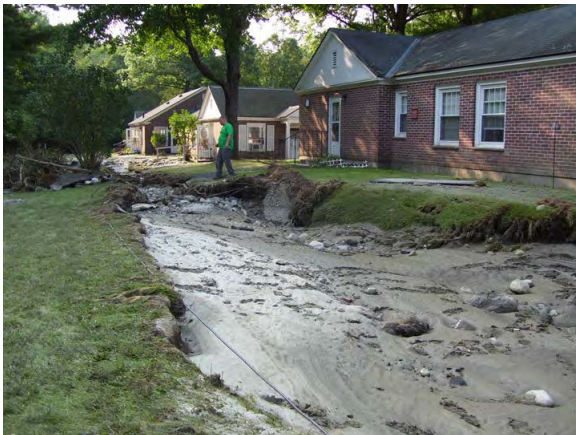
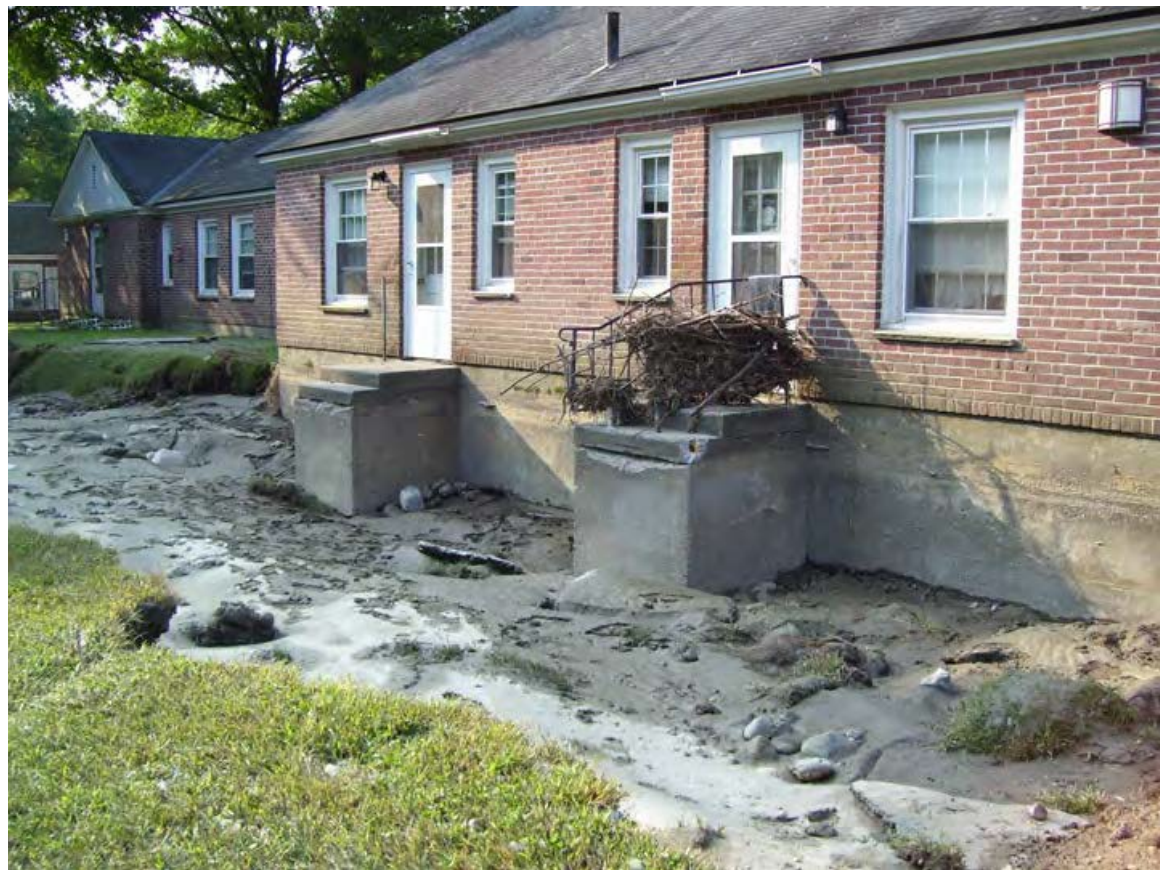
Damage from Tropical Storm Irene

Significant damage to buildings, roads, property

- Volume & velocity of water caused erosion and scour
- The most damage was not closest to the river

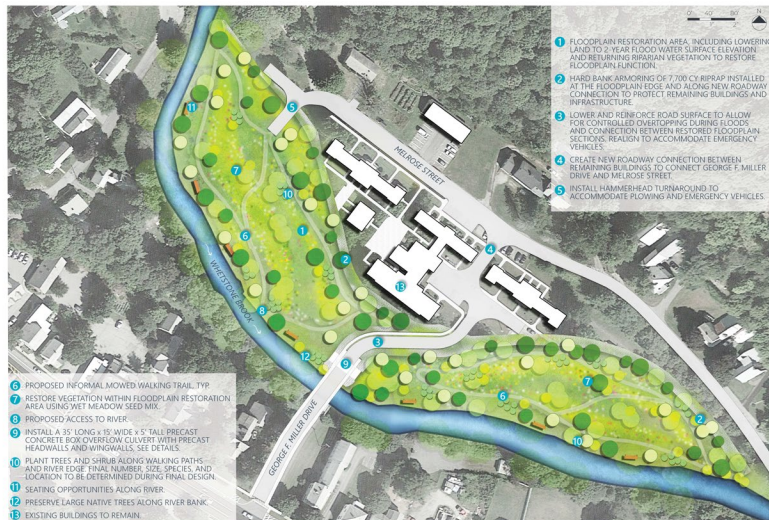
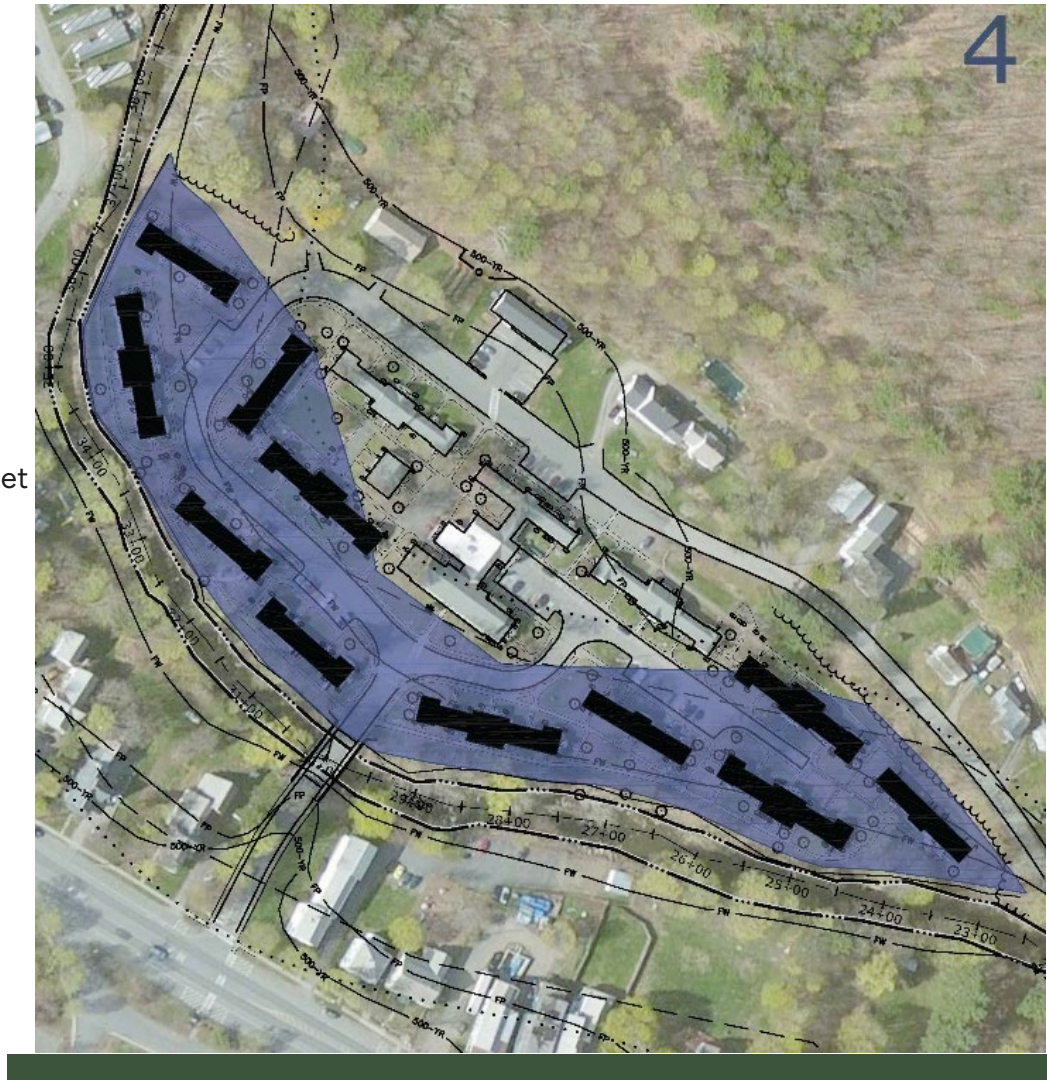
Removing buildings & people & infrastructure from most vulnerable locations

- Remove 11 buildings
- Relocate road
- Relocate sewer main / utilities

Increase floodplain storage capacity

- Remove 28,000 CY fill in floodplain & lower land average 5 feet
- Plant restored 4.4-acre floodplain with native vegetation

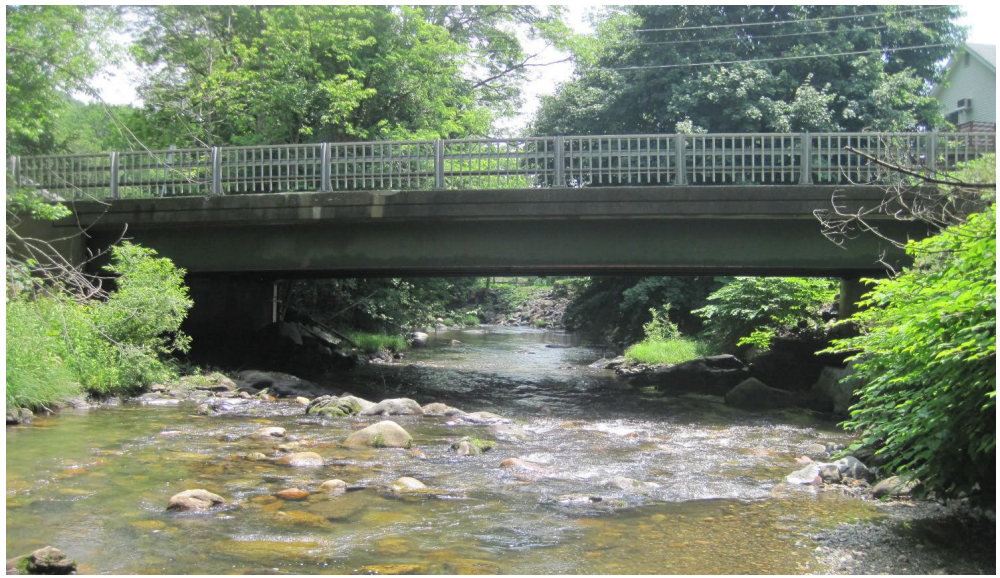
Bridge capacity improved

- Overflow culverts
- Lower road embankment to allow to overtop – road will flood before buildings and before bridge damaged
- Storms >25-year flood had overtopped
- Backwatering raised water 5.5 feet upstream for Irene flood

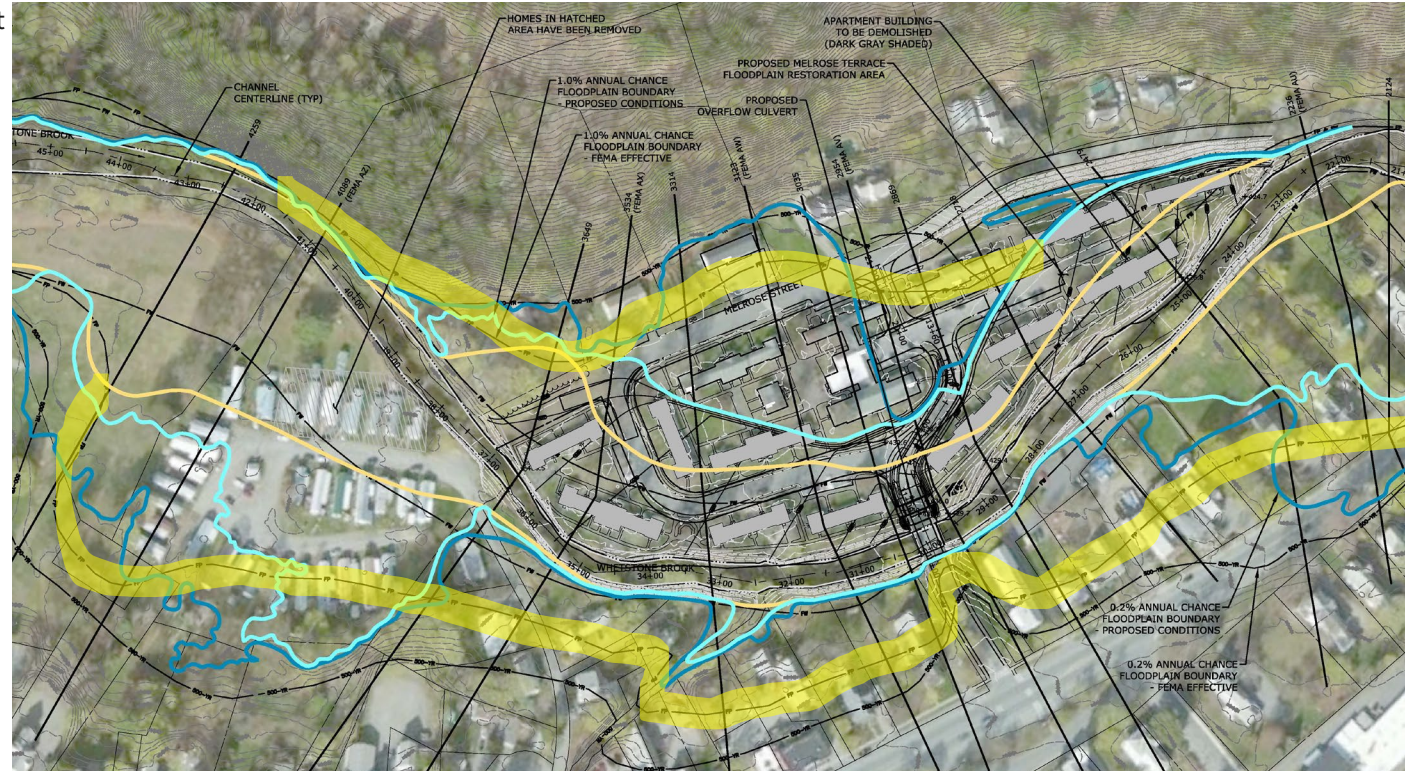
Flood Reduction

- Remaining onsite buildings removed from floodplain
- Reduced flooding across river and upstream
- Irene flood size water elevation reduced:
 - Glen Park = 1.9'
 - Upstream GF Miller = 2.9'
 - Downstream GF Miller = 1.1'
 - Melrose Street = 3.0' - 7.0'
- Flood storage and debris catchment may reduce damages downstream

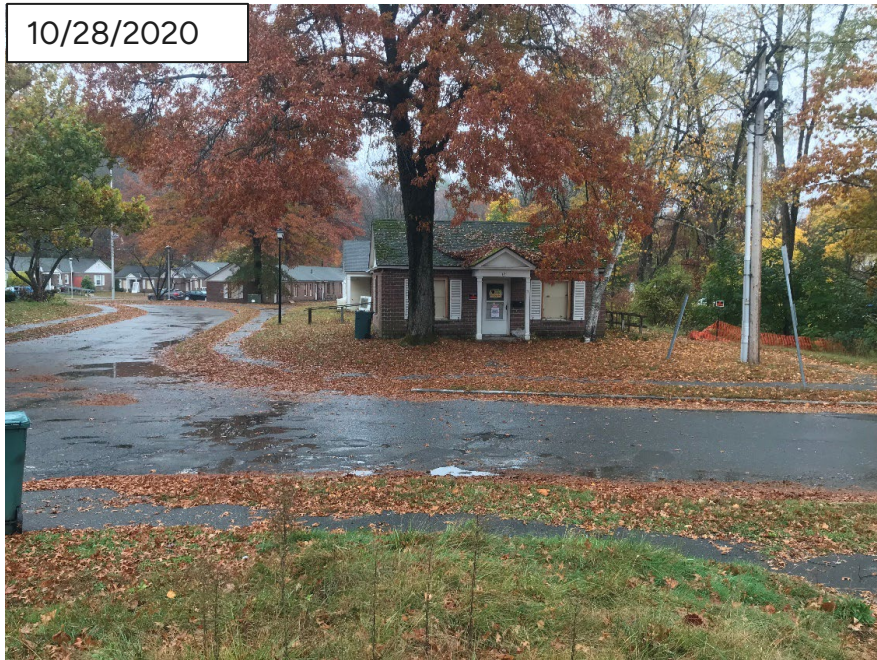
10/28/2020

Melrose Terrace – Completed Project

Pre-construction

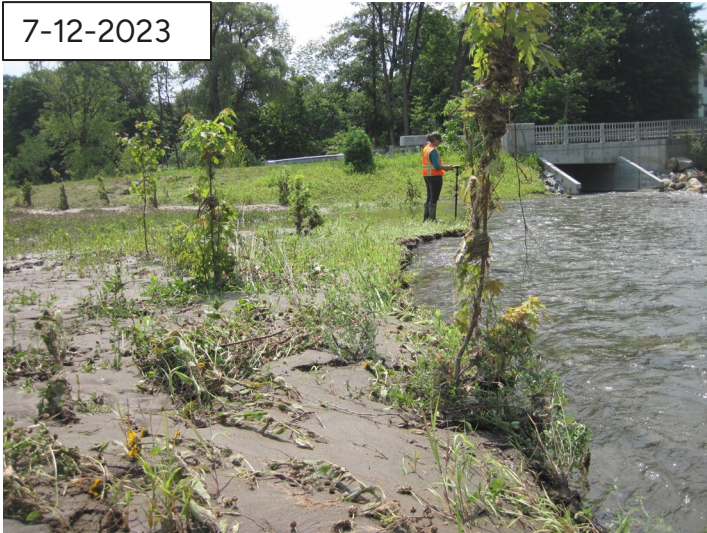
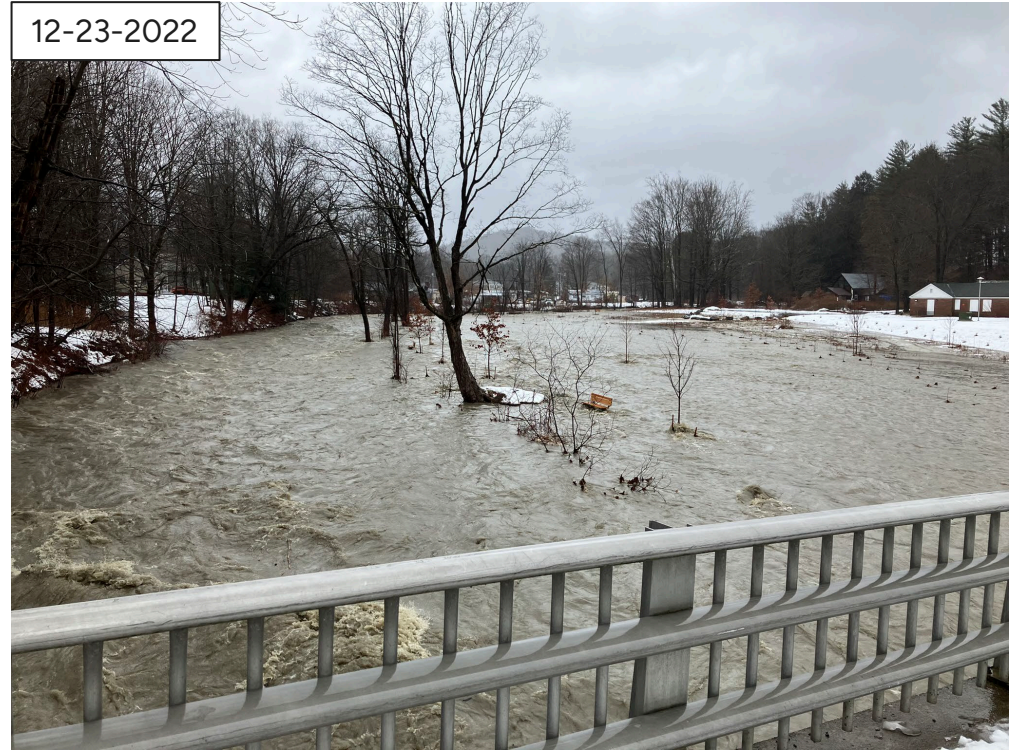
River using floodplain

- Meander bend created on upper floodplain, where previously straightened
- River accessed floodplain 4 times
- Flows are slowed, depositing sediment and reducing erosion capacity

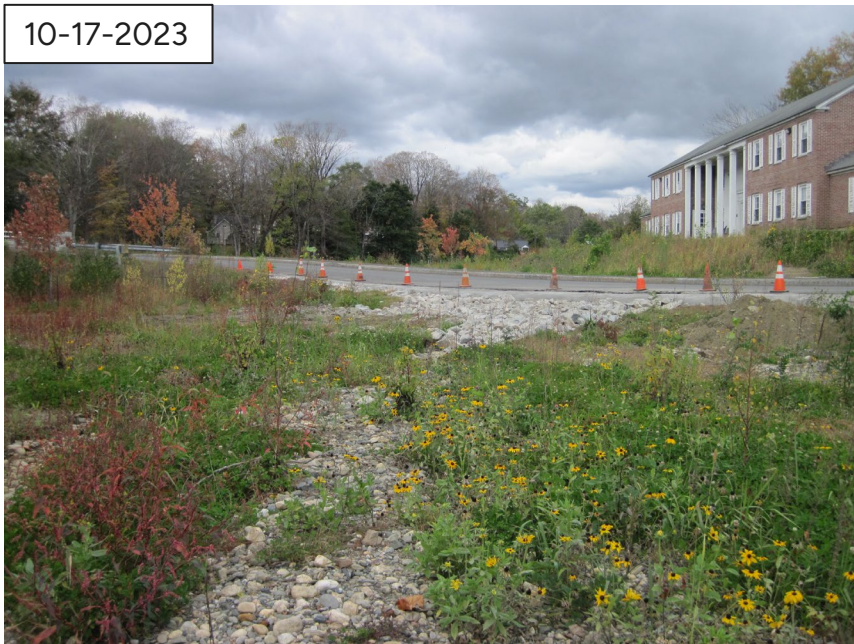
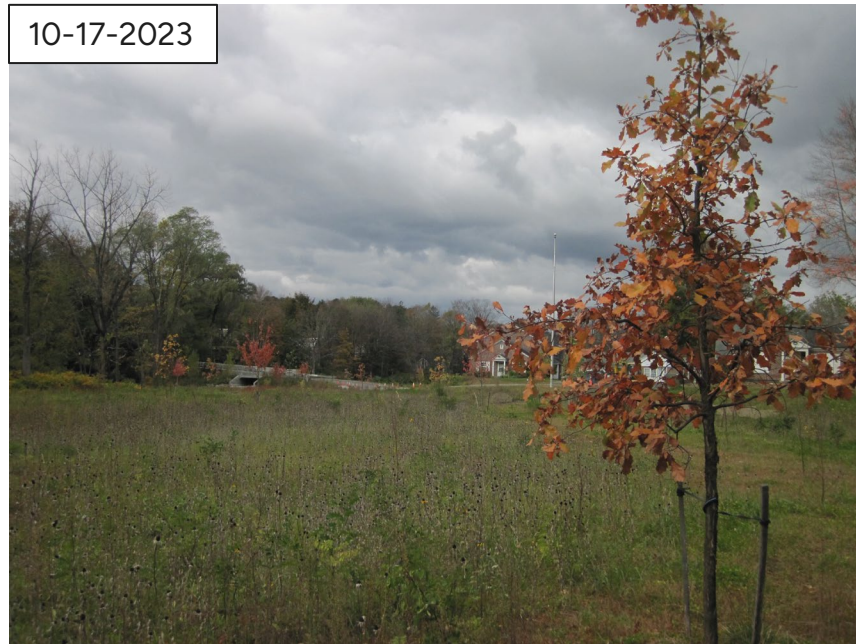
Remaining buildings and infrastructure safe

- Water stayed within the designated onsite areas
- 4.4 acres floodplain covered with feet of water
- Buildings not flooded
- Road overtopped as planned

Flood elevations reduced

- July 10, 2023 estimated approximately 10-year flood based on rainfall (not gauged)
- Modelling predicts this flood had 1.0-2.5 feet lower flood elevations than if project not completed
