Vermont Veterans' Home  
Mold Removal

Vermont Veterans' Home Mold Update October, 2013  
Prepared by Peter Hack, PE, BGS Project Manager

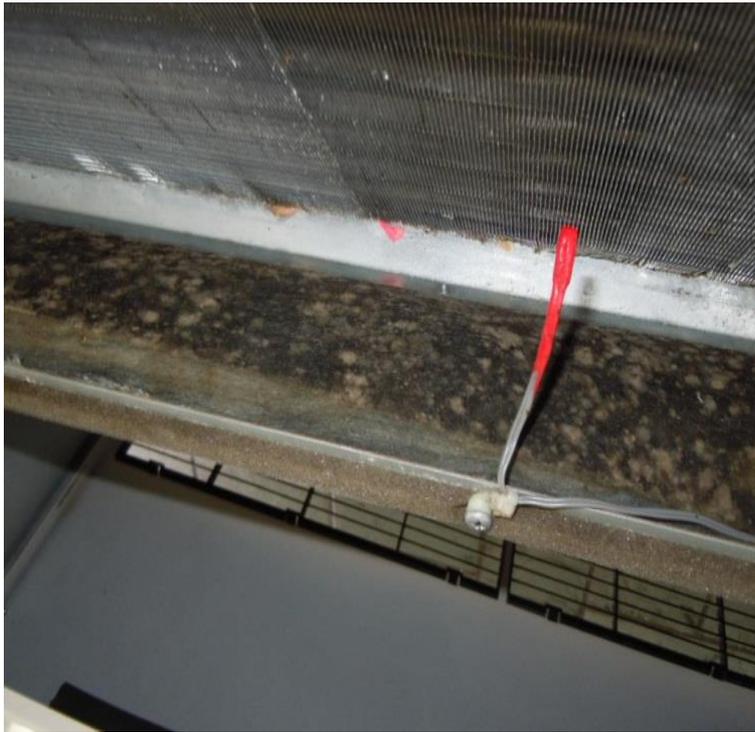
# Mold in Heat Pump, 2012 (L) Typical basement Area (R)

- II- August 2012 (PHASE 1 Mold): Catamount Environmental Inc., contracted to perform emergency remediation measures, including cleaning and removing mold from the floor mounted heat pumps in common rooms. Heat pumps retrofitted with UV lights and closed-cell insulation instead of fiberglass.

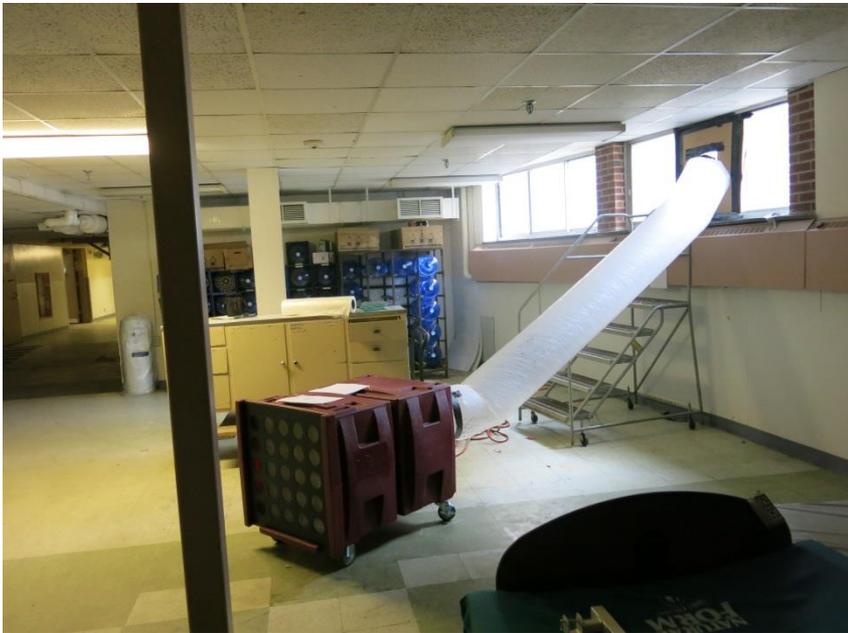
# HEPA Air Blower September 2012 (L) Kitchen Storage 2012 (R)

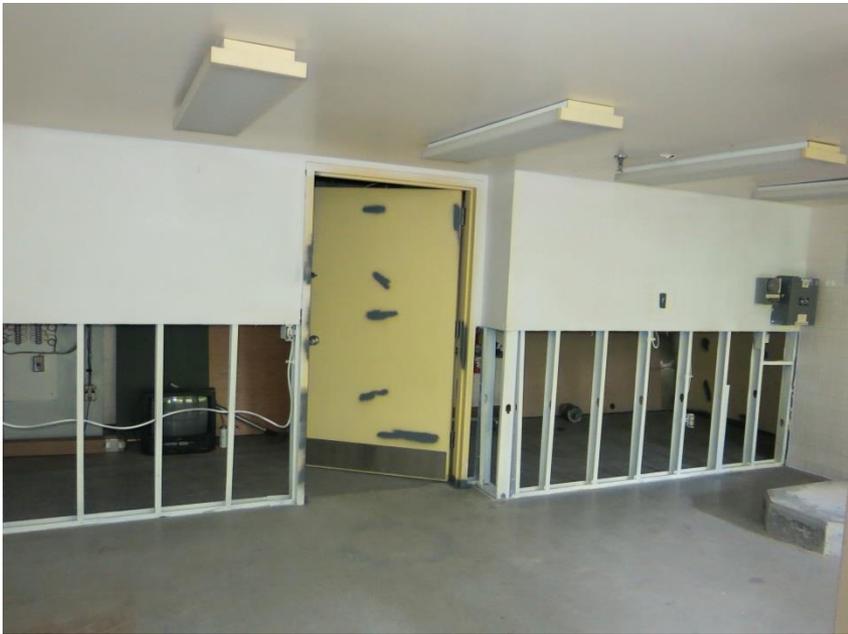
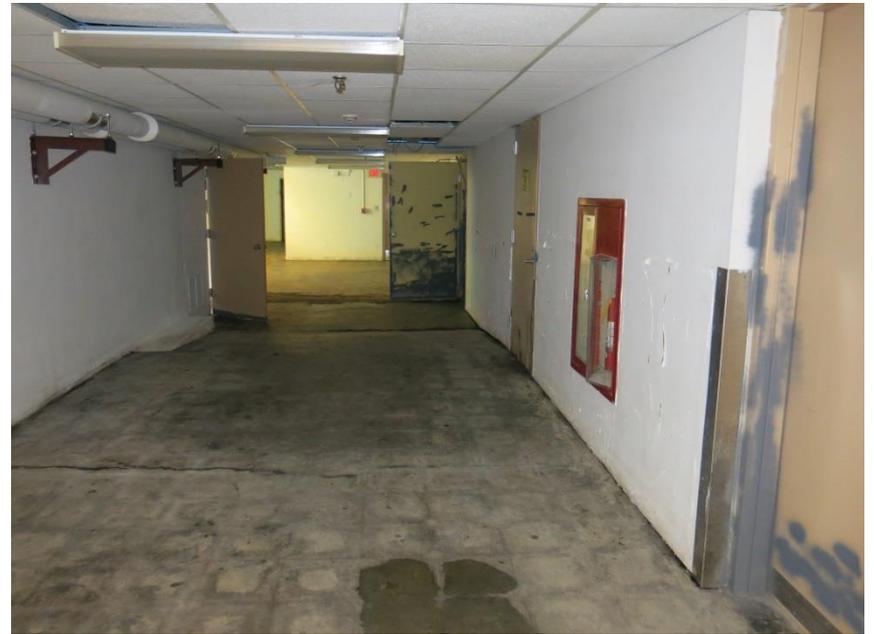
# Drywall and Asbestos Flooring Removal (July 2013)

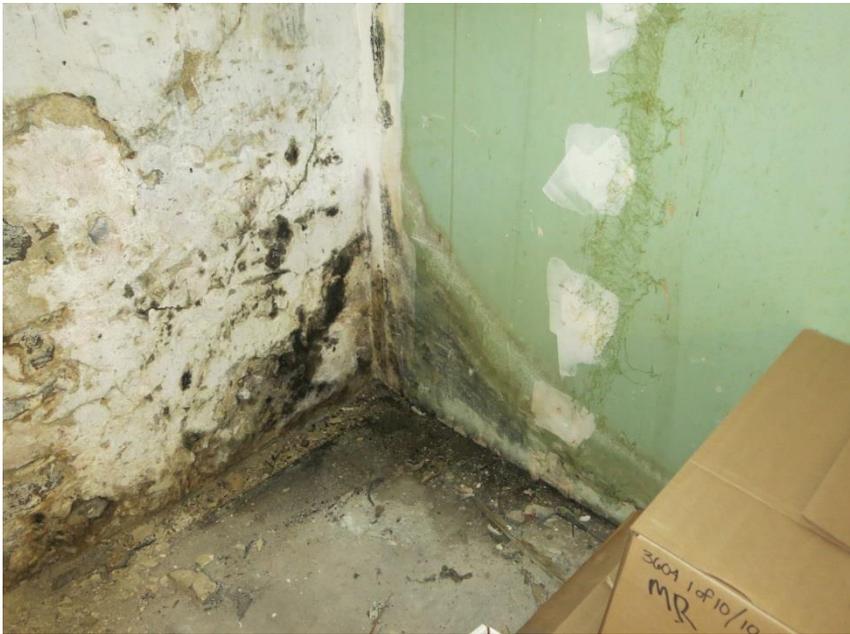
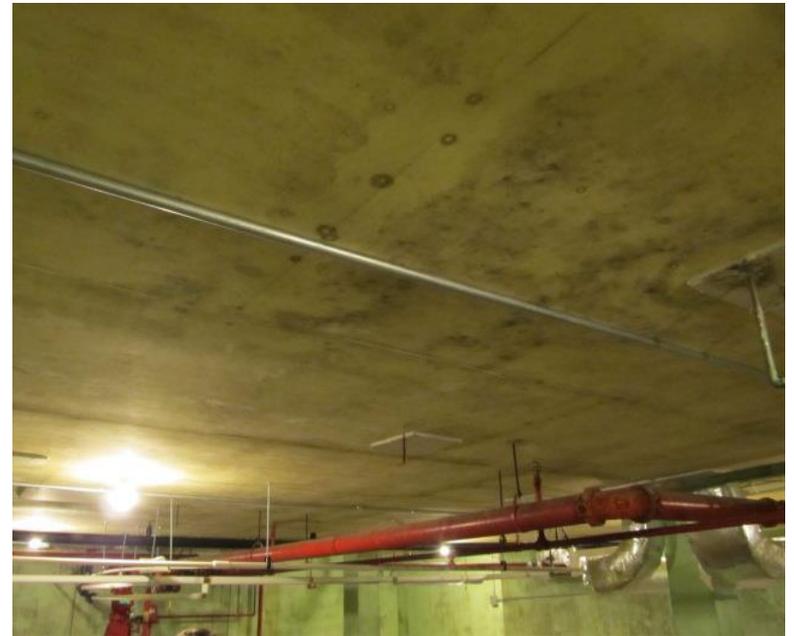
# Typical Conditions for Phase 2

- VIII- August 2013: Management and Operations Report completed (H533 Sec 17.d.1.E)
- IX- November 2013 – (PHASE 2 Mold) mold removal documents ready to bid, including mold removal, asbestos removal, waterproofing and HVAC Improvements.

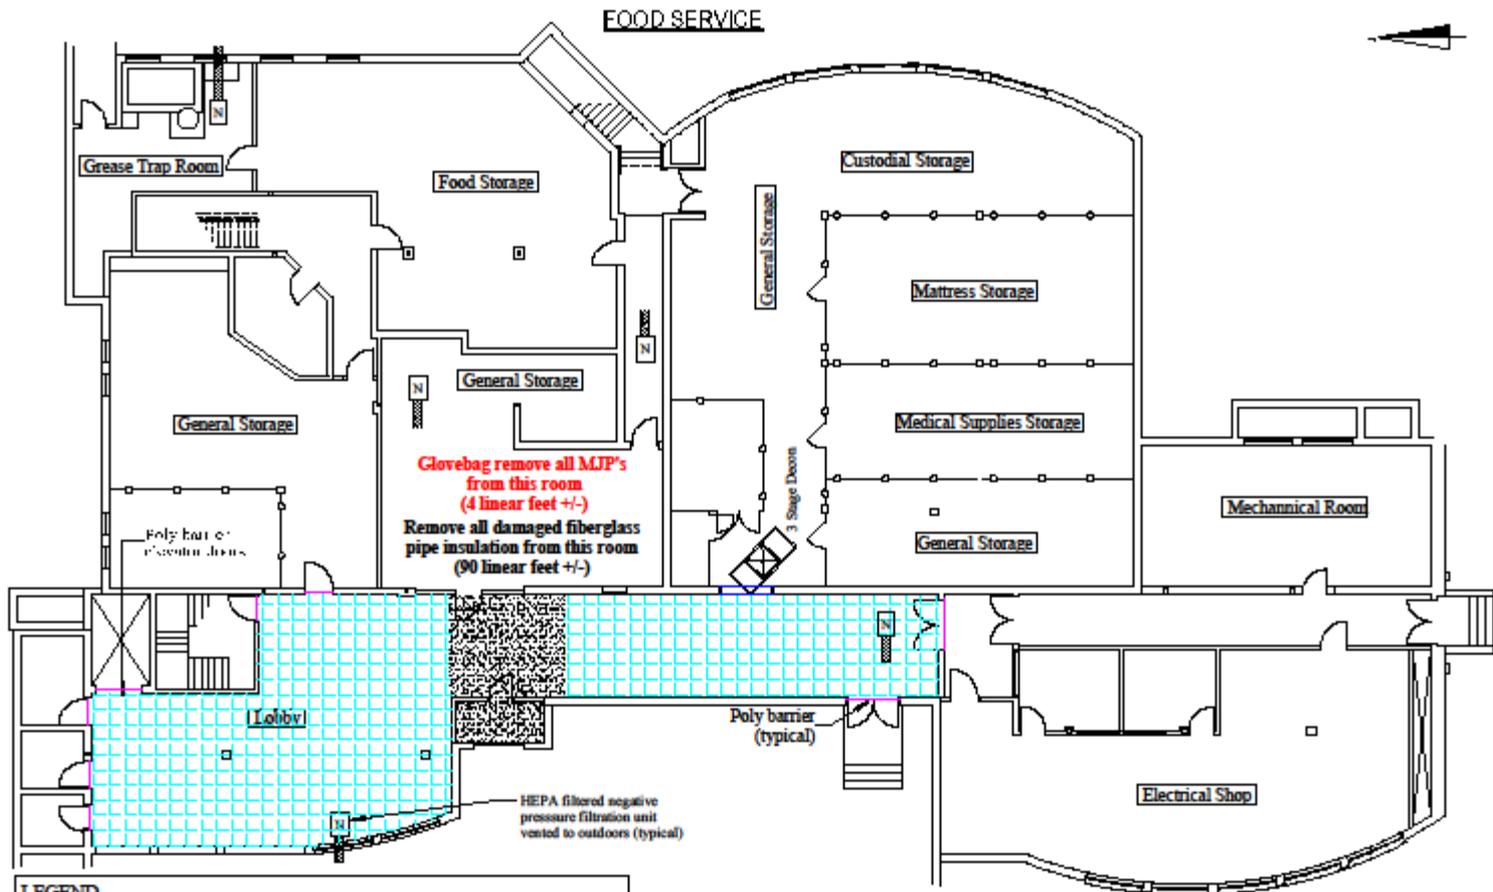
# Asbestos Flooring Removed August 2013

- Vinyl floor tile & black mastic to be removed (1700 square feet +/-)

- Black flooring mastic to be removed utilizing soy bean based solvents. Properly clean, neutralize and prepare concrete for application of concrete sealer (by others) (250 square feet +/-)

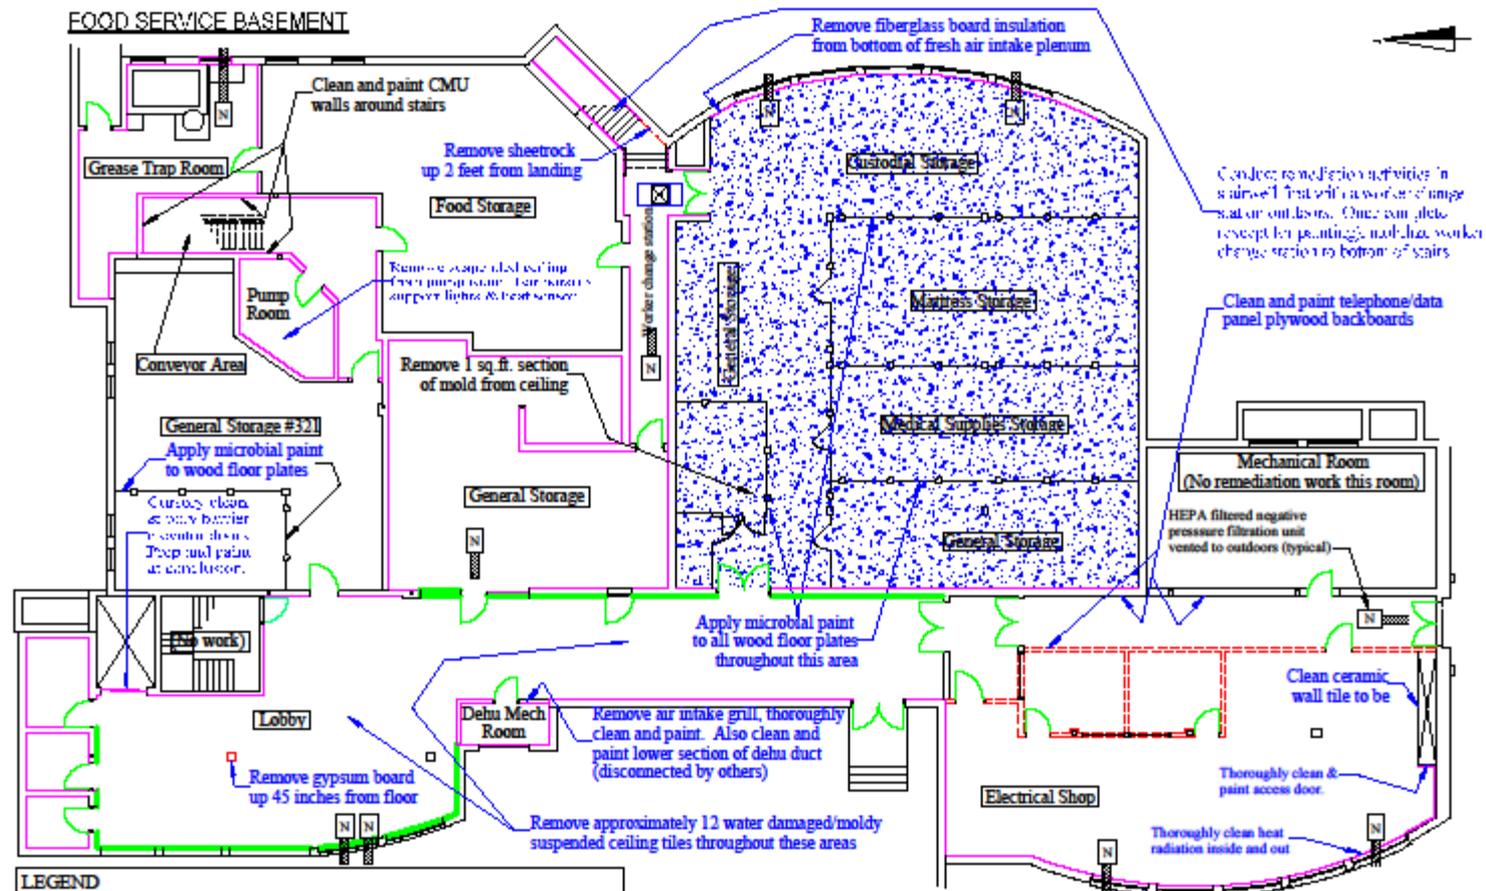
# Mold Removal, Cleaning, Painting August 2013

- LEGEND**
- - Remove gypsum board up 45 inches from floor. Clean and apply microbial paint to floor plates (remove cove base where present). Take care not to damage light gage metal stud framing.
  - - Conduct cursory cleaning of walls, then apply microbial paint from the floor up 8 feet or to suspended ceiling height.
  - ..... - Conduct cleaning of ceiling, then apply microbial paint.
  - - Remove & dispose of fiberglass panels and associated cove base. Clean and apply microbial paint to wall.
  - - Conduct thorough cleaning of doors, treat rust per specification.

**NOTES:** With the exception of the Food Storage area and General Storage area #321, all wall surfaces not demarcated by magenta colored lines shall be cursory cleaned. Remove all cove base encountered in basement work areas

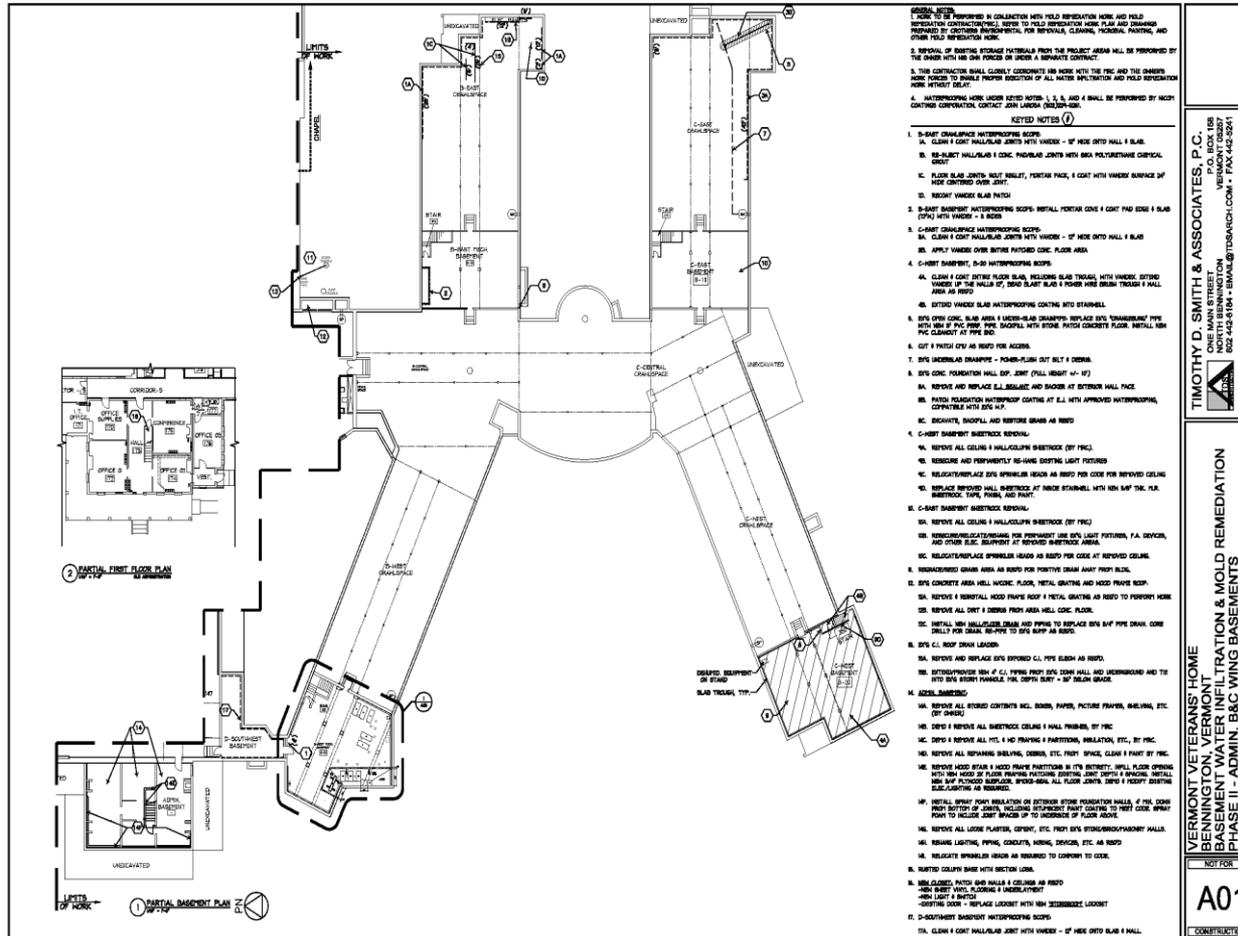
# Waterproofing and Water Control

**VERMONT VETERANS' HOME  
BENNINGTON, VERMONT  
BASEMENT WATER INFILTRATION & MOLD REMEDIATION  
PHASE II - ADMIN. & B&C WING BASEMENTS  
BASEMENT PLAN**
