Grazing, Weed Management & Riparian Buffer Zones following Tropical Storm Irene

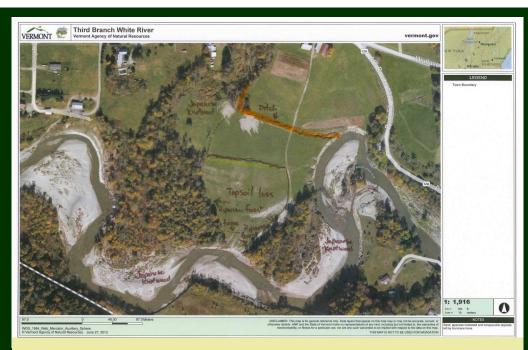
Aerial view of Third Branch of the White River, where high water and flooding occurred with TS Irene, sweeping away nearly 5 acres of topsoil of this farm field and depositing several feet of sand and gravel carrying Japanese knotweed and other invasive species in its material.

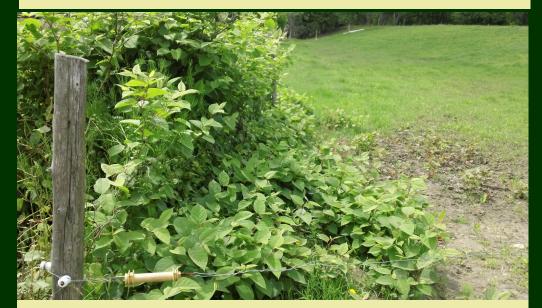
In the areas where the animals are allowed to graze, they graze all of the invasive species; Japanese knotweed, honeysuckle, chervil and others. While it might not completely eradicate the plants, it does keep them from becoming aggressively invasive and taking over the pastures. It allows for good grasses, forbs and other pasture forages to compete, and grow, keeping the land in useful production as pasture which holds the soil in place. This state of perennial pasture is one of the most resilient in extreme weather events – wet or dry. The important piece is the correct management for the animal grazing periods. It must be kept brief, but with enough animals to have an impact, and the animals usually need some training to get them to graze on these species.

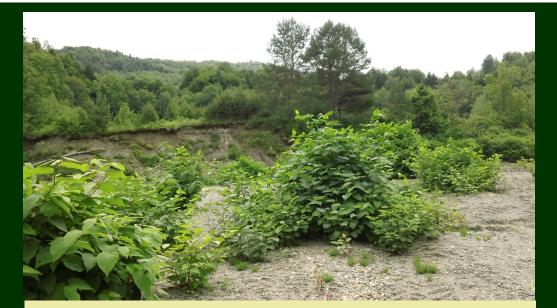
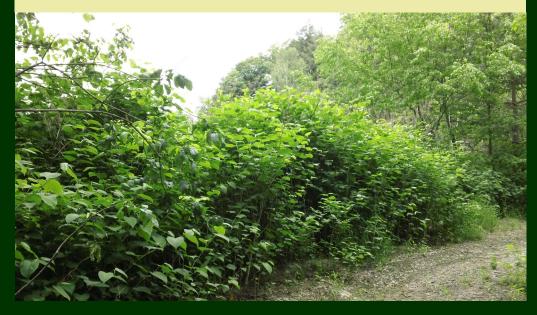
Ground view of Japanese Knotweed emerging from the heavy sand and gravel deposits. The above photo is early May 2013, the photo below is late June. This is the riparian edge that the farmer is not allowed to let his animals graze, so the knotweed and honeysuckle are unchecked in growth.
