## *Lessons from the* **FLOODS**

*A publication of the Lake Champlain Committee, a membership-supported, bi-state non-profit organization working for Lake Champlain's health and accessibility since 1963.*

# Lessons from the Floods

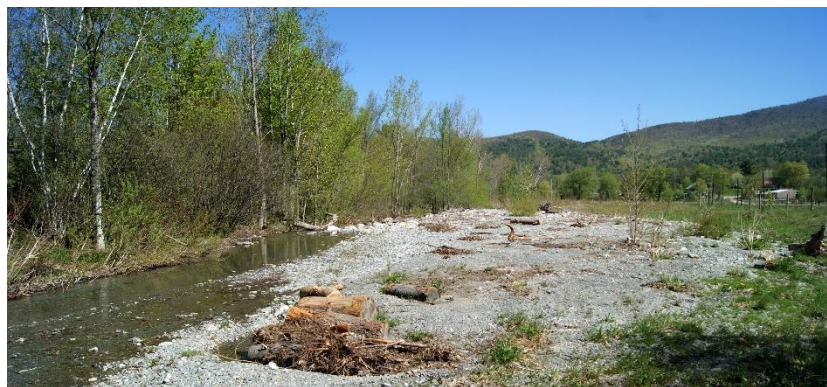
*A berm along the right bank of Gully Brook (far left of photo) was removed prior to the storm providing the river additional flood storage capacity. Photo by Lori Fisher.*

Berm removal also helped avoid flood damage along Gully Brook in Castleton. Gully Brook parallels Birdseye Road near its confluence with the Castleton River just south of Route 4A. At the point where the land around the brook levels off, the stream was bermed in 1959 to protect adjacent cropland and pasture. Berming increased the velocity of the water and its ability to carry sediment which the stream then deposited as it reached the Castleton River. Sediment accumulation led to regular flooding of the Traverse Farm barnyard and cattle pasture. The farmer found himself regularly removing sediment from the stream. Scientists from the Agency of Natural Resources suggested taking out the upstream berm to allow the river to deposit sediment where the berm was, thus reducing the risk of downstream barnyard flooding and the need to dredge the channel. The berm came out in 2004 and indeed land and property damage during Irene was minimal, as predicted. Property owner Bob Traverse told the [Poultney-Mettowee Conservation District](#), “Gully Brook did as well as any stream in Vermont” during Irene.

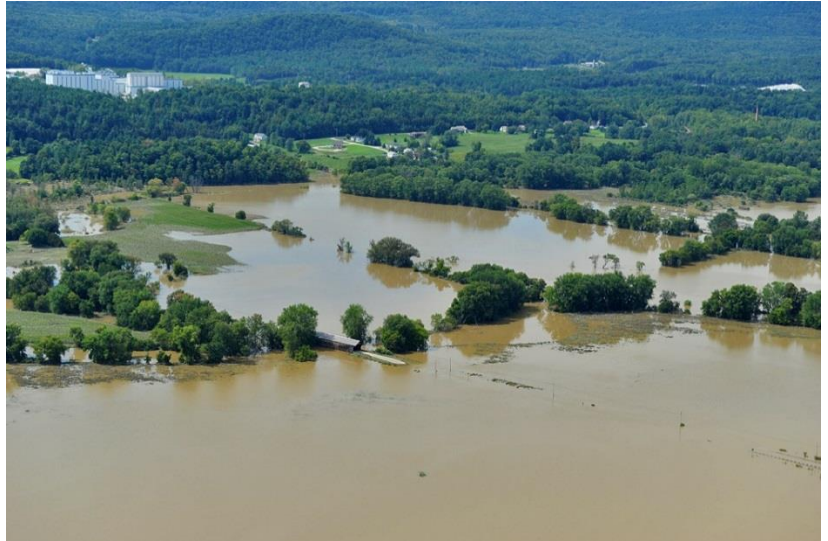
*Flooded Otter Creek Wetlands in 2011. Photo by Mansfield Heliflight.*

During Irene, the Otter Creek in Rutland swelled reaching a peak discharge of 15,700 cubic feet of water per second (cfs) and flood waters caused tremendous damage. Thirty miles downstream Middlebury is situated on the Otter Creek, but conditions there were quite different. The maximum peak discharge was only 6,180 cfs. Within four days the storm flow in Rutland had returned to normal, but in Middlebury flows did not even peak until then. Middlebury flows remained high for another two weeks and there was no flood damage! The dramatic differences in the Otter Creek at these two points can be explained by the presence of a vast, 9,000-acre complex of wetlands, in the floodplain of the Otter Creek between Middlebury and Rutland. The wetlands stored flood waters, slowly releasing them over time so that Middlebury and points downstream never experienced the full force of the flood. Businesses remained open and life went on as usual.

The story of the Otter Creek in Rutland and Middlebury provides a stark reminder about the importance of wetlands and floodplain access to ameliorate flooding. Throughout our region wetlands have been lost to dredging, filling and development. Their loss exacerbates flood damage during Irene-like events. While the Otter Creek Wetlands are massive, there are many smaller places where floodplains could store more water. Restoring wetlands and increasing river access to floodplains will limit downstream flood damages.

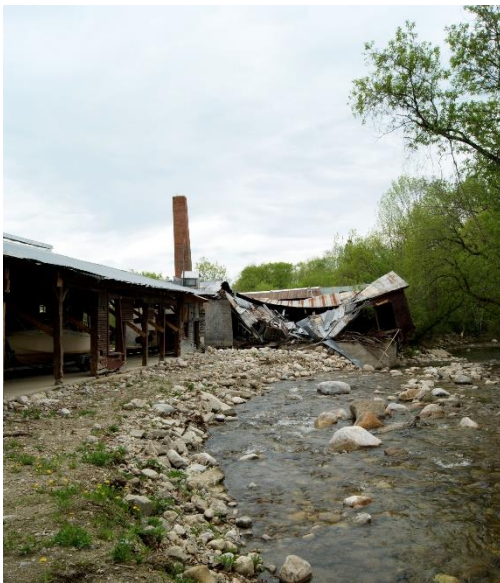
*The former Vermont Tubbs furniture factory in Forestdale. The factory was destroyed when the Neshobe River escaped a berm on the left bank.  
Photo by Lori Fisher.*

Where the river channel narrowed, Irene's waters crashed through the berm. Portions of the Vermont Tubbs furniture factory were destroyed. The river carved two-foot ditches on either side of Newton Road, and gouged channels through corn fields, tearing away topsoil and leaving only gravel deposits. Basements filled with river water.

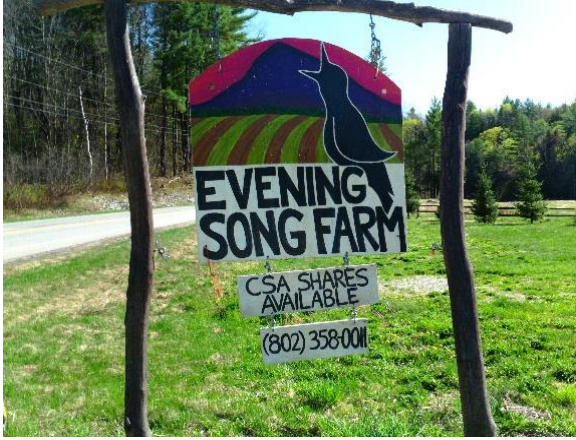
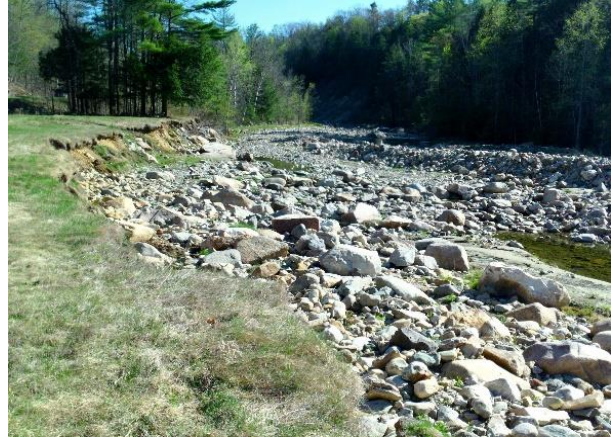
*The Mill River (right) broke through its berm wiping out prime agricultural land at Evening Song Farm. Photos by Mike Winslow.*

For river scientists, the destruction at Evening Song Farm was not a complete surprise. A river corridor management plan prepared prior to Irene noted how the river had been straightened and forced against the valley wall. The plan recommended removing the berm.

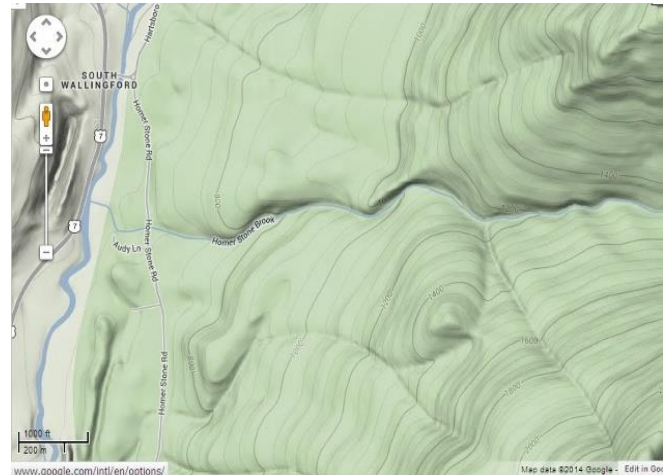
*Homer Stone Brook drops over 1,200 feet between Little Rock Pond and the Otter Creek.*

Like the Mill River, Homer Stone Brook escaped from its berms during Irene, carving a new route to the Otter Creek. Once outside the berm, the river could no longer access its old channel. The new channel paralleled the railroad tracks for a few hundred feet before cutting underneath them to a new outlet. The railroad incurred hundreds of thousands of dollars in damage as a result. Despite this failure, the berms were reconstructed and heightened after the storm, and the river channel was narrowed even more.

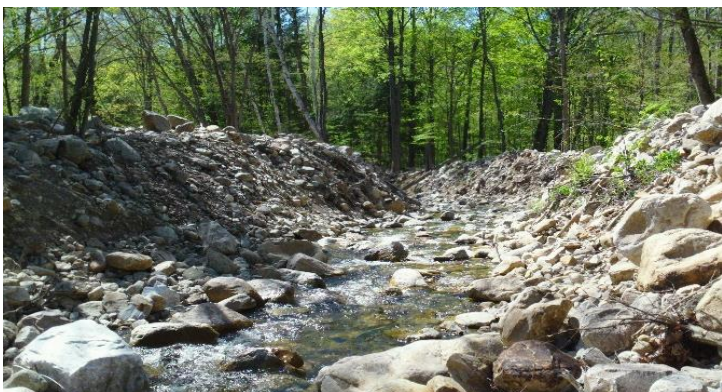
*Berms along Homer Stone Brook gave local residents a sense they were safe from the water, but the brook escaped the berms during Irene. Photo by Mike Winslow.*

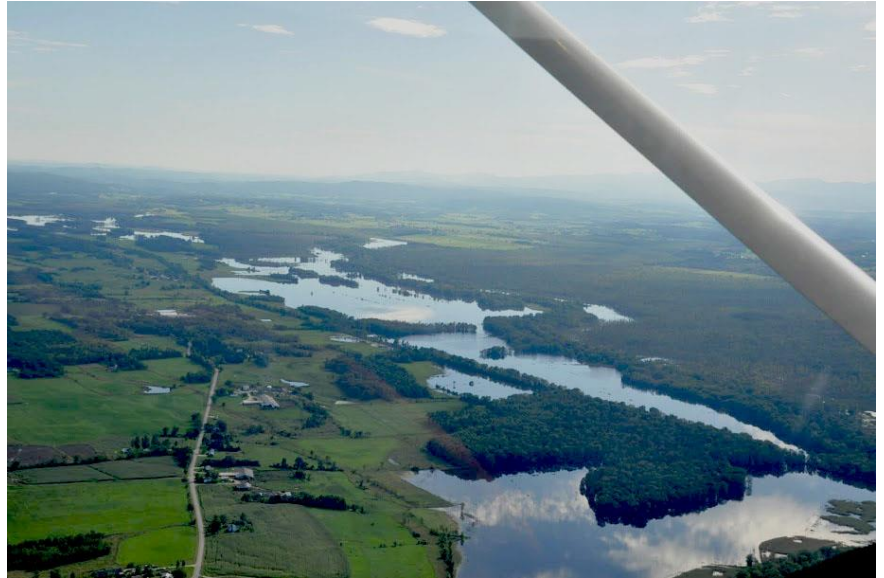
*A vast complex of wetlands sits along the Otter Creek between Rutland and Middlebury. The wetlands protected downstream communities by soaking up immense amounts of water during Irene. Photo by VTDEC.*

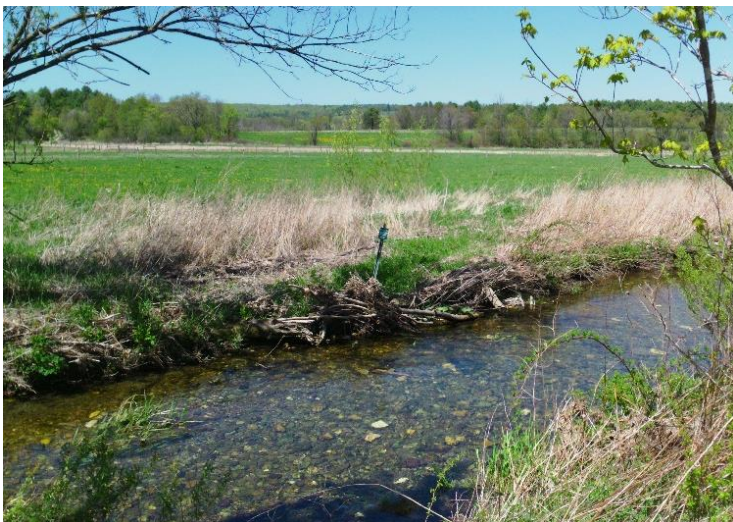
*Berm removal allowed access to extensive floodplains (top of photo) along the Indian River in West Pawlet at the Consider Bardwell Farm. Photo by Mike Winslow.*

In 2007, farm owners used conservation grants to remove 2,000 feet of a berm that constrained the Indian River to a narrow channel between the Delaware and Hudson Rail Trail and an old corn field, now pasture. Berm removal allowed the river access to extensive flood storage to the west. Areas downstream saw little damage during Irene – clearly the added flood storage helped.

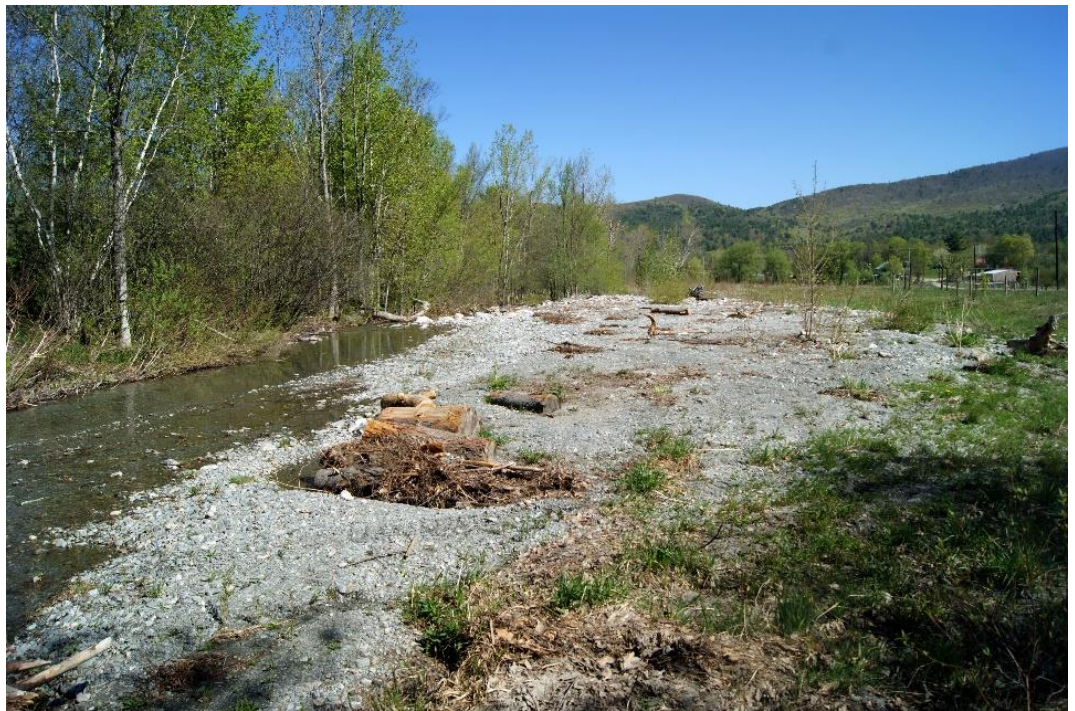
*A berm along the right bank of Gully Brook (far left of photo) was removed prior to the storm providing the river additional flood storage capacity. The white rocks in this photo were deposited in the restored floodplain during Irene. Photo by Lori Fisher.*

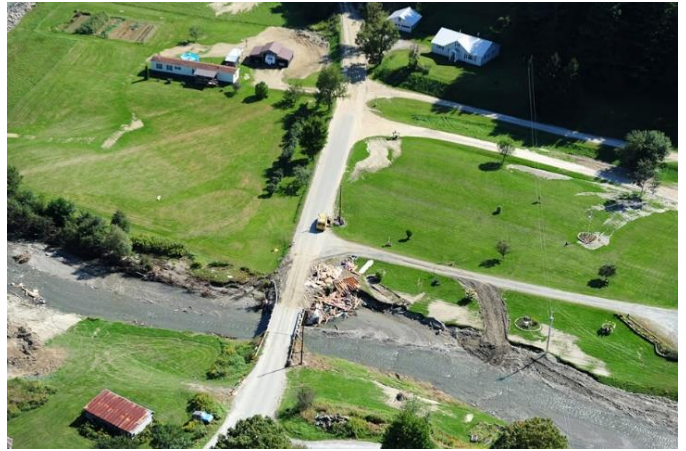
*In Bridgewater Corners a house washed up against the bridge, blocking water and threatening to wipe out the bridge. Photo by Mansfield Heliflight.*

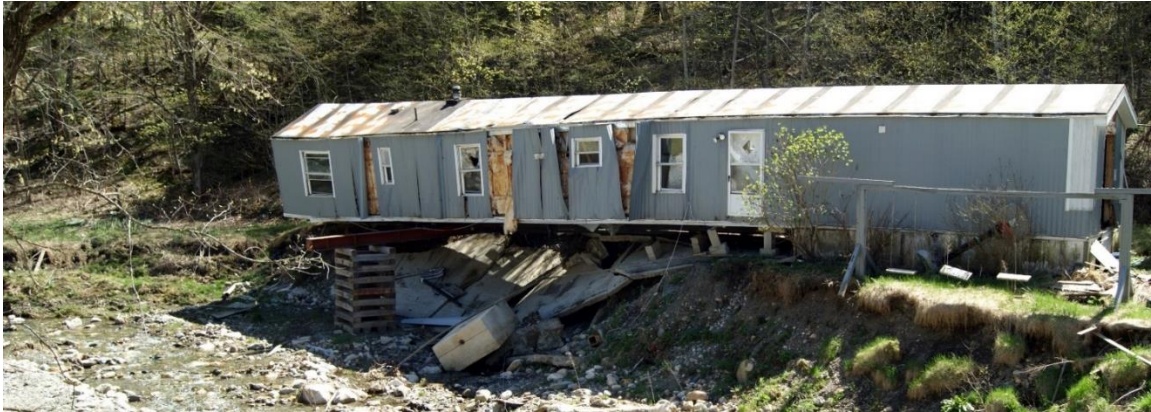
*Structures built in floodplains like this one along the Danby-Pawlet Road are a risk for homeowners and the community at large. Floods can threaten to wash them downstream into bridges or other structures. Photo by Lori Fisher.*

Living by a gurgling brook may have great appeal, but homes built too close to water represent a danger to the owners and to the community. Municipalities must take steps to limit new development, and outdoor storage of materials in known flood hazard areas. Any new structures in hazard areas need to be securely anchored and designed to withstand periodic flooding. Existing structures should be retrofitted to the extent feasible so that they do not become a hazard. Towns need to enact strong regulations that limit new floodplain development to minimize such risks.

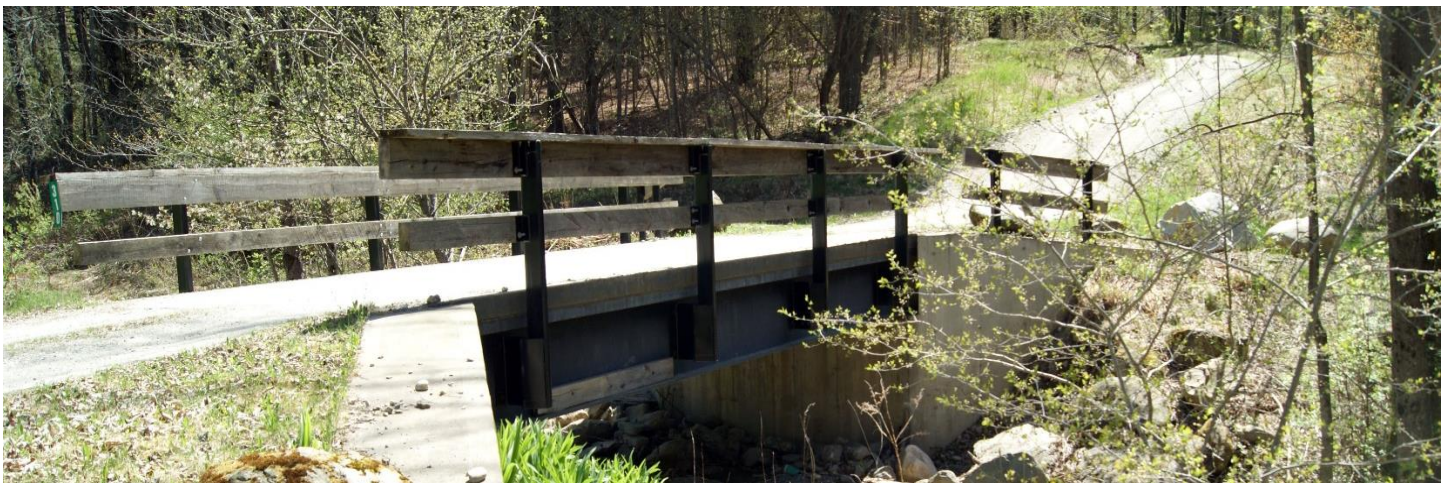
*Of four stream crossings along North Road in Middletown Springs, this is the only one to have survived Irene. It was the only crossing built in consultation with a river scientist. Photo by Lori Fisher.*

Advanced preparation can help individuals as well as towns. Along North Road in Middletown Springs the Irene-swollen North Brook wiped out multiple stream crossings. Of the four stream crossings along the road, only one bridge survived; the one where homeowners sought input from a river scientist prior to construction. Heeding the consultant assured the bridge would be wide enough to outlast high water events. Stream crossings that failed were substantially smaller.

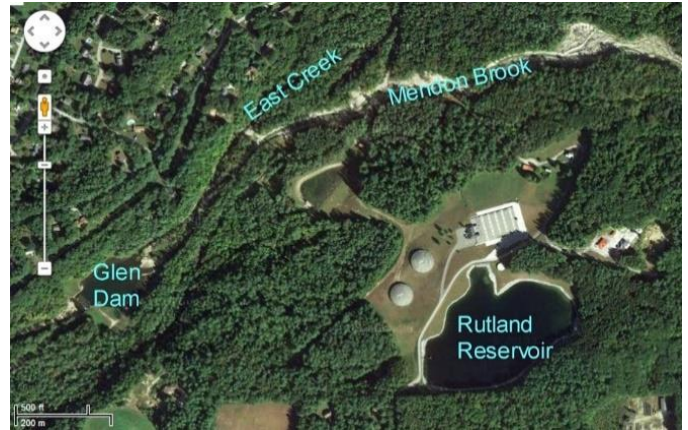
*Emergency measures to protect the Rutland water supply led to later sediment build-up in Glen Dam, a hydropower source. Affected parties worked together to go back and correct the problems.*

Glen Dam sits just downstream of the confluence of Mendon Brook and East Creek. It was owned and managed by Central Vermont Public Service (CVPS – now Green Mountain Power). From Glen Dam water passes via a penstock to the 2,000-kilowatt Glen Station on the western side of Route 7 in Rutland Town, generating power. Excess accumulation of sediment in the impoundment threatened future power generating ability.

CVPS/GMP worked with Rutland and the Department of Environmental Conservation to reconfigure some of the stream alterations that had taken place under emergency conditions. They lowered berms, brought large debris into the stream channel to help slow the water flow, and opened floodplain access along the river bank opposite the drinking water intake. While the stream still shows clear signs of channelization, the future flood risk has been reduced.

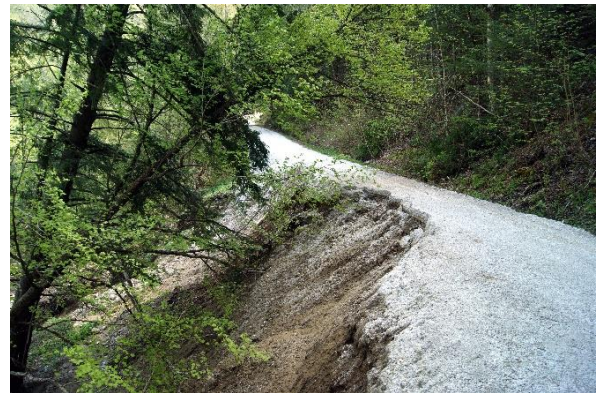
*Upper Cold River Road in Shrewsbury washed away during Irene. Continued water seepage from the nearby hillside poses a significant construction challenge for this dirt road.  
Photo by Lori Fisher.*

Upper Cold River Road in Shrewsbury is a dirt track that angles off of Cold River Road four miles east of its intersection with Route 7. The road hugs a steep hill before crossing the Cold River at a picturesque covered bridge. Brown's Bridge has spanned the Cold River since 1880 and is listed on the National Register of Historic Places. Irene spared it, barely. The bridge was knocked off its foundations and required substantial repair. With assistance from FEMA the bridge was rebuilt but still no traffic traverses it. Landslides along the road between Brown's Bridge and Cold River Road have made the route impassible. The inability to use Brown's Bridge costs a handful of residents an additional 20 minutes each way to Route 7. The slopes along the road remain unstable and future landslides are likely. Rebuilding the dirt track is one of the most expensive reconstruction efforts remaining after Irene, and reconstruction should be subjected to a strict cost-benefit analysis.

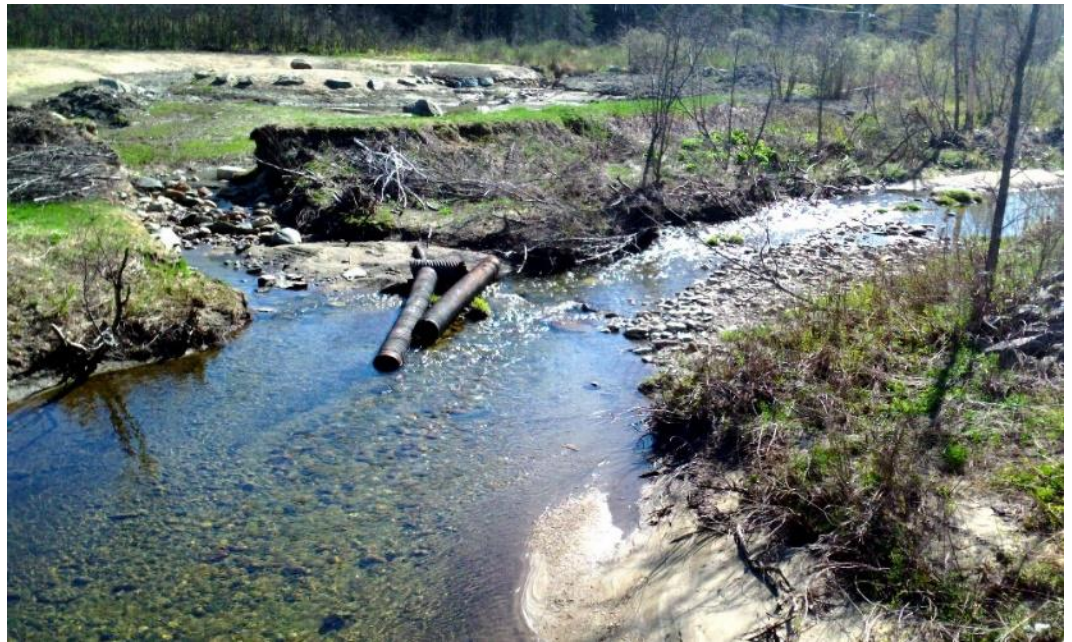
*This Mt. Holly pond (top of photo) was constructed in the floodplain. During Irene the stream captured the pond releasing a surge of water and sediment downstream. Photo by Mike Winslow.*

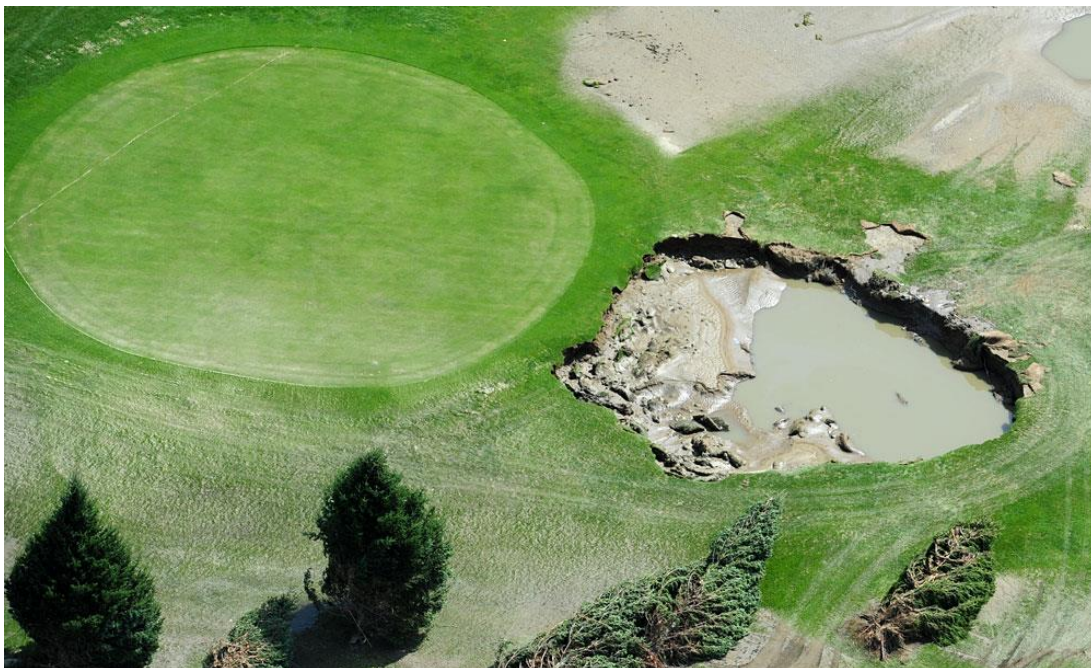
*This sand trap on a central Vermont golf course was captured by the nearby river during Irene. Note the sand that has been delivered downstream at the top of the photo. Photo by Mansfield Heliflight.*

Ponds can be “captured” by flooding streams. Digging a hole next to a river leaves a depression lower than the river bed, and water will always seek the lowest point. During high water a river may flow into or capture an adjoining pond, and change its course. Over time, fine sediments accumulate in ponds. When ponds get captured by a flooding stream, those sediments wash out, accentuating any downstream debris jams. Gravel pits and golf course sand traps and water features are also susceptible. Care must be taken when planning, approving or constructing any depressions like ponds within a river corridor.

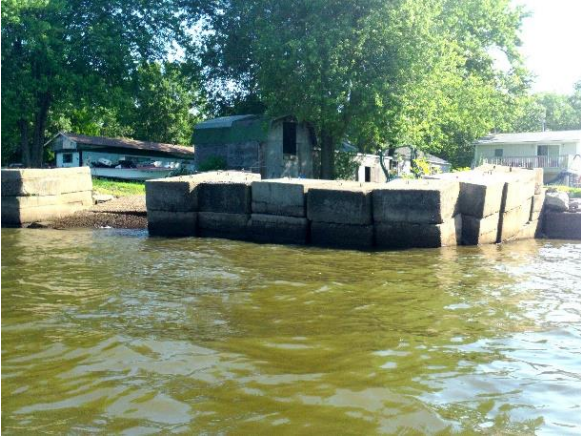
*Poorly planned do-it-yourself projects like this one often lack structural integrity and soon fall apart. Photo by Mike Winslow.*

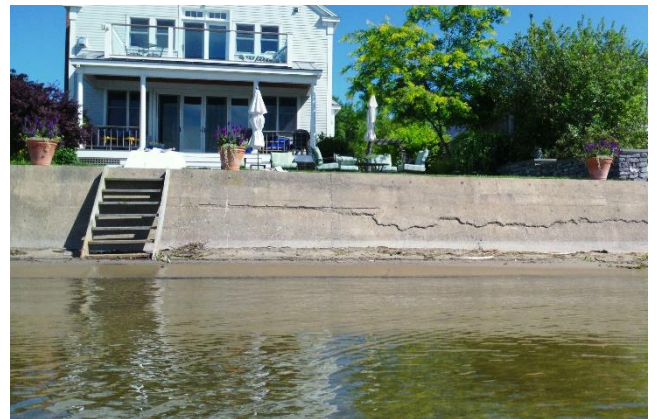
*The push and pull of ground water from the landside plus waves from the lakeside rock sea walls back and forth leading to cracks like this one. Cracks can be seen in scores of sea walls around the lake. Photo by Mike Winslow.*

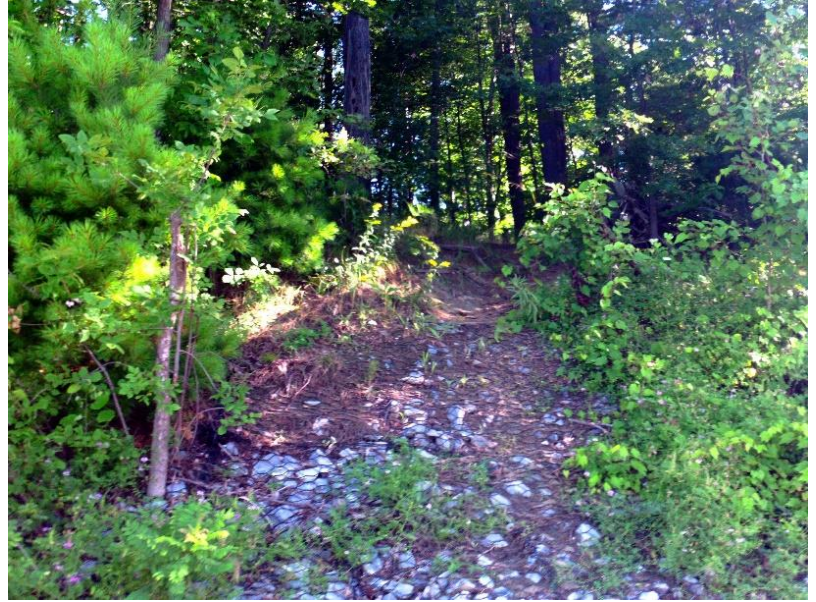
*Failure to provide controlled access to the waterfront can lead to development of herd paths like this one. Once a herd path forms, erosion accelerates along it and it is extremely difficult to reestablish vegetation. Photo by Mike Winslow.*

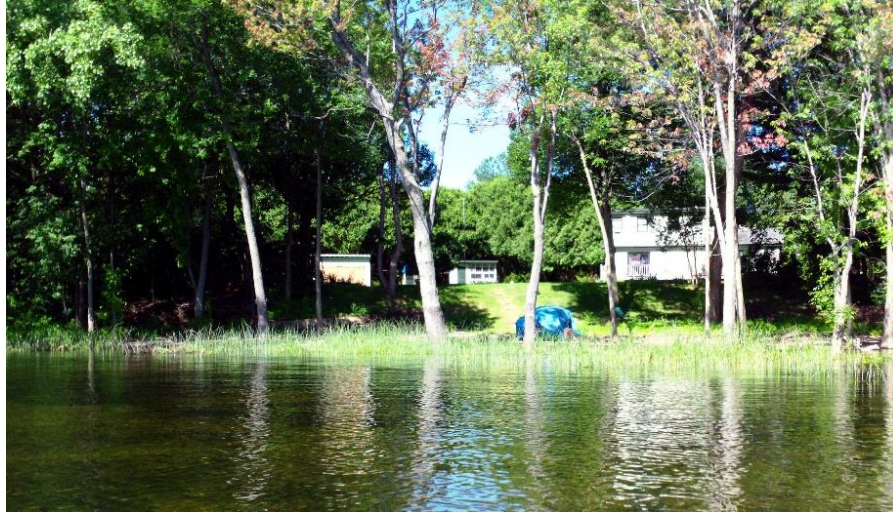
*The trees in the foreground of this photo provide protection from wave action and lessen erosion along the lakeshore. Photo by Mike Winslow.*

Good vegetation management can enhance most any erosion control project, and even eliminate the need for some. Shoreline vegetation breaks the force of waves before they reach land. Clearing vegetation to create a view, building site, or boat launch will often accelerate erosion.
