Effects of unpaved roads on water quality in the Lake Champlain Basin

Dr. Beverley Wemple

Presentation to the Vermont House Committee
on Fish, Wildlife and Water Resources
February 3, 2016

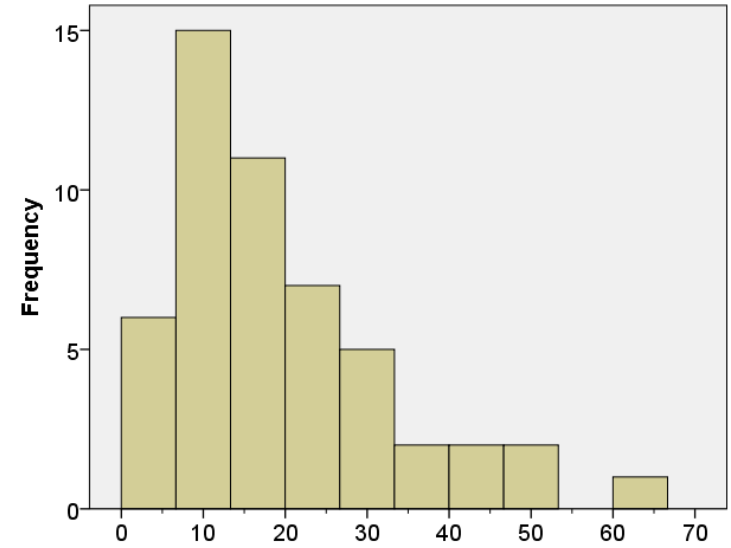
Erosional feature frequency (#/km)

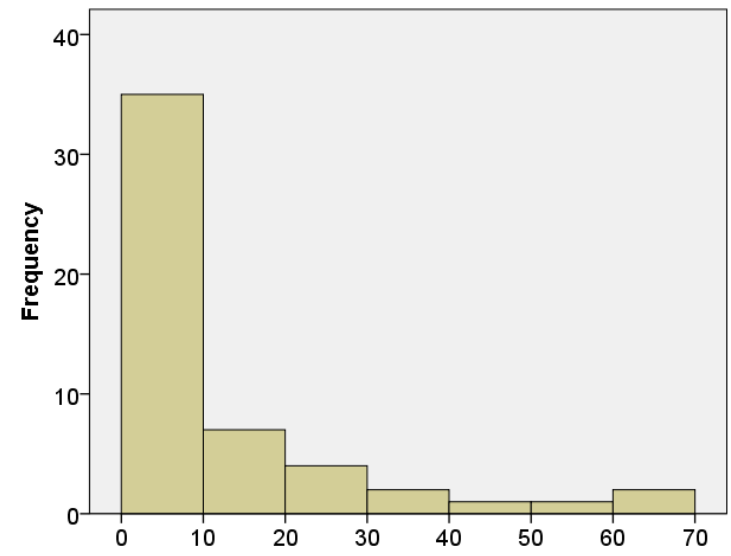
Volume of eroded sediment (m³/km)

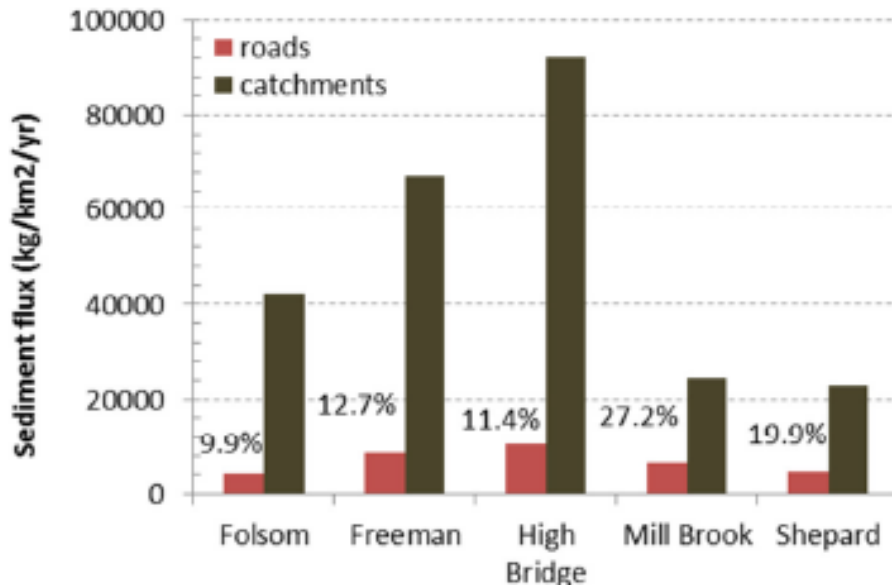
Suspended Sediment

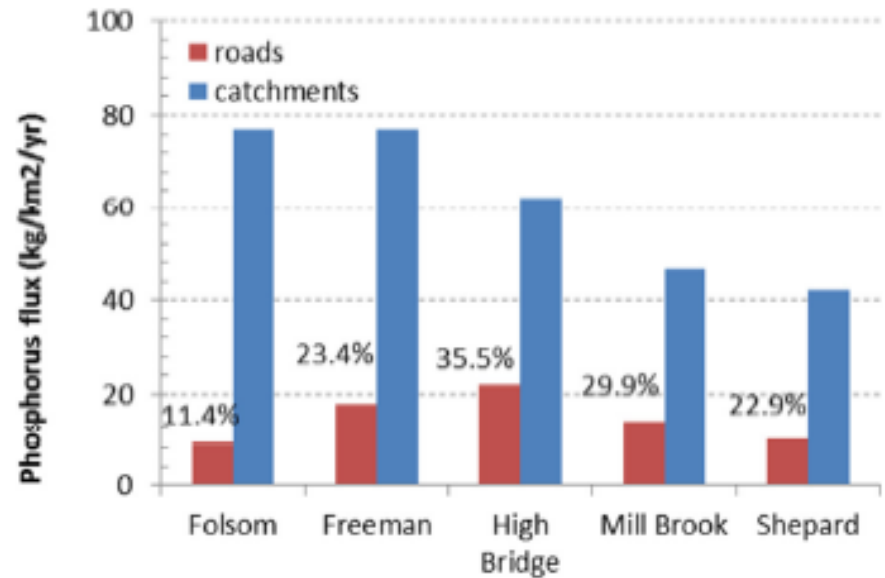
Total Phosphorus

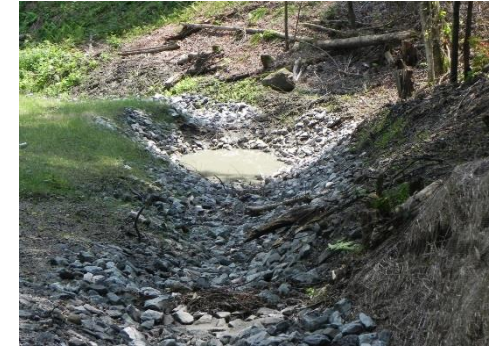
intact

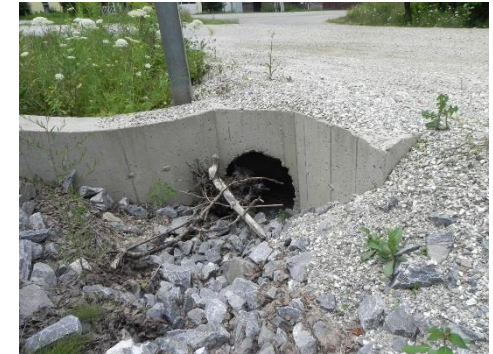
compromised

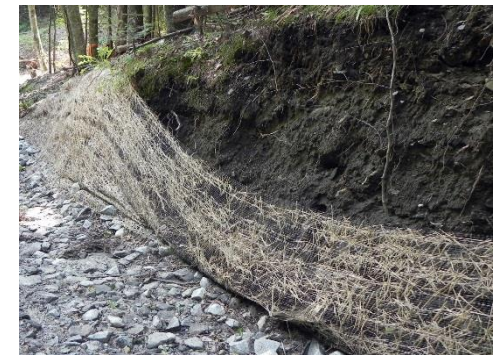
failed

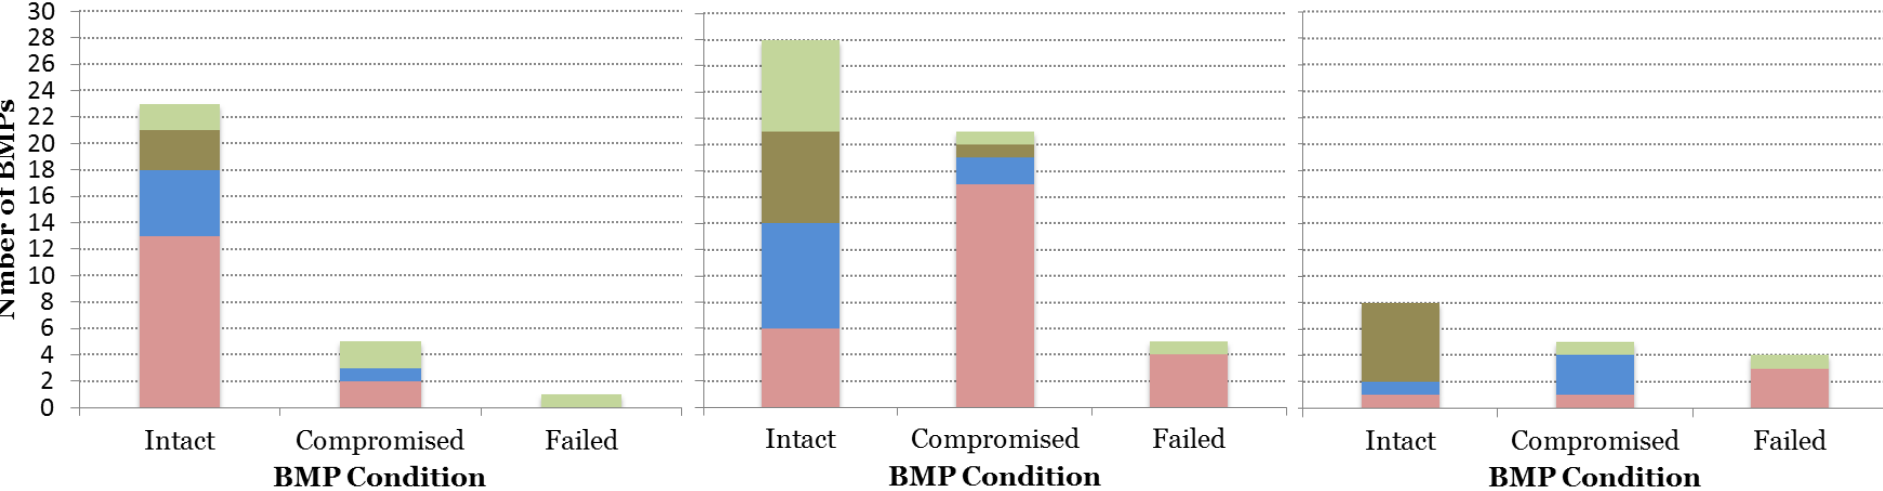
BMP persistence with time

1-2 Years
29 BMPs at 11 Sites

3-5 Years
54 BMPs at 20 Sites

6-8 Years
17 BMPs at 12 Sites

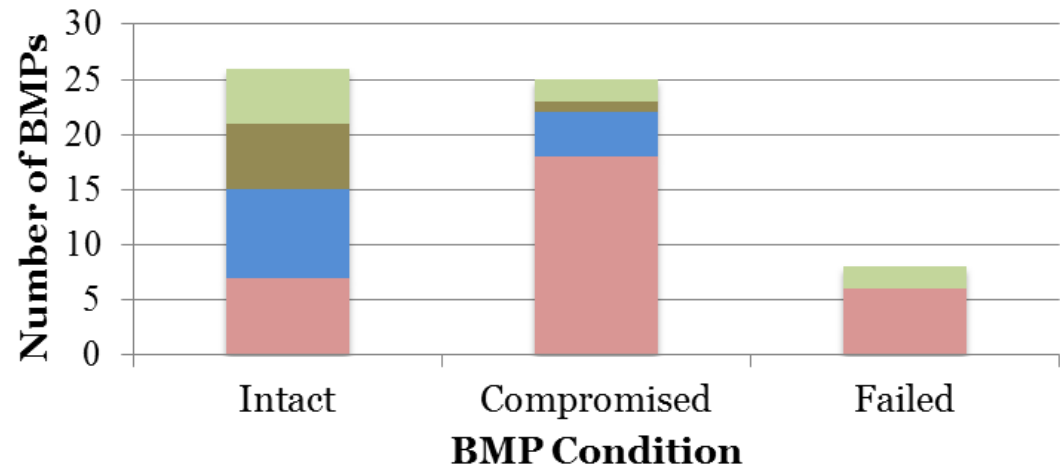
BMP effectiveness with flood exposure

Exposed to flood events

59 BMPs at 23 Sites

Average Age 4.8 years, SD 1.6

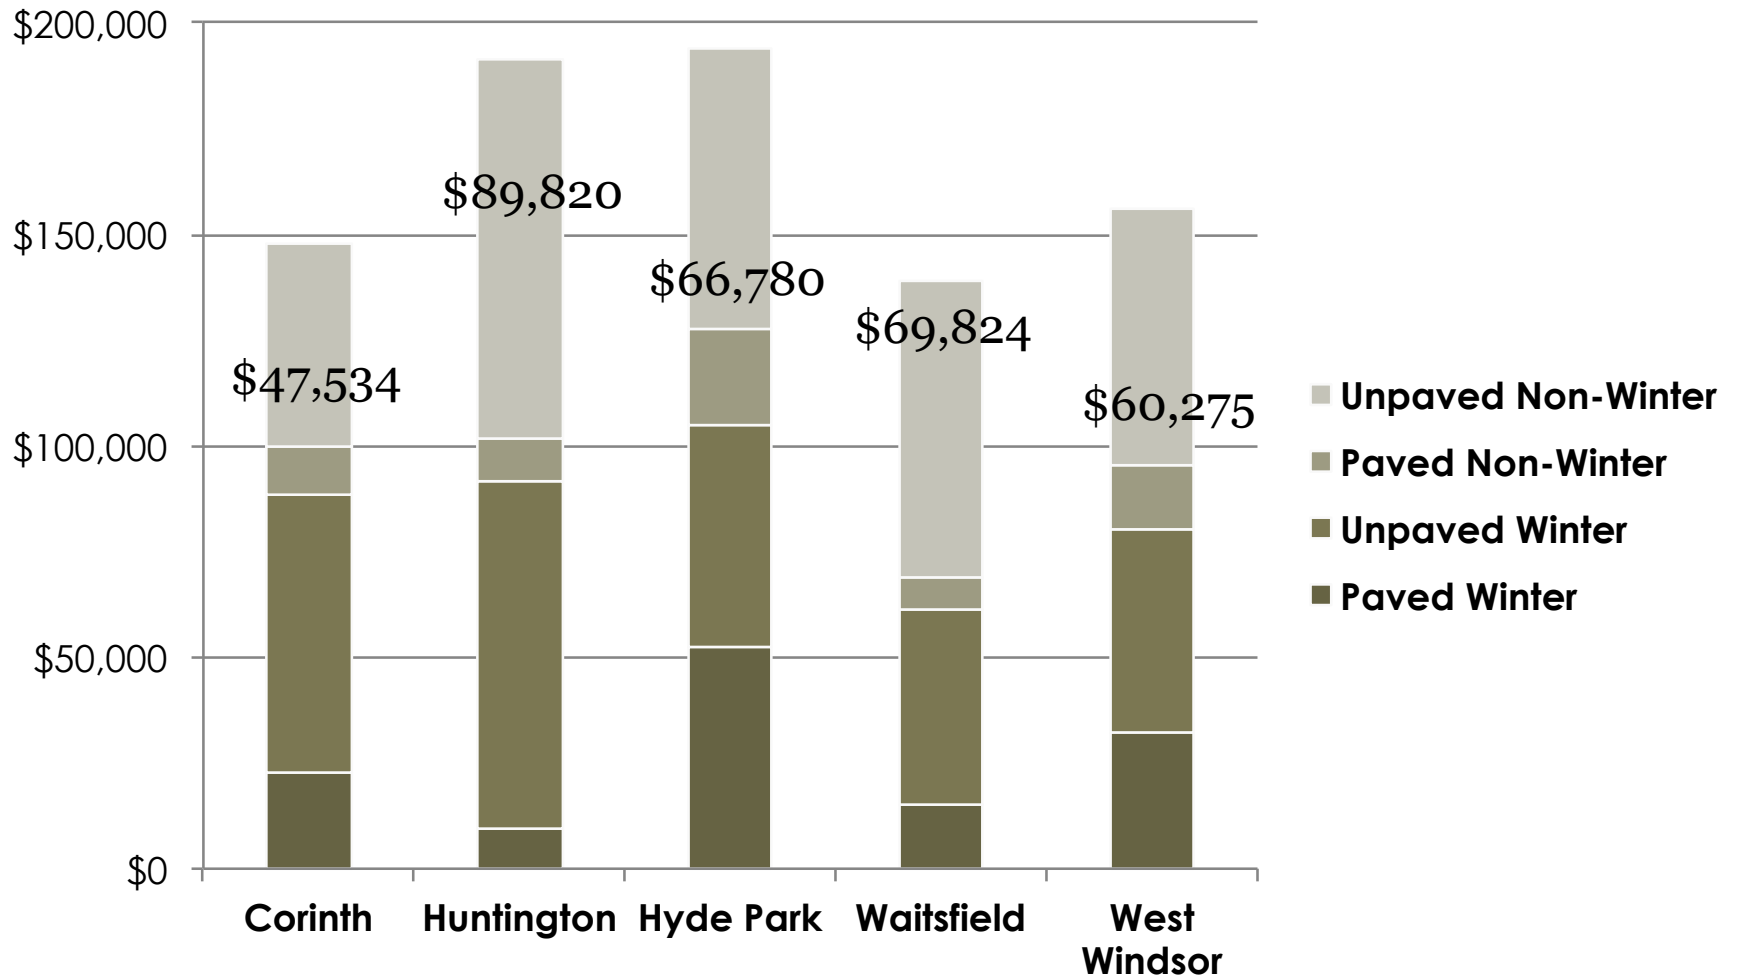
Annual road crew salary

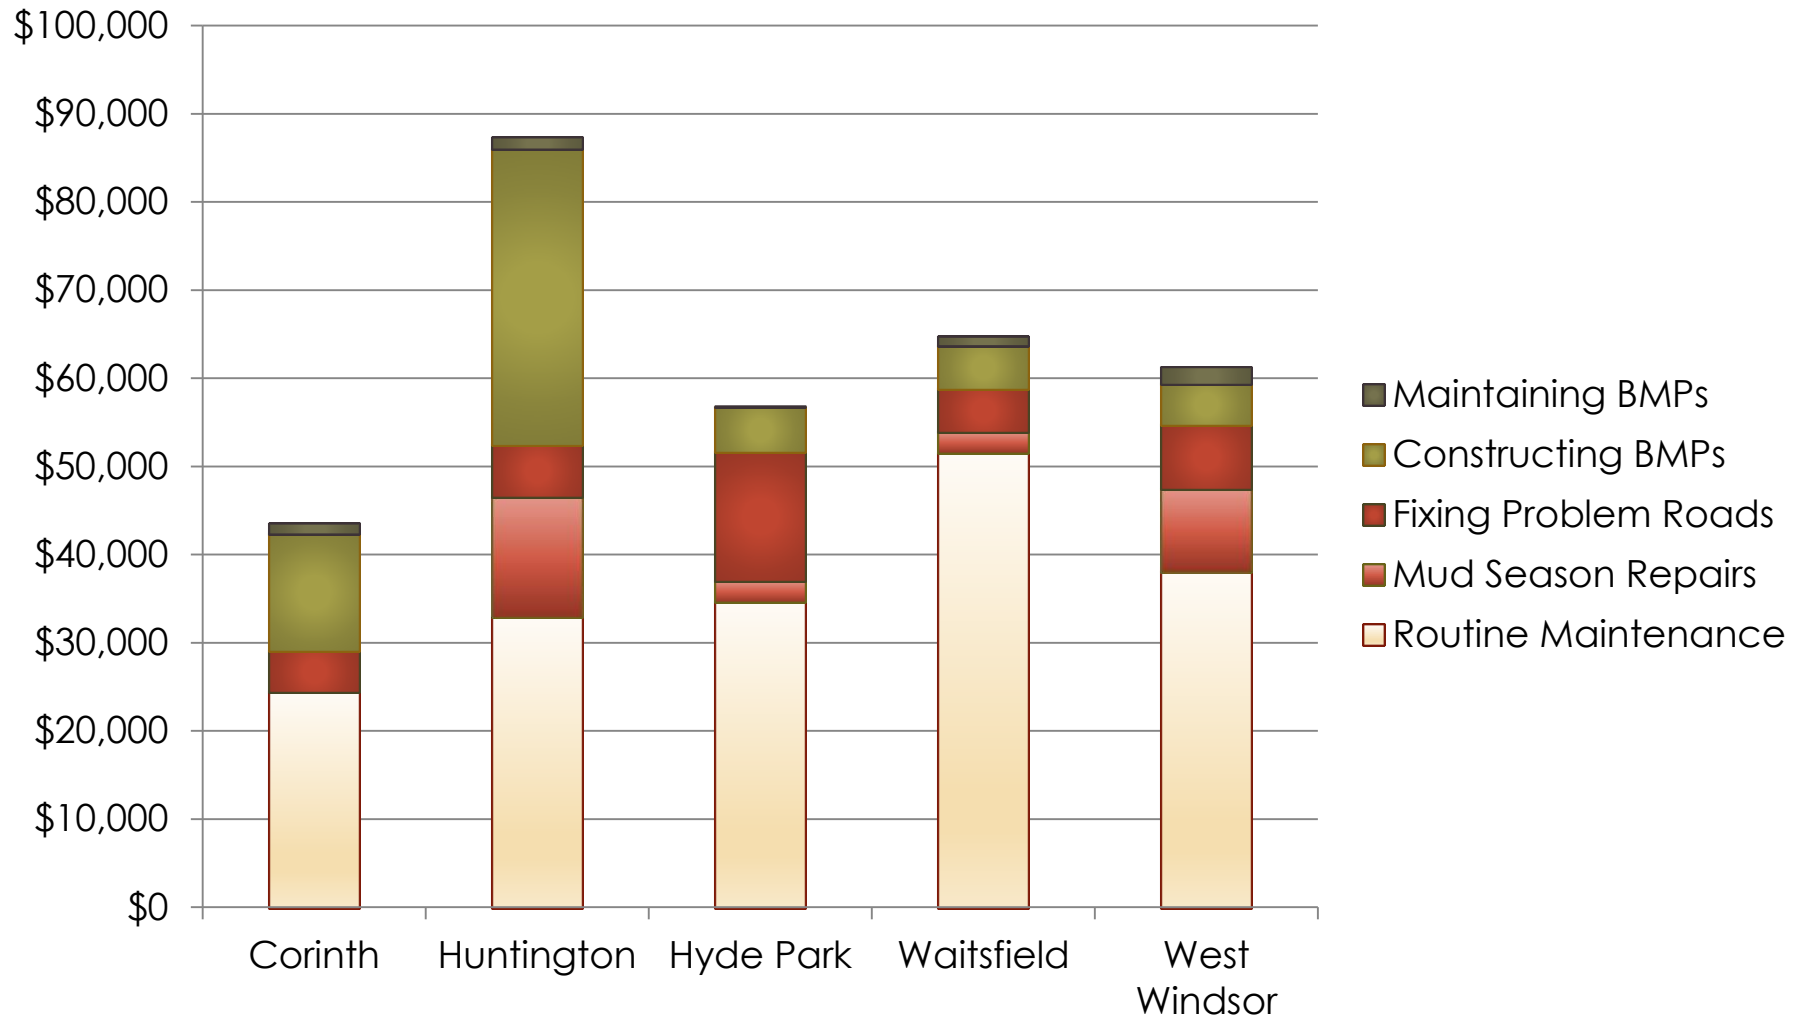
Distribution of road crew salary by non-winter unpaved road maintenance tasks

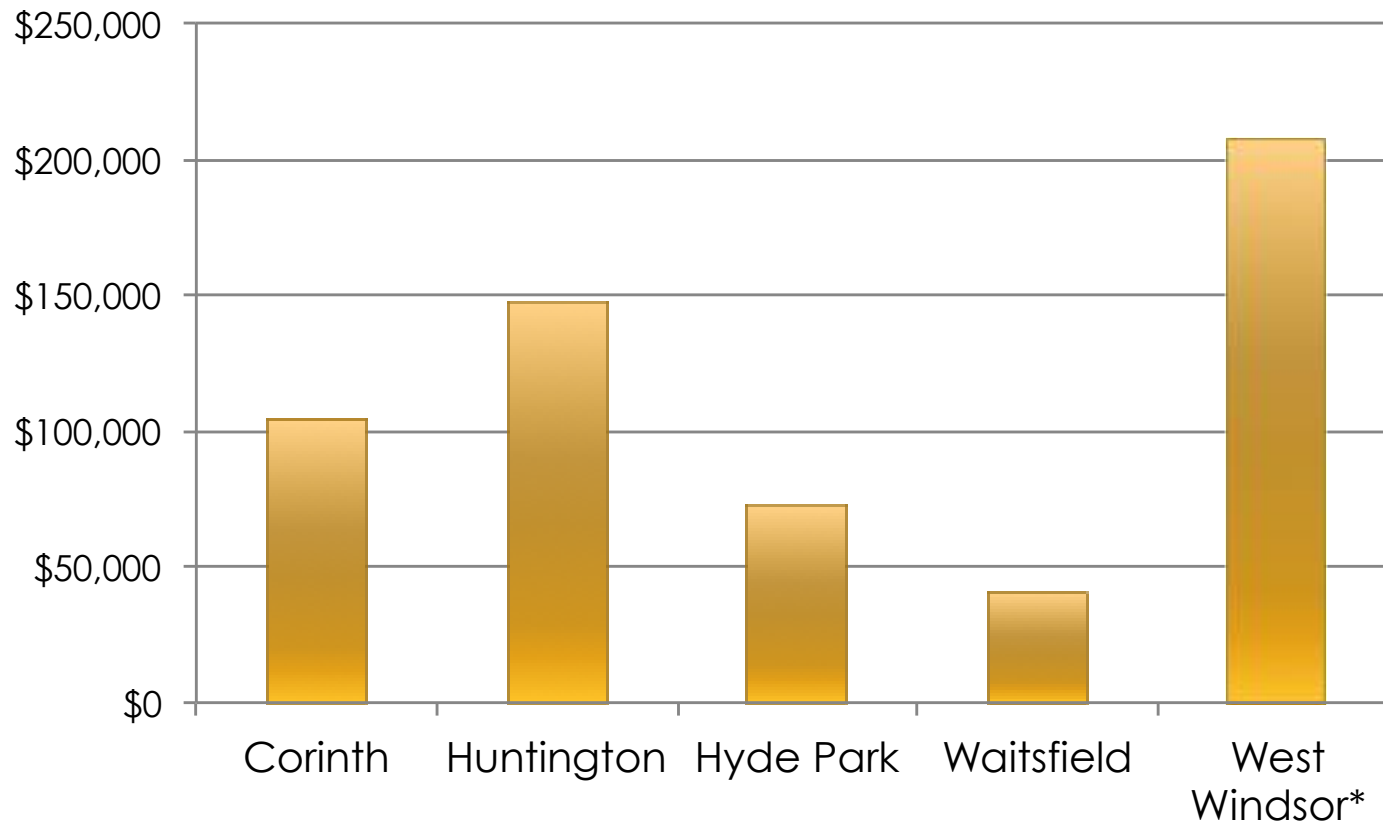
Annual materials costs

Non-Winter Unpaved Road Maintenance

* West Windsor materials total includes \$55,686.81 of itemized equipment rental, materials and trucking as a needed after a 2013 flood event

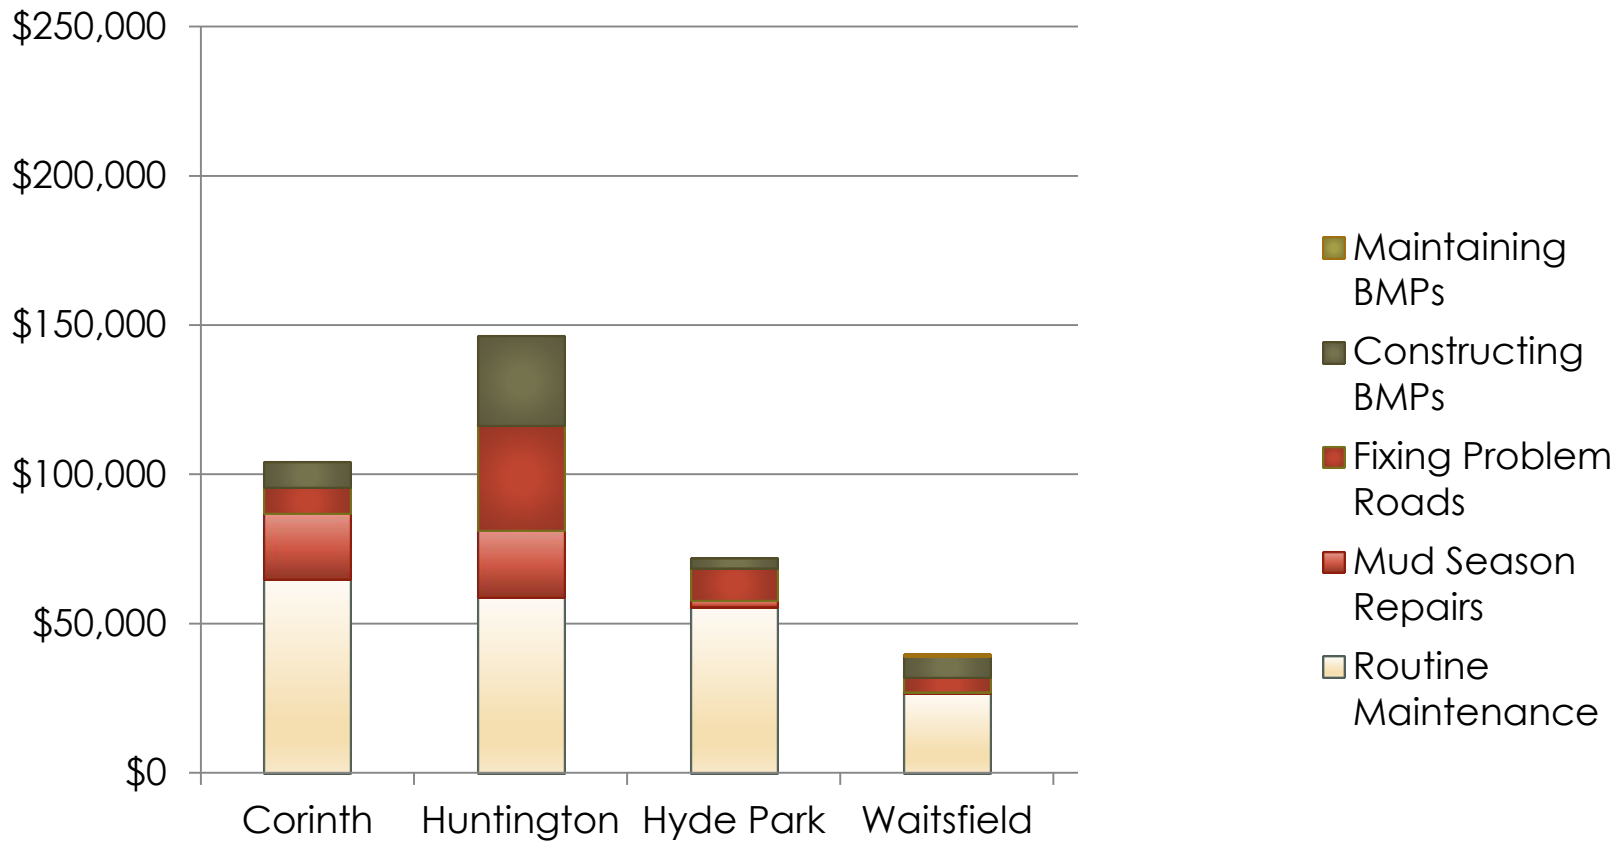
Distribution of materials costs by non-winter unpaved road maintenance tasks

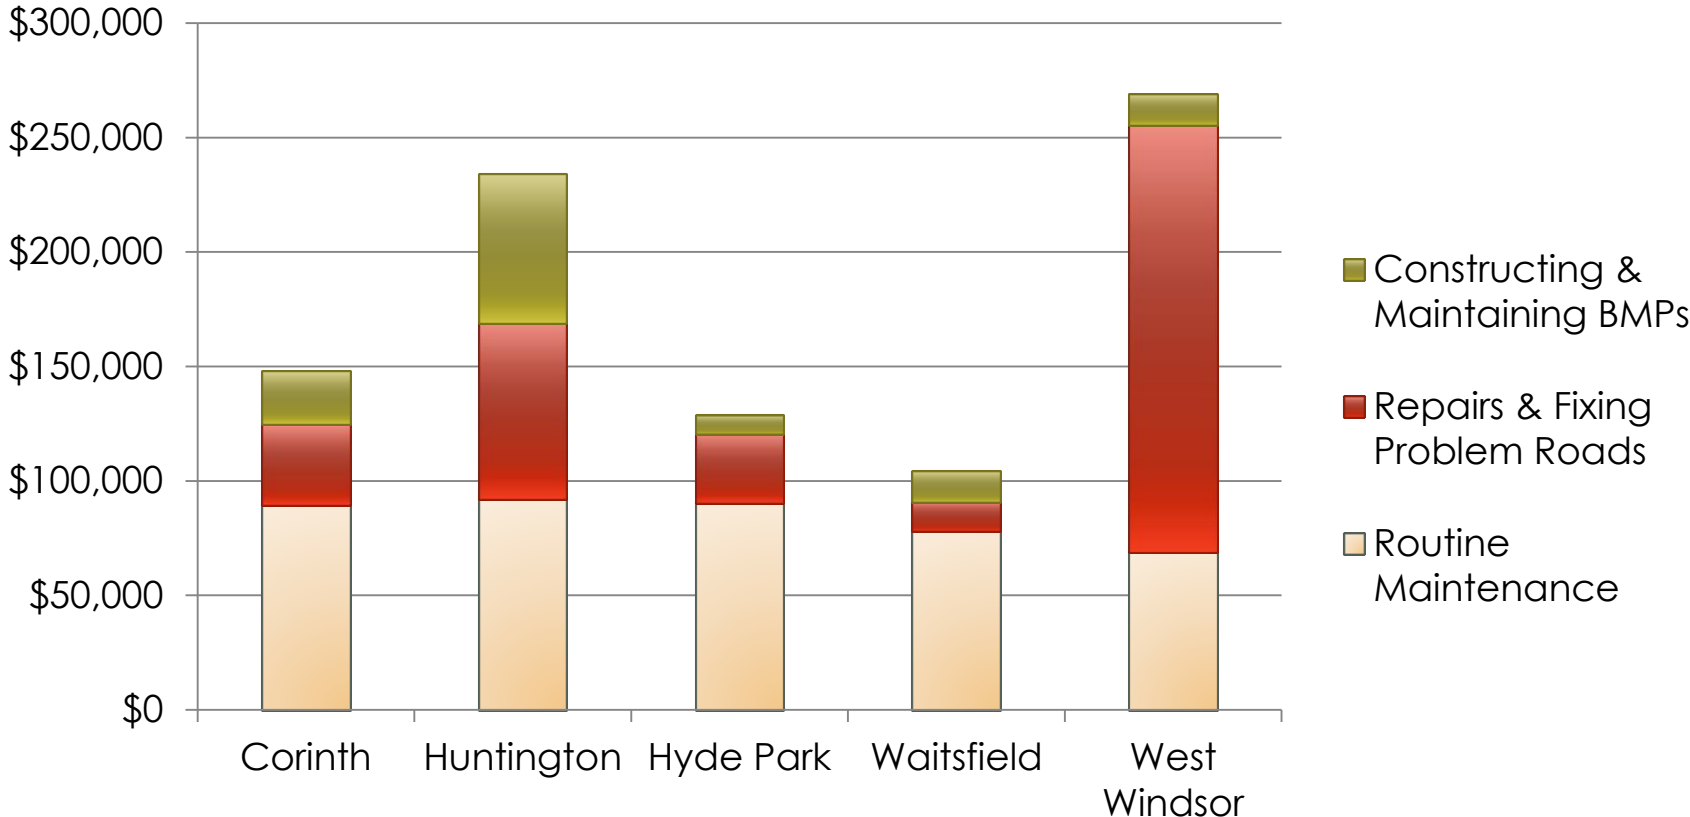
Total salary and materials costs unpaved non-winter road work
