STONE ENVIRONMENTAL

Removing Dissolved Phosphorus from Tile Drain Water

March 23, 2016

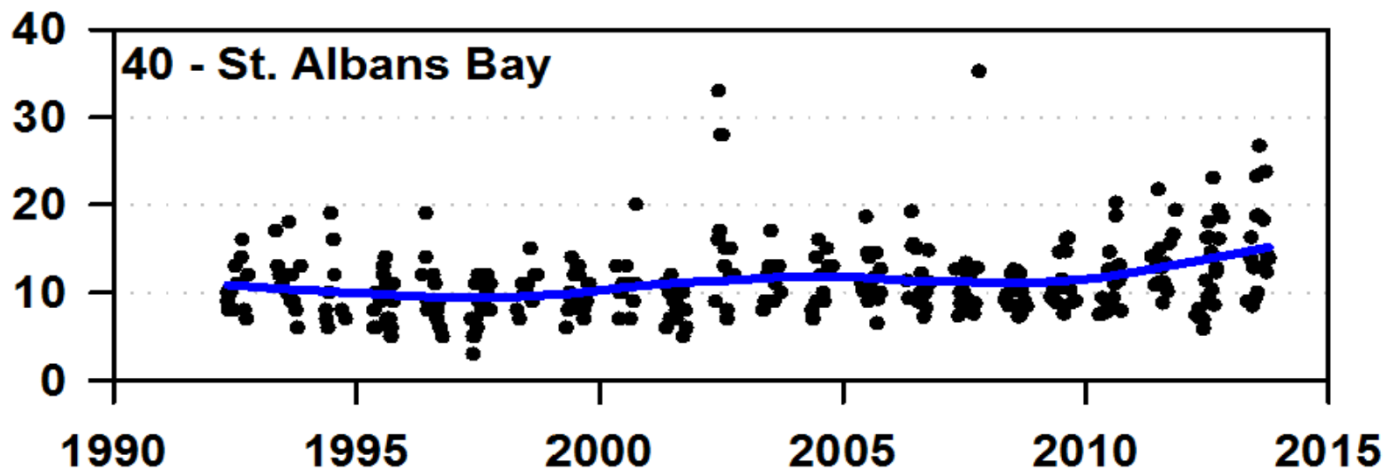
Soluble Phosphorus (TDP) Concentrations (a 20% increase over the last 5 years)

Source: VTDEC LC Long-term Monitoring Program

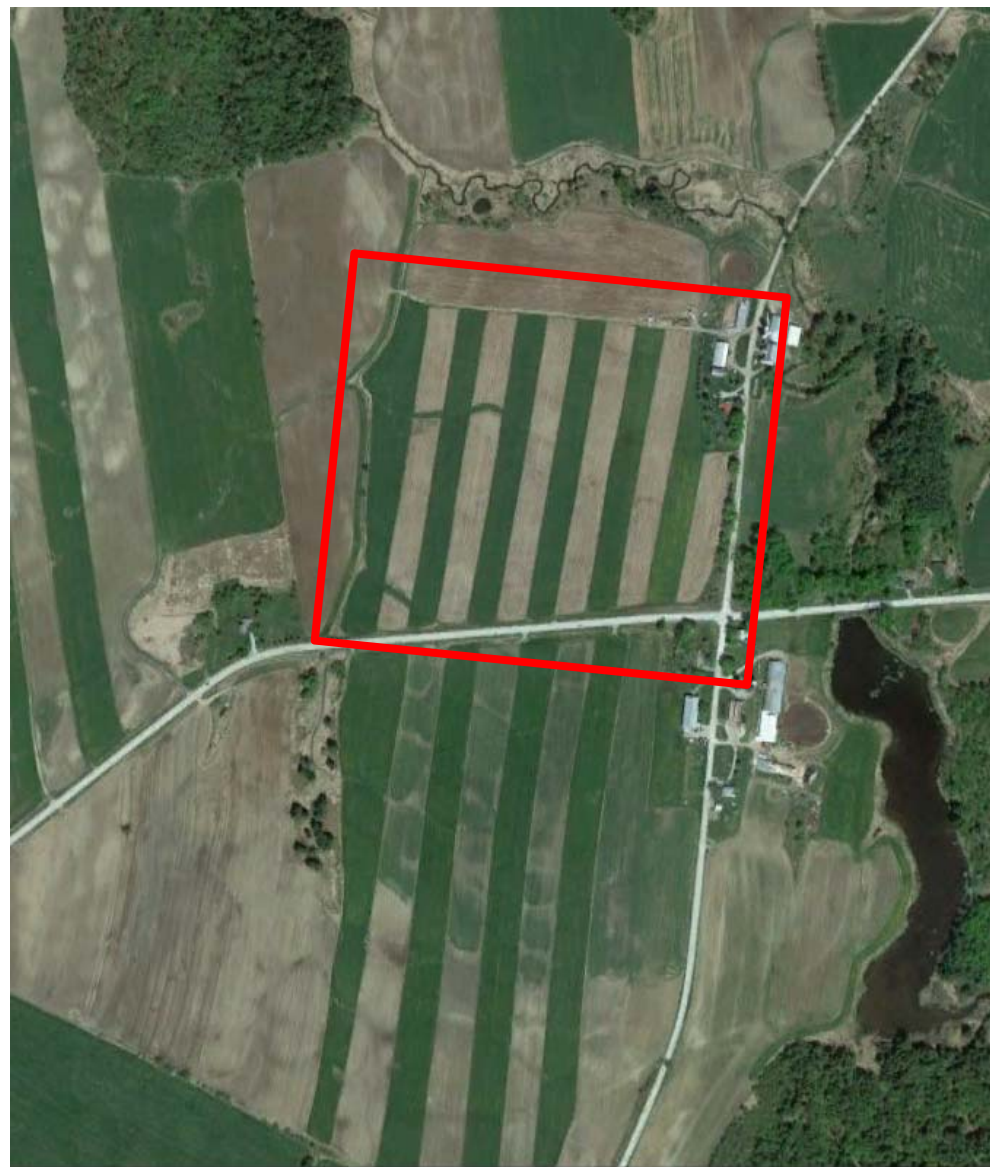
Site in Franklin, VT

Study Farm Characteristics

- Small dairy farm
 - Milking ~120 cows
- Soybean/corn strips on field
- Tile drainage system drains about 35 acres
- Tile discharges into a ditch on the west side of the field

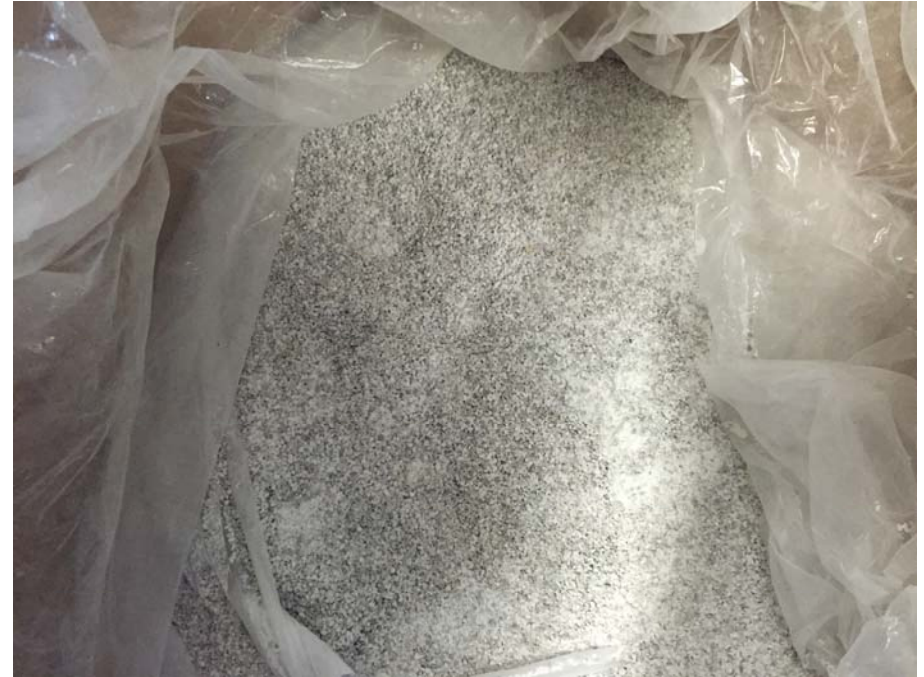
Filtration Media #2 – Bedding Sand

Bedding sand from Swanton facility was selected

- Good phosphorus removal capacity
- Appropriate hydraulic conductivity

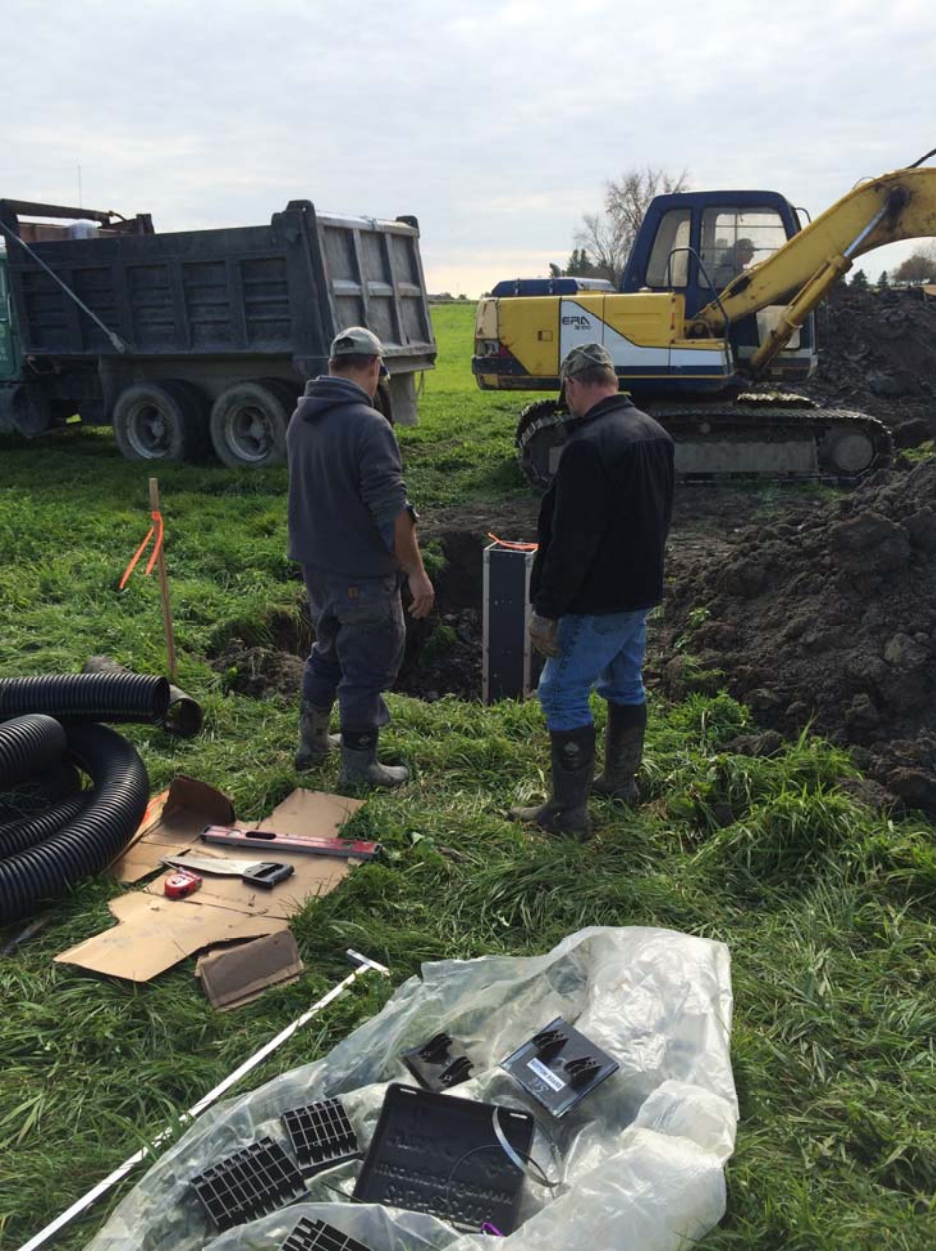
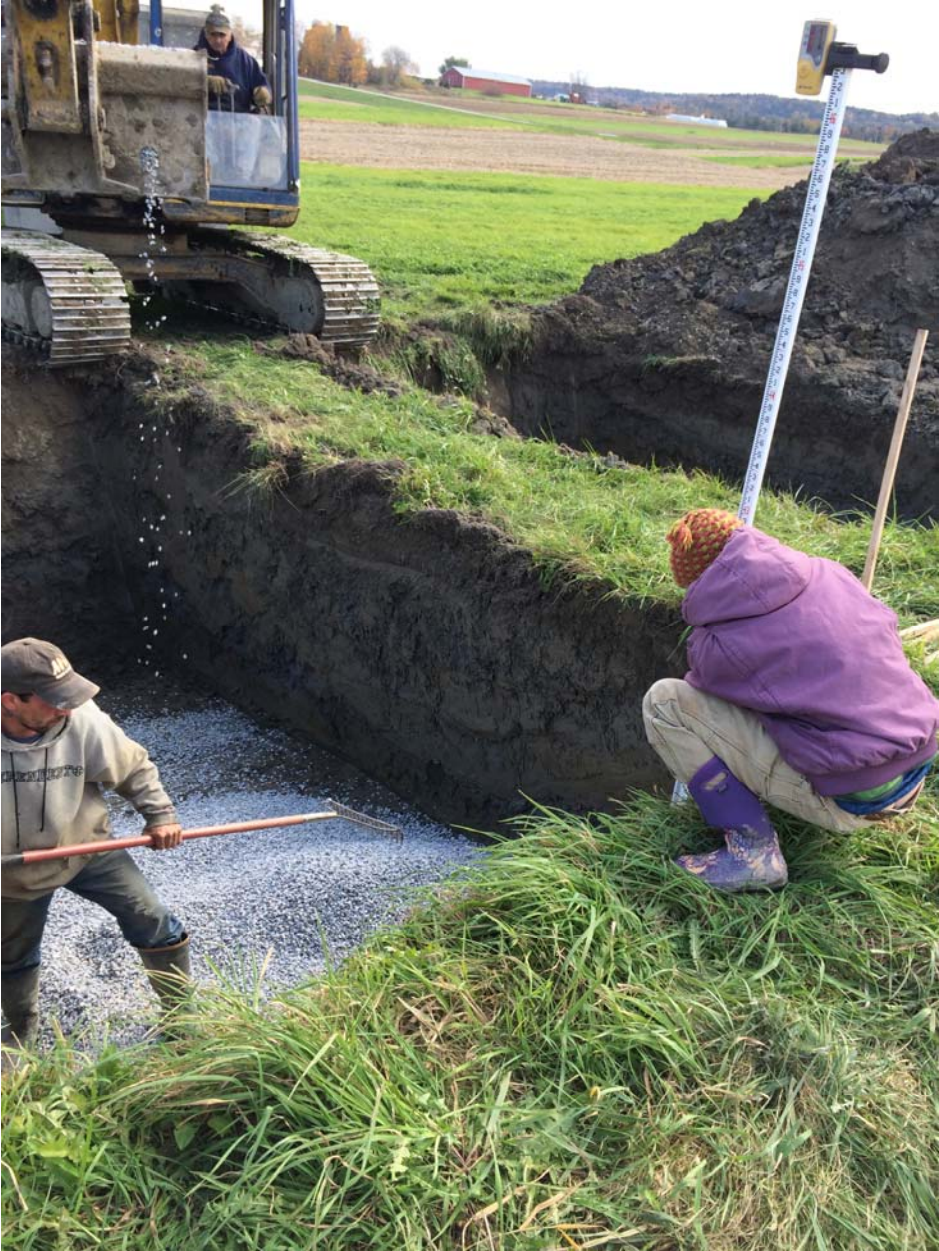
System Installation

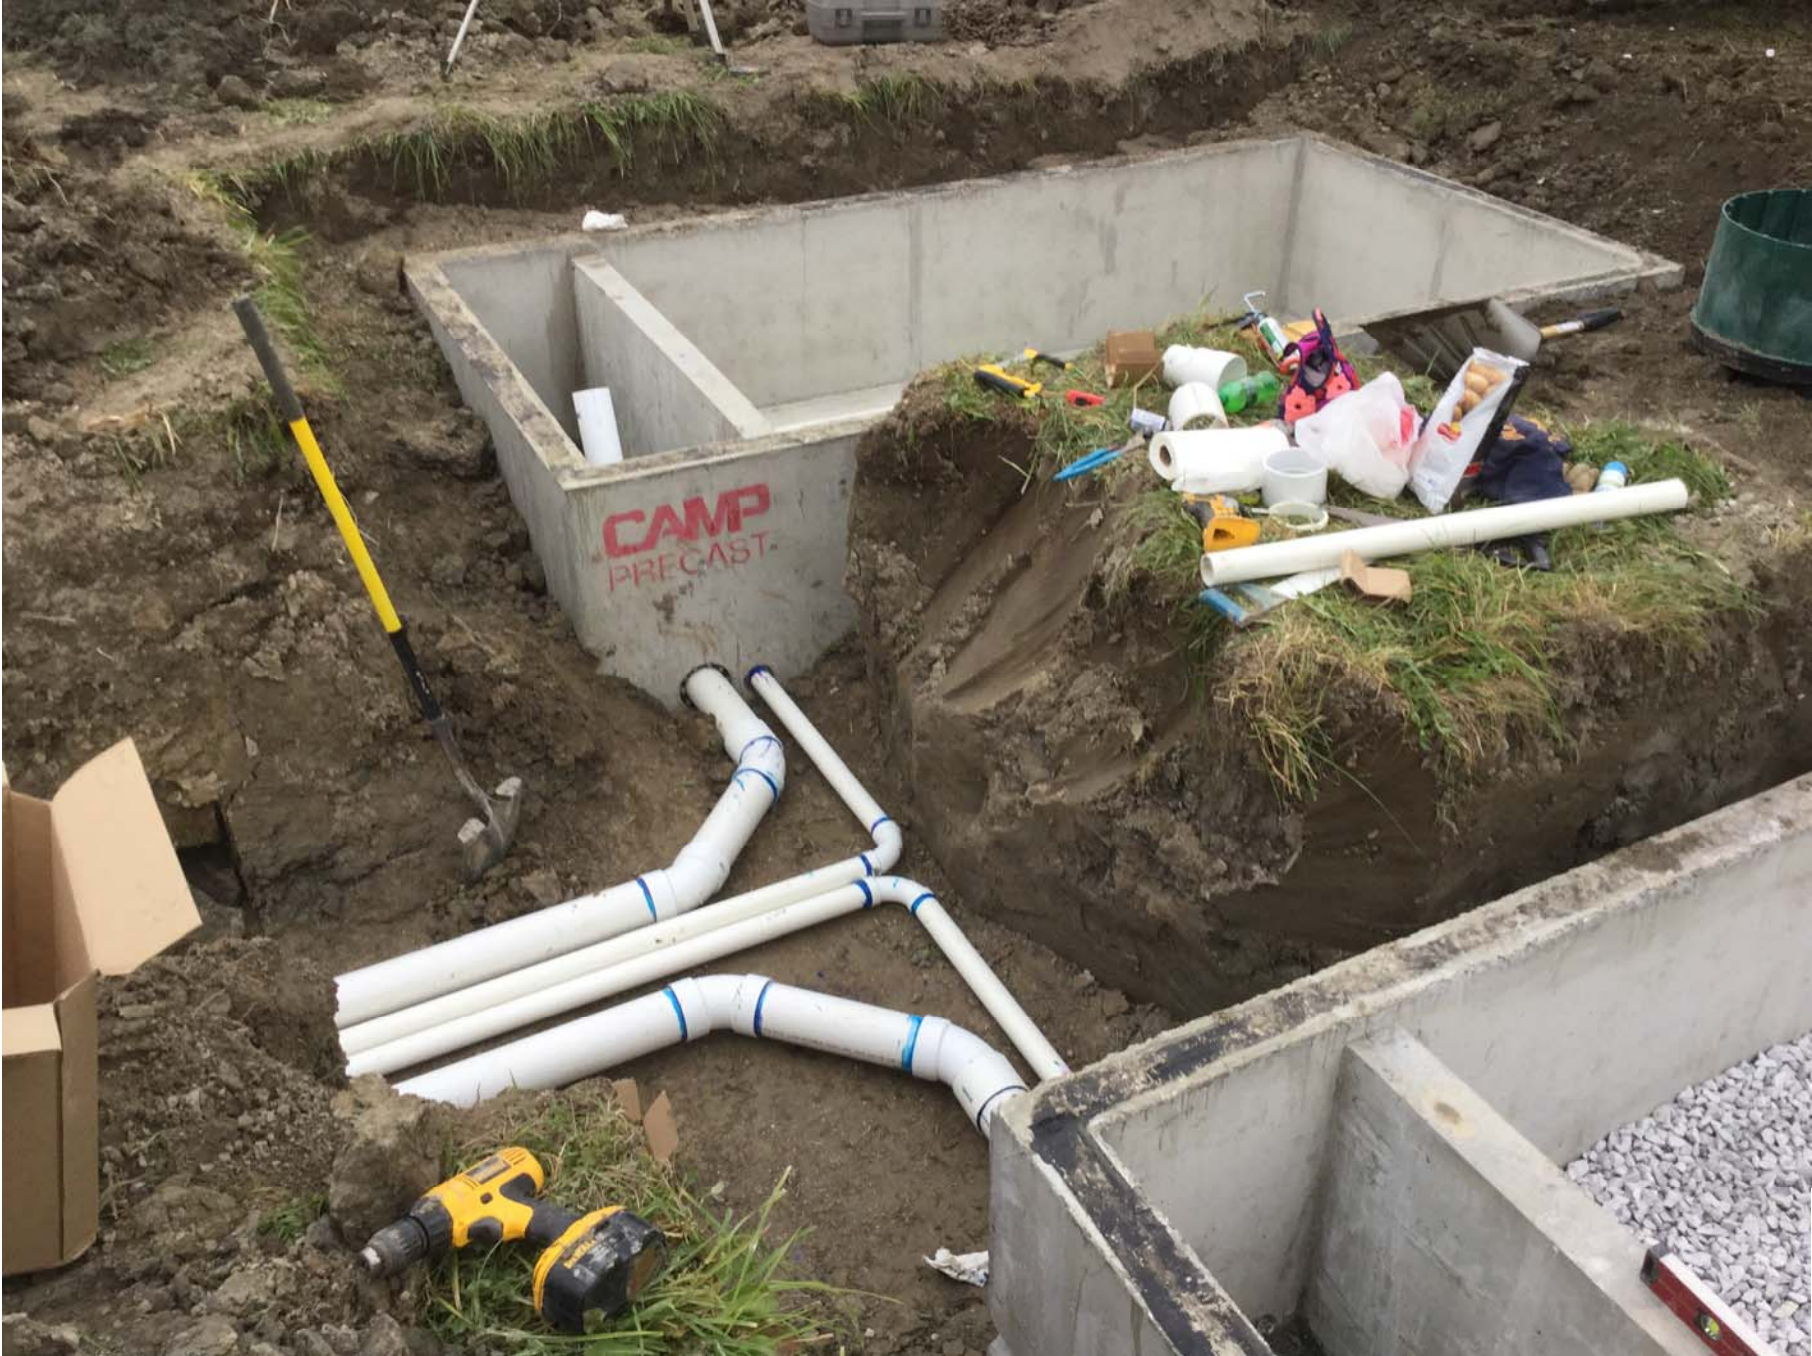
System Installation

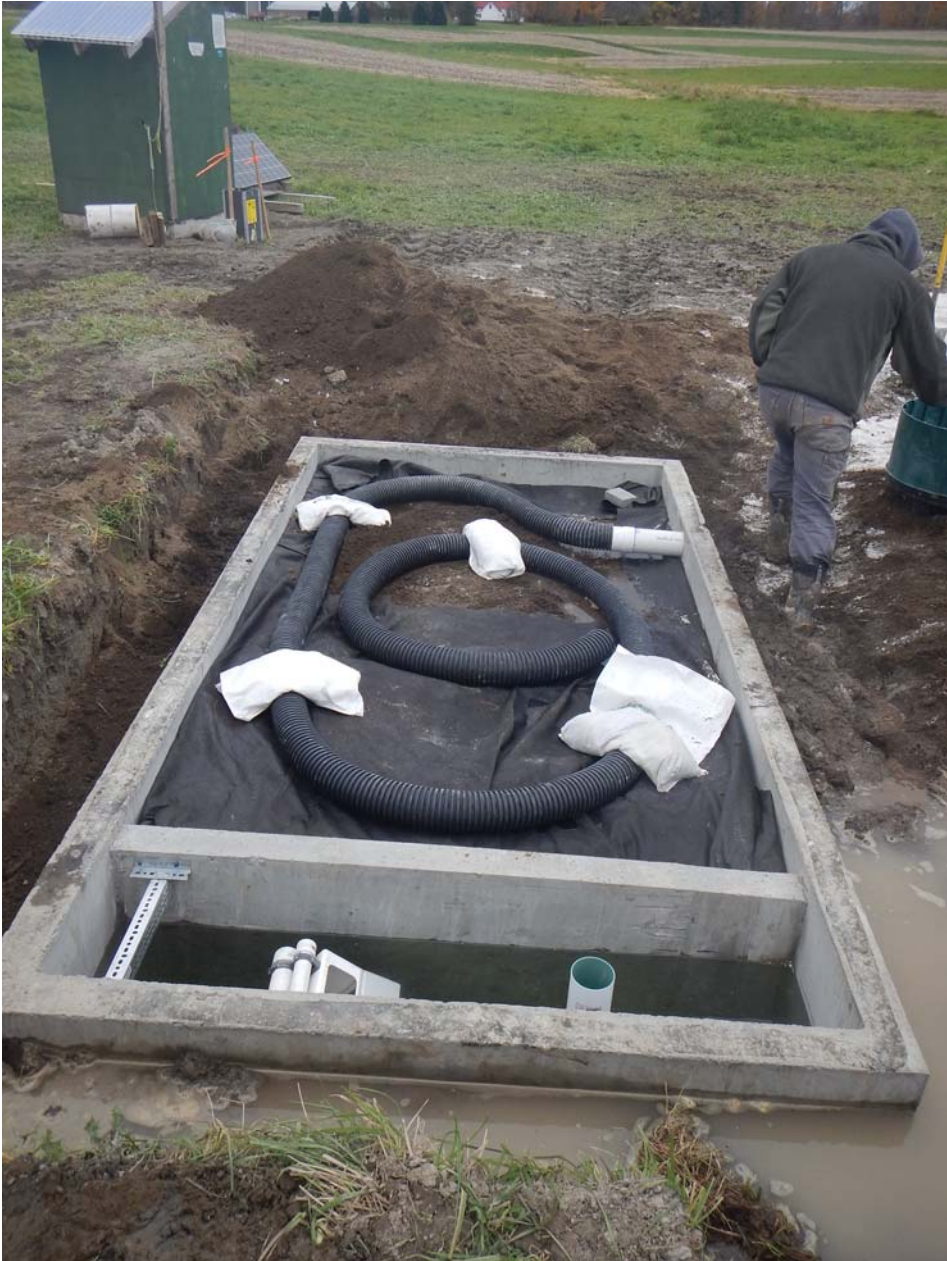
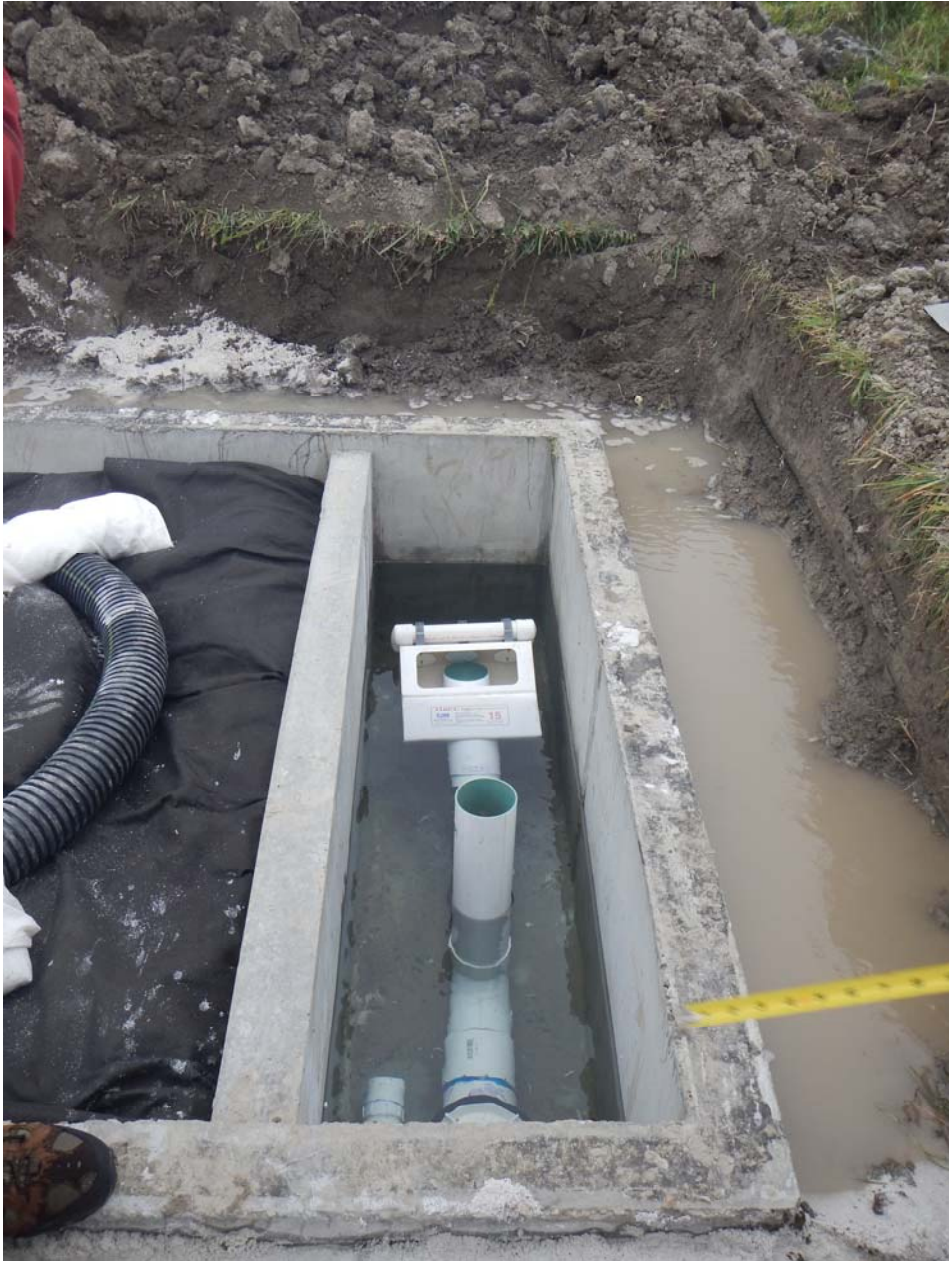
System Installation

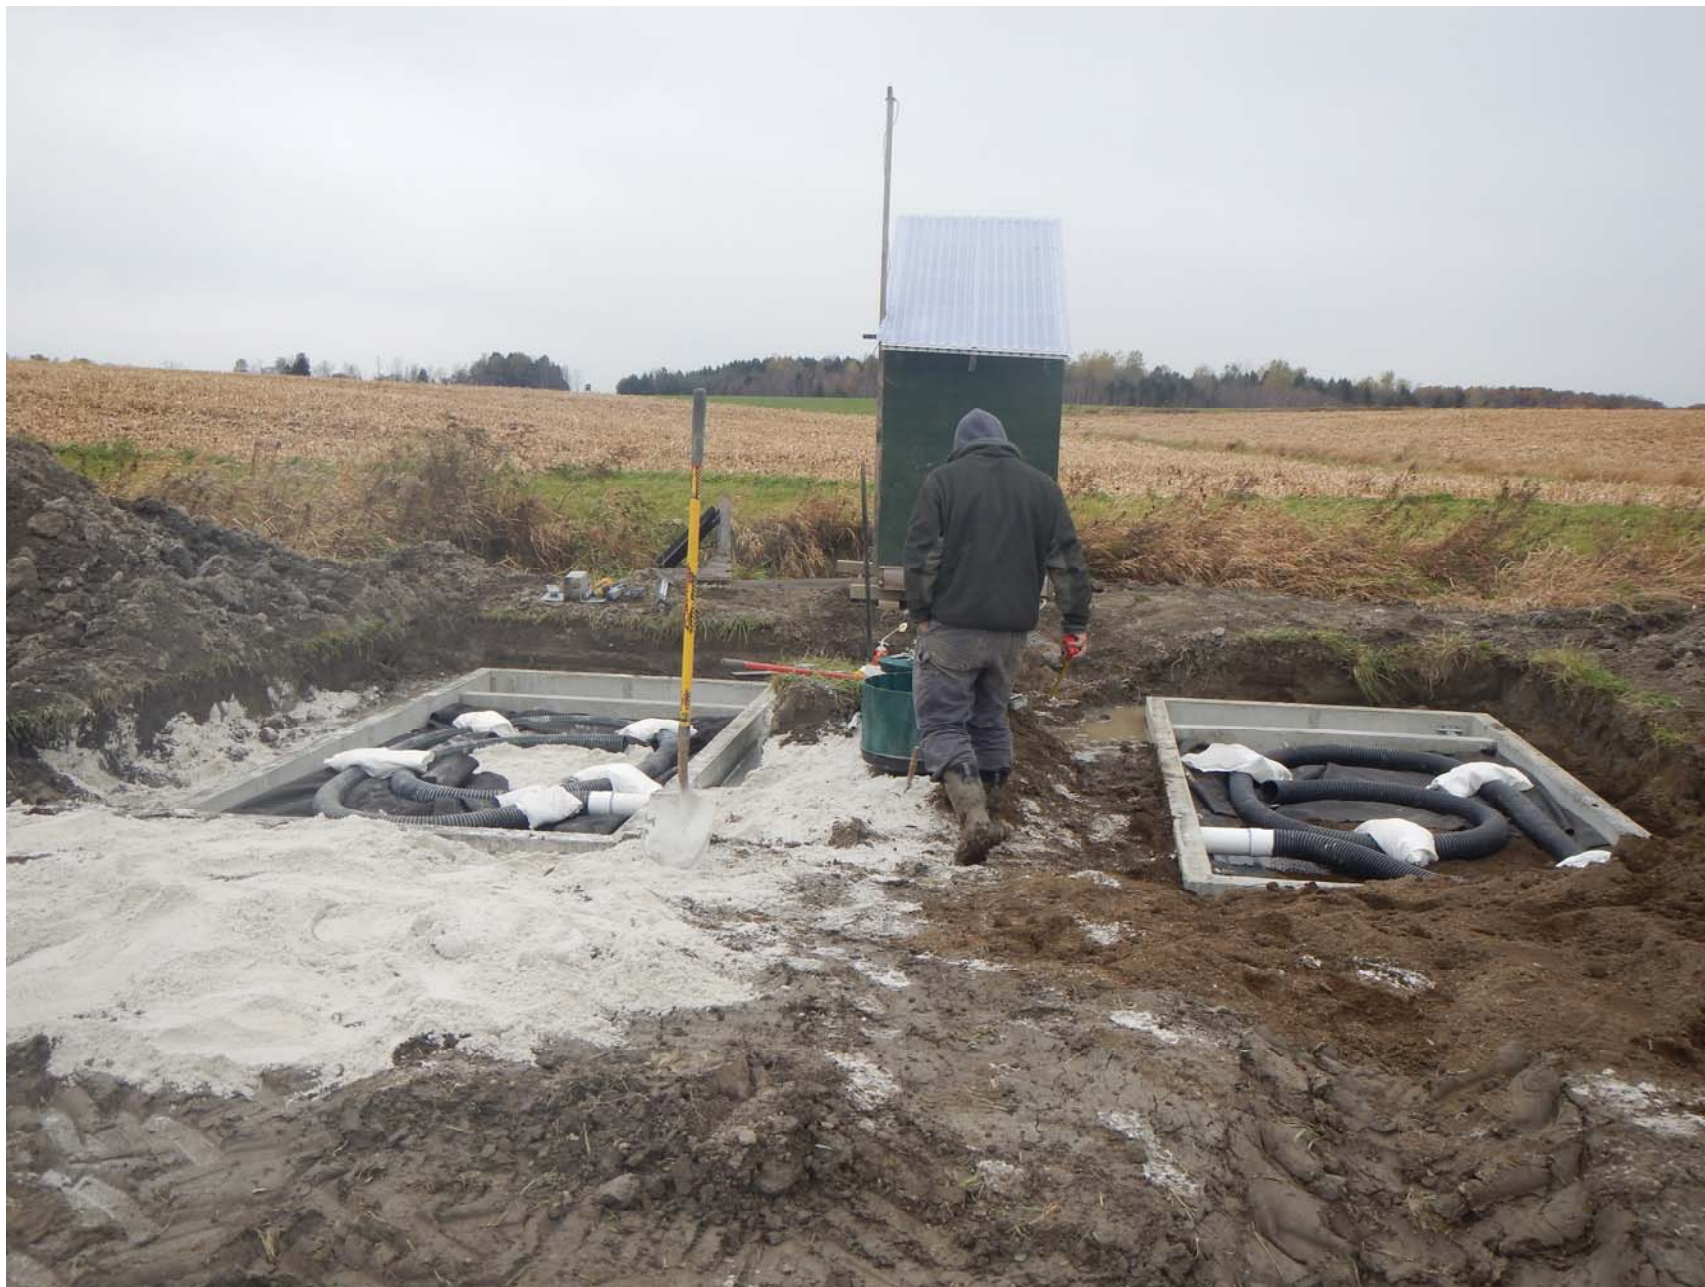
System Installation
