Re: Green Mountain Power Corporation
Kingdom Community Wind
Lowell, Vermont
Stormwater Discharge Permit No. 6216-INDS
Level Spreader Monitoring Study - 2016 Monitoring Report

Level Spreader Monitoring Study

Kingdom Community Wind
Lowell, Vermont

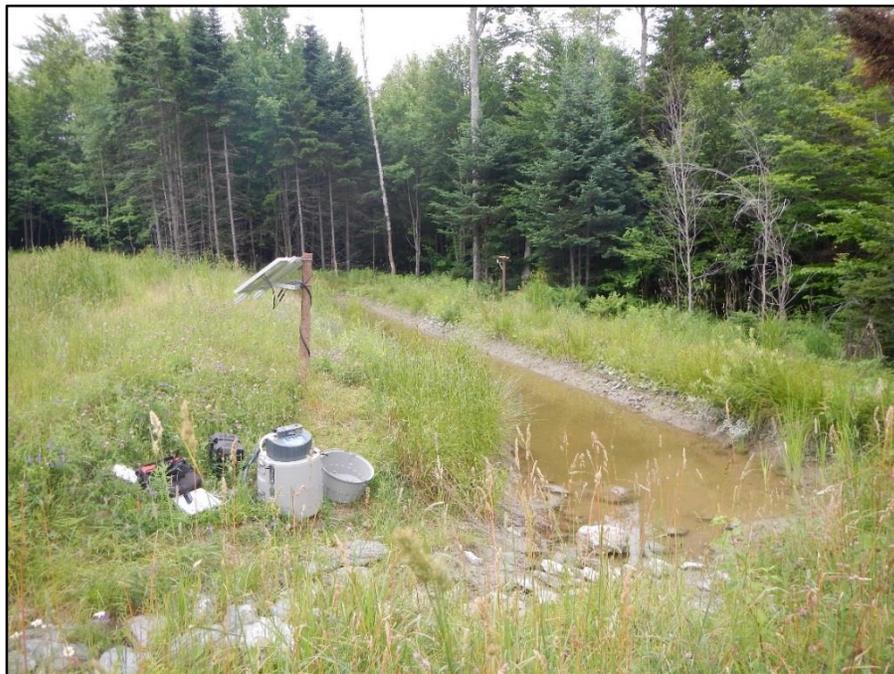
Photograph 1. Automated sampler at LS-A9 inlet. Flow enters LS-A9 in the stone-lined swale in the foreground of the photograph (VHB, 07/08/16).

The "Inlet" sampler was positioned to measure and collect samples from the stone-lined swale that conveys stormwater runoff to LS-A9. See Photograph 1.

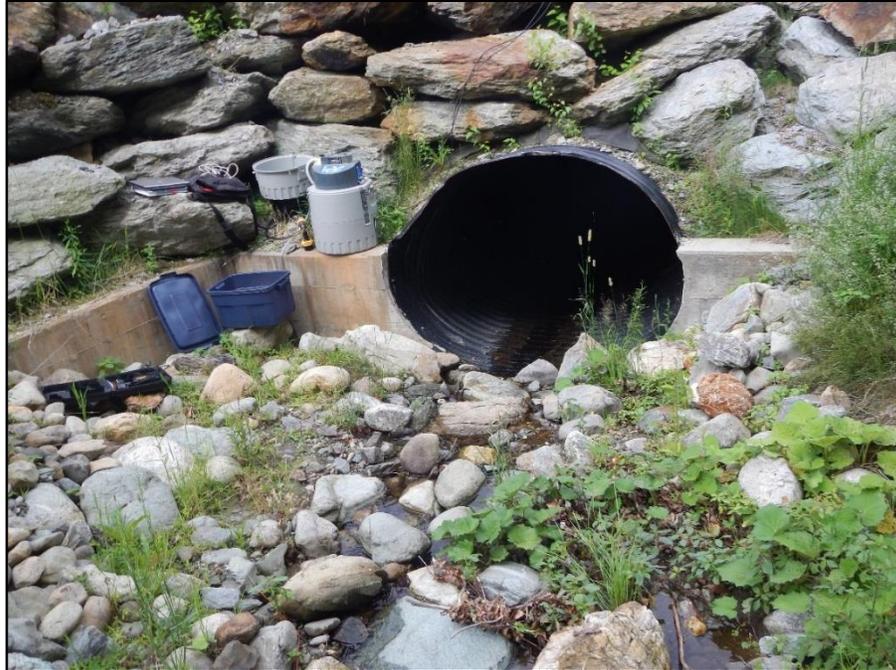
Photograph 2. Automated sampler at Access Road culvert inlet, upstream from LS-A9 vegetated buffer area (VHB, 07/08/16)

The “Upstream” sampler was positioned to measure and collect samples from stream 2009-TB-C3 as it flows through the culvert beneath the Access Road north of LS-A9. See Photograph 2.

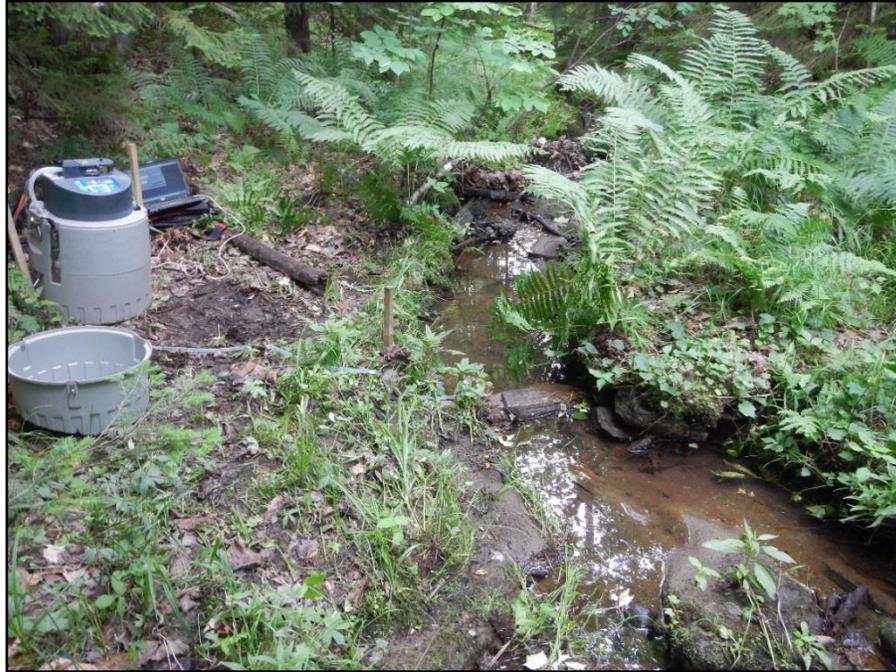
Photograph 3. Automated sampler adjacent to stream 2009-TB-C3, downstream from LS-A9 vegetated buffer area (VHB, 07/08/16)

The “Downstream” sampler was positioned to measure and collect samples from a downstream reach of 2009-TB-C3 located west of LS-A9. See Photograph 3.

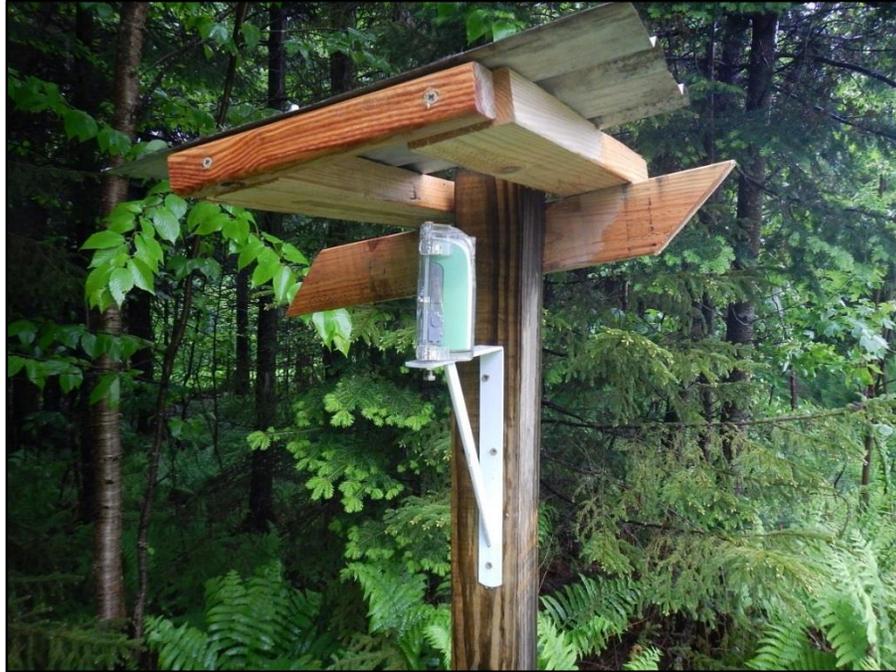
Photograph 5. Time-lapse camera mounted adjacent to LS-A9. Shed roof was added to prevent rainwater from obscuring lens during storm events (VHB, 06/05/2016)

A digital camera installed in a weather-proof housing attached to a post near LS-A9 automatically recorded photographs on a 5-minute interval. See Photograph 5.

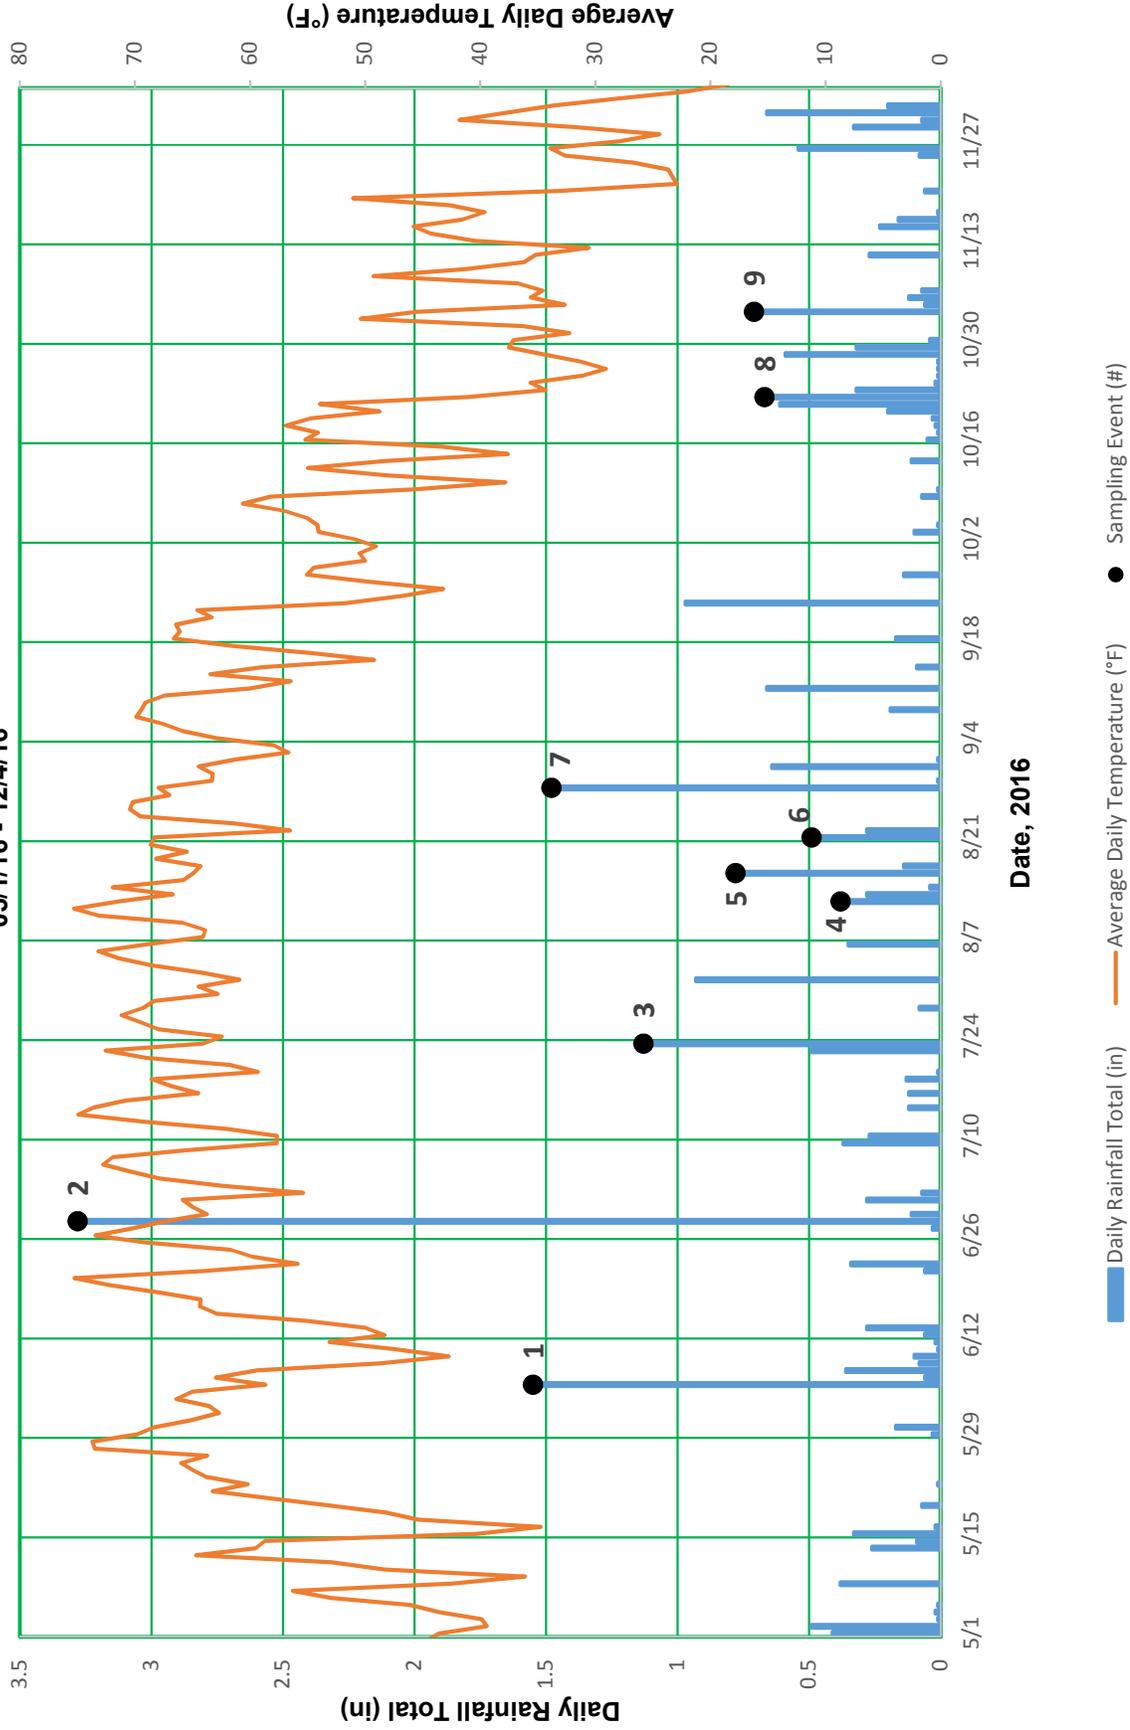
**Green Mountain Power - Kingdom Community Wind
Alternative Stormwater Treatment Practice Study
Summary Table of Rainfall and Temperature Data
Prepared by VHB on: January 3, 2016**

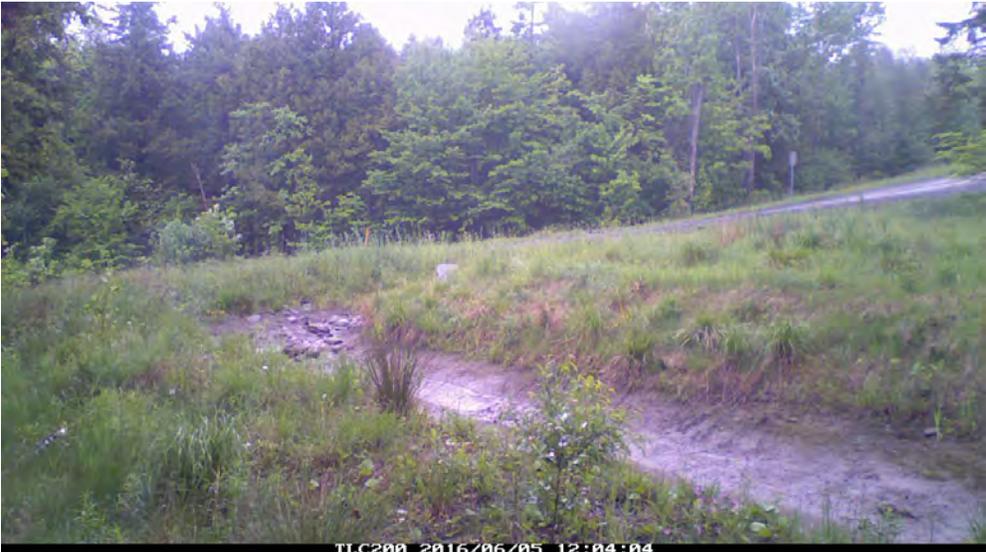
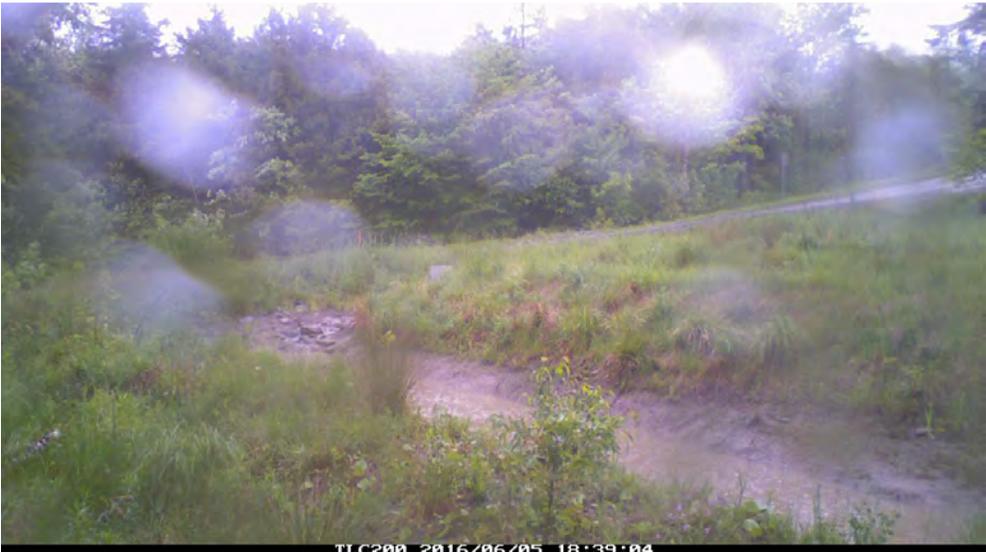
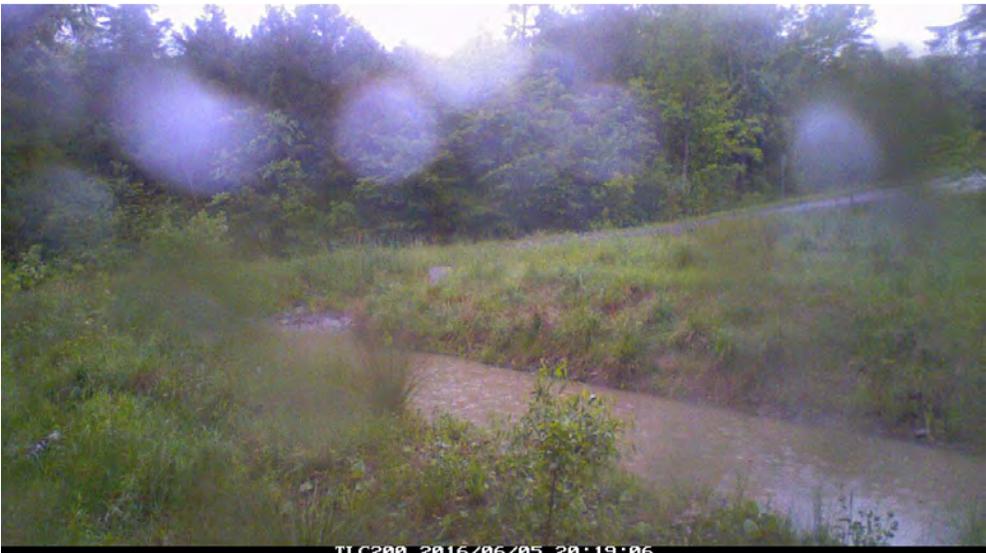
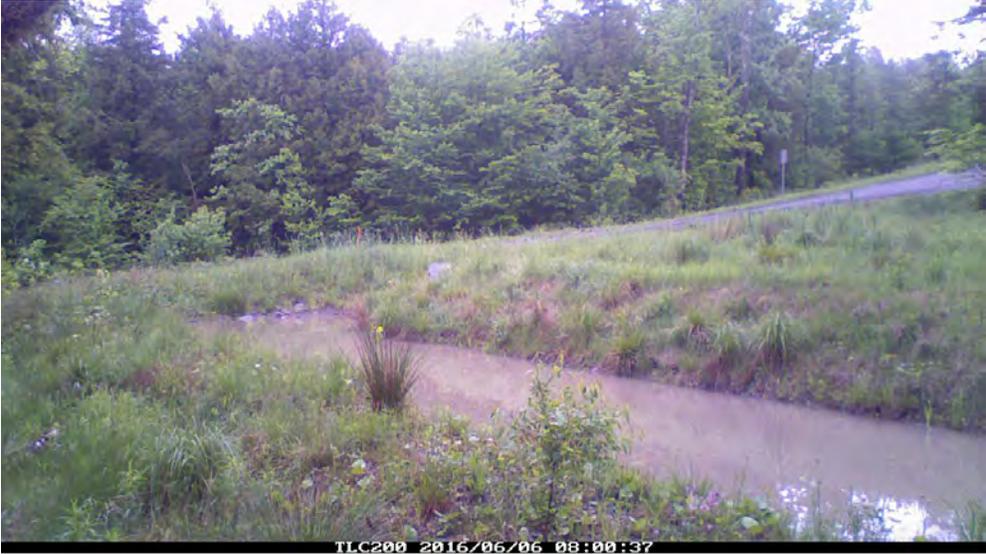
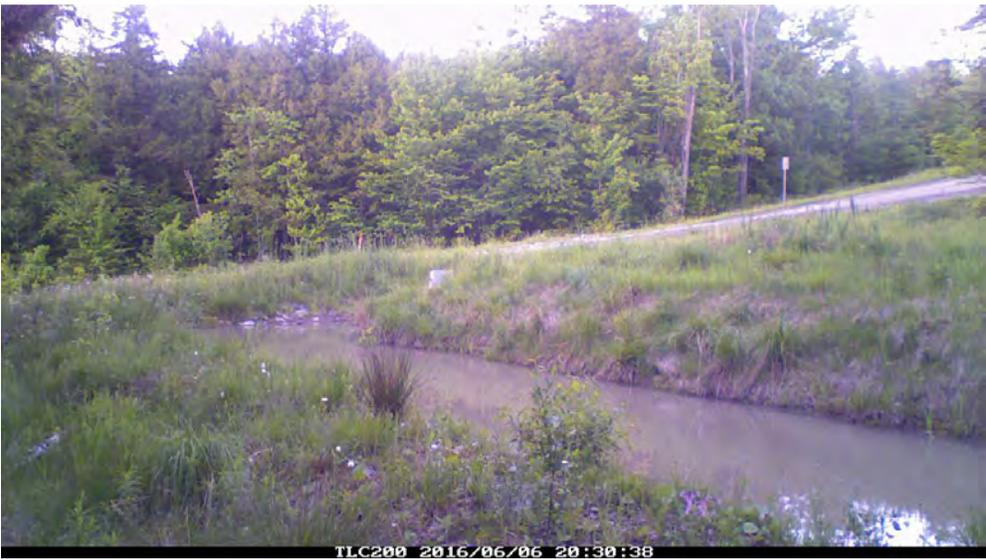
<p>This rain event is believed to have filled the level spreader enough to overtop the level lip and discharge water to the downgradient disconnect area, although it is not visible due to the peak water level occurring after dark when the camera could not capture an image.</p> <ul style="list-style-type: none"> • 5 Minute Peak Intensity = 0.6 in/hr • Total Depth of Rainfall = 1.55 in • Duration of Event = 9 hrs 30 mins • 72-Hour Antecedent Rainfall = 0 in

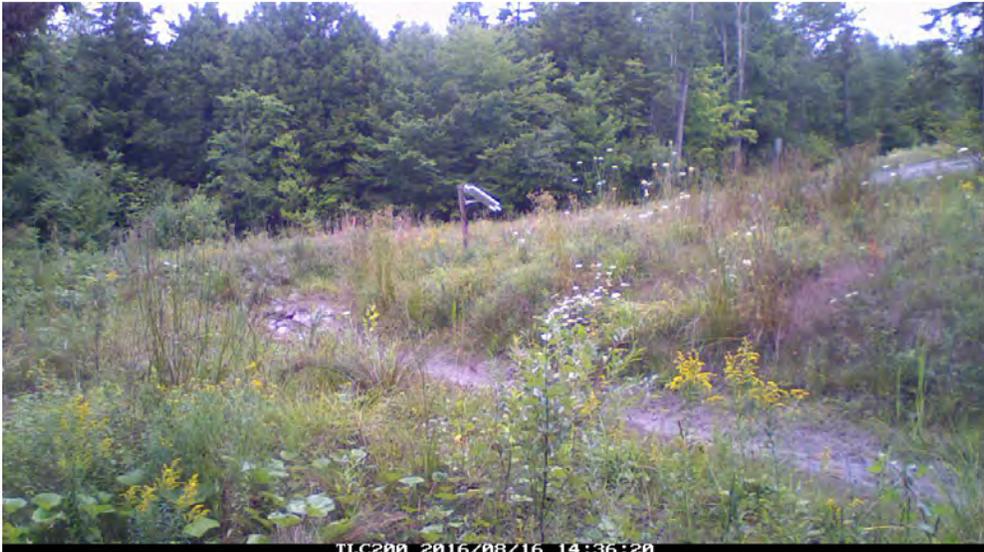
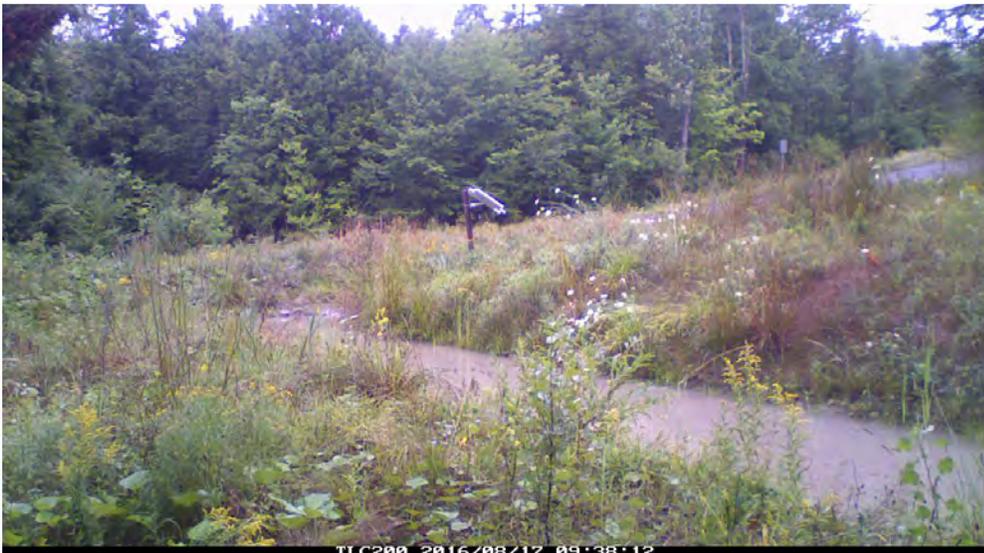
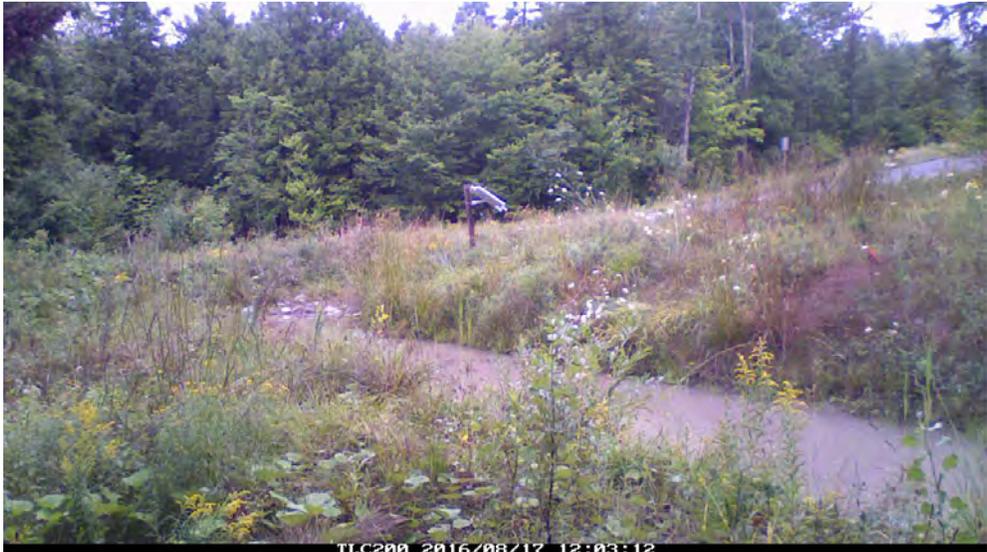
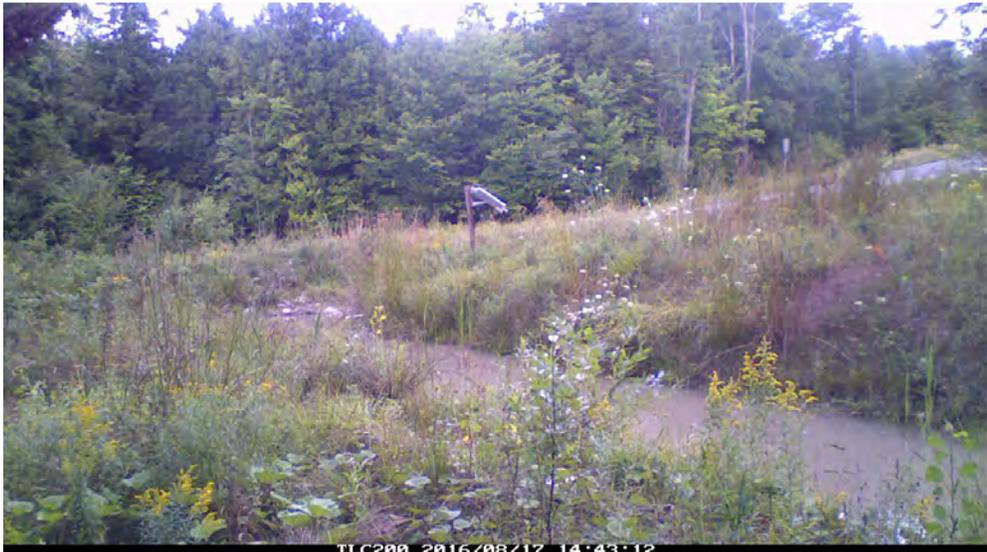
<p>This rain event did not fill the level spreader enough to overtop the level lip.</p> <ul style="list-style-type: none"> • 5 Minute Peak Intensity = 0.84 in/hr • Total Depth of Rainfall = 0.92 in • Duration of Event = 15 hrs 25 mins • 72-Hour Antecedent Rainfall = 0.19 in

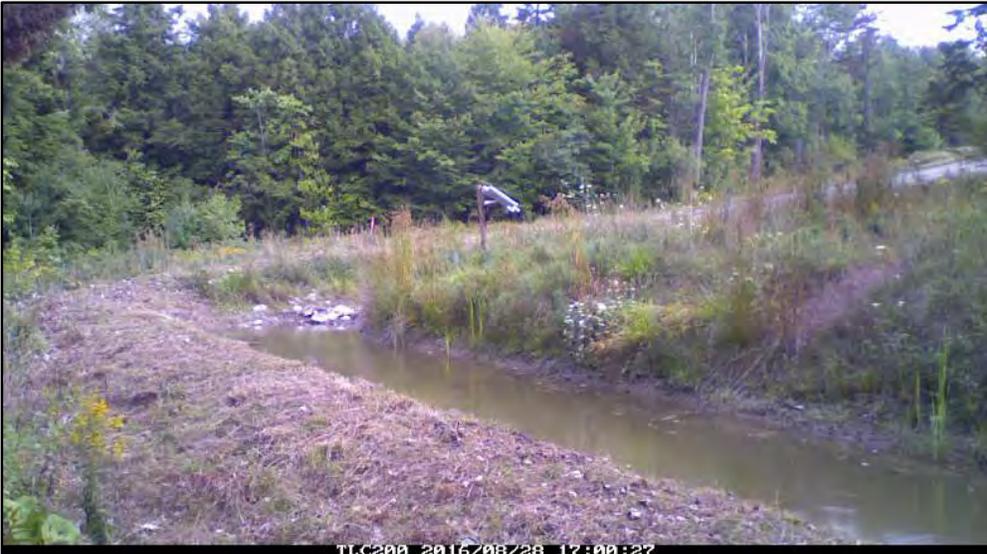
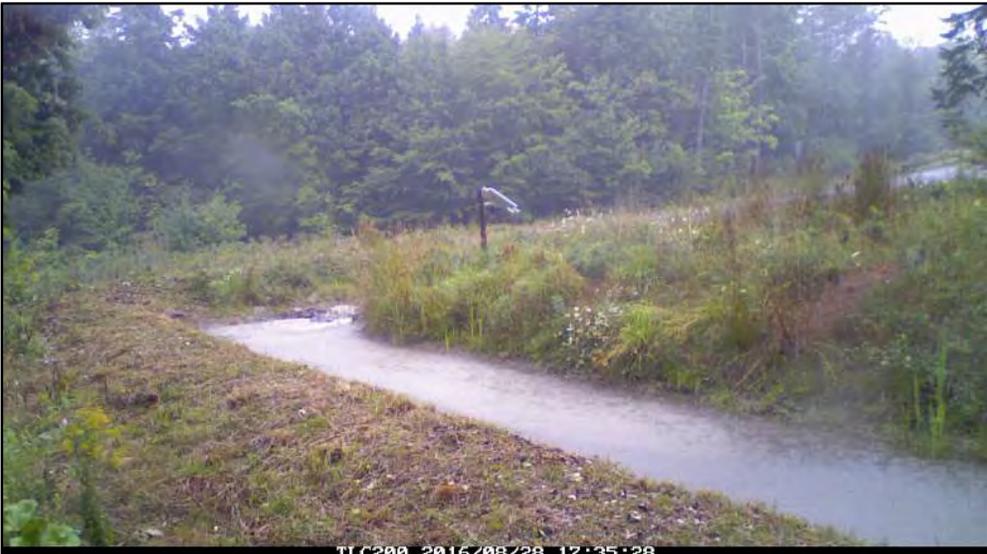
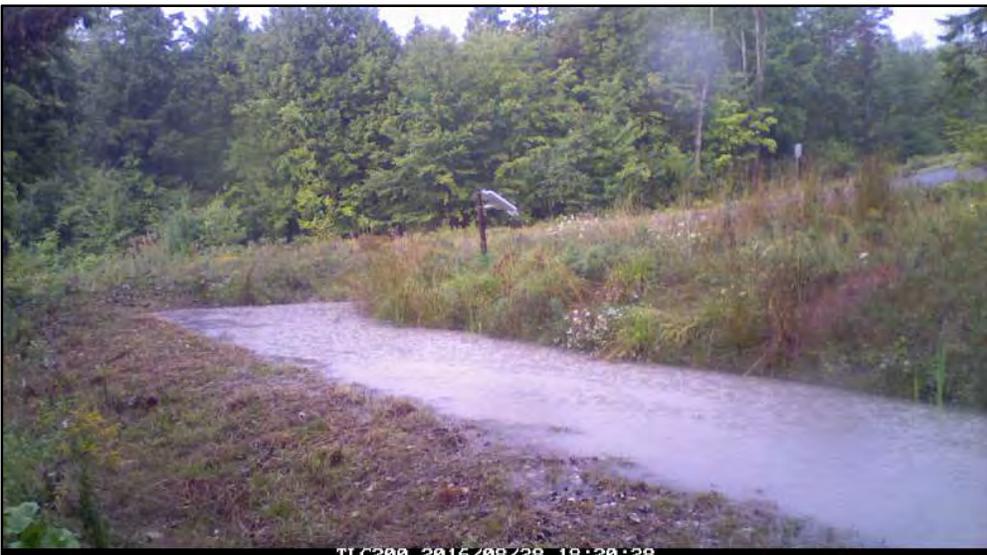
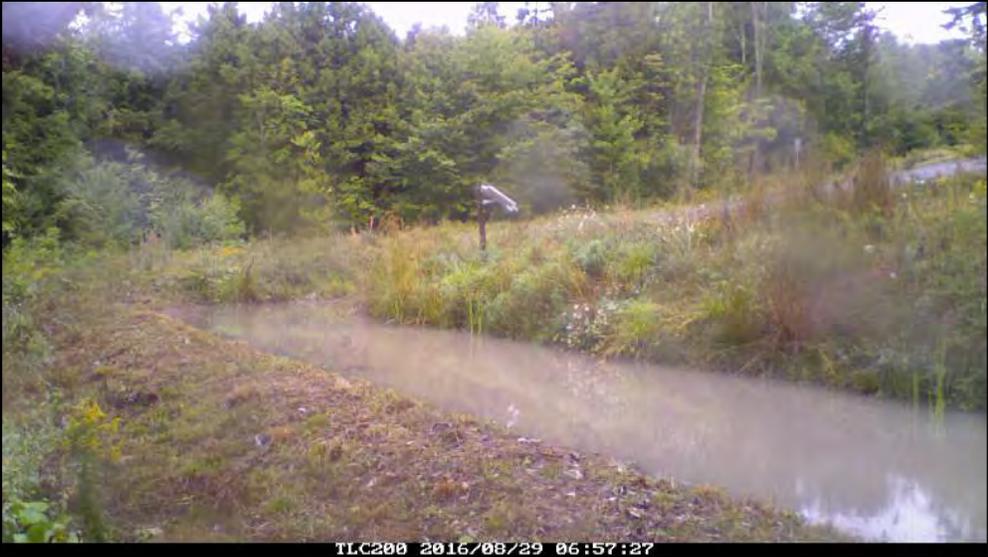
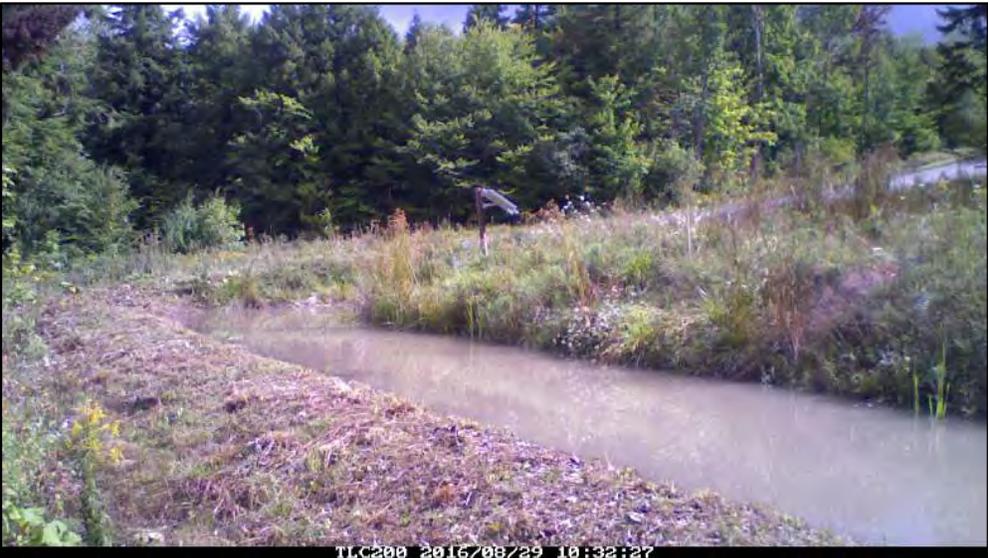
<p>This rain event filled the level spreader enough to overtop the level lip and discharge water to the downgradient disconnect area.</p> <ul style="list-style-type: none">• 5 Minute Peak Intensity = 3 in/hr• Total Depth of Rainfall = 1.48 in• Duration of Event = 2 hrs 40 mins• 72-Hour Antecedent Rainfall = 0 in

As shown in Table 2, the highest TSS concentration for all events was observed at the inlet sample collected during the intense event of August 28, 2016. This event had a total rainfall depth of 1.48 inches over a period of 2 hours and 40 minutes. Larger quantities of sediment can be liberated during intense storms due to the higher energy and increased flow velocities.

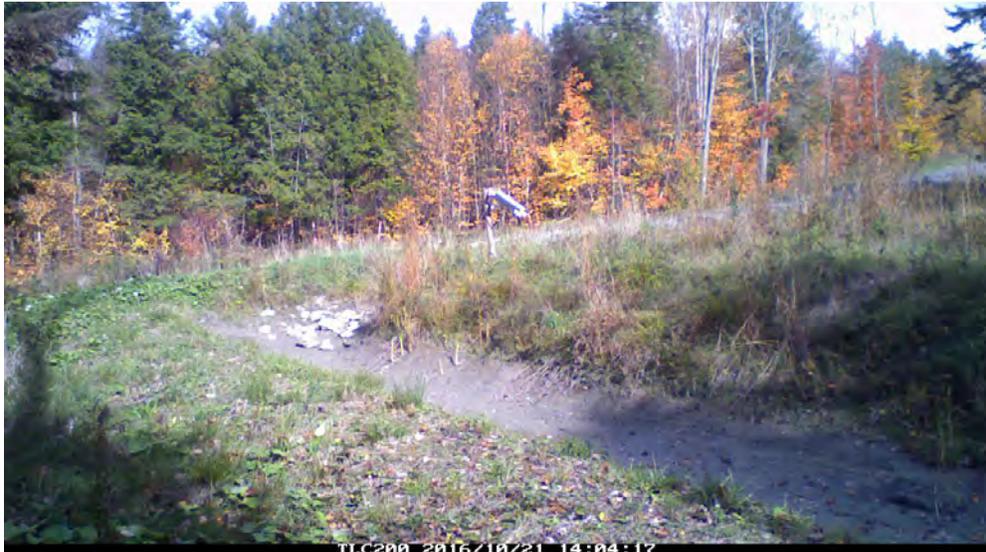
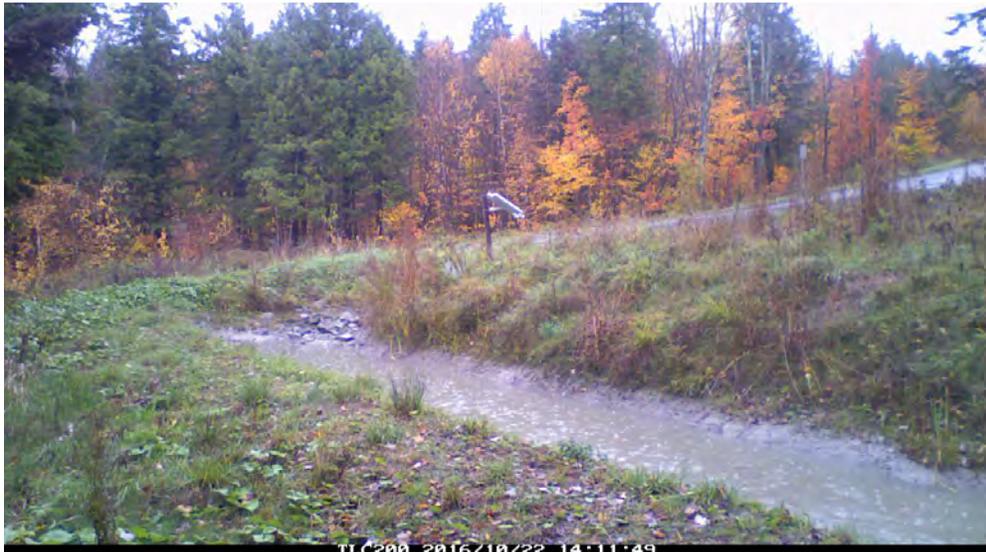
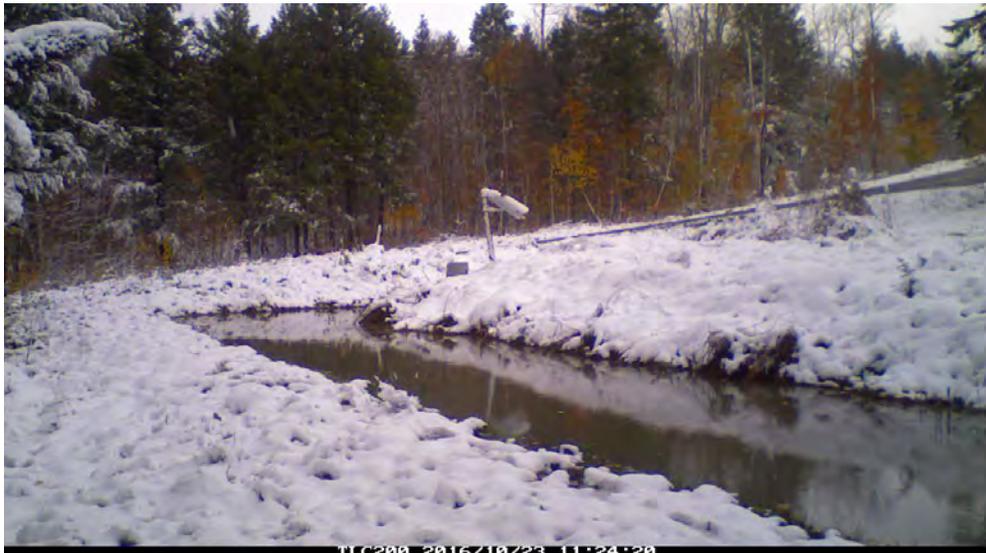
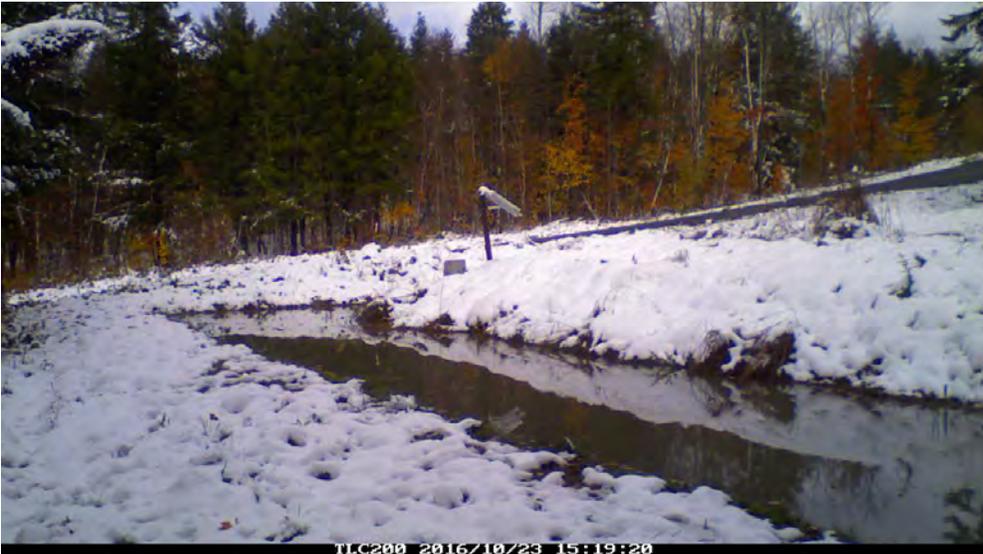
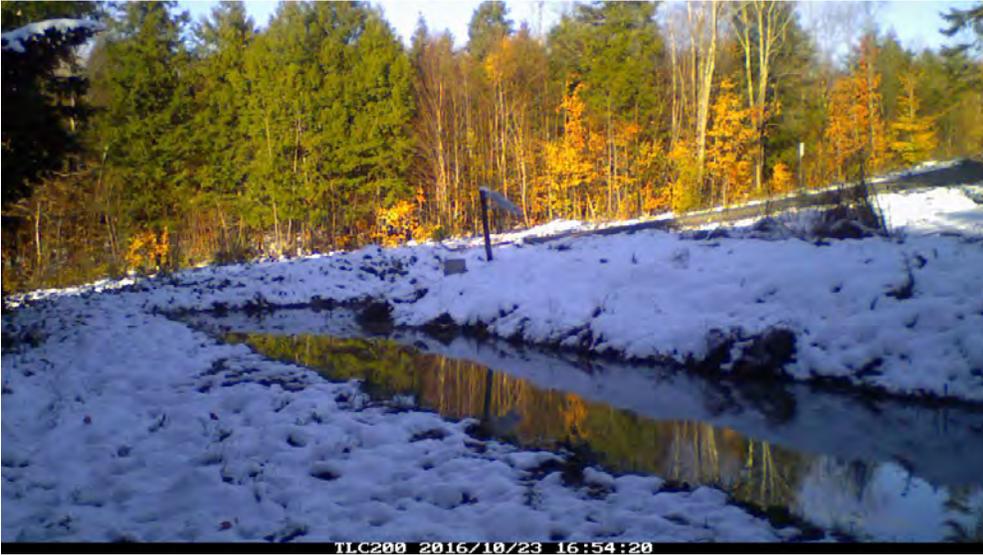
<p>This rain event filled the level spreader enough to overtop the level lip and discharge water to the downgradient disconnect area.</p> <ul style="list-style-type: none"> • 5 Minute Peak Intensity = 0.6 in/hr • Total Depth of Rainfall = 1.48 in • Duration of Event = 51 hrs 50 mins • 72-Hour Antecedent Rainfall = 0.05 in

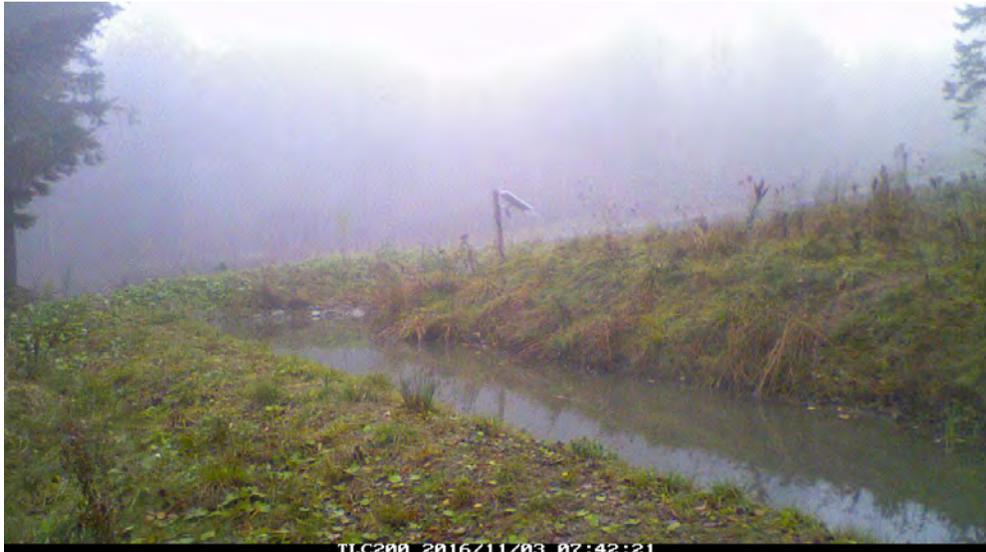
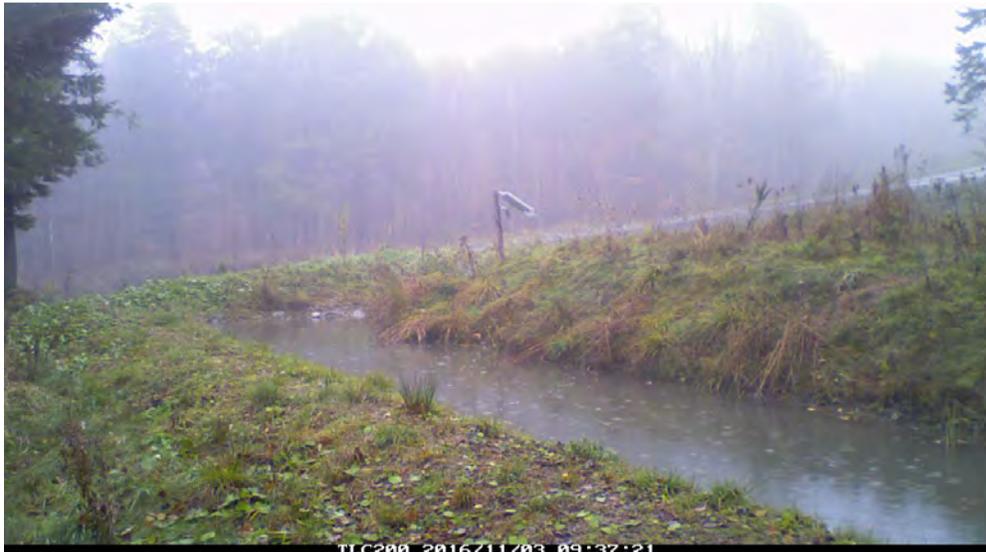
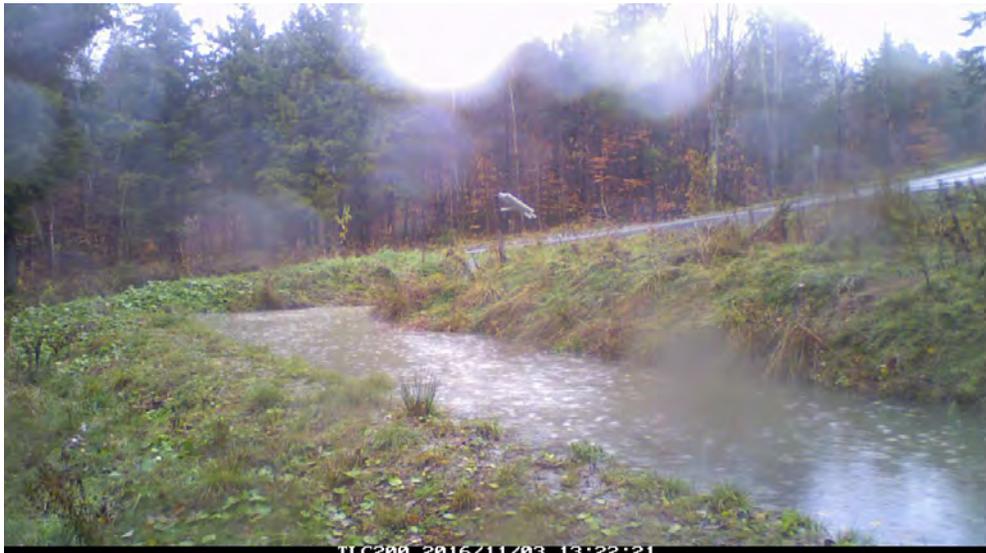
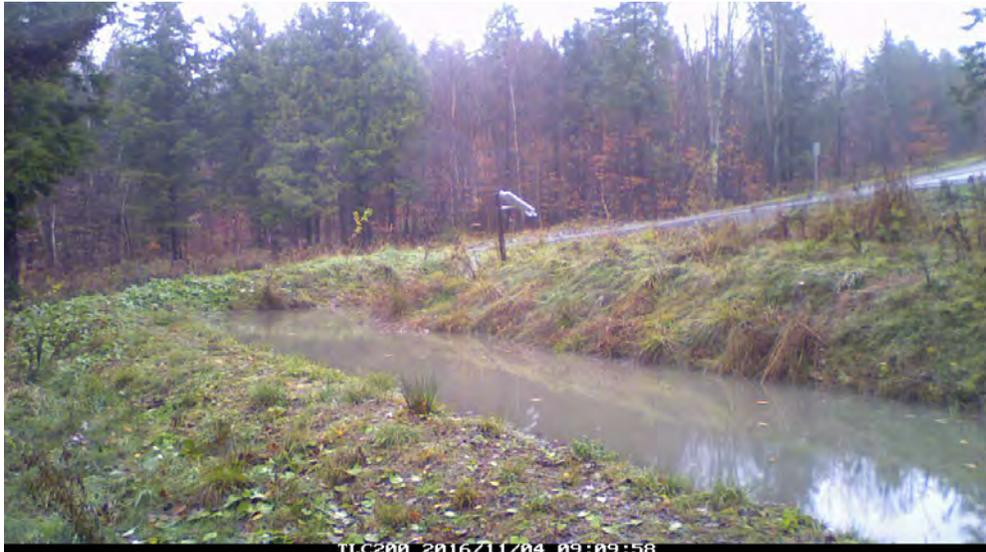
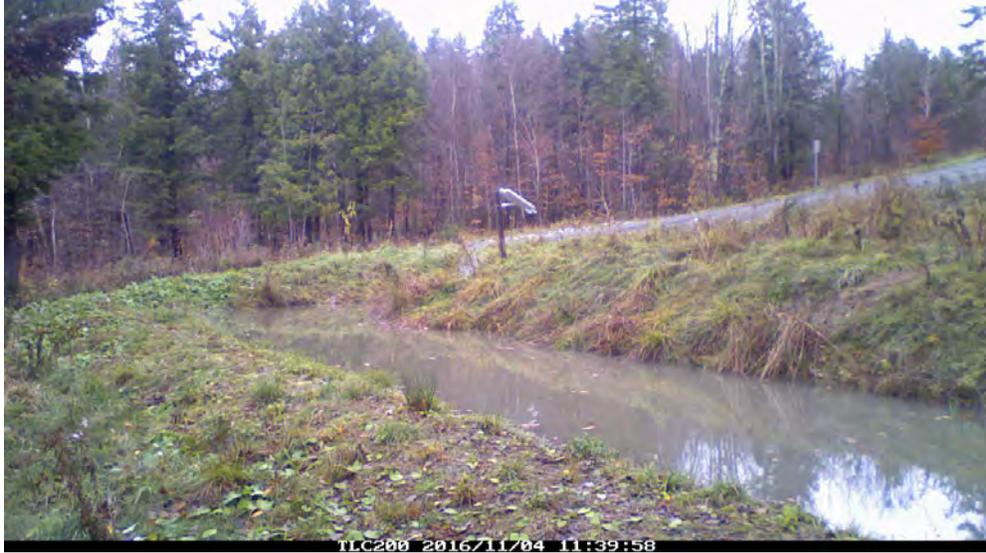
<p>This rain event filled the level spreader enough to overtop the level lip and discharge water to the downgradient disconnect area.</p> <ul style="list-style-type: none"> • 5 Minute Peak Intensity = 0.36 in/hr • Total Depth of Rainfall = 0.77 in • Duration of Event = 24 hrs 45 mins • 72-Hour Antecedent Rainfall = 0 in

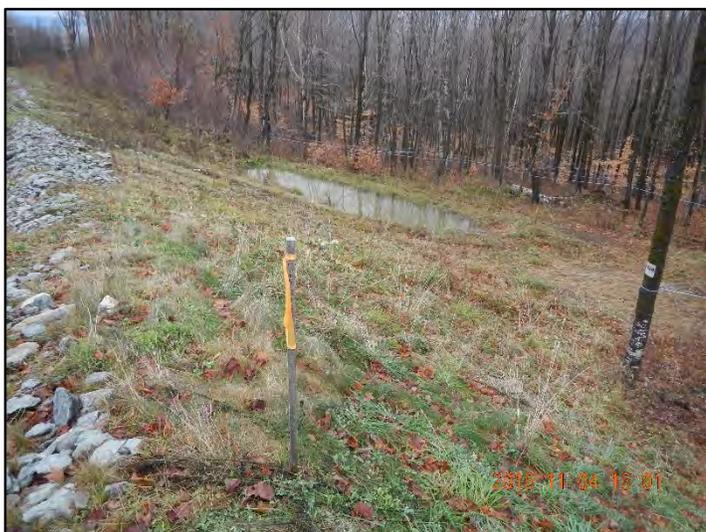
Photograph 3. Overview of LS-A18 following November 3, 2016 storm event. (VHB, November 4, 2016)
