Indian Lake, Cass County, Michigan

restorativelakesciences.com/success-stories/indian-lake

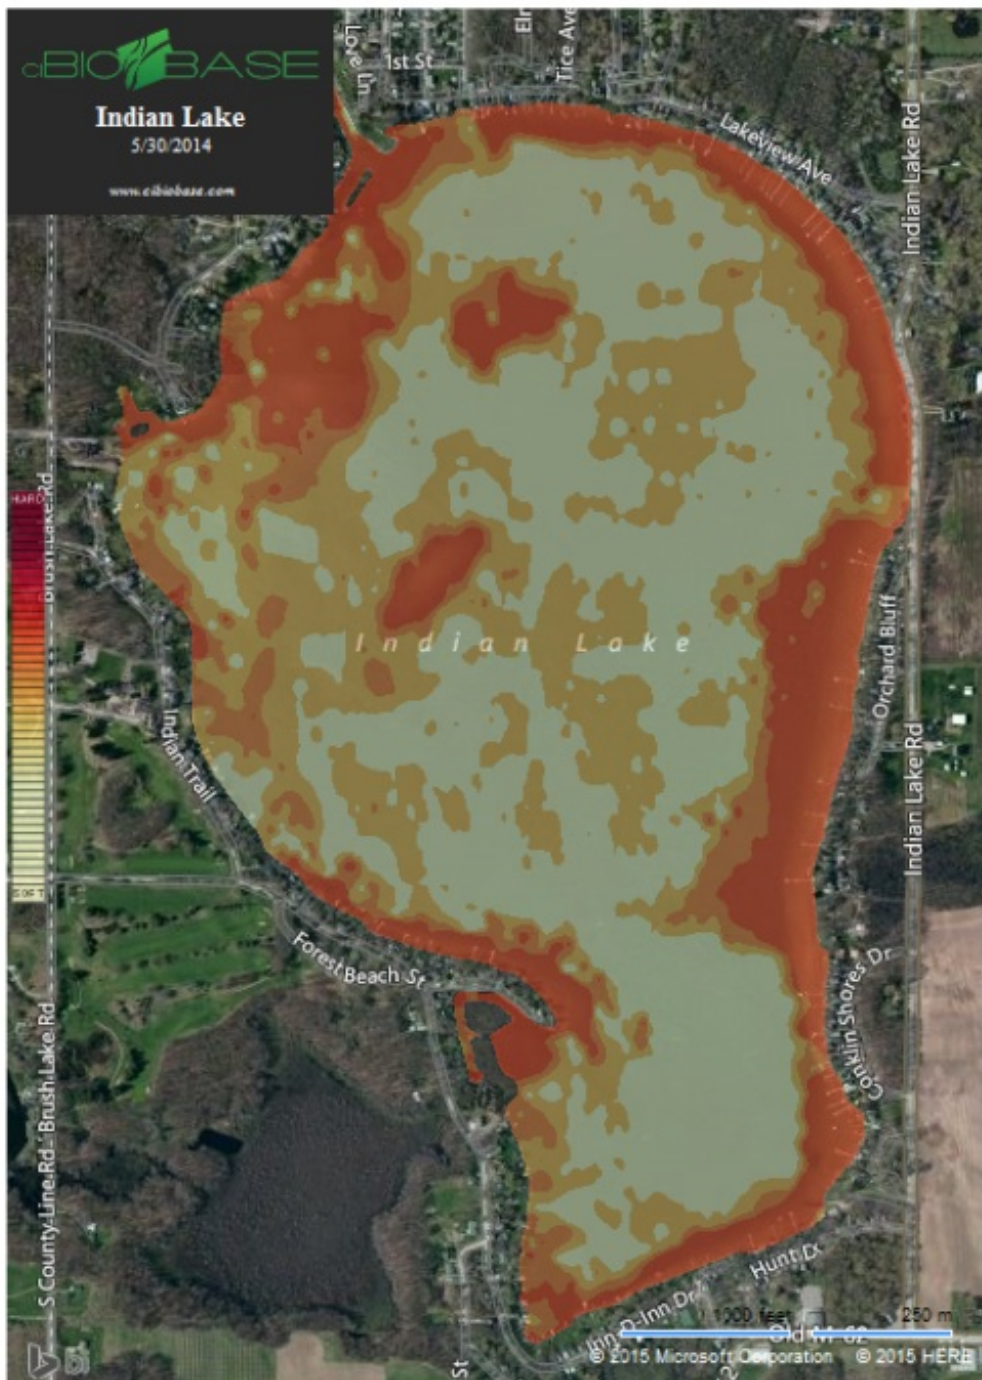
Attached are 4 maps. The first set of bottom composition maps show the 2014 (beige colored) soft bottom conditions

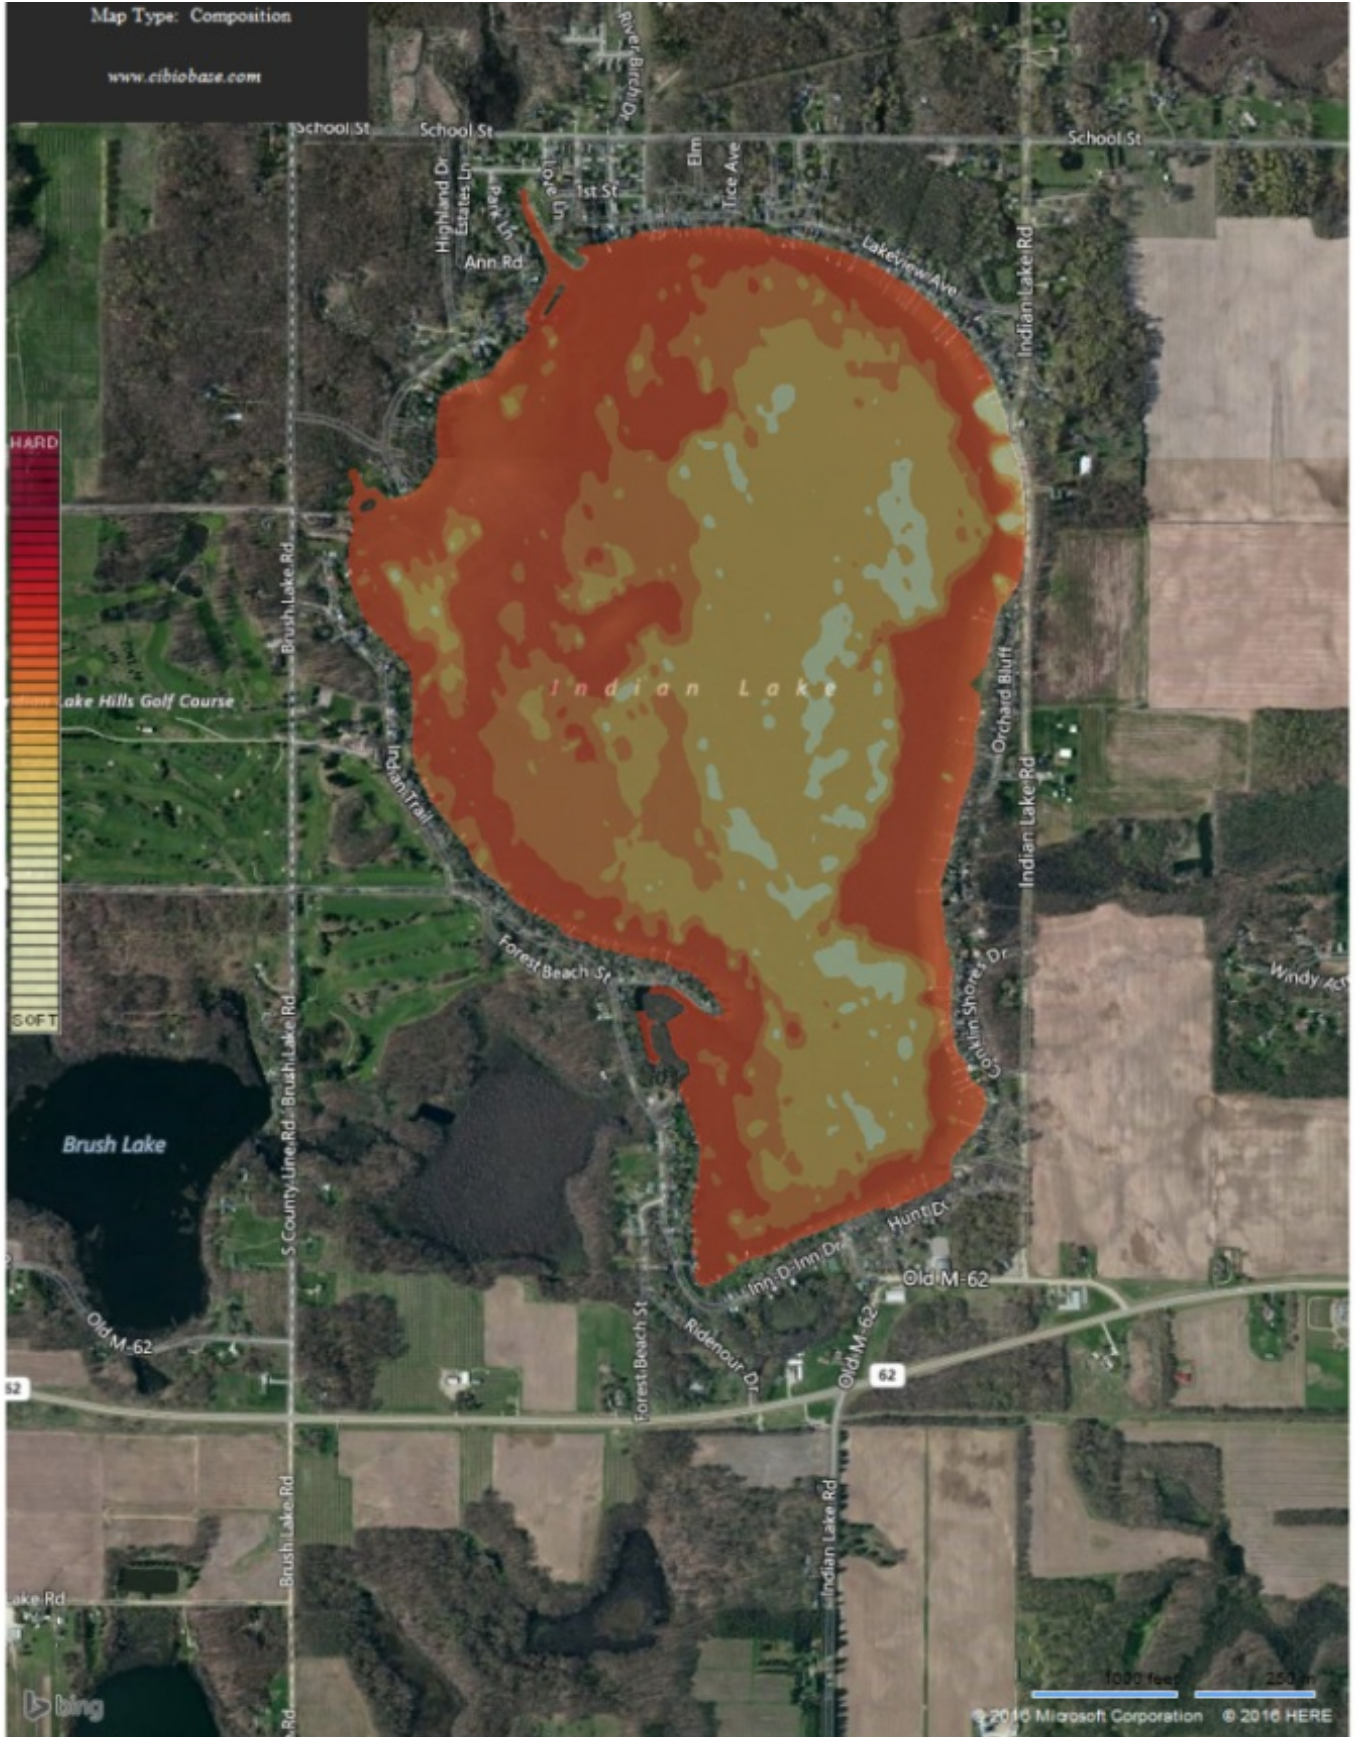
the 2016 map shows the (orange colored) more consolidated bottom conditions.

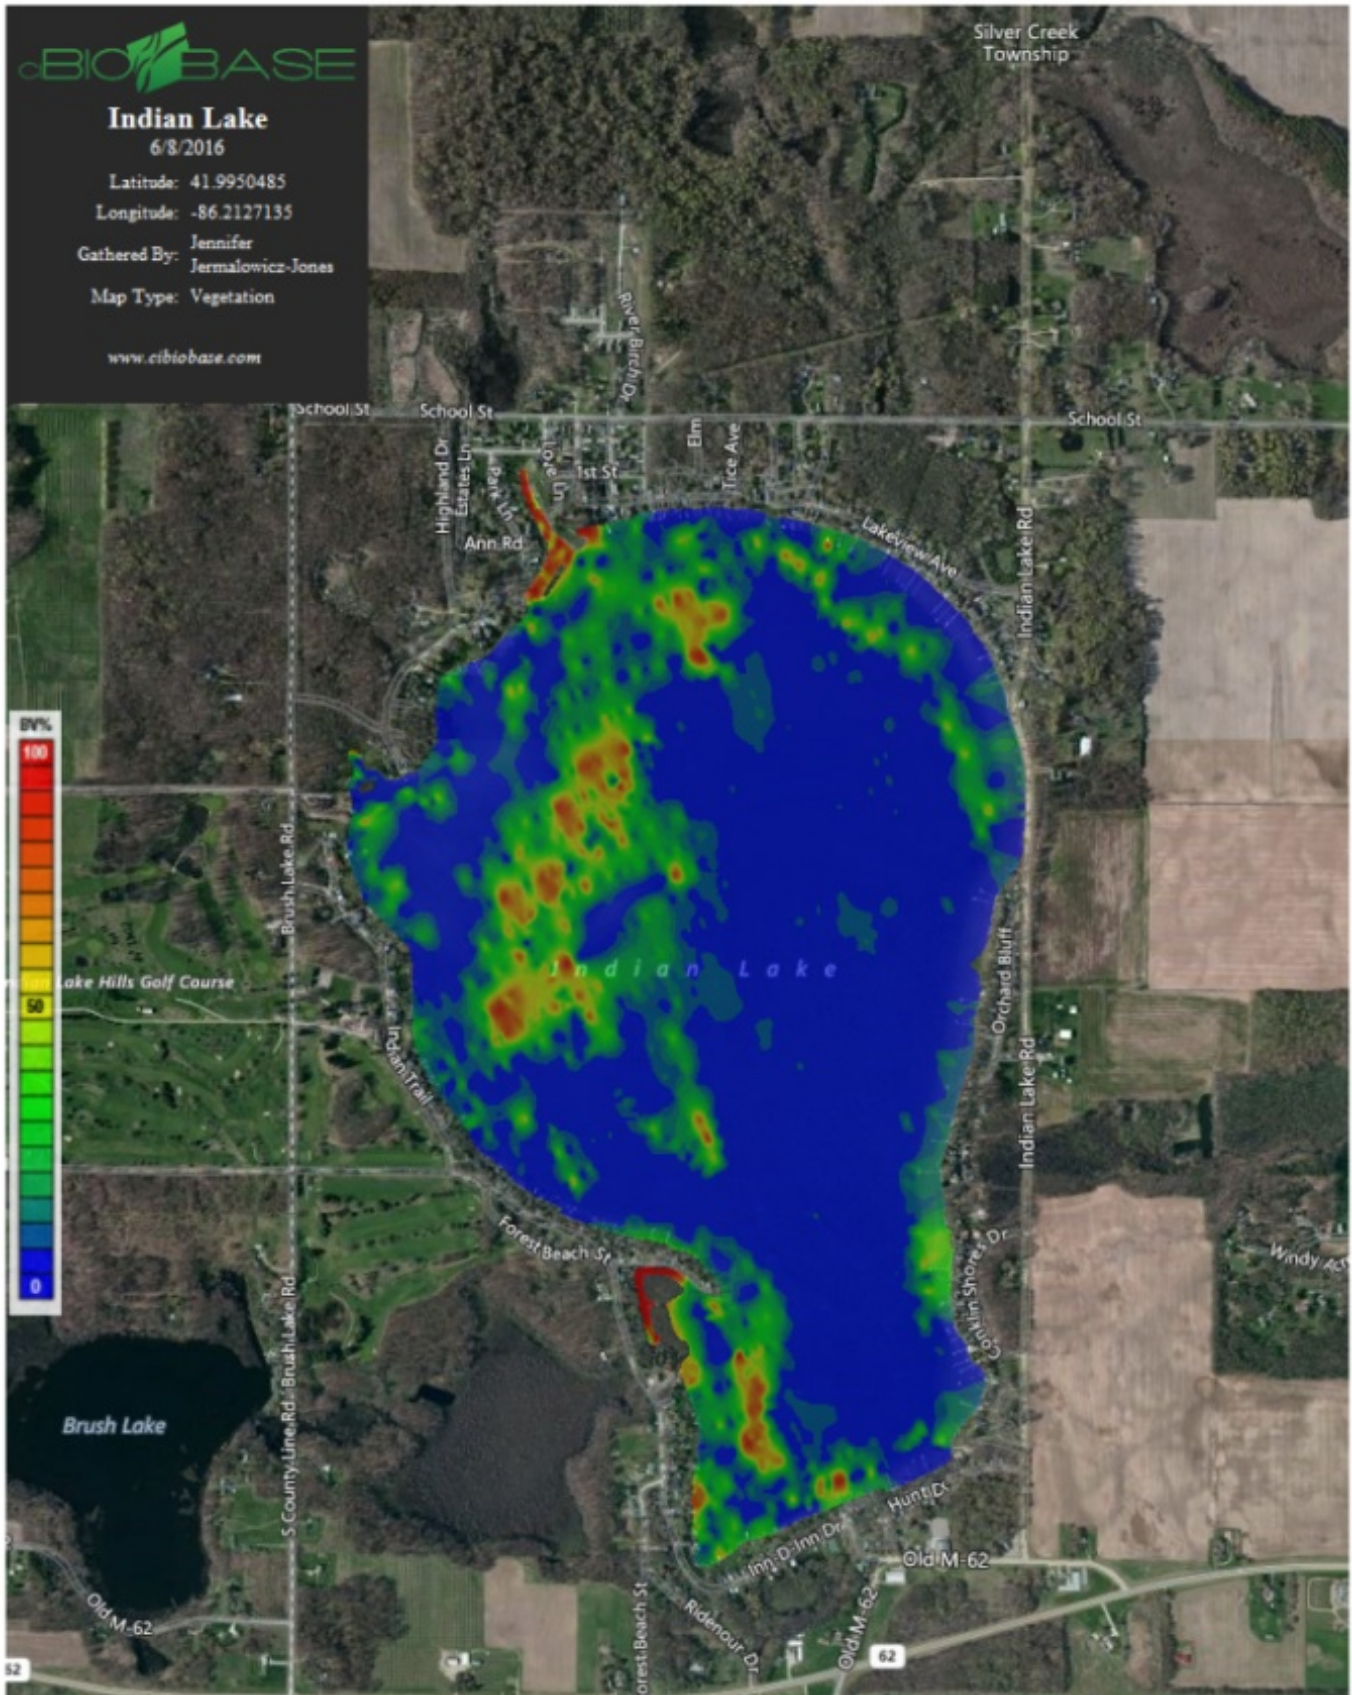
The 2016 aquatic vegetation biovolume map shows areas in green which denotes the removal of the milfoil and sustaining of low-growing, favorable native aquatic vegetation.
