North Hero – Grand Isle Drawbridge Replacement

Estimated Completion: July 2023

Project Summary

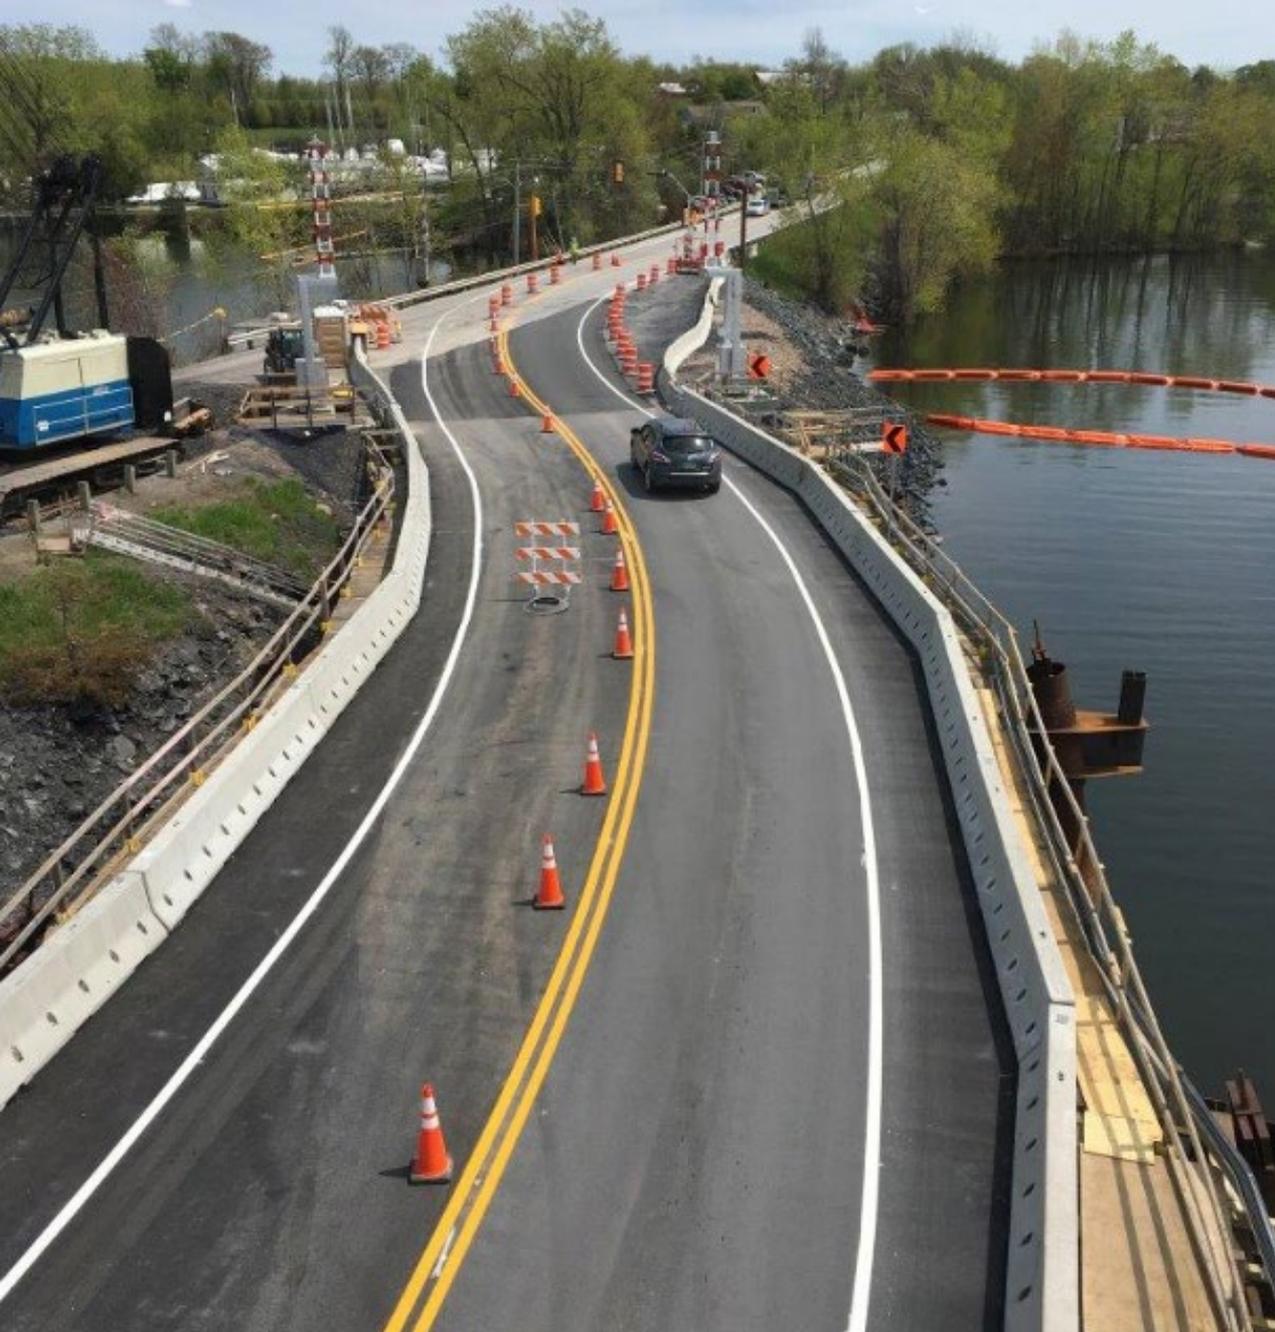
Temporary Construction

- Temporary Bridge Opened 2019
- Total Length – 541'
- Movable Span – 60'
- Provides a 40' Channel
- Total Cost - \$13 Million

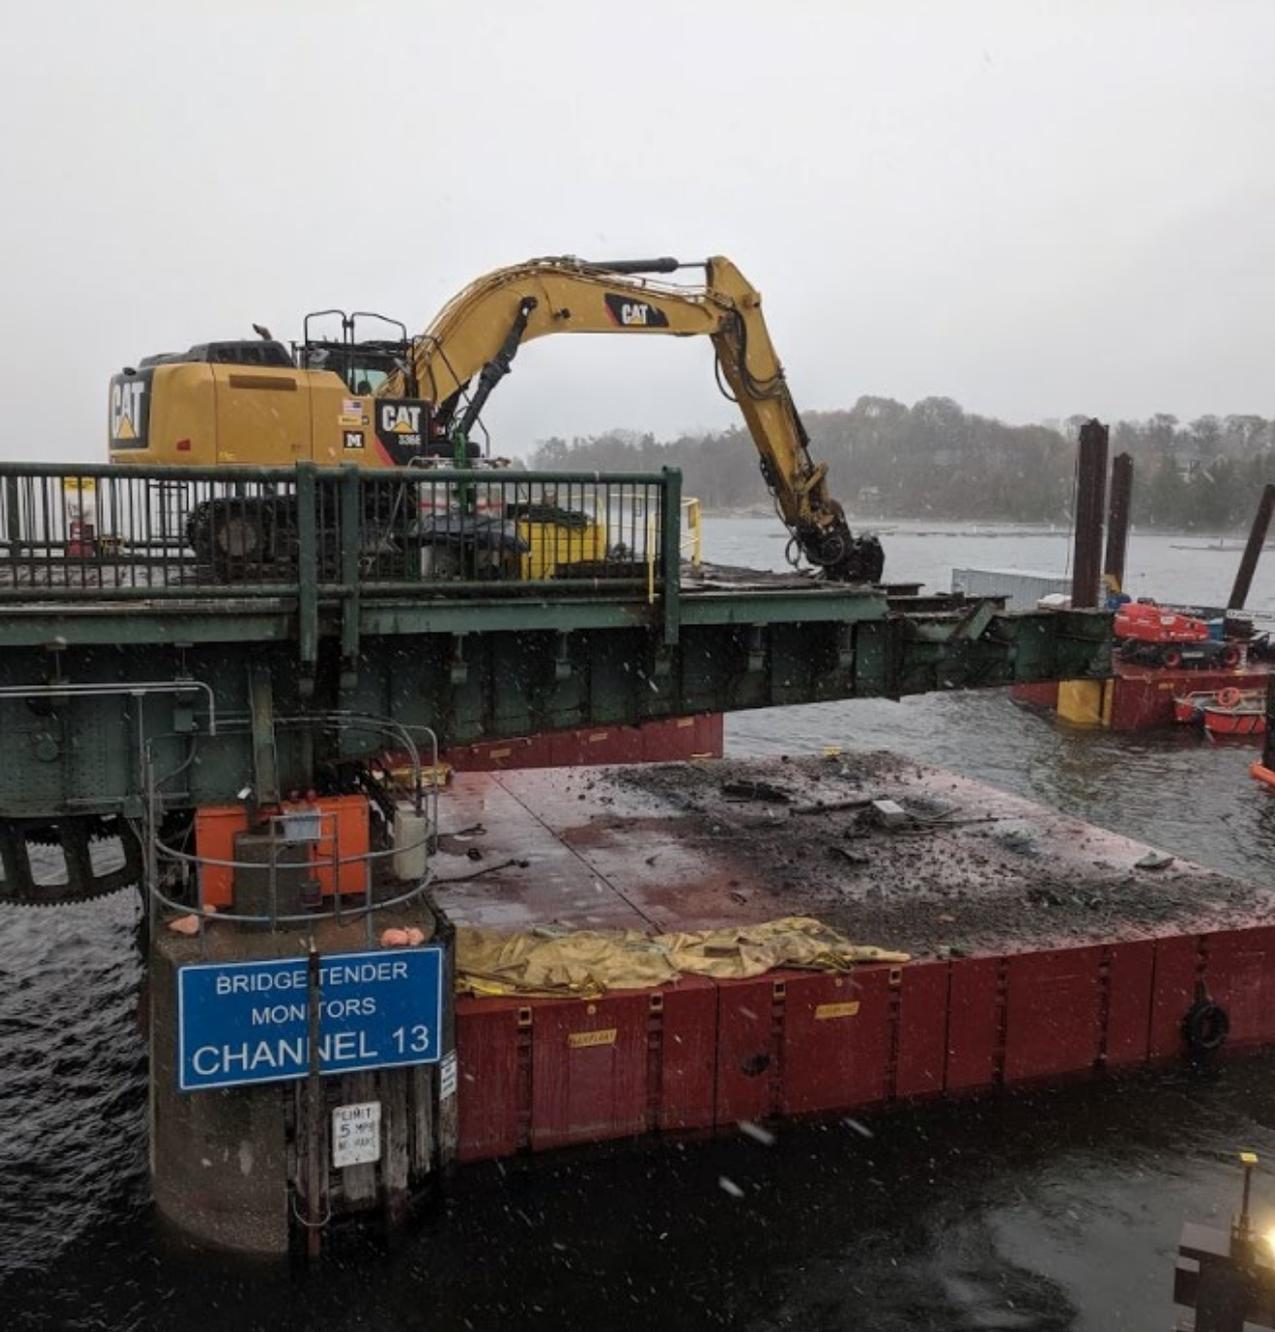
Bridge Demolition

- Demolition of Bascule Span
- Complicated demolition because the span is balanced.

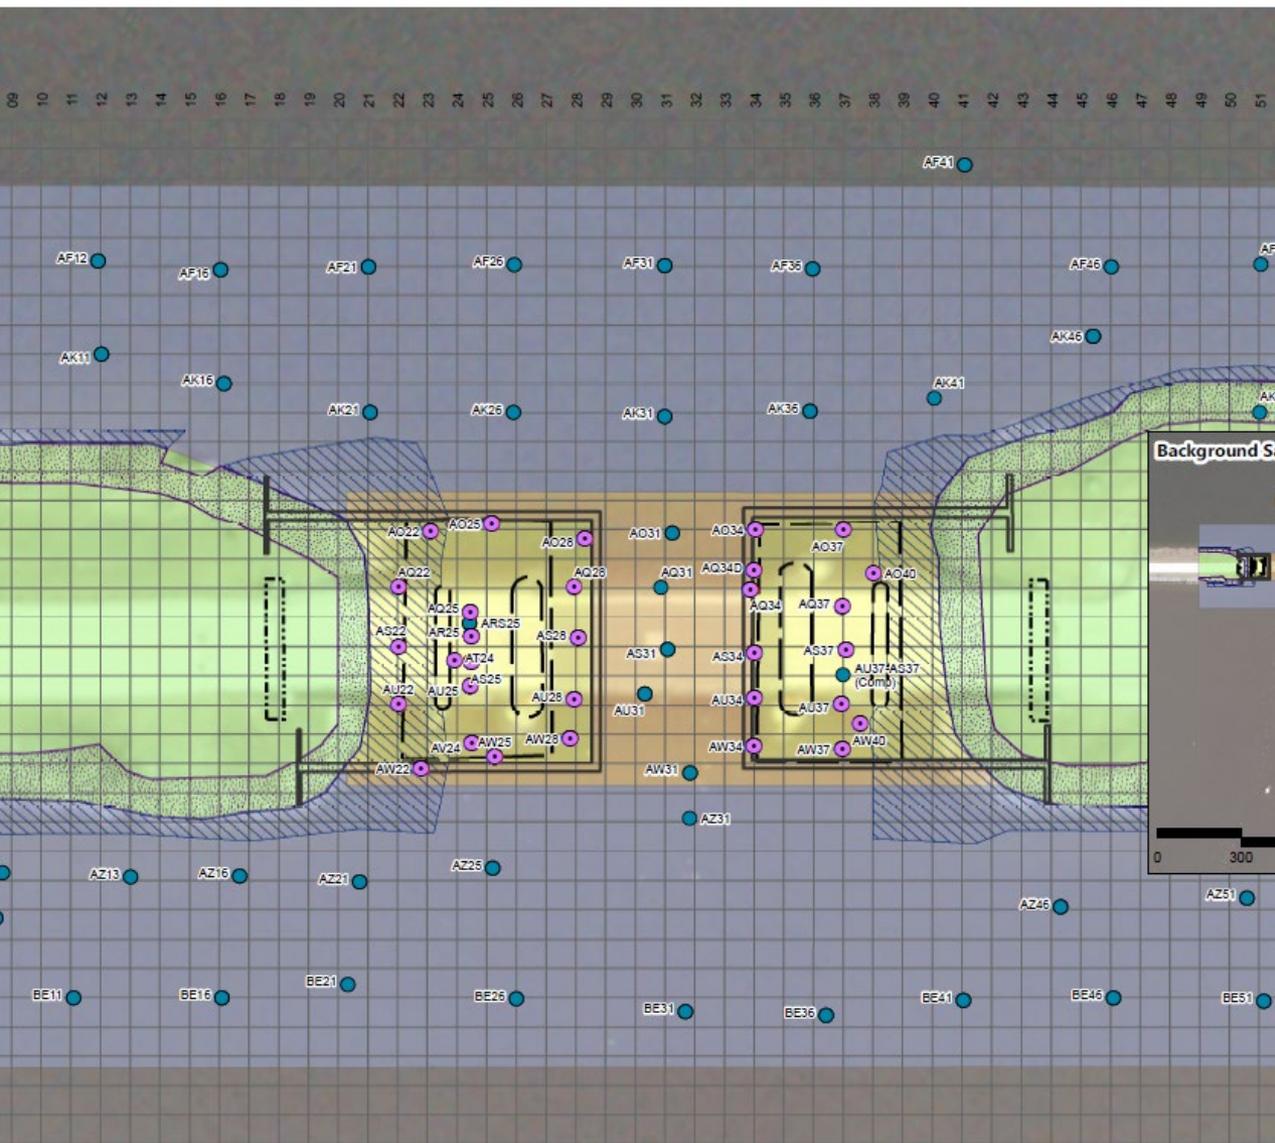
North Hero Drawbridge Site Investigation

Sources: Background Orthoimagery by VCGI (2018)
 VHB - Digitized (2019)
 VCGI - Vermont Center for Geographic Information (Various Years)
 VTTrans - Vermont Agency of Transportation

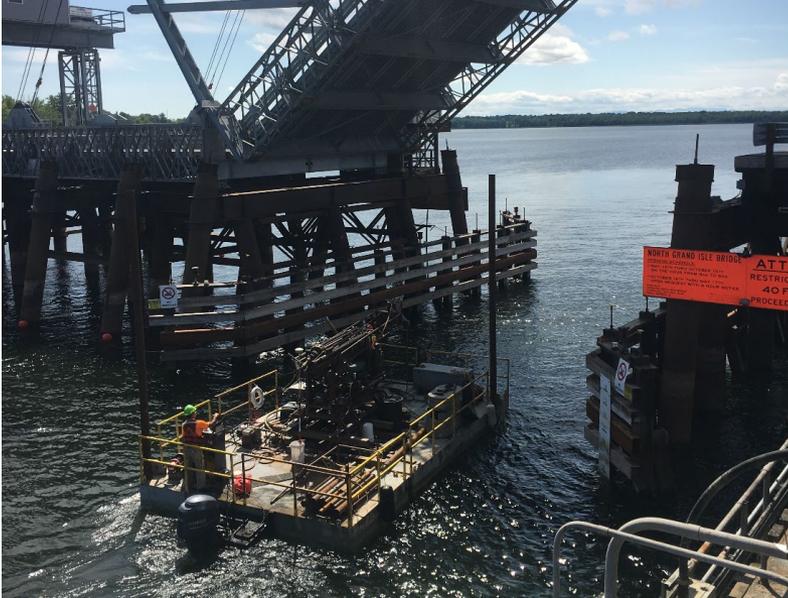
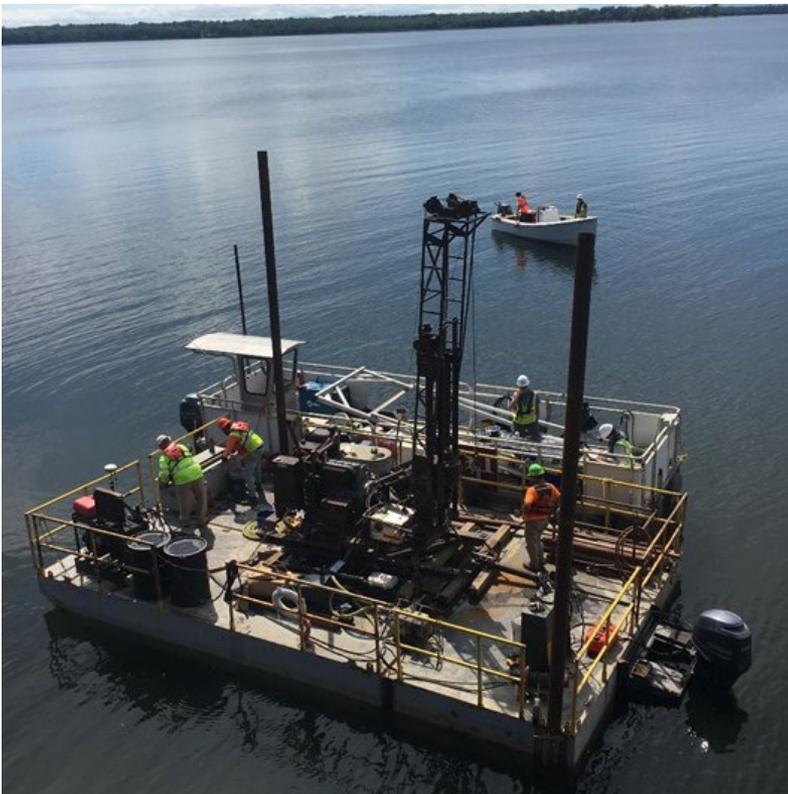
- Contaminates of concern were identified in spring of 2019
- AOT retained Environmental consultant to perform extensive site characterization in sediment and causeway soils.
- The identification of contaminated materials changed the sequence of work and cofferdam requirements.
- Delayed new bridge opening one calendar year
- Channel open May to November

- Originally site was considered jurisdictional under TSCA (EPA oversight).
- Through Rapid Site investigation and sample analysis the source was identified.
- By review of maintenance records the contaminate release date was identified and determined that TSCA was no longer jurisdictional.
- Eliminated EPA oversight and allowed VTrans to work with DEC. (Anticipated this saved one year and over \$1M)

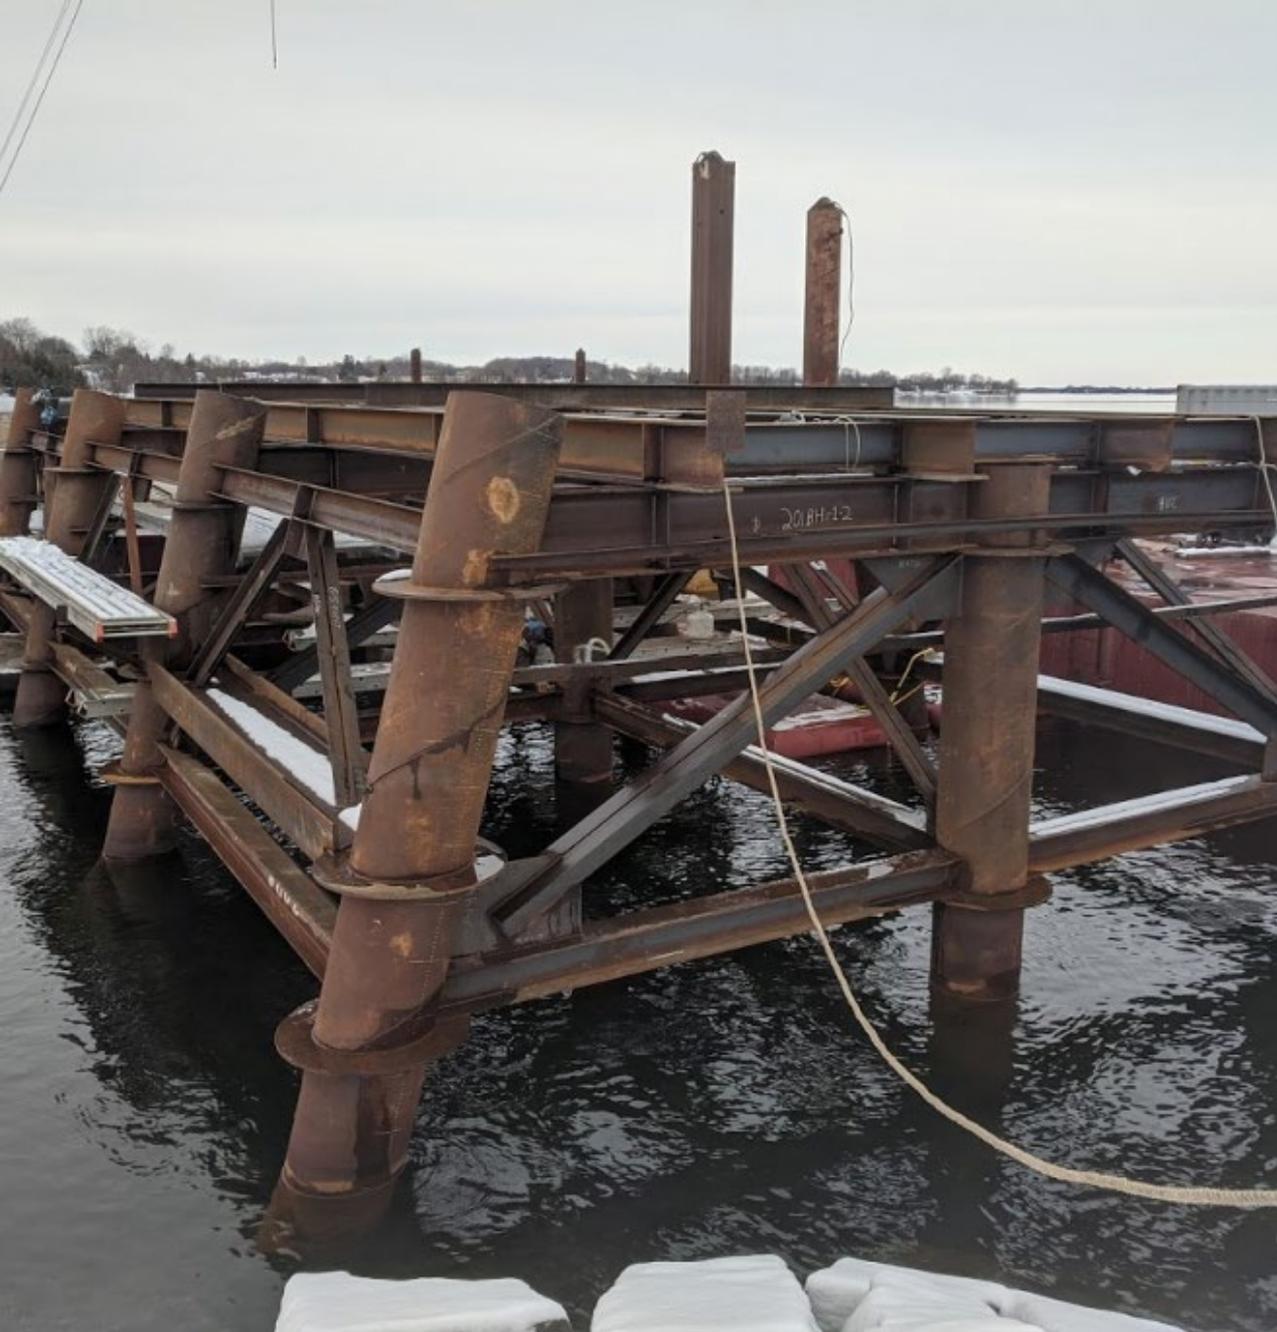
Temporary Construction

- Lateral support of cofferdam

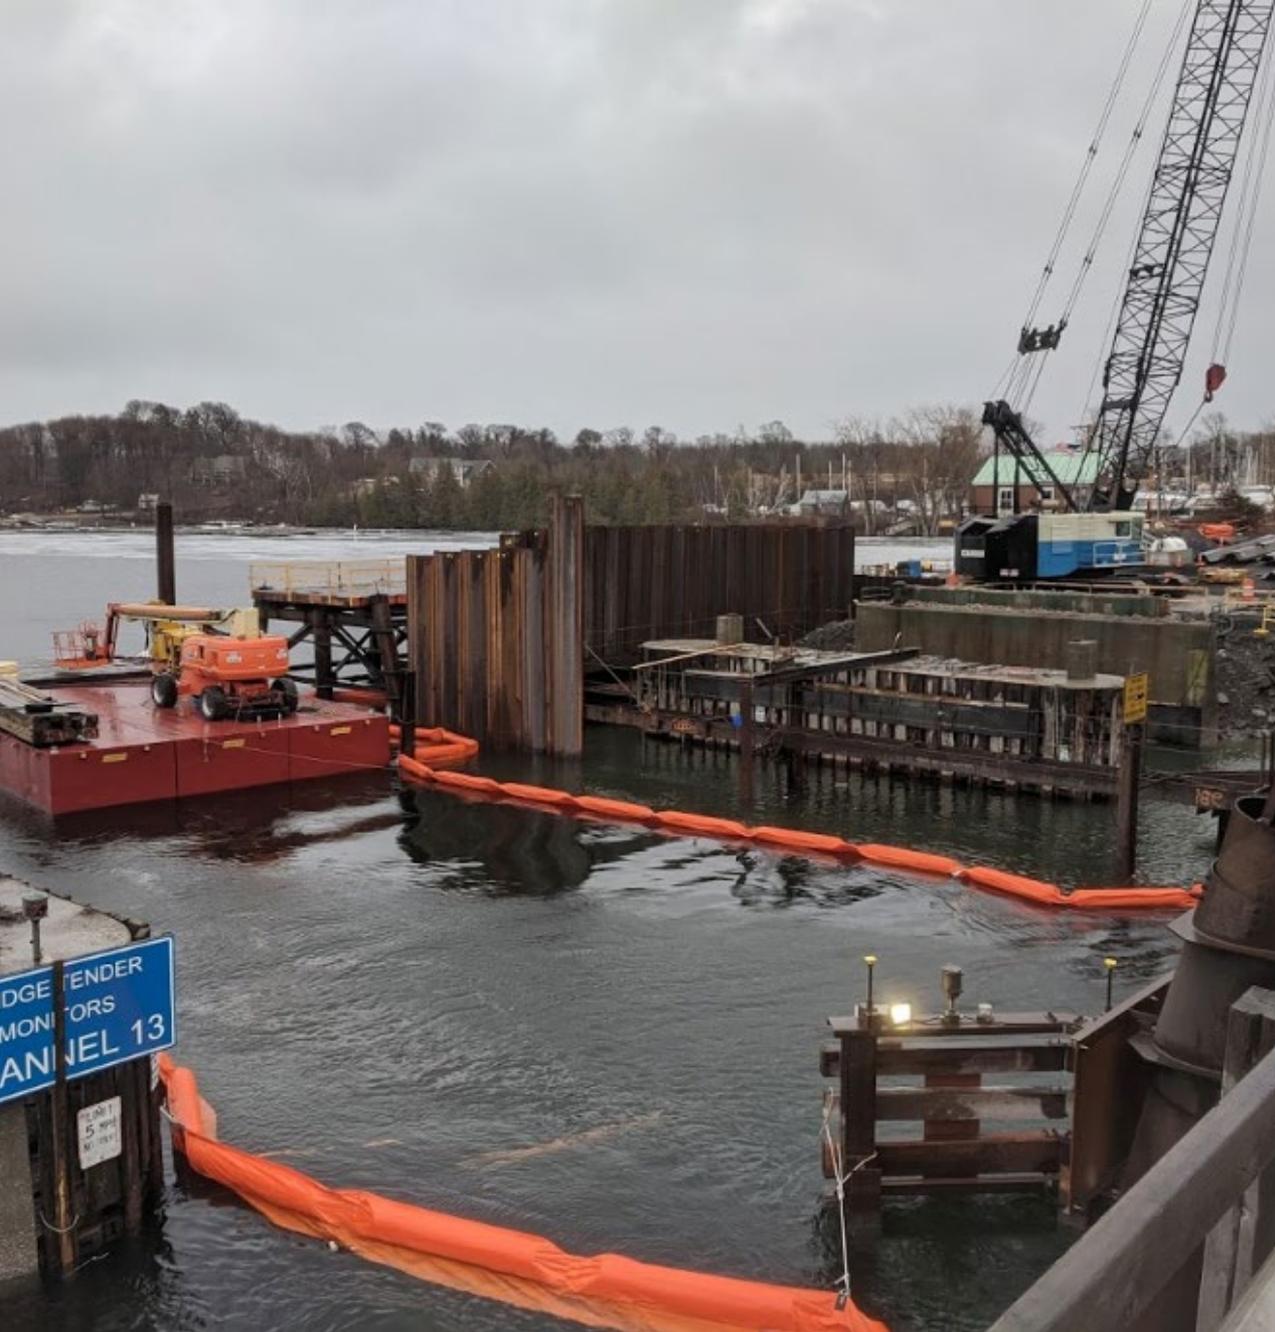
Temporary Construction

- First row of cofferdam sheets
- Two rows of sheets installed to contain sediment during pier demolition

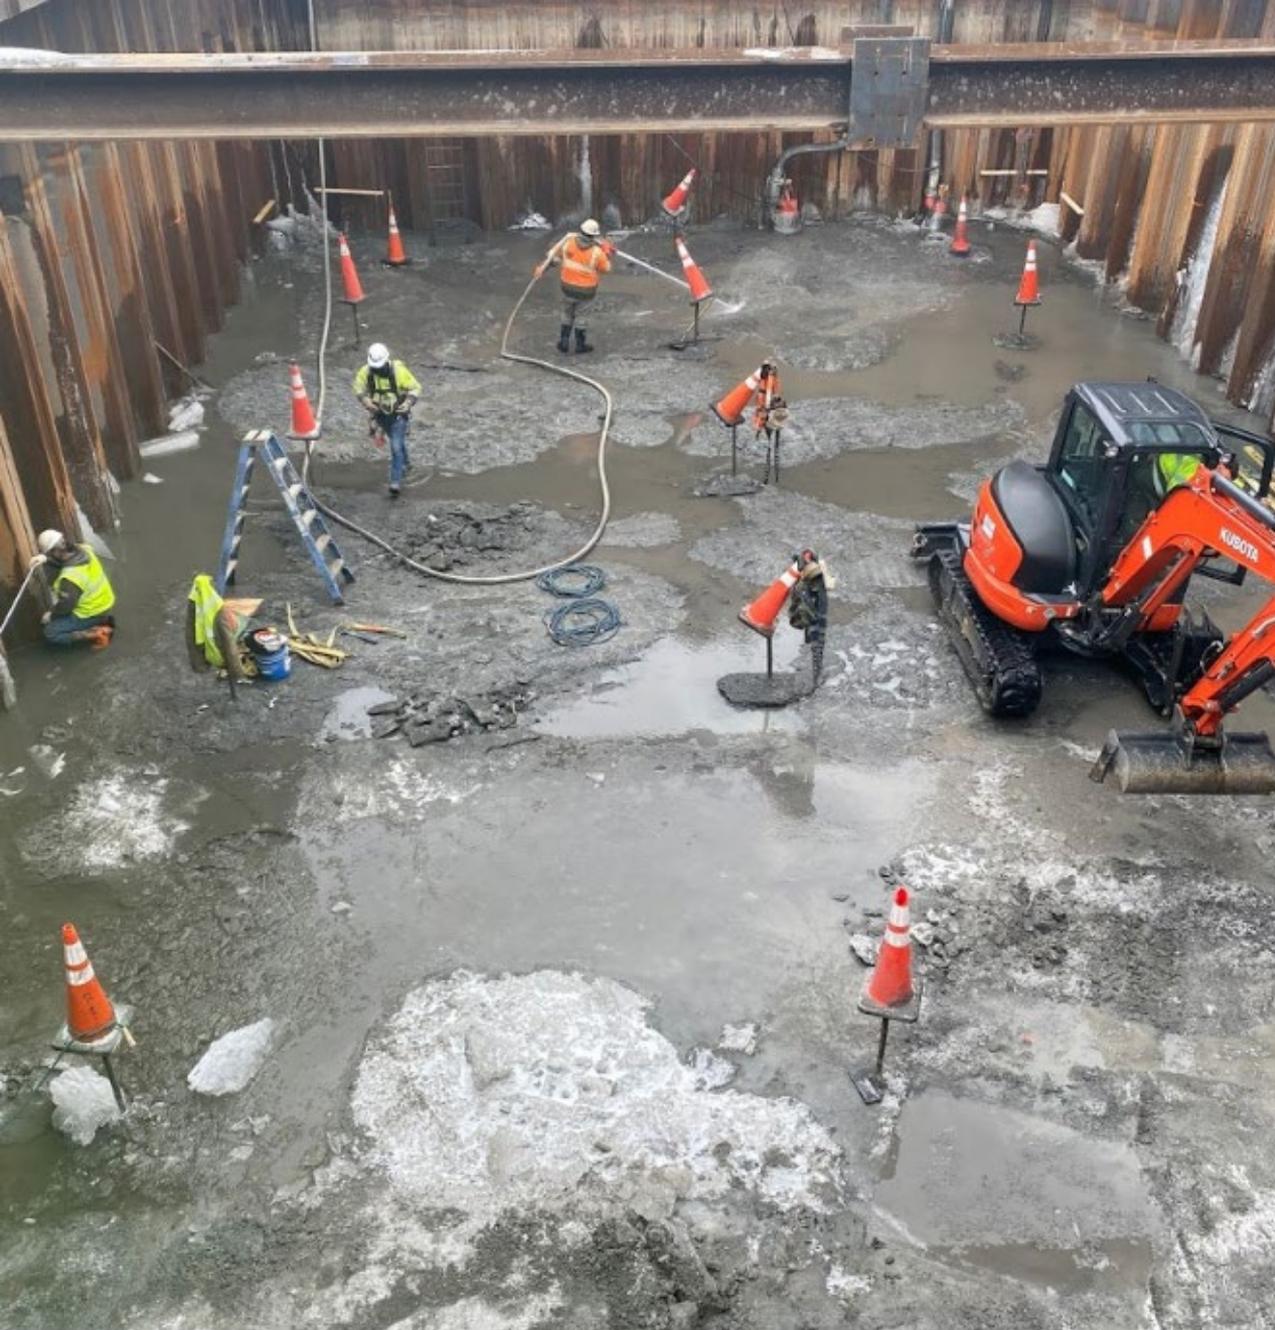
Current Construction

- Pier 1 tremie 1,100 CY of concrete
- Pier 2 tremie 1,000 CY of concrete

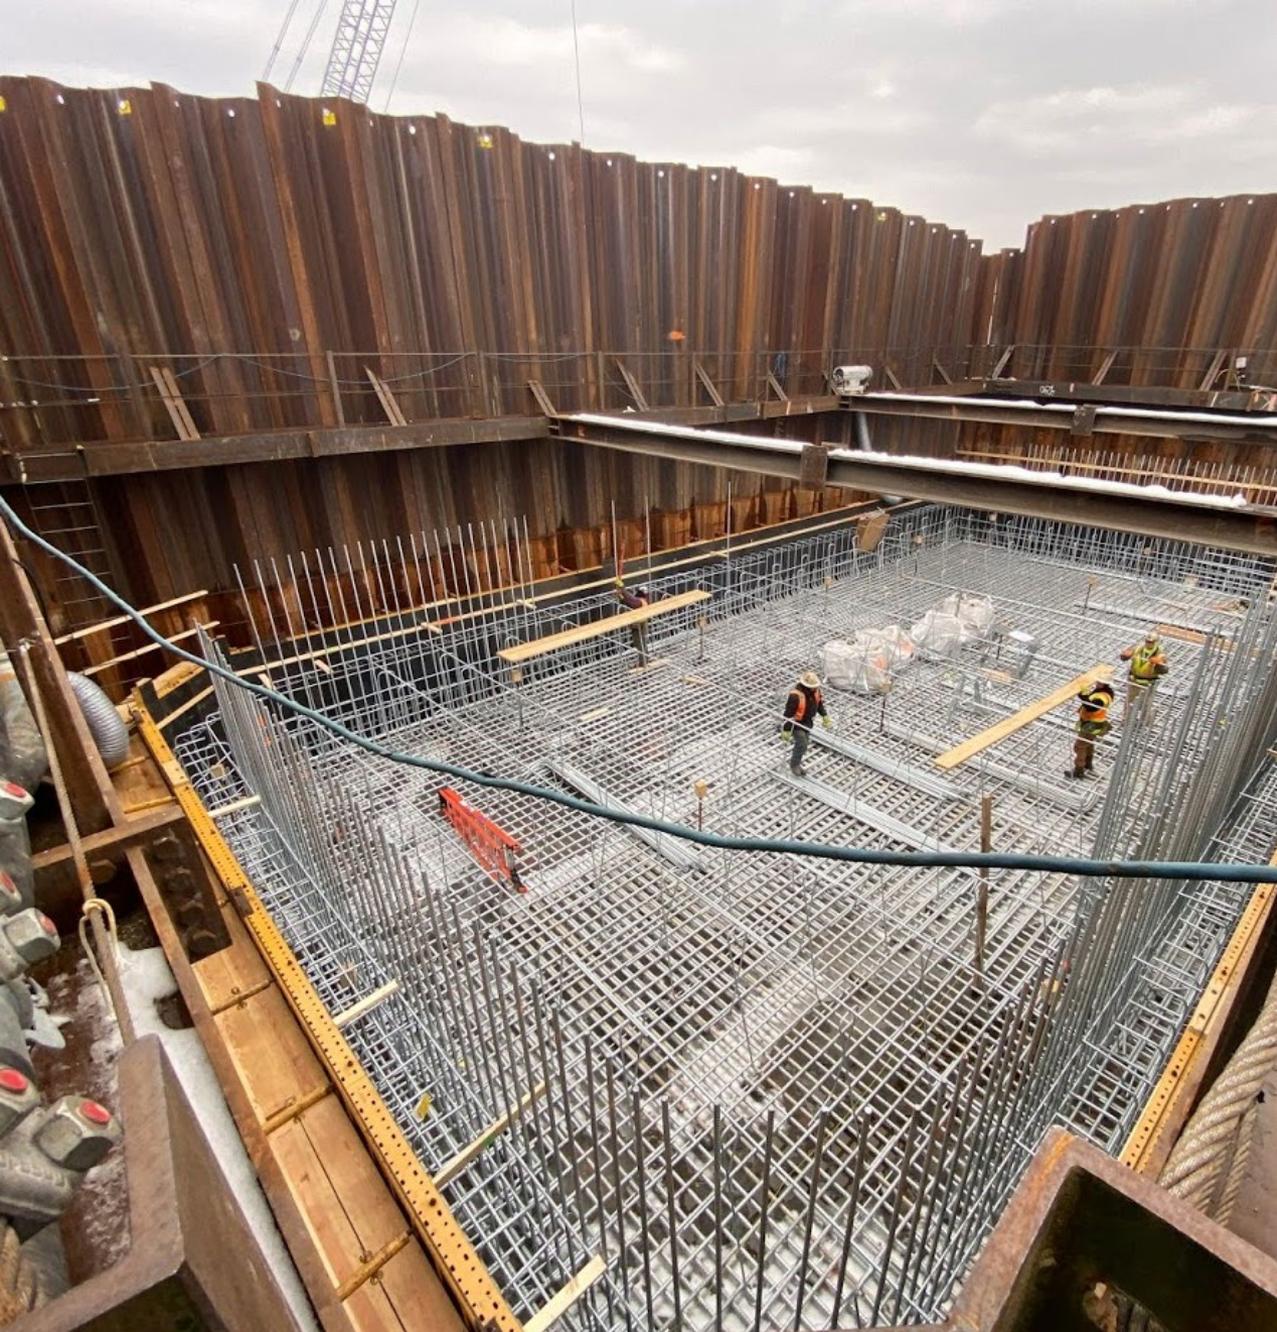
Current Construction

- Pier Construction (Reinforced Concrete)
- Approximately 15' below lake elevation to the bottom of the footing

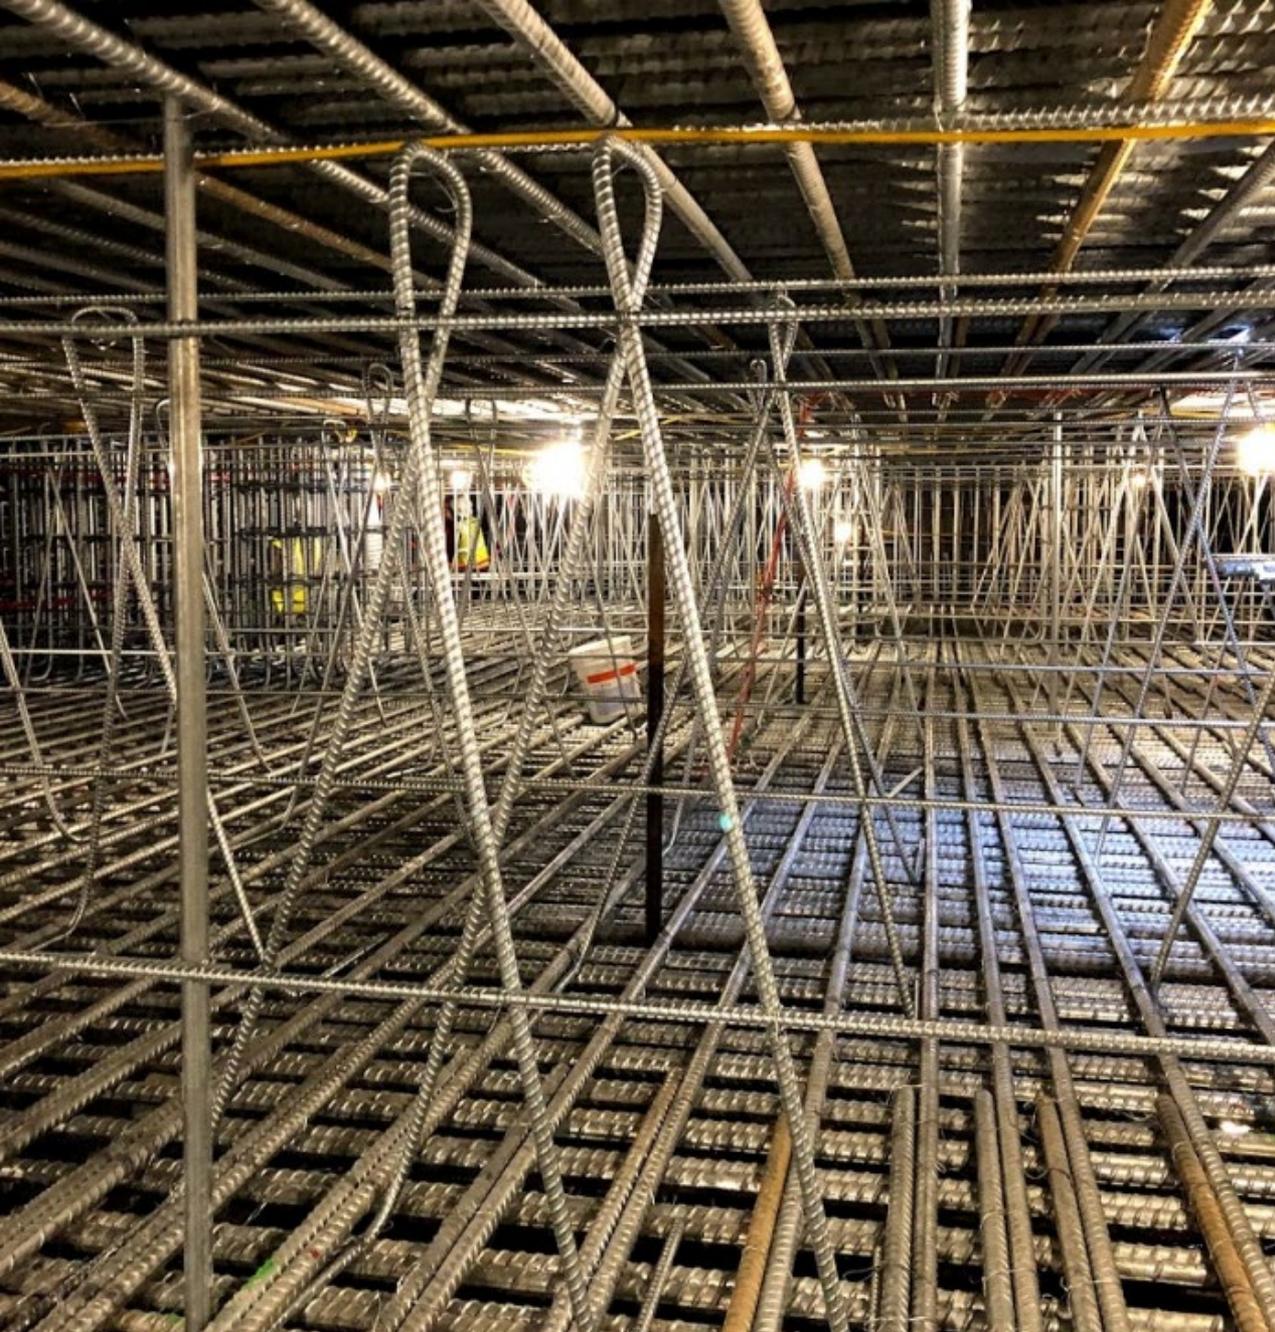
Current Construction

- View from inside the Pier 2 footing rebar cage
- Mass concrete pour on March 1st.
- 660 CY of Concrete Placed

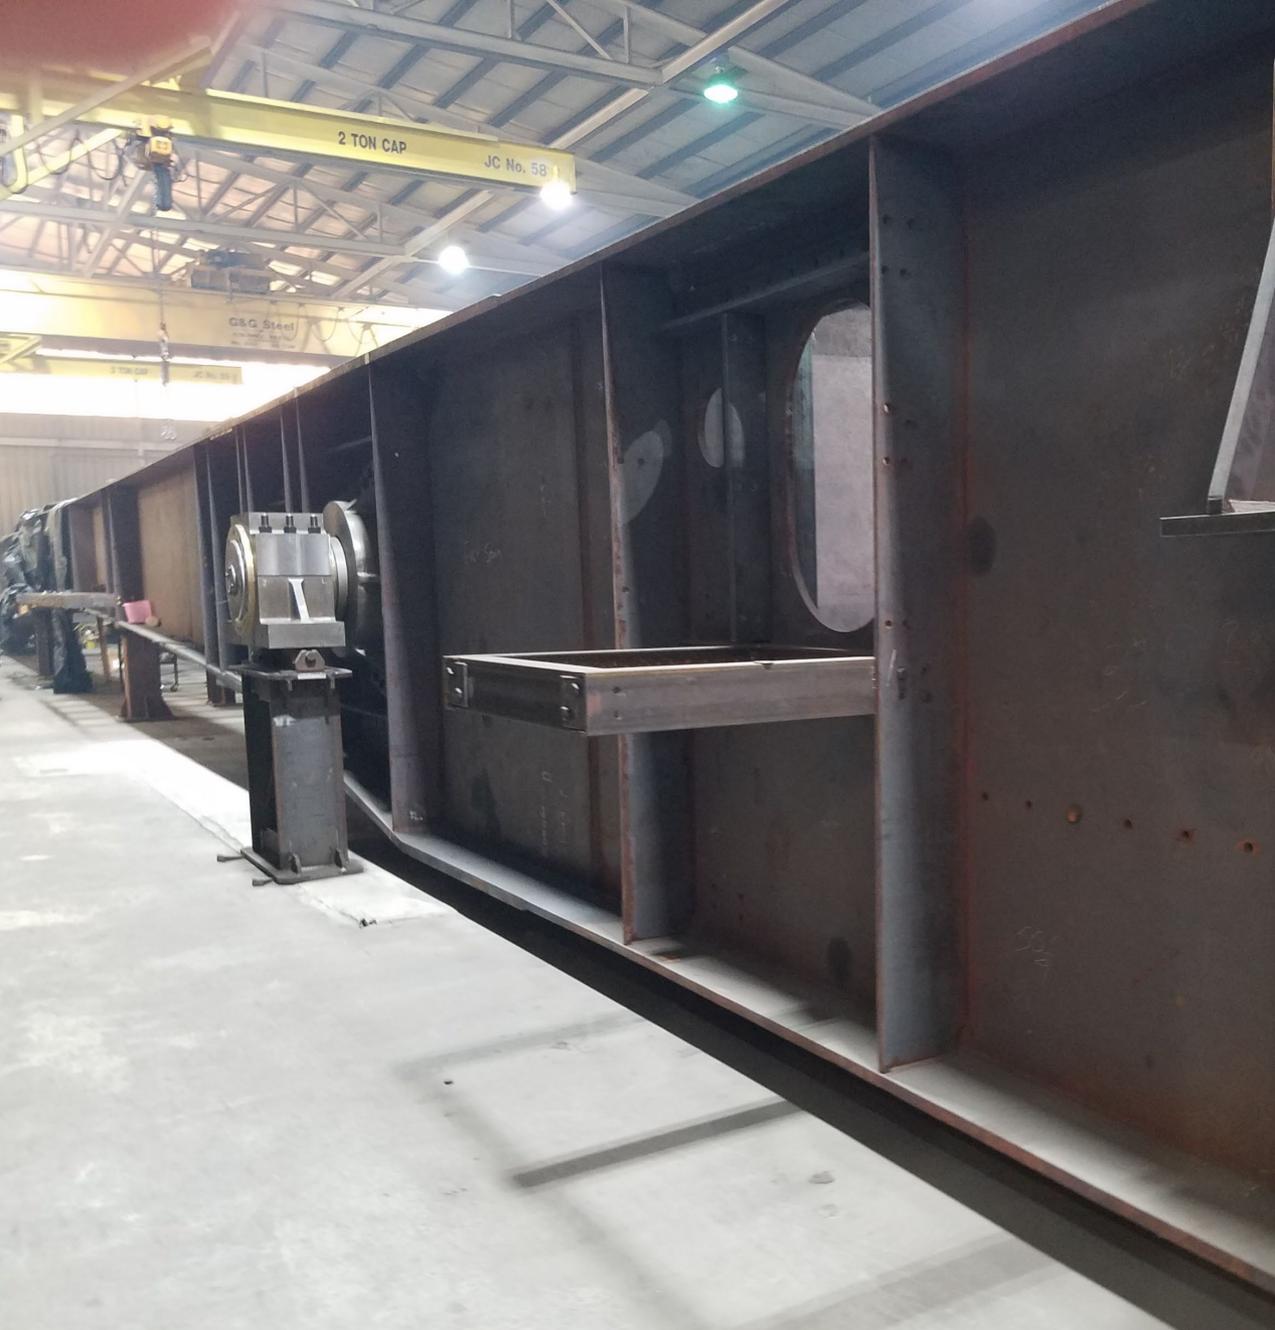
Current Construction

- Fabrication of all structural steel nearly complete
- Photo of the bascule steel and trunnion shown
