VTRANS UAS

UNMANNED AIRCRAFT SYSTEMS

Presented by
Evan Robinson
UAS Manager

March 24, 2021

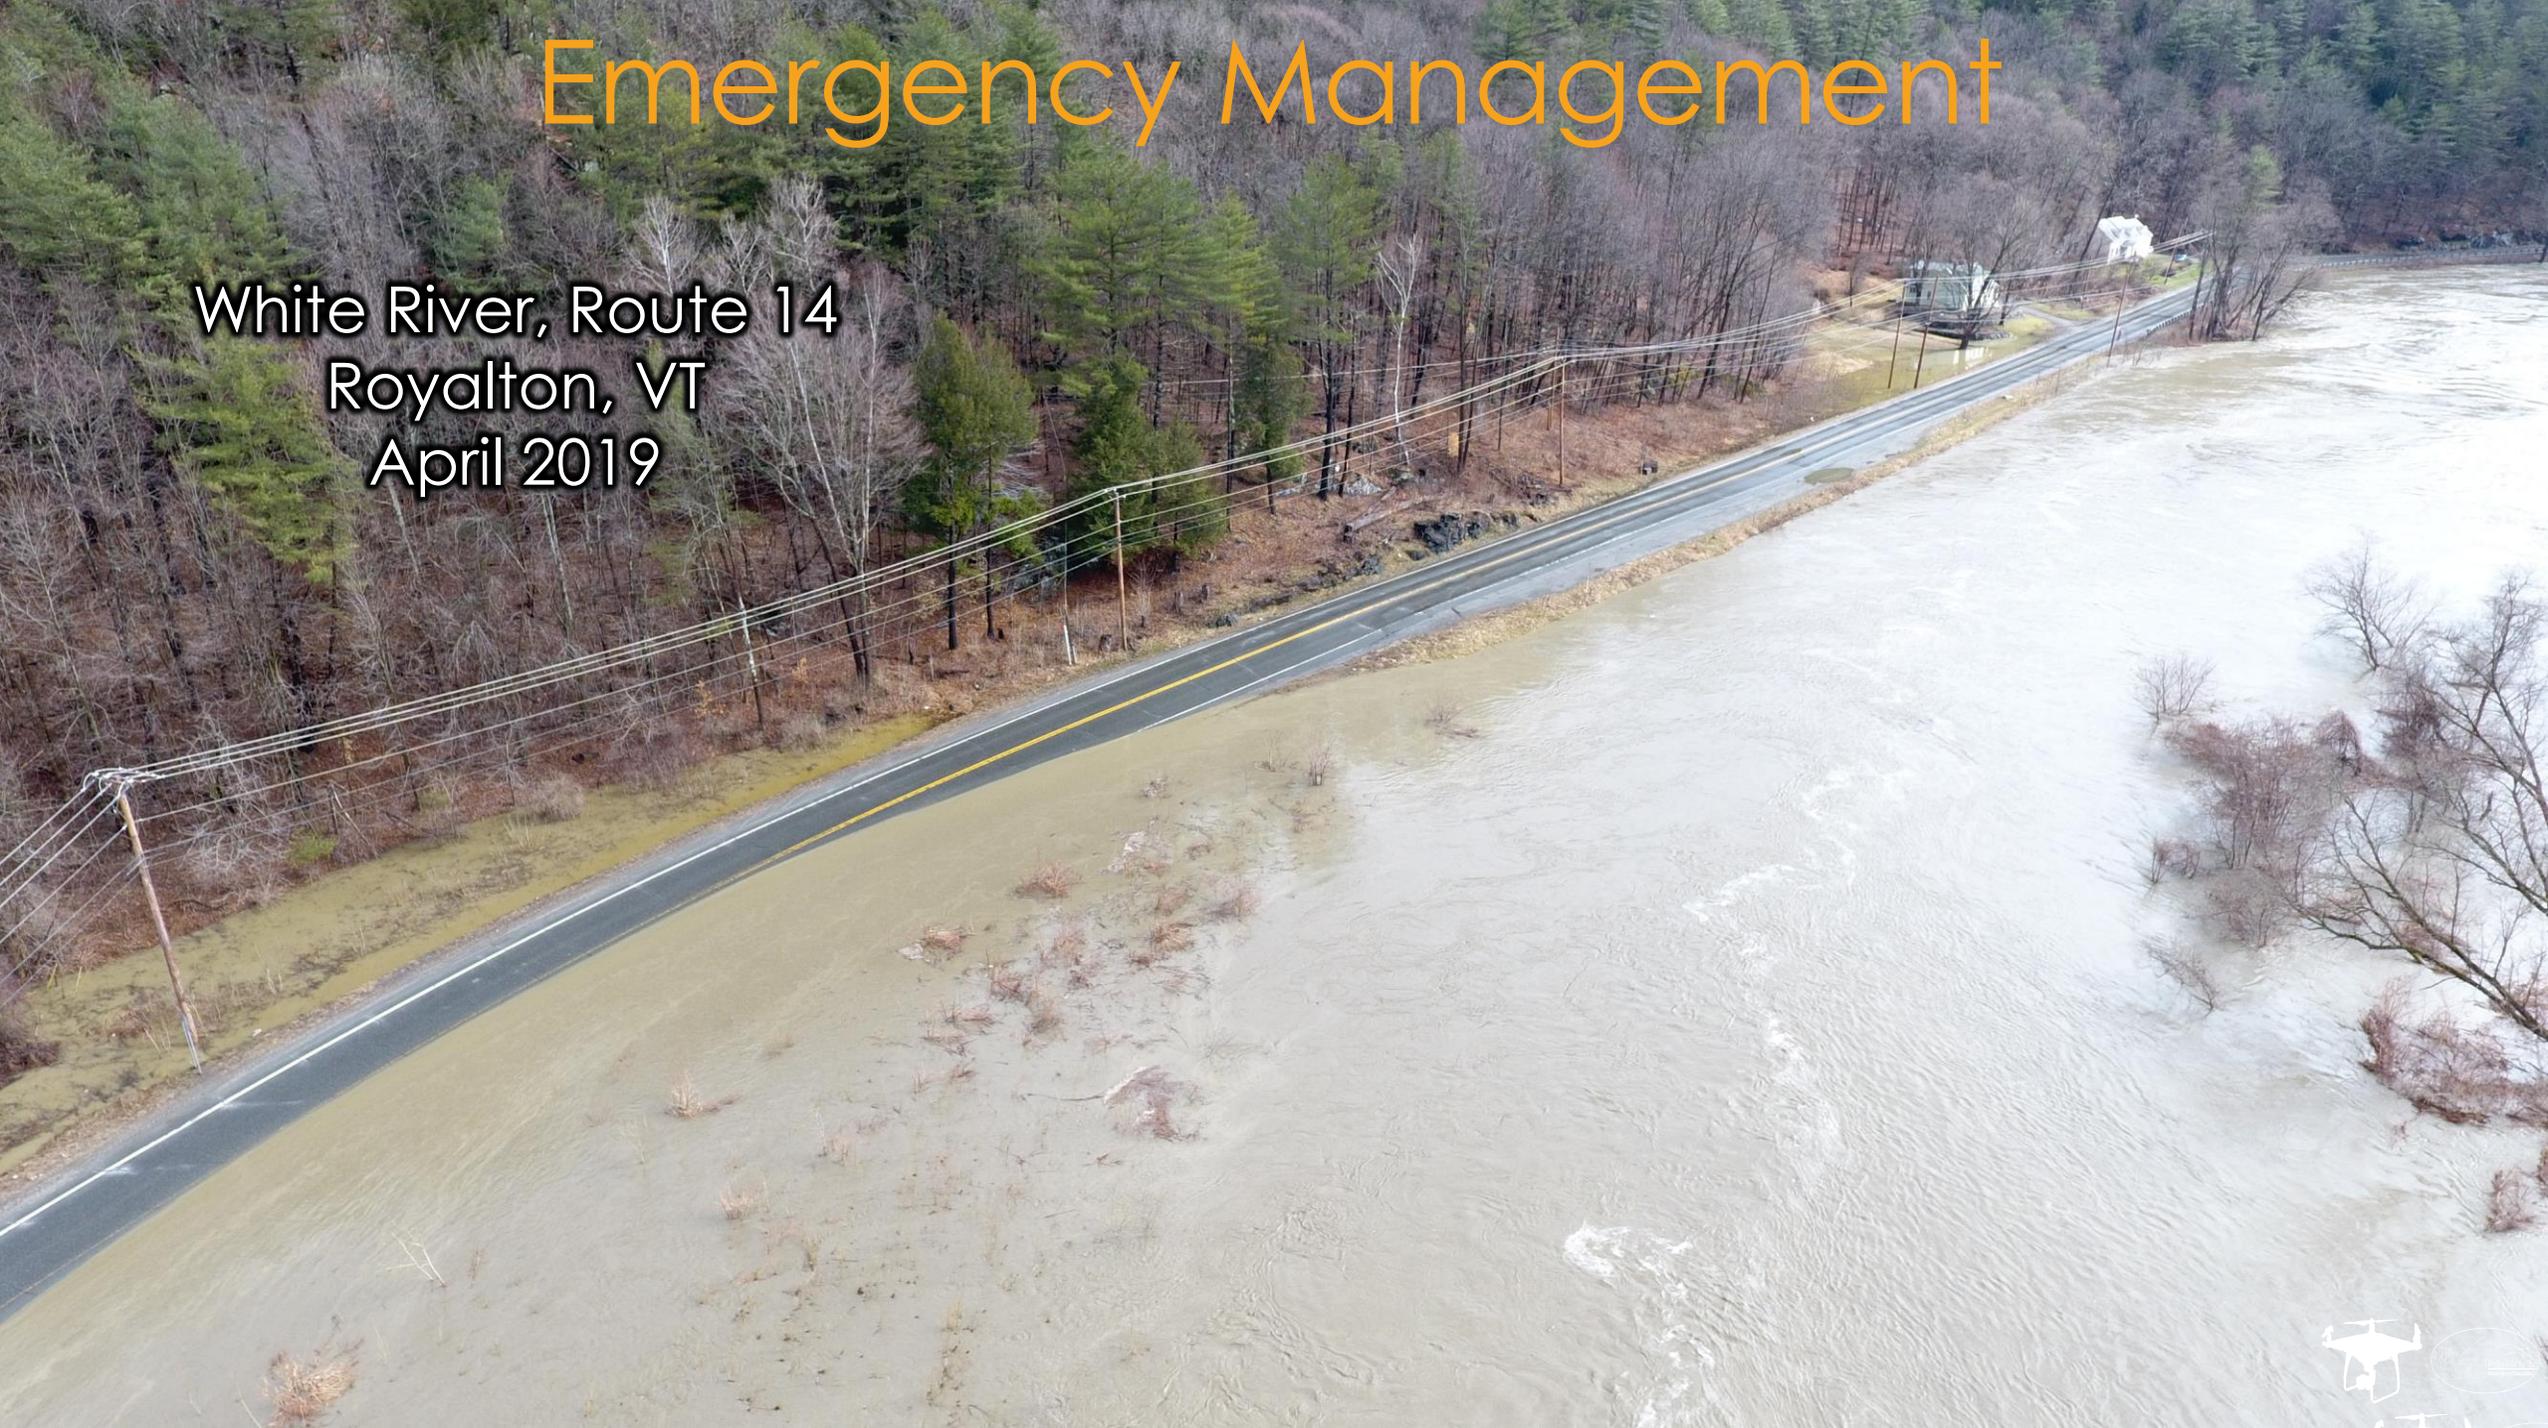
White River, Route 14
Royalton, VT
April 2019

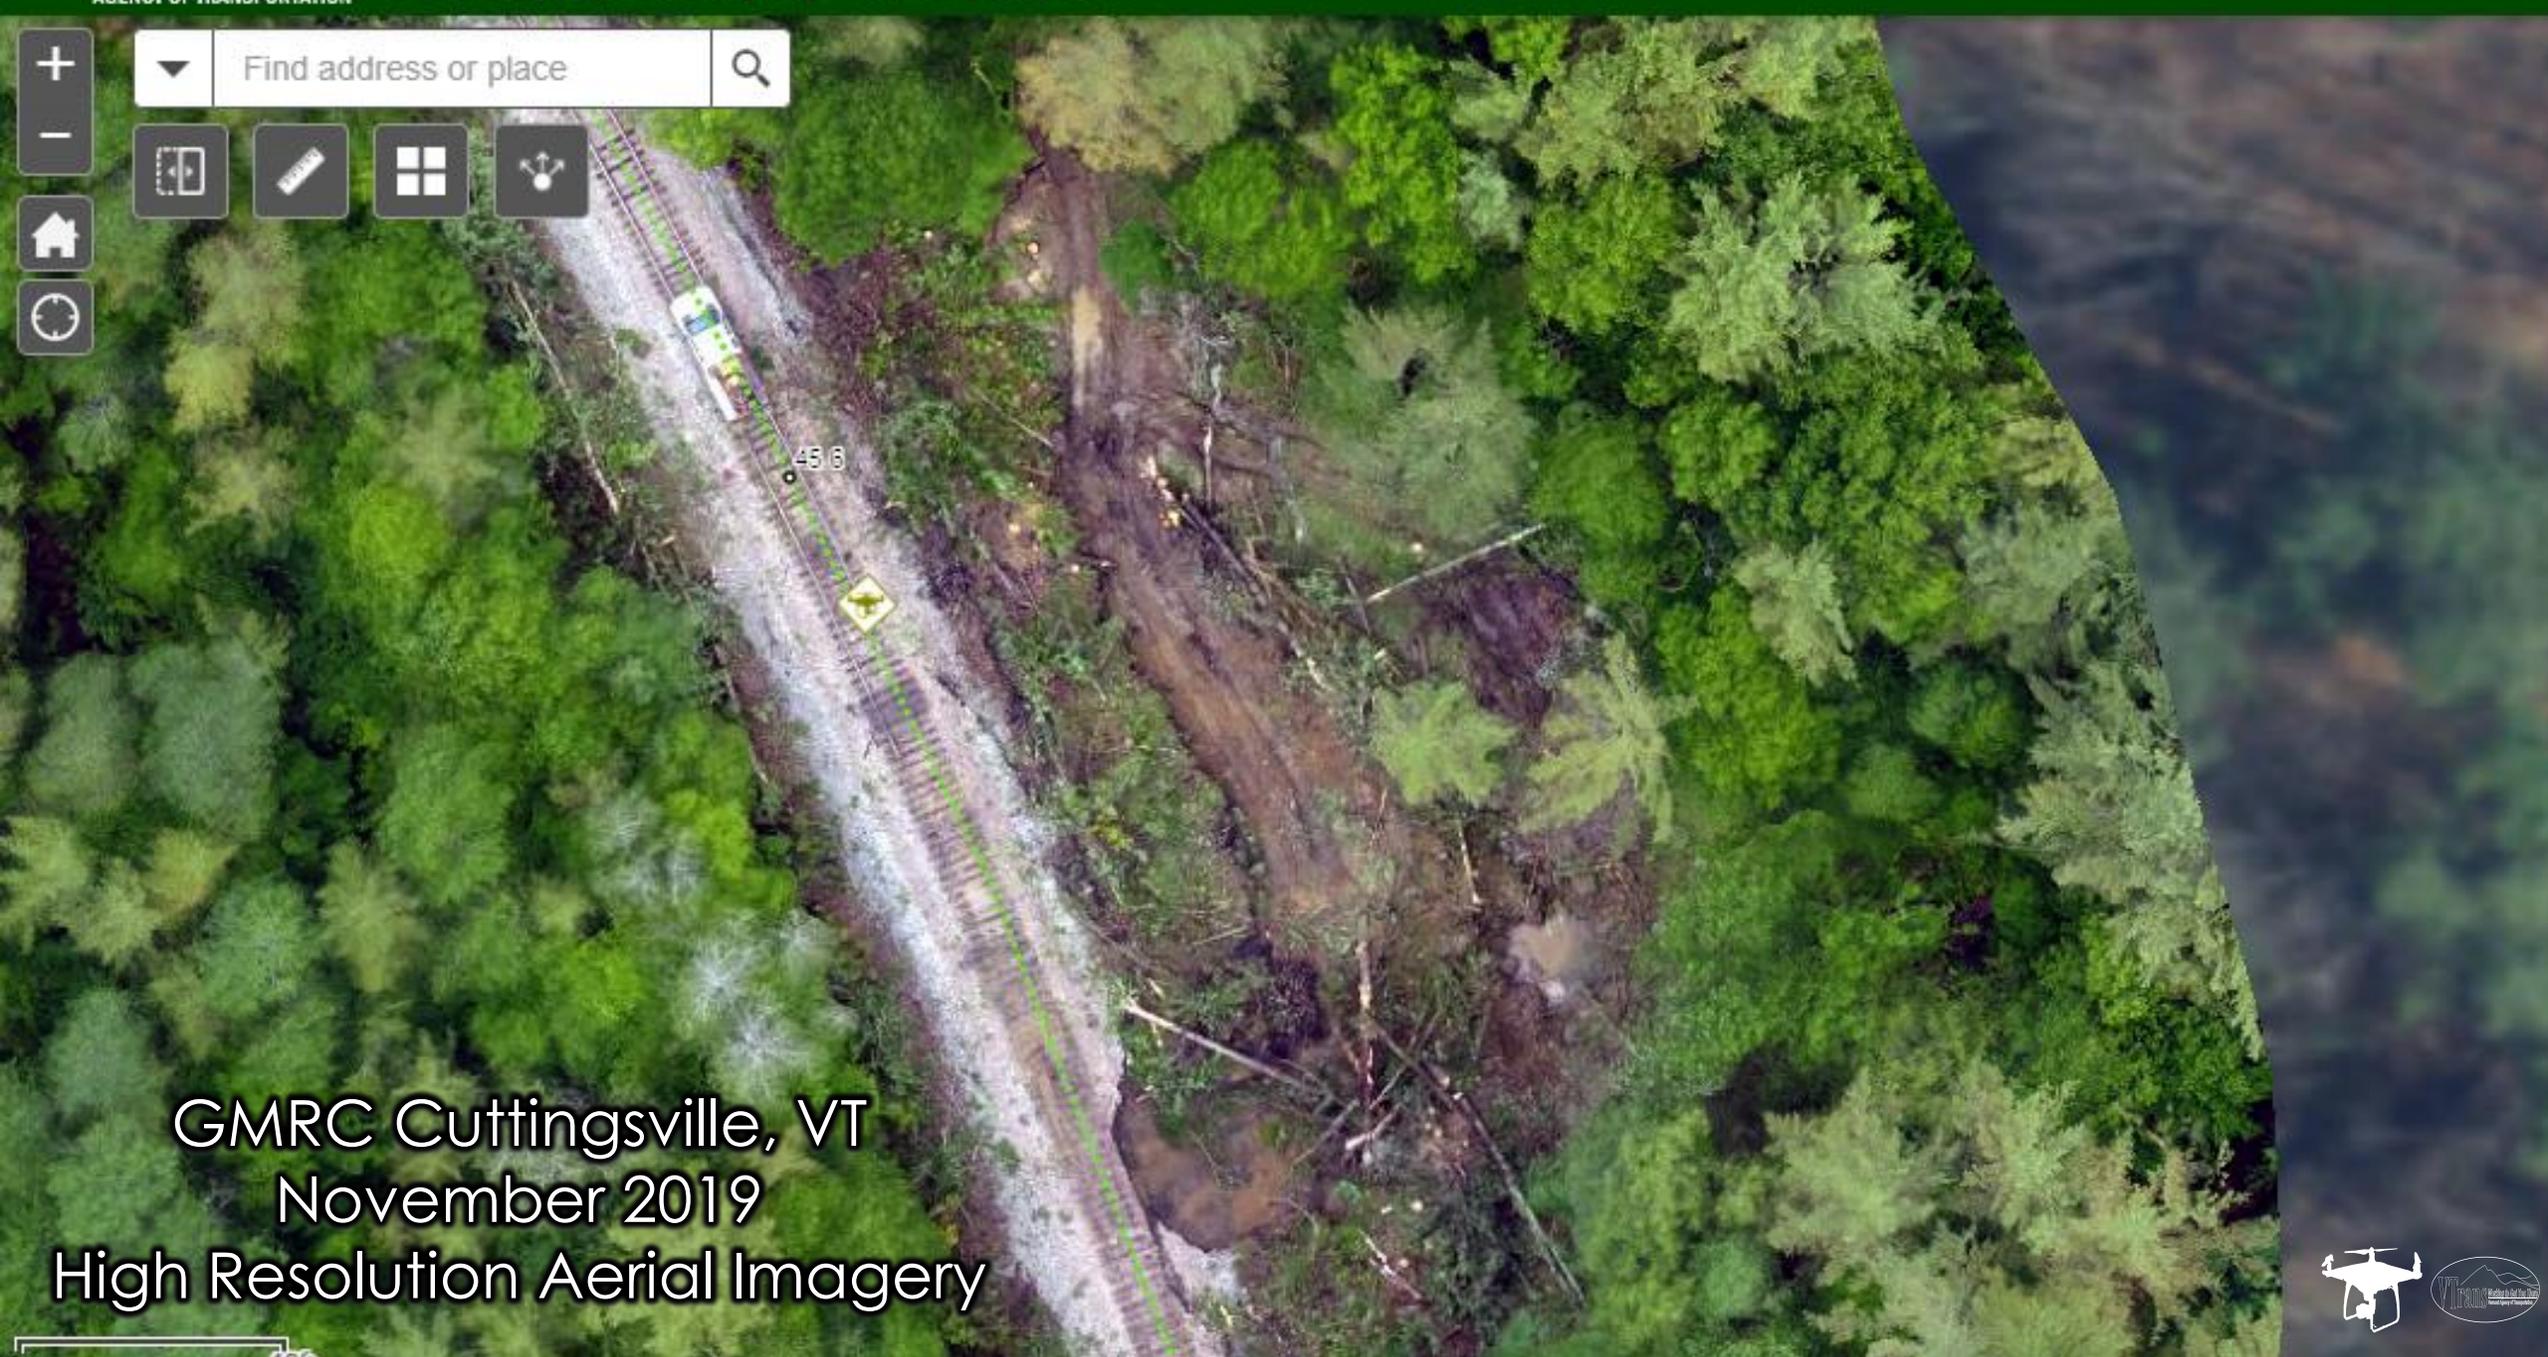
GMRC Cuttingsville, VT
November 2019

High Resolution Aerial Imagery

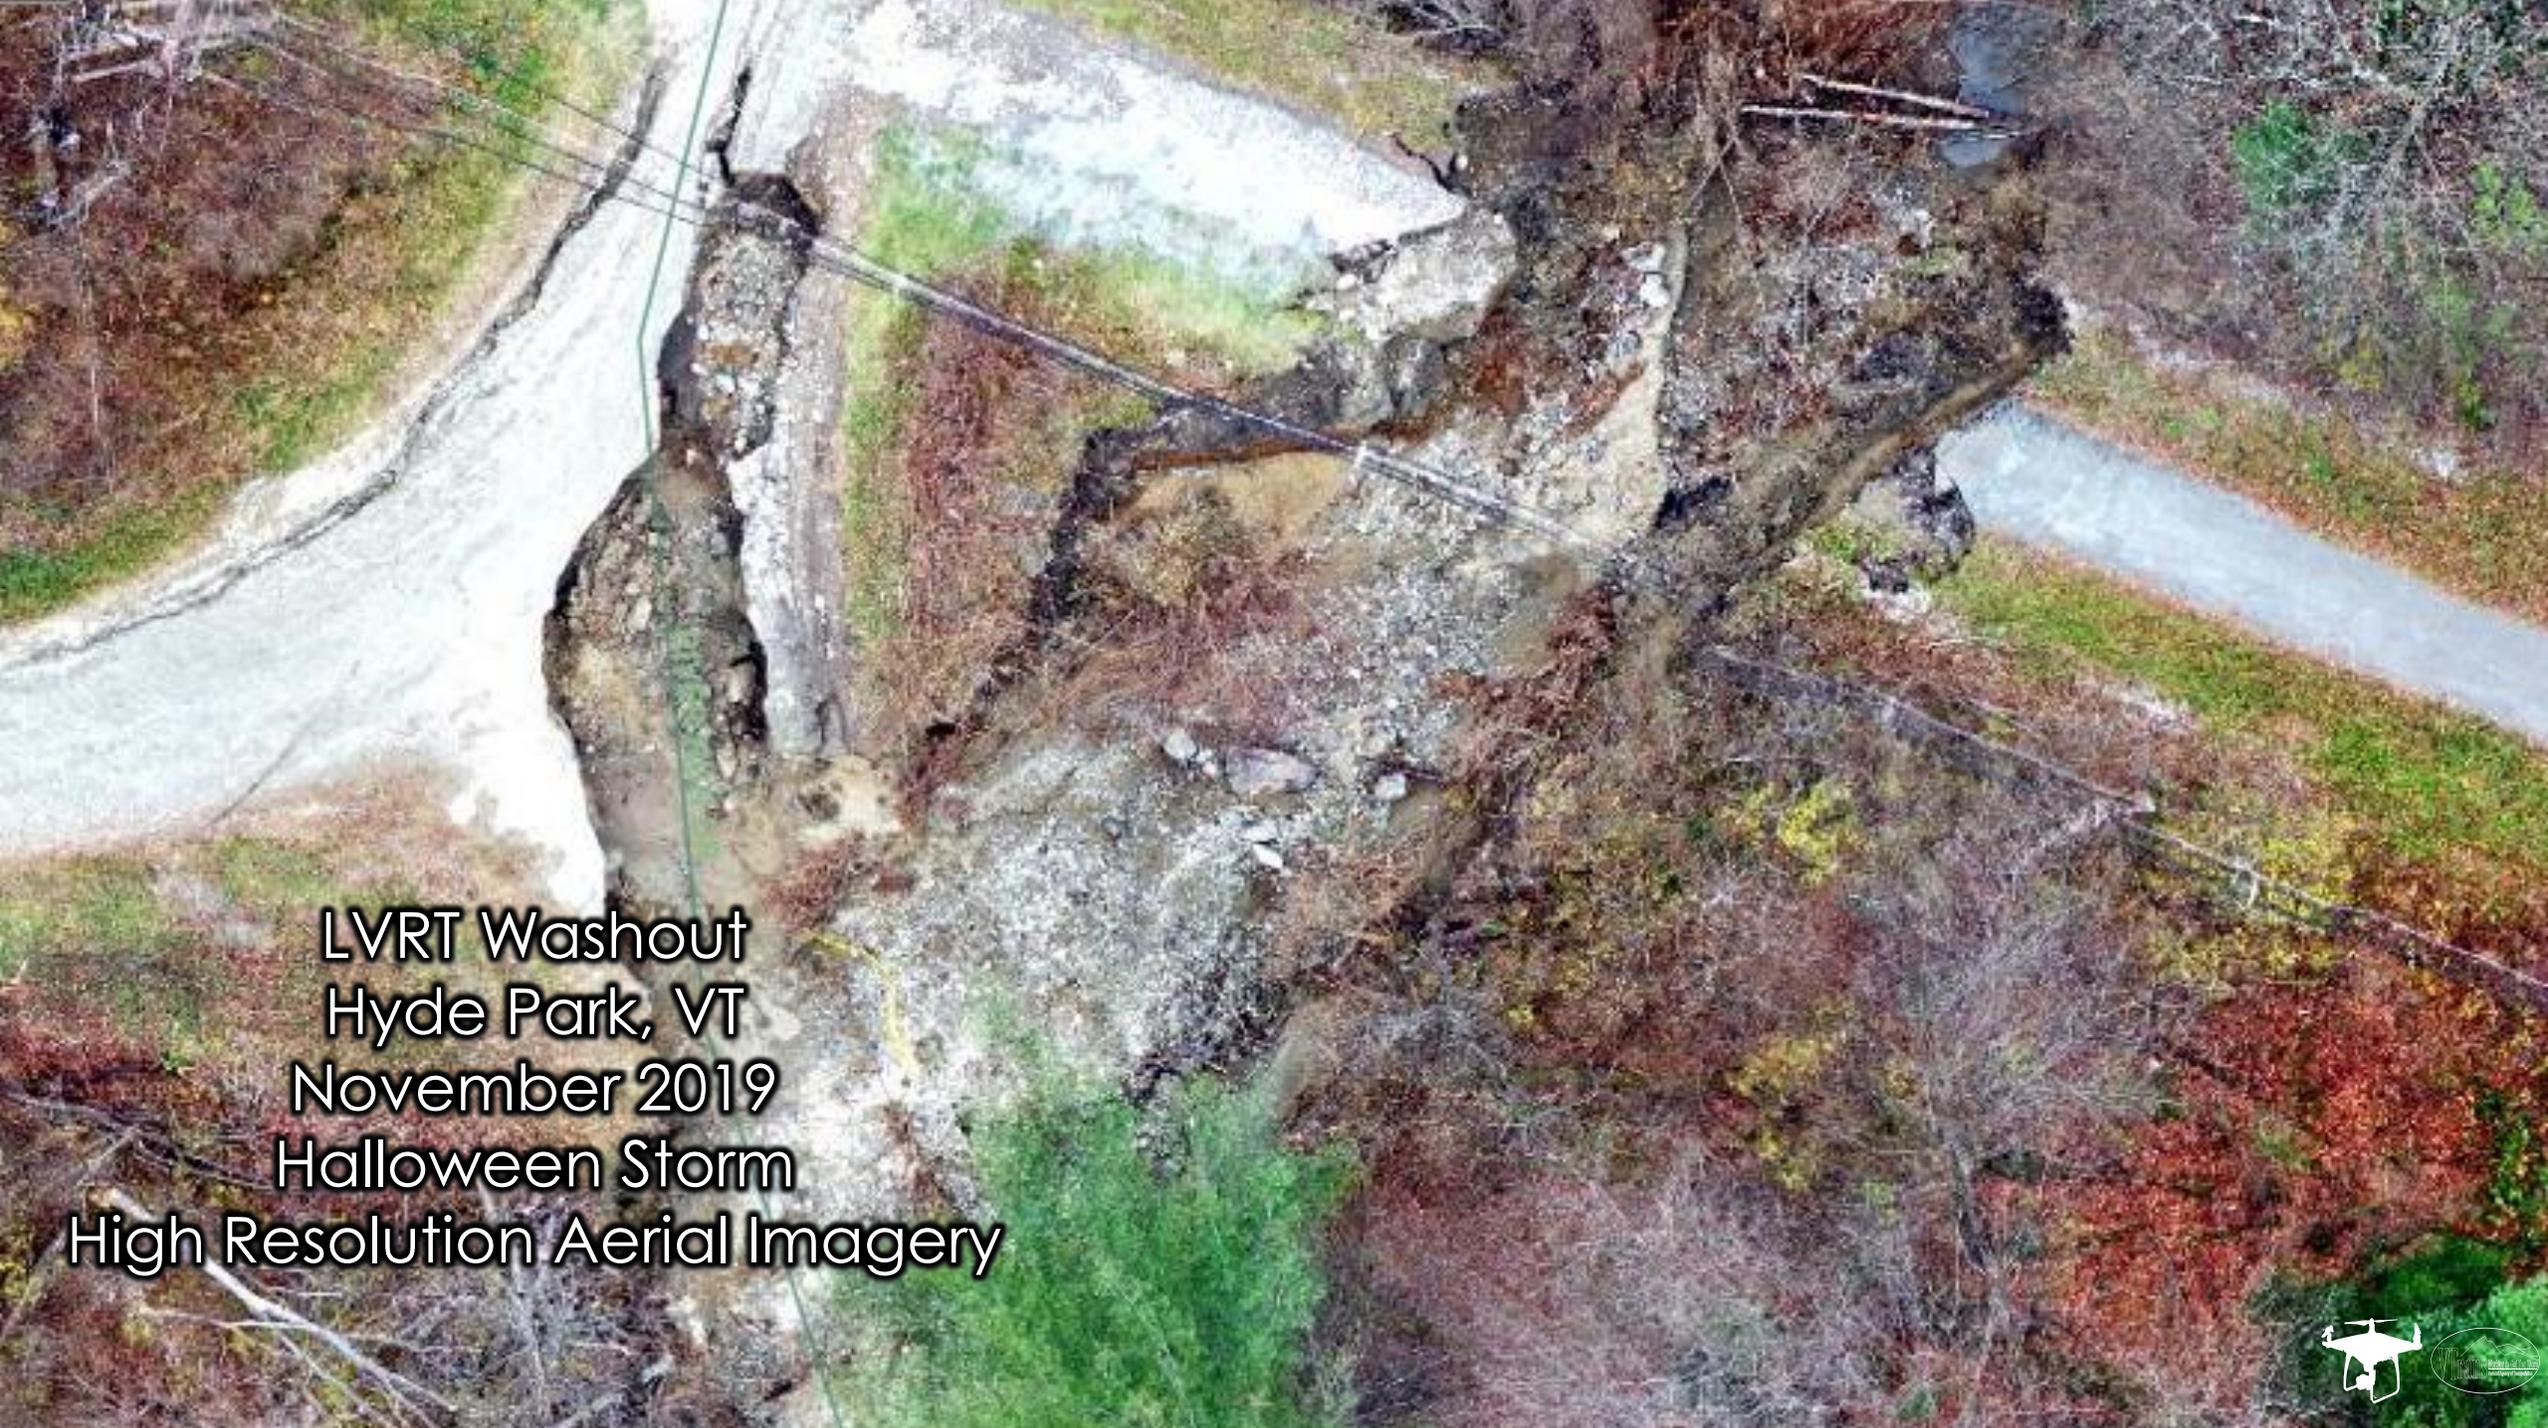
LVRT Washout
Hyde Park, VT
November 2019
Halloween Storm

High Resolution Aerial Imagery

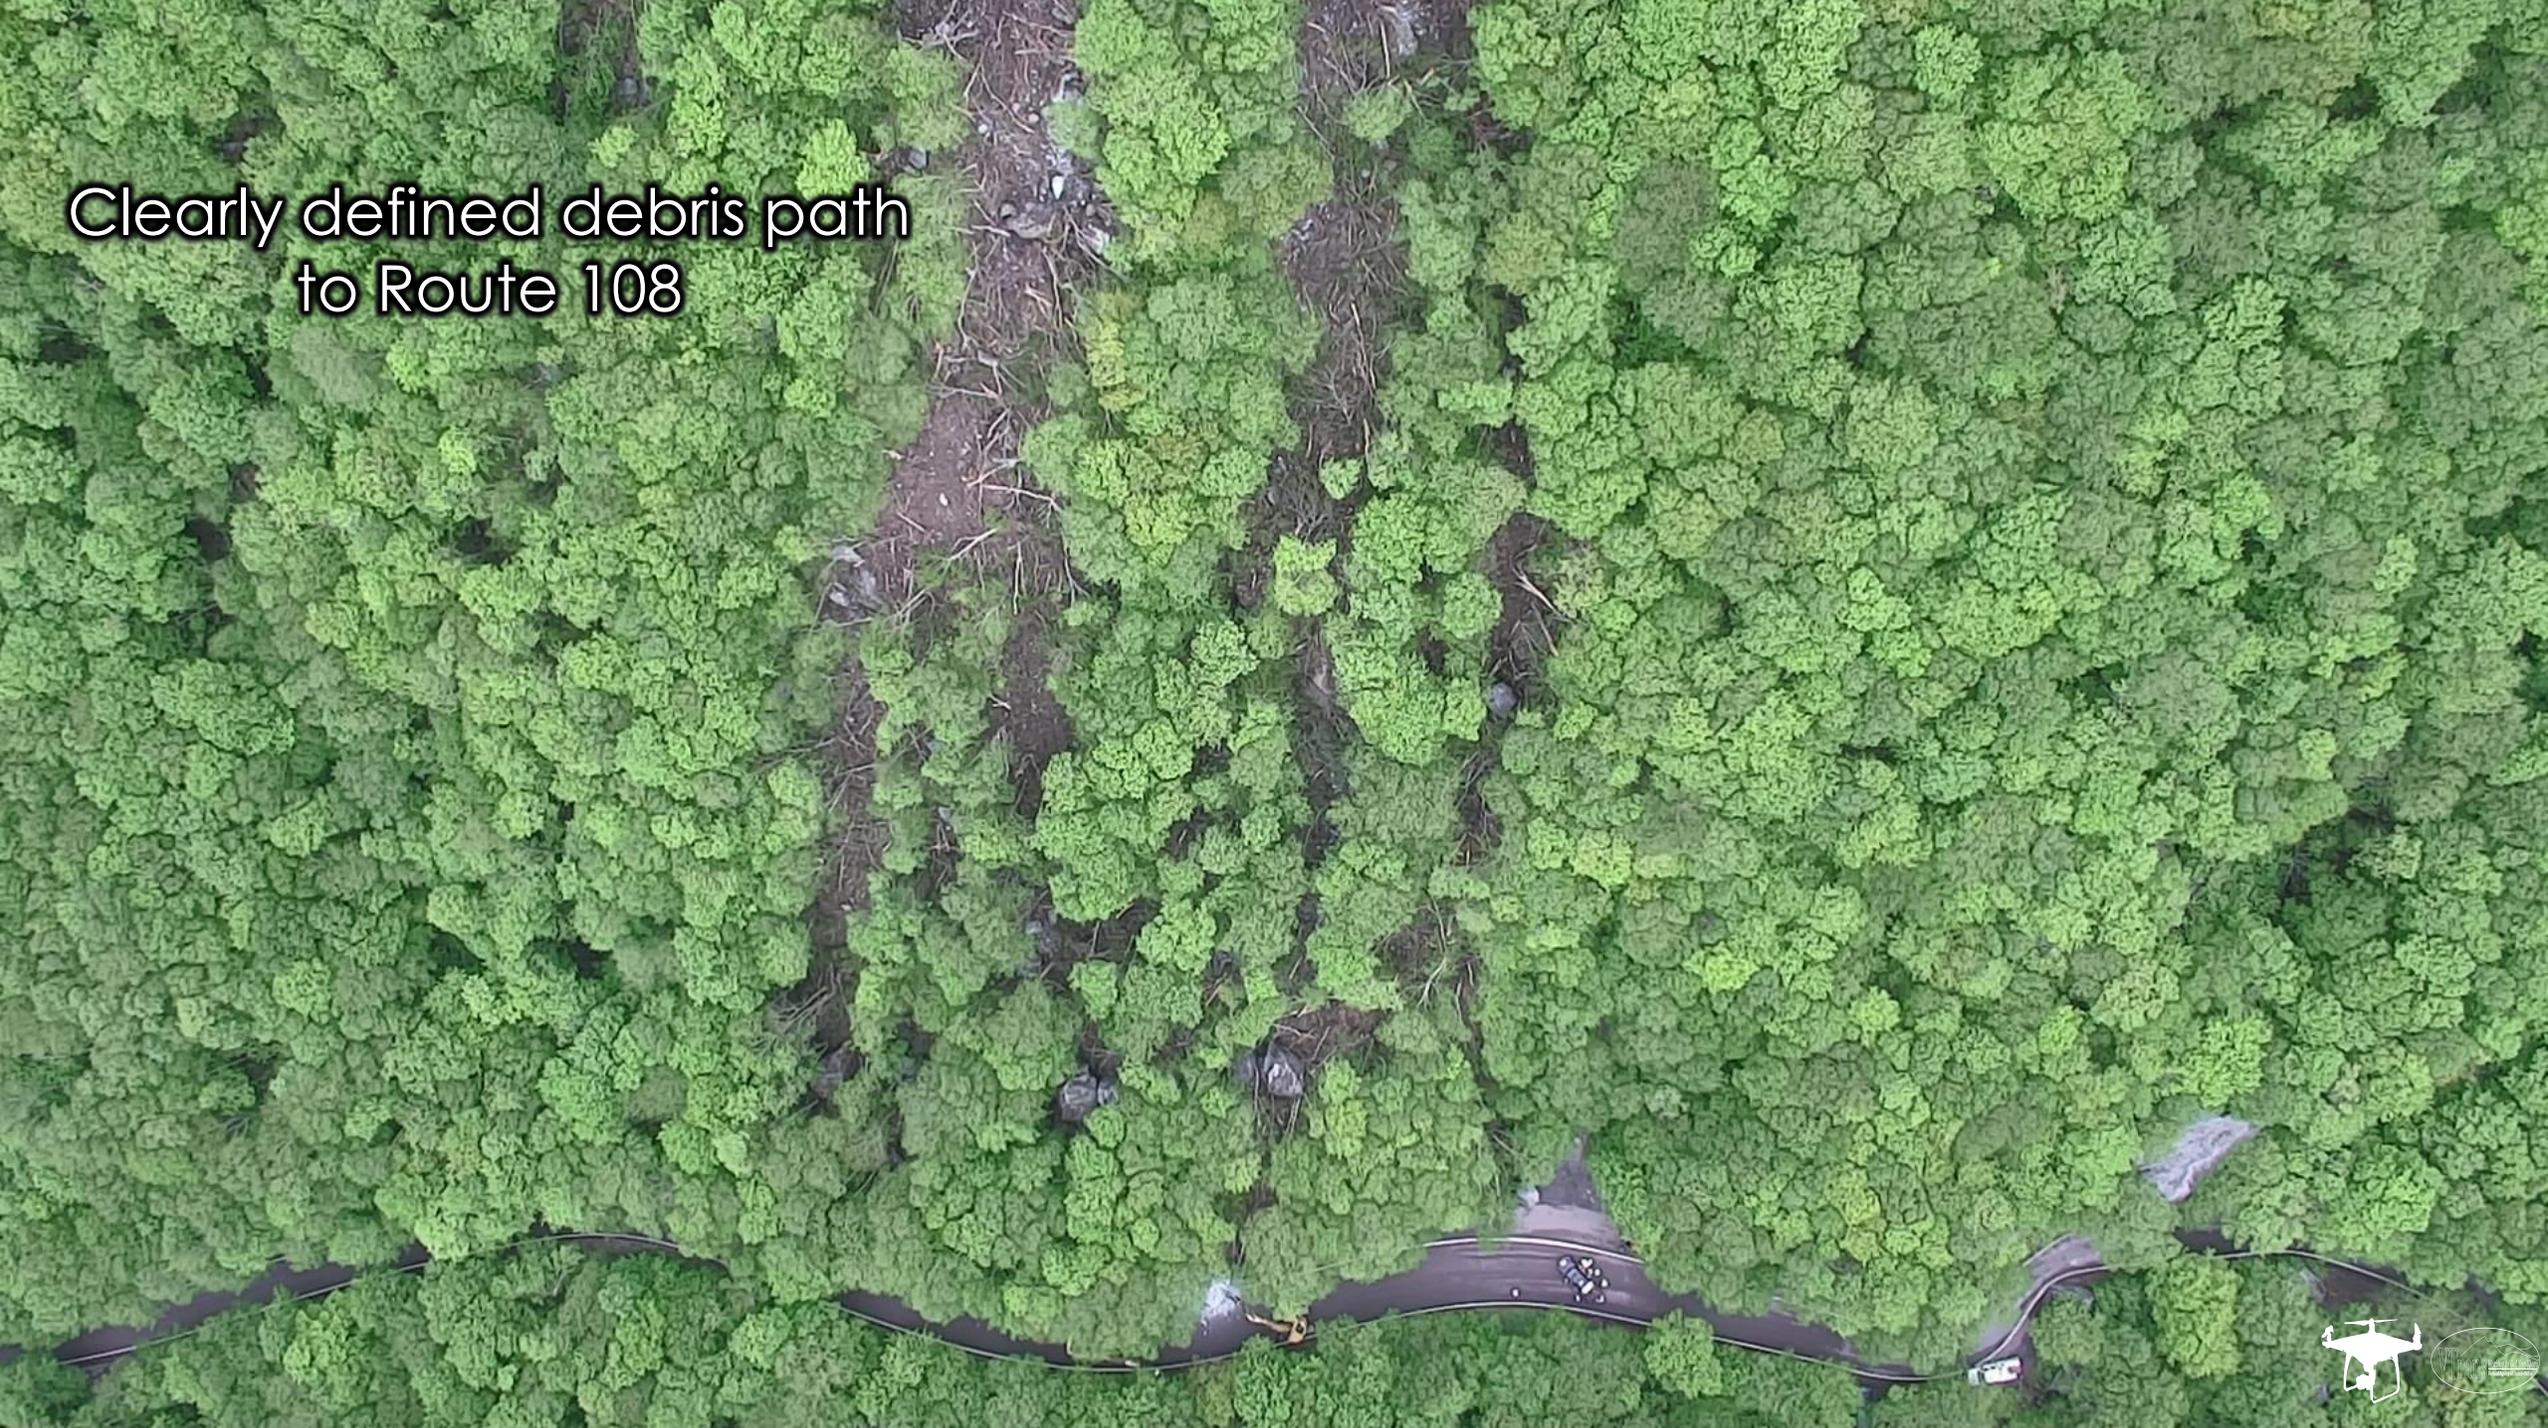
Rockslide in Smuggler's Notch
Route 108 Cambridge, VT
May 2020

VTrans Geologists were able
to perform a stability assessment based on
UAS Imagery

Clearly defined debris path
to Route 108

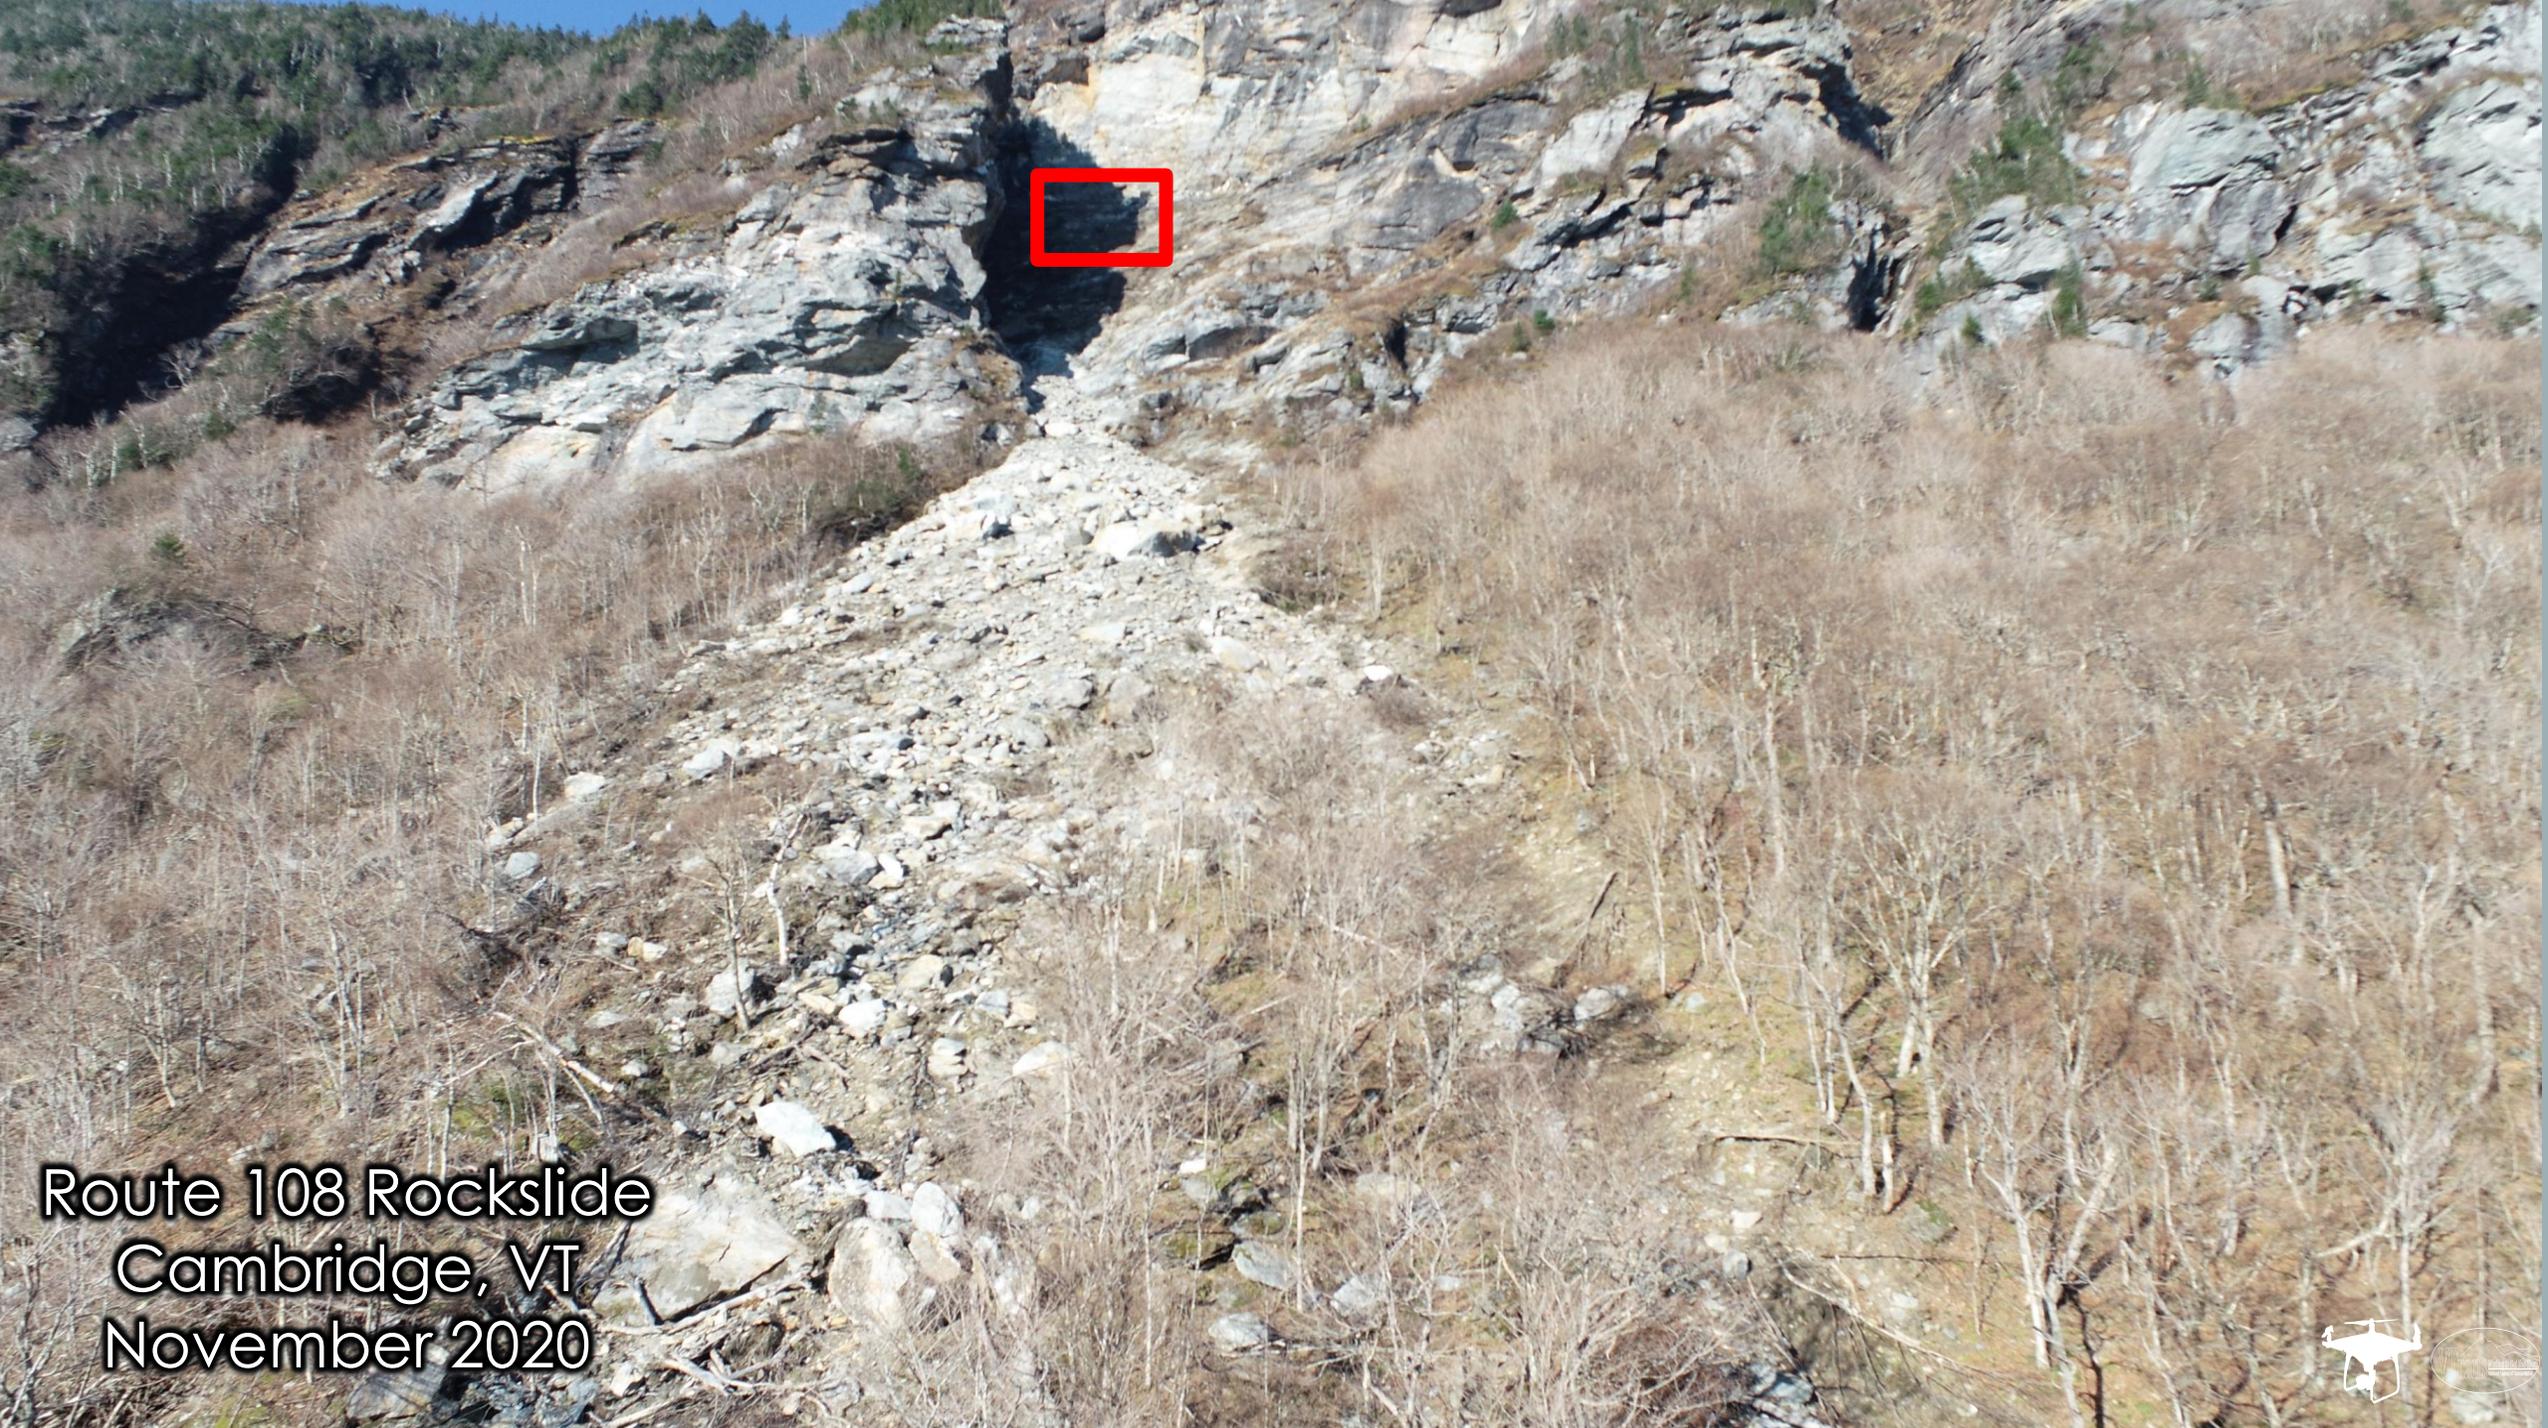
Route 108 Rockslide
Cambridge, VT
November 2020

Origin of Route 108 rockslide. Not safely accessible by VTrans and VGS geologists for assessment.

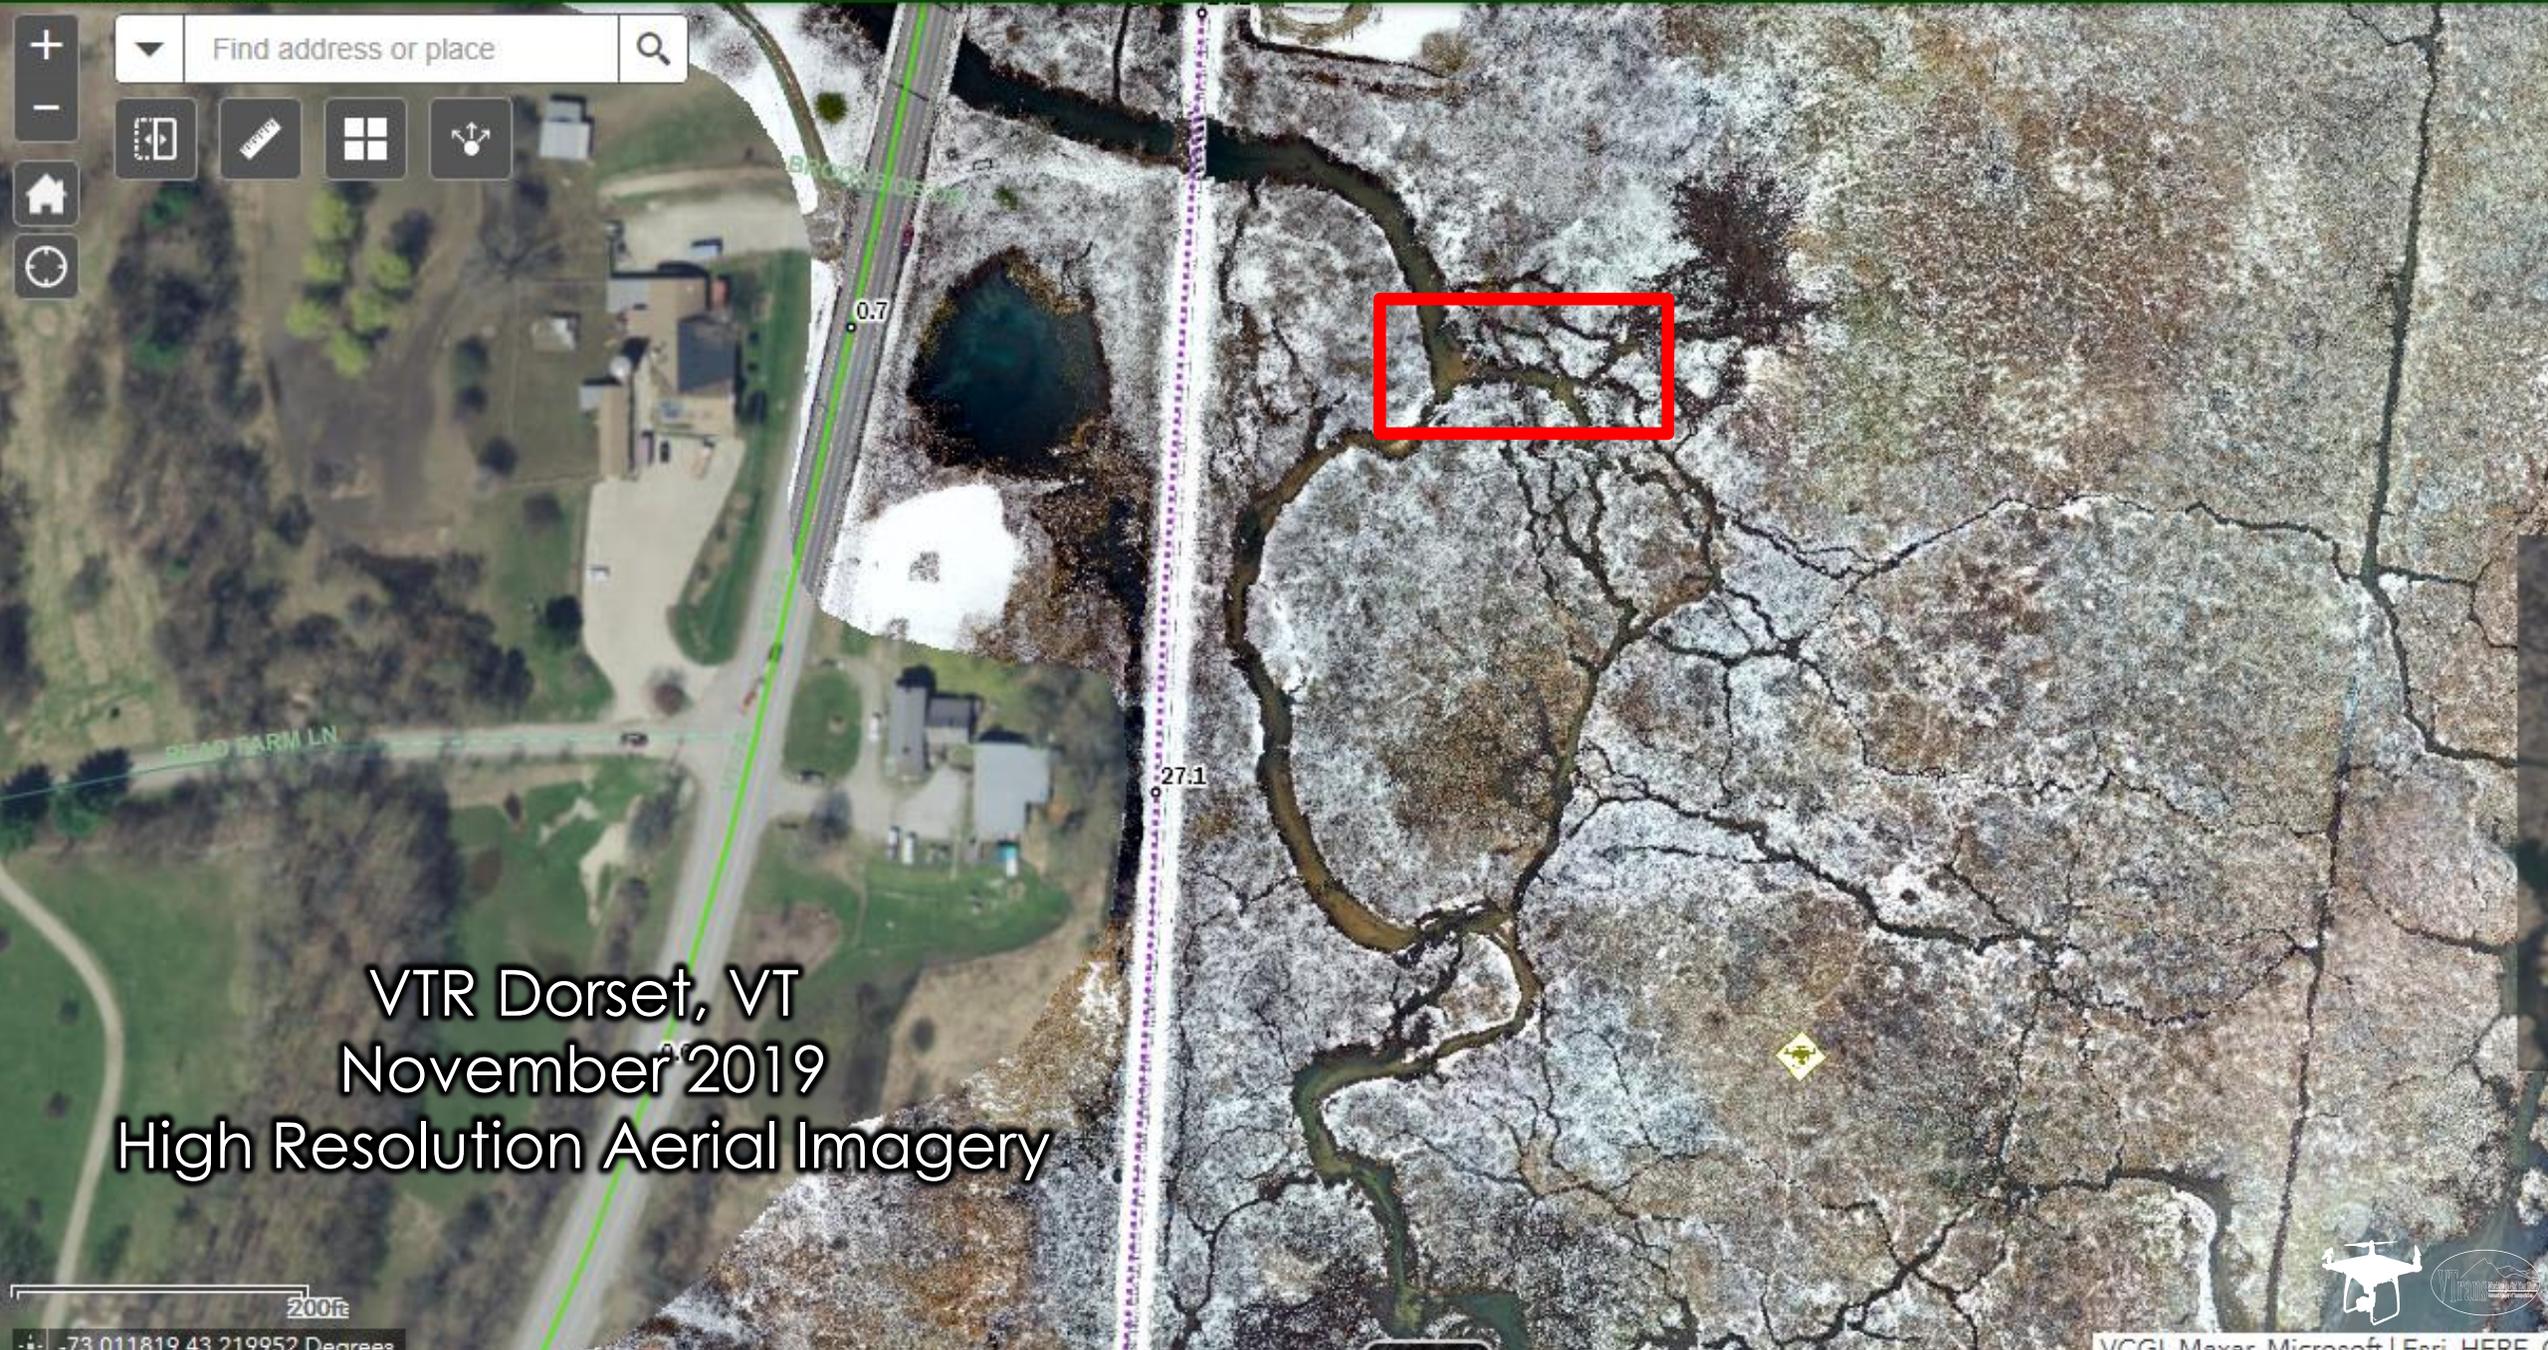
VTR Dorset, VT
November 2019
High Resolution Aerial Imagery

Identification of hydrological features, used to develop potential flood mitigation strategies
