VTRANS UAS

UNMANNED AIRCRAFT SYSTEMS

Presented by
Evan Robinson
UAS Manager

March 24, 2021

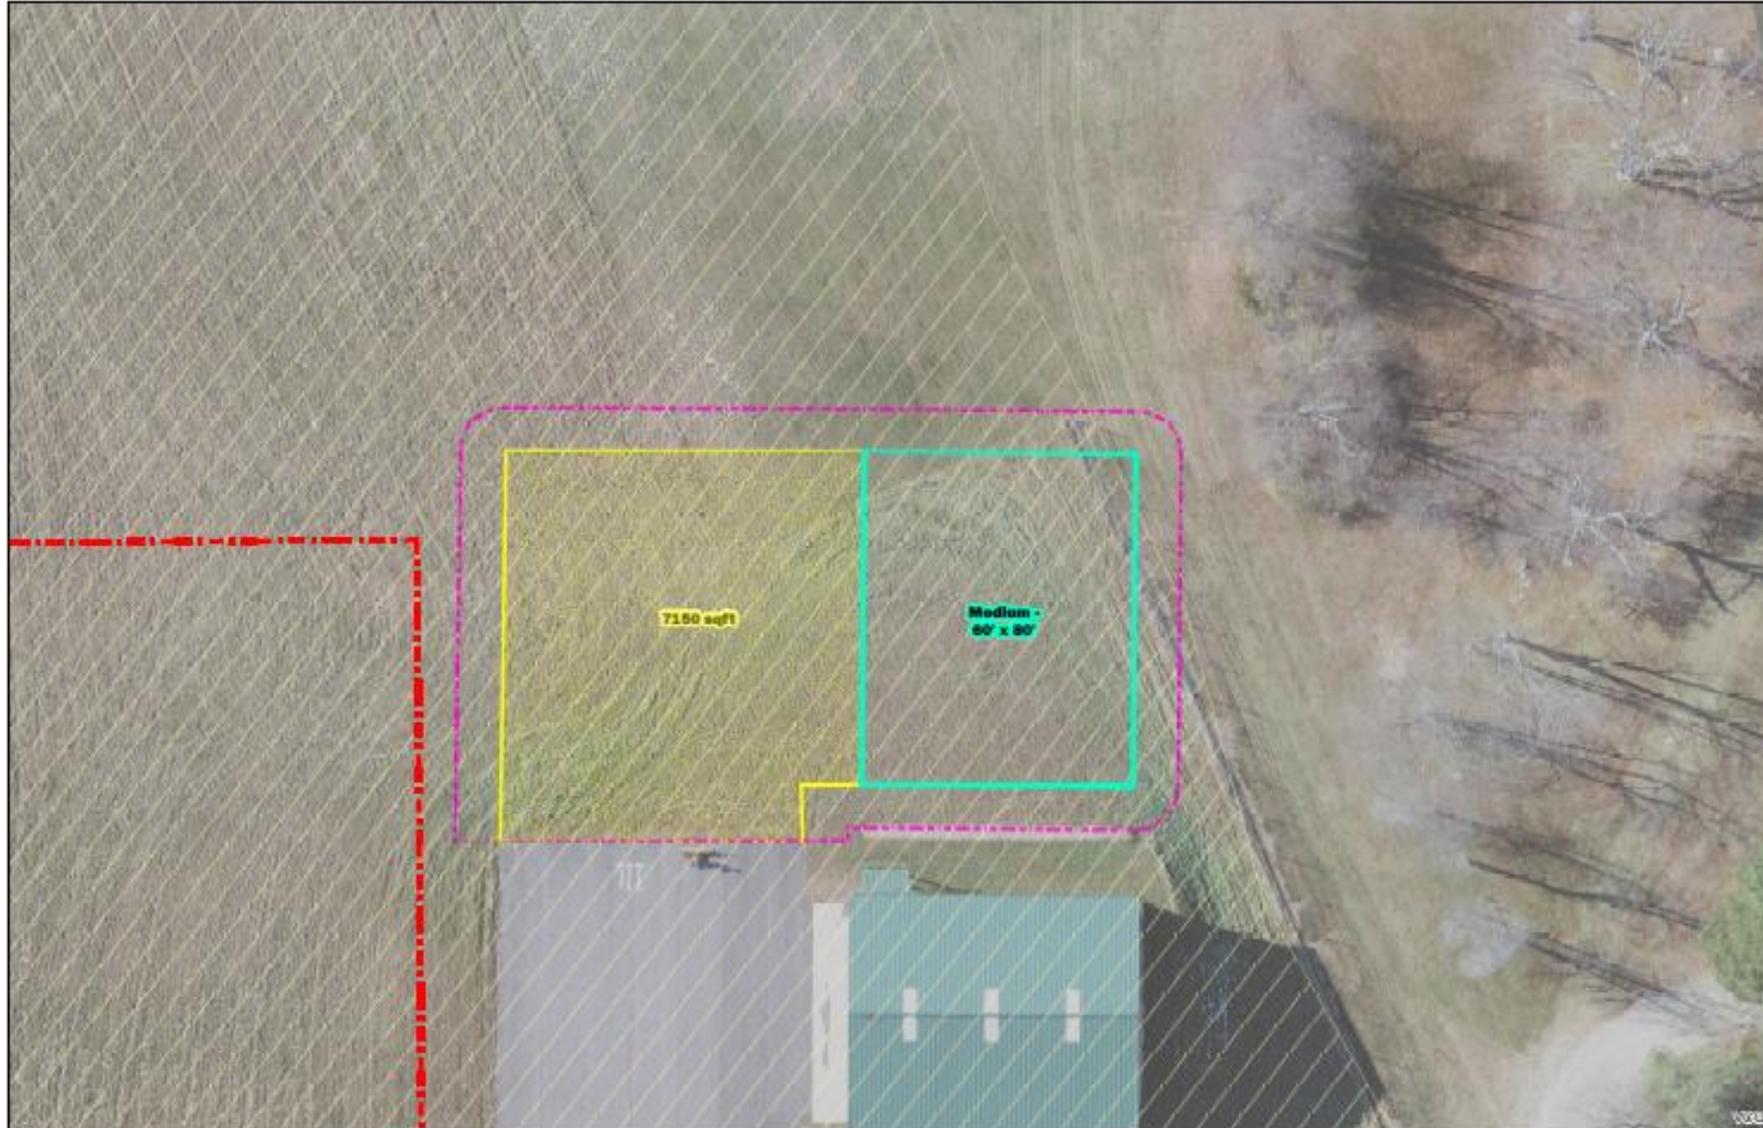
Hartness (VSF) - Springfield, VT

2019 Master Permitting Plan - Next to Existing Row

Disturbed Area: 15940 sqft

New Apron/
Taxilane = 7150 sqft

1 Medium, 60' x 80' = 4800 sqft

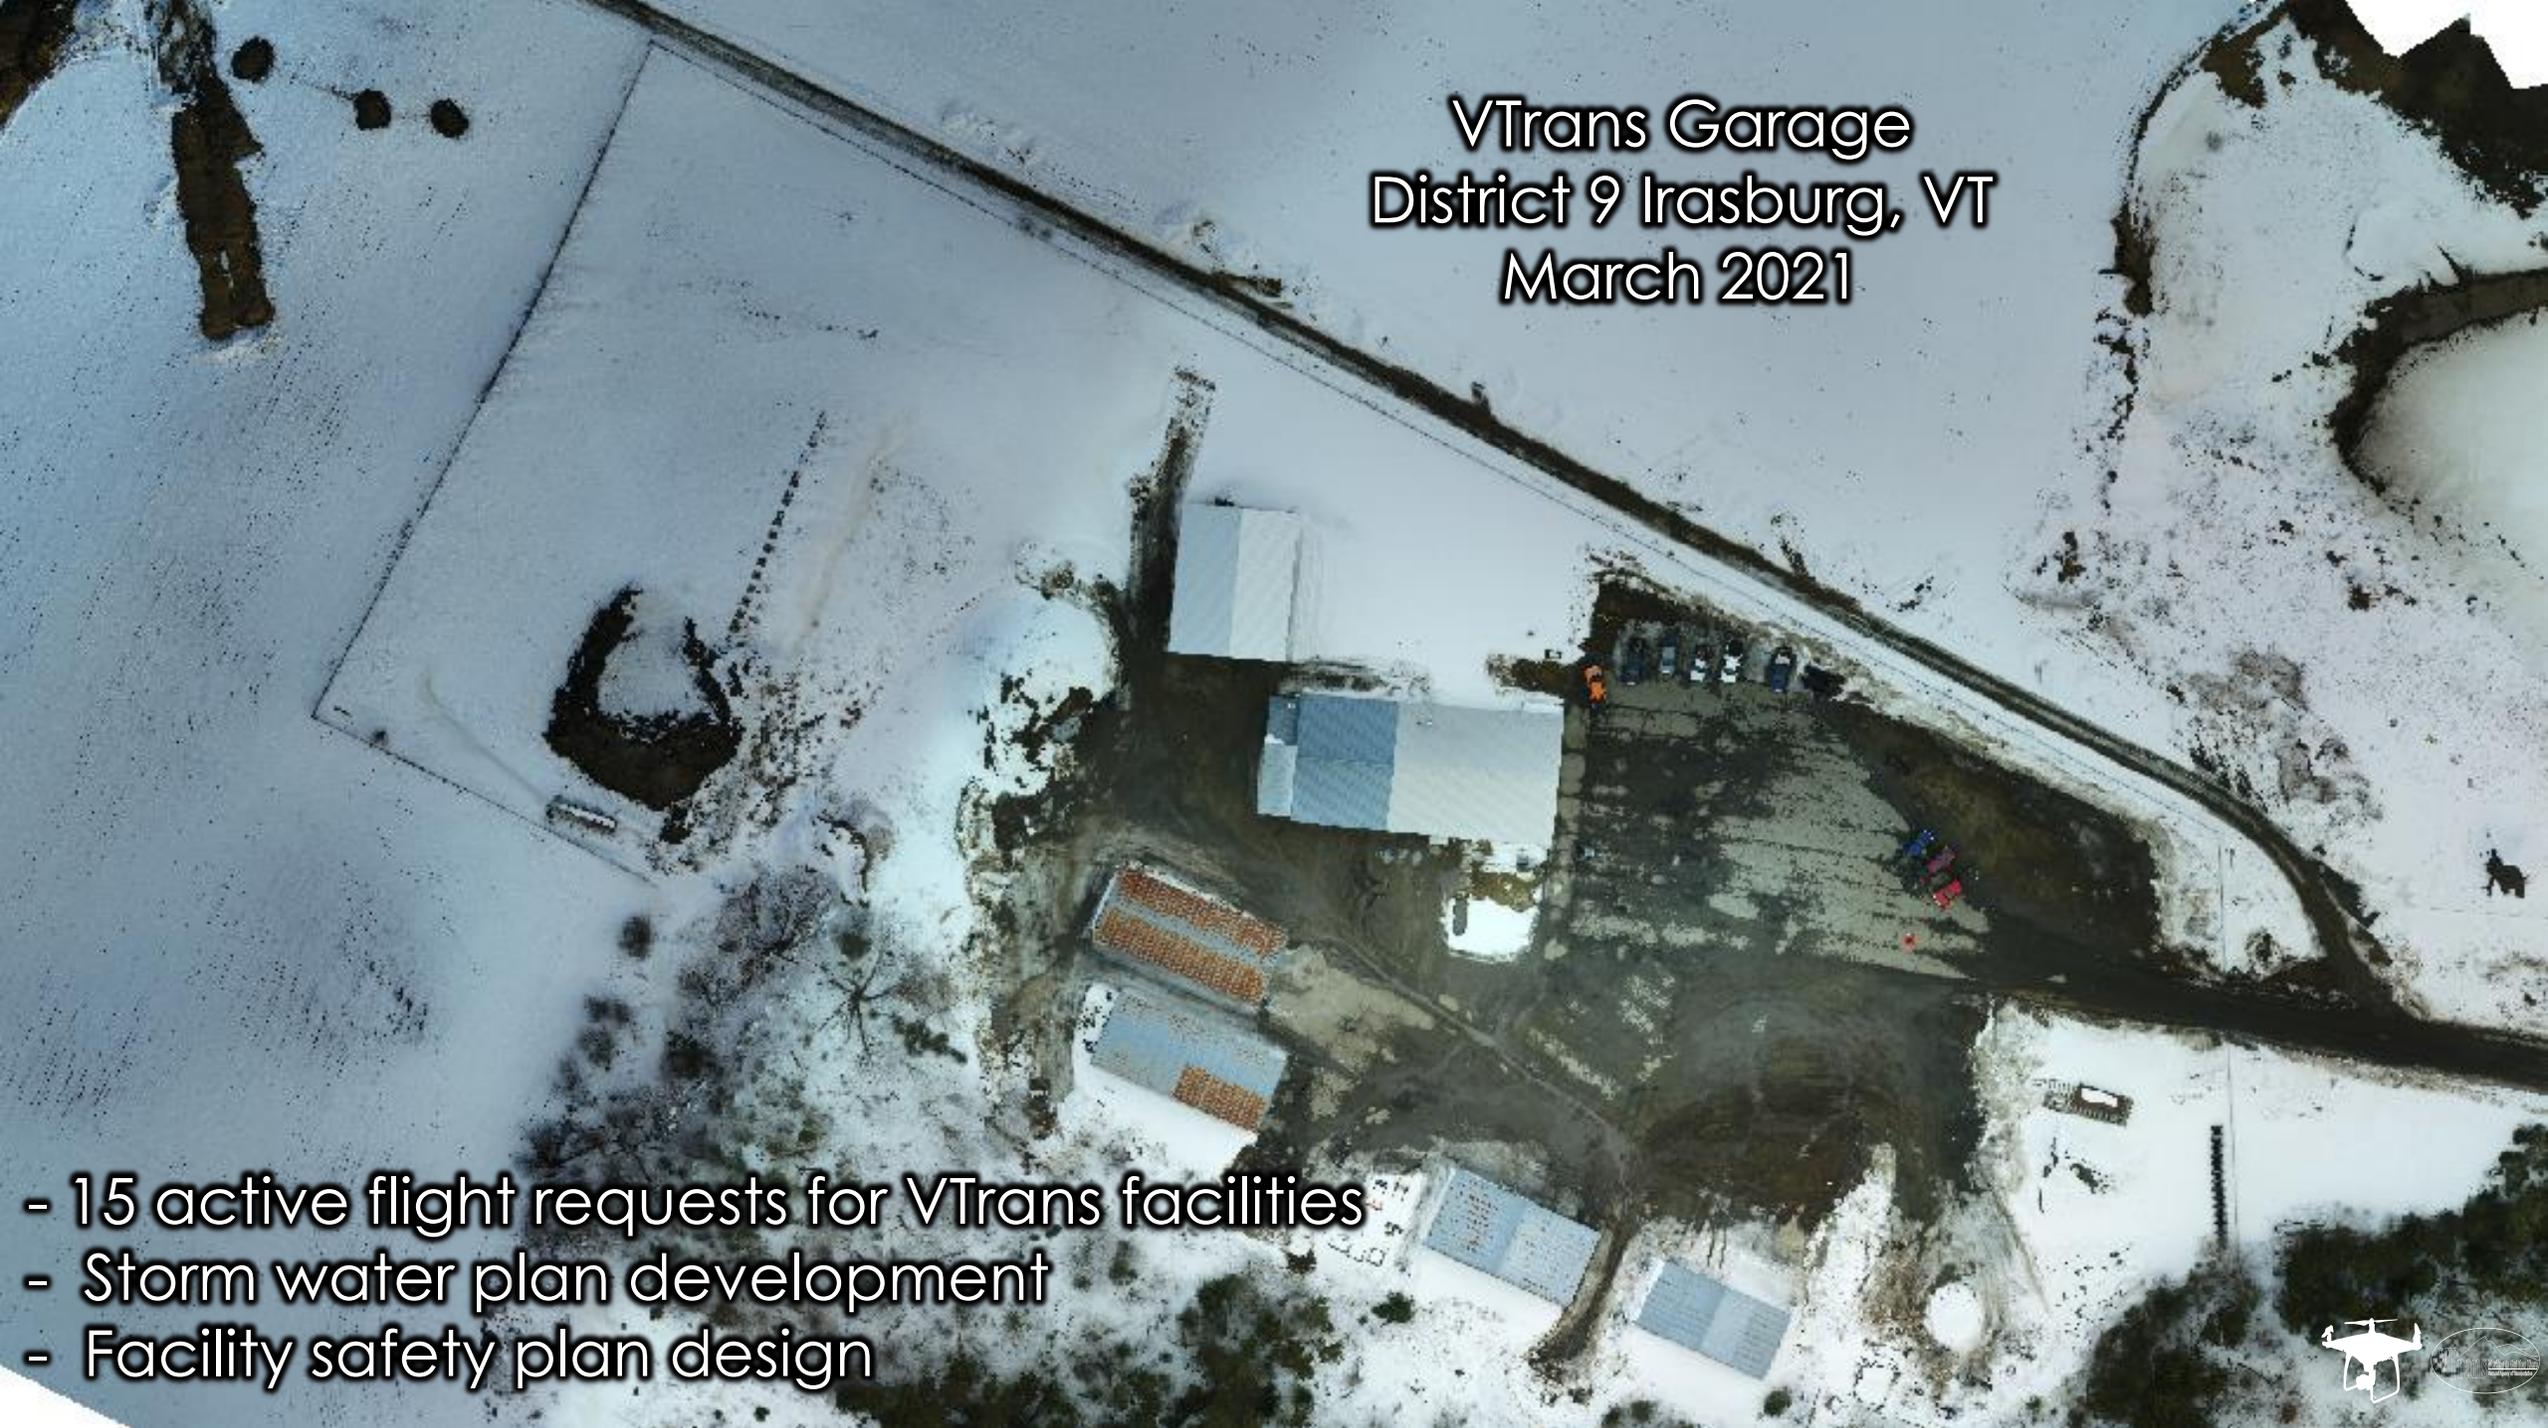
An aerial photograph of a large industrial or construction site in winter. The ground is covered in snow, with some dark patches of earth or gravel visible. Several large, rectangular buildings with light-colored roofs are scattered across the site. A road or path runs diagonally from the top right towards the center. In the bottom right corner, there is a small white drone icon and a circular logo for 'Aerial Solutions' with a mountain range in the background.

VTrans Garage
District 9 Irasburg, VT
March 2021

- 15 active flight requests for VTrans facilities
- Storm water plan development
- Facility safety plan design

Digital Surface Model
Elevations by color
From UAS Imagery

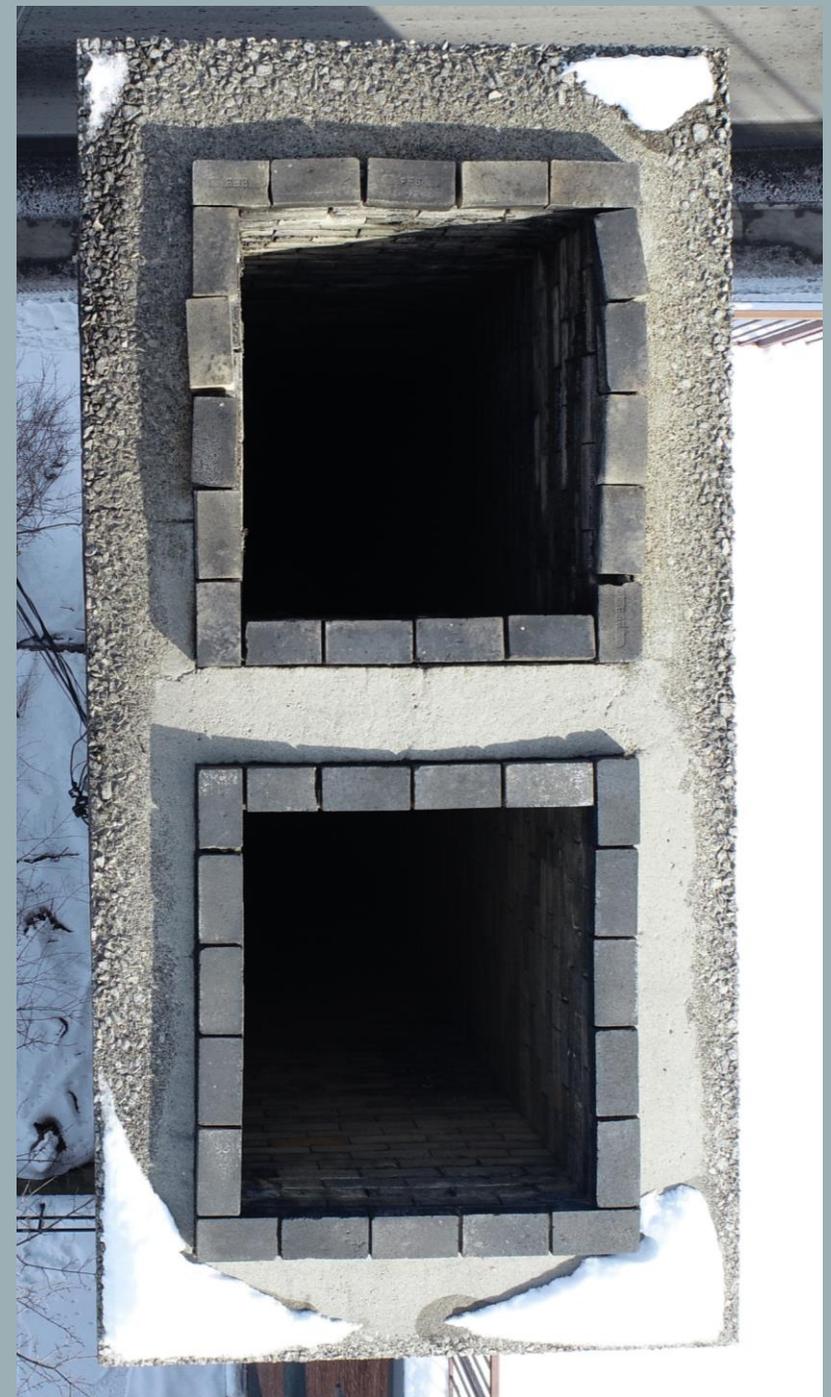
Macfarland State Office Building
BGS Request
Brick Condition Inspection
Barre, VT
January 2021

This section of chimney was not safely accessible with traditional staging or inspection methods. The condition was unknown until the UAS inspection

- 300 detailed photos in one day of flight
- Eliminated the need for staging or person-lift
- Photos given to BGS architect to prioritize repair
- **“In-house” solution makes UAS technology attainable for many project budgets**

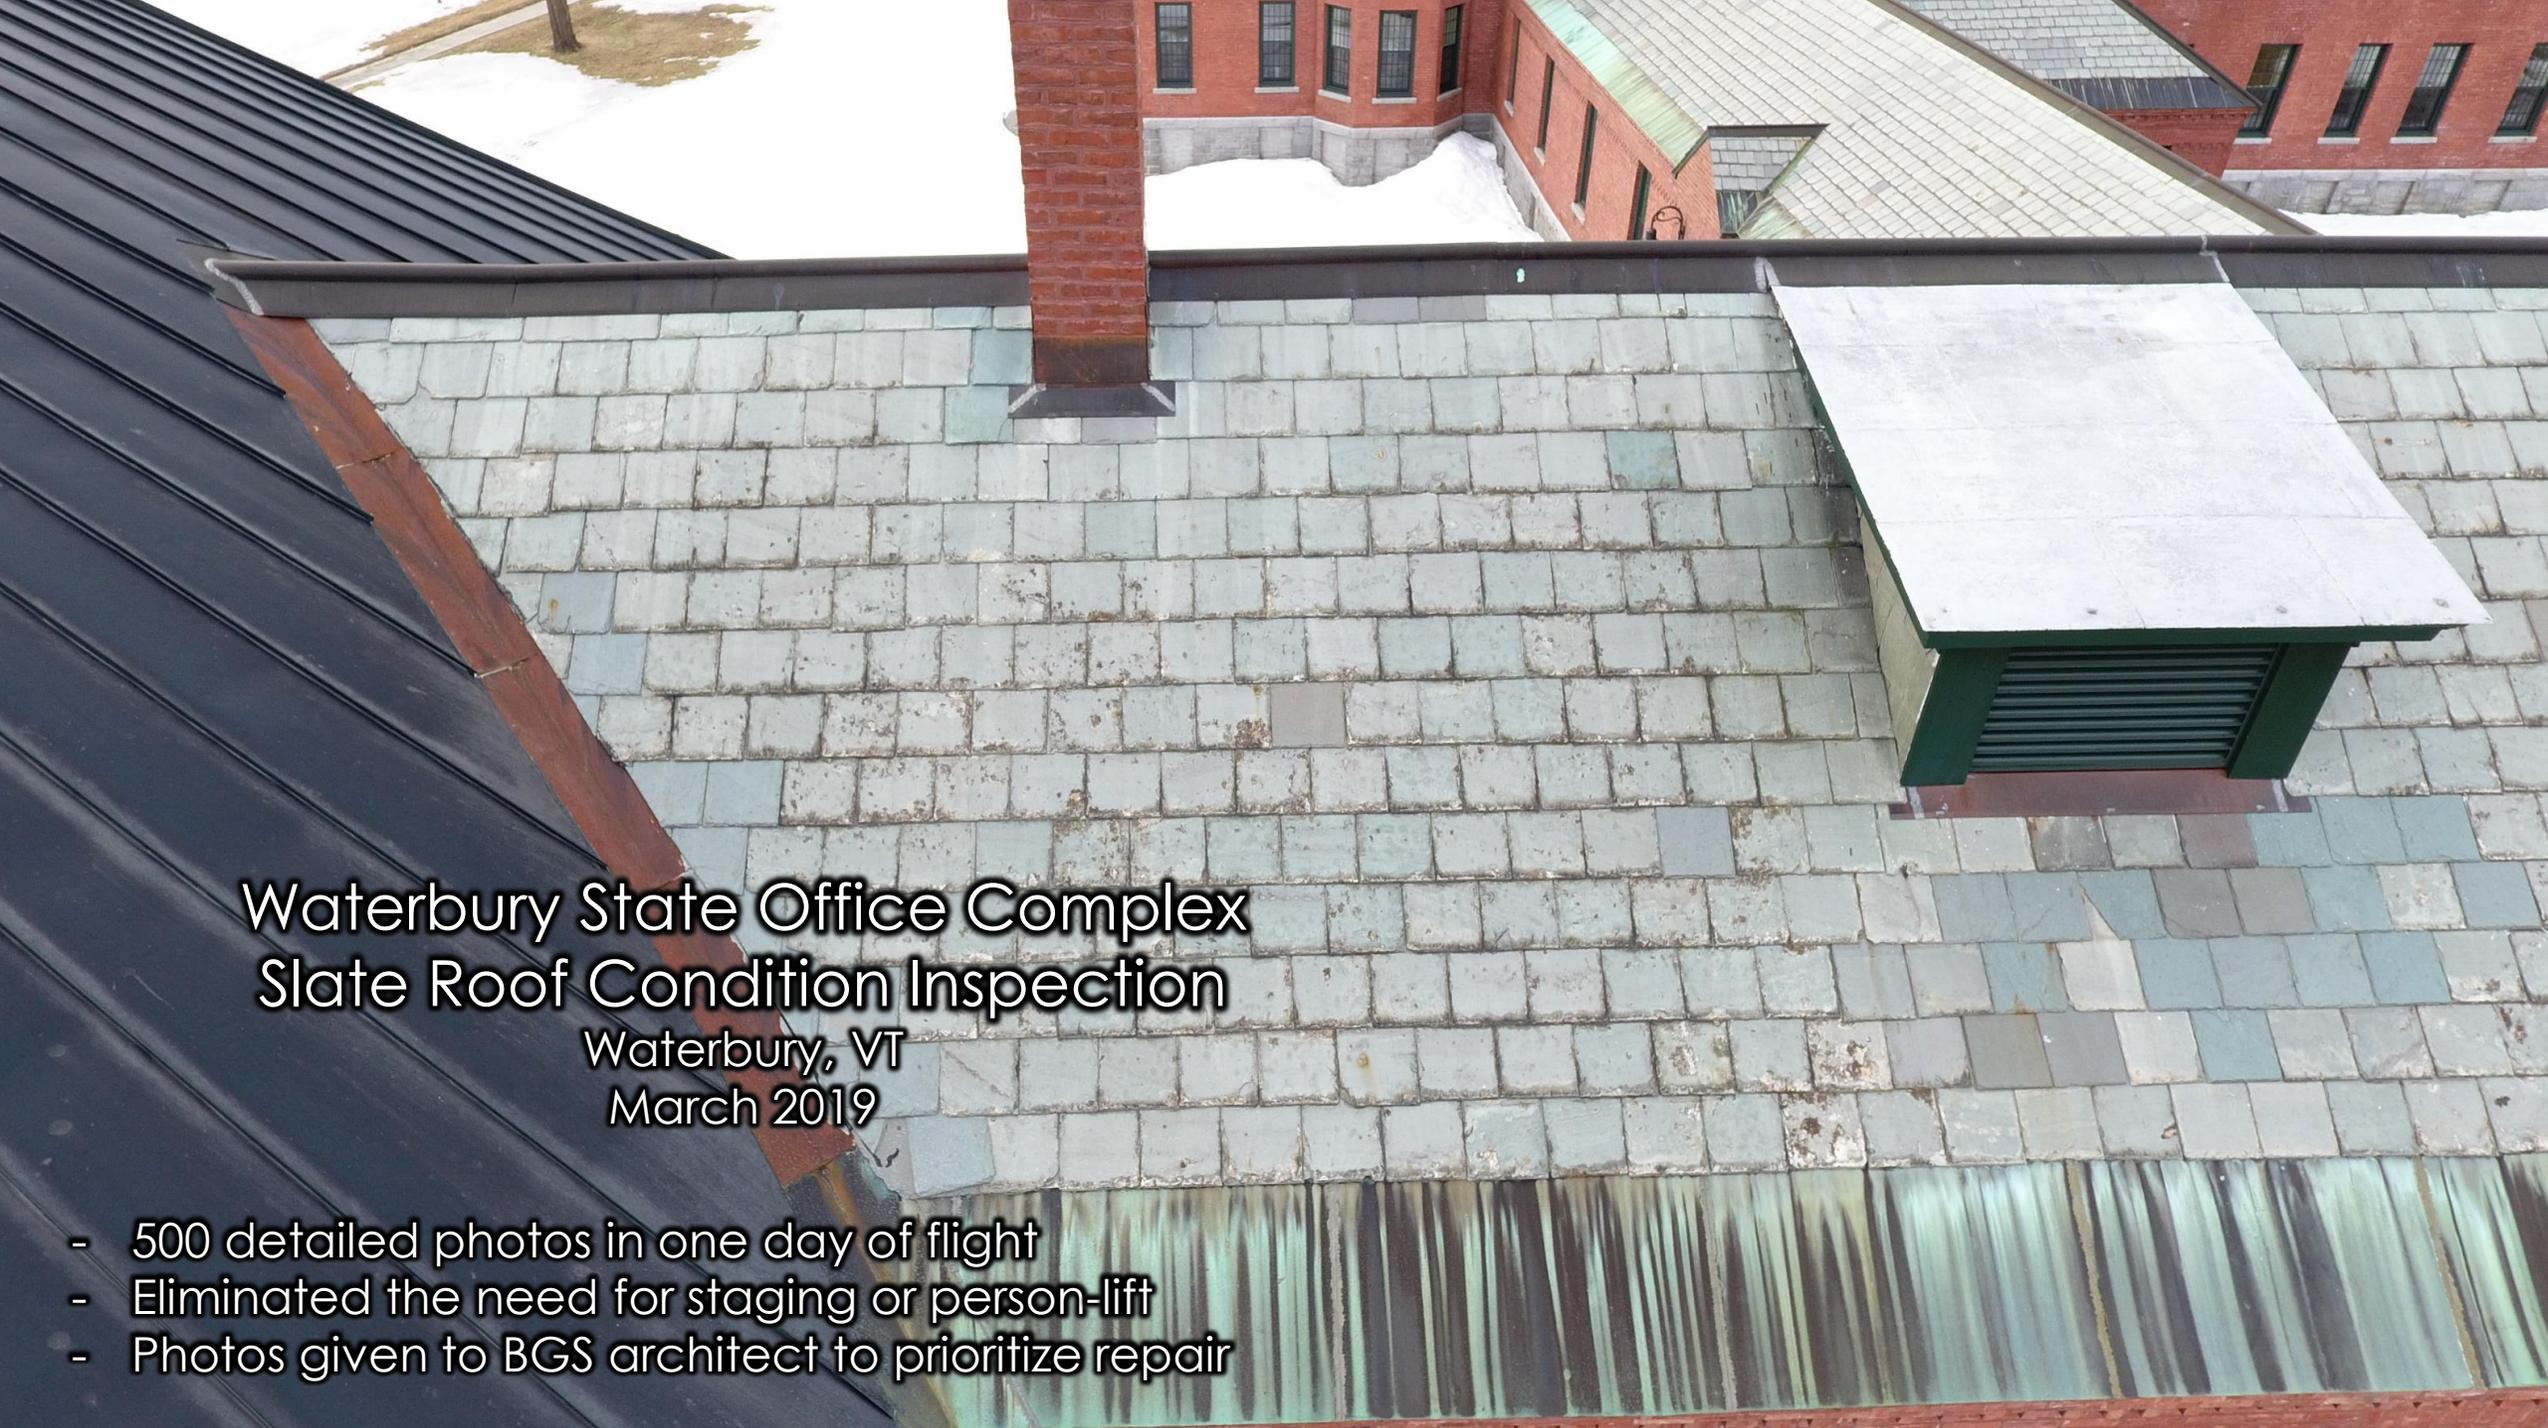
An aerial photograph of a slate roof. A brick chimney is visible in the upper center, and a green vent is on the right. The roof is covered in grey slate tiles, some showing signs of wear and discoloration. A dark metal roof is visible on the left side.

Waterbury State Office Complex Slate Roof Condition Inspection

- 500 detailed photos in one day of flight
- Eliminated the need for staging or person-lift
- Photos given to BGS architect to prioritize repair

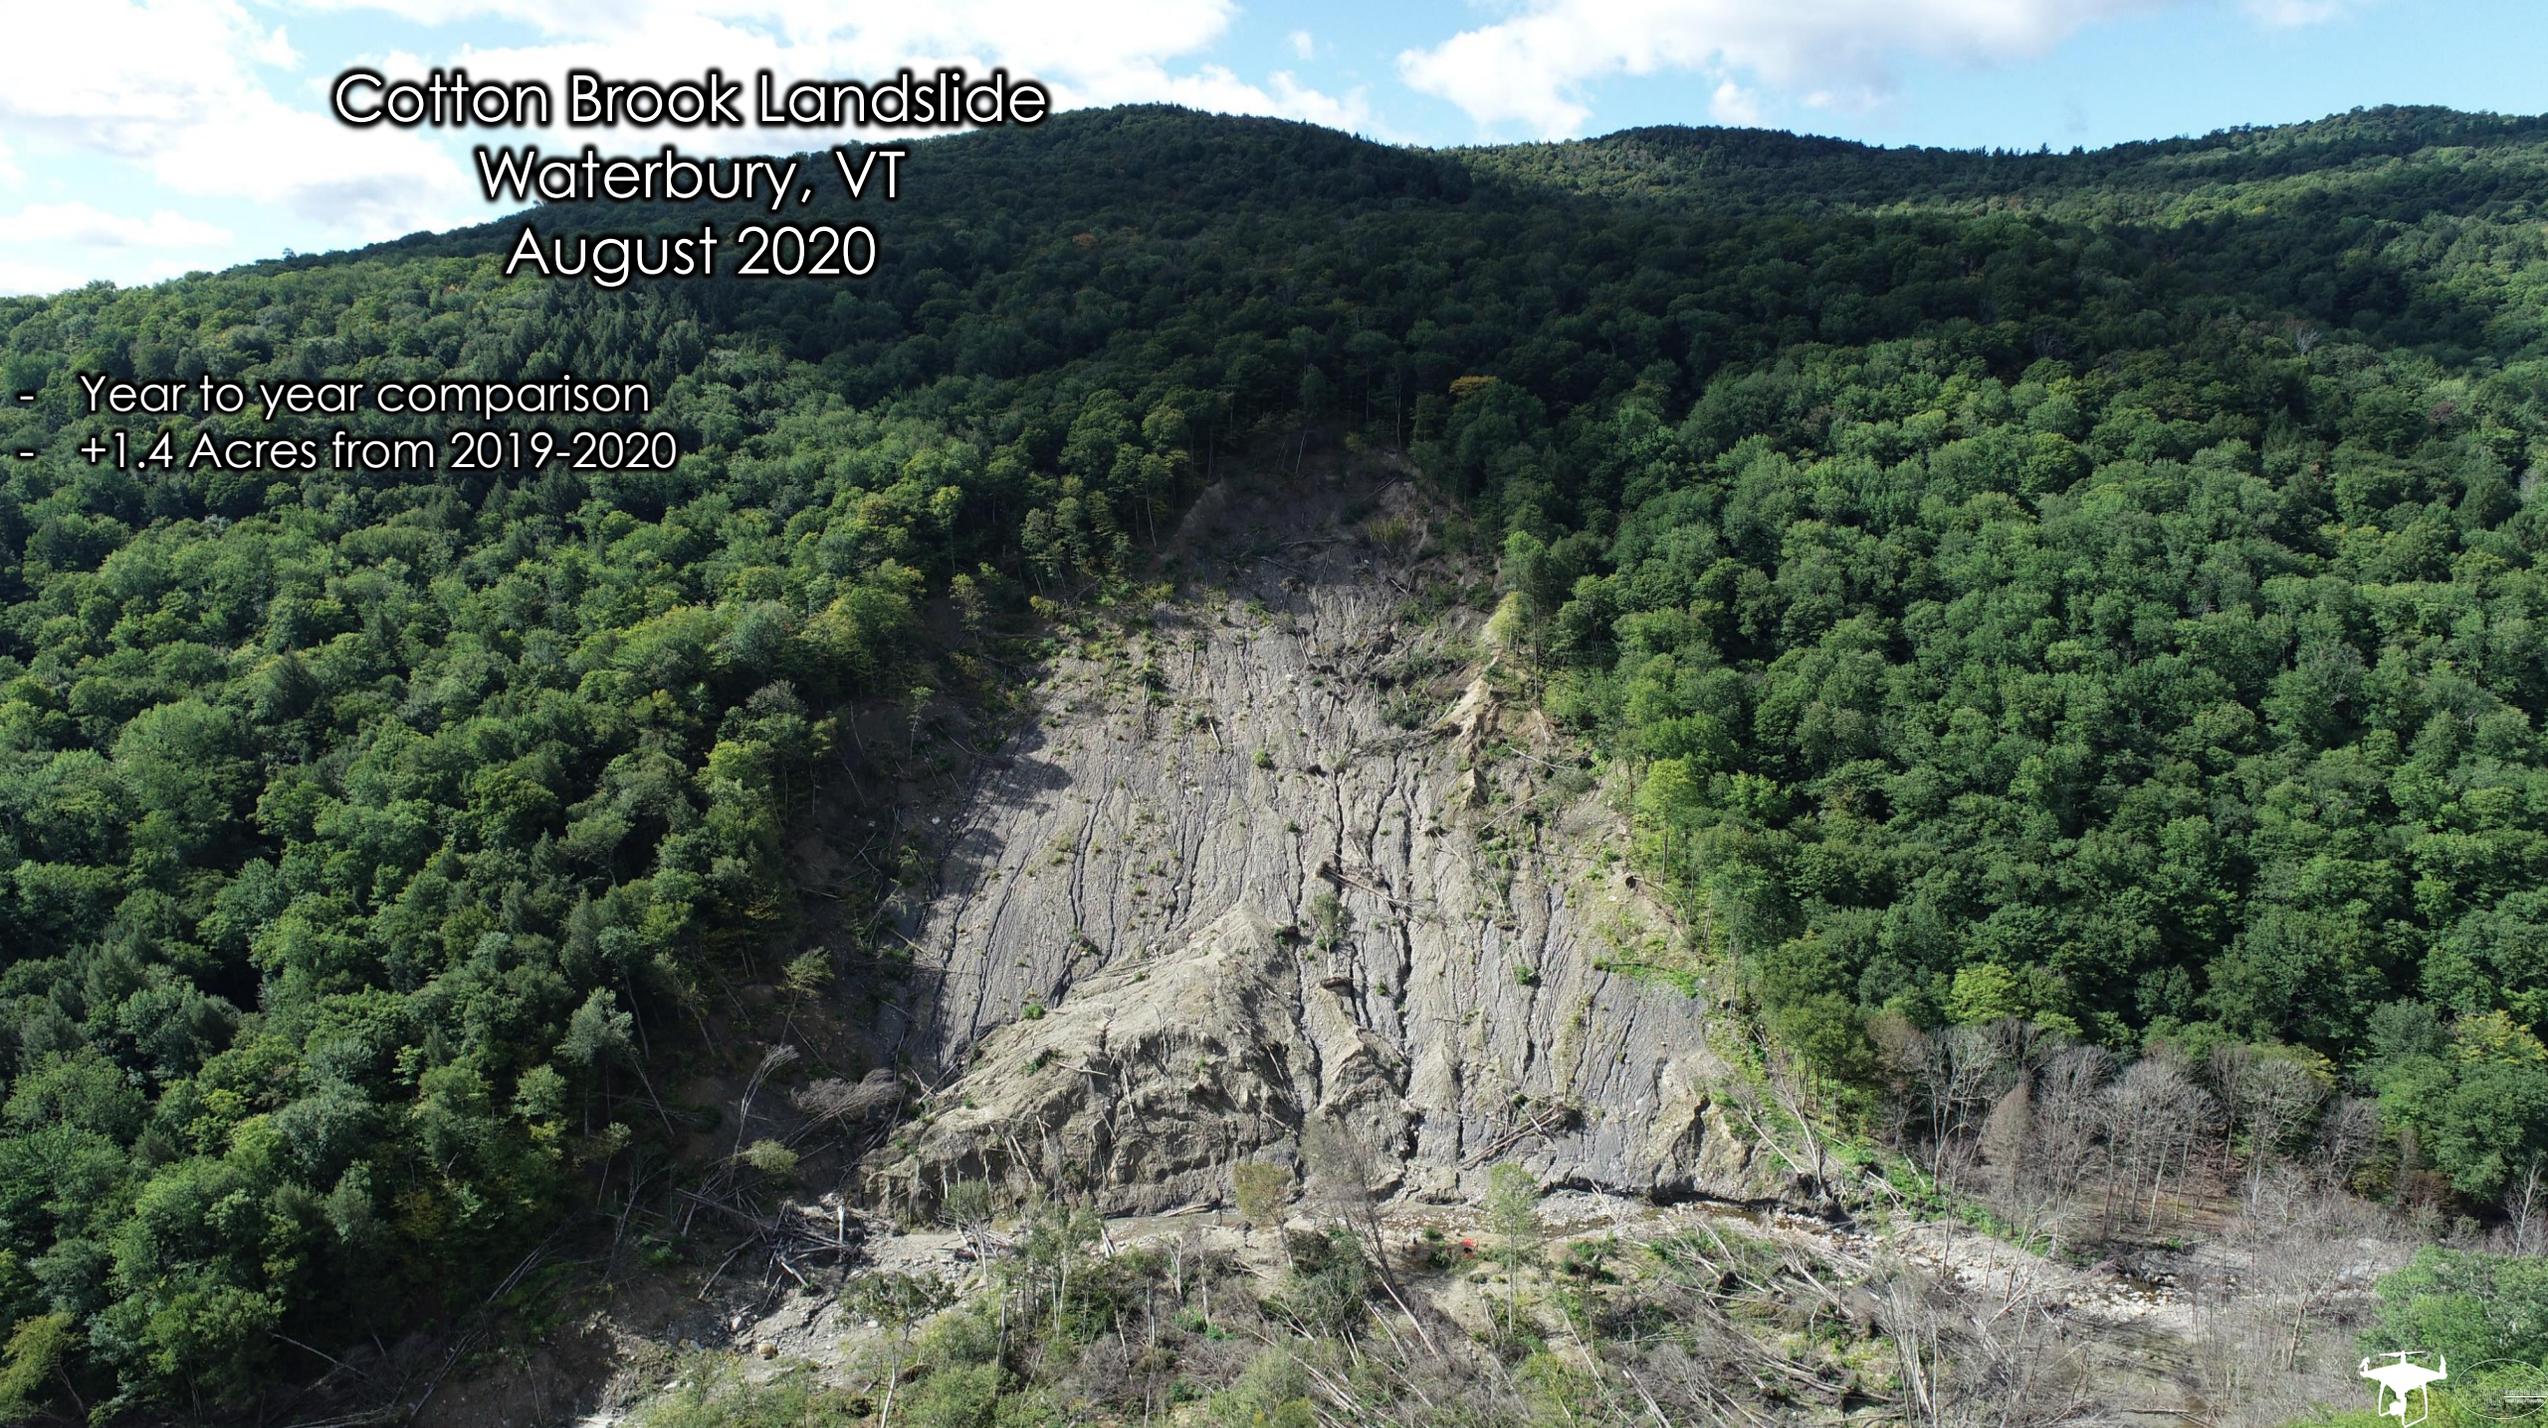
Cotton Brook Landslide

- Year to year comparison
- +1.4 Acres from 2019-2020

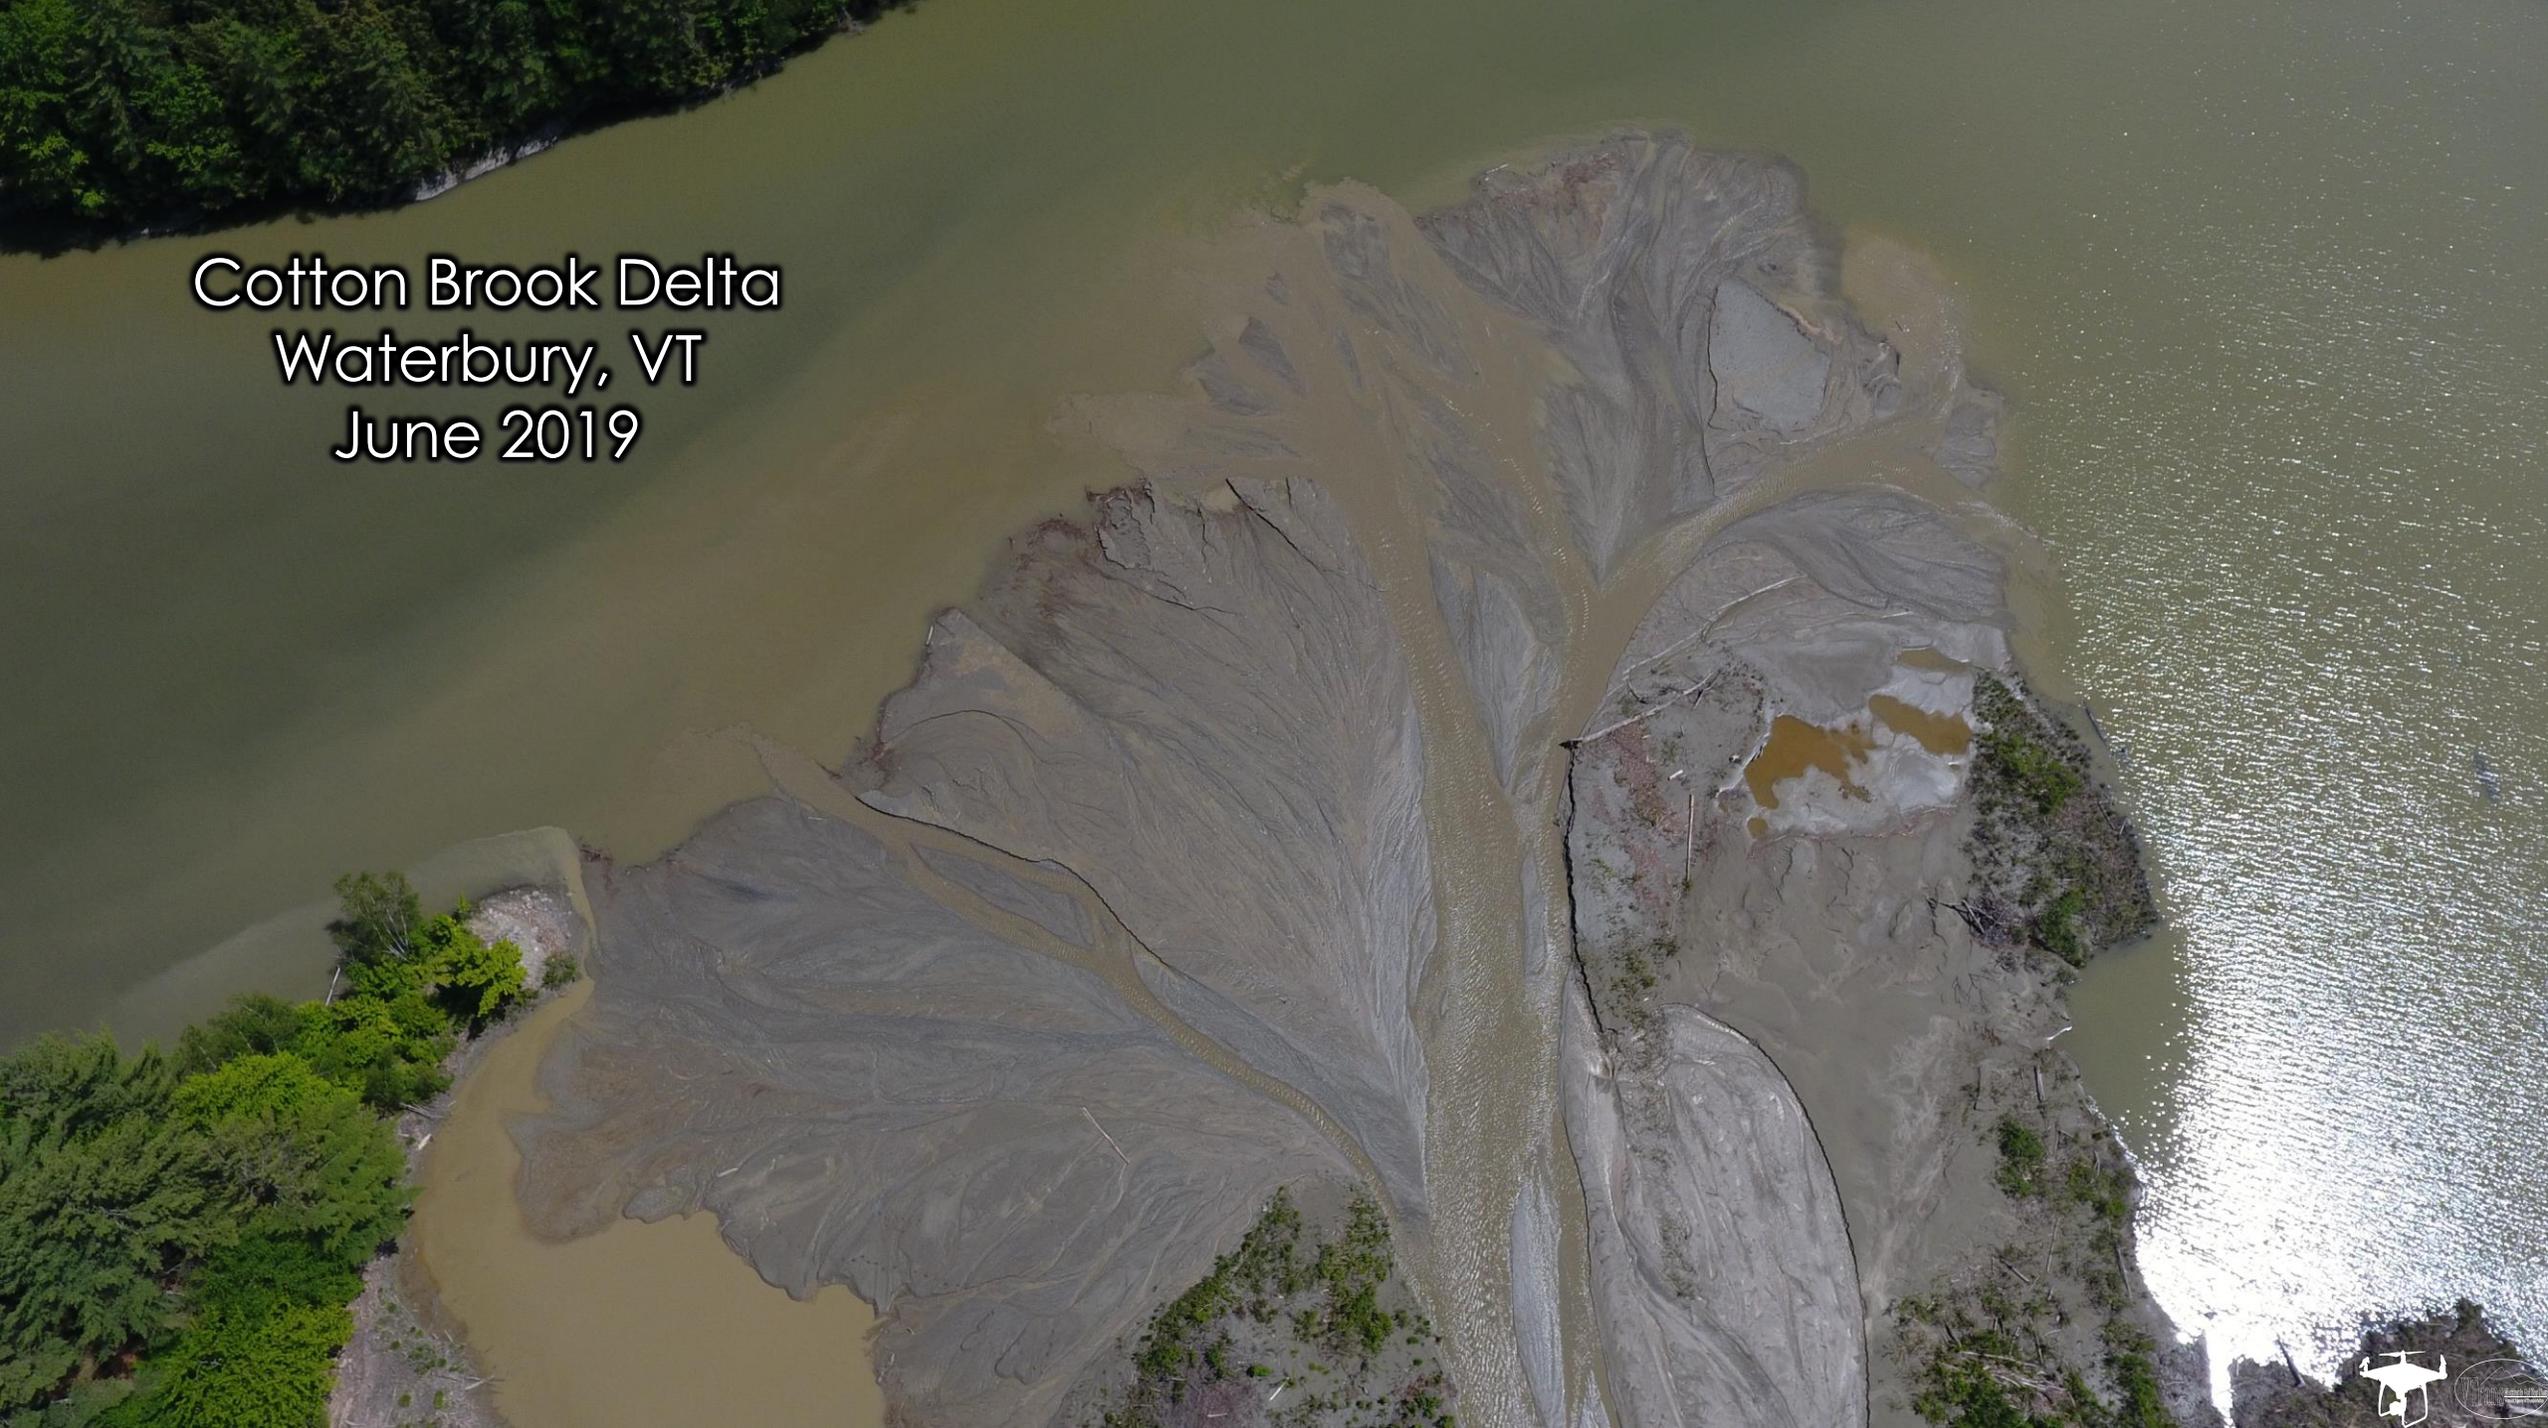
Cotton Brook Delta
Waterbury, VT
June 2019

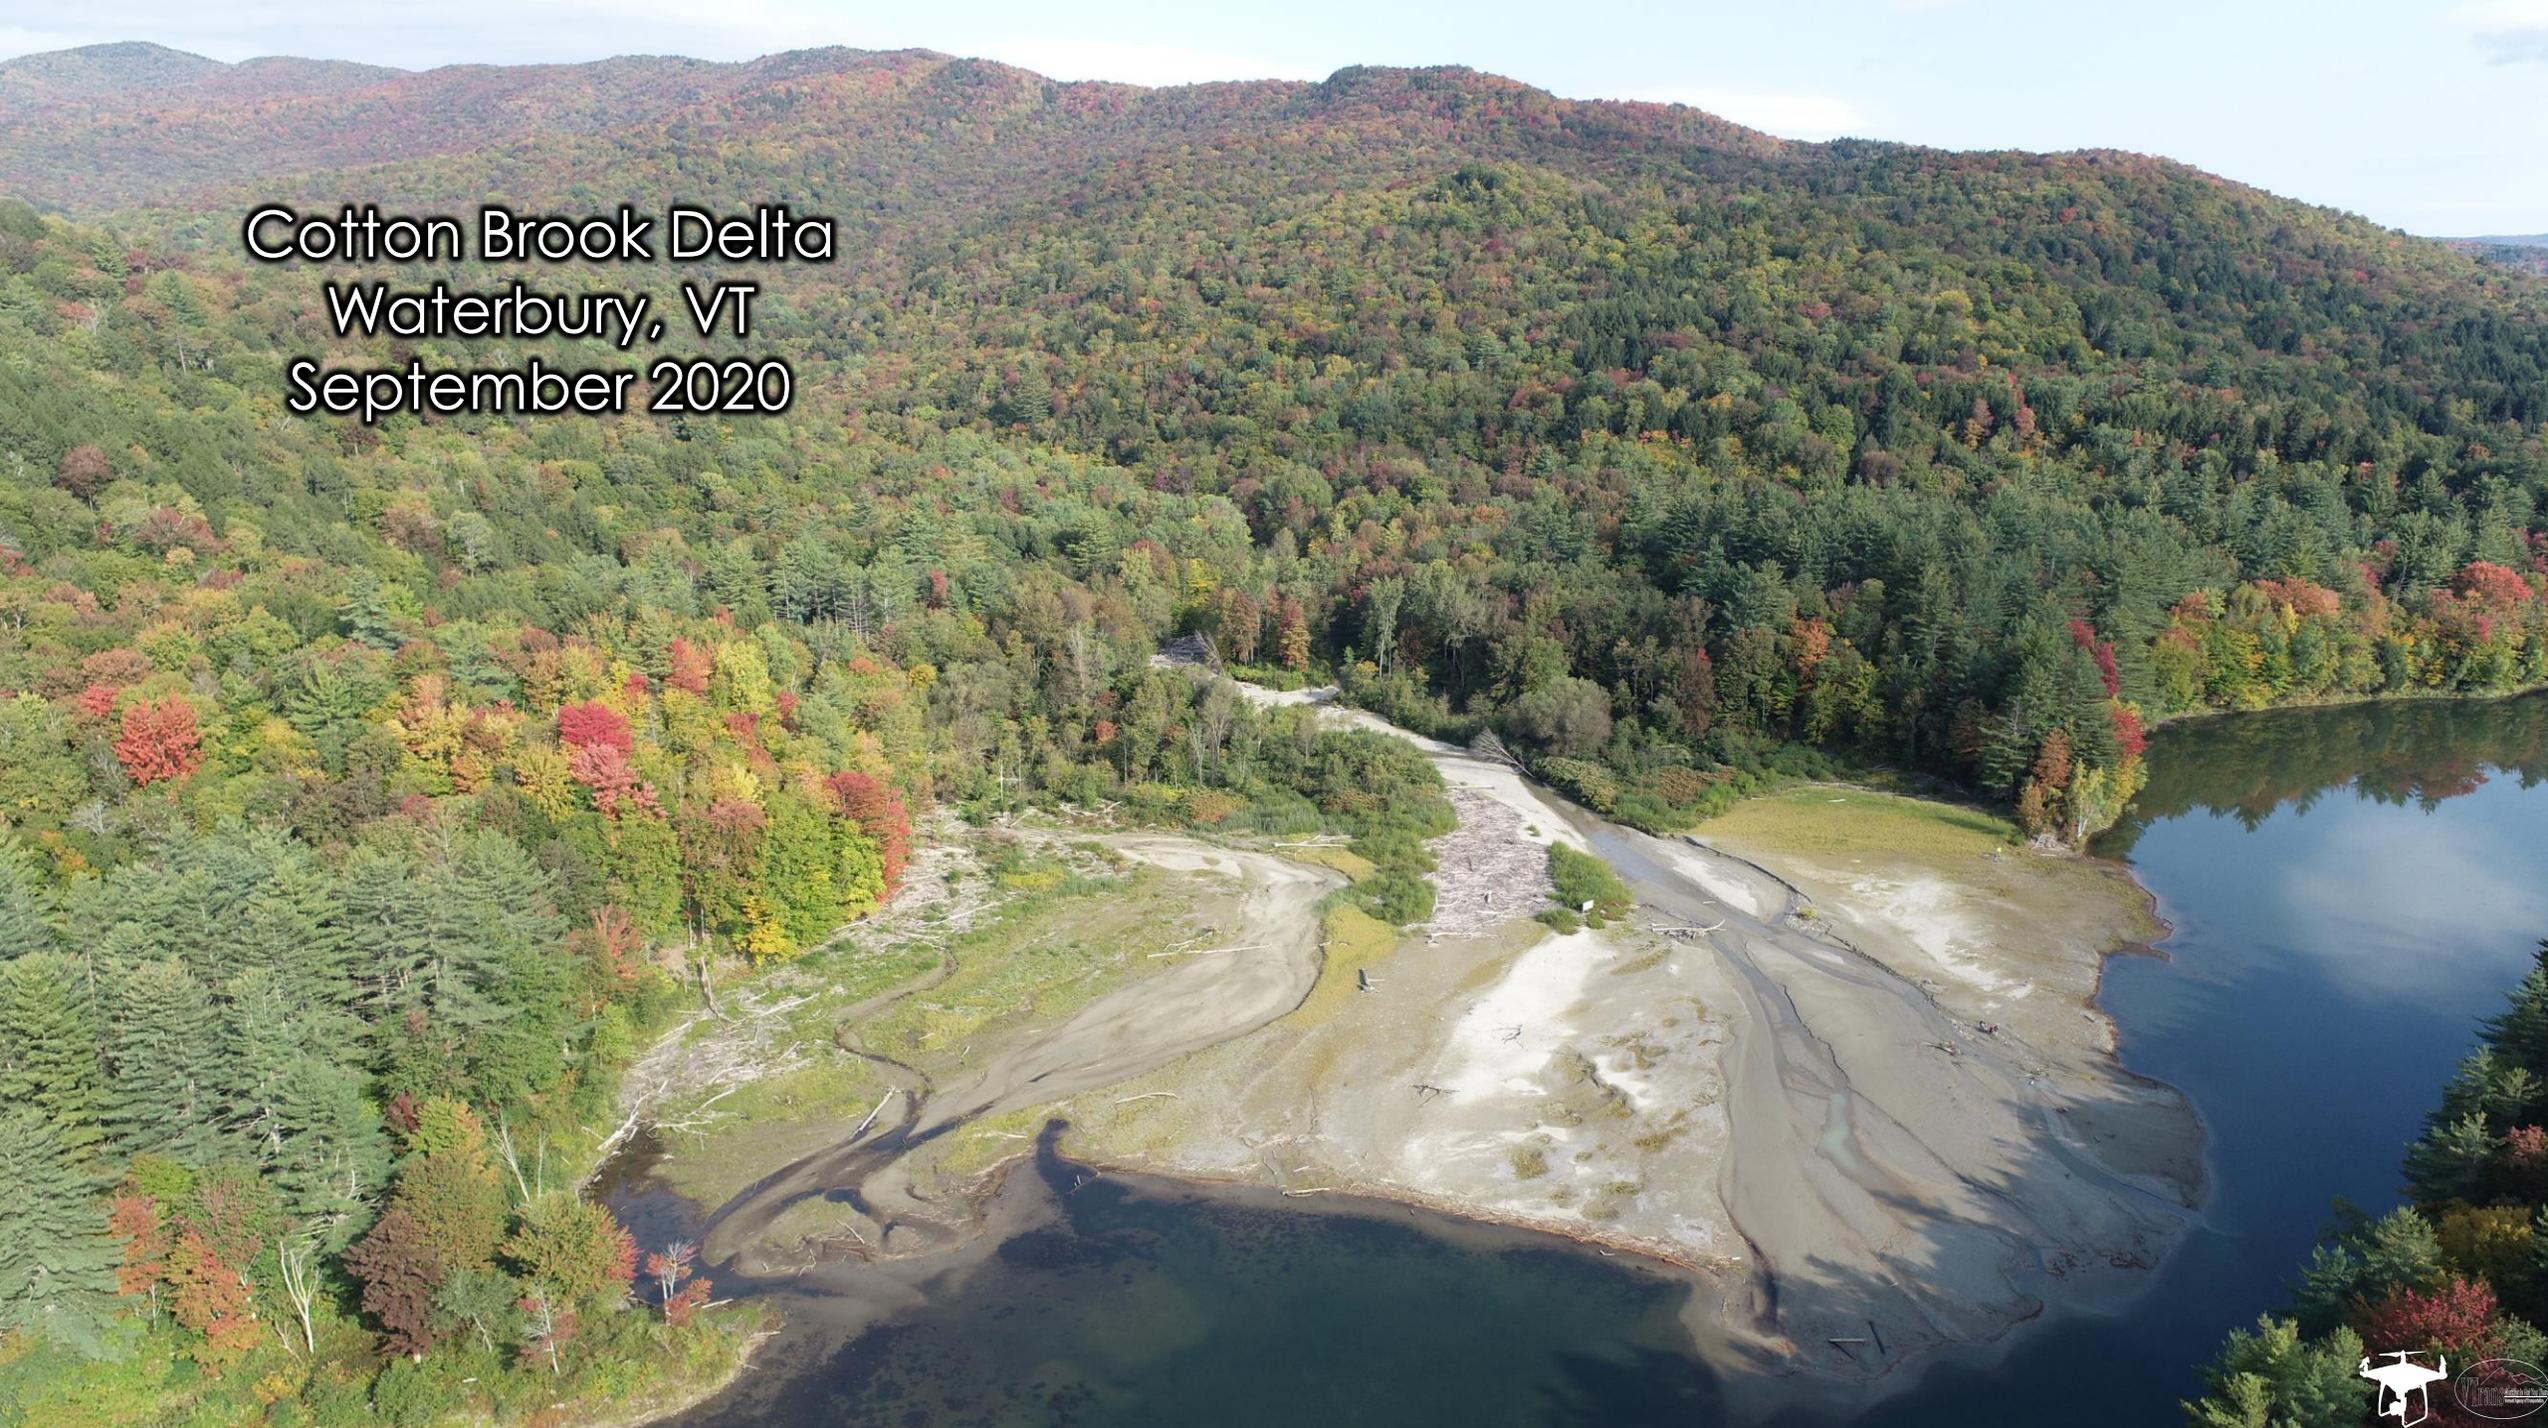
Cotton Brook Delta
Waterbury, VT
September 2020
