Vermont Historical Society

FY26 -FY27 Capital Budget Request

Proposal Sheet – Vermont History Center, 60 Washington St., Barre, VT

270 VERMONT HISTORICAL SOCIETY-BARRE

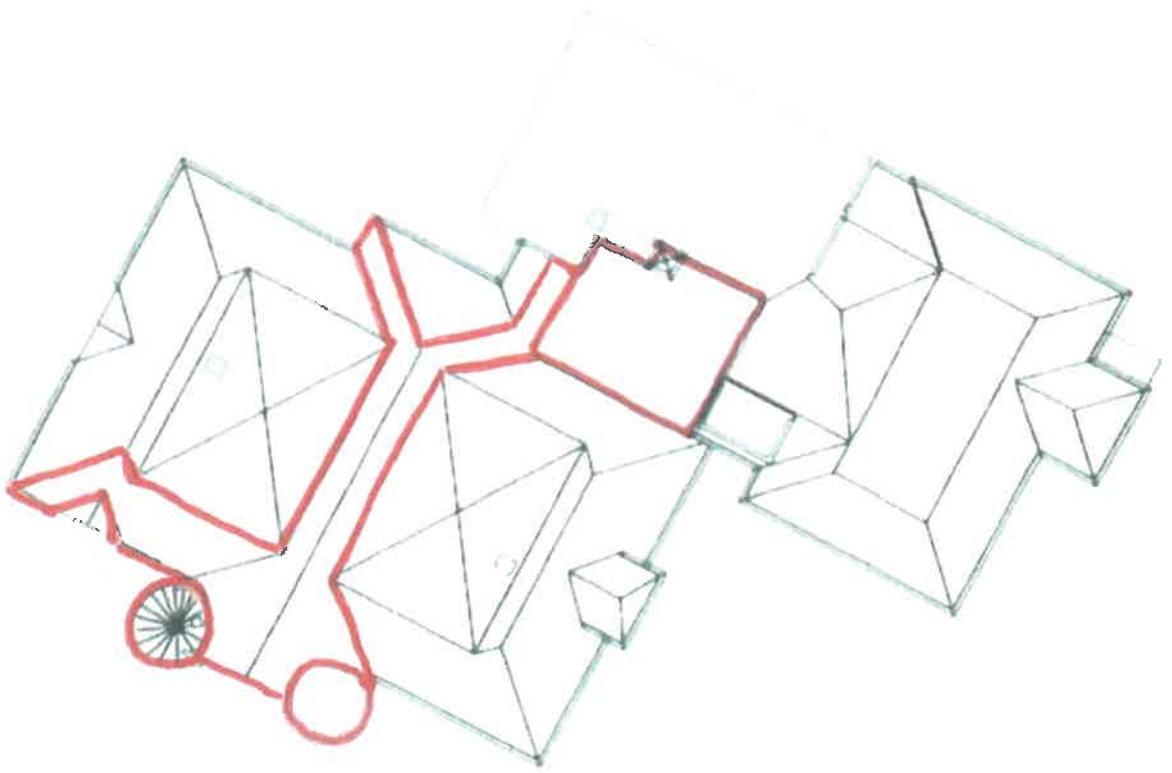
Replace the patched and suspect roofing above the west building entrance. This will also provide a ten-year warranty and address the repaired pitched asphalt roofing at the west entrance, as well as provide new flat membrane roofing at the southwest entrance tower. Replace the centrally located flat membrane roofing system that has been problematic with leaking near the elevator area.

Replacement of the existing east and west building perimeter foundation drains. The existing drains are over twenty years old and appear to be damaged from recent severe storms. Replace the existing shallow stormwater catch basin #4 with a deeper precast structure and tie this new structure into both the new foundation drain piping and also into the existing city storm water catch basin #5 at the street, by replacing the damaged section of pipe that connects the existing smaller catch basin #4 to the city storm water catch basin #5. The existing foundation drain system sections on the north and south sides of the building would be further inspected and cleaned/jetted while the east and west sections are being replaced to minimize the amount of foundation drain replacement work required during future projects.

Provide foundation and basement exterior wall waterproofing where the below grade areas are exposed for the perimeter foundation drain replacement work (east and west sides).

Provide masonry restoration work for the west entrance elevation façade. Replace and repoint brick as necessary.

Please see the attached corresponding drawings that illustrate the work areas described above.

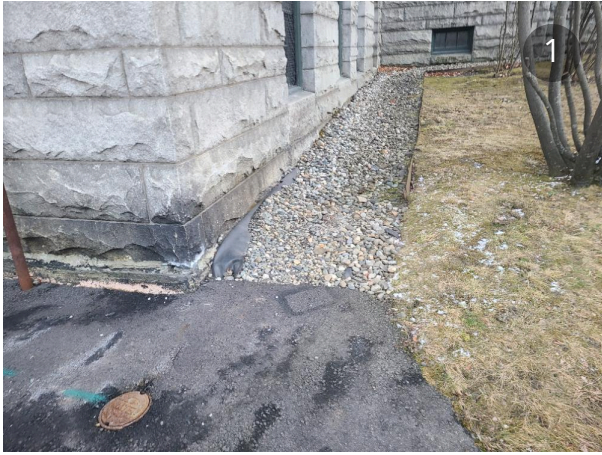
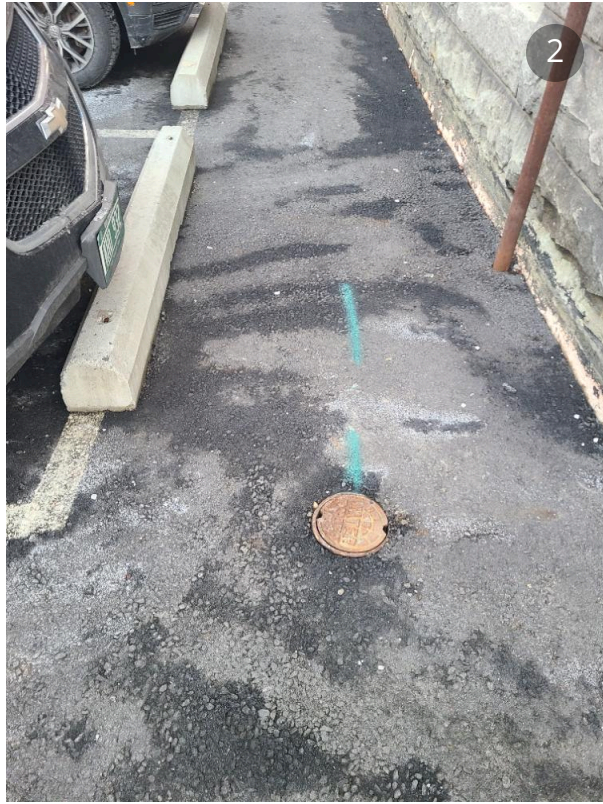
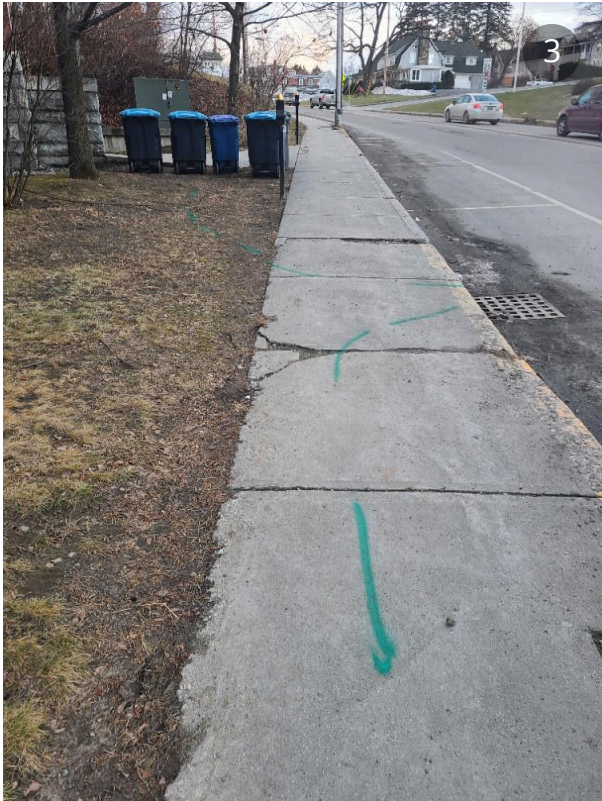
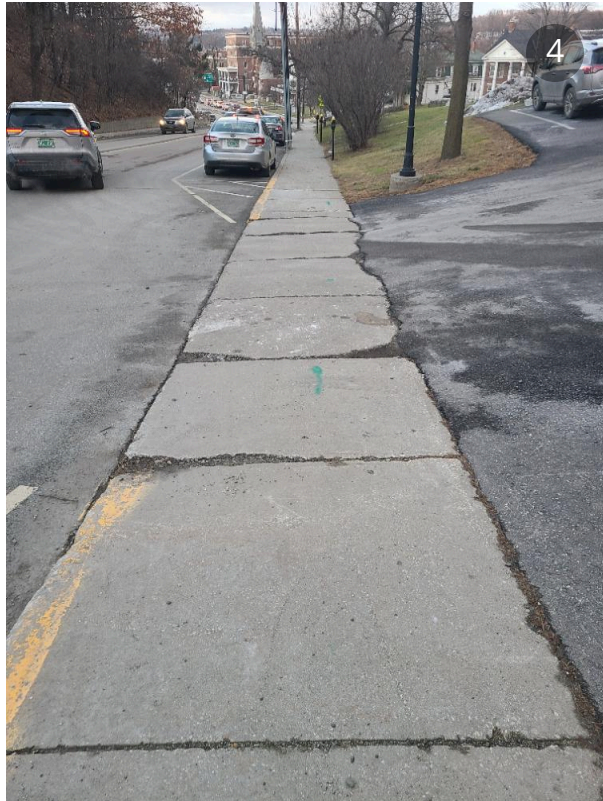
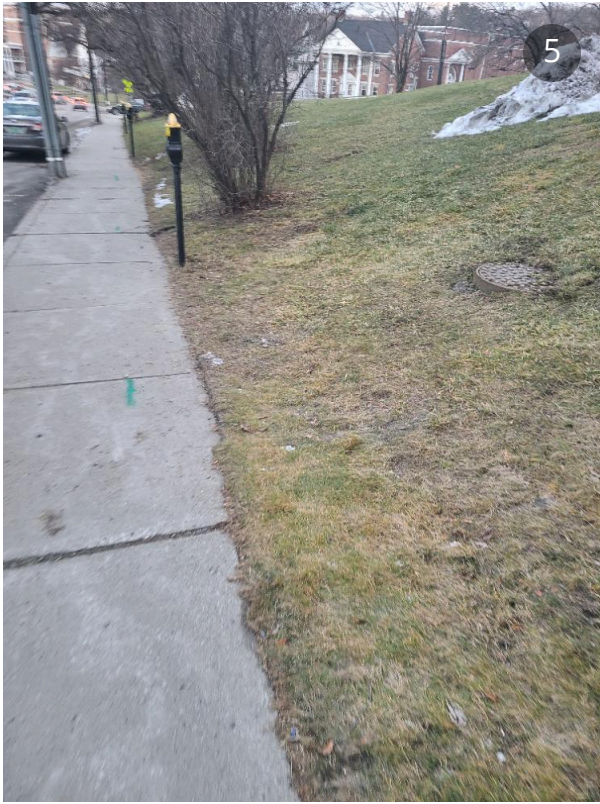
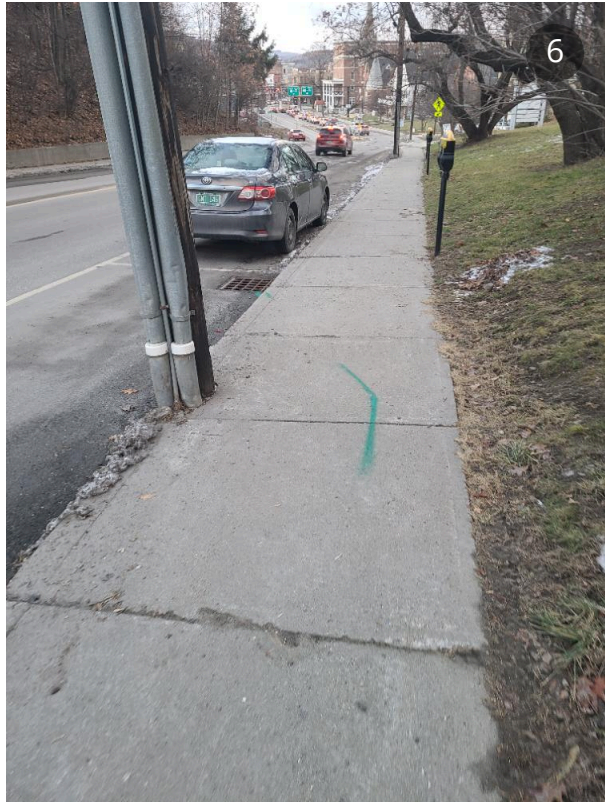
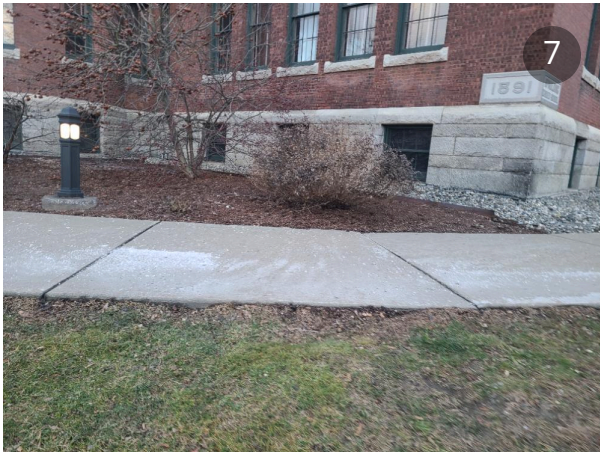
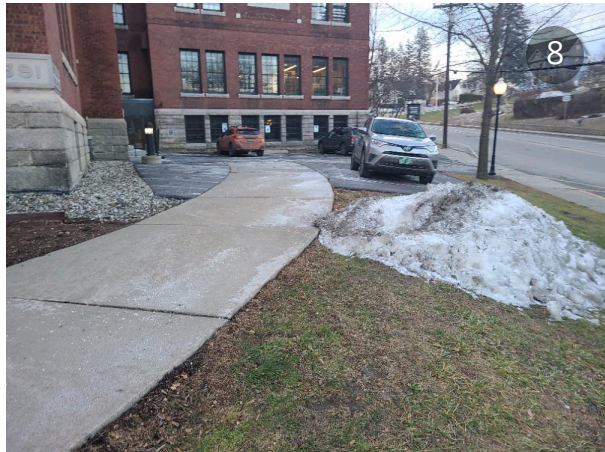
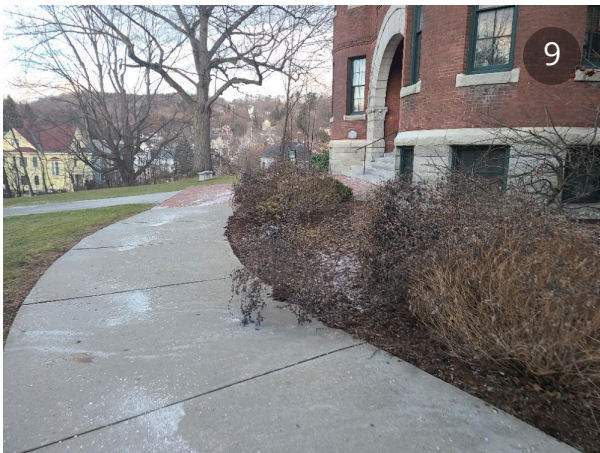
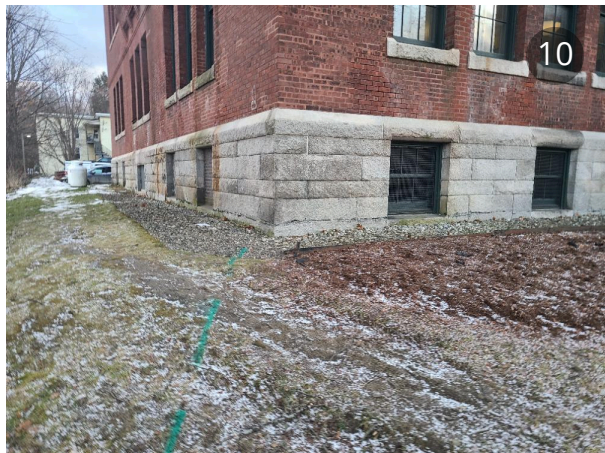
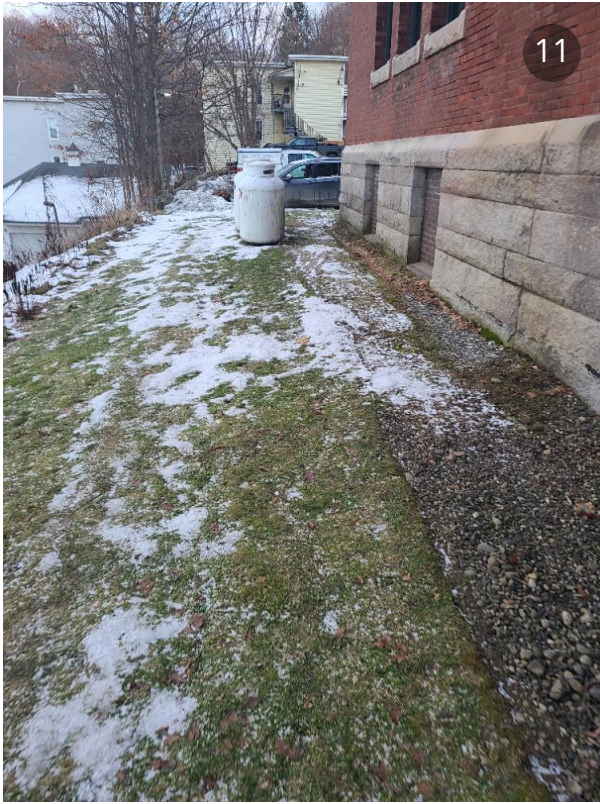
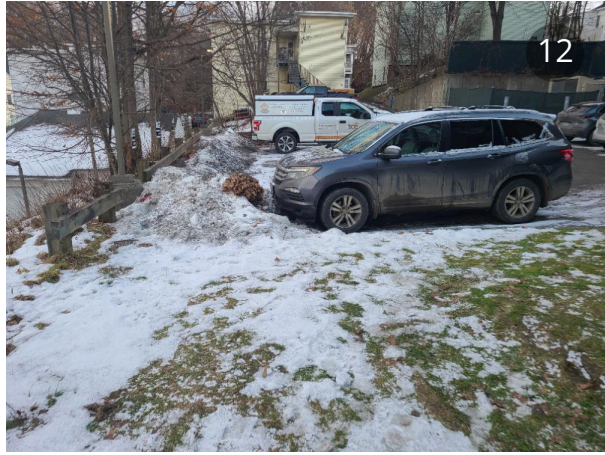
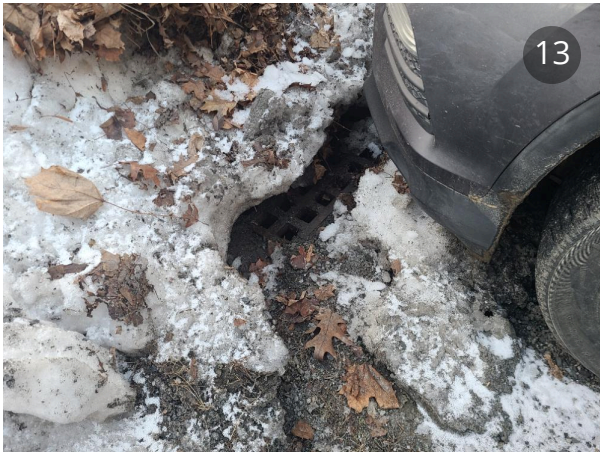
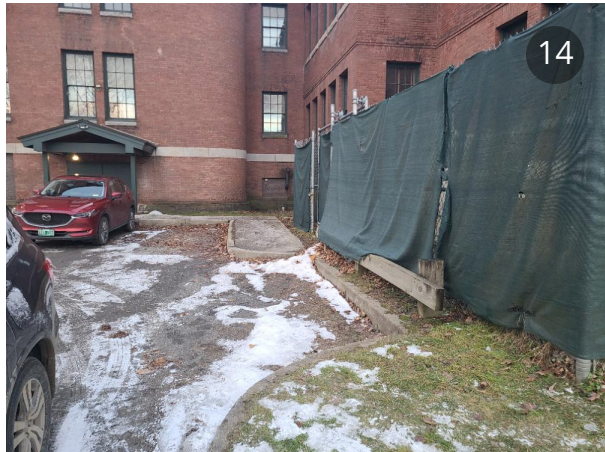
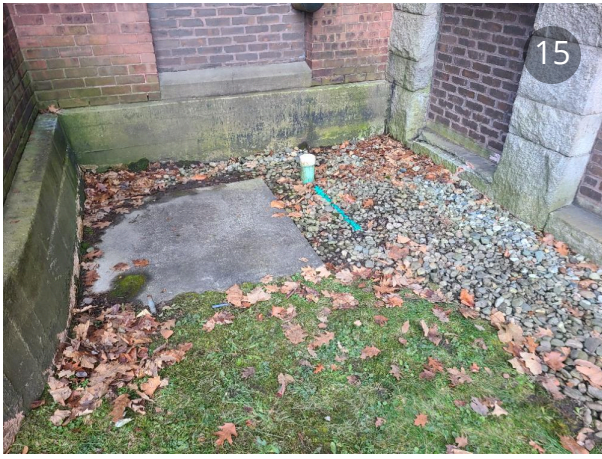
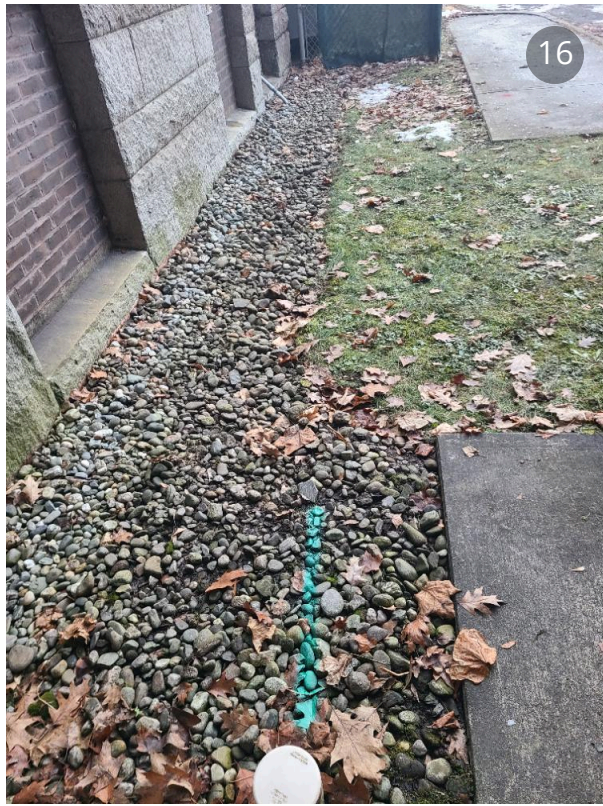
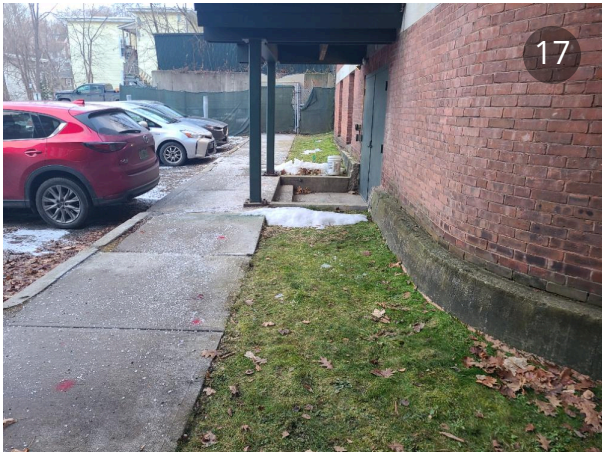
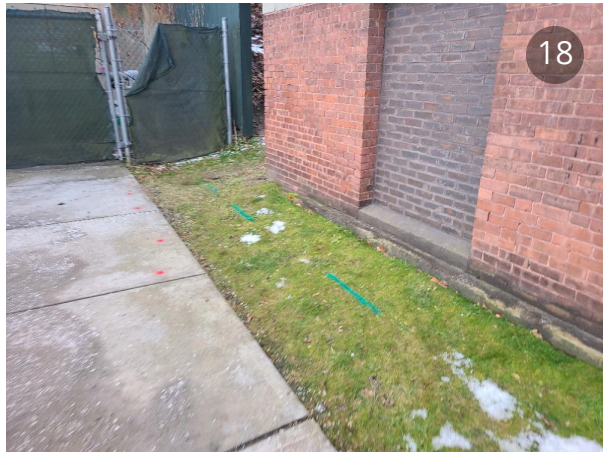
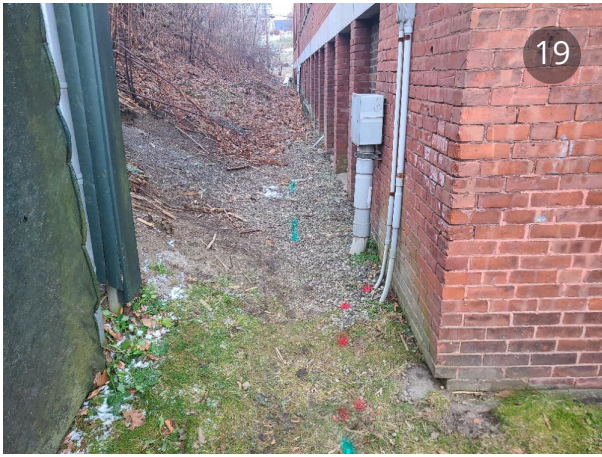
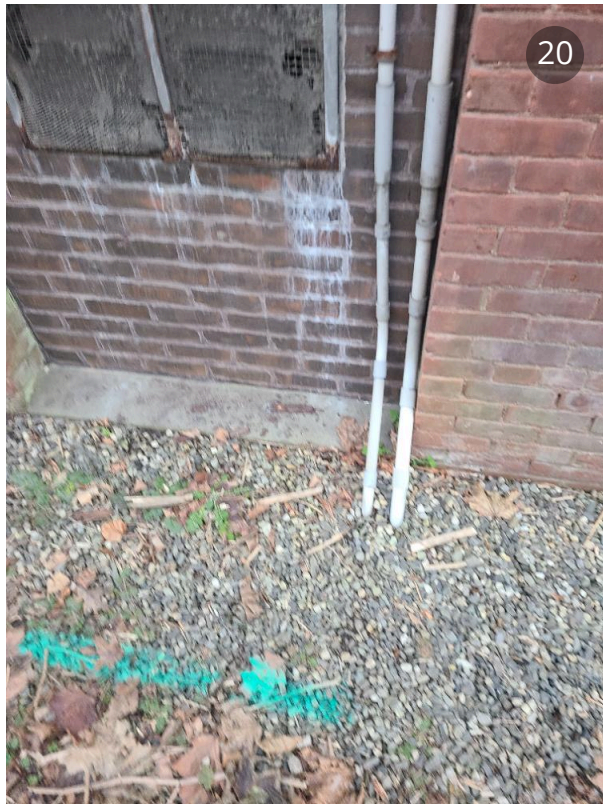
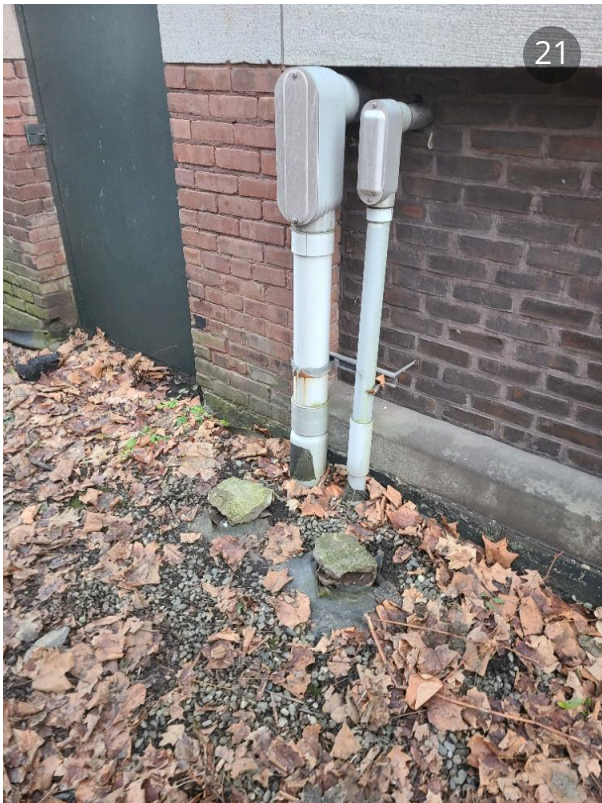
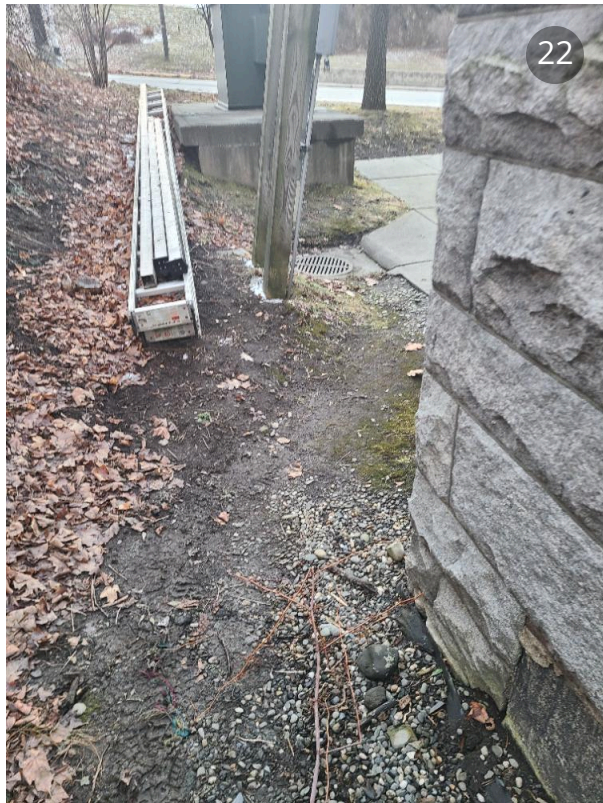
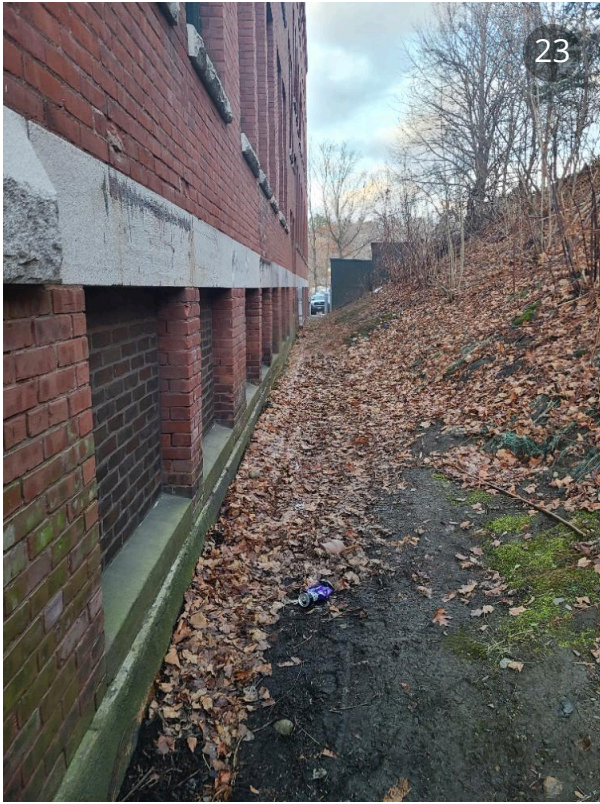
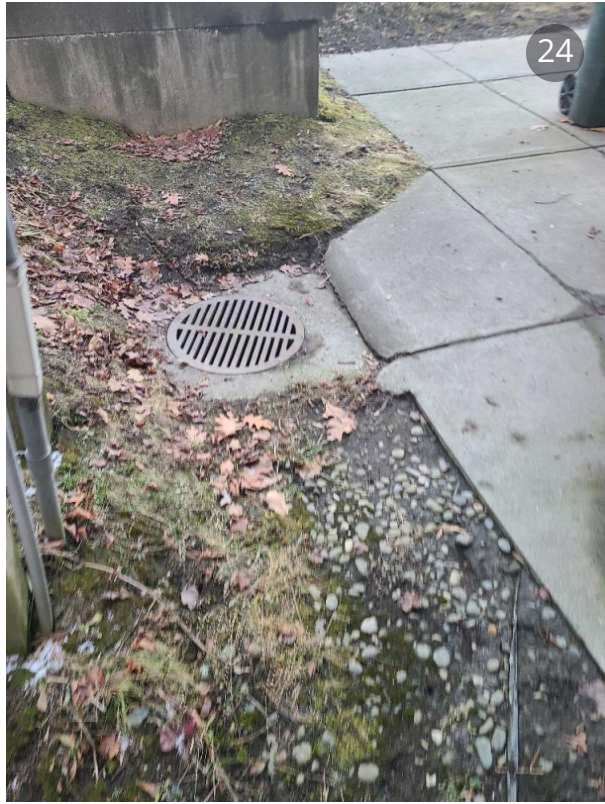
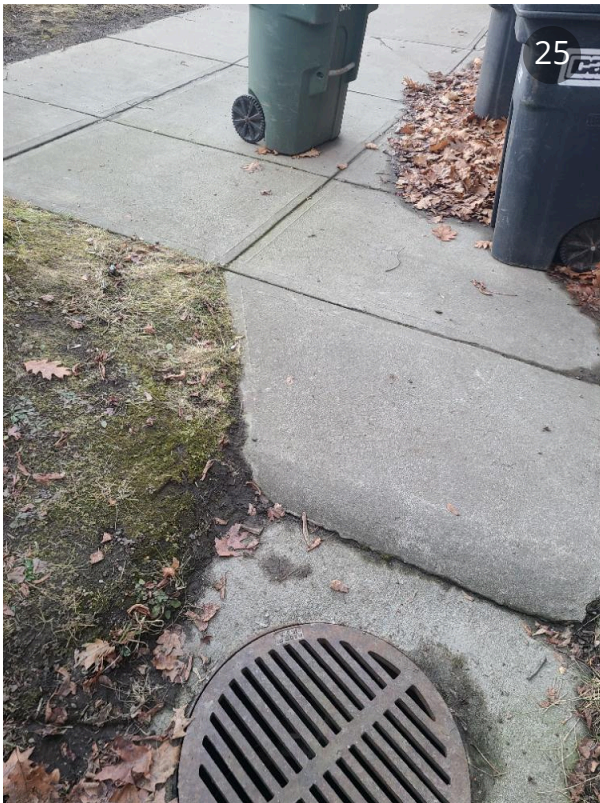
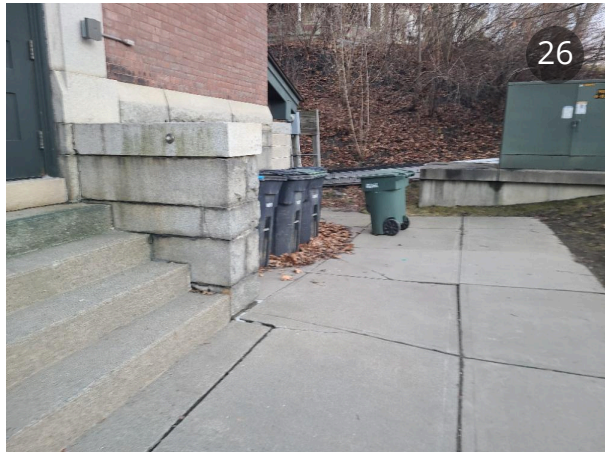
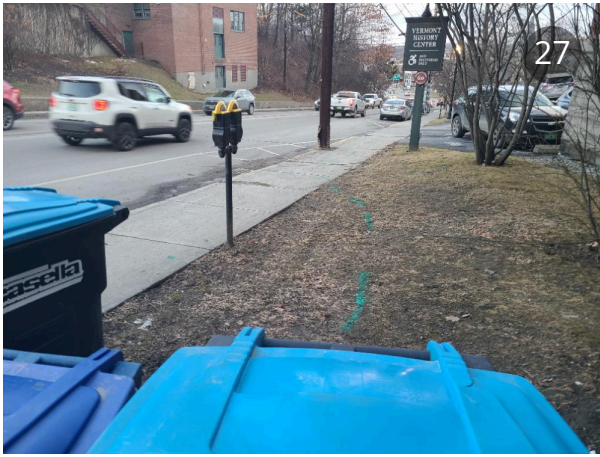
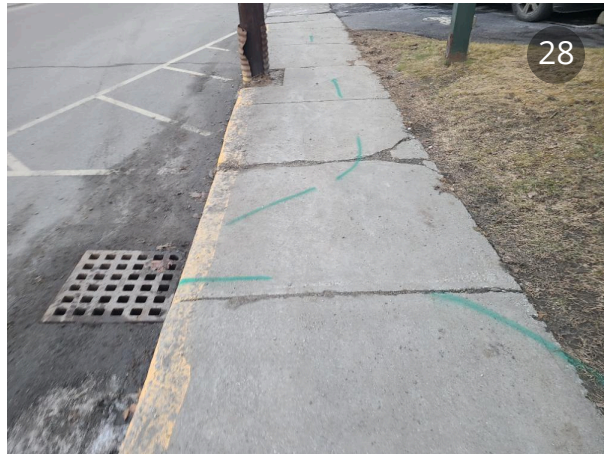
Started on the north side of the building, at the cleanout on the Southwest side of the parking lot. Was only able to push the rodder in one direction, about 30ft before it seemed to get stuck. Too much interference with all other utilities in this area to be able to locate exactly where the pipe was. Based off footage pushed, it seemed to get stuck at the first building corner(just south of the Air Handling Unit) north of the cleanout. Started to locate electric in this area, but after speaking with the client, we decided to just focus on the drains due to amount of time to locate everything.

Moving Clockwise, pushed the rodder through the next cleanout on the NE corner of the building, just south of the Fluid cooler. Could only push the rodder west from here and seemed to get stuck where the entrance doors were.

We then moved south about halfway along the Eastern wall of the building where there were 2 cleanouts. Pushed the rodder in the first cleanout, going north, and got stuck up near the previous cleanout. We then

pushed the rodder through the second cleanout which we assumed went south, but got stuck as soon as the pipe went horizontal. Here we tried to use the camera to see what was going on, and found the cleanout to be about 10' deep, then it seemed to be filled with dirt where the pipe turns horizontal. No other access found to this pipe.

Moved to the catch basin on the south east corner of the building (new CB). No building drain here, just one pipe that drains to a catch basin in the road. We did find a pipe break and some debris in this pipe, about 30ft west of the catch basin.

We then moved to the catch basin in the road (CB5). The pipes here were deceiving, as both inlet and outlet pipes seemed to head to the building rather than up and down the road. Using both camera and rodder, we found these pipes has significant bends. They seemed to cross the sidewalk and then travel up and down the road. Same with The next CB (CB1). City flushed the main lines so we did not camera them.

Lastly moved to CB2 on the north west side of the building. Attempted to camera the line going to the building drain, but this pipe was completely plugged with mud. There was a large snowbank and car on

CB3, client stated he was satisfied with what we found so far and was good with calling it a day.
