# Foxstand Bridge

CLOSURE – ROYALTON, VERMONT

Gidget Lyman

# Foxstand Bridge Closure – Royalton, Vermont

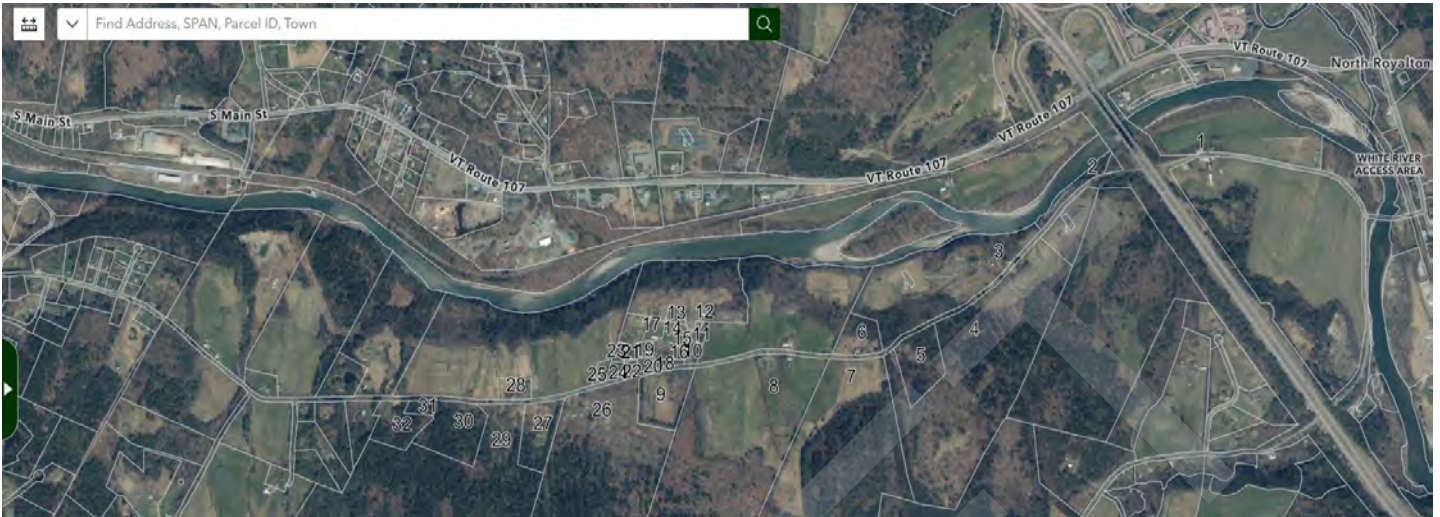
**Gilman Road – estimated 32 properties affected.**

- Estimated affected properties (approximately 133)
    - Gilman Road – 32
    - Royalton Hill Road/Tortolano Road – 37
    - Sewall Brook Road – 10
    - Back River Road (partial)/Satellite Lane – 10

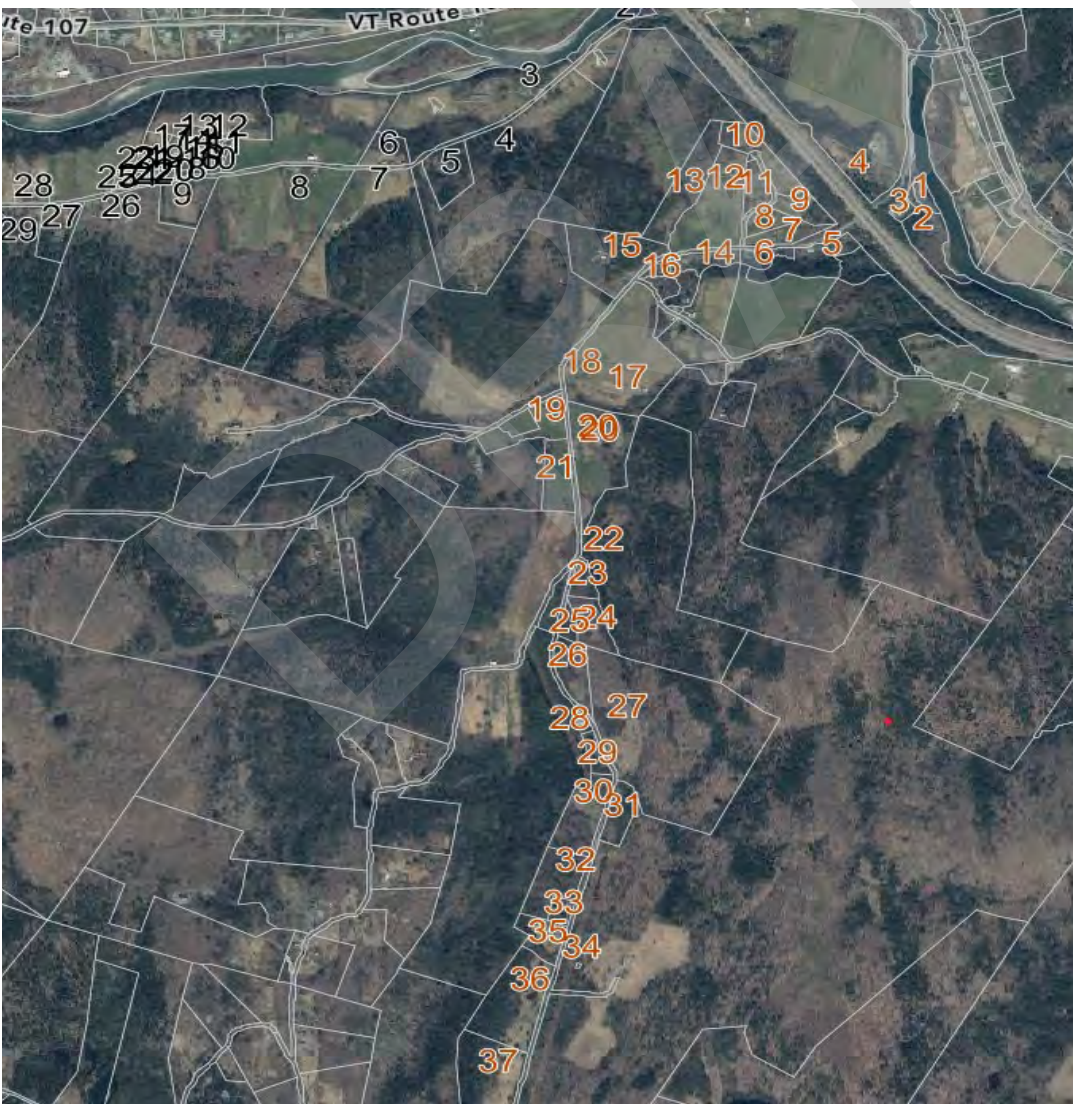
**Royalton Hill Road/Tortolano Road – estimated 37 Properties.**

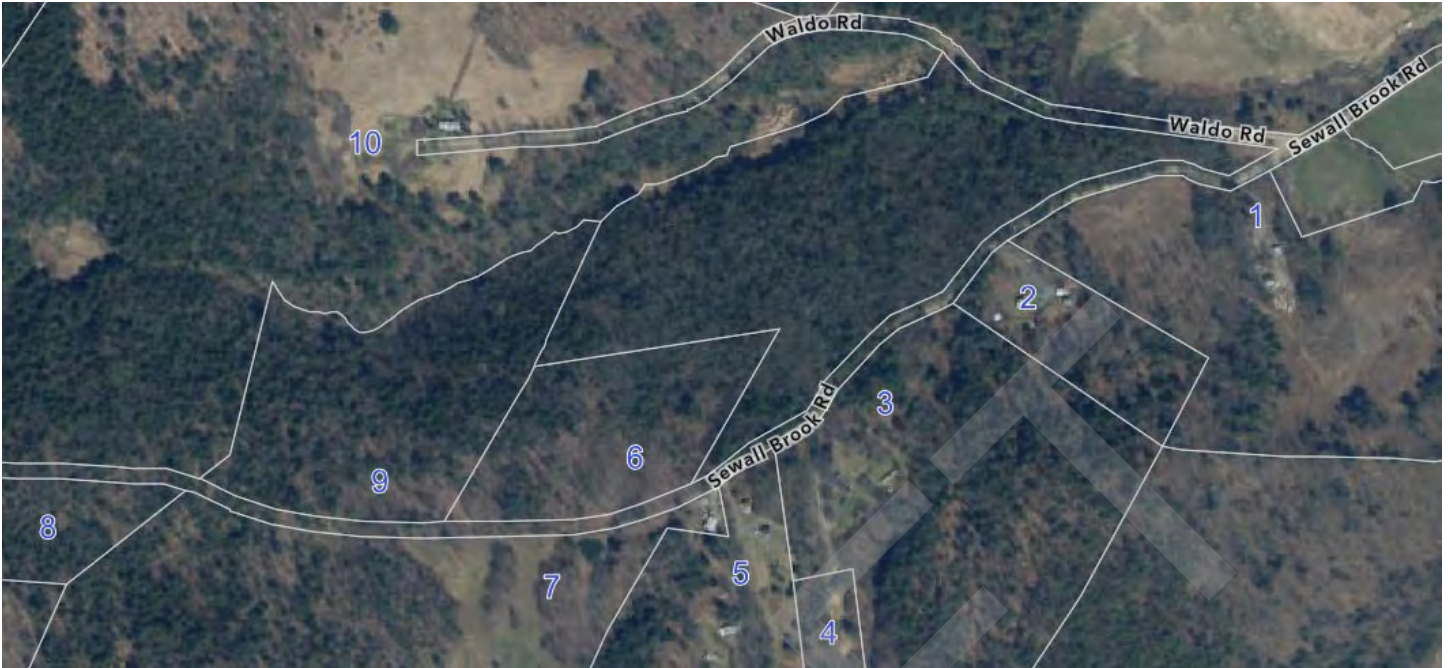
Sewall Brook Road/Waldo Road – estimated 10 properties.

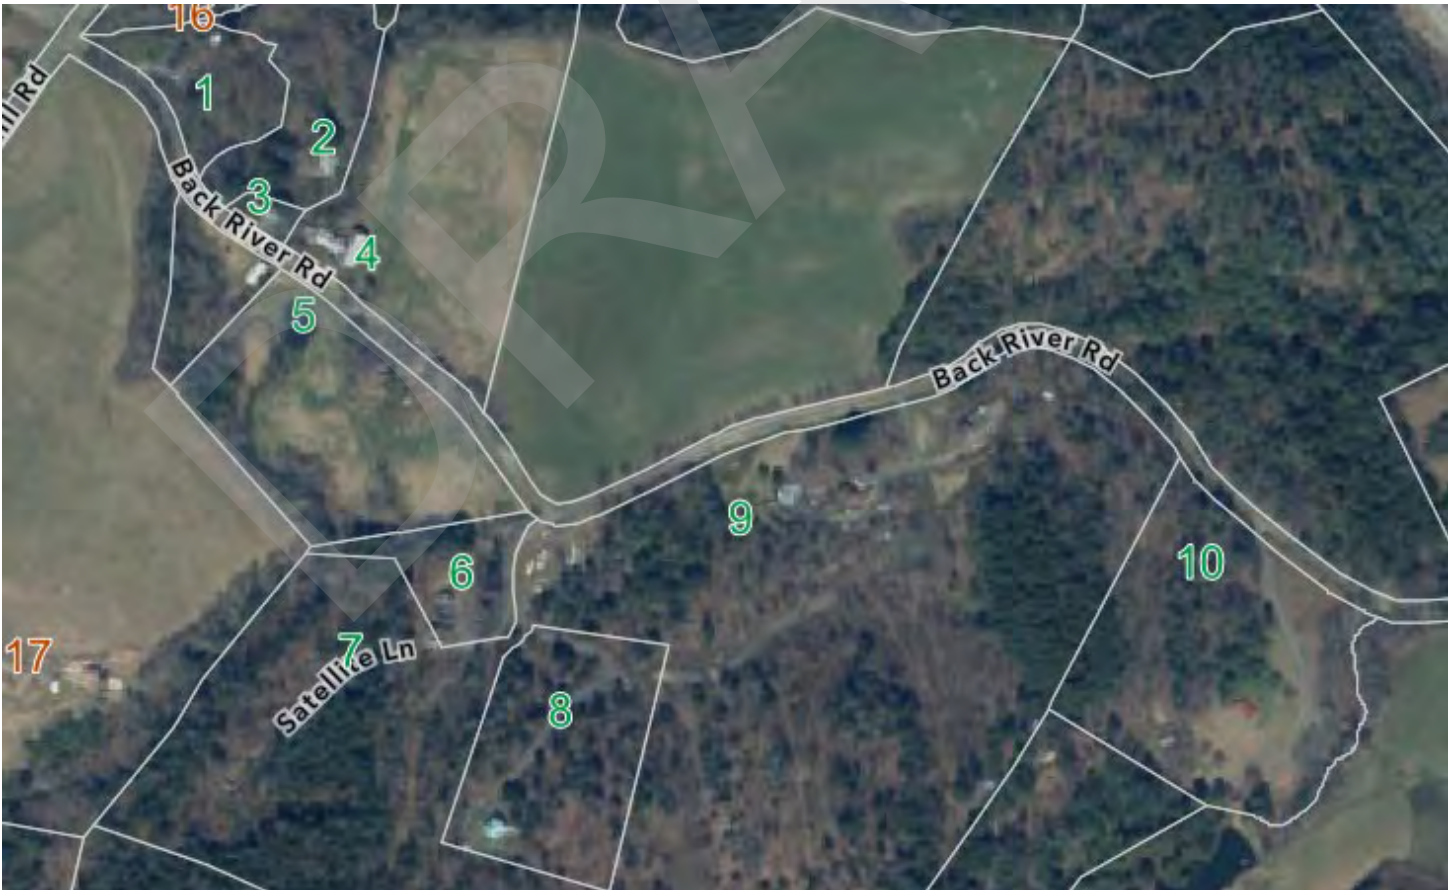
Back River Road/Satellite Lane – estimated 10 properties

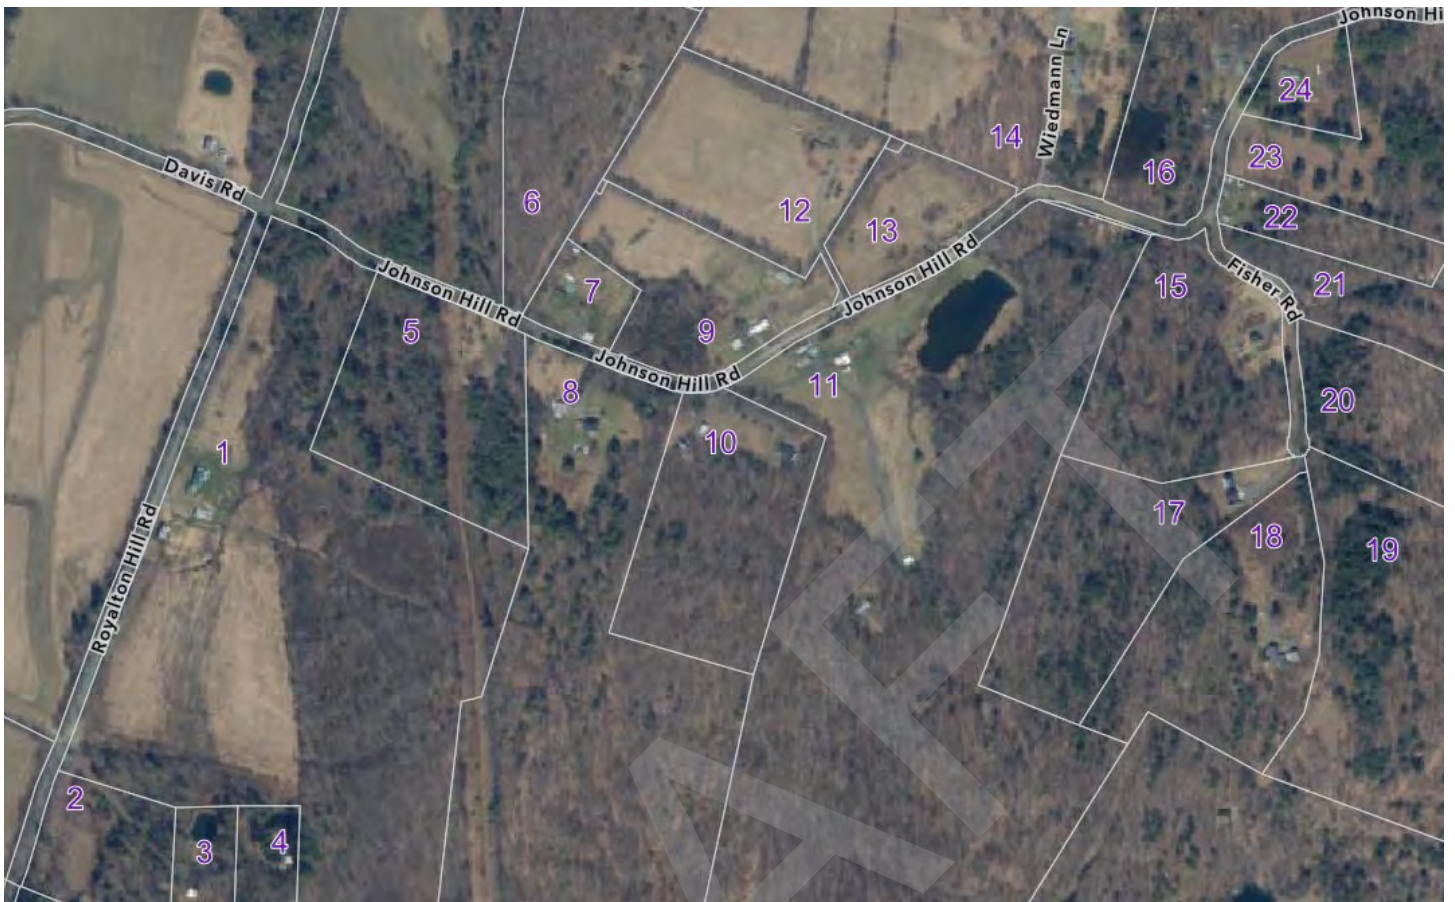
Upper part of Royalton Hill Road/Johnson Hill Road & Fisher Road – estimated 24 properties.

- Upper part of Royalton Hill Road/Johnson Hill Road/Fisher Road – 24
    - Davis Road - 20

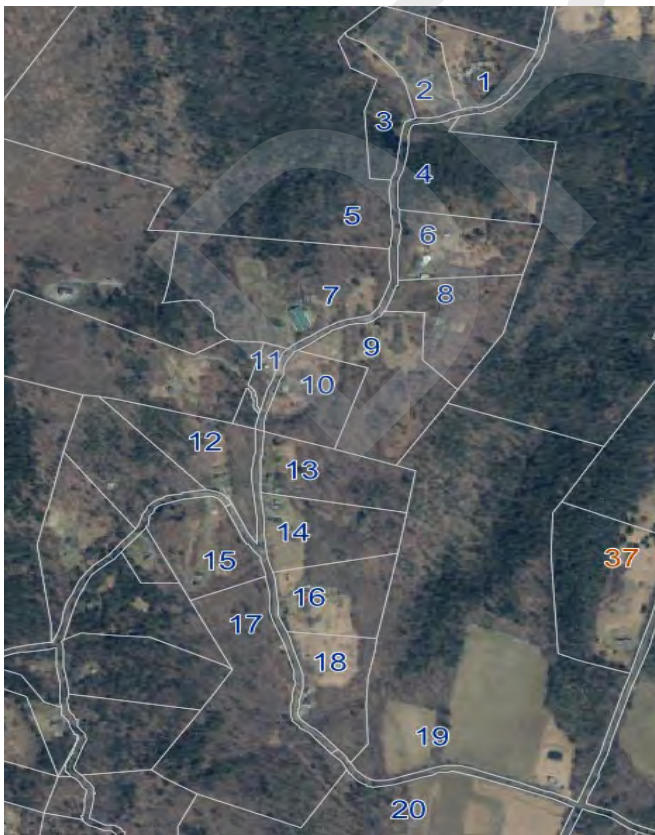
Davis Road – estimated 20 properties.

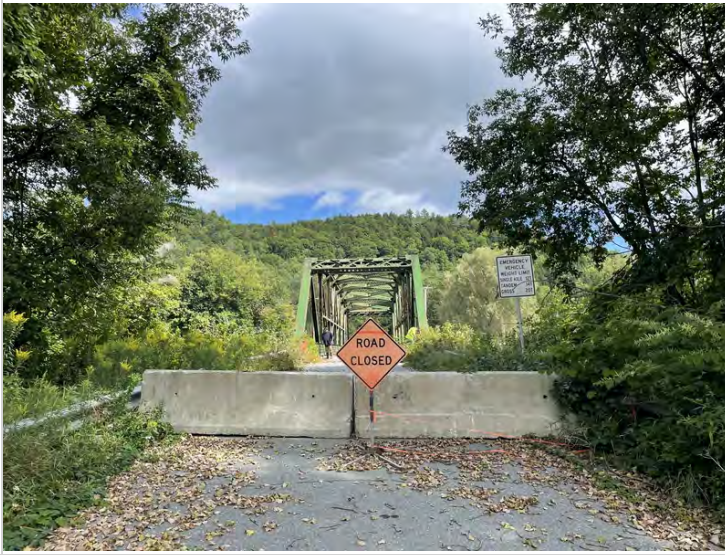
Bridge remains closed

Structure was closed due to gusset deterioration, consultant were doing in-depth inspection with staging and able to gain access to panel points and discovered advance deterioration progression .

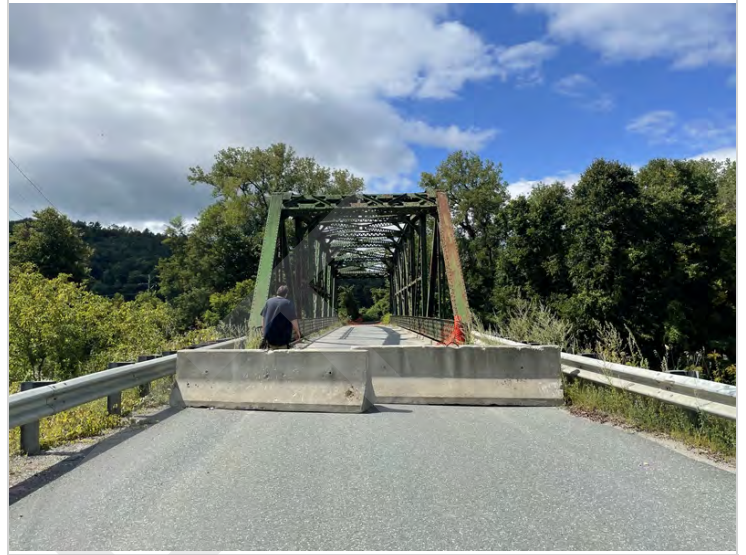
Bridge remains closed
