Town of Middlebury

Flooding Concerns
July- August 2023

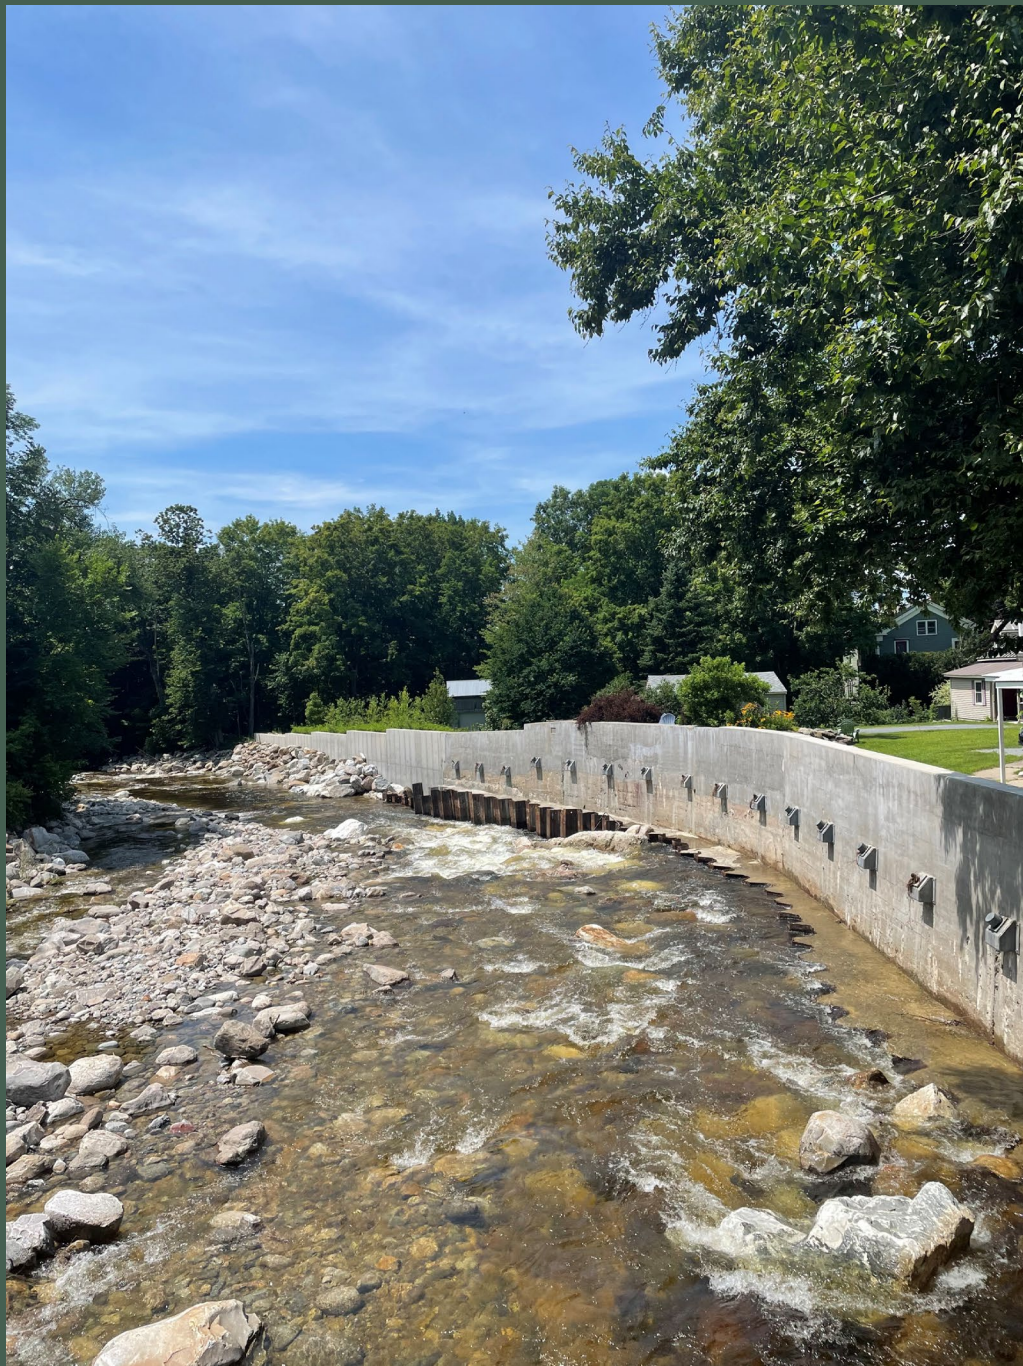
Photo- Thursday July 20, 2023

Steel sheets designed to prevent scour at wall footing.

Sheets have pulled away from concrete- leaving flowable fill exposed.

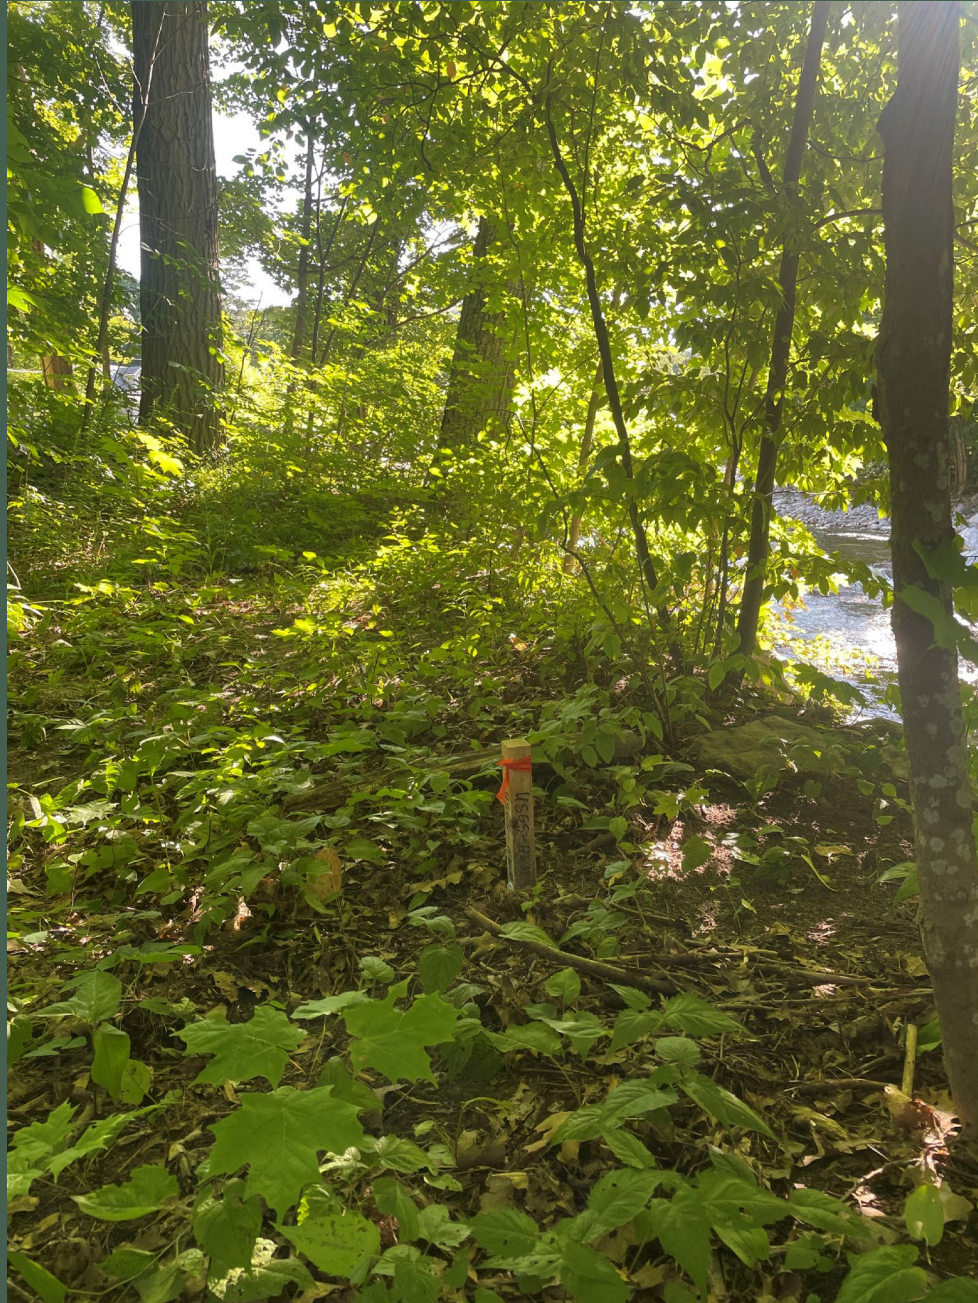
Photo- Wednesday August 2, 2023

USGS High Water Marker

- Physical evidence of flood level.
- Useful in recreating location, depth, height, and extent of floodwaters.
- FEMA will potentially be using data to revise mapping.

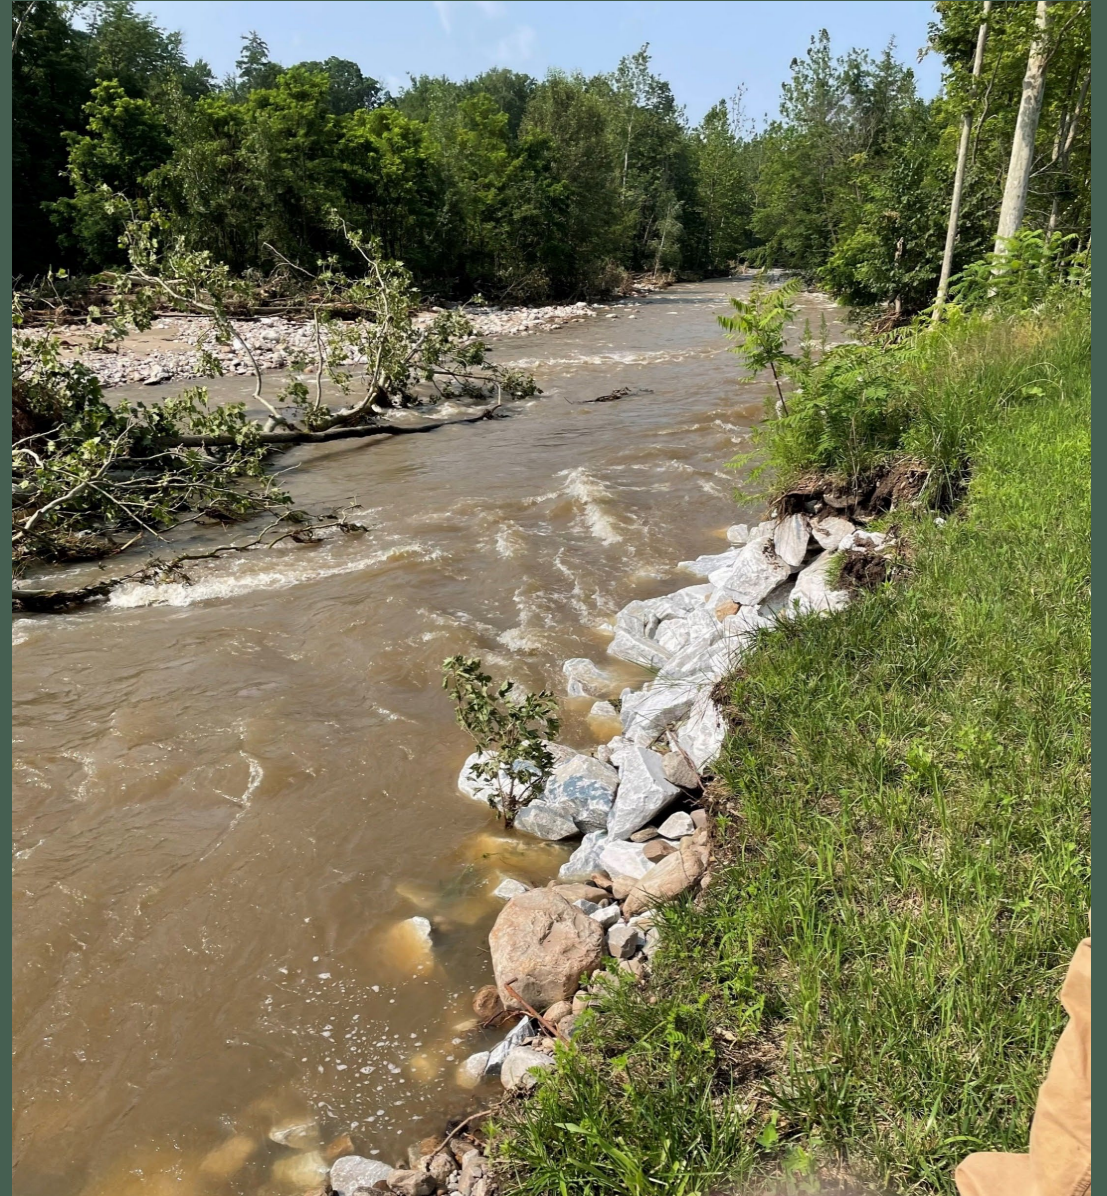
Photo- Monday July 17, 2023

- Berm initially constructed after 1988 flood
- Stone Armoring was reinforced with recent efforts
- Significant scour occurred along berm.
- Flood chute does not appear to be active
- Flood level did not breach the berm but caused significant scour

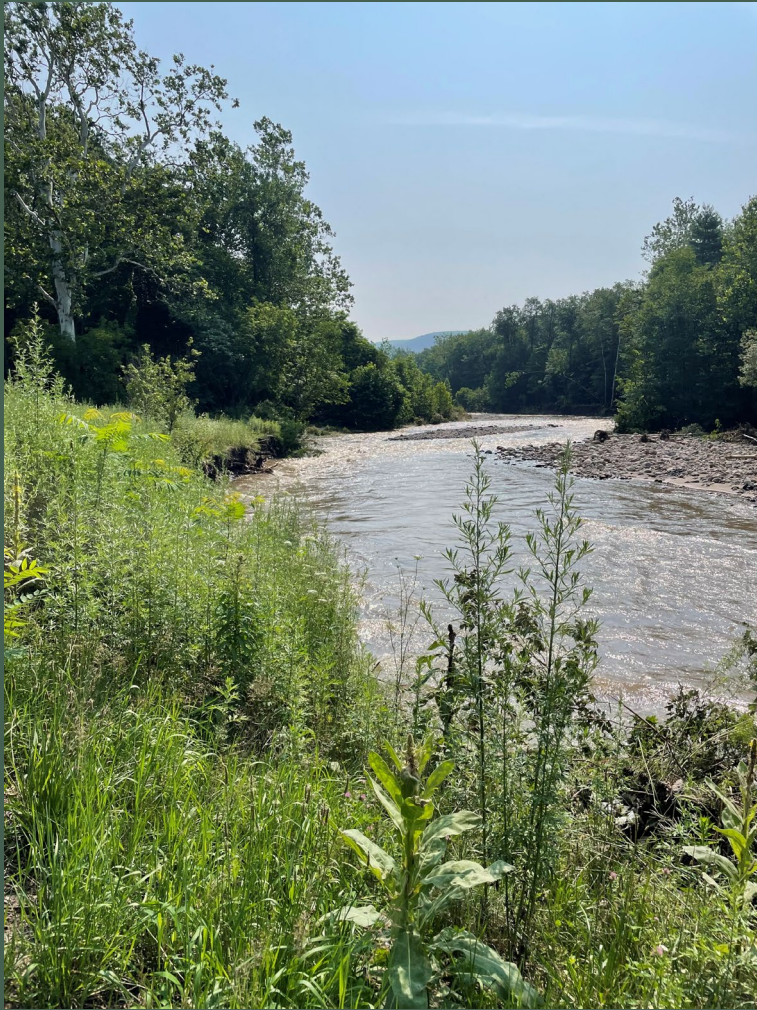
Photo taken July 17, 2023

Ossie Rd Berm
