**LUDLOW WASTEWATER
POST JULY 2023 FLOOD
TREATMENT PLANT ASSESSMENT
WINDSOR COUNTY, VERMONT**

**NPDES PERMIT NUMBER VT0100145
STATE OF VERMONT PERMIT NUMBER 3-1208**

September 13, 2023

This report was prepared based on observations made during the July 18th site visit by Heather Collins, VT DEC, WSMD, WWMP in conjunction with Army Corps of Engineers and US EPA Region 1 representatives.

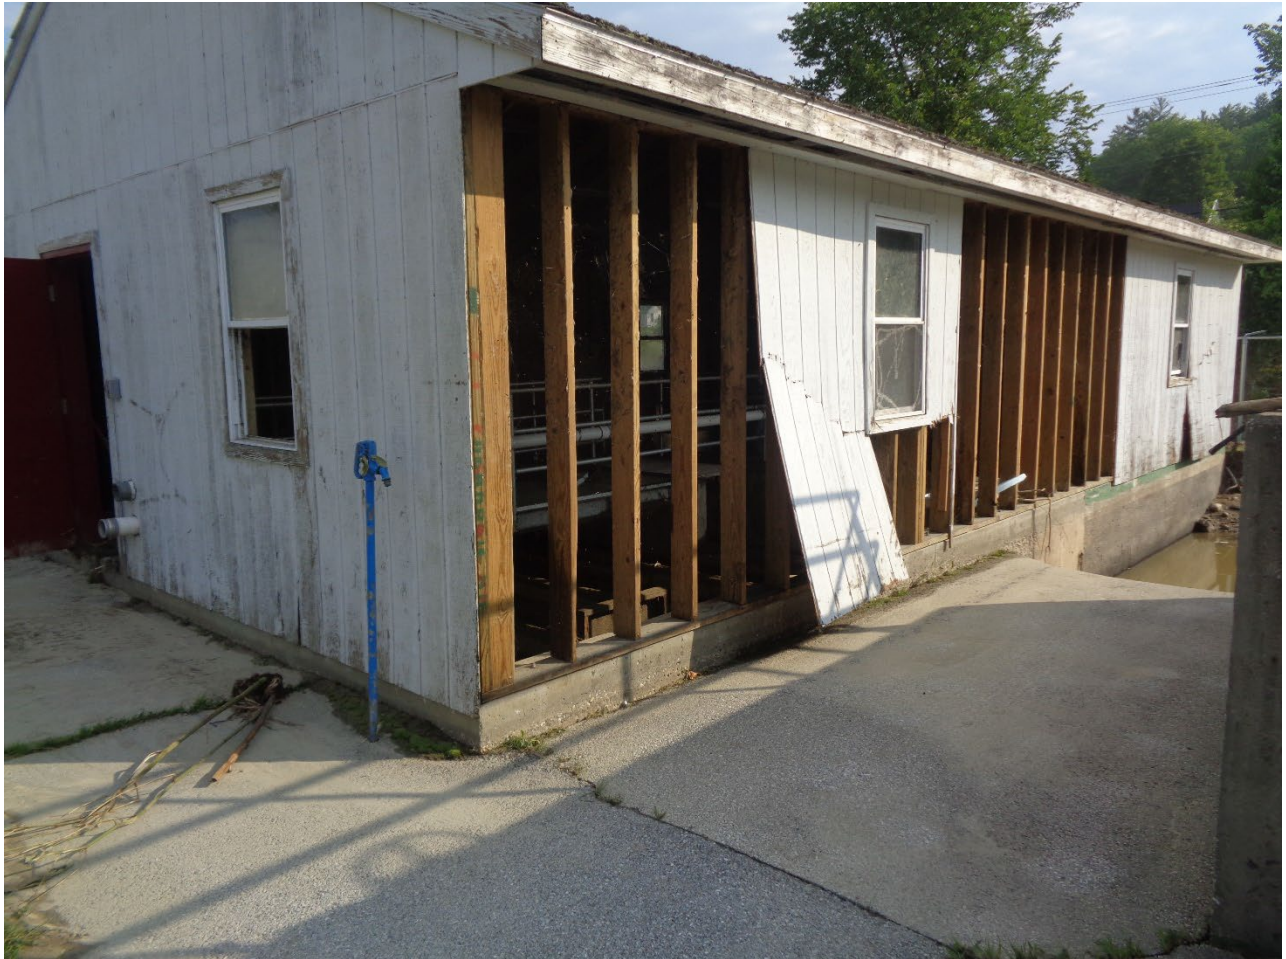
20 –Chlorine Contact Chamber. Note Extreme Scour and Debris (Photo courtesy of Aldrich and Elliot, PC)

- Railing, mixers, level measurement transmitters, and siding at the chlorine contact basins will require replacement. Although one tank is conveying flow, sediment and debris will need removed from both tanks.
