TOWN OF LUNENBURG

Road Erosion Inventory and Capital Budget Plan

Prepared by: *Sam Mayne*
 Assisted by: *Heather Johnson*

Essex County Natural Resources
 Conservation District

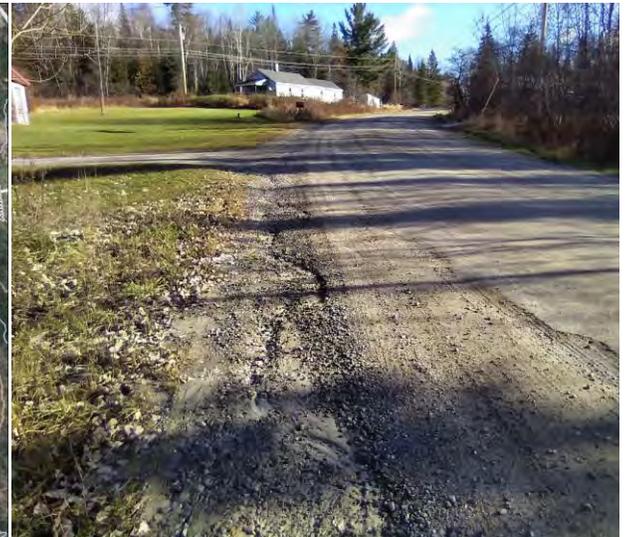
Figure 2: Water runs along the road surface in segment 4171 due to poor crowning and absent ditches

In segment 4170 and 4171 ditches will be reestablished and stoned to shed water evenly without erosion. Shoulders will be reshaped in areas where distributed flow away from the roadway is possible. 5 inches of ¾” minus gravel will also be added to allow for adequate crowning to shed water off the road surface as sheet flow. The two cross drain culverts will be replaced with 2’ steel culverts, and an 18” steel culvert will be installed across the driveway in the segment to allow adequate road drainage. Turnouts will be added to ensure water entering Mink Brook does so as distributed flow through vegetation. These measures will reduce erosion of the road surface and sediment transport to surface waters. The sink hole near Culvert 3 on Mink Brook will be stabilized by filling it with stone and gravel. The town is seeking funding to replace Culvert 3 in partnership with ECNRCD.

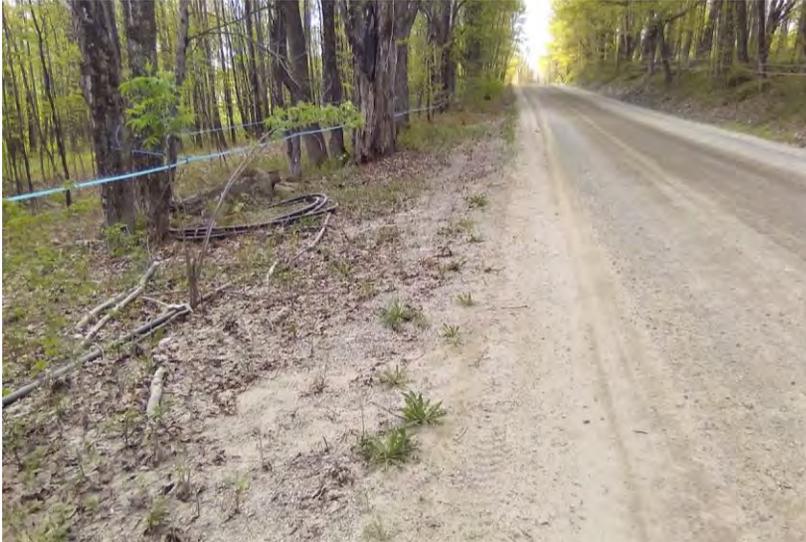
Figure 3: Some parts of segment 4166 lack ditches altogether. Water from these segments flow toward Mink Brook at the bottom of the hill.

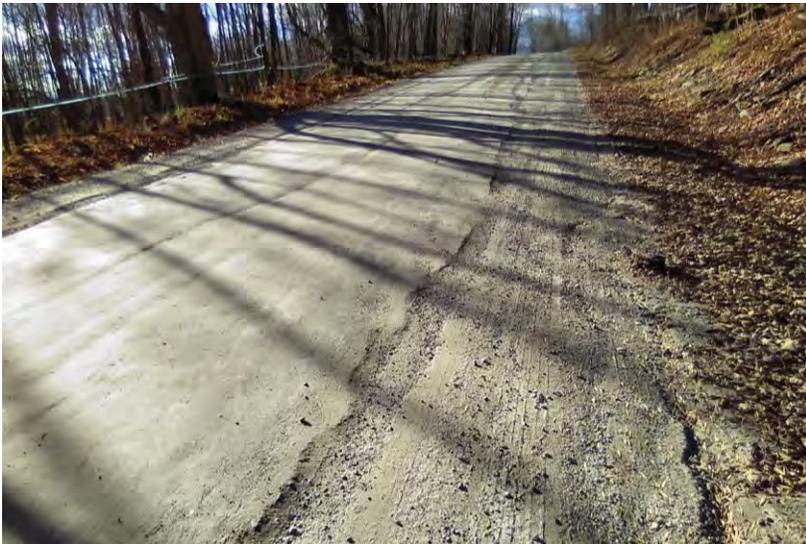
Figure 4: Water runs along the road in segment 4166 due to poor crown and shallow ditches, picking up sediment.

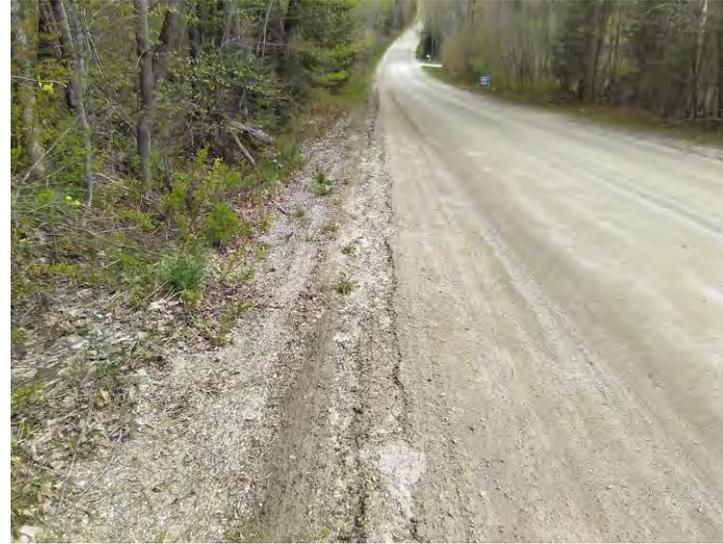
Figure 4: Ditches have filled with sediment and lack stone lining in steep sections

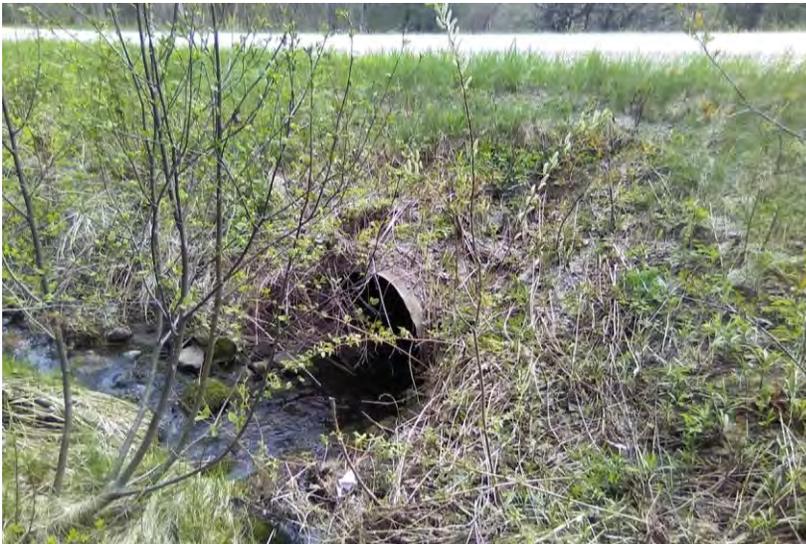
Figure 5: Erosion is occurring around culvert 14's inlet because there is no stone stabilization

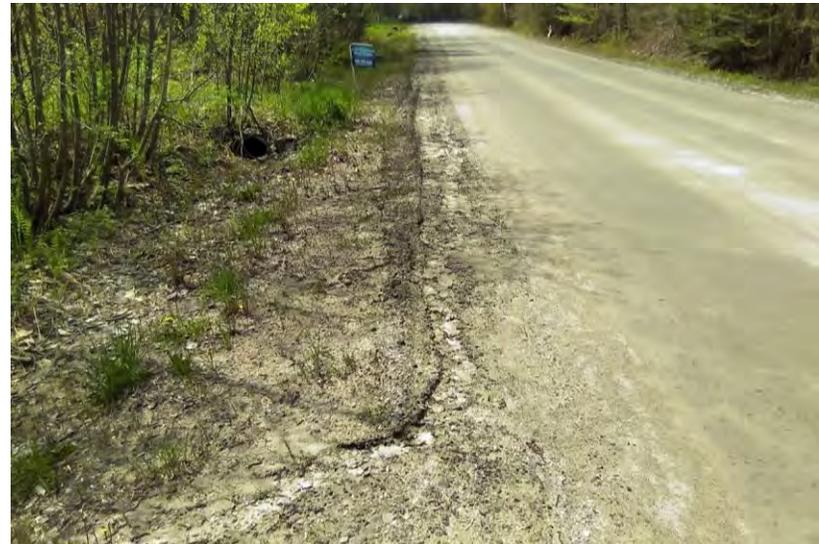
Figure 6: Water runs along the road surface picking up sediment in segment 4156 due to a grader berm and shoulder shaping

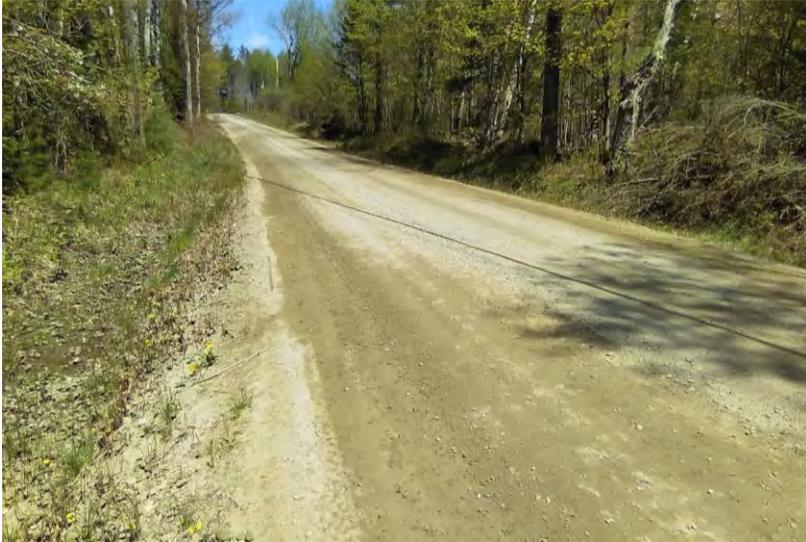
Figure 3: The ditches in segment 1938.1 and 1937.1 have filled with sediment and lack stone, causing sediment transport to waterbodies.

In both segments 1938.1 and 1937.1, ditches will be reestablished and stoned to shed water evenly without erosion. The road surface in both segments will also be removed and replaced with better material. The road will be underlined with road fabric to stop migration of road material, and 8 inches of 5" minus will be added, followed by 4 inches of ¾" minus, which will be properly crowned.

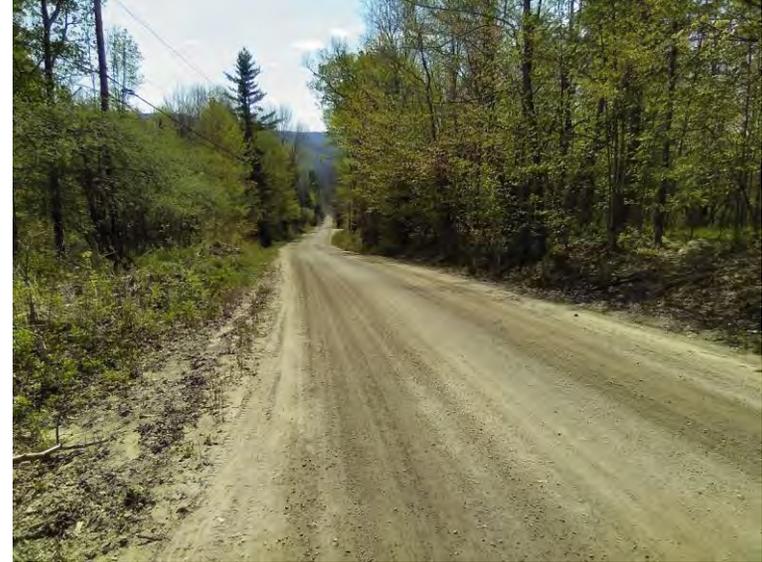
Figure 5: The ditches in segment 1938.1 and 1937.1 have filled with sediment and lack stone, causing sediment transport to waterbodies.

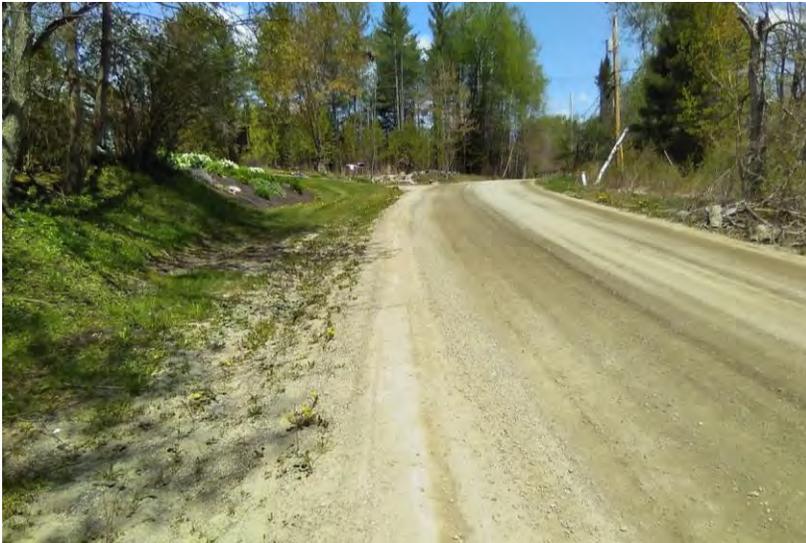
Figure 4: The ditches in segment 1938.1 and 1937.1 have filled with sediment and lack stone, causing sediment transport to waterbodies.

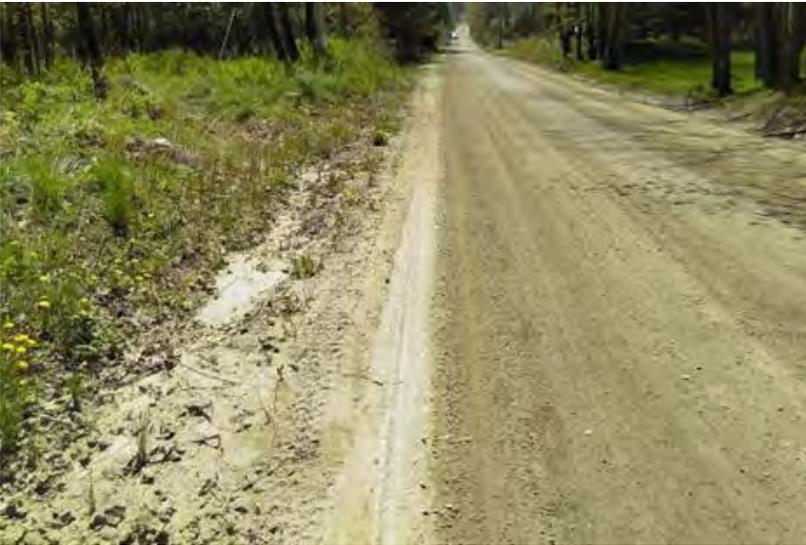
Figure 4: The ditches in segment 1936.1 and 1937.1 have filled with sediment and lack stone, causing sediment transport to waterbodies.

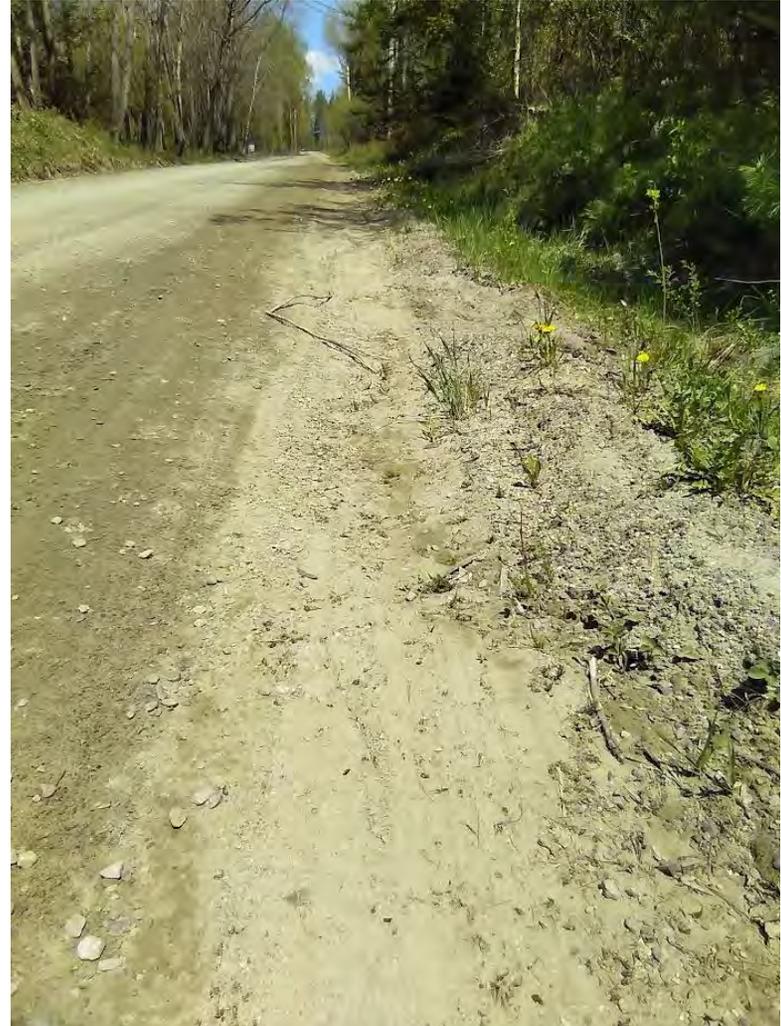
Figure 5: The ditches in segment 1936.1 and 1937.1 have filled with sediment and lack stone, causing sediment transport to waterbodies.

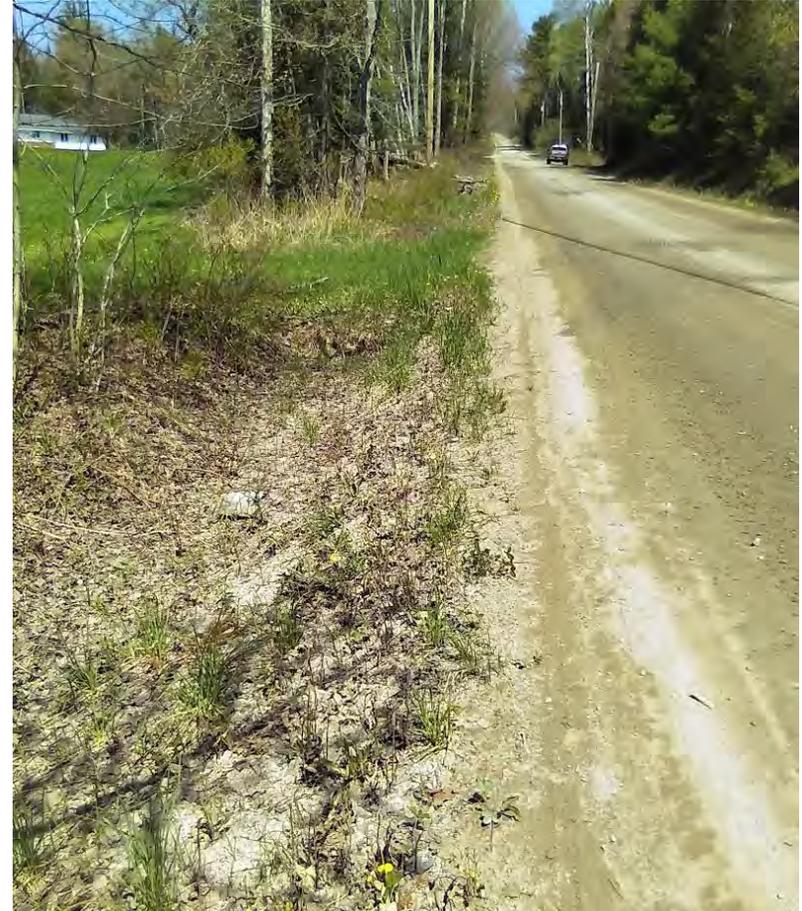
Figure 5: The ditches in segment 1931.1, 1932.1, and 1933.1 have filled with sediment and lack stone, causing sediment transport to waterbodies.

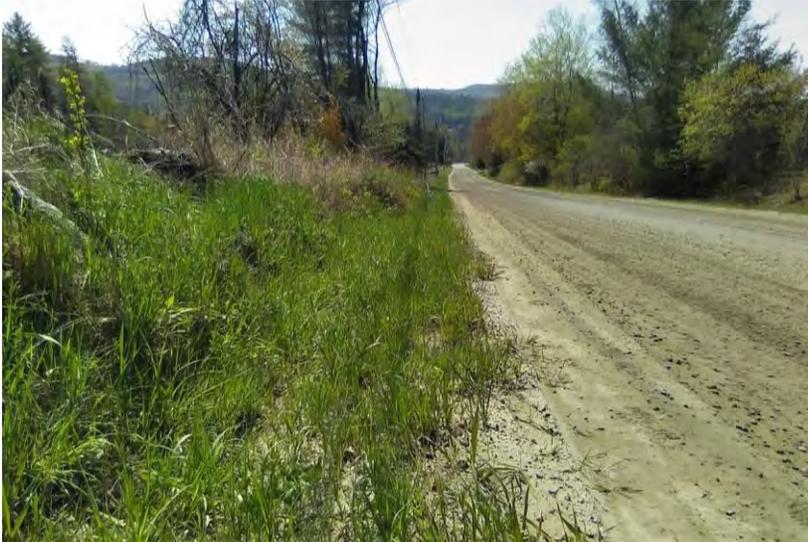
Figure 3: In segment 1930.1 the ditches lack stone and a berm prevents water from entering as sheet flow.

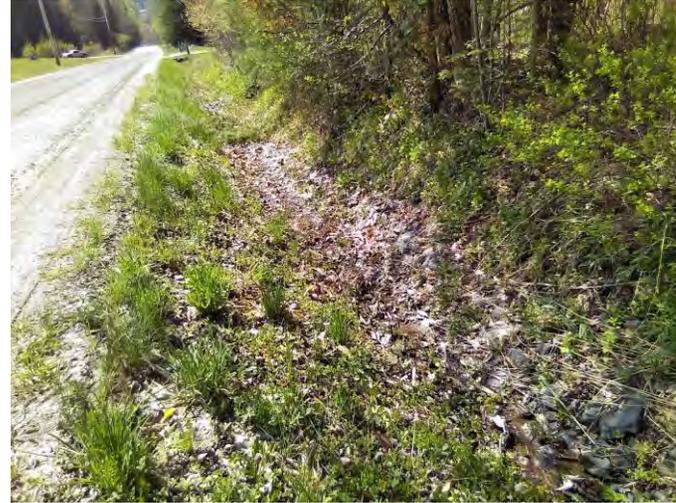
Figure 5: Not enough stone is present in steep sections of segment 1930.1.

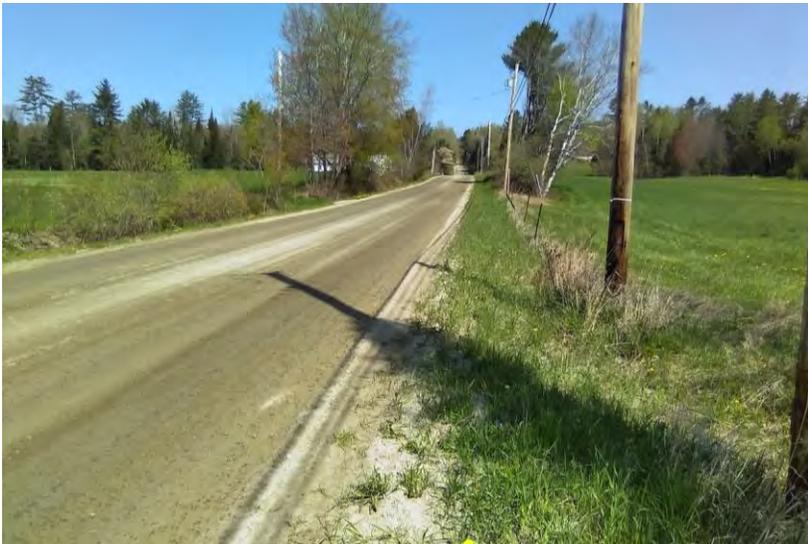
Figure 4: The shoulder in segments 1930.1 and 129.1 do not shed water evenly as sheet flow.

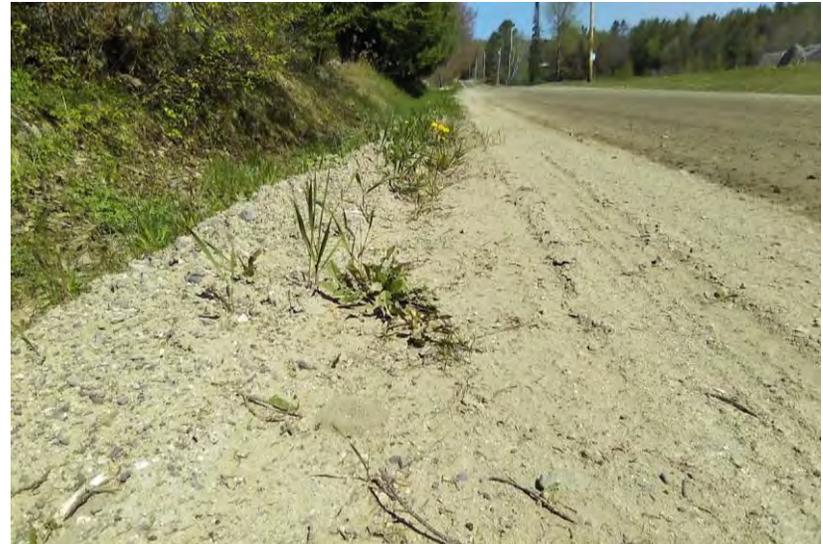
Figure 6: In segment 1928.1 the ditches have filled with sediment, preventing even runoff from the road.

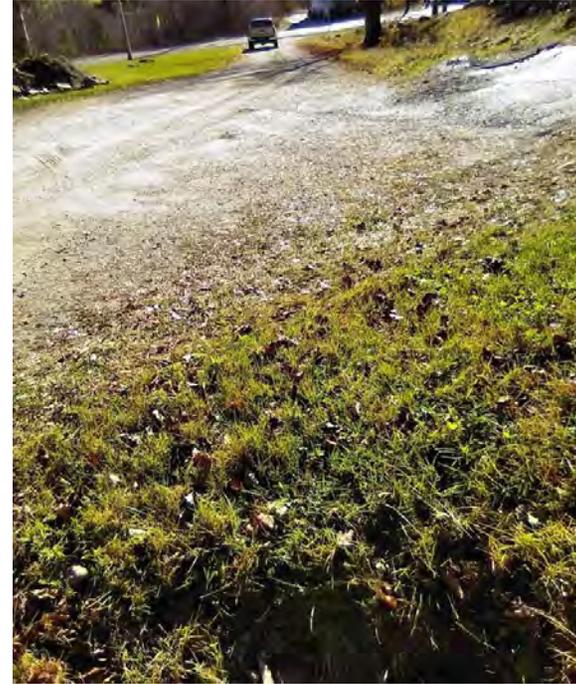
Figure 5: Segment 22134 lacks proper ditching and culvert 101 is plugged, causing water to run along the road surface.

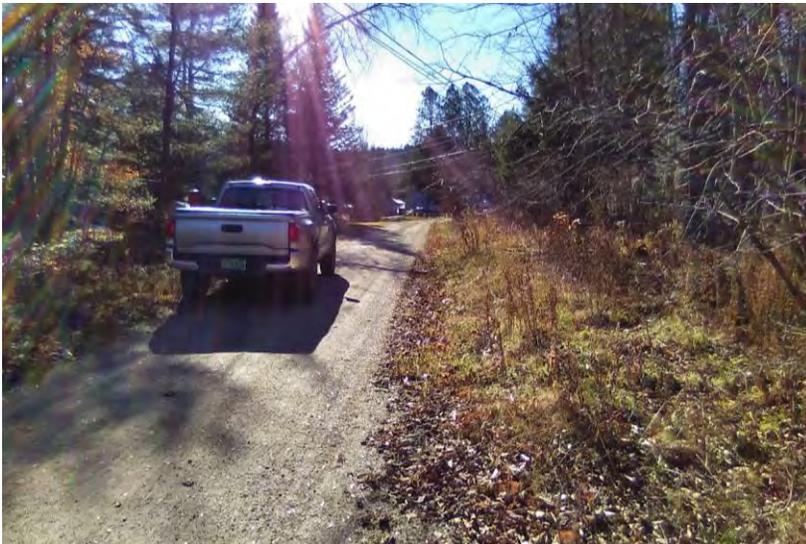
Figure 4: Water runs along the road picking up sediment in segment 22132 and 22134 due to poor crown and no ditches.

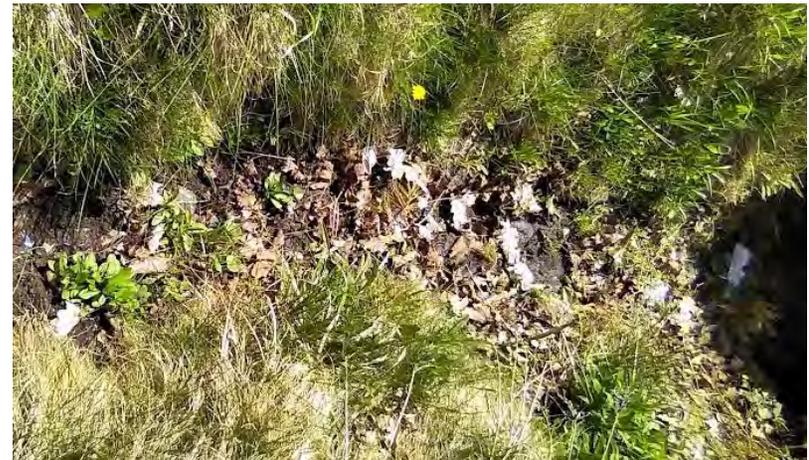
Figure 3: Stone is needed in segment 22132 to stop erosion in the ditch.

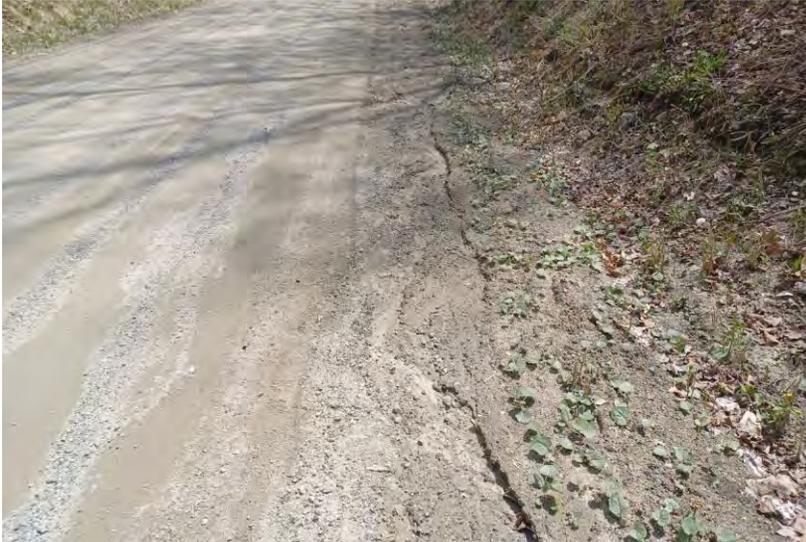
Figure 3: The ditches in segment 152091 have filled with sediment and lack stone, causing erosion.

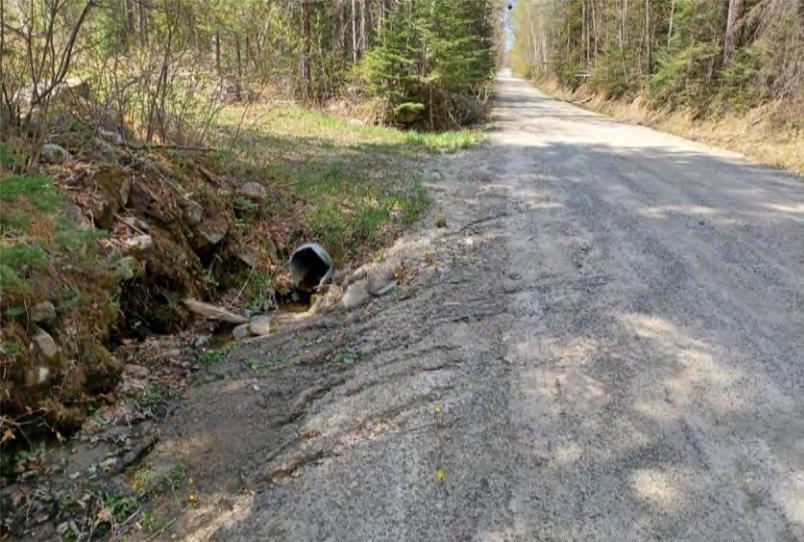
Figure 3: Culvert 264 in segment 152094 is undersized, causing erosion in the ditch. The crown is also not shedding water as sheet flow, causing erosion of the road into the ditch.

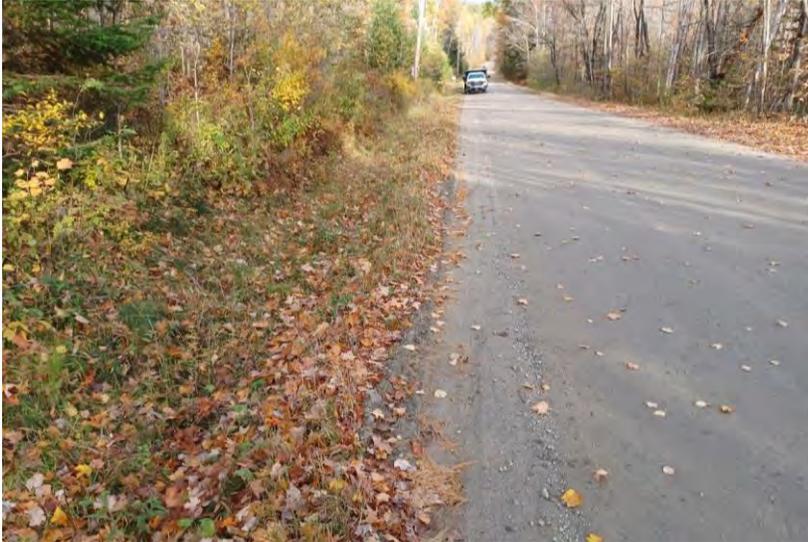
Figure 3: In segments 152099 and 152100 grader berms stop water from escaping the roadway, causing erosion on the road surface.

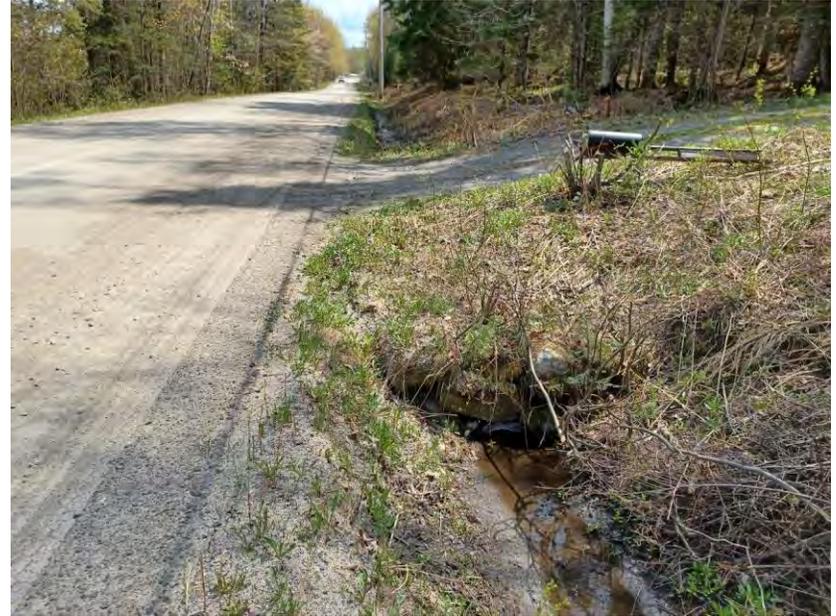
Figure 5: Sediment in ditches s clogging culverts, stopping proper water transport.

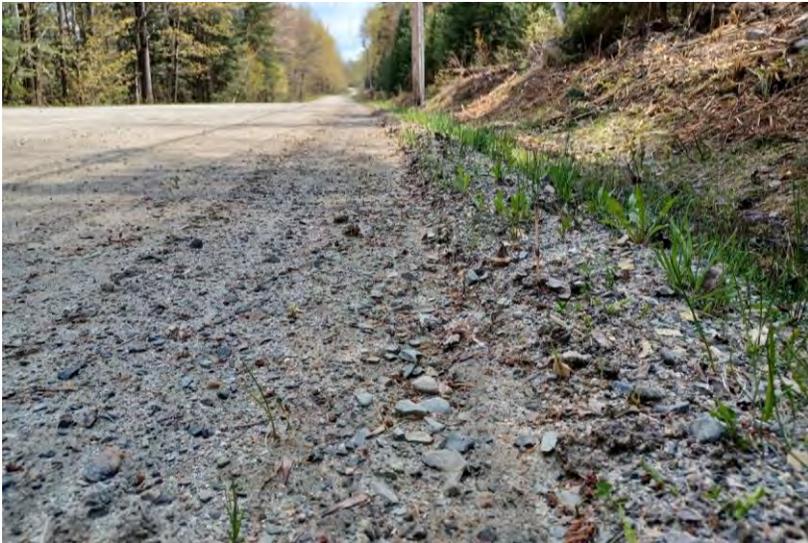
Figure 4: Water runs along the road in all segments due to poor crown and grader berms, picking up sediment.

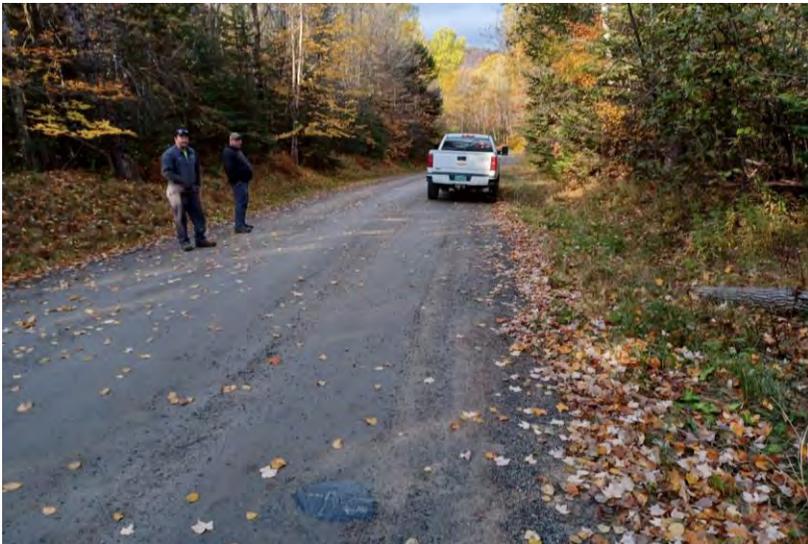
Figure 4: Shallow ledge in all segments may make ditching difficult and requires additional gravel for building a crown.

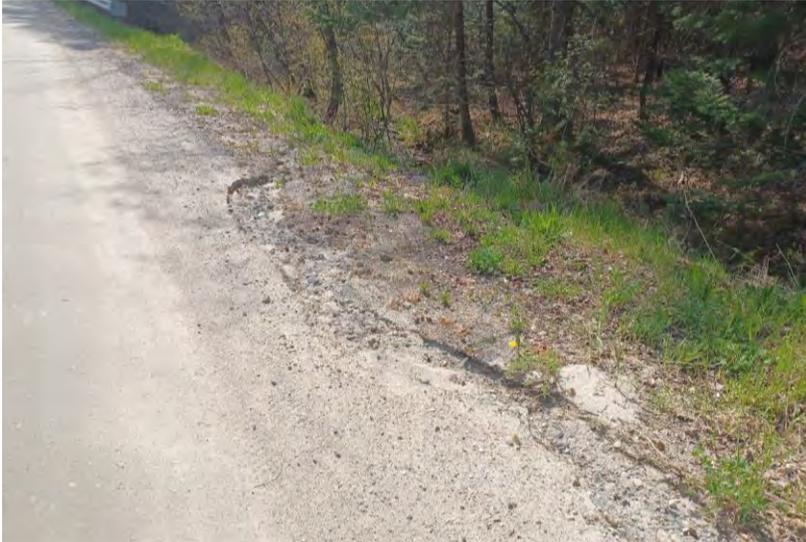
Figure 3: In segment 4597.1 the ditches lack stone and water and does not reach the ditch as sheet flow due to insufficient crown and the ditch being too far from the road.

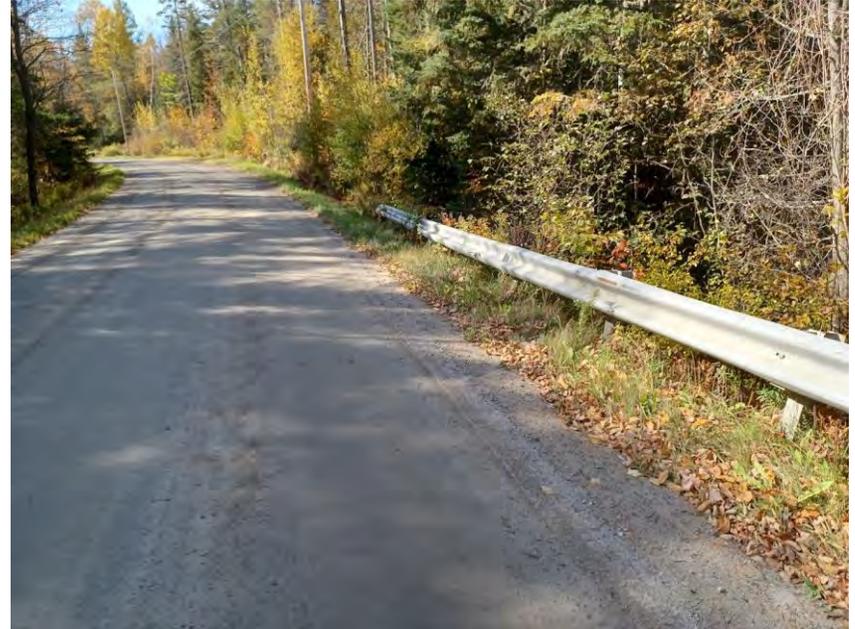
Figure 5: In segment 4596.1 a poorly shaped shoulder and lack of crown prevents water from escaping the roadway as sheet flow.

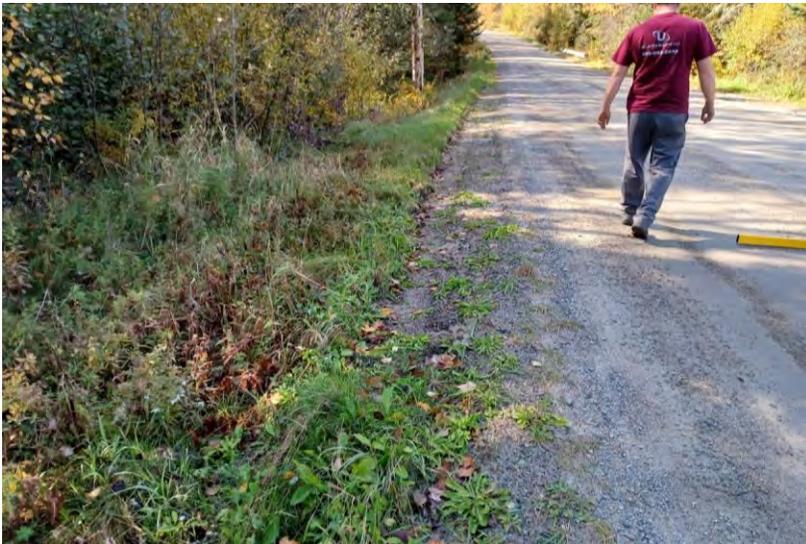
Figure 4: A grader berm and poorly shaped road shoulder prevents water from flowing away from the road to the south in both segments.

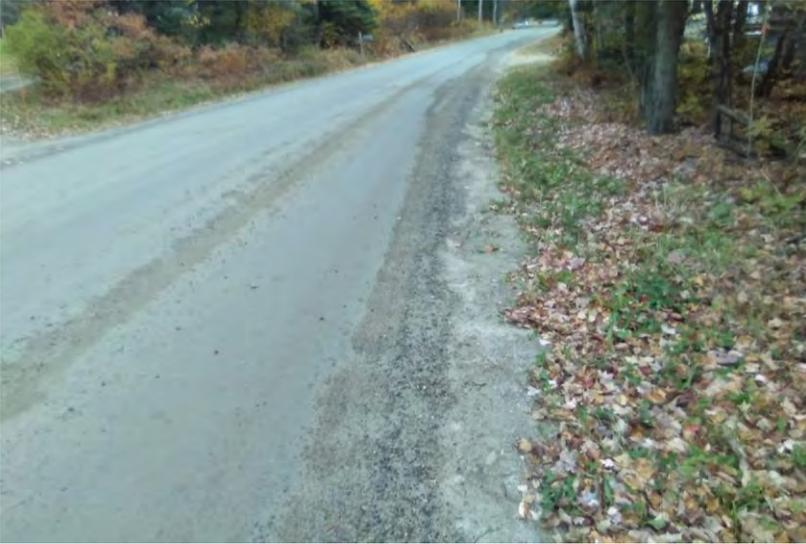
Figure 3: Water is running down the road surface due to insufficient crowning, no ditching, and no driveway culvert in segment 10509.

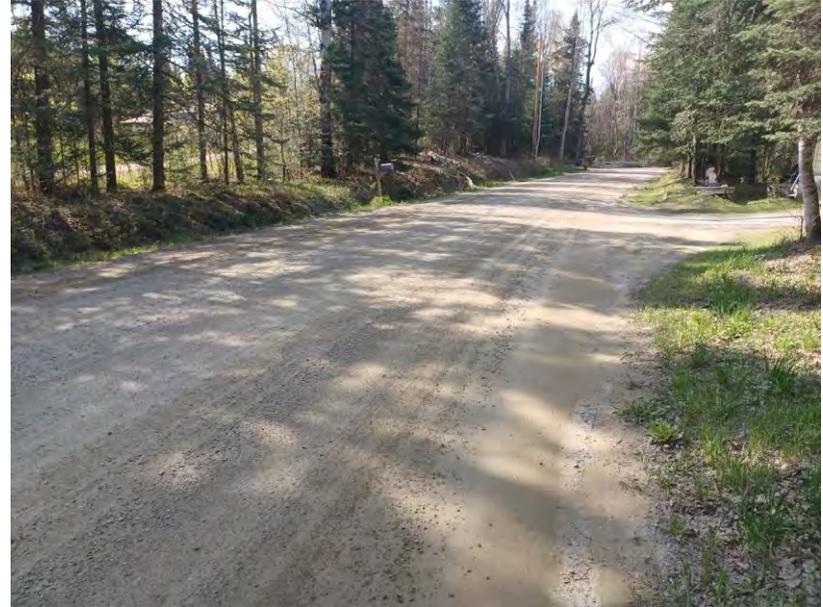
Figure 5: A driveway lacks a culvert and the shoulder lacks ditches in segment 10509.

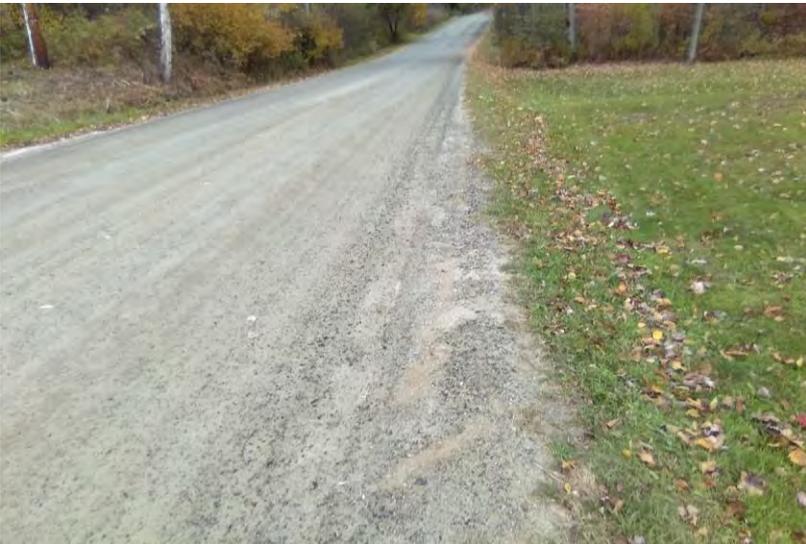
Figure 4: Water runs along the road edge in segment 1050 due to insufficient crowning and a grader berm.

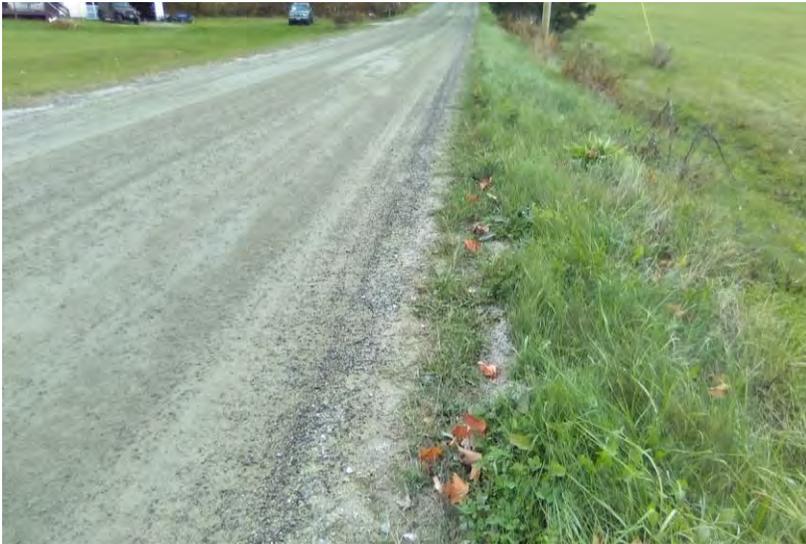
Figure 3: A grader berm, insufficient crown, and slightly malformed shoulder prevent water from escaping the road, causing erosion in segment 106696.

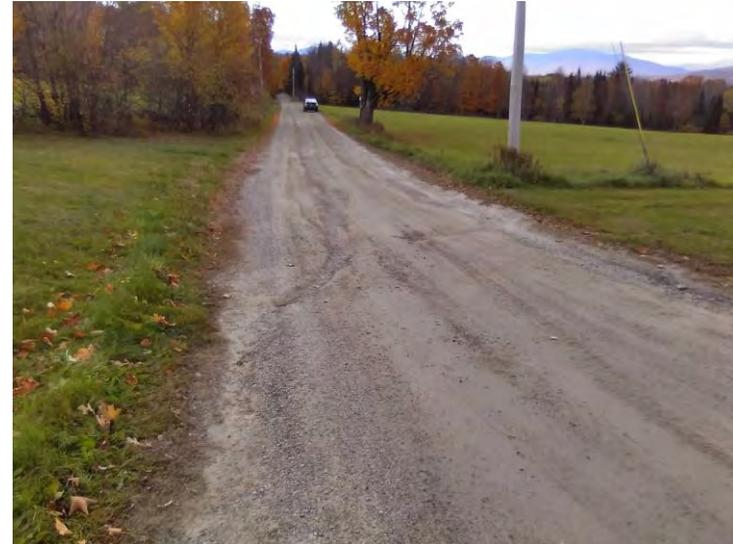
Figure 5: In segment 167350, water runs along the road surface due to insufficient crowning and shoulders and ditches that do not shed water. Water eventually flows across the road surface, causing erosion.

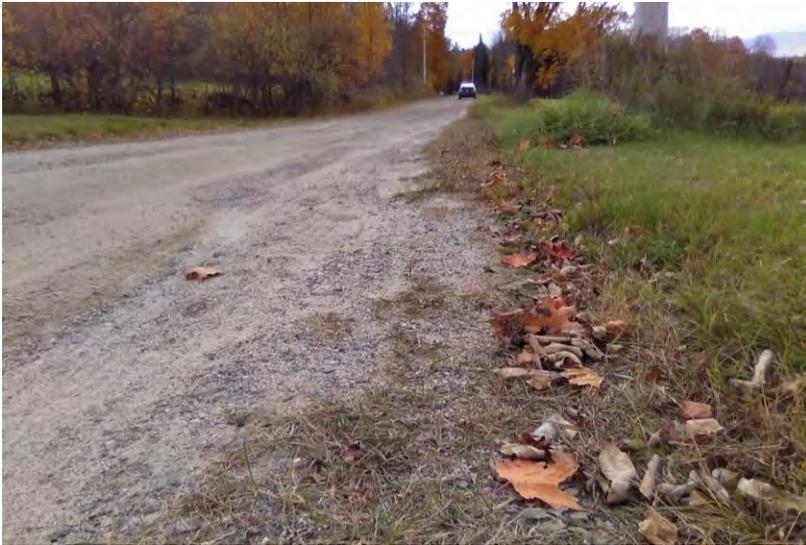
Figure 4: The shoulder in segment 167350 prevents water from escaping the road surface, causing erosion.

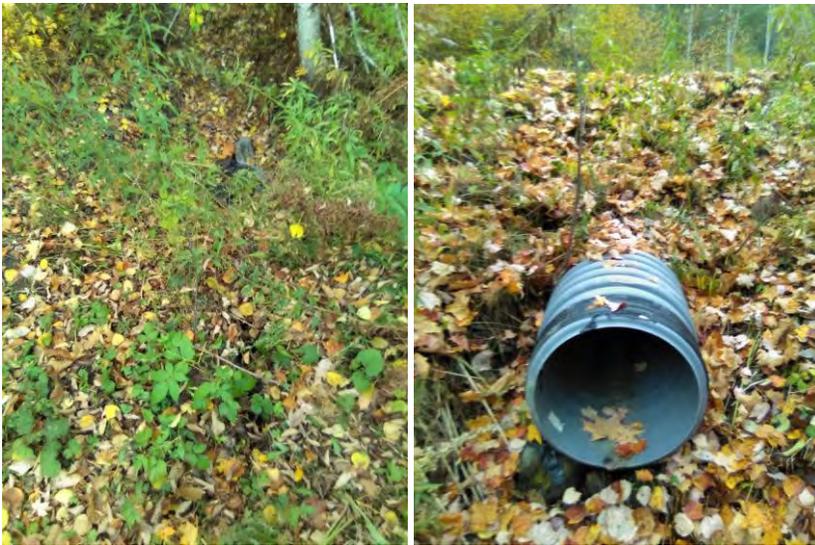
Figure 4: Erosion is occurring around culvert 361, which is undersized, not armored, and passes a perennial stream.

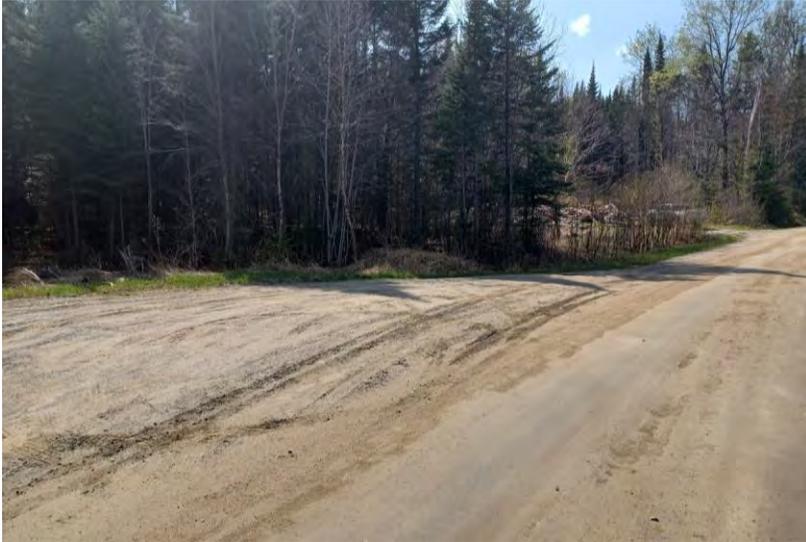
Figure 3: Water should be turned out before the parking area next to Catbow Brook.

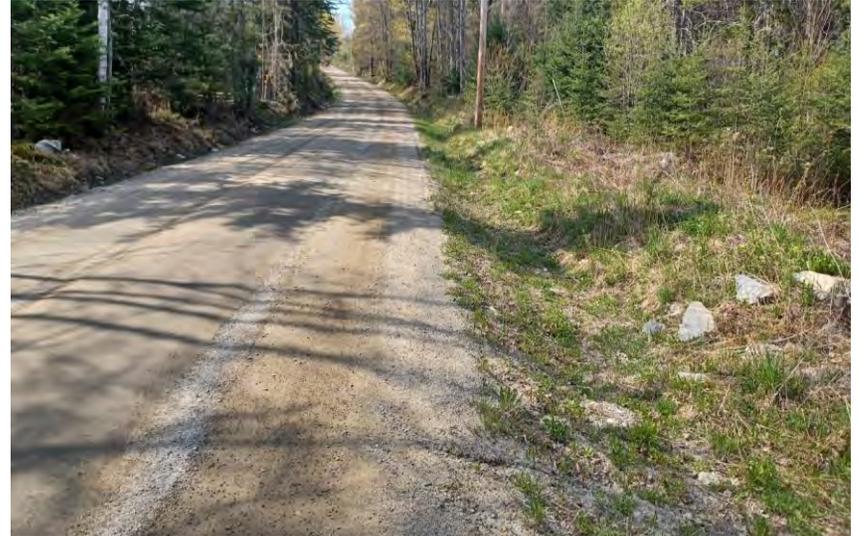
Figure 5: Steep section of segment 24571 lack stone, resulting in in-ditch erosion and sediment transport to Catbow Brook.

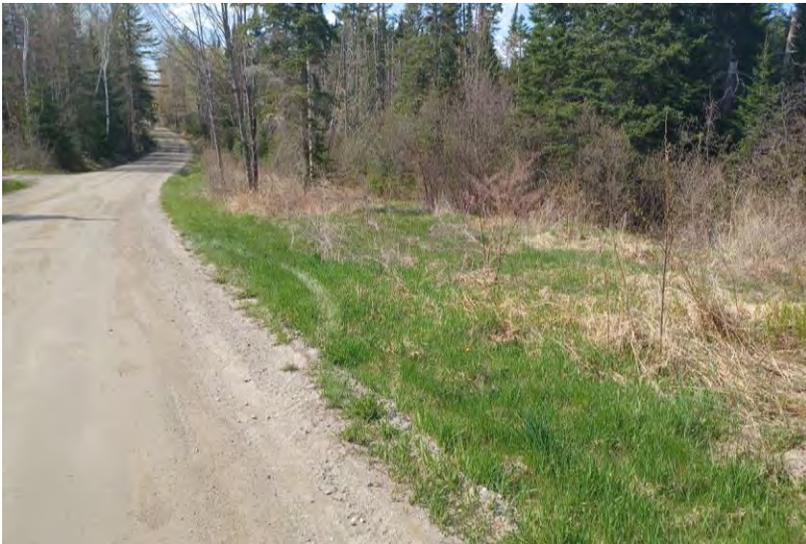
Figure 4: Ditches in the downhill parts of segment 24571 have filled with sediment, causing water to flow along the road surface.

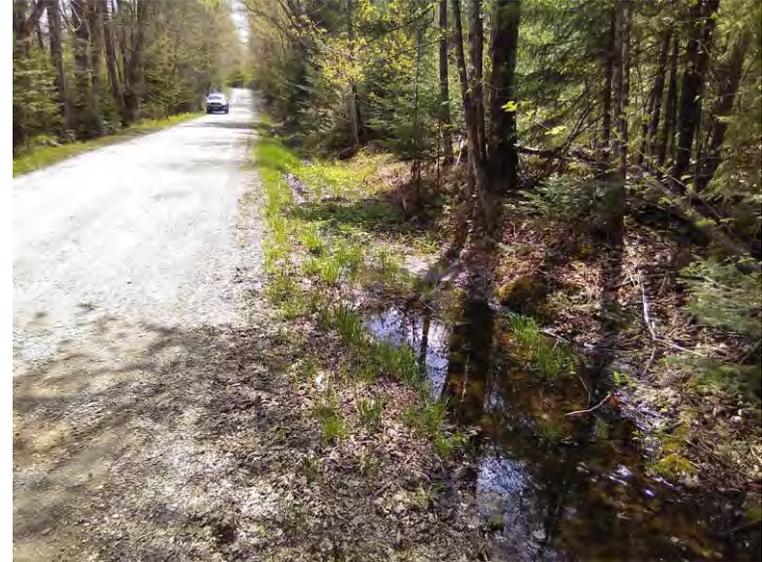
Figure 5: The uphill ditches in both segments are too shallow to effectively move water.

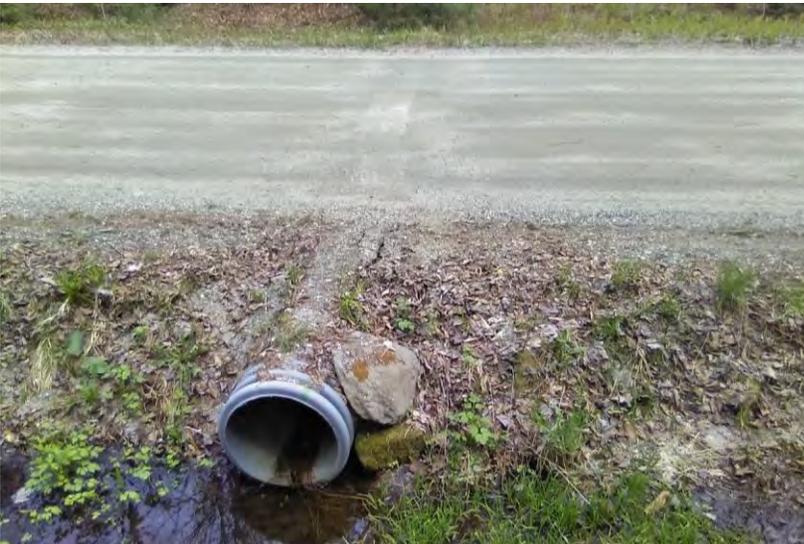
Figure 4: Culvert 158 in segment 91828 is not stabilized with stone headers and some erosion is occurring around it.

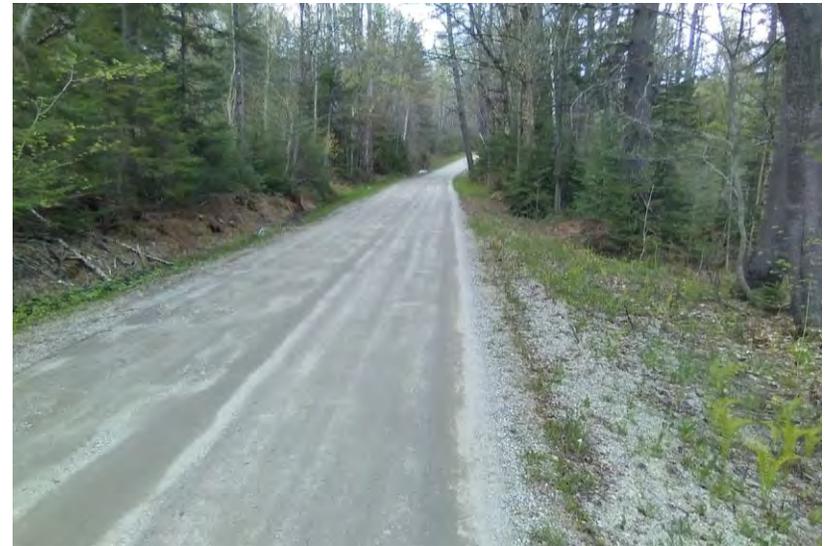
Figure 4: The downhill shoulder in both segments does not shed water as sheet flow away from the road.

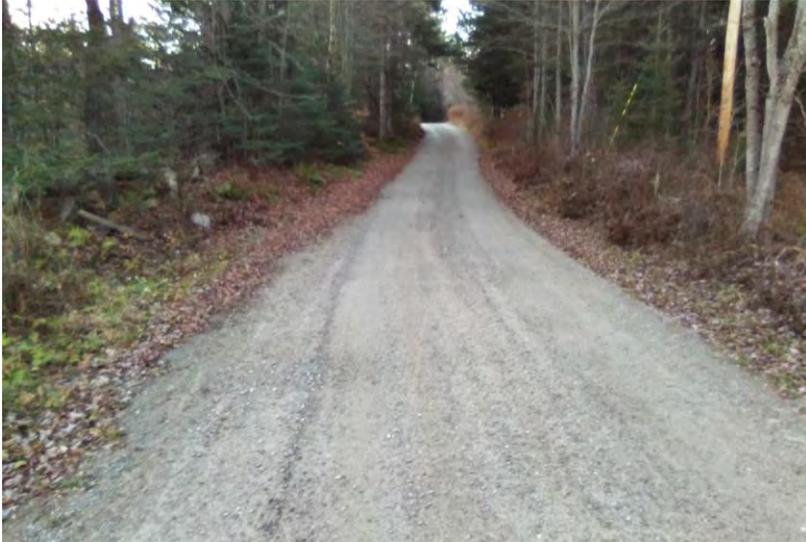
In segment 193243 ditches are absent or not deep enough to adequately transport water off the road surface, leading to erosion on the road surface. Ditches lack stone, which may result in erosion in the ditch. Water also runs along the road surface, picking up sediment, due to inadequate crowning.

Figure 3: The ditches in segment 193243 are narrow and shallow and lack stone. Crowning on the segment does not shed water as sheet flow, causing erosion. Stone walls may prevent adequate ditching in areas.

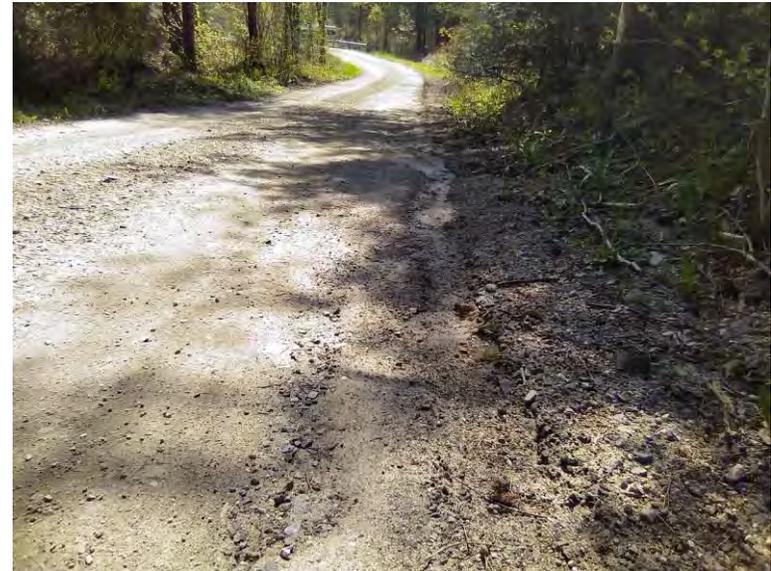
Figure 5: In segment 193243, flow along the road surface due to lacking ditches is transporting sediment to Scales brook.

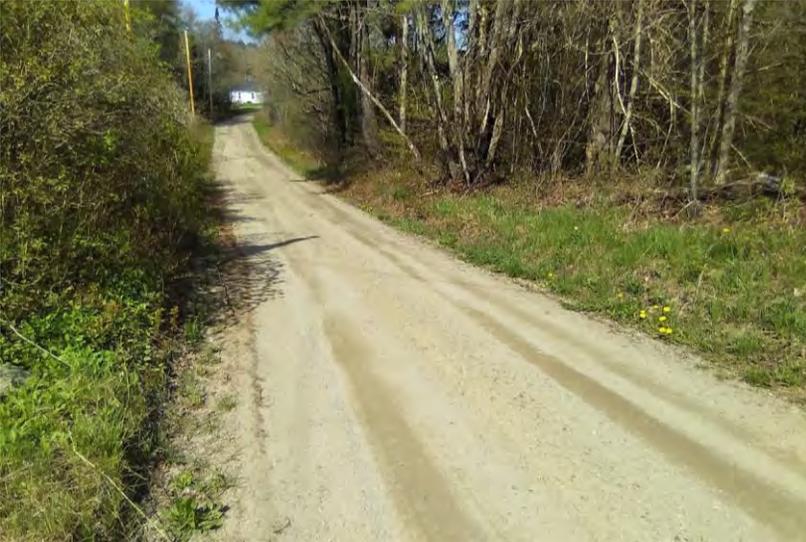
In segment 193229, ditches are absent or not deep enough to adequately transport water off the road surface, leading to erosion on the road surface. Inadequate crowning and poorly formed shoulders area also causing water to flow along the road surface, picking up sediment. Sediment from the road surface is entering an unnamed stream in the segment.

Figure 3: Ditches and more crown need to be established in segment 193229 to prevent erosion on the road surface.

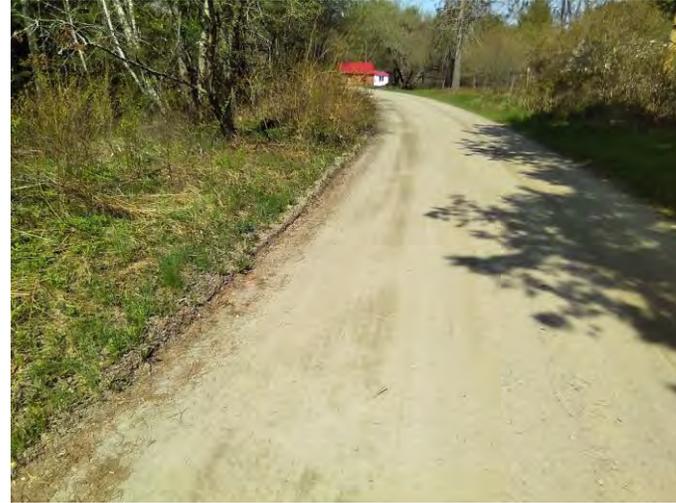
In segment 193231 road shoulders and ditches do not adequately shed water away from the road surface, causing flow and erosion along the road. Water also runs along the road surface, picking up sediment, due to inadequate crowning. Water flowing along the road surface in this segment moves toward an unnamed stream to the west and Scales Brook to the east.

Figure 5: A ditch needs to be established in segment 193231 to allow water to escape the road surface.

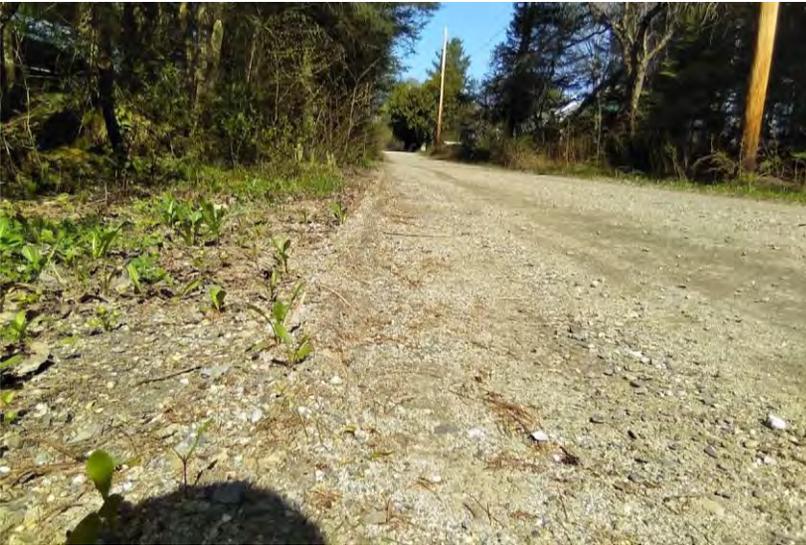
In segment 193230, one driveway does not have a culvert, leading water to flow into the roadway picking up sediment. Ditches and road shoulders are not adequately transporting water off the road surface, leading to erosion on the road and sediment transport toward Scales Brook. Inadequate crowning is also causing water to flow along the road surface, picking up sediment.

Figure 4: A ditch needs to be established in segment 193230 to allow water to escape the road surface.
