TOWN OF LUNENBURG

Road Erosion Inventory and Capital Budget Plan

Prepared by: *Sam Mayne*
 Assisted by: *Heather Johnson*

Essex County Natural Resources
 Conservation District

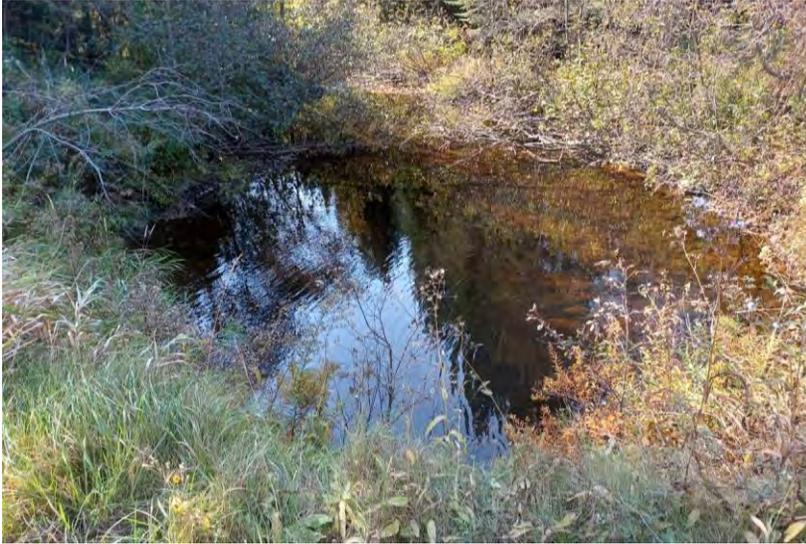
In segment 24570, the structure crossing Catbow Brook is degraded and undersized, causing in-stream erosion, erosion at the culvert headers, and risking failure. The existing structure is two heavily degraded and partially collapsed culverts (ID 122, 123), each roughly 5 feet in diameter, with several steel overflow culverts, one 30" (ID 121), and another 18" (unknown ID).

Figure 3: The undersized culverts have created a large scour pool downstream of the conveyance, indicating in-stream erosion.

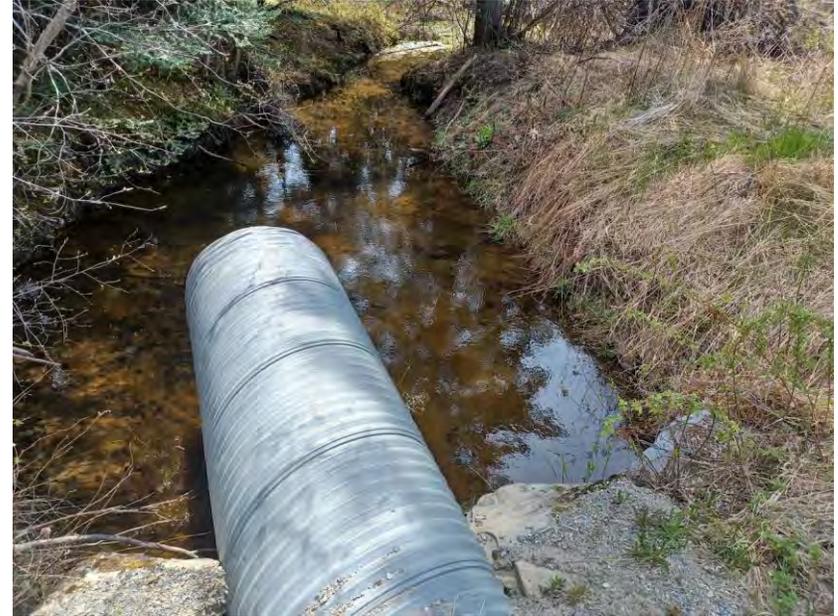
Figure 5: Two 30"x30" overflow culverts are present, with erosion occurring around the headers and in-stream erosion occurring in the large downstream scour pool.

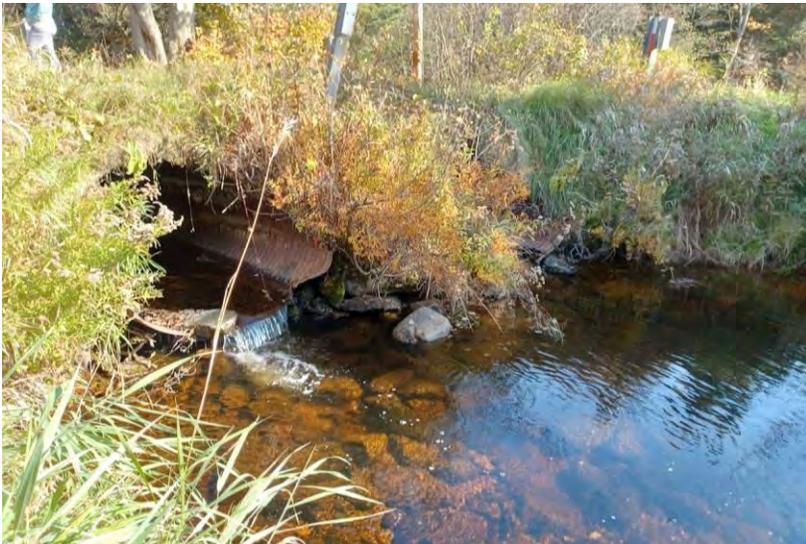
Figure 4: The culverts are perched, causing in-stream erosion and blocking fish passage.

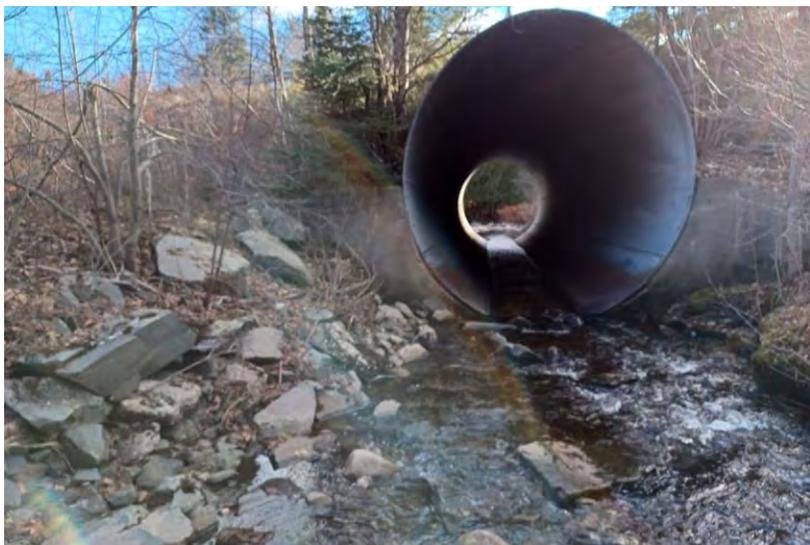
Figure 3: At normal flow, the culvert restricts Mink Brook to much less than it's natural bank full width.

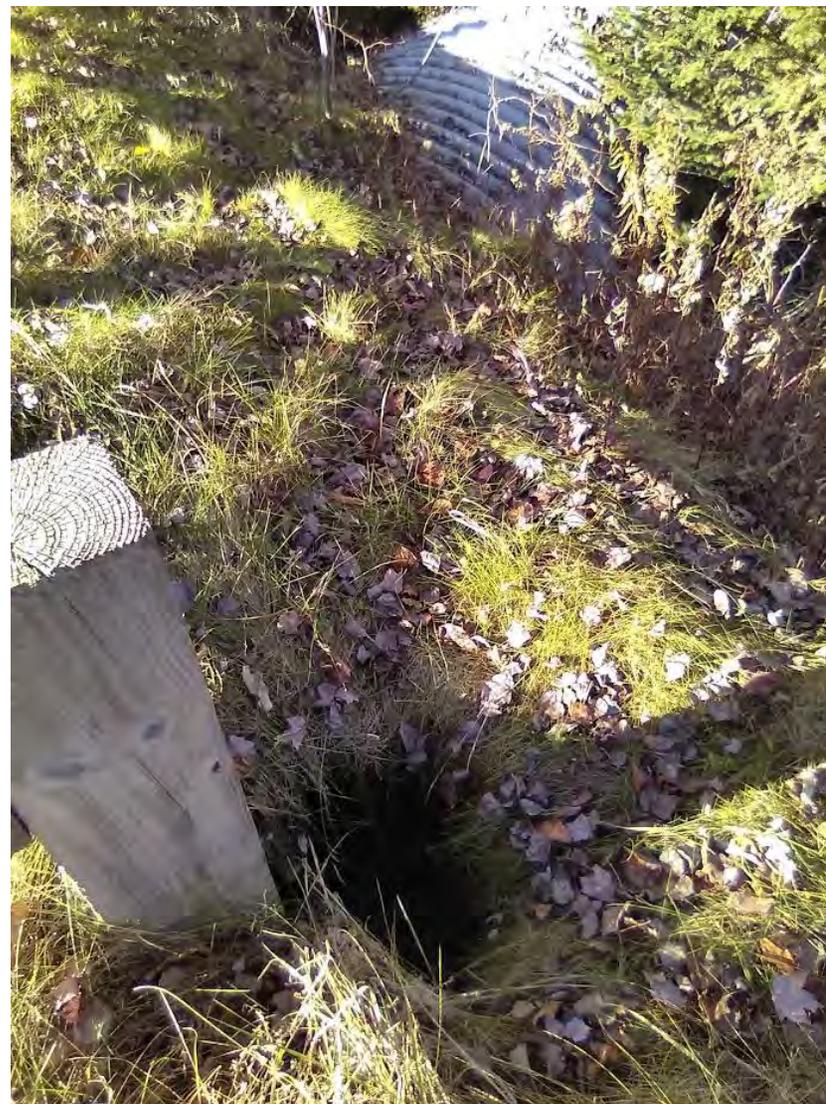
Figure 5: Erosion is occurring around the upstream header of the culvert.
