**STRUCTURAL AND ELECTRICAL ASSESSMENT OF
THE BENNINGTON BATTLE MONUMENT**

**PHASE II: COMPREHENSIVE STRUCTURAL &
MATERIAL TESTING AND EVALUATION AND
OUTLINE OF RESTORATION APPROACH**

15 MONUMENT CIRCLE
BENNINGTON, VT, 05201

PREPARED FOR:
VERMONT DEPARTMENT OF BUILDINGS & GENERAL SERVICES
BGS PROJECT ID #200016

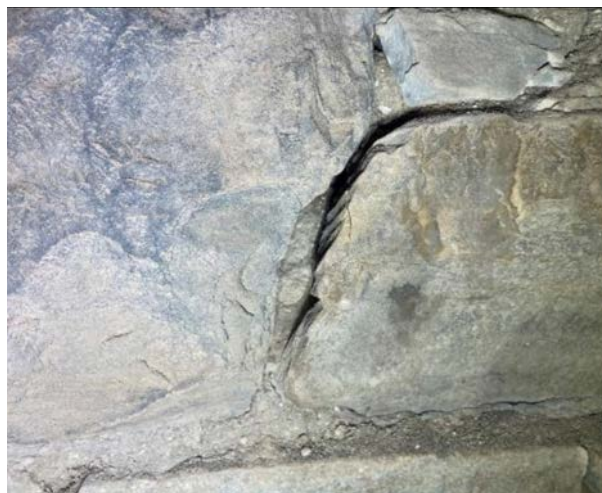
Image 37. Void between two stone units. *Jablonski*

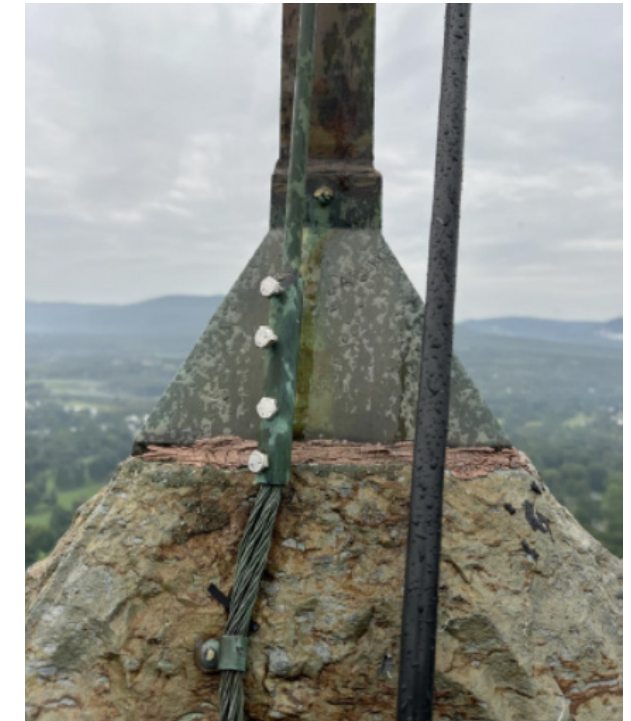
Image 60. Bolted connection from air terminal to class II copper lightning conductor. *Smokestack Lightning.*

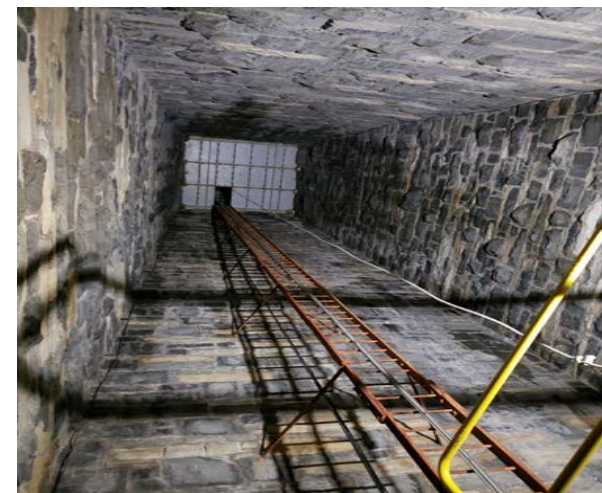
Image 88. Ladder to Level A, above elevator mechanical room. *Stevens & Associates*
