STRUCTURAL, ELECTRICAL,  
AND ELEVATOR ASSESSMENT  
OF THE  
BENNINGTON  
BATTLE MONUMENT  
OLD BENNINGTON, VERMONT

DECEMBER 22, 2023

STEVENS & ASSOCIATES, P.C.

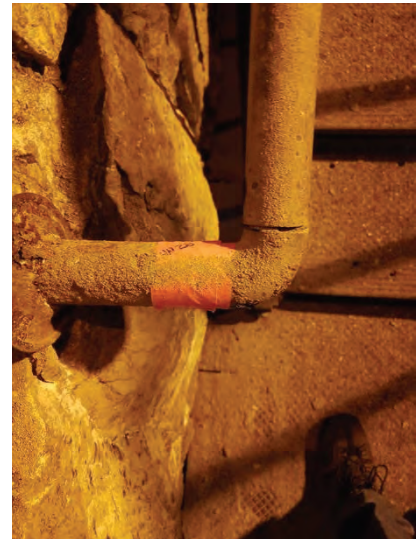
FIGURE 6

- Dust from deteriorating mortar quickly coats surfaces within the Monument (figure 6). Clean marking tape was placed on the handrails during the initial November visit. By early February the tape was coated with a thick film of dust. This was during the off season when the structure is closed, and air flow is minimal.

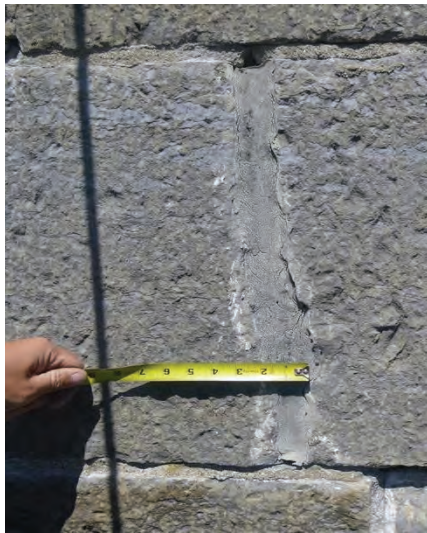
FIGURE 11

- The sealant used for repairing a high percentage of the cracks is failing (figure 11). The sealant is over 30 years old and is beyond its useful service life. It is cracking and separating from the stone surfaces. In many cases, the failed sealant now has a deleterious effect of trapping moisture within the wall, or at least slowing down the natural drying process.

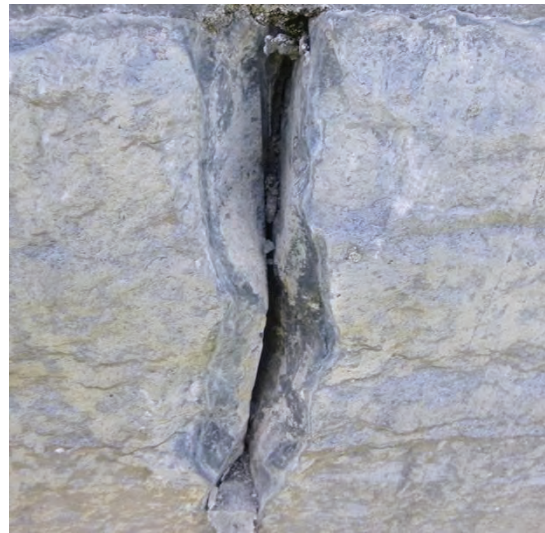
FIGURE 12

- Many of the wider cracks that were repaired with mortar are failing. In a few areas loose mortar was removed, and it was observed that the crack had been routed out, or widened, and the result is a wide wedge-shaped mortar joint that is now failing (figure 12).

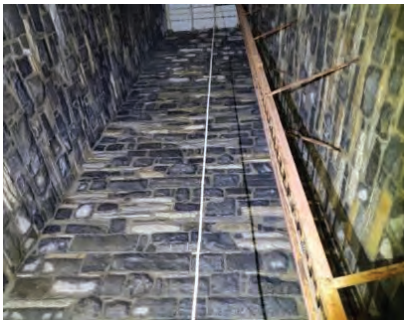
FIGURE 13

- Varying amounts of moisture were observed during all site visits (figure 13, 14, and 15). Areas of the walls varied from dry, to almost dry, to light surface moisture, to a heavy coating of moisture with a visible sheen. In general, Winter of 2021-2022 was a fairly mild winter with few snowstorms. By mid-summer Bennington was considered to be in a moderate drought. Visibly damp stones were observed in all seasons and the embedded moisture meters reported 99-100% moisture (meaning liquid water was present at the meter) for the entire duration of the Phase 1 monitoring program.

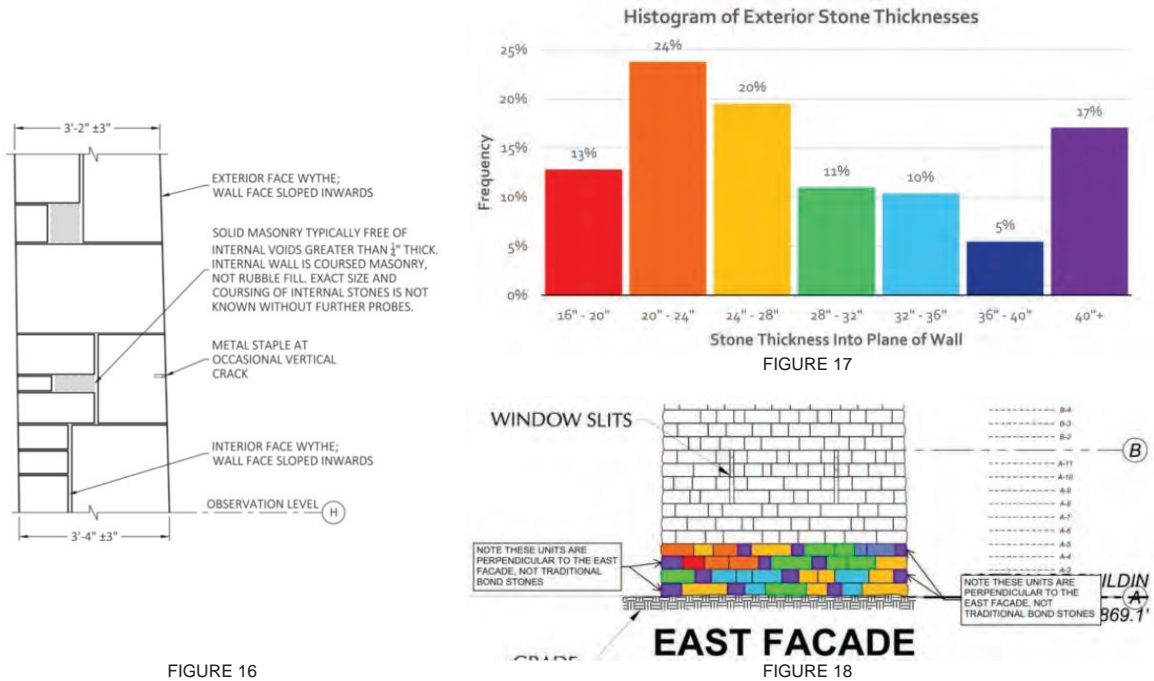
FIGURE 16

- ANA determined with surface penetrating radar (SPR) that the walls of the Monument are most likely constructed as mortared stone walls that coursed through their full thickness, rather than two separate walls with rubble fill between faces (figure 16, 17, and 18). The head and bed joints between exterior stones were found to be solid and sound. Some small voids were found in collar joints, but videoscoping confirmed these were small, isolated voids that did not appear to be interconnected. SPR also confirmed that based on a broad statistical analysis of the 100 or so scans, roughly 17% of the scanned stones appear to be header stones. These are stones that extend lengthwise into the wall, tying the blocky exterior stones and irregular interior stones together.

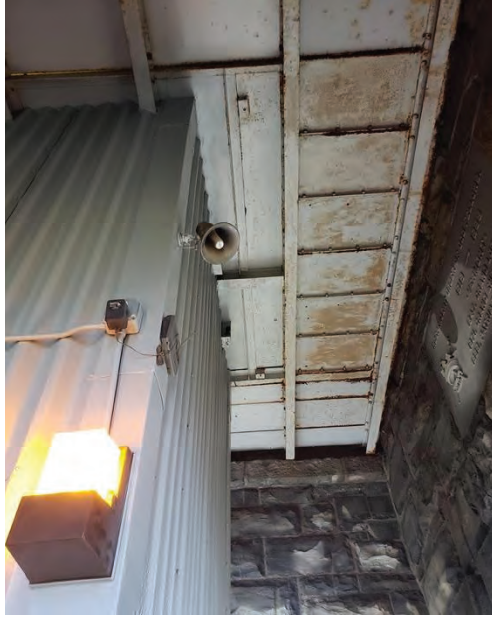
FIGURE 19

- The framing at Level B also appears to be in fair to good condition. The existing coatings on the beams and plates are beginning to fail. The rust and rust staining is very visible from the observation deck since Level B serves as the ceiling of the observation level (figure 19). The framing consists of 8" tall I-shaped beams spaced at approximately 3-ft on-center that span north-south across the Monument and are supported at either end on a stone ledger that protrudes from the Monument walls. Some of the heaviest rust was observed at the beam ends. However, a tall ladder is required for closer observation, which should be completed in early design phases.

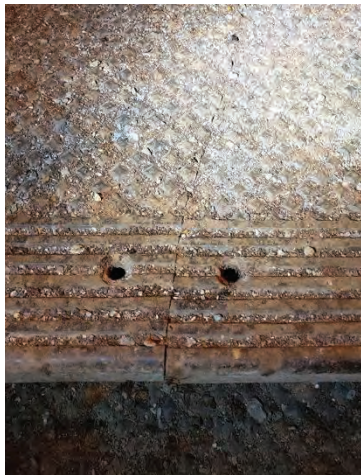
FIGURE 22

- Cracked stair treads and floor plates were noted on several flights and landings of the main interior staircase (figure 22) as well as on the spiral staircase between Levels D and C. The specific locations of cracked treads and plates are noted in the HEP stair condition report. The stair treads are a cast metal, and we did not find records of them being tested for metallurgy. The floor plates were determined to be a cast steel in the 1988 RBA assessment, but this has not been verified with new testing.

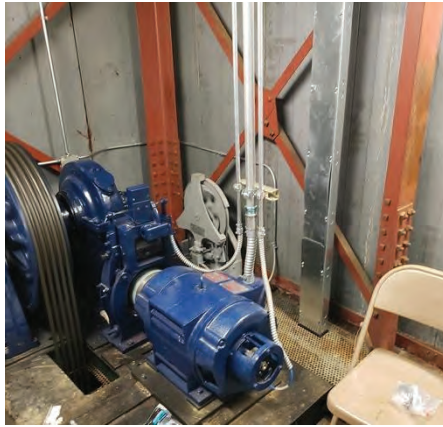
FIGURE 27

- The 2016 modernization included a new MCE 4000 elevator controller with variable voltage variable frequency (VVVF) lift drive, a new 12.5 HP Imperial AC motor and coupling, a new Hollister Whitney governor, new ADA compliant car station, hall fixtures, position indicators, direction lanterns, and braille labels. A new GAL MOVFR door operator and new car and hall doors were installed, as well as new infrared door protection systems. The original Otis elevator drive that actually moves the cab was refurbished and retained (figure 27). The bearings and gears within the drive were retained but new seals and fresh oil were installed.

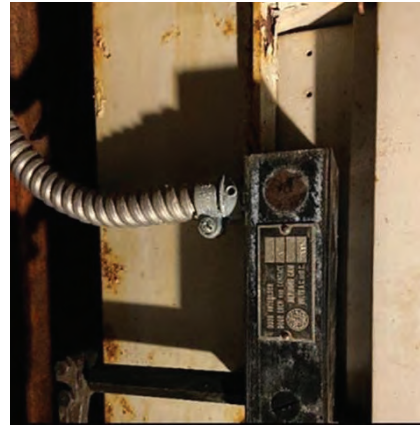
FIGURE 28

- The various sensors within the shaft consist of magnetic tape and copper contacts (figure 28). These are wear items that usually need to be serviced or replaced every few years. These sensors are malfunctioning multiple times a year at the Monument, despite being replaced and/or cleaned annually. When these malfunction, the elevator will not run. This has caused multiple shutdowns.
