# PERMITTING SETBACK REQUIREMENTS FOR WIND TURBINES IN CALIFORNIA

**PIER INTERIM PROJECT REPORT**

November 2006  
CEC-500-2005-184

Scott Larwood and C. P. van Dam  
California Wind Energy Collaborative  
Davis, California  
Contract No. 500-02-004  
Work Authorization MR-017

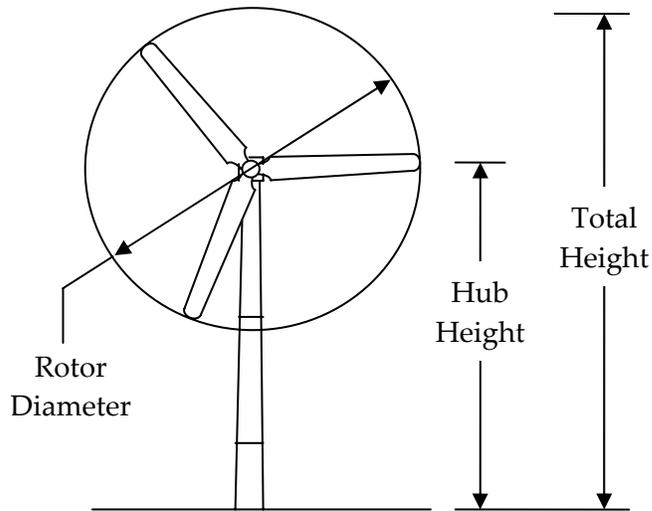
Setbacks are established to minimize risk of damage or injury from component failure on property and personnel. The setbacks are usually a multiple of the total turbine height, from tower base to upper extreme point of the rotor (see Figure 1). Generally the setbacks can vary from 1.25 to 3 times the overall machine height. Larger setbacks are sometimes required for special areas. In contrast to these standards, counties in California with more rural development, such as Merced and San Joaquin, use building setbacks and do not distinguish wind turbines separately.

Figure 1. Wind turbine dimensions

Table 2 compares setbacks for several of the counties organized by feature that the turbine must be displaced from, such as a property line. The distances are stated in multiples of overall turbine height (Figure 1). If a fixed distance is included with the multiple, then the maximum of the two values must be used for the setback.

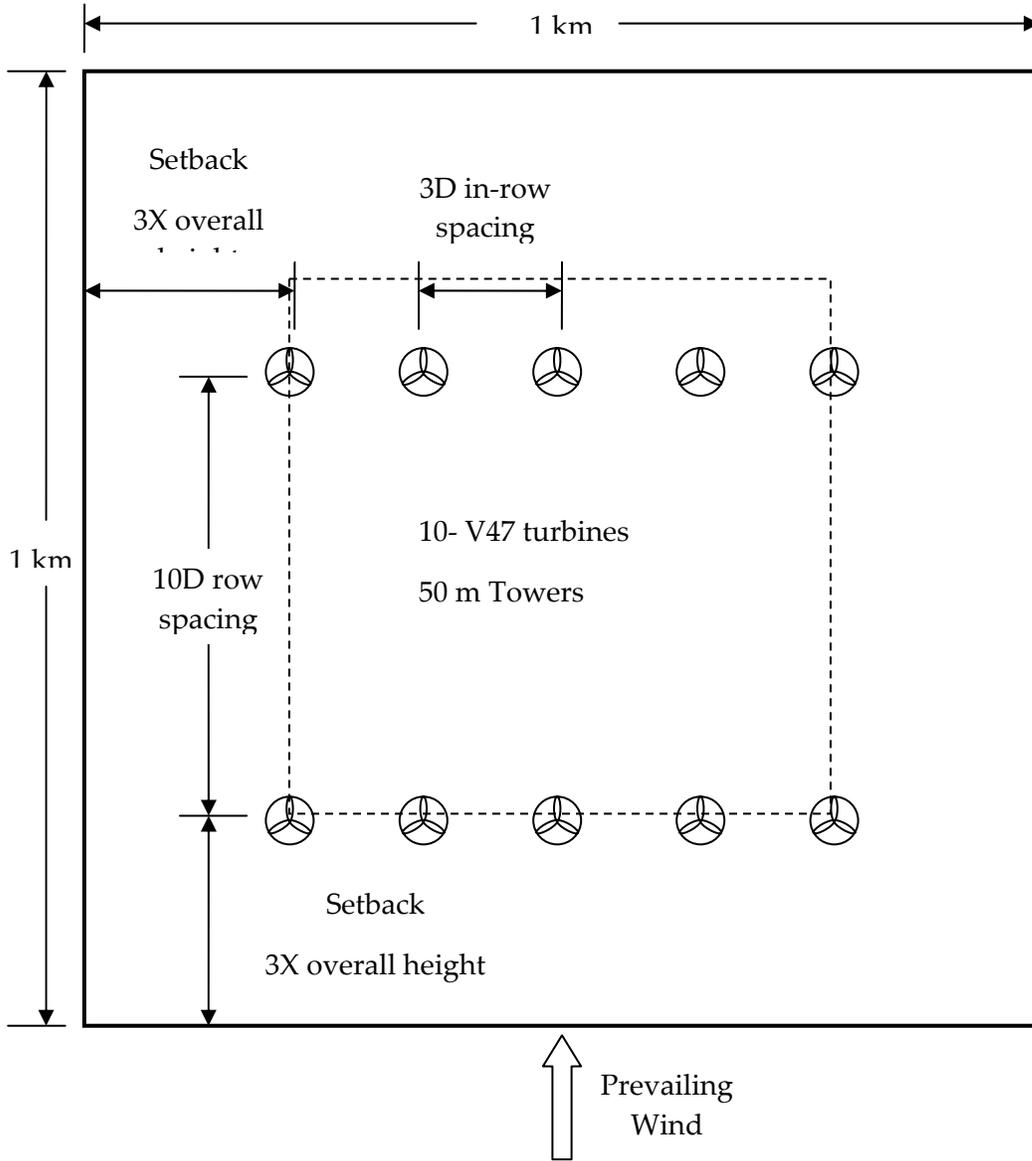
The layouts are shown in Figure 2 and Figure 3, with shaded zones representing the setback areas. The overall height is the sum of the tower height plus half the rotor diameter.

**Figure 2. Layout for V-47 wind turbines based on setback requirement of three times total turbine height**

For the V47 machine, the spacing requirements and setbacks allow for 10 machines with total rating of 6.6 MW. In contrast, the requirements allow only three GE 1.5 turbines with total rating of 4.5 MW. The crosswind spacing in this case would probably be reduced slightly. Downwind spacing requirements would force a second row of turbines off the parcel. The setback requirements for this example result in lower energy production with the application of larger, modern machines. The options available to a

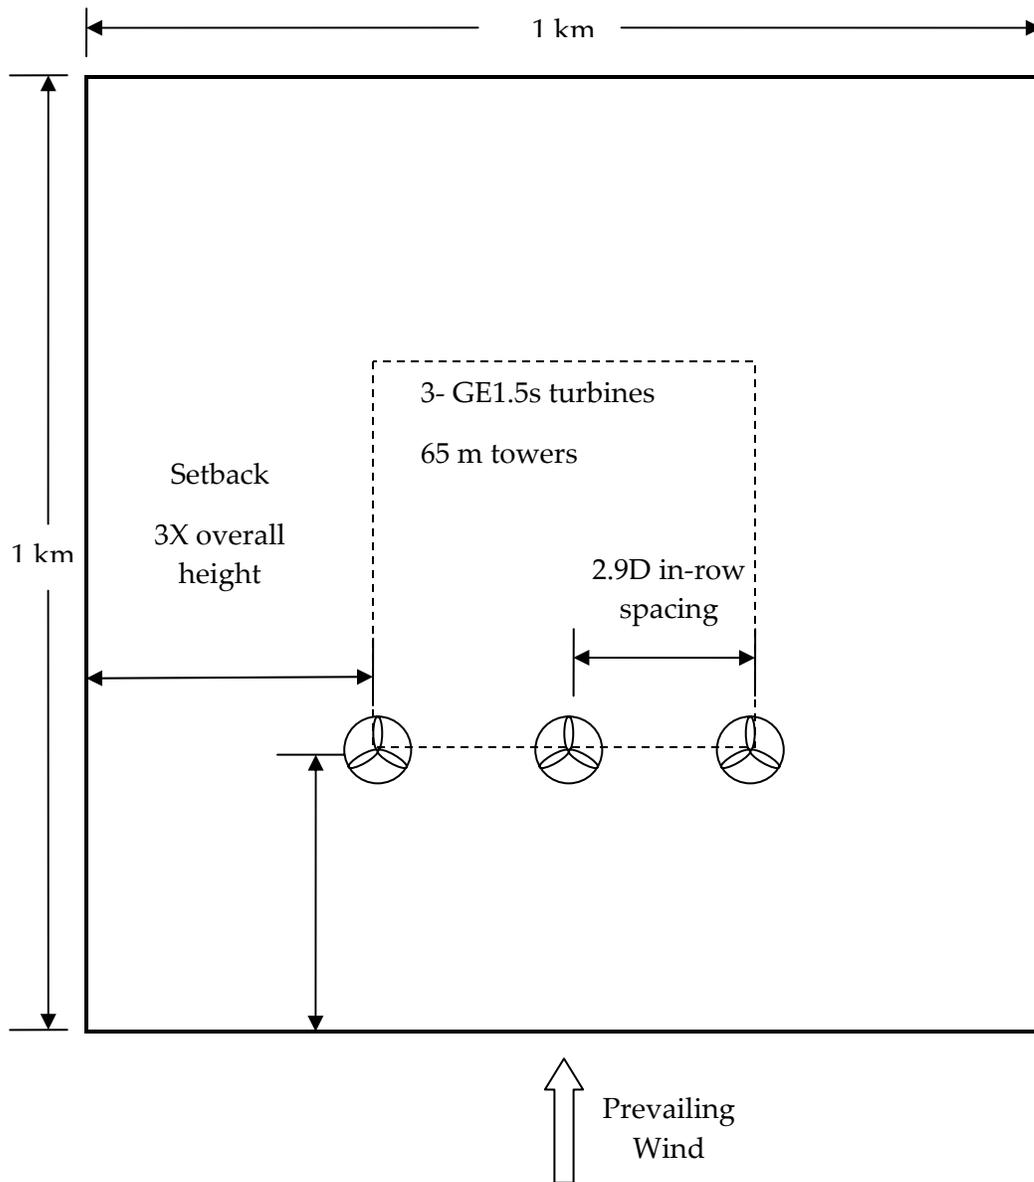
**Figure 3. Layout for GE 1.5s machines based on setback requirements of three times total turbine height**

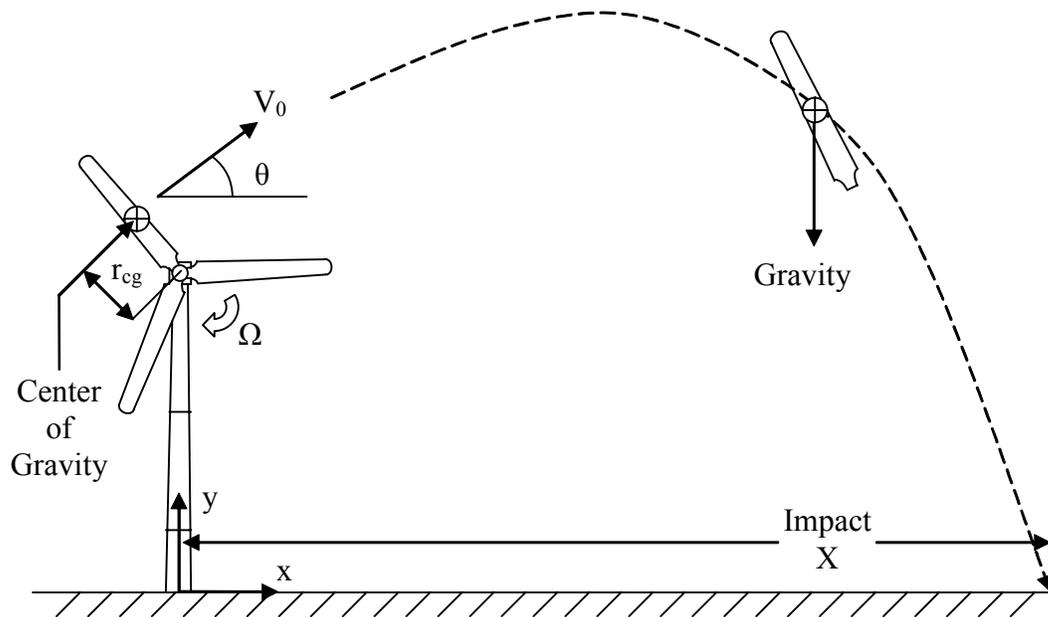
Analysis of rotor failure uses methods of classical dynamics in order to describe the problem. Figure 4 is a representation of a rotor failure. If there is a rotor failure, either a fragment or the entire blade, the motion of the fragment is governed by specific forces. If the failure has taken place while the turbine is operating, the fragment has an initial velocity due to rotation, while in flight the motion is constrained by gravity and aerodynamic forces. The initial velocity of the rotor fragment is a function of the tip velocity, determined by Equation 1:

**Figure 4. Rotor fragment schematic**

A simplified impact probability can be derived from Equation 3. Since this relationship is only valid for a ground release, only release angles of 0 to 180° (see Figure 4) result in movement away from the release point. Release angles of 180 to 360° result in impact at the base. The random release angle is assumed to have uniform distribution from 0° to 360°. Using methods of probability, the probability that a fragment will fall within an annulus that is less than the maximum range is given by Equation 5.

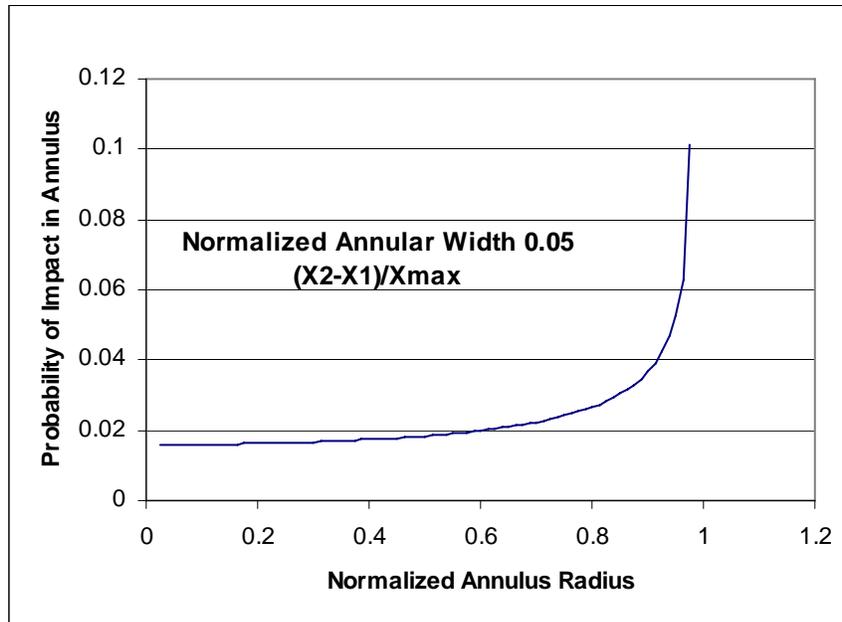
This relationship is plotted in Figure 5 for a normalized annular width of 0.05. Note that the relatively high probability of the fragment landing directly under the tower is not

shown. The nature of the equation results in an increasing probability of impact in the outermost annuli, due to a wide range of release angles that provide nearly the maximum range. However, the annular area increases with increasing radius.

Figure 5. Probability of impact within an annular region

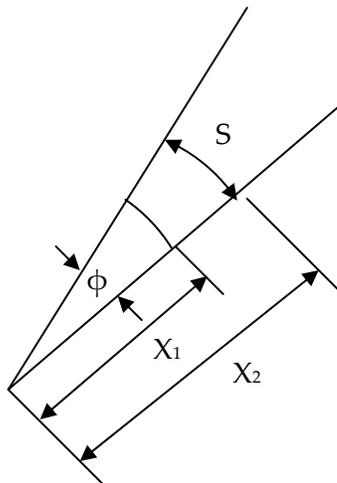
We next assume that the target is an annular sector, as in Figure 6.

Figure 6. Target annular sector

In order to make the sector size roughly equal throughout the ballistic range, we set the outer arc length (S) equal to the annular width, given by Equation 6:

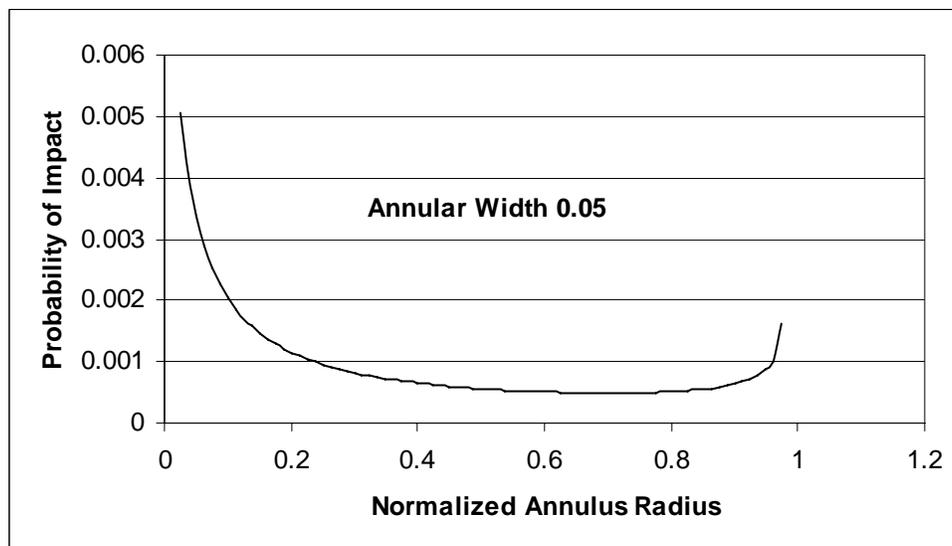
This relationship is plotted in Figure 7. This simplified model shows a peak in probability near the tower base, and then a relatively constant probability until the probability rises again near the maximum range. This behavior is similar to more complex models incorporating aerodynamics. The peak at maximum range places a constraint on the overall hazard and acceptable setback distances.

Figure 7. Probability of impact within annular sector

The probability of impact is weighted by area (per square meter), and assumes equal distributions in all directions. Probability distributions showed peaks near the tower and at the maximum range, similar to the results of the simplified model in Figure 7. The probability of impact was then a function of the target and fragment size. Macqueen reasoned that the rotor fragments would be large compared to target, making the probability independent of target size; however this would not be the case with a busy roadway, with many targets over a large area.

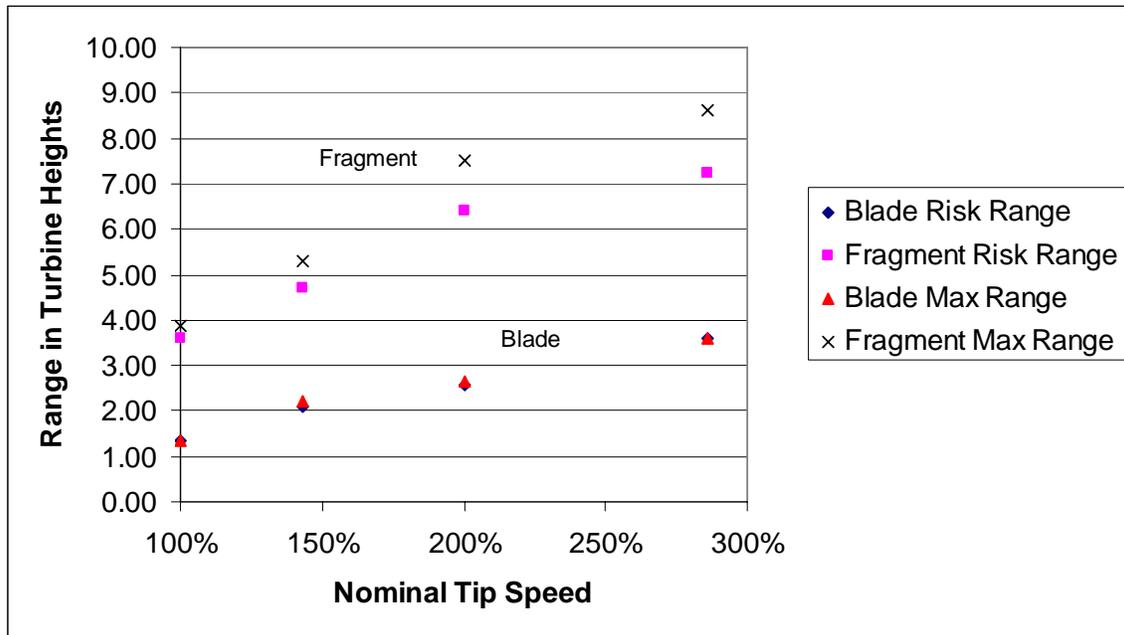
Probabilities were only presented for the Project “K” turbine for a full 30-m blade throw and 10-m blade fragment throw. This turbine is of 1.5 to 2.0 MW size with a 60 m hub height. Release angle and wind speed were varied and multiple throws were calculated. The probabilities were presented as a function of tip speed. Results are shown in Figure 8, comparing the range with  $10^{-4}$  probability (the “risk” range) to the maximum range.

**Figure 8. Throw distances in Sørensen conference paper with  $1 \times 10^{-4}$  probability risk range**

The maximum ranges do not increase exponentially as would be predicted for a vacuum in Equation 4. This is the result of including the aerodynamic forces. Also, there is negligible difference for the full blade maximum range and range with  $10^{-4}$  probability. This is not true for the fragment.

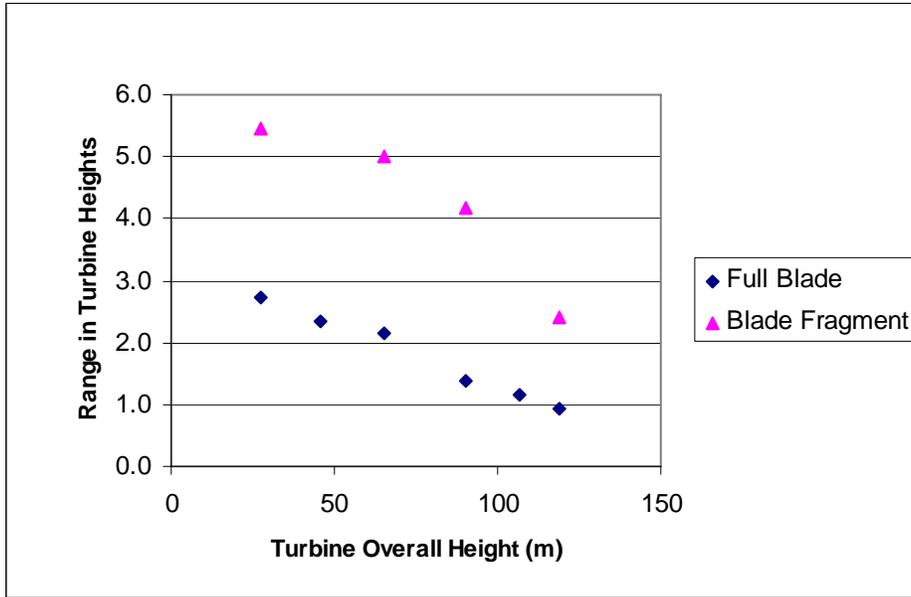
Studies of example turbines were performed in all the analyses discussed previously. A comparison is shown below in Figure 9. The maximum attainable lateral throw distance, normalized by overall turbine height, for a failure at nominal operating conditions is shown for the various analyses. The results show the drop in the normalized maximum throw distance with increasing turbine size.

**Figure 9. Comparison of rotor fragment analyses for maximum range at nominal operating conditions**

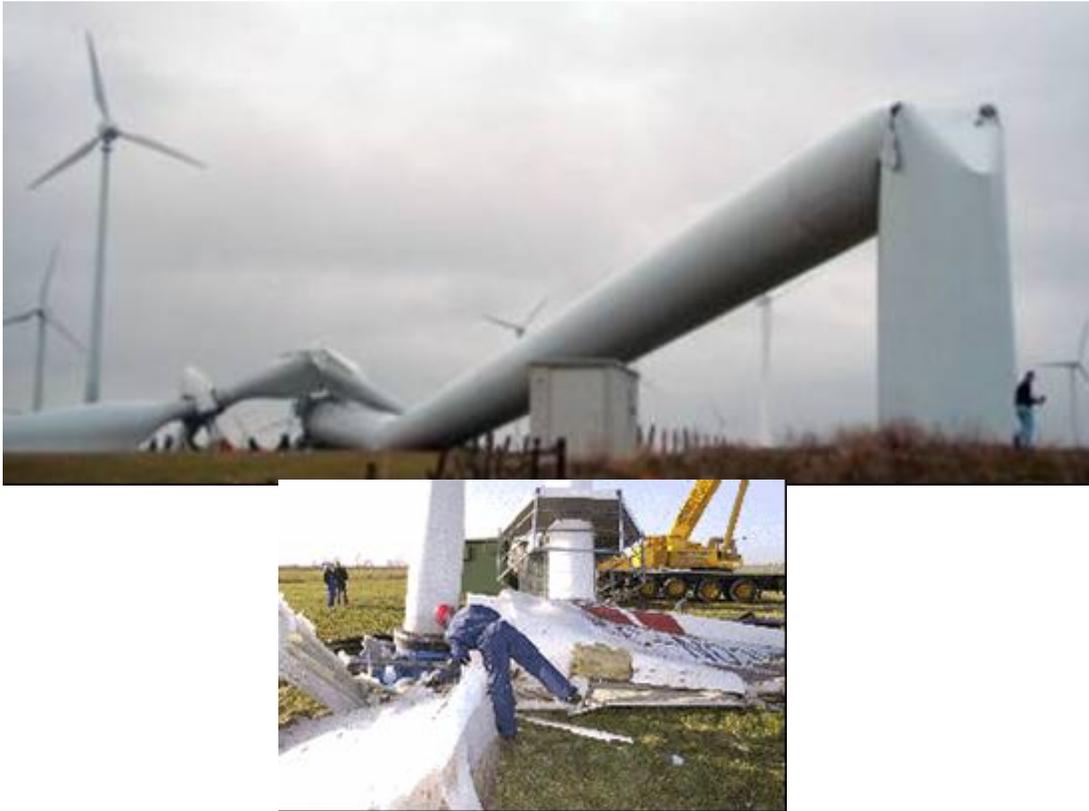
**Fig. 2.1: Two examples of incidents that pose possible danger to the surrounding area.**

In many cases it appeared difficult to indicate exactly whether a turbine had indeed lost parts as in Fig. 2.1, or was just heavily damaged as in Fig. 2.2. The final results from the selection of risk involved incidents are given in Table 2.2. The total can be seen in Table 2.3. This table includes the total number of operating years for each type. This number is obtained by summing the number of turbines in operation per year over all the years.

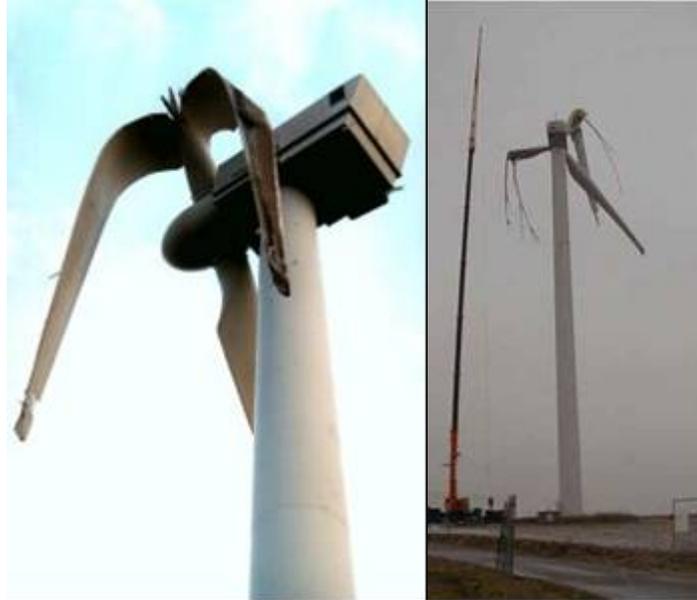
- Most incidents are poorly documented, and the actual number of risk-involved incidents cannot be determined for certain. EMD uses codes to indicate which component failed, the reason for failure, and whether parts were thrown from the turbine. From the codes it is difficult to determine the size of the thrown object, the distance thrown, and the order of events. In some cases this information is included in the comments. Between 1993 and 2000 the code was expanded. Between 1984 and 1992, the code was severely restricted. It was seldom even noted whether a compromised turbine had done damage to the surrounding area. This made it possible for a turbine that had a complete failure and lost many parts (see Fig. 2.1) to be reported exactly like a turbine that had a complete failure and posed no risk to the surrounding area (see Fig. 2.2).

**Fig. 2.2: Two examples of turbines that failed, but caused no danger to their surroundings.**

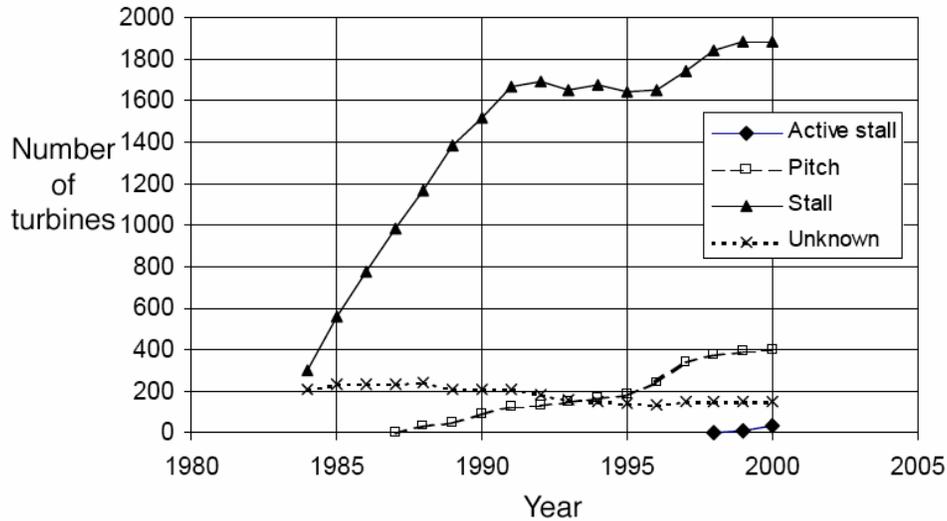
The turbine population from 1984 through 2000, as provided by EMD, is separated into the different types. The results are presented in Fig. 2.3. At the end of the year 2000 the total turbine population reached about 2900 turbines. The total number of operating years reached almost 30,000. By far the most turbines are stall-regulated turbines.

Fig. 2.3: Number of wind turbines in the EMD database, separated by type.

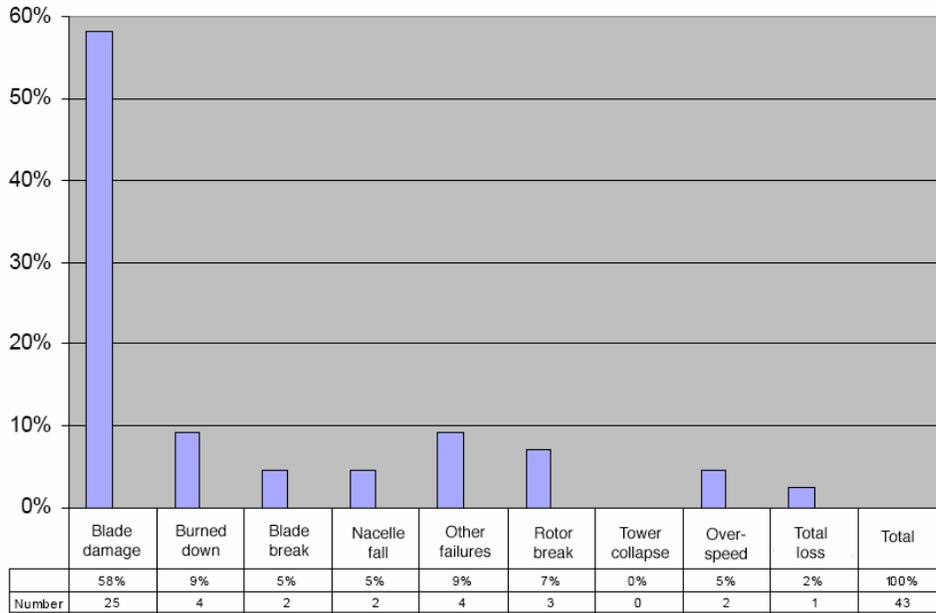
The 43 cases of turbine damage from the WMEP database are arranged by type of damage. The results are presented in Figure 3.1.

**Fig. 3.1: Type of damage for 43 cases involving serious damage.**

Blade fracture, rotor failure, nacelle fall, and tower collapse are all of importance to risk analyses, because it is these phenomena that can cause damage to people or objects in the nearby surroundings. The other types of damage result only in economic damages.

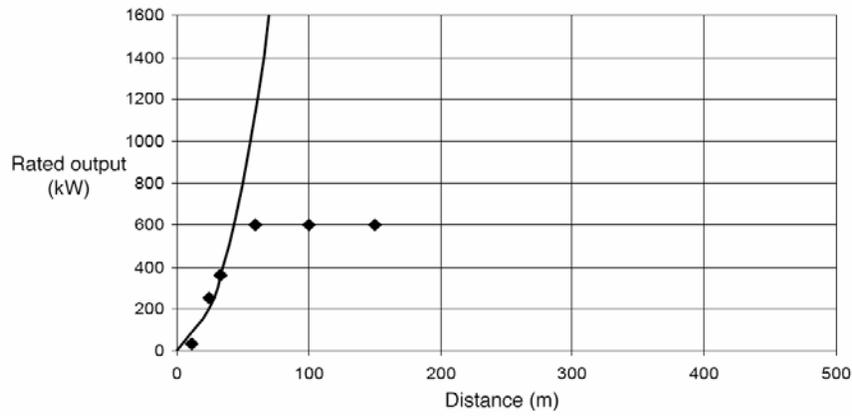
The results of the analyses are presented in Figures 5.1 through 5.4. In these figures, one for each type of incident, the reported throw distance is presented (x-axis) as a function of the rated power (y-axis). The curves in each graph relate the approximate rotor diameter associated with corresponding rated power level. The curves are added to put the throw distances in perspective.

**Fig. 5.1:** Throw distance of entire blades as a function of the rated power output, the drawn line gives the rotor diameter.

The following can be concluded from Figures 5.1 through 5.4.

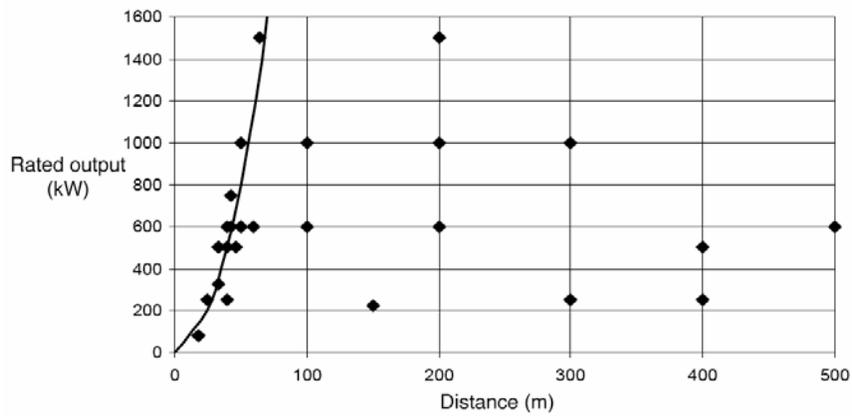
**Fig. 5.2:** Throw distance of tips and small blade pieces as a function of the rated power output, the drawn line gives the rotor diameter.

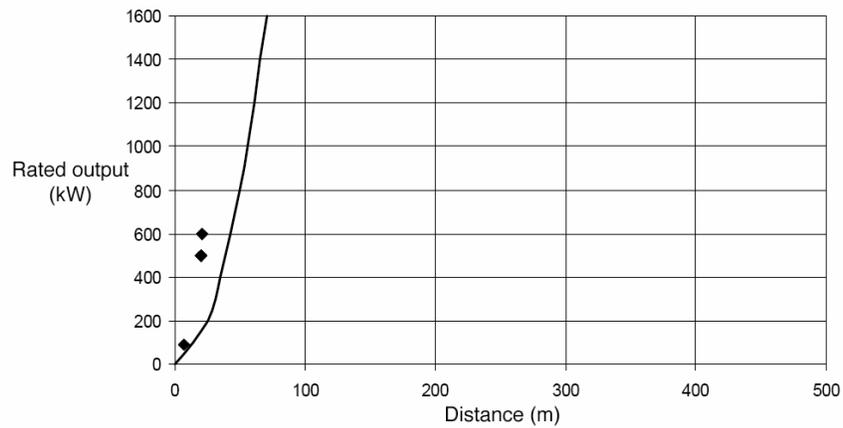
**Fig. 5.3:** Throw distance due to fall of nacelles and rotors, as a function of the rated power output, the drawn line gives the rotor diameter.

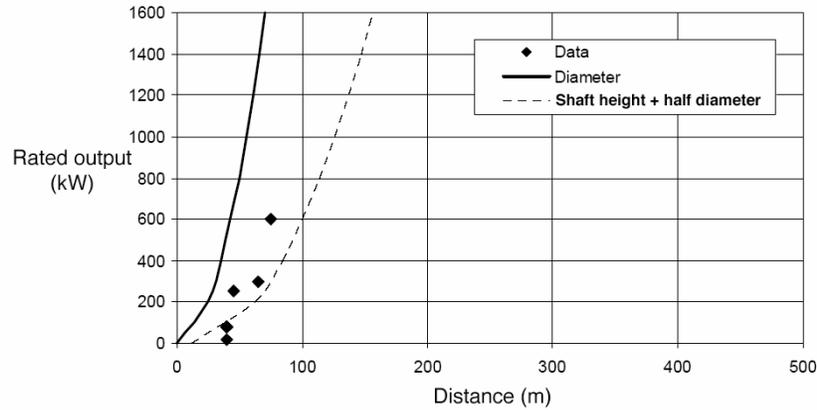
**Fig. 5.4:** Throw distance due to tower collapse as a function of the rated power output, the drawn line gives the rotor diameter. The dotted line gives the shaft height plus rotor radius (half diameter).
