STATE HOUSE PANDEMIC RENOVATION PROJECT

DEPARTMENT OF BUILDINGS & GENERAL SERVICES

December 15, 2023

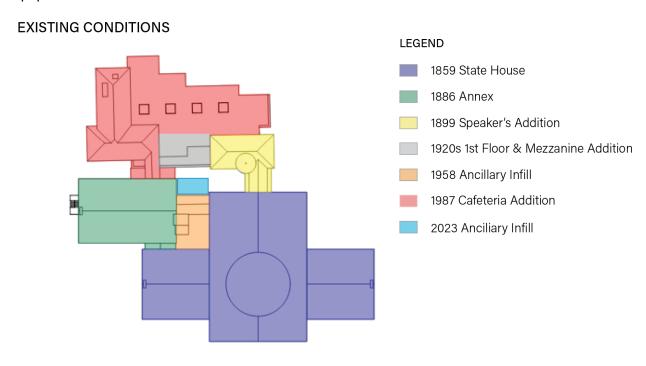
The diagram below illustrates the layout of the existing State House, which is comprised of five main structures: The 1859 State House, occupied continuously since and is the oldest active legislative hall in the US; the Annex, added in 1886; the Speaker's Addition, built in 1899; and the Cafeteria Addition, completed in 1987. There is a fifth infill building housing mechanical systems, completed in stages between the 1920s and 1970. During the summer of 2023 an additional ancillary infill was added to the mechanical room (off of the 1958 ancillary infill) for new HVAC equipment.

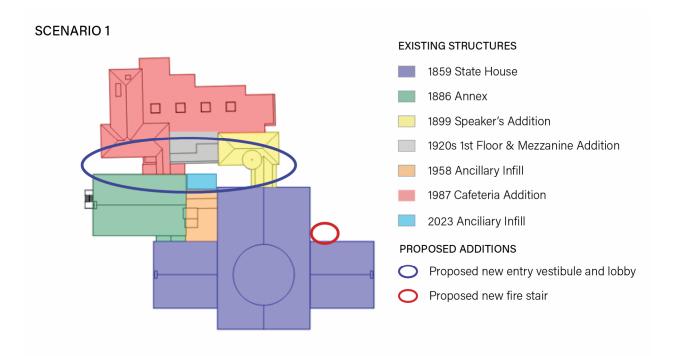
SCENARIO ONE

The following program was used to develop the Opinion of Probable Cost and Project Schedules for Scenarios 1.

Scenario 1 is comprised of the minimum amount of work required to bring the State House building up to code and address the building entry requirements for screening during a pandemic and accommodate program areas such as committee rooms and the cafeteria within the existing spaces. This option includes a new entry vestibule on the west side of the State House to the north of the Annex. The vestibule leads to a public lobby that will occupy the existing courtyard, connects the buildings, and continues to a vestibule on the east side of the State House that connects to the Main Lobby along Lincoln Corridor in the State House. This connection will be made possible by removing the existing stair to the mezzanine. The west entry will access a new code-compliant egress stair and a stretcher compliant elevator. The new stair and elevator will have a connection to the Annex to the south, allowing the removal of the existing external fire escape located in the west façade of the Annex. The connection from the Annex will require that the effected House Committee rooms to be renovated in order to access the new stair / elevator tower. Giving the opportunity to optimize the existing space into larger committee room spaces. On the east side of the State House a new code-compliant egress stair will be added outside of

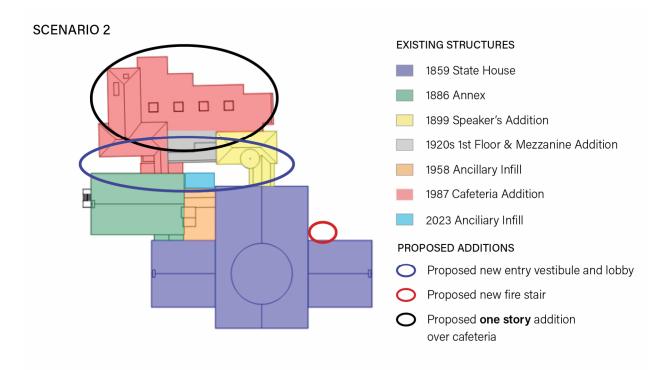
SCENARIO TWO

The following program was used to develop the Opinion of Probable Cost and Project Schedule for Scenario 2.

Scenario 2 is comprised of previous entry vestibule, public lobby, and code required work described in Scenario 1, Phase I. As the Phase II for this scenario, it also includes constructing a 9,200 square foot addition above the cafeteria for committee rooms to accommodate the large committee rooms within the State House. As outlined in Scenario 1, portions of this addition are used to connect to the Annex to the south in order to create a second exit and allow the fire escape to be removed from the building. This scenario provides room for all 11 small committee rooms plus an additional small committee room. It also provides room for all 13 large committee rooms, although some of these large committee rooms may be smaller than the optimum sizes shown in this report. The following issues are addressed:

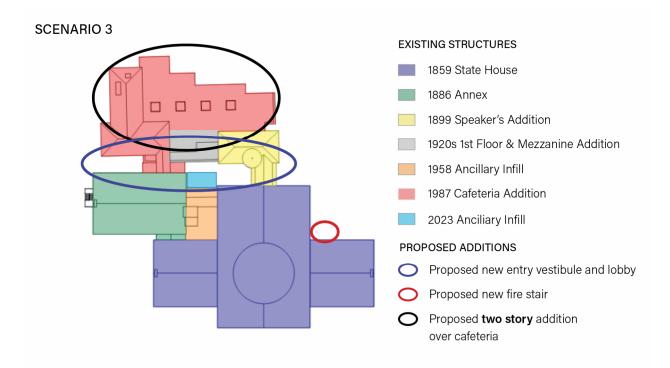
SCENARIO THREE

The following program was used to develop the Opinion of Probable Cost and Project Schedule for Scenario 3.

Scenario 3 is comprised of previous code required work in Scenario 1, Phase I. As the Phase II for this scenario, it also includes a two-story addition above the existing Cafeteria to house the large committees within the building. This option provides room for all 11 small committees plus two additional rooms and all 13 large committees plus one additional room. The following issues are addressed:

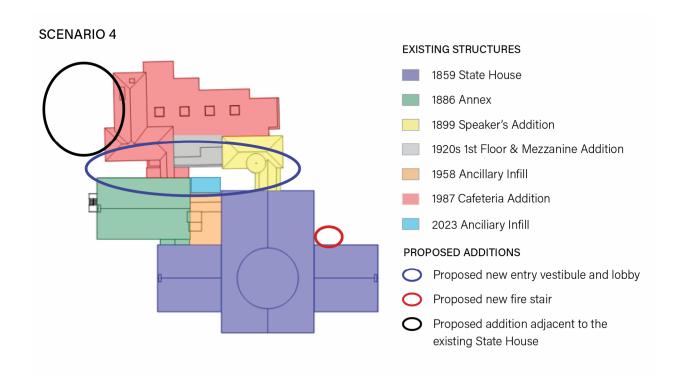
'The following program was used to develop the Opinion of Probable Cost and Project Schedule for Scenario 4.

Scenario 4 is also comprised of previous code required work shown in Scenario 1 , Phase I. As the Phase II for this scenario it also includes a two and a half story addition to the west of the cafeteria addition to house the large committee rooms. The second floor would be a 6,400 square foot addition to the west of the existing cafeteria; this area includes the connector space between the Annex and the building to the north. The third floor would have a 5,600 square foot addition and would also connect on the north side of the Annex. This option provides room for all 11 small committee rooms plus one additional room and all 13 large committee rooms. The following issues are addressed:

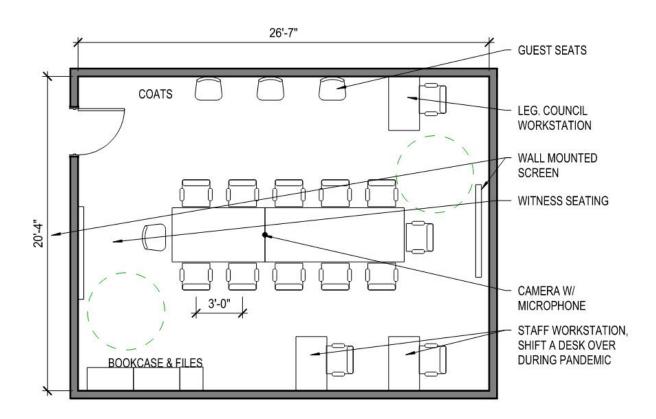
Optimum 11-member Committee Room – 540 square feet

30 SF PER PERSON = PANDEMIC

11 COMMITTEE MEMBERS 2 COMMITTEE STAFF

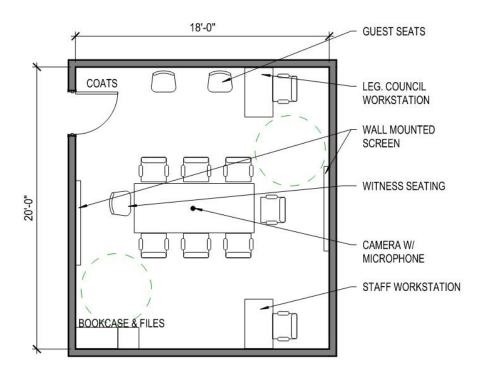
Optimum 7-member Committee Room – 360 square feet

30 SF PER PERSON = PANDEMIC

7 COMMITTEE MEMBERS
1 COMMITTEE STAFF
1 LEGAL COUNCIL
3 ADDITIONAL SEATS (OTHERS)

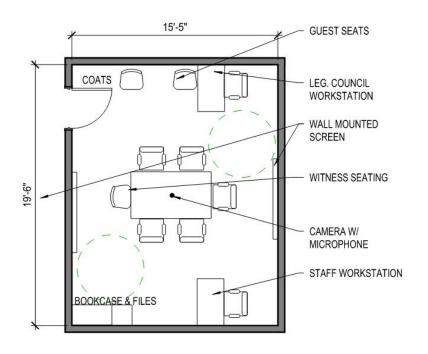
Optimum 5-member Committee Room - 300 square feet

30 SF PER PERSON = PANDEMIC

5 COMMITTEE MEMBERS
1 COMMITTEE STAFF
1 LEGAL COUNCIL
3 ADDITIONAL SEATS (OTHERS)
10 OCCUPANTS
10 x 30 SF = 300 SF

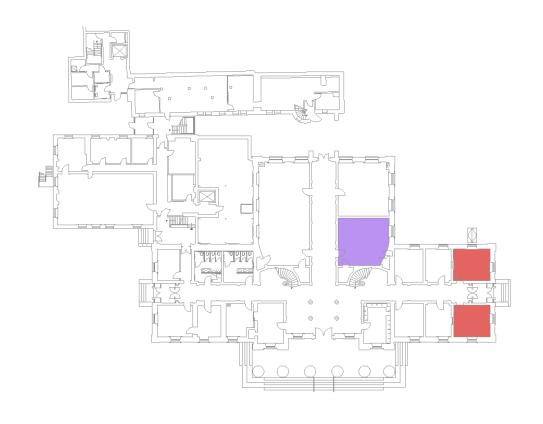
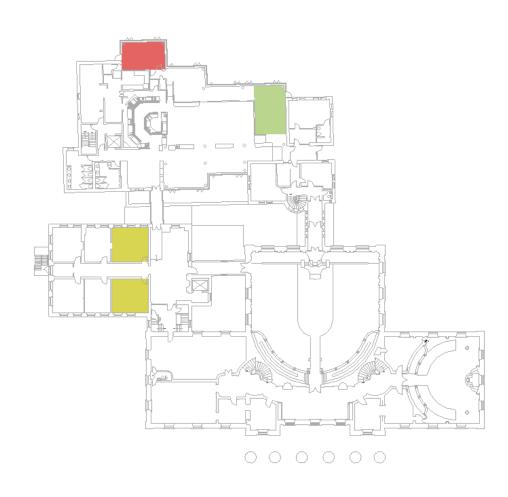
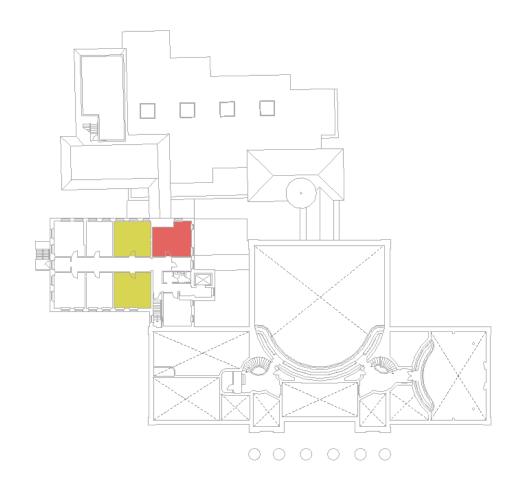
APPENDIX C: STATE HOUSE REUSE DIAGRAMS

FIRST FLOOR DIAGRAM

SECOND FLOOR DIAGRAM

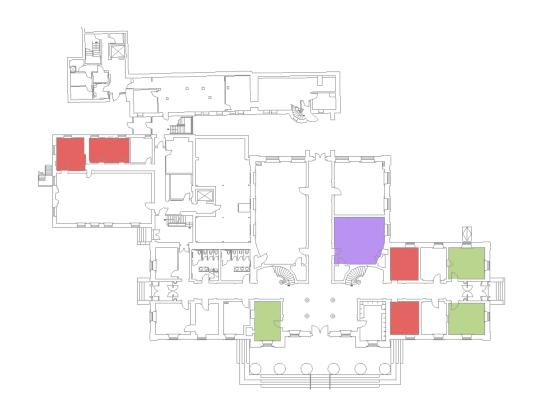
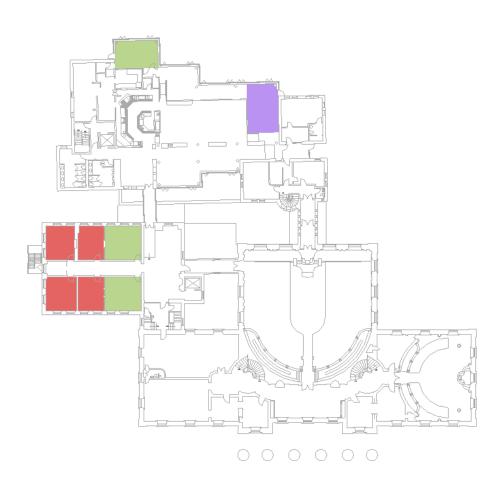
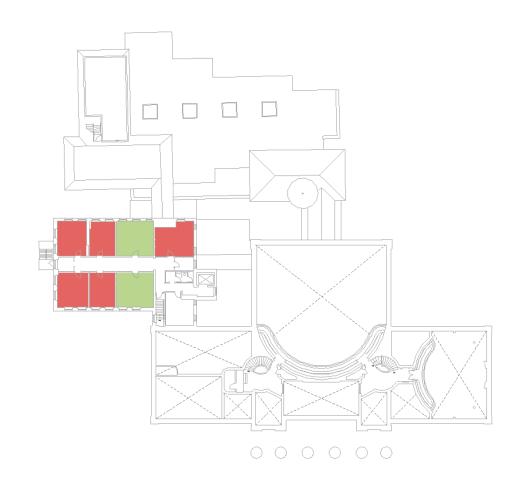
FIRST FLOOR DIAGRAM

SECOND FLOOR DIAGRAM
