Assessment of Floodplain Reconnection at Geprags Park Hinesburg, Vermont

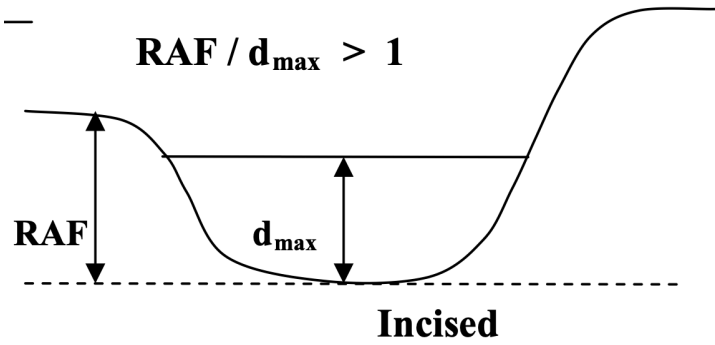
Pre-beaver, the incision ratio of the Gegrags stream was > 3. This can be determined by measuring the channel geometry and calculating the flows that would be generated by the watershed (there may be geomorphic assessments with the Vermont Gas Pipeline project.) While much of the stream channel geometry is intact, the bankful conditions have drastically increased, driving the incision ratio back to 1. This is pretty typical for an active beaver complex, particularly in a low gradient system.

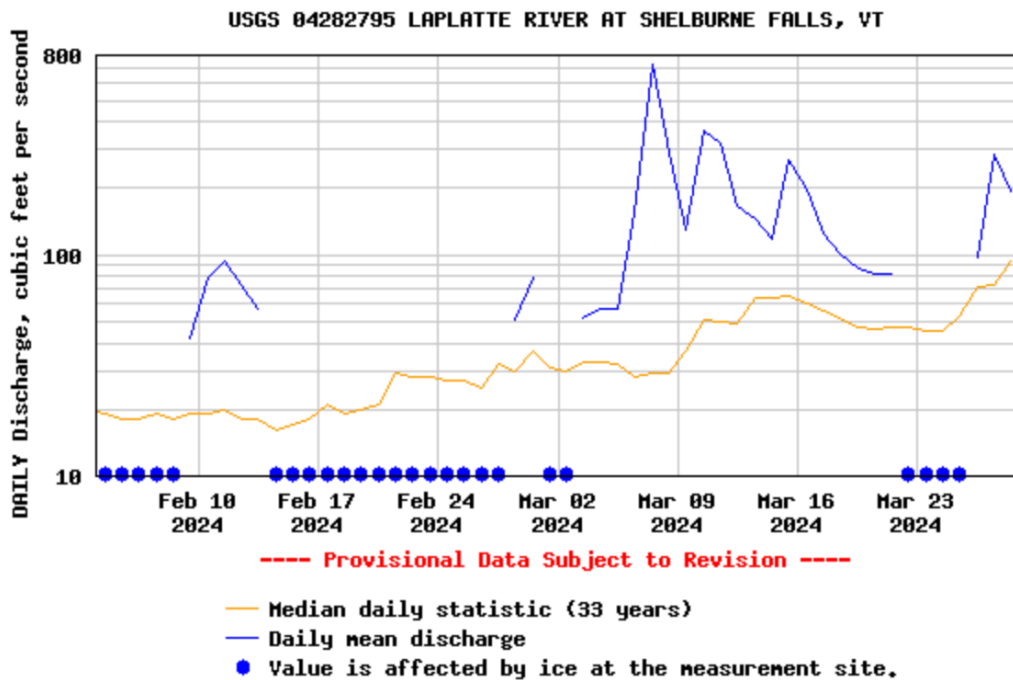
Monitored Flows: the drone imagery was obtained on March 4. Typically, March 4 could yield high flows due to spring runoff. The closest and likely most relevant stream gauge is the Shelburne Falls gauge on the LaPlatte River, approximately 7.5 stream miles (downstream) from the park. Referring to the flow graph below, it looks as though the flows on March 4 were in the 50-60 cubic feet per second. Flow readings two days before were impeded by ice, and flows approximately 2 days after spiked at 790 ft³/s.

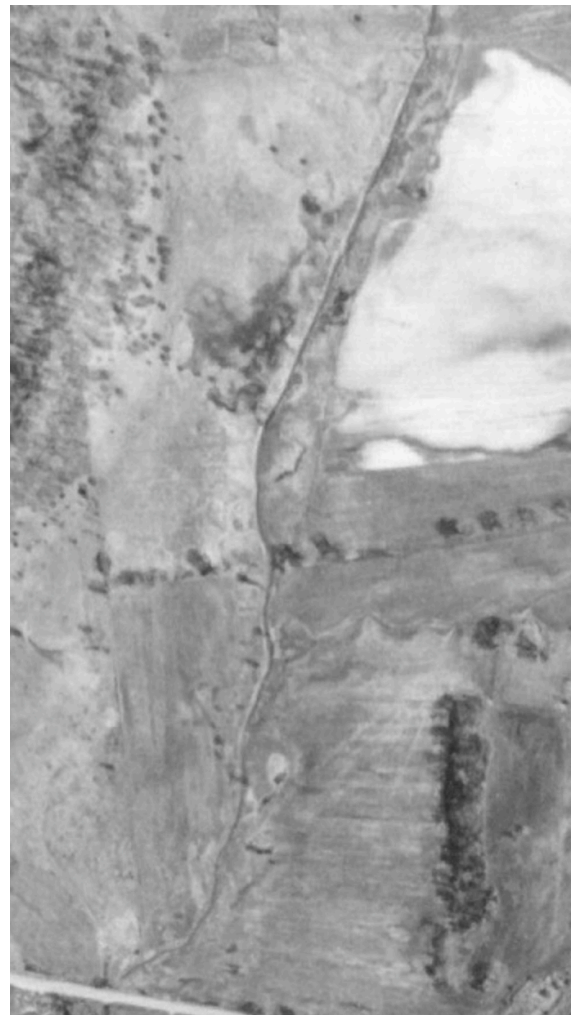
1962 aerial survey

The channel has maintained the pre-beaver incised condition since 1962, at least. Left to geomorphic processes alone, this degraded condition could easily persist for another 63 years. While the stream channel languished, the riparian plant community and the adjoining woods were allowed to regenerate. This regeneration resulted in a largely native plant community (a rarity for the Champlain Valley). This native plant community is key to the riverscape restoration, as non-native woody vegetation does not serve as a food source for beavers. This plant community was nearly lost 8 years ago, when Vermont Gas attempted to lay a pipeline through the stream corridor. This operation would have removed, at minimum, a 60' wide swath of vegetation, and would have created additional zones of disturbance and soil compaction as well. The capacity for this site to support beavers would have been severely compromised.
