**VERMONT ELECTRIC POWER COMPANY (VELCO)
&
GREEN MOUNTAIN POWER
(previously Central Vermont Public Service)**

**BEST MANAGEMENT PRACTICES
FOR THE AVOIDANCE OF
LISTED THREATENED AND ENDANGERED SPECIES
INTEGRATED VEGETATION MANAGEMENT AND O&M ACTIVITIES**

**2012
(rev. October 2013)**

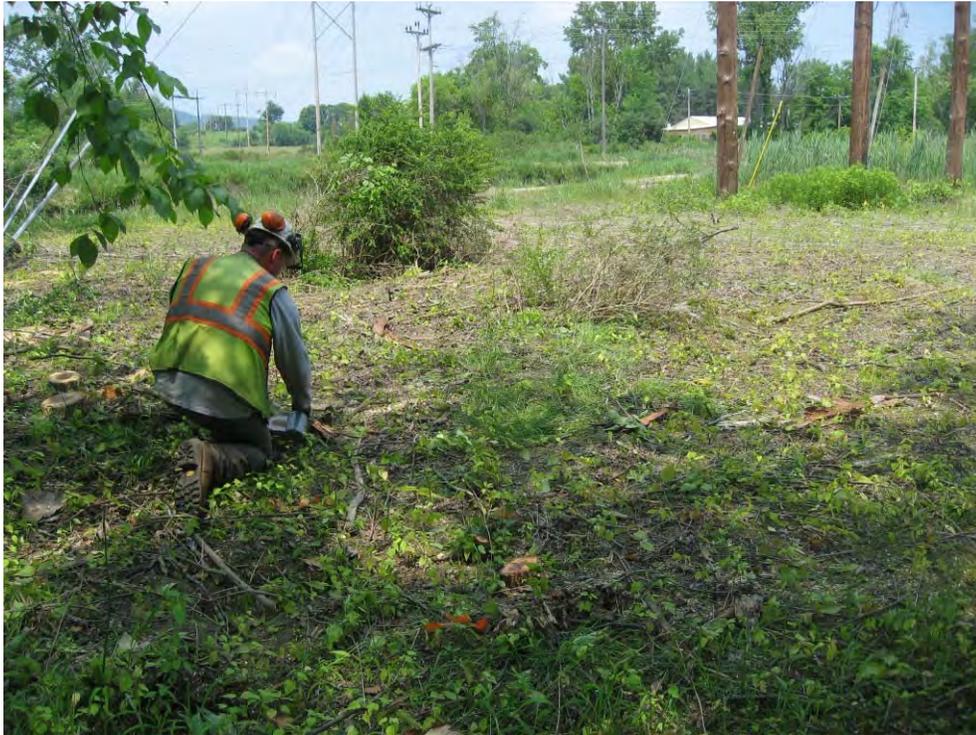
On June 20, 2012, a TRC biologist observed cut stump treatment on the K37 Line in Rutland Vermont, immediately west of Route 7 and south of Post Road. This area, as with all areas that will be subject to vegetation management, had been prescribed suitable management practices during previous inventories and planning. In this case, hand clearing with cut stump treatment was prescribed. These activities typically occur simultaneously (otherwise one will lose track of the stumps). Management prescriptions are rarely changed, except in unforeseen circumstances or when a landowner requests a change. Several 2- to 8-inch diameter elm (*Ulmus* sp.) trees had been cut along the edge of the corridor in the vicinity of a wetland and stream. A 15-foot buffer along the stream was flagged to indicate where cut stump treatment was prohibited. Trees were chipped, and excess wood chips and woody debris had been removed from the area. Contractor crews applied herbicide to the cut stumps by hand with spray bottle applicators. First, the top of the cut stump was sprayed and then the sides were treated. No herbicide was observed to have

“missed” the stump - all herbicide applications were targeted and accurately applied (see photographs below).

View of cut stump treatment with herbicide mix along K37 line.

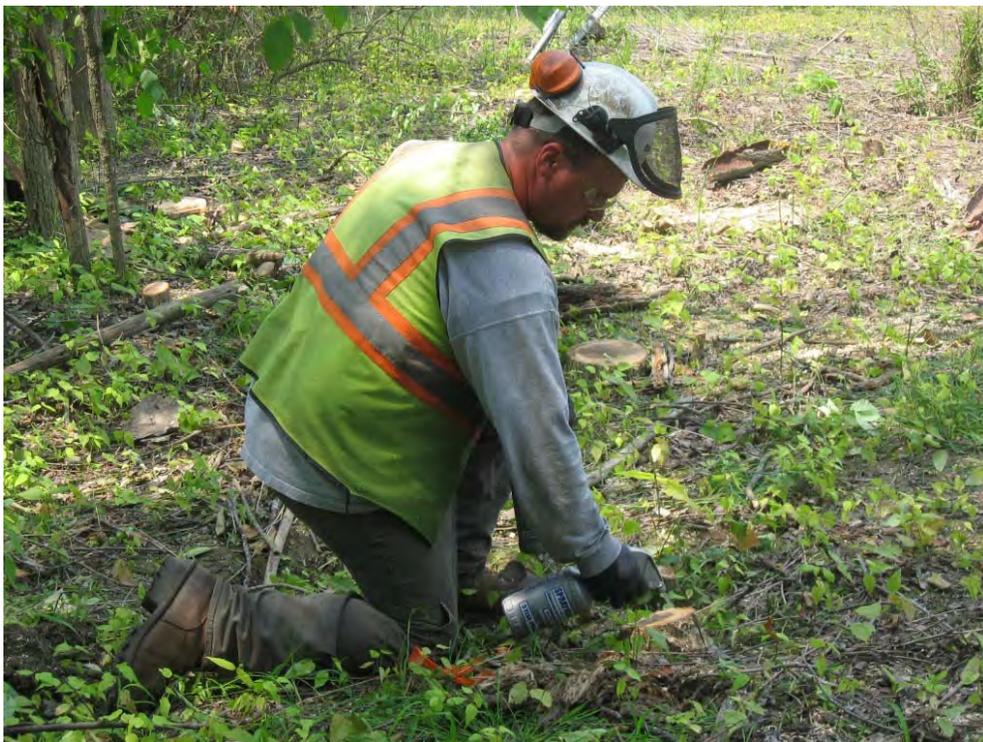
Close-up of cut stump treatment with herbicide mix along K37 line.

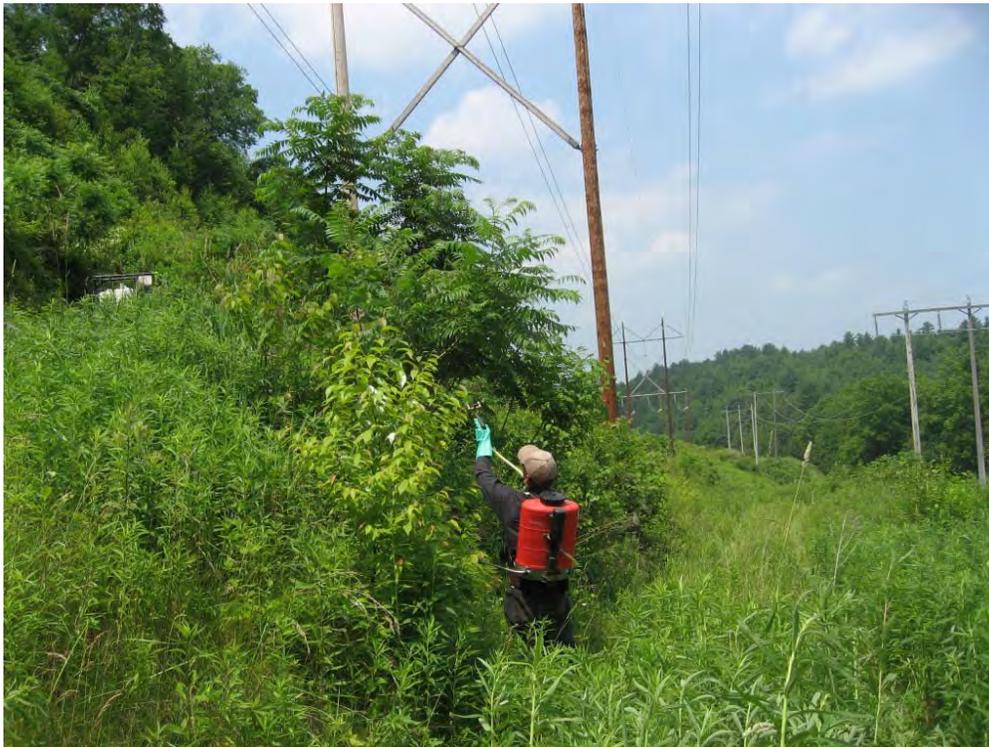
On June 20, 2012, a TRC biologist observed low-volume foliar herbicide application activities along the right-of-way for the adjacent 370 and K30 Lines, which are within an approximately 250-foot-wide easement. Five individuals were conducting herbicide treatment with hand-pump backpacks and hand sprayers. For each structure span, the five individuals would proceed from one structure to the next on one side of the easement and would double-back on the alternate side. While walking down the easement, the crew sprayed incompatible woody vegetation species with extreme accuracy. This area was thick with incompatible species and high-growing herbaceous species, such as goldenrods (*Solidago* spp.), yet very little herbicide was observed missing the targeted leaves of incompatible species (see photographs below). Two utility task vehicles (UTVs) were utilized to transport larger containers of herbicide and were staged near the hand-work activities. UTVs were utilized along existing right-of-way access roads.

View of low volume foliar application along 370 line.

VELCO staff will review the success of treatment in the fall and will require re-treatment by work crews if determined necessary.

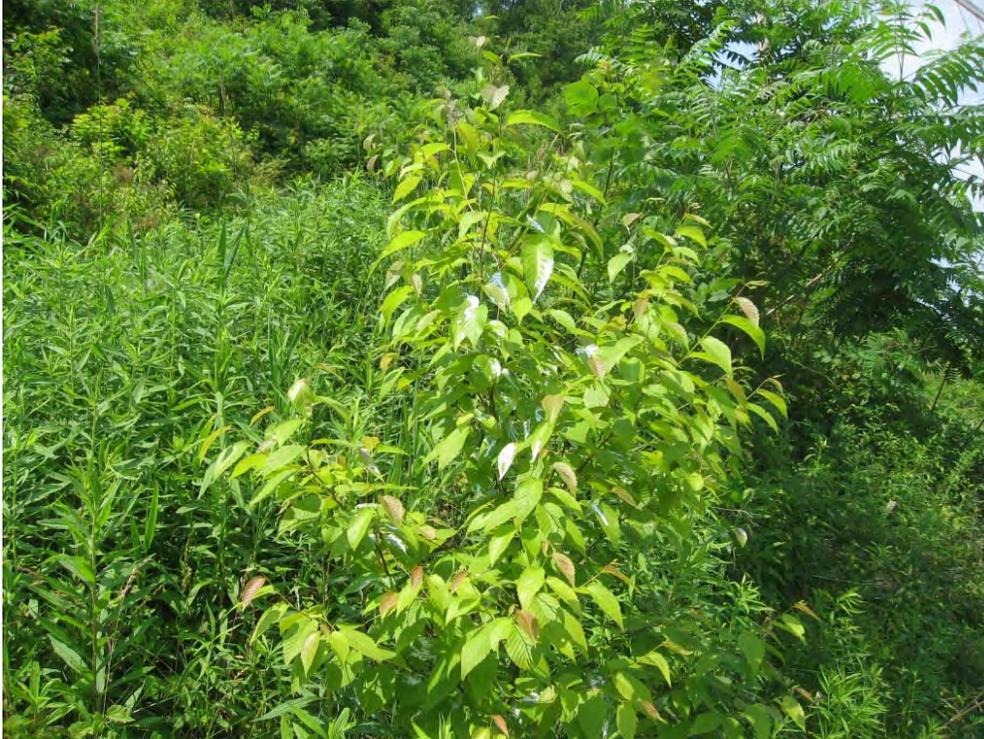
View of sapling along 370 line subject to low-volume foliar herbicide application. Note white areas where herbicide was applied to foliage. None was observed on surrounding herbaceous vegetation.

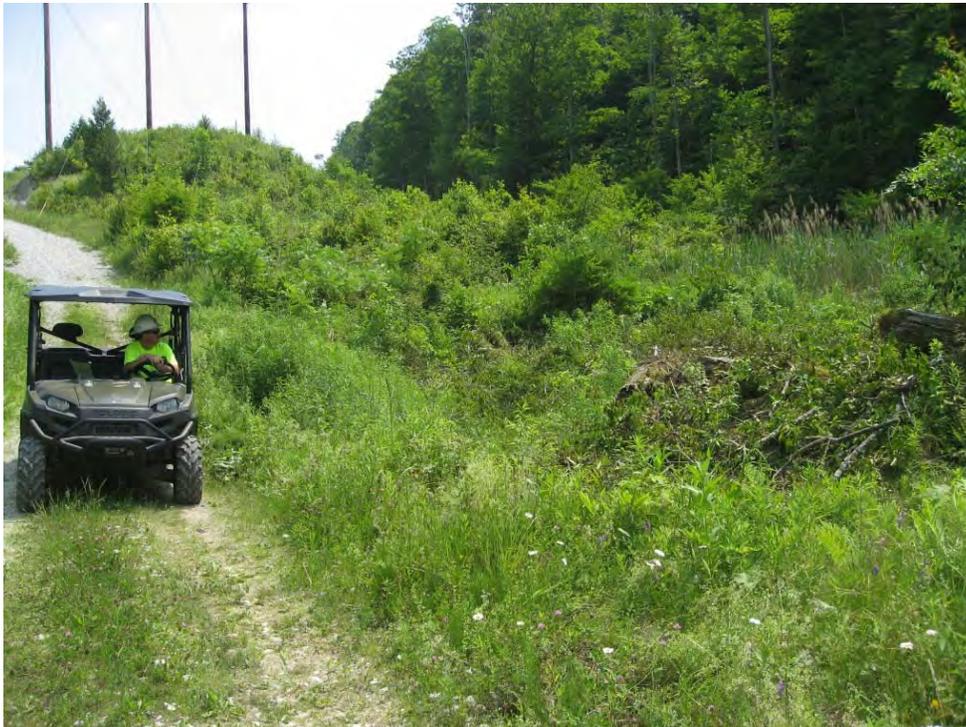
During the visit, several areas were observed near standing or open water. These areas were flagged in the field to denote herbicide restricted areas, and incompatible species had been recently hand cut in these areas.

View of area in the vicinity of surface water that was subject to hand cutting along the 370 line.

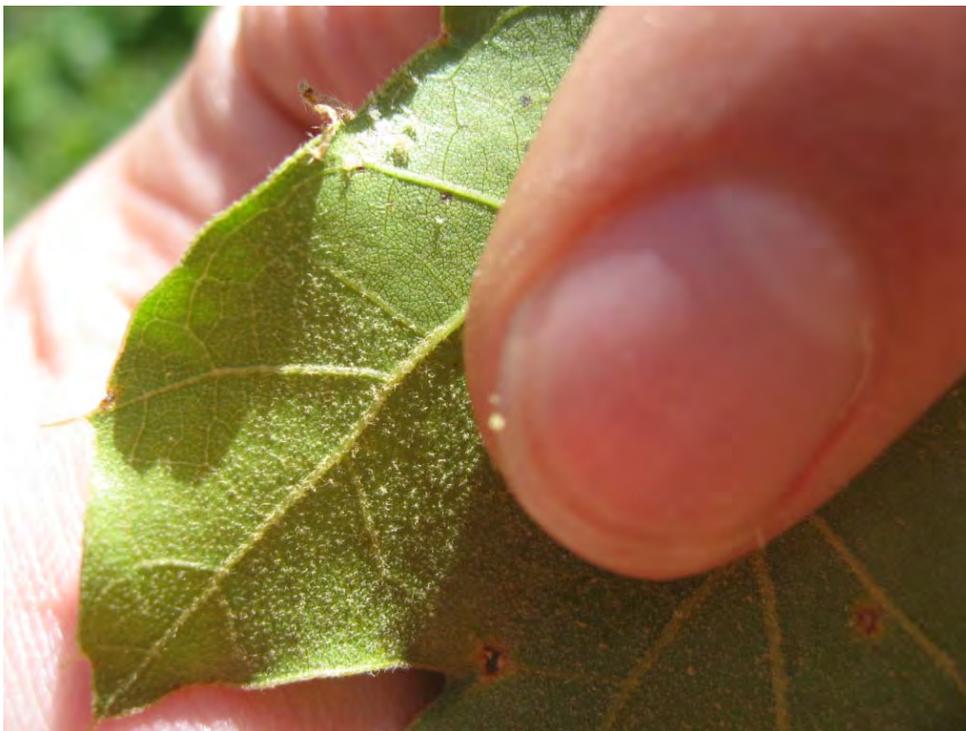
Underside of Scrub Oak leaf with off-white fuzz.

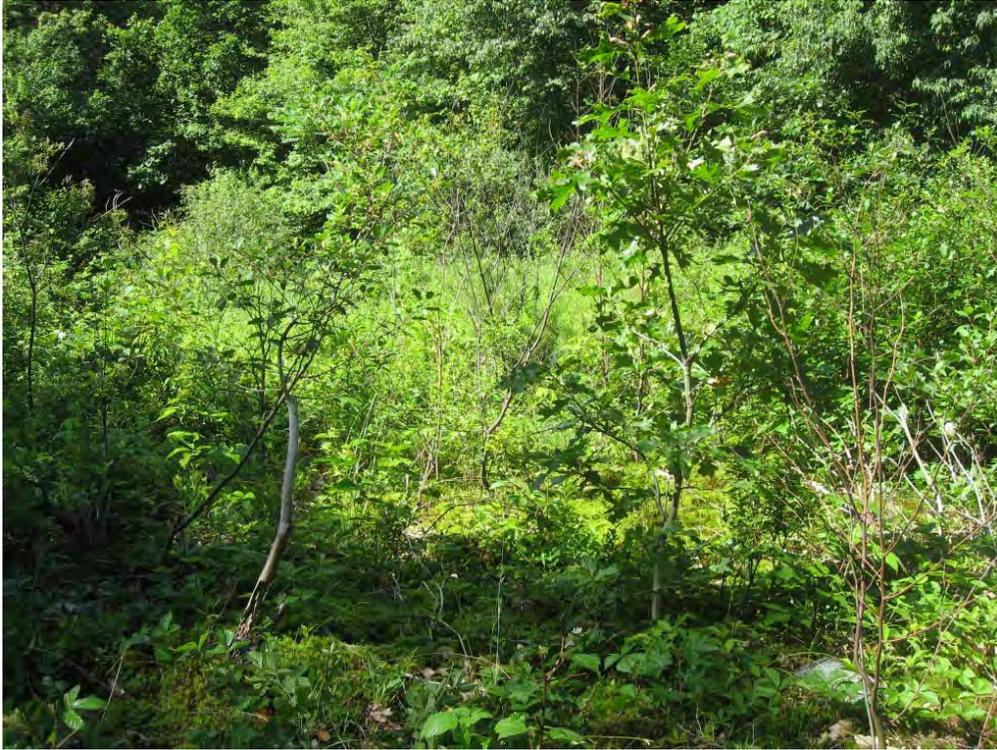
The invasive Glossy Buckthorn (*Rhamnus frangula*) was observed growing in the vicinity of Scrub Oak (see photographs below). It was noted that cut stump treatment of the buckthorn would improve the habitat for Scrub Oak.

View of endangered Scrub Oak at right, with Glossy Buckthorn surrounding plants.

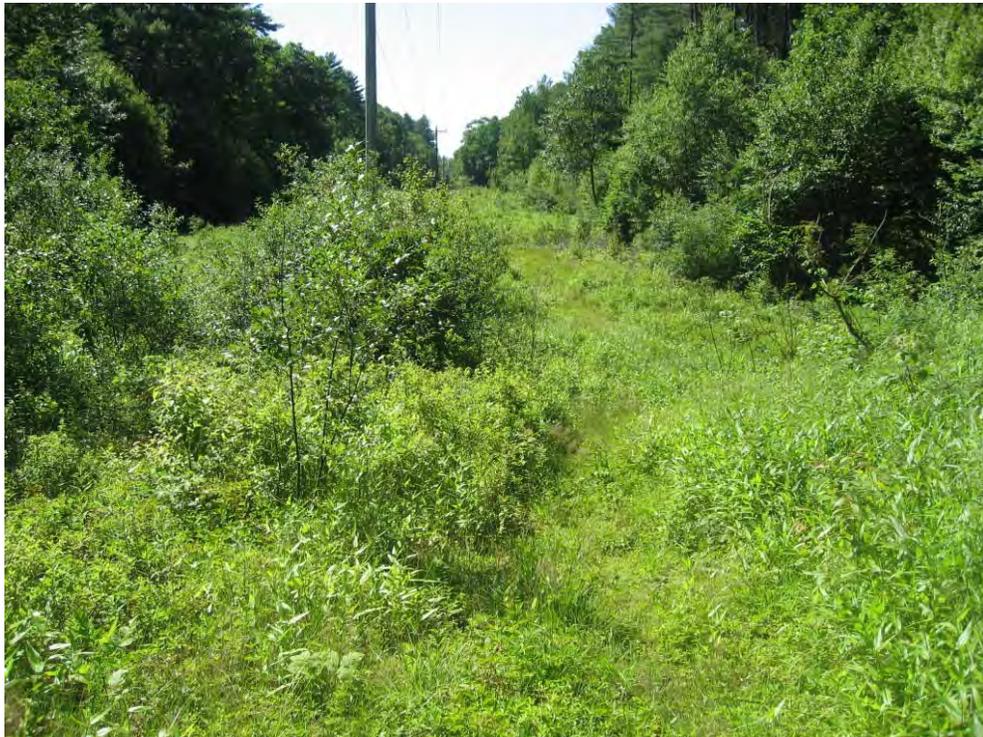
On June 28, 2012, a TRC biologist observed right-of-way clearing activities on the North Brattleboro to Dummerston 46kV Line 32 in the Black Mountain area and within a Scrub Oak (*Quercus ilicifolia*) element occurrence polygon (this is a state endangered species). Right-of-way clearing activities involved removing young and mature tree along the edge of this approximate 100-foot-wide corridor. The three-person crew was working on the western side of the polygon and were progressing eastwards. Crew members had parked their pickup trucks along an existing, disturbed access road. A single skidder bucket was being utilized to top trees and hand crews were removing the bases and cutting the timber into smaller pieces. Crews had utilized existing access routes with the equipment.

View of Scrub Oak habitat within CVPS Line 32 easement.

While onsite, work plans were reviewed for the polygon and it was re-emphasized to the crew lead the necessity of avoiding Scrub Oak by the hand felling operation. In accordance with the BMPs, crews were instructed to hand fell trees and restrict the use of the skidder bucket to the existing access route within the polygon. The crew Lead was trained on how to easily identify the Scrub Oak for avoidance—it was readily distinguished from Red Oak (*Quercus rubra*) by observing its substantial off-white downy fuzz on the undersides of the leaves. The fuzz easily fell off if rubbed.

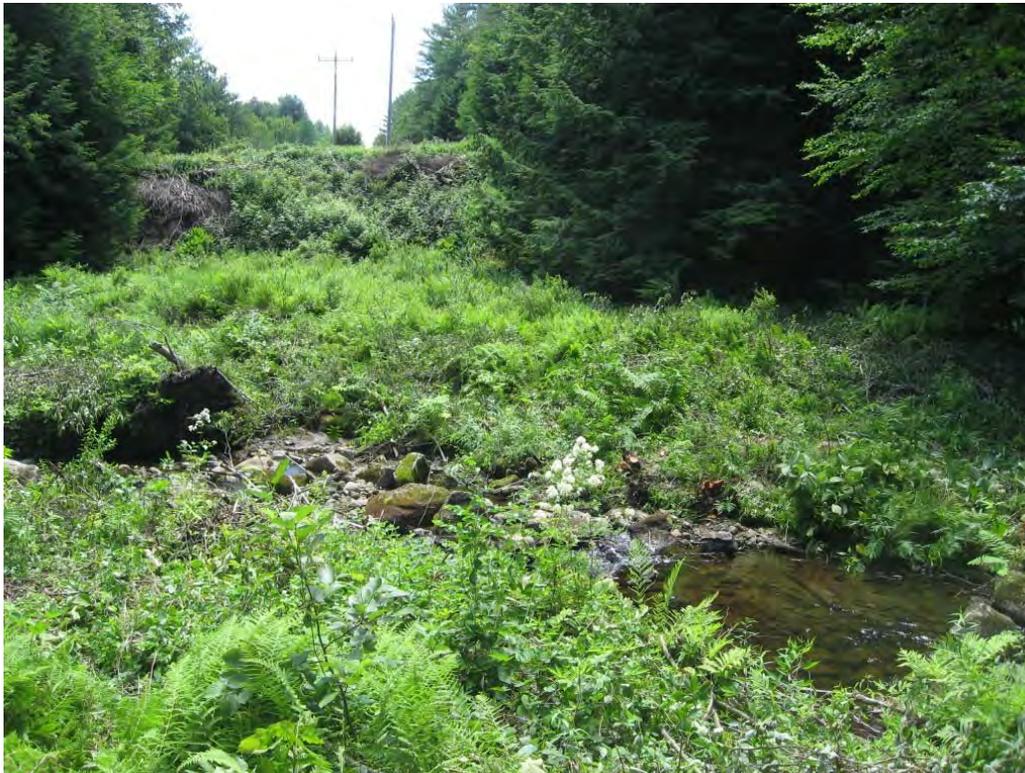
On June 28, 2012, a TRC biologist observed the result of right-of-way hand cutting activities along the Cavendish to Springfield 46kV Line 93. Hand cutting was underway on this line for the areas within 30 feet of surface waters and other herbicide restricted areas (e.g., vicinity of water supplies). Woody vegetation clearing had just occurred along a perennial stream. No slash or debris was observed in the stream, and limited slash was observed in the riparian corridor. Crews had completed work by hand and access had been conducted by all-terrain vehicle. No soil disturbance was observed.

View of perennial stream corridor within the CVPS Line 93 easement that was recently hand cleared of incompatible vegetation.

Following hand cutting, low-volume foliar herbicide application crews will proceed with treatment on this line in the unrestricted areas. It was discussed that this was the typical order of operations for the vegetation management cycles—hand clearing crews “prep” the right-of-way by removing incompatible vegetation from herbicide-restricted areas (e.g., buffers from surface waters and water supplies) during one pass, and low-volume foliar herbicide application crews follow with a second pass.

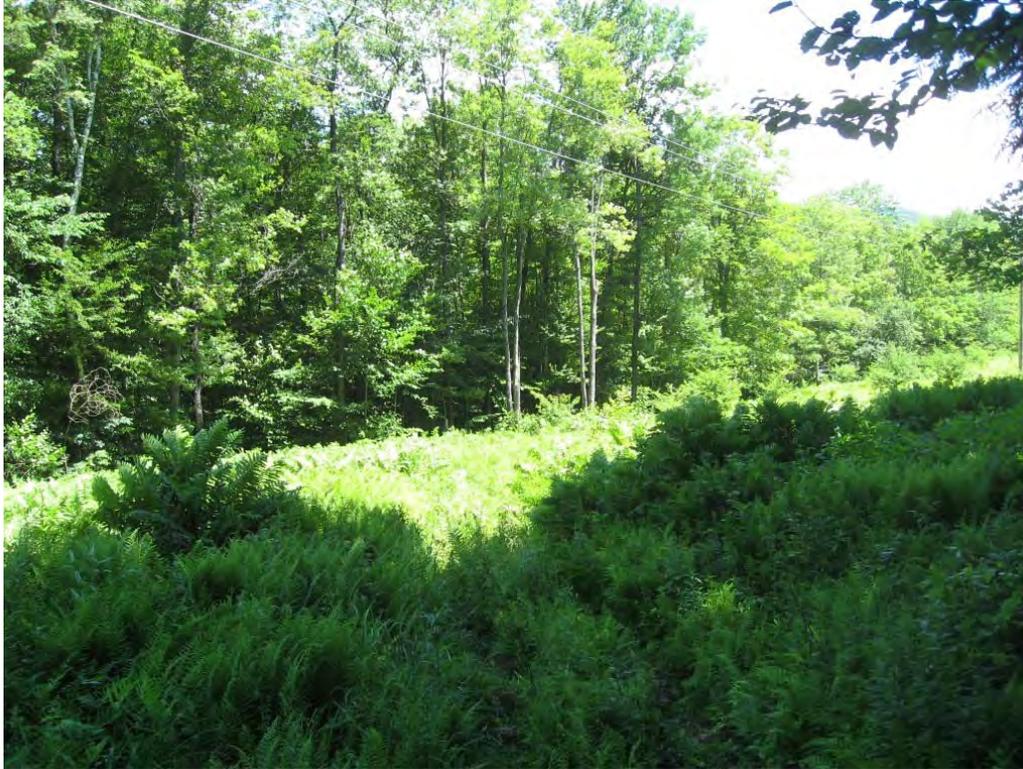
On June 28, 2012, a TRC biologist observed the Ascutney to Cavendish 46kV Line 91 in Cavendish Vermont, east of the Cavendish Gorge, shortly after treatment by low-volume foliar herbicide application crews. A three-person crew and a UTV conducted one-pass of the ROW following the hand cutting crew. Crews were equipped with hand-pump back-packs and hand sprayers, while the UTV transported containers of herbicide (in accordance with the Agency of Agriculture herbicide use permit conditions).

No evidence of soil disturbance was observed, and only limited evidence of UTV use along an existing ATV trail was observed.

View of the CVPS Line 91 easement following a pass by low-volume foliar herbicide treatment crews. Note the nearly imperceptible evidence of ATV use—two slightly matted tracks within the herbaceous vegetation along a previously utilized trail.

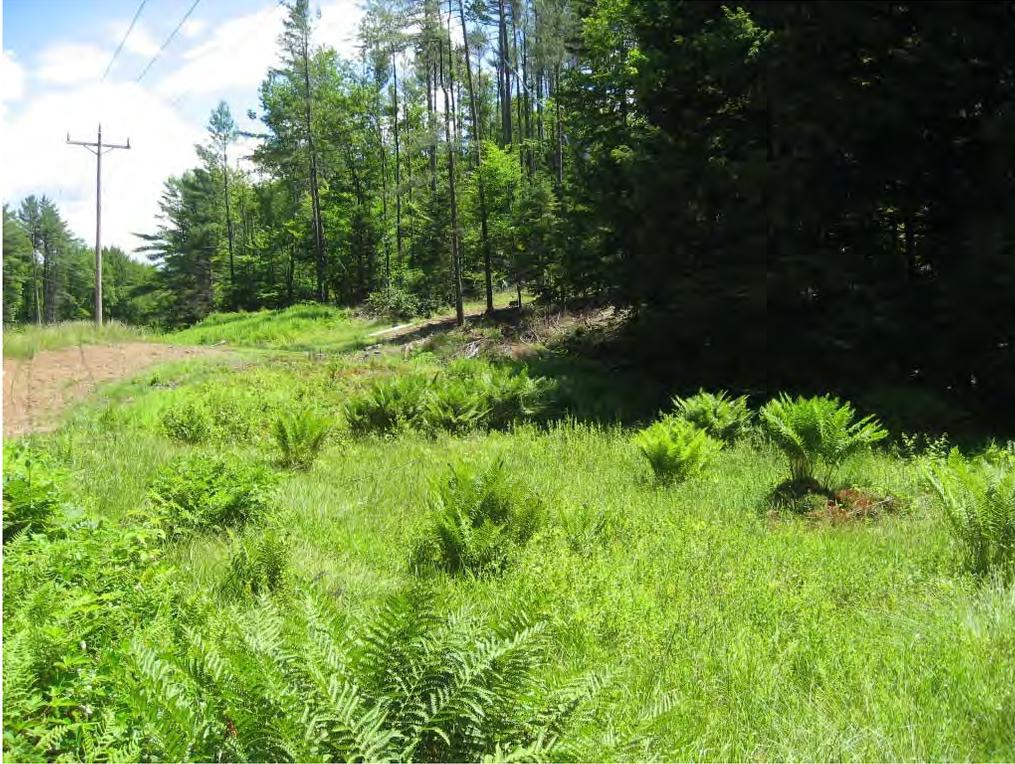
A documented occurrence of Wiegand's Sedge (*Carex wiegandii*), an S1-ranked rare species, was reviewed in this area. The species occurs in two wetlands within the cleared easement in this area. Several felled small white pine were observed along the wetland margin that were apparently removed by hand. Otherwise no incompatible species were observed in the vicinity of the habitat. Treatment within the wetland was not necessary and the area had been avoided. Fruiting Wiegand's Sedge plants were observed.

View of Wiegand's sedge habitat within the CVPS Line 91 easement that was avoided.

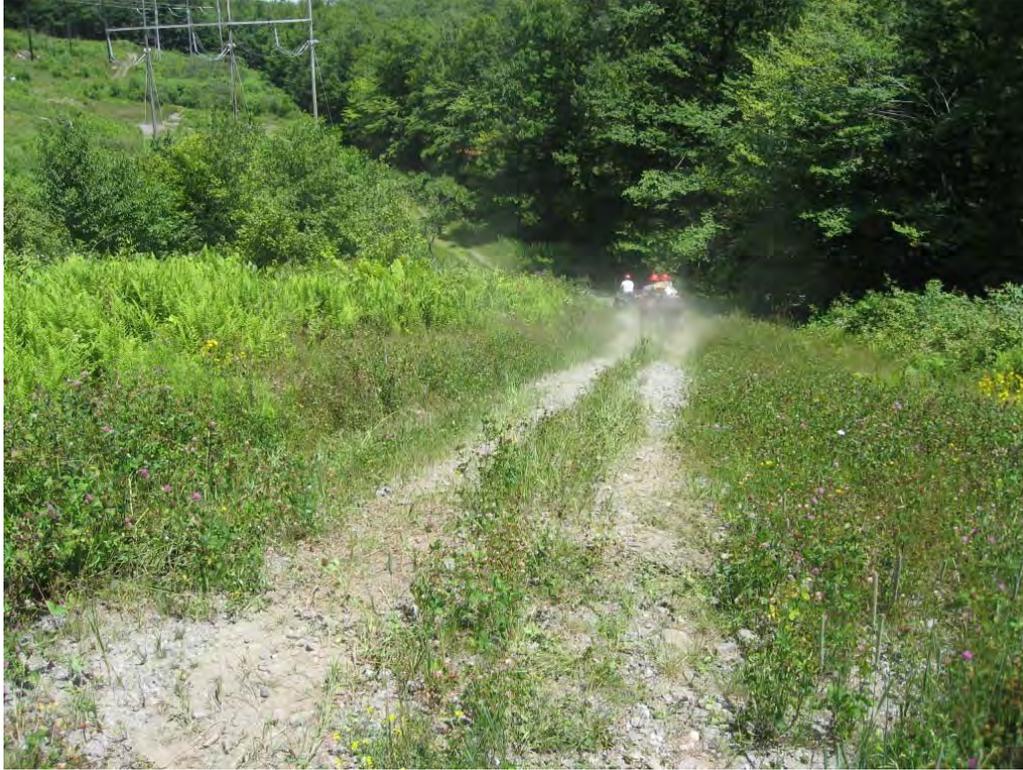
On July 9, 2012, a TRC biologist observed pole refurbishment (topping) activities along the 345kV 340 Line, which extends from the Vernon Substation in Vernon to the Coolidge Substation in Cavendish. Crews were observed working in Townshend, and work involved climbing wooden poles, cutting the tops of poles (where necessary), and applying a new pole topping (cover) to protect the integrity of the wood and extend the life of the poles. Work was conducted at a small subset of the transmission poles along this line. Crews were utilizing several ATVs for access to the structures, and they had been instructed to utilize existing access roads and avoid threatened and endangered species population polygons. No soil disturbance was observed or expected to occur as a result of the activities.

View of O&M crew utilizing ATVs on existing access road in the 340 Line right-of-way near Structure 211.

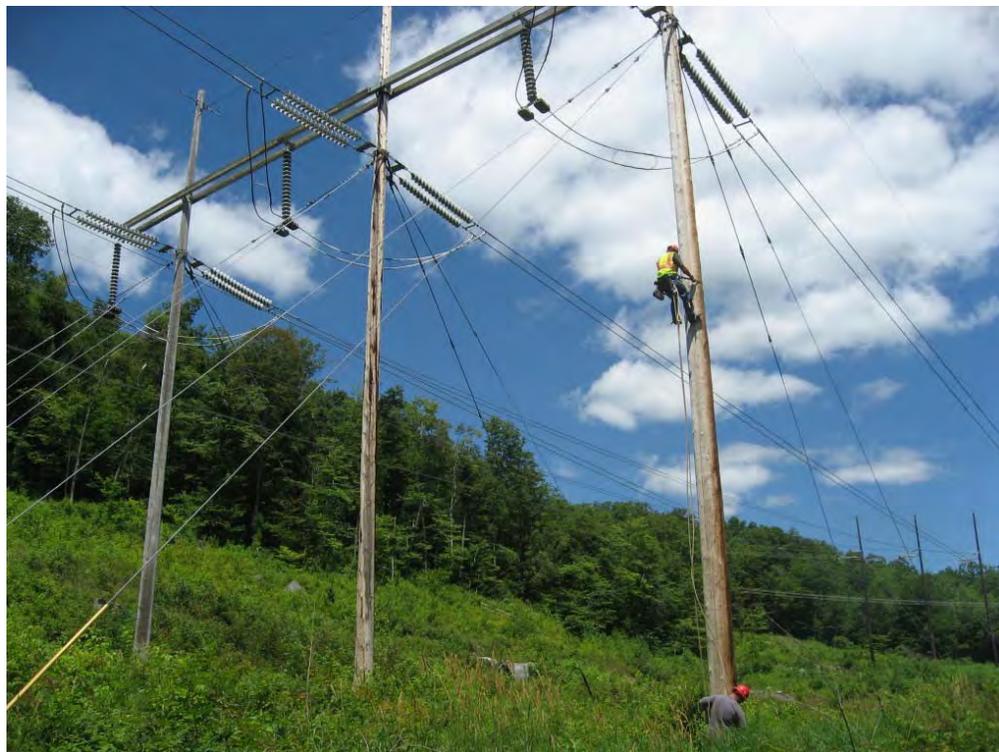
View of O&M crew climbing Structure 211 of the 340 Line to cut and top the wooden pole. No soil disturbance was observed or expected to occur.

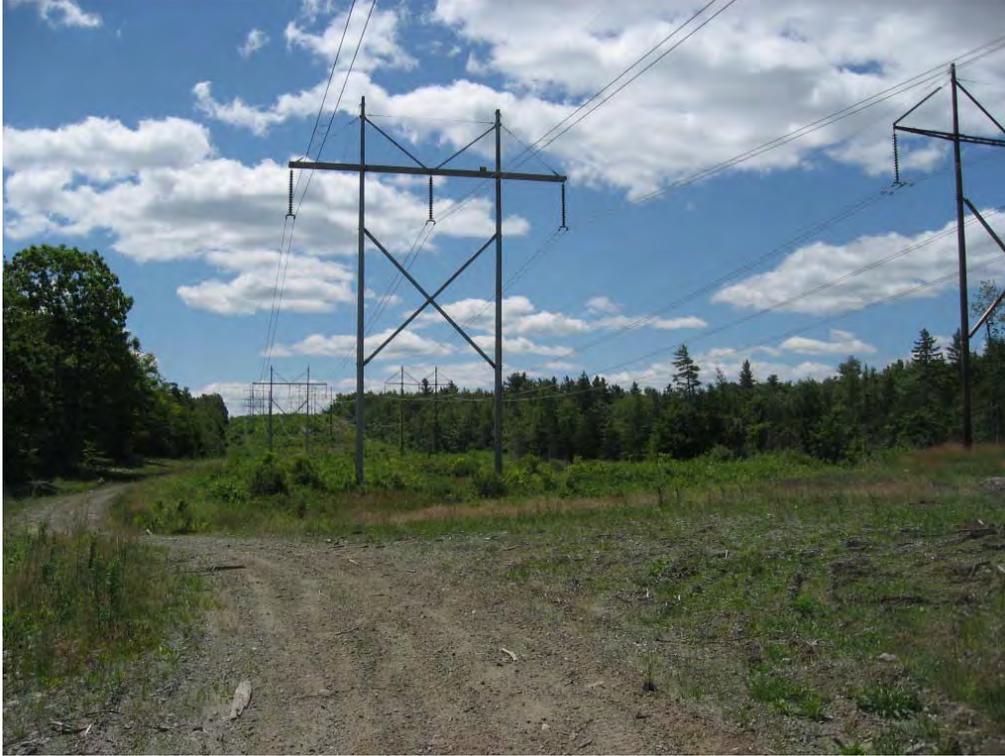
View of existing access road that was utilized by crew in the vicinity of Structure 220. Crews avoided a mapped polygon of Northeastern Bulrush (*Scirpus ancistrochaetus*), a state and federally listed endangered species.
