MANURE INJECTION

Scott Magnan's Custom Service

Initial Issues

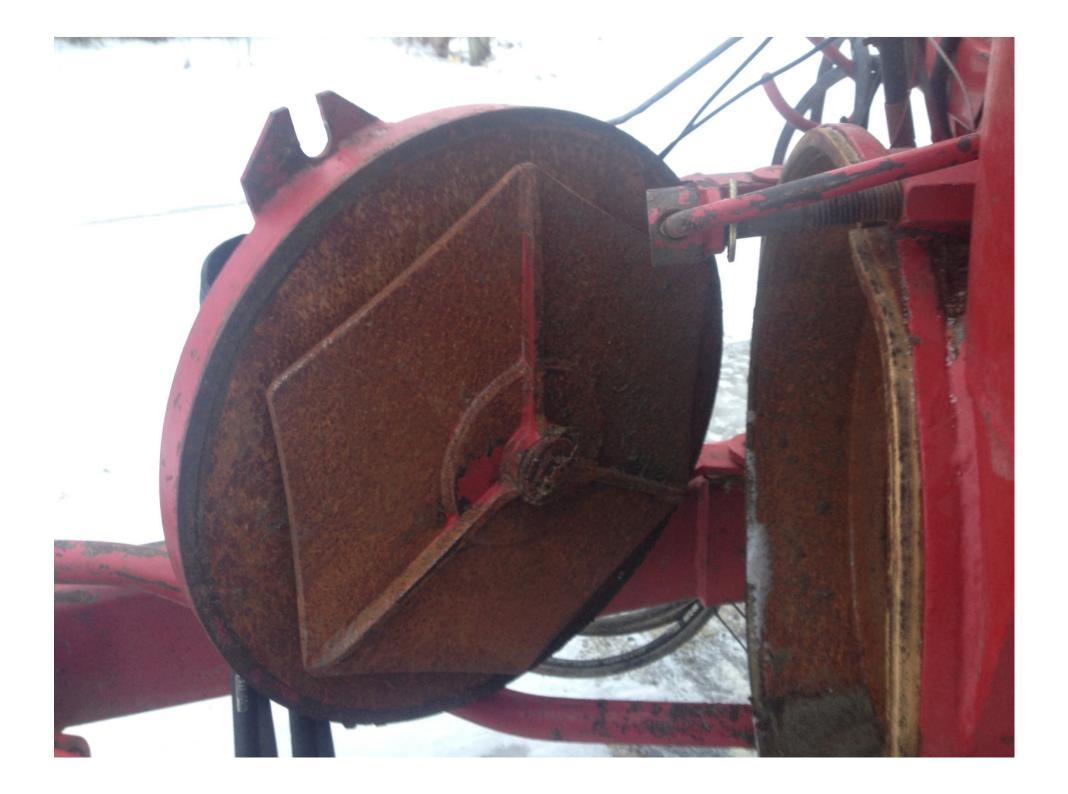
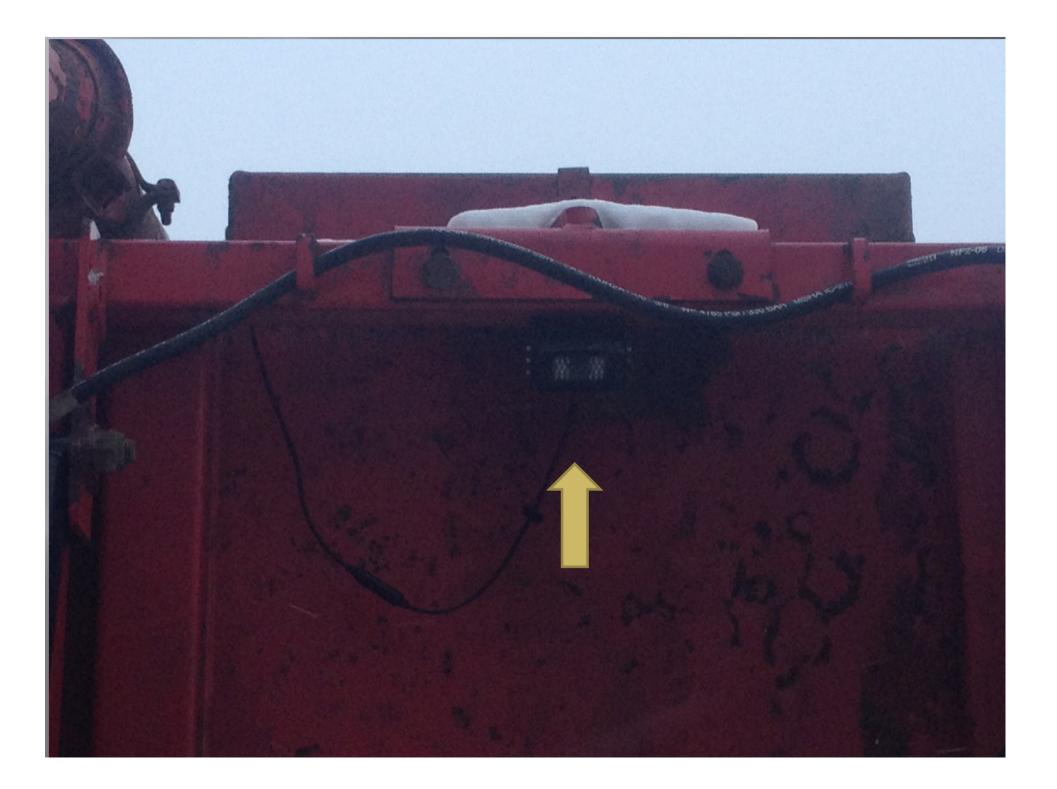
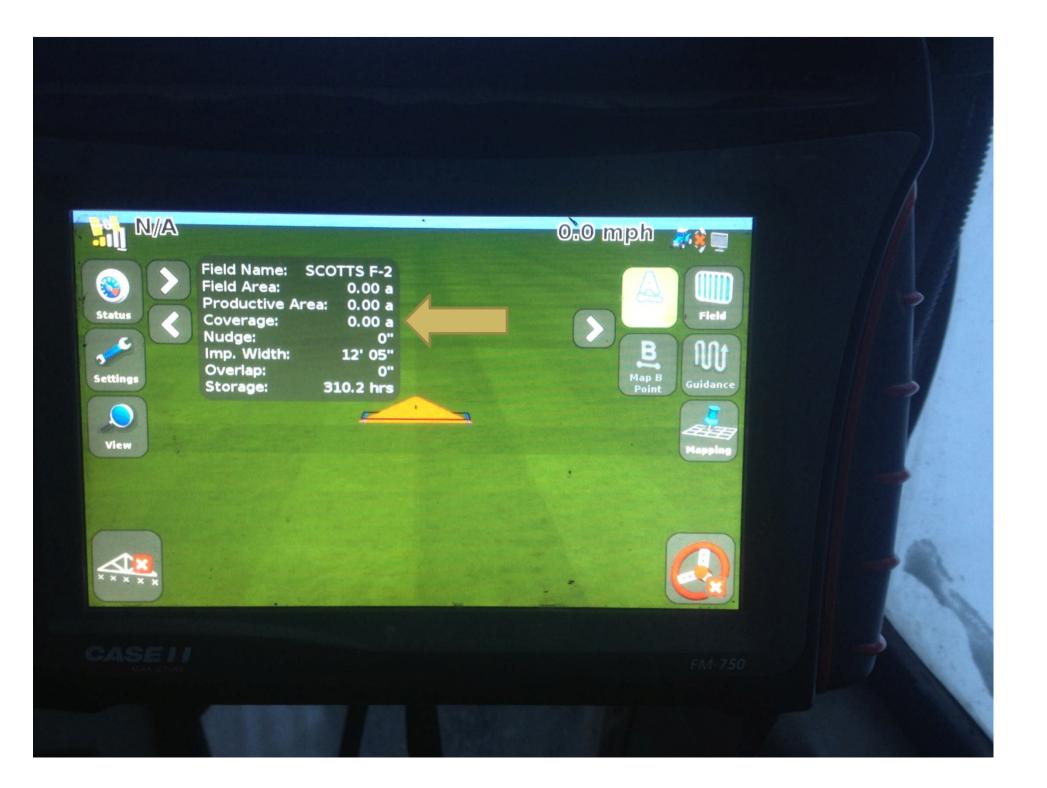
Setup after initial test

- Reduced pump size- Cut horsepower requirement, kept main hose from blowing apart
- Flow valve- We can maintain a ground speed of 3-5mph, and adjust flow with this valve to control rate.
- GPS- Allows us to have a more professional looking, evenly applied field, and gives us the acreage per load, allowing us to quickly calculate GPA
- Camera- Having visual contact has saved on repairs, allows us to do a cleaner job, and know when the implement is up or down and if service is needed.
- Tank Balance- We slid the tank ahead to increase tongue weight applied to drawbar
- Routine Inspection- It is important to check the machine every day for loose bolts, worn points, ETC. The injector is a tool that requires more care than a broadcast spreader

- High flow from stock pump on tank required us to spread over 6 mph in order to drop application rates, resulting in mechanical failure's and uncontrolled application rates.
- We mounted a flow valve to control flow. With the stock pump, the main hose built pressure and blew off.
- Unable to see the injector, we broke points, and had issues knowing what the implement was doing.
- Application rate was difficult to calculate.
- Weight of the injector decreased tongue weight
- Loose bolts

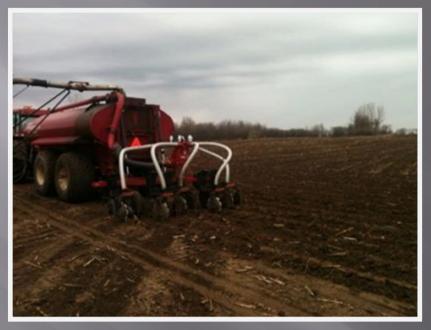
Management comparison

Farm 1- (Spring) 55 acres we injected from nurse trucks in the field, Farmer followed us on the same day with a primary tillage pass, We were able to spread in a field near camps that had not been covered is recent years.

Farm 2- (Spring) 8 acres Injected into a field directly from the pit that was later no-till planted into corn

Farm3- (fall) Spread into 88 acres near the farm, directly from the pit. The farmer later made a primary tillage pass

Farm-4 (fall) 214acres mostly transferred in the field with no additional tillage. The farmer has the option to do conventional, reduced till or no-till this spring.

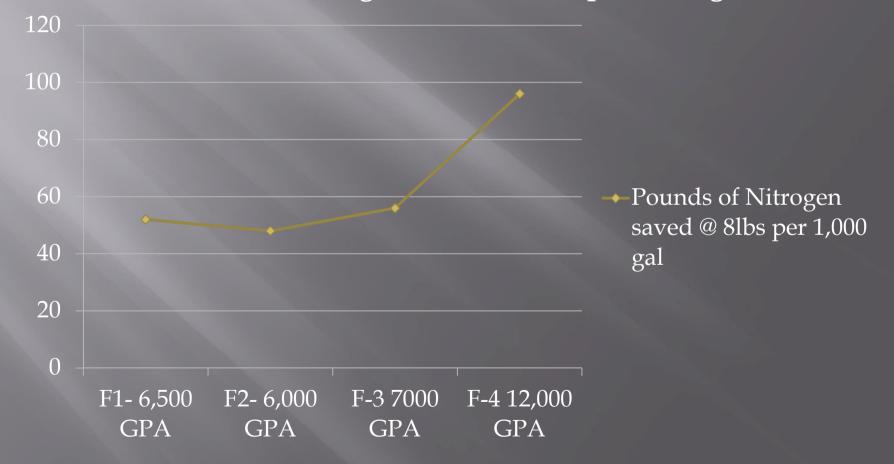
Estimated Nitrogen saving per acre

Pounds of Nitrogen saved @ 8lbs per 1,000 gal

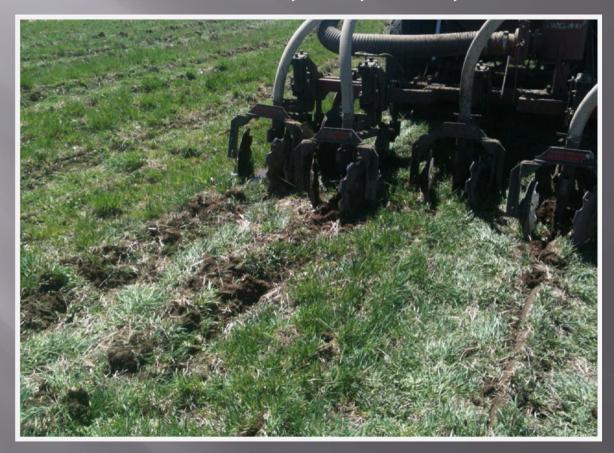
Future goal- injection into hay

This field was being rotated into soybean. Replacing the closing discs which did most of the damage in this photo, may be trialed this summer. Complete alternatives to this system may be necessary.
