Quechee Gorge Bridge Safety Issues

Suicide Prevention Alternatives

Report to the Vermont Legislature

Prepared by the Vermont Agency of Transportation
With assistance from DuBois & King, Inc.

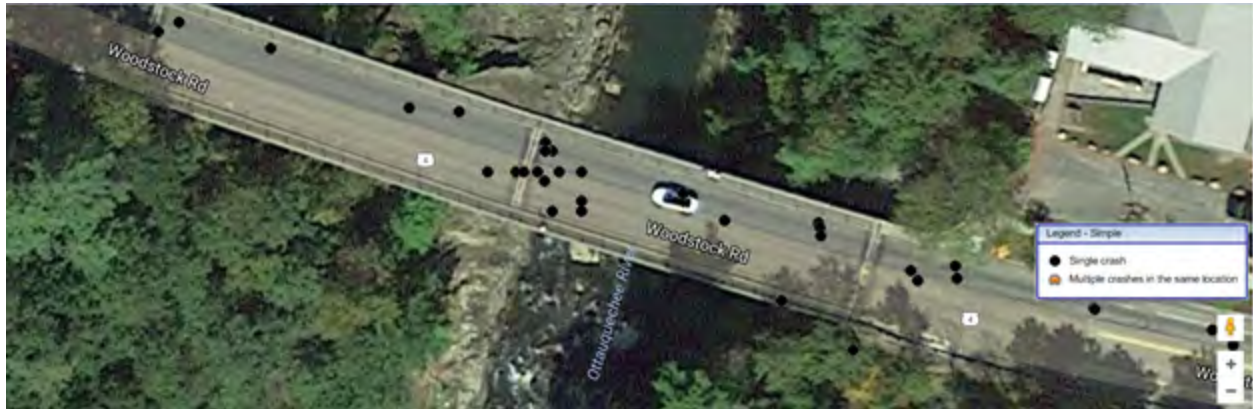
Figure 2: Crash Locations on the Quechee Gorge Bridge, US Route 4

The VTrans crash database indicates that there have been 22 crashes on bridge between 1/1/2010 and 10/5/2016. All of these were rear end collisions, and four of which involved injuries. This data, combined with the team’s observations, suggests that the crashes primarily involve stopped vehicles that are either viewing the gorge or yielding to crossing pedestrians.

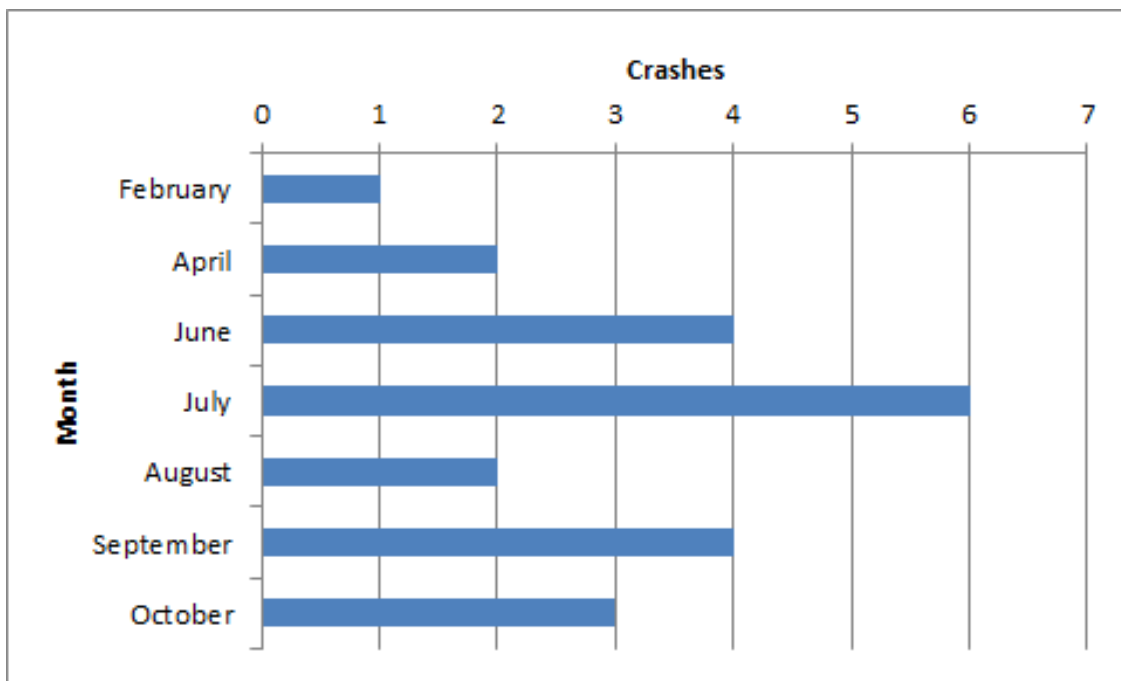
Figure 3: Month of Crashes on Quechee Gorge Bridge

The seasonal patterns of the crashes strongly correlates to the tourist season, with July being the peak month for crashes.

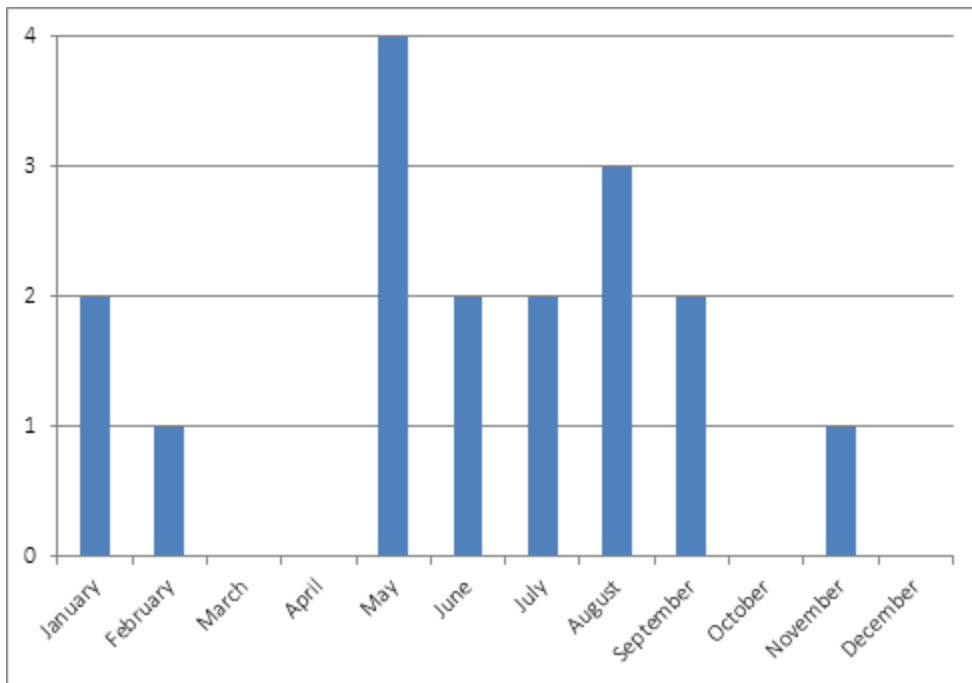
Figure 7: Month of death at Quechee Gorge suicides

The seasonal distribution follows widely observed patterns of suicides peaking in the month of May, and are more prevalent from May to September. The high number of people that visit the Quechee Gorge Bridge and surrounding area during these same months makes the impact of the incidents on witnesses and the community much more traumatic.

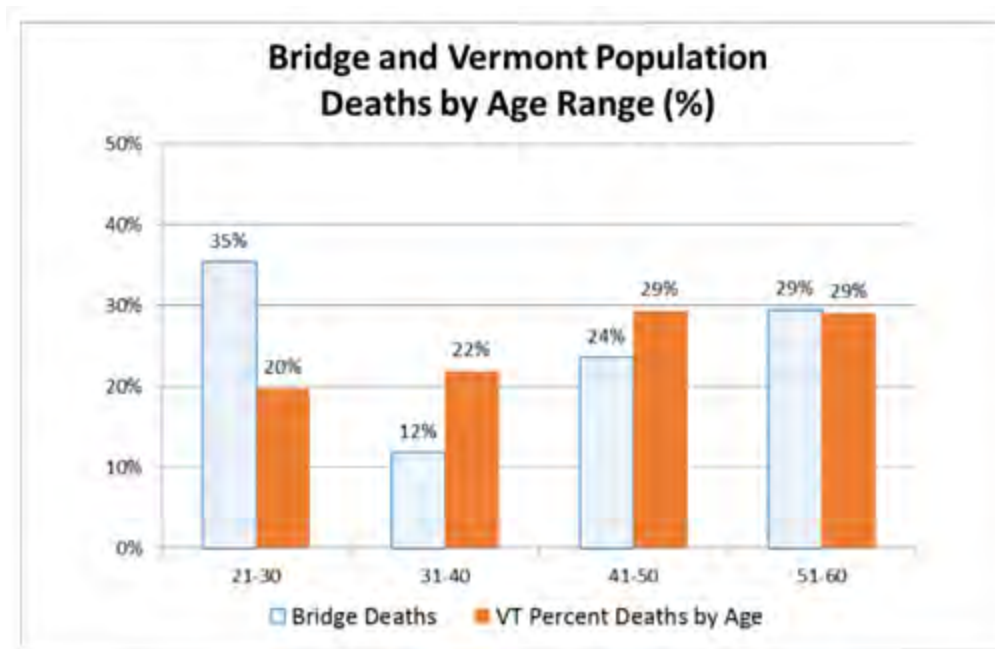
Figure 9: Quechee Gorge bridge ages of death compared to statewide suicide age distribution (source VT Child Health Improvement Program, UVM)

Patterns somewhat similar to this are observed at other bridges. Nationally, bridge suicide ages are on average about 10 years younger than overall average suicide ages.

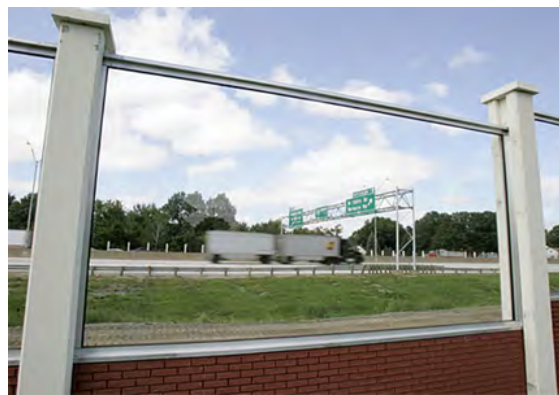
Plexiglass

This is often used as a combination noise barrier/ fence, when visibility is an important consideration. However, it has significant disadvantages including high cost, high wind shear impact, vulnerability to vandalism (painting or scratching), and high maintenance requirements (cleaning).

In consideration of the characteristics of Quechee Gorge site conditions, the chain link barrier is not appropriate due to the high visual impact, and plexiglass barrier is not appropriate due to the high maintenance requirements and potential for scratching or vandalism.

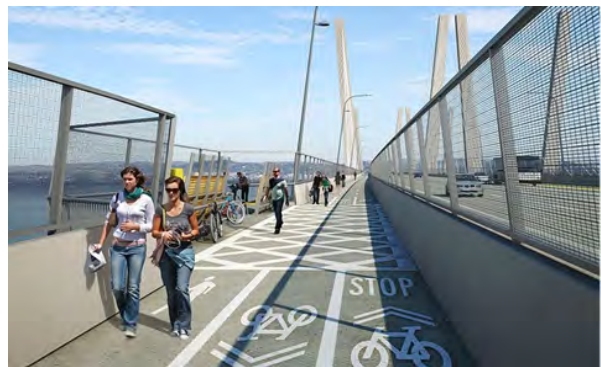
Steel Mesh

This type of barrier is relatively cost effective and easy to maintain. It can be almost completely transparent for drivers, but has a significant visual impact for pedestrians. The gaps in the mesh are small so that it cannot be climbed; but that will not allow pedestrians to have an unobstructed view, nor take a clear photograph.

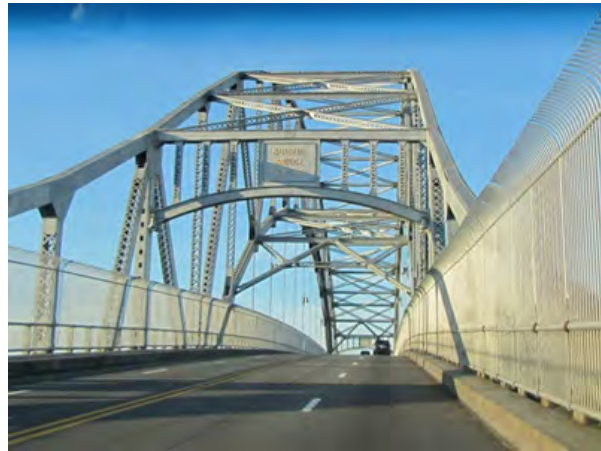
Steel Balusters

These are very commonly used, and are composed of vertical steel balusters, typically one inch in diameter and spaced 6 to 8 inches apart. The tops are typically curved inward to make climbing more difficult. The spacing allows a clear view for pedestrians if they stand right at the railing and opportunity to photograph the scenery through the balusters. They add weight and stress to the bridge, and can be more costly to install than lighter weight barriers.

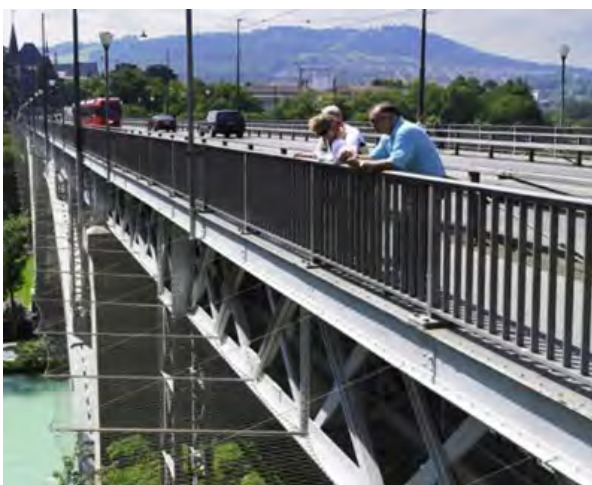
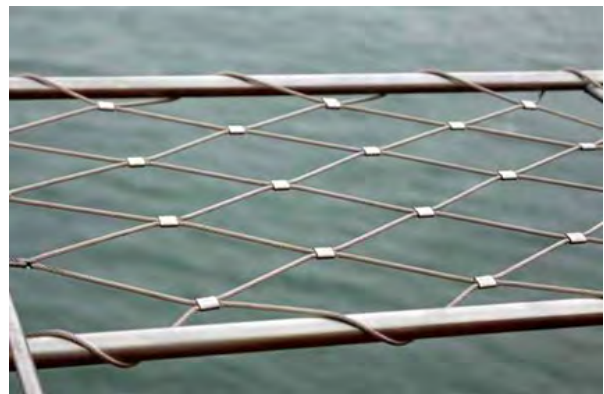
Figure 10: Suicide prevention nets on Muenster Terrace Bridge in Bern, Switzerland; net material

Suicide prevention nets have been used on buildings, and increasingly on bridges as an alternative to barriers due to their lower visual impact. The nets are mounted 15 to 20 feet below the bridge rail, and extend out the same distance. They are constructed of stainless steel wire with 8 inch openings. This size opening makes the nets relatively transparent and less likely to trap debris or snow. Nets work by deterring jumps, as the distance down to the nets is sufficient that a potential jumper could be injured, and unable to climb out of the net. Experience has shown that jumps into a suicide prevention net are very rare, and that suicidal individuals are deterred from jumping because it is clear that the jump will not be lethal.

The first use of a suicide net on a bridge was at the Muenster Terrace bridge in Bern, Switzerland, which had been the site of between two to three suicides per year for decades through the late 1990s. The Bern region overall had a very high portion of suicides from jumping, with several bridges being the sites of suicides³. Nets were installed on the Muenster Terrace bridge because it spanned a park, and suicides caused significant trauma and risk to the public. An incident of a jumper landing near a young child prompted the City to install nets in 1998. Since that time, there have been no jumps from the bridge. There had been six suicides at other Bern area bridges in the four years before the nets were installed, and three suicides at these other bridges in the four years after the nets, so there is no evidence of “displacement” to other bridges. The City of Bern has since installed barriers on the two other bridges in the region that had frequent suicides. The overall suicide rate has dropped dramatically, with jumping suicides in Bern now near zero⁴.

Above: Sample of net material; Left, Muenster Terrace Bridge nets, Bern, Switzerland

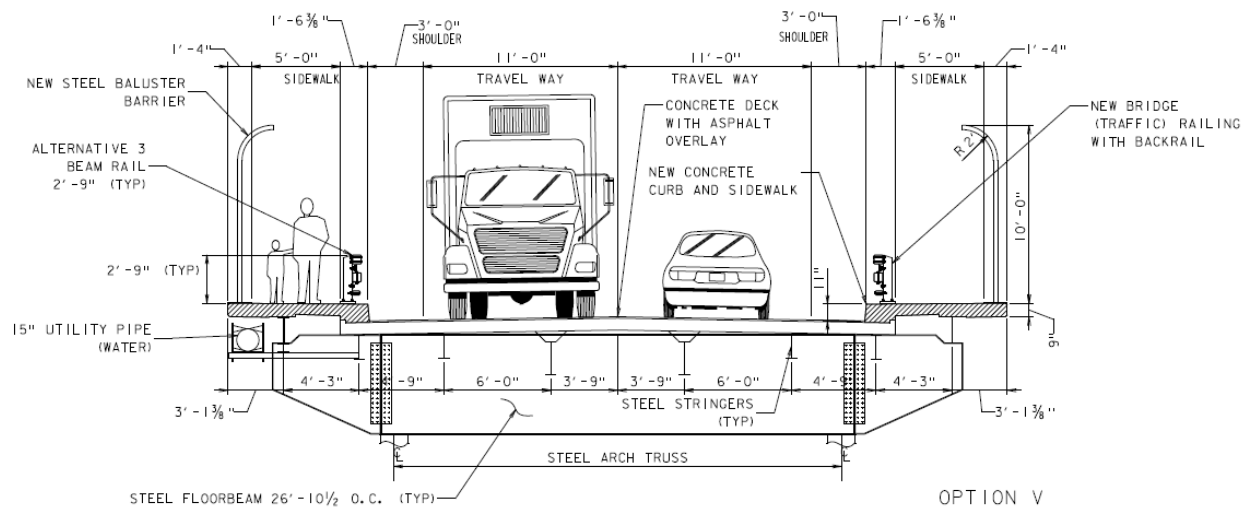
Figure 13: Means Restriction Barrier Cross Section

- Vehicle barrier replaced and installed on the curb adjacent to the road shoulder
- New pedestrian railing/suicide prevention barrier installed on outside of bridge
- No modification of bridge beams or relocation of water line required

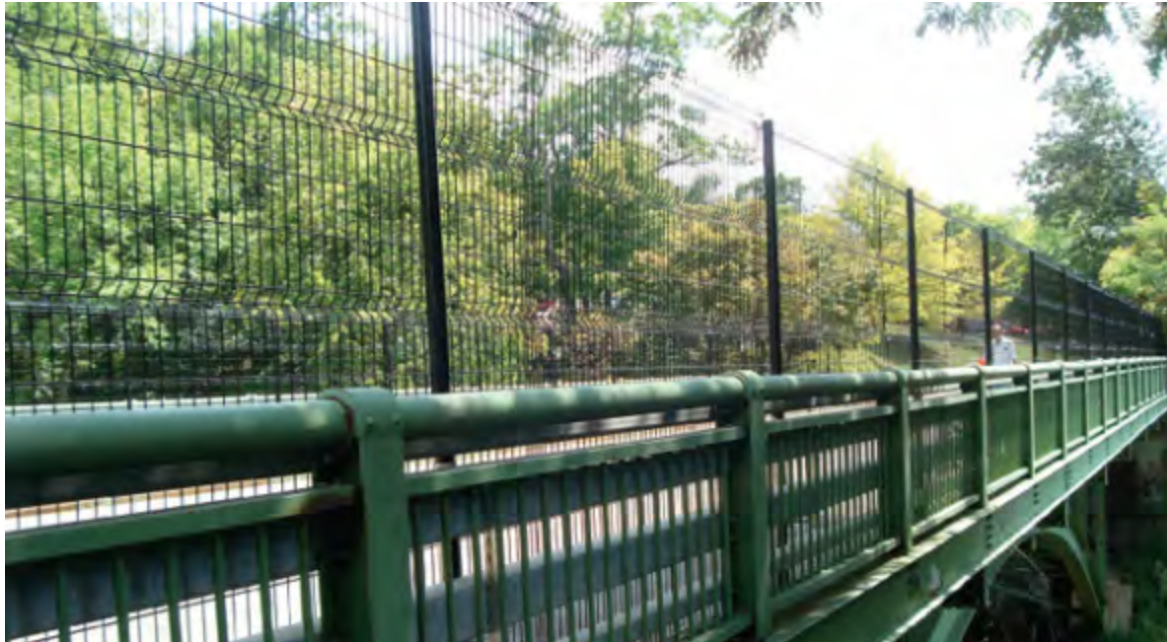
Figure 15: Example of temporary wire mesh barrier from Ithaca, NY

It is anticipated that the wire mesh fence would be installed outside of the existing vehicle rail, with posts interspersed with the existing vehicle rail posts. The wire mesh will need to be of very lightweight gauge if installed in this manner, and should be considered a temporary measure, as the material will not be highly durable.

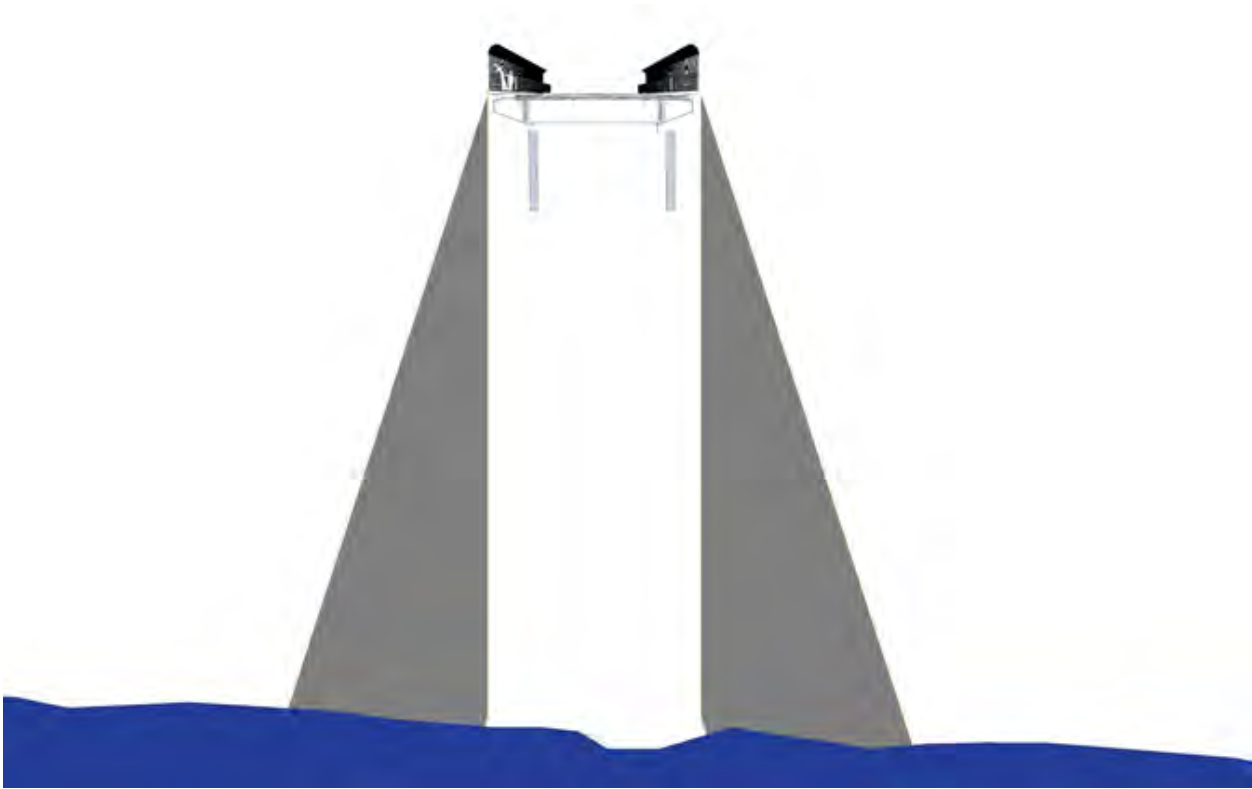
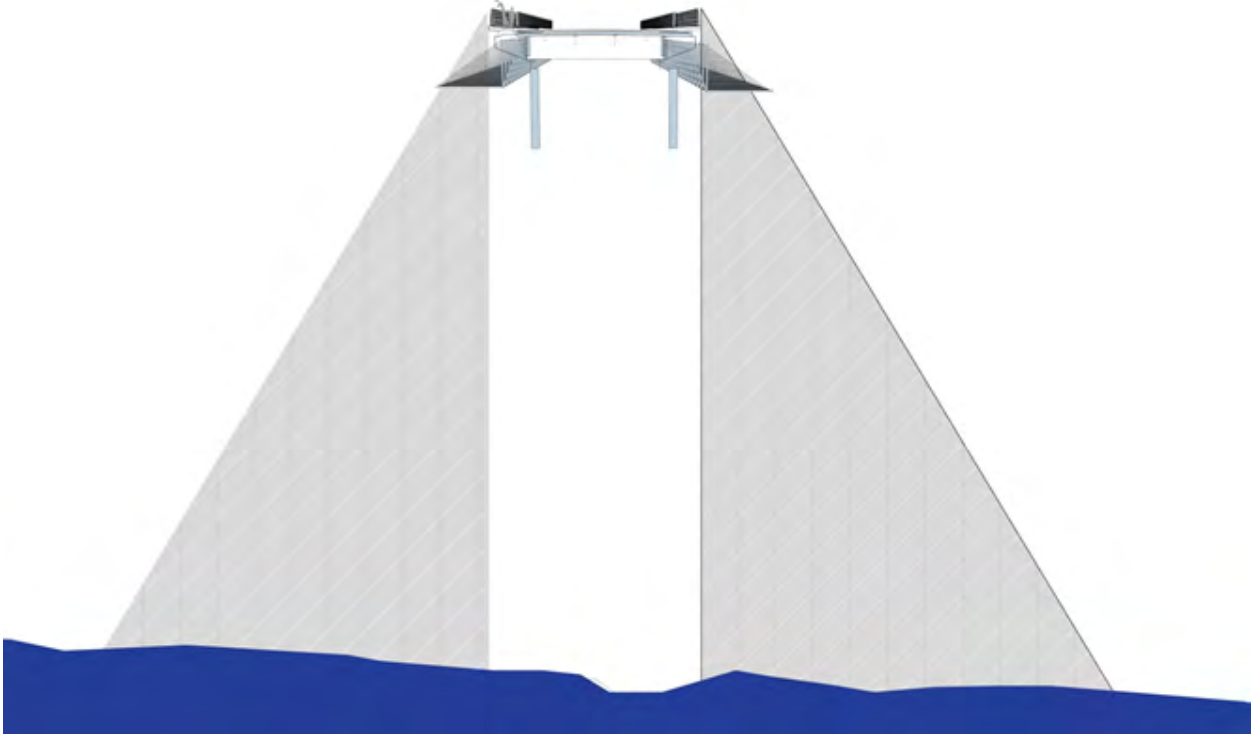
Figure 16: Viewshed Impacts from Barrier and Nets

The following photos and photo-simulations illustrate the potential visual impact of the barrier and net alternatives. Views are provided from a variety of perspectives: the sidewalk, the railing, and a driver perspective.

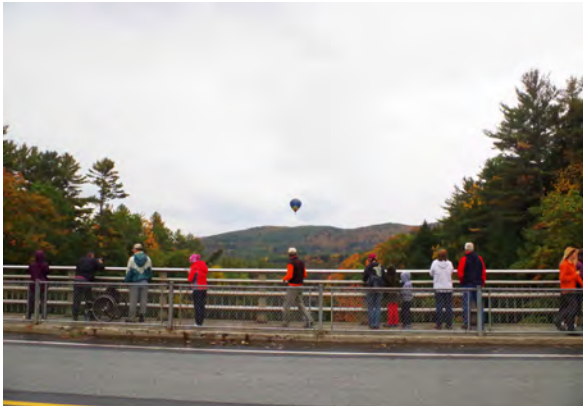
Existing Conditions:

The photos below show views across the bridge from the sidewalk. Both the barrier and wire mesh affect the view; the nets would not be visible from this perspective.

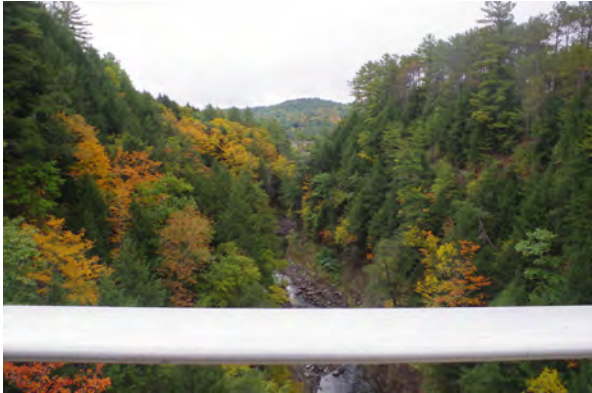
Existing Conditions: View from railing of gorge landscape

The photos on the following page show a view from the bridge railing down of the gorge's landscape. The barrier will obstruct the view, though it will be possible for a visitor to peer down between the railings to see the gorge or take a photograph. The nets would not be visible at the angle shown, though a later simulation shows how the net will affect the view down into the gorge. Many visitors enjoy taking selfies of their group, which which will be obstructed by the barrier.

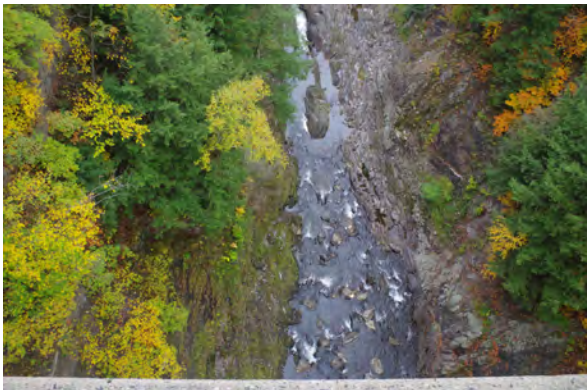
Existing Conditions: Looking into gorge

The height of the existing bridge rails allow visitors to peer straight down into the gorge. The barrier option will not allow visitors to look straight down into the gorge between the balusters due to their close spacing (6 to 8 inches). Visitors can put their camera through the balusters and take a photo. The nets will be visible, but their relatively thin gauge wire and large spacing (8 inch) makes the net somewhat transparent.

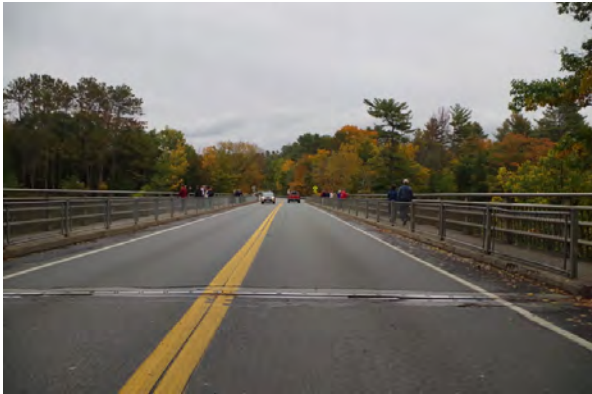
Existing Conditions: Passenger Car View

From a driver perspective, the gorge is not highly visible, but the existing railings allow some view of the landscape. The baluster barrier (below, right) result in a feeling of enclosure while approaching the bridge due to its relatively tall height when compared to the width of the bridge. Most bridges with steel balusters are much wider than the Quechee Gorge Bridge. The landscape would be somewhat visible through the railings while the car is in motion, but they would affect photography and visibility at very low speeds. The nets would not be visible from a car. The wire mesh would be visible, but its narrow gauge would make it more transparent than the steel balusters.

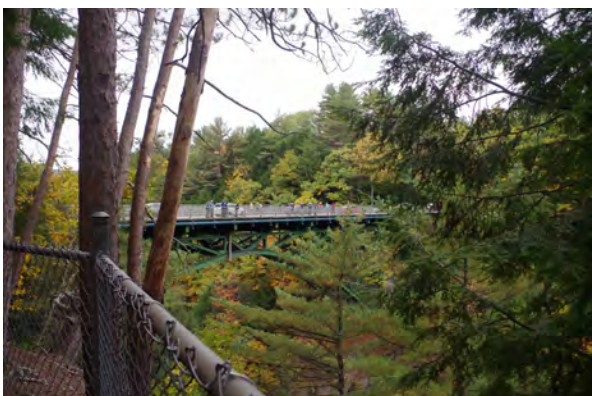
Existing Conditions

The view of the bridge from the Quechee Gorge State Park trails would be affected, depending on how close the viewer is to the bridge. From a short distance away, all of the options have a muted effect. The selection of color for the barrier or net supports will also affect the visibility.

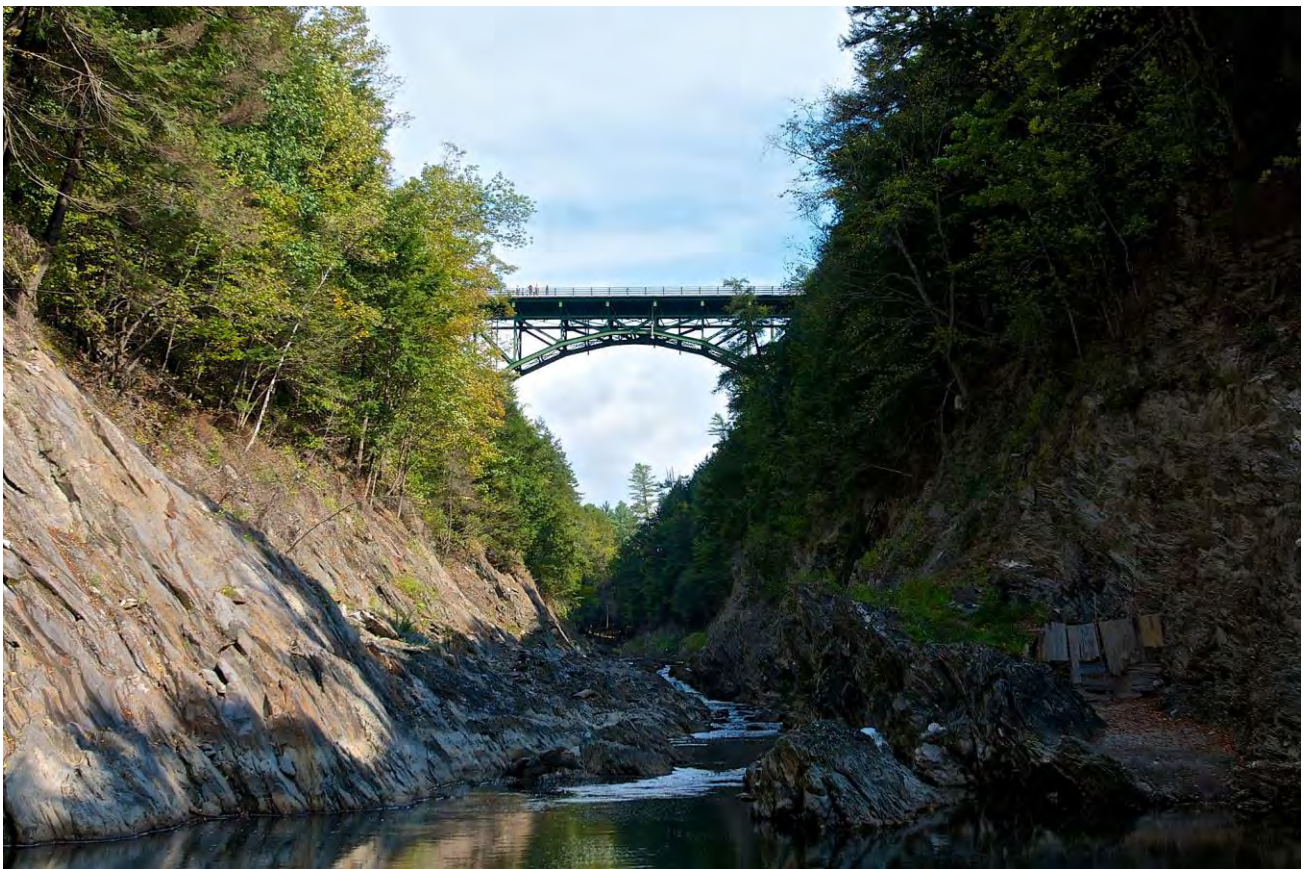
Figure 1. Quechee Gorge Bridge (Bridge No. 61), looking south

Constructed in 1911, the Quechee Gorge Bridge (Bridge No. 61) was designed for the former Woodstock Railroad in 1911, by John W. Storrs. Fabricated by the American Bridge Company, this arched, tri-span parabolic, spandrel-braced steel Pratt truss measures 285 feet long by 41 feet wide and carries US Route 4 approximately, 163 feet above the Ottauquechee River in Hartford (Figure 1).

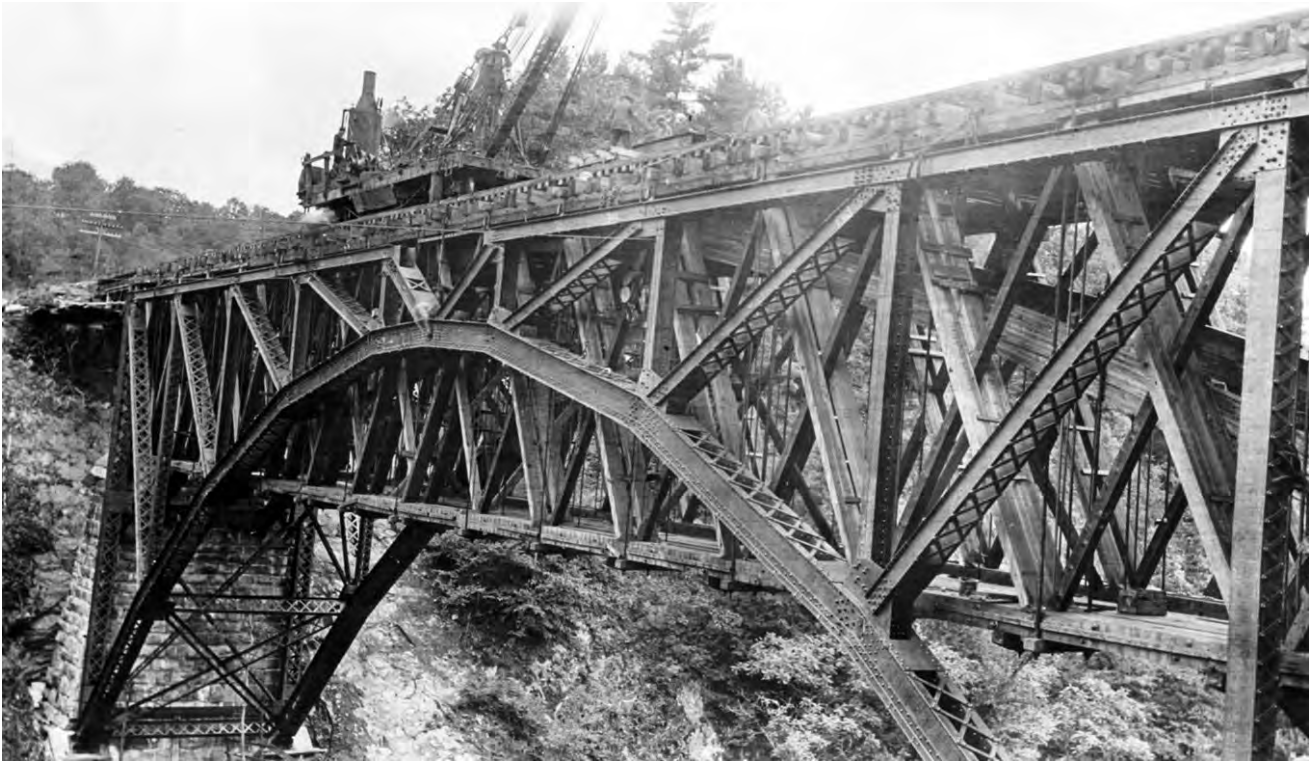
Figure 2. Construction of Quechee Gorge Bridge in 1911.

The bridge (Bridge 61) was built in 1911, to carry the tracks of the Woodstock Railroad over the gorge and replaced an 1875 wooden truss bridge which was less suited for heavyweight, twentieth century locomotives. In 1933, the right of way was taken over for U.S. Route 4, and the bridge was converted for highway use. This procedure chiefly required adding stringers and a concrete deck to the system... At the time John W. Storrs designed this bridge, he was employed as a bridge engineer for the Boston and Maine Railroad. He also worked as an independent consultant for others including the Woodstock and Montpelier and Wells River Railroads. Around 1909, his son Edward, associated with him and by 1915 the firm, known as Storrs and Storrs, was doing a large business in northern New England...The Quechee Gorge bridge appears to be the largest and most sophisticated bridge Storrs designed.

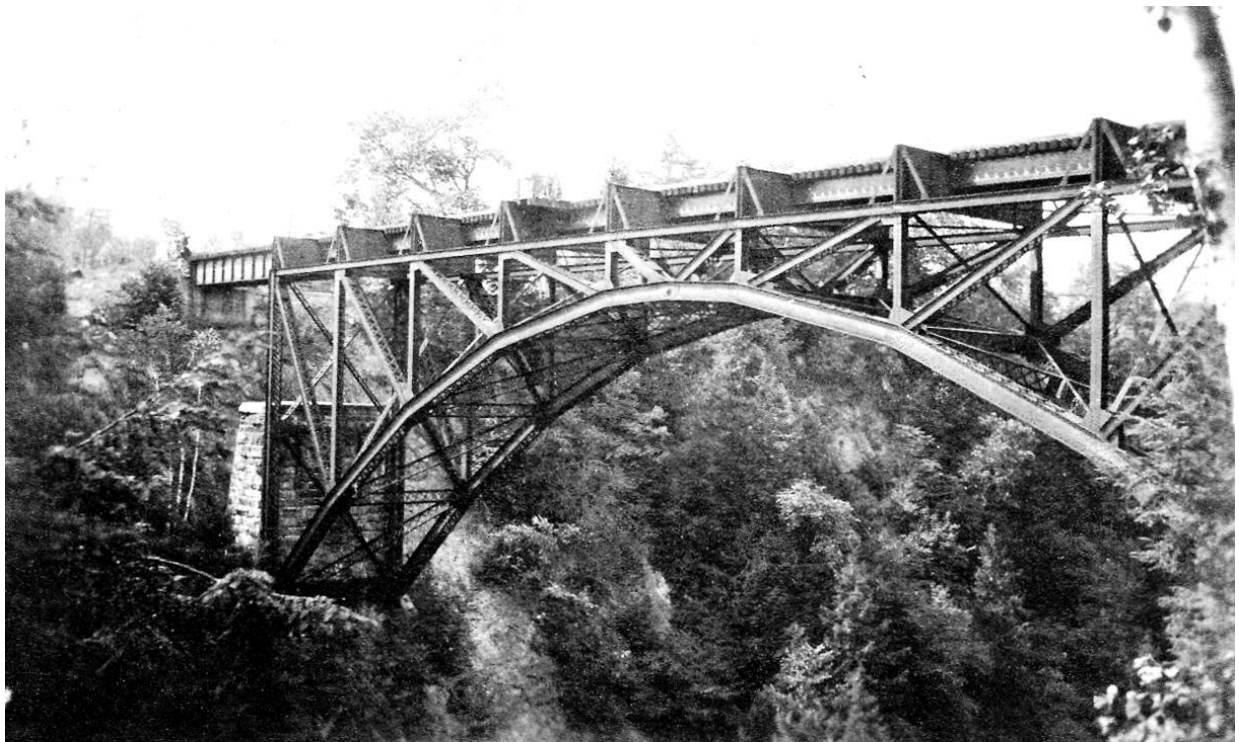
Figure 3. Completed bridge in 1911. Note rail deck.

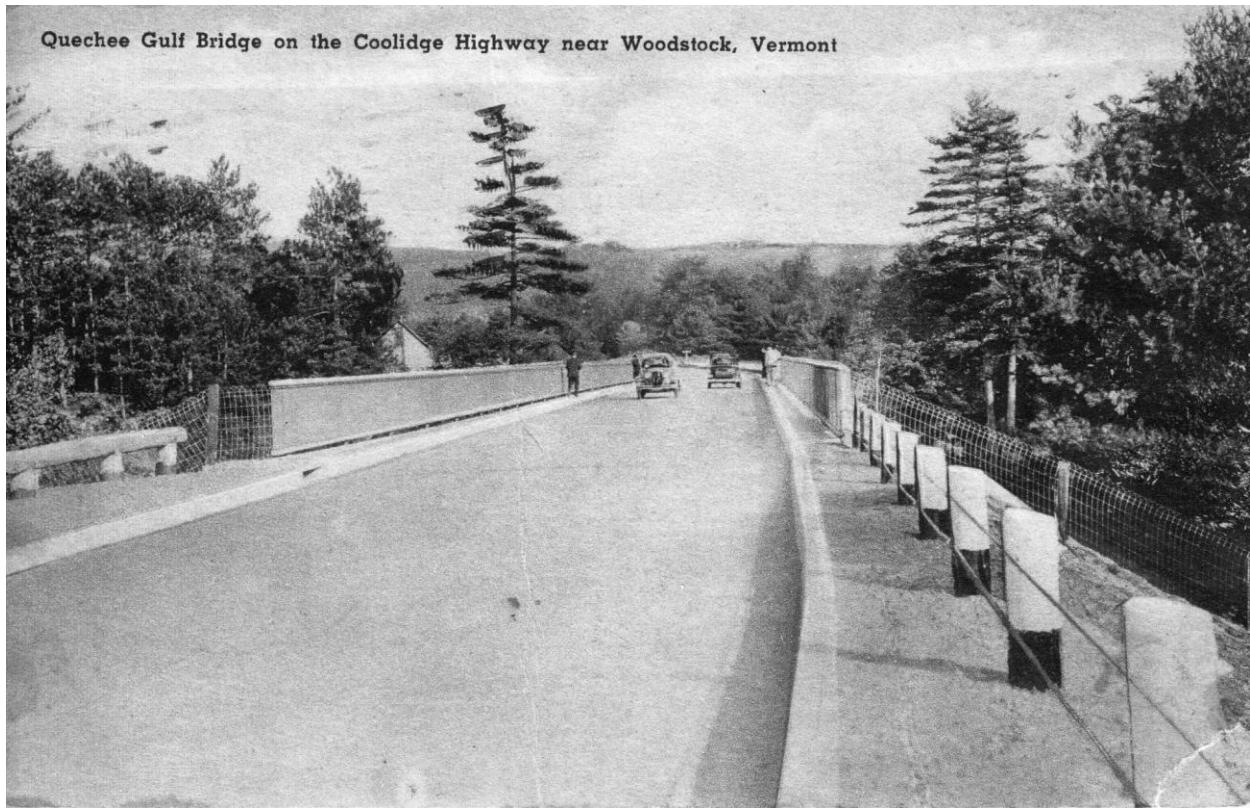
Figure 4. Alterations and new functions on deck of Quechee Gorge Bridge in 1933, looking east on US Route 4.

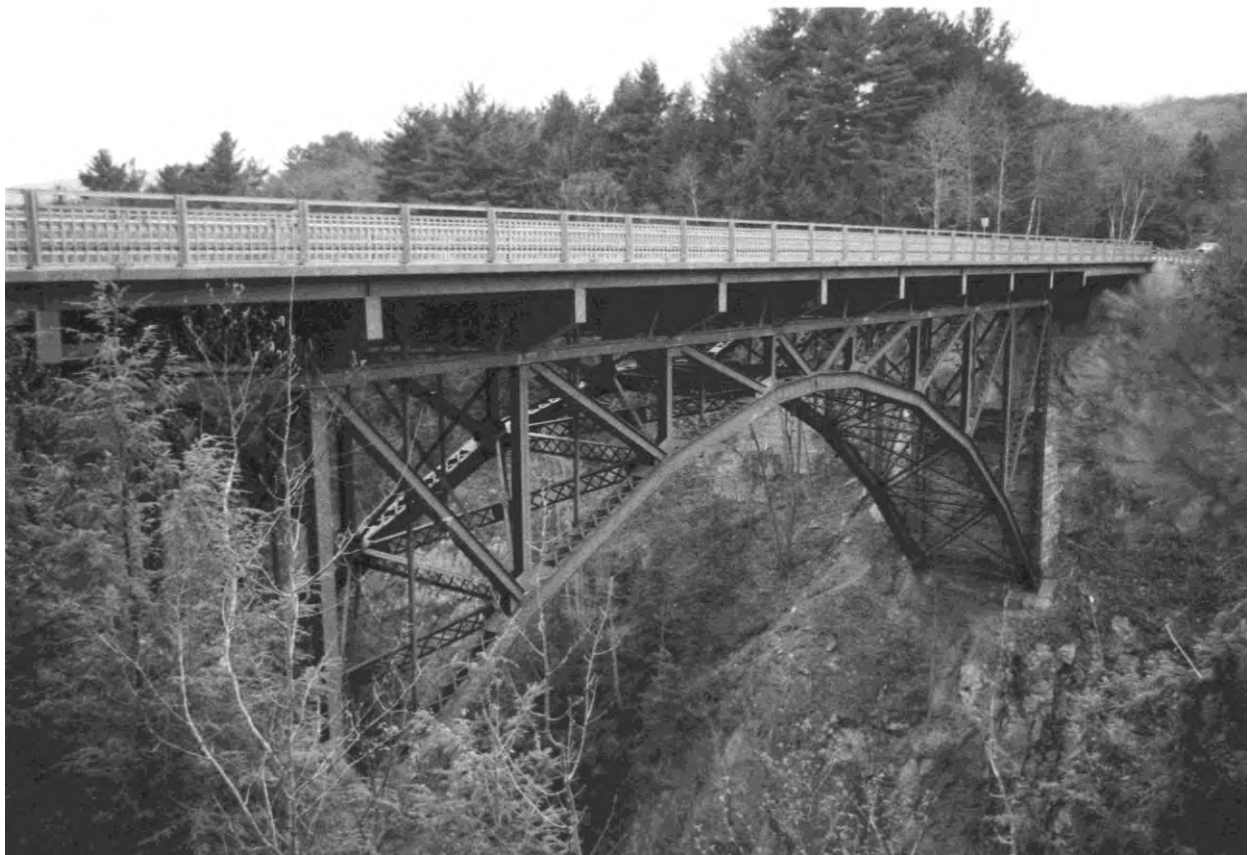
Figure 5. Quechee Gorge Bridge looking northeast. Image from 1990 NRHP nomination. Note contemporary rails.

Today, Bridge No. 61 is the largest steel arch truss bridge in Vermont. When the structure was converted to automobile use during the Great Depression, its deck was substantially altered, including the addition of a paved roadway and railings (Figures 2-5). However, these alterations did not substantially diminish the historic integrity of the Quechee Gorge Bridge and today, two contemporary metal rail types line both sidewalks at the inner- and outer edges of this structure. The extant railings and fencing on the Quechee Gorge Bridge are not considered character defining features of this NRHP-listed structure (Figure 6).

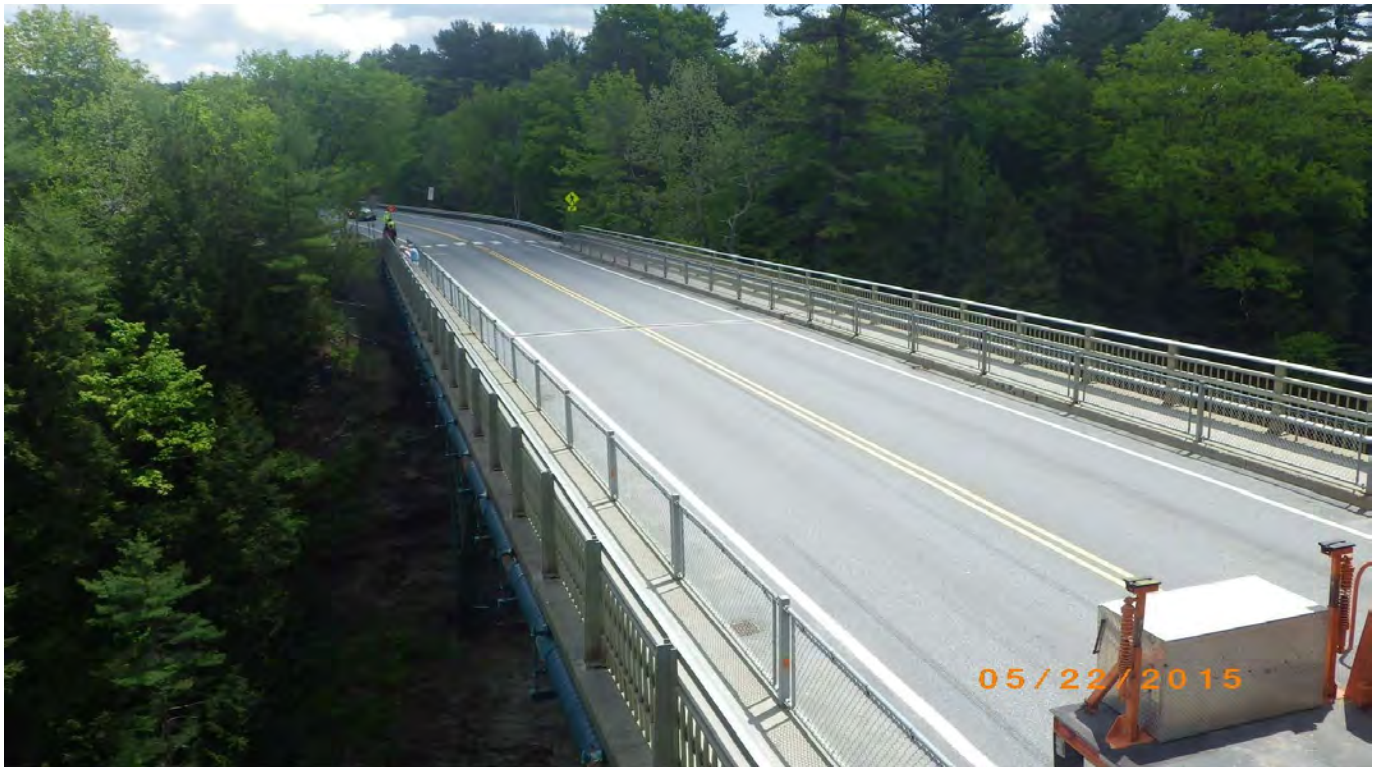
Figure 6. Contemporary rails on the Quechee Gorge Bridge, looking west.

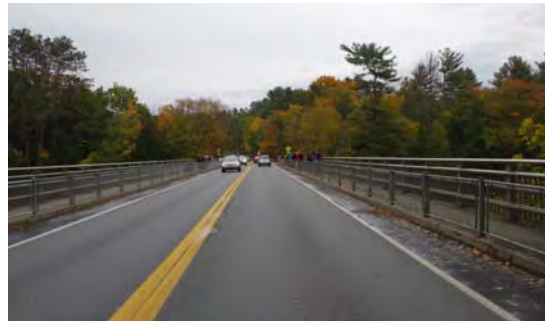
Quechee Gorge Bridge: Sidewalk

- Added in 1972, with bridge rail and removable barrier at curb
- 3.5 ft wide; does not meet ADA guidelines

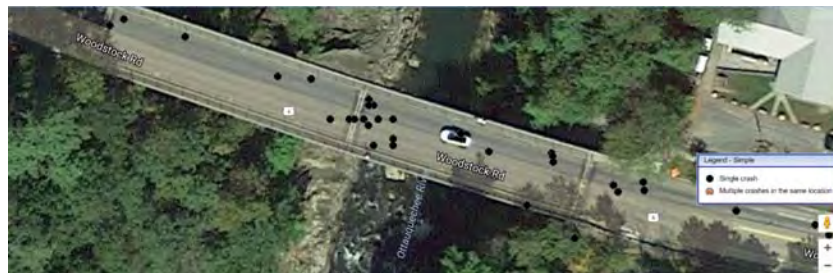
Crashes

- 33 crashes on bridge 2010 to 2016
- Many rear enders, few injuries

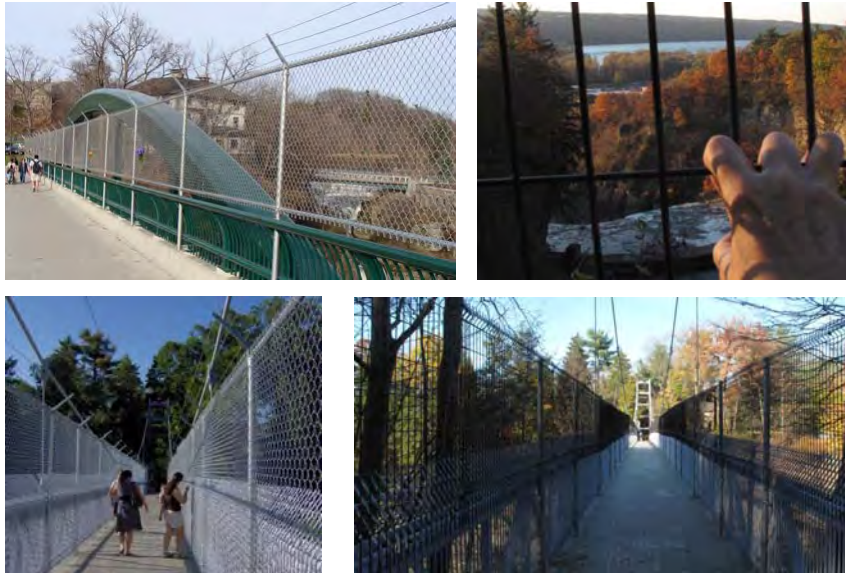
Chain Link barriers - 2010

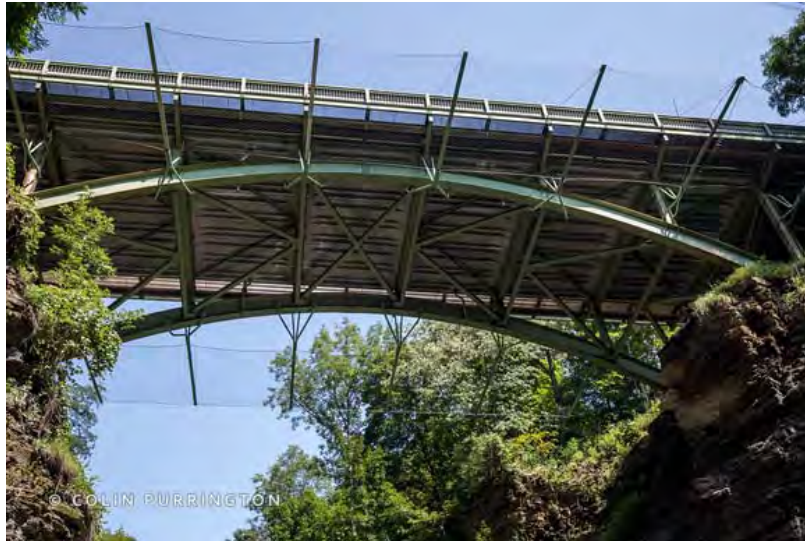
Nets replaced barriers 2012

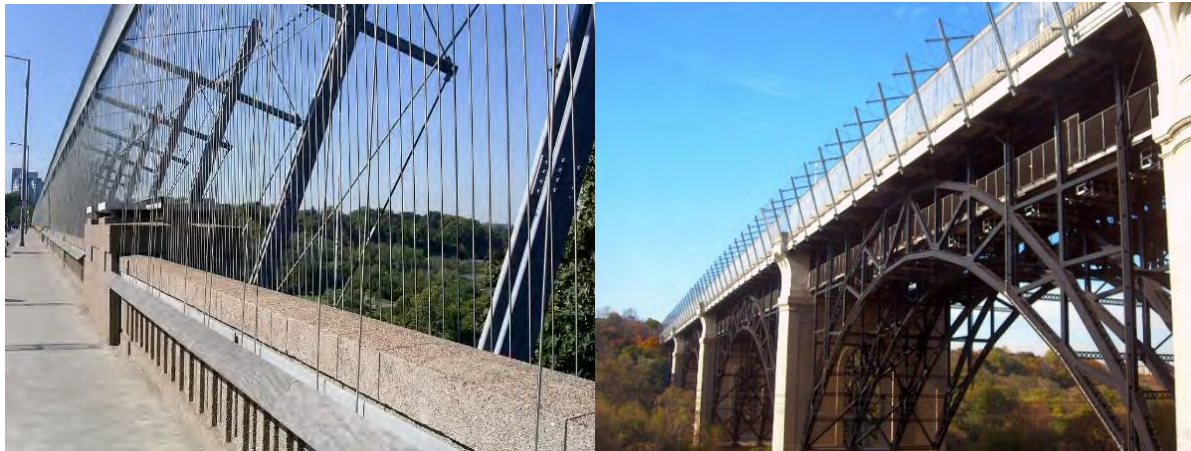
- Bloor Viaduct, Toronto. From 1918-2003- more than 400 people lost their lives by jumping from the bridge. In 2003, the City of Toronto added a \$6 million safety barrier.

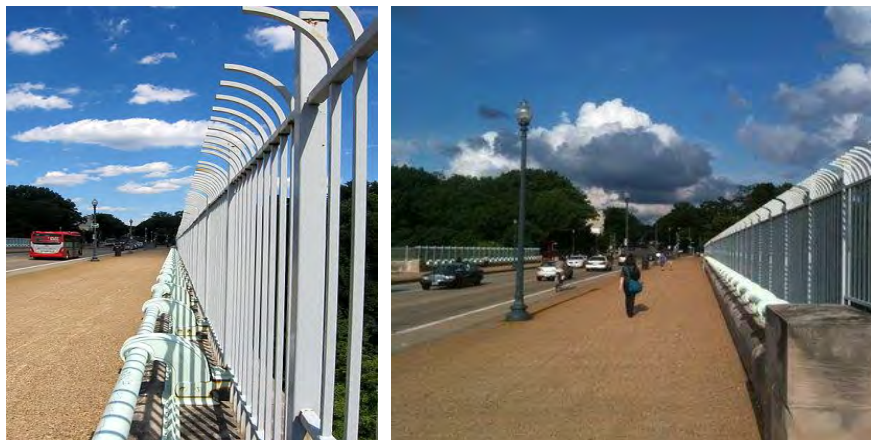
- Duke Ellington Bridge, Washington, DC. 3 arch concrete structure, 825' long and 60' wide roadway framed by 12' sidewalks with pedestrian lookouts. 1974-1985 24 deaths from jumping occurred. 1986- 8' high fence completed costing \$229,000.
