# FACILITY CONDITION ASSESSMENT AND ENERGY AUDIT

#### VERMONT VETERANS' HOME

325 North Street Bennington, Vermont 05201

**EMG Project #:** 106686.13R-001.305 **Date of Report:** November 18, 2013 **On-Site Date:** October 14-16, 2013

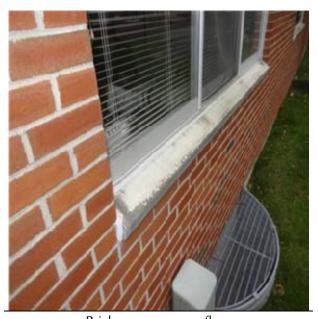
Brick veneer - upper floor

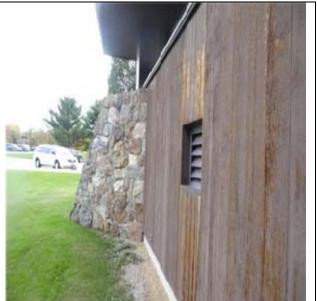
Vertical wood siding

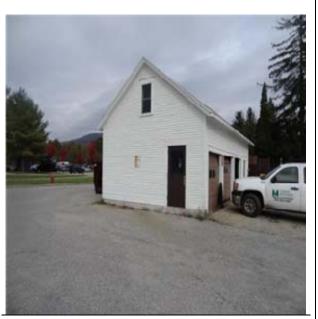
Garage wood siding

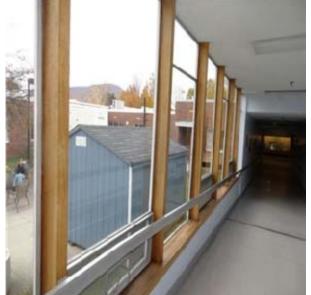
Fixed windows

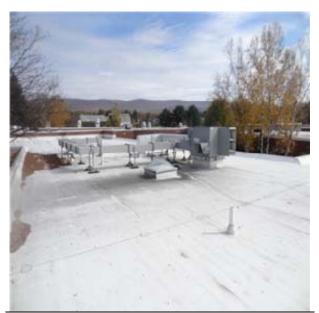
TPO roofing, North Wing

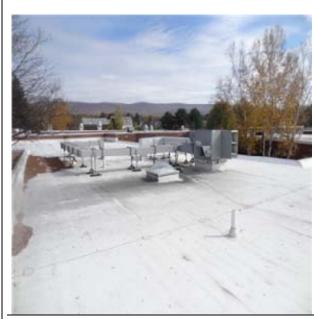
TPO roof membrane

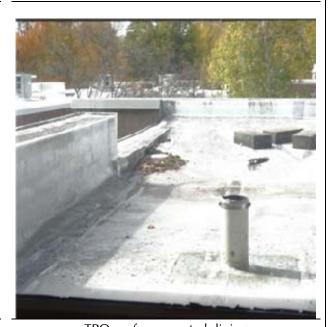
TPO roof over central dining

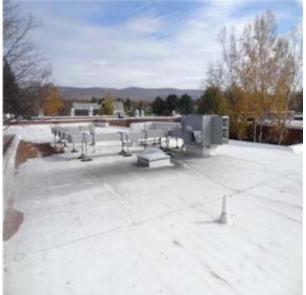
Flat roof over entrance

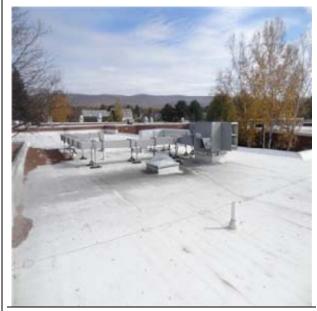
Main roof finishes

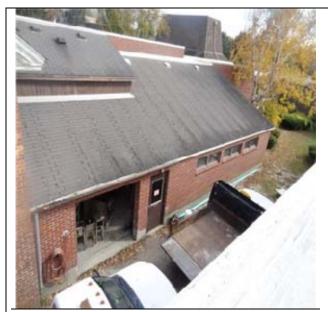
Old boiler and maintenance shingle roofs

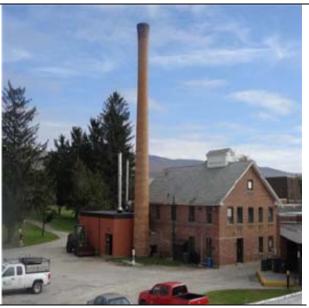
Asphalt shingle roof on old boiler building

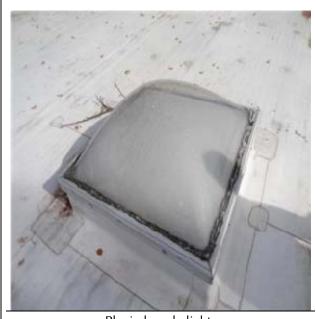
Plexi-glass skylights

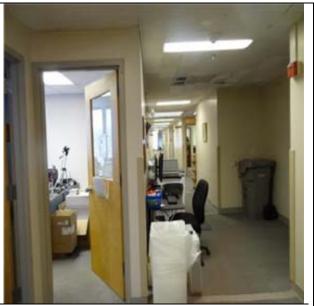
Automatic accessible door

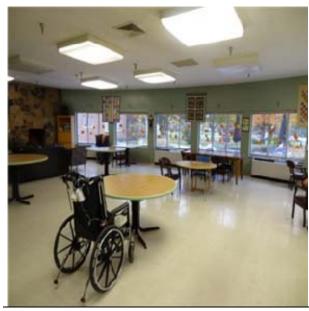
Vinyl floor tile

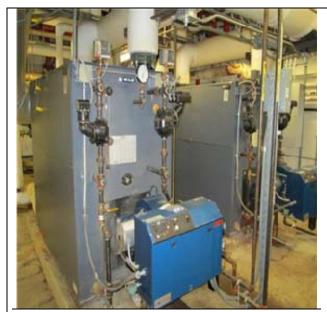
Laundry hot-water steam-fed tank

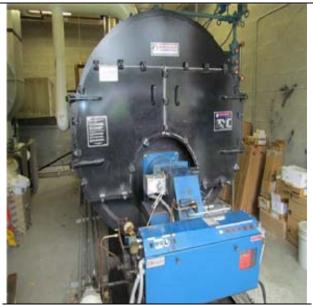
Oi-fired steam boiler, domestic hot water

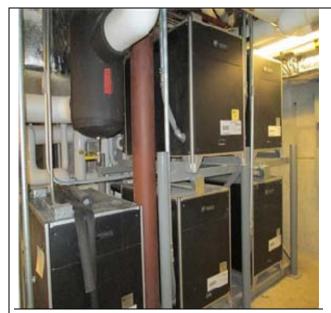
Common area AHU

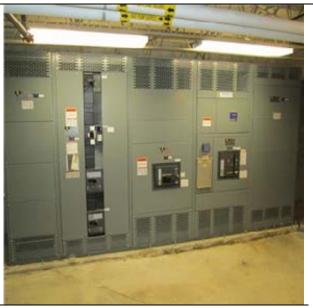
Electrical distribution panels

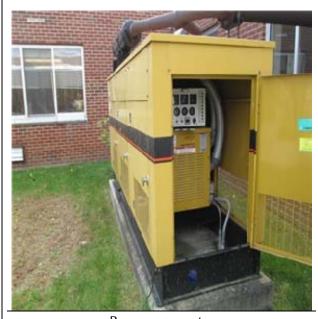
Diesel generator

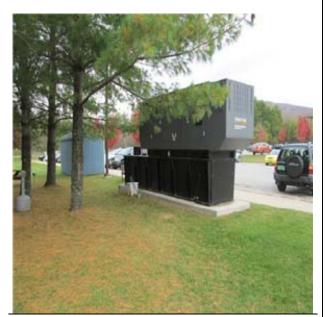
Propane generator

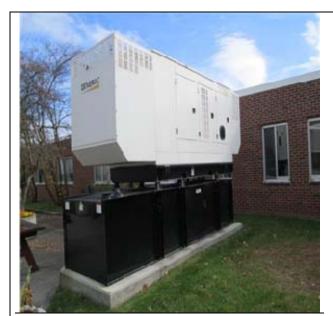
Diesel generator

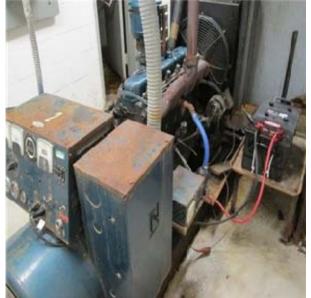
Diesel generator

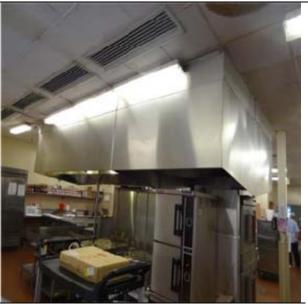
Cook hood with fire suppression

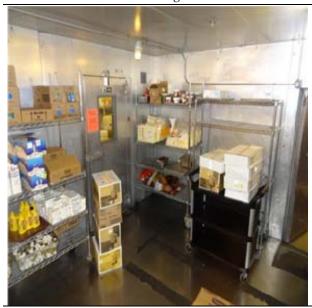
Walk in refrigerator

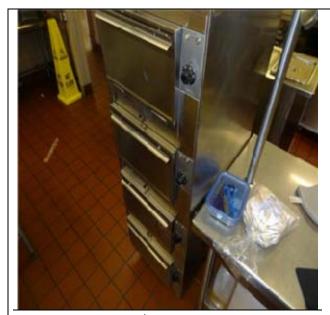
Four drawer warmer

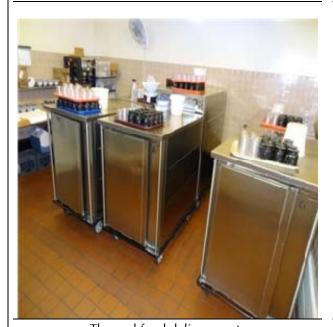
Thermal food delivery carts

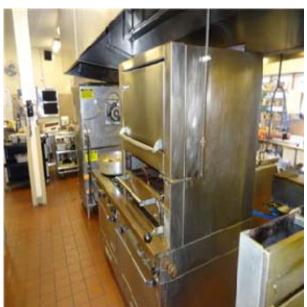
Stove broiler oven combo

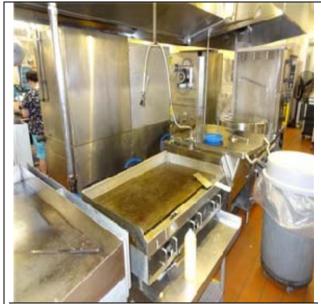
Griddle

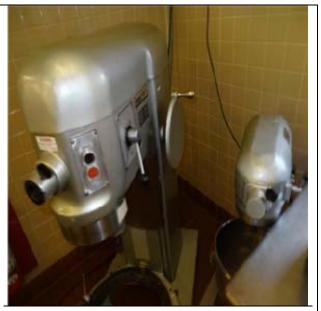
Mixer

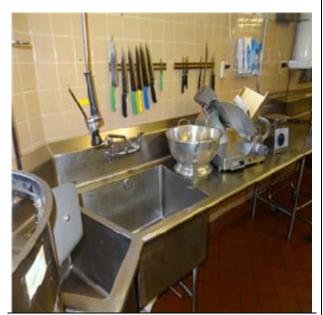
Custom corner sink

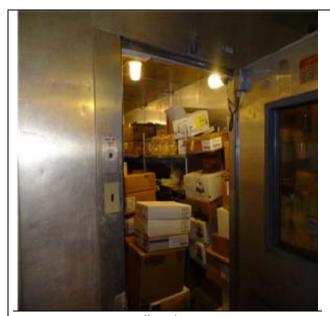
Walk in freezer

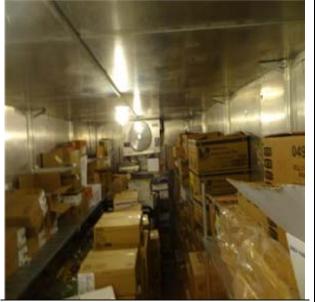
Walk in freezer

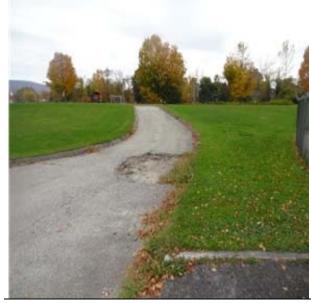
South Crescent Drive

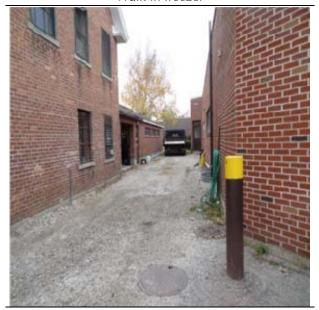
Asphalt pavement at Maintenance Service Drive

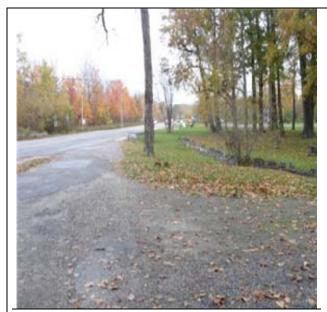
Fence

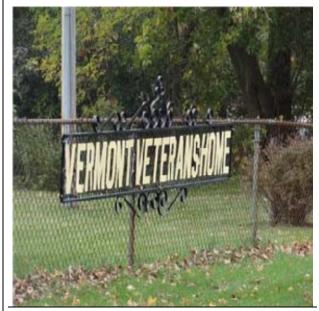
Chain link fence at east boundary

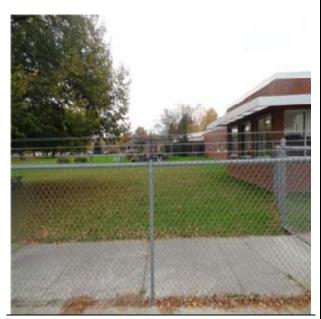
Security fence along Dementia Courtyard

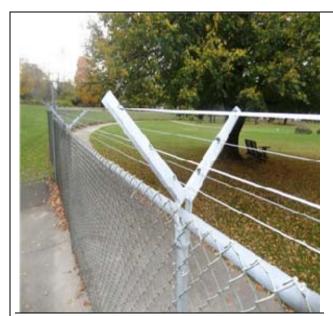
Security fence along Dementia Courtyard

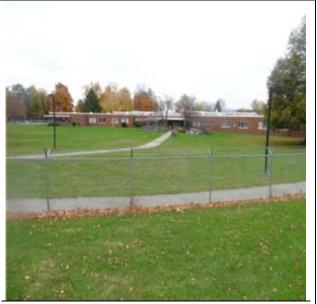
Security fence along Dementia Courtyard

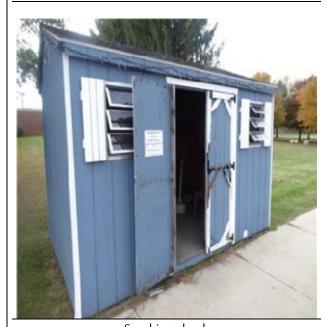
Smoking shack

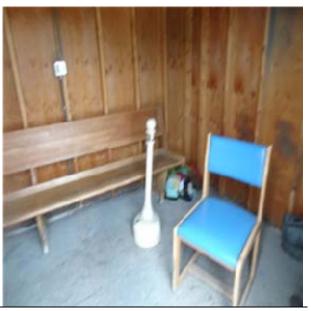
Smoking shack

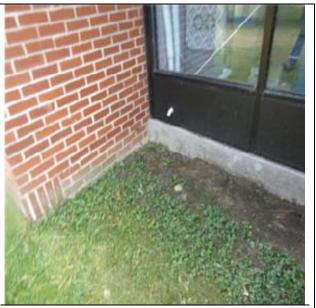
Poor site grading at building perimeter

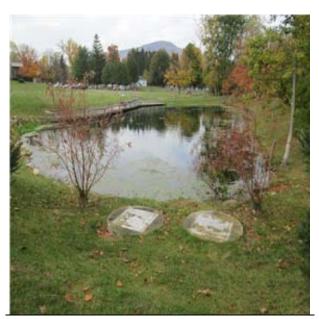
Geothermal well site

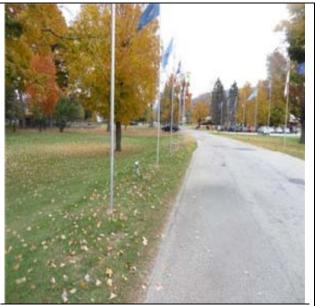
Entry flag poles
